Midland Railway Workshops site, Helena East Precinct: Review of reports relating to hydrogeology of the site and potential impacts of groundwater contaminants on the Helena River.

**Report to ATA Environmental for Midland Redevelopment Authority
by Crisalis International Pty Ltd**

June 2005

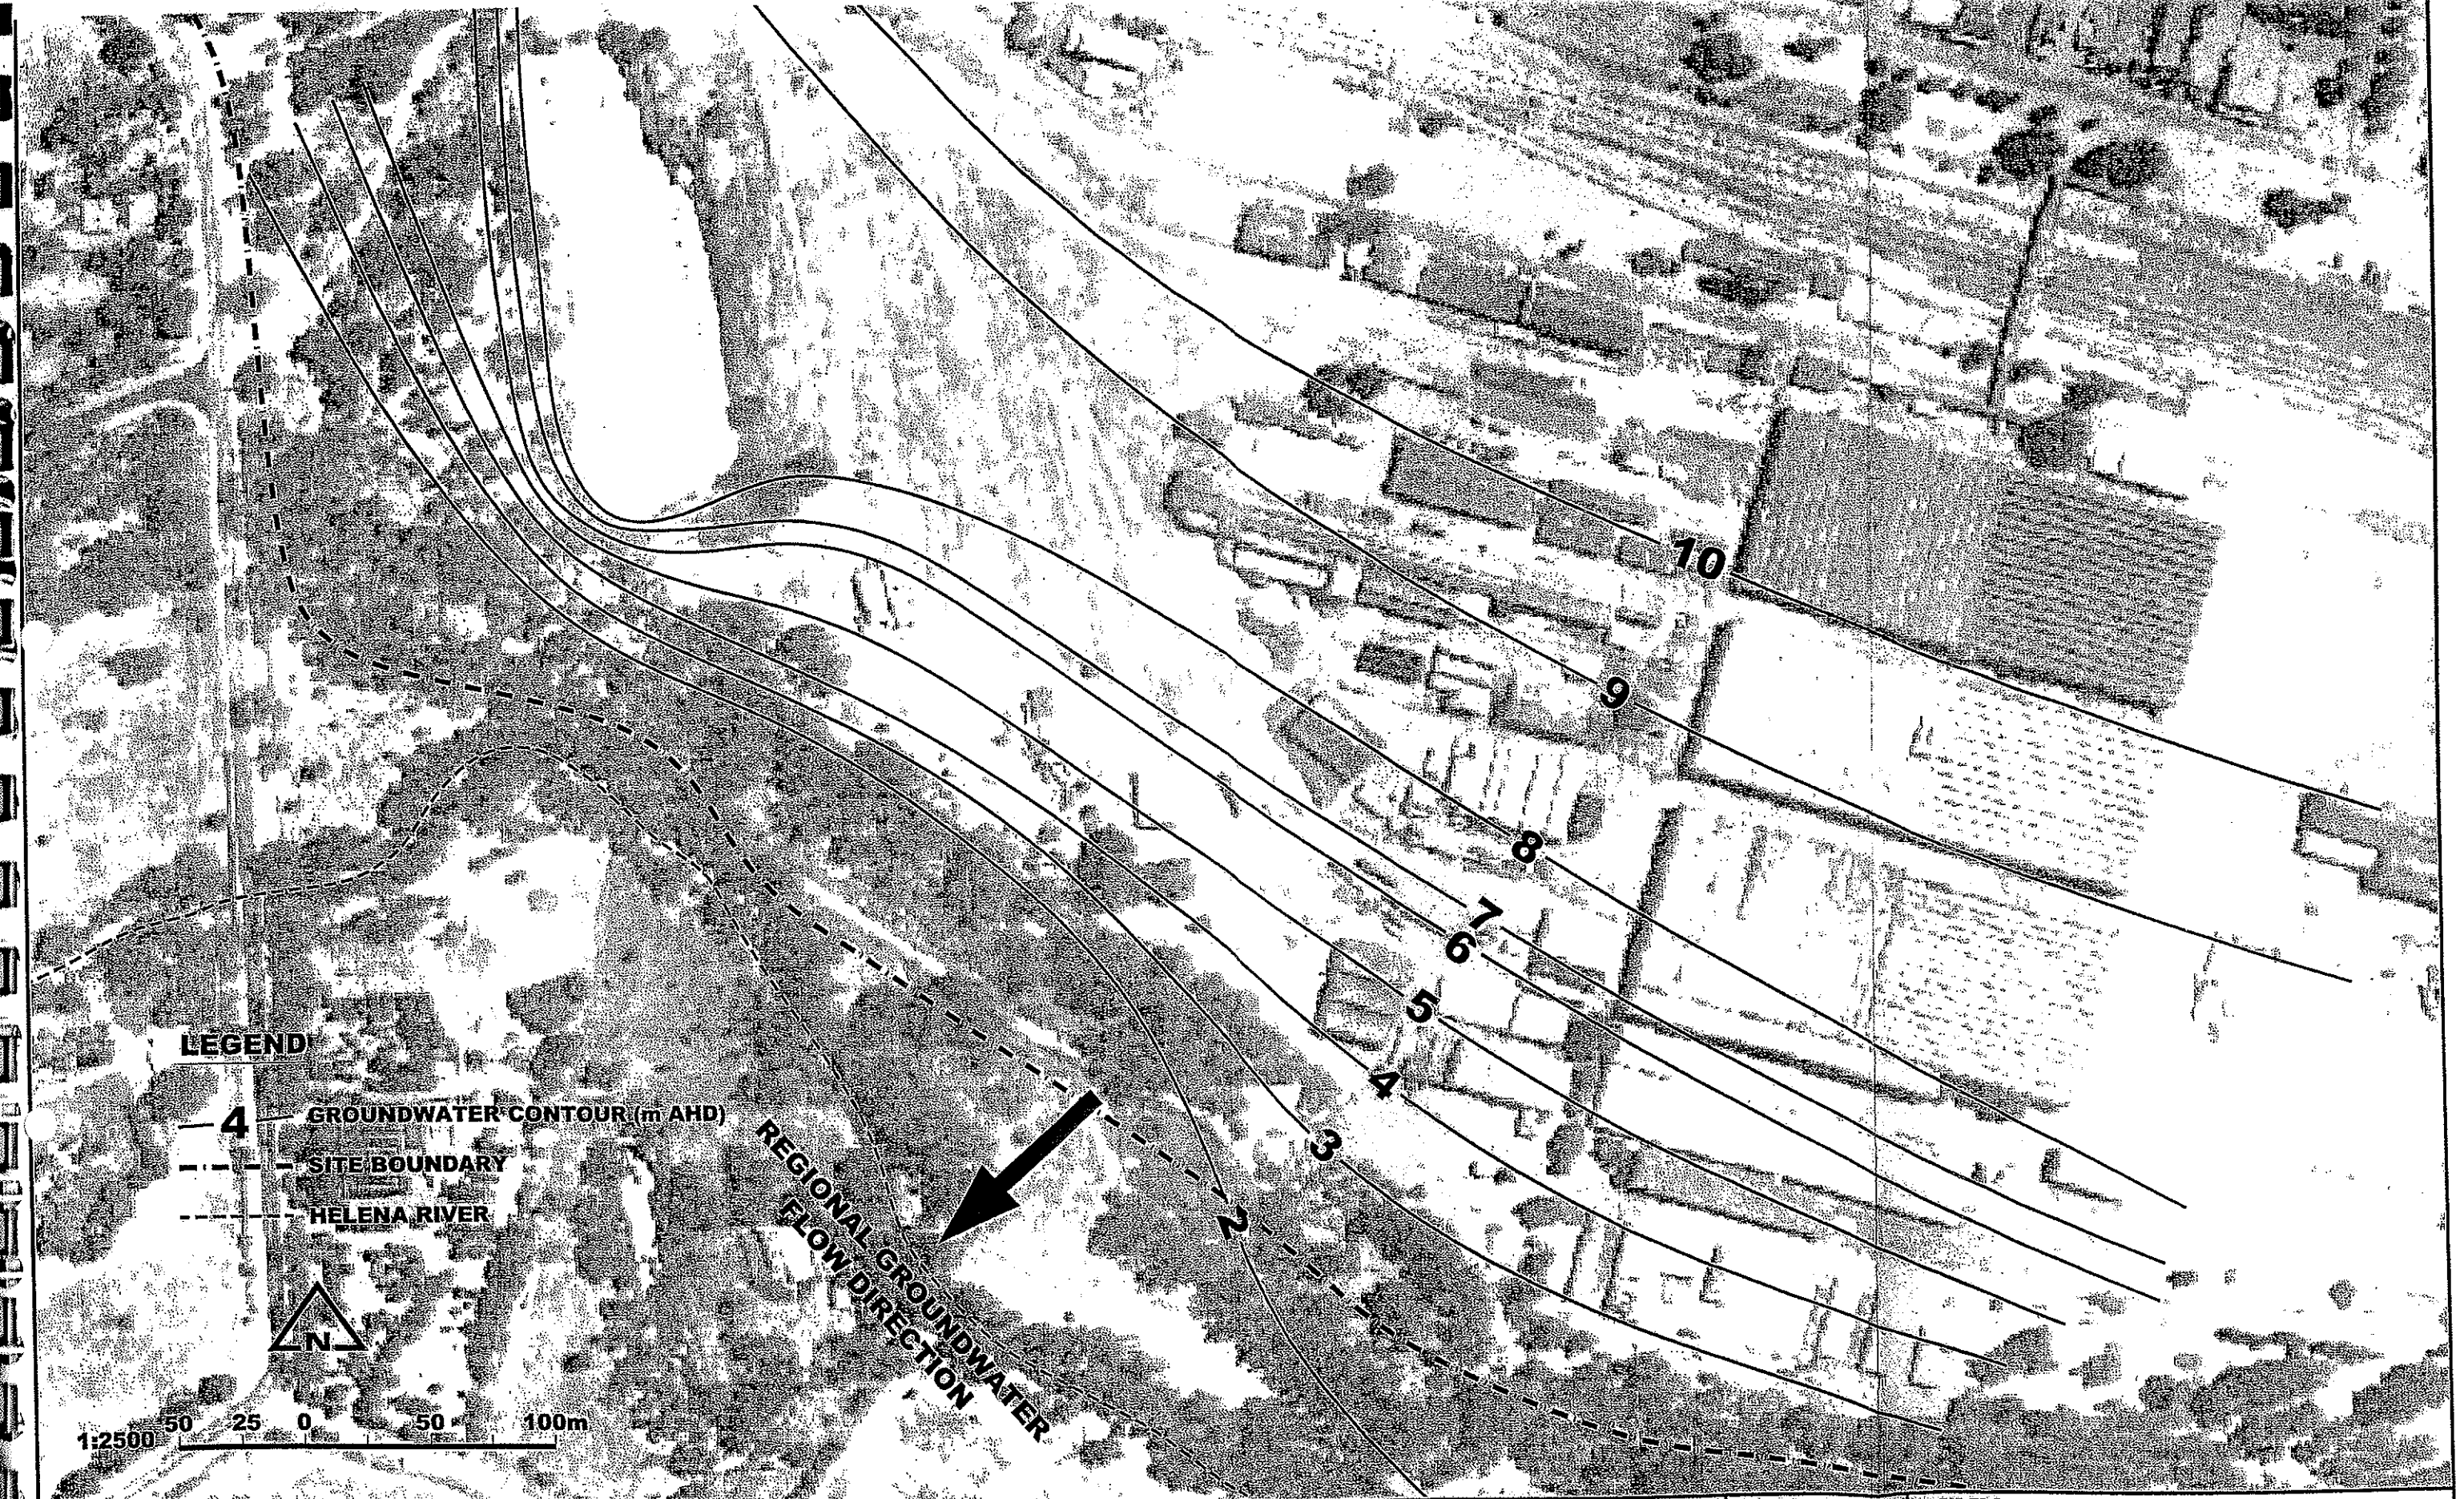
Figure 1. Reported groundwater level contours for the Shallow Superficials^(1,2,6).

Approximate contouring of groundwater levels from data shown in Figure 8 in ENV(2003)⁽³⁾, shown in Figure 2 in this report, suggests there is a reasonably uniform flowfield which is dominated by what seems to be a non-symmetric recharge mound towards the southeast of the Coal dam. There is also a broad groundwater movement to the southwest towards the Helena River from the site. These approximate contours, shown here in Figure 2 in this report, are very similar to the interpreted flowfield shown in earlier ENV reports^(1,2,6) and shown here in Figure 1. In particular, these suggest that the Coal dam and groundwater within the more permeable sand/gravel horizon are in hydraulic continuity, and that the Shallow Superfcials act as a single (but complex) aquifer system. These would indicate some potential for movement of groundwater within the Upper Superfcials towards the Helena River.

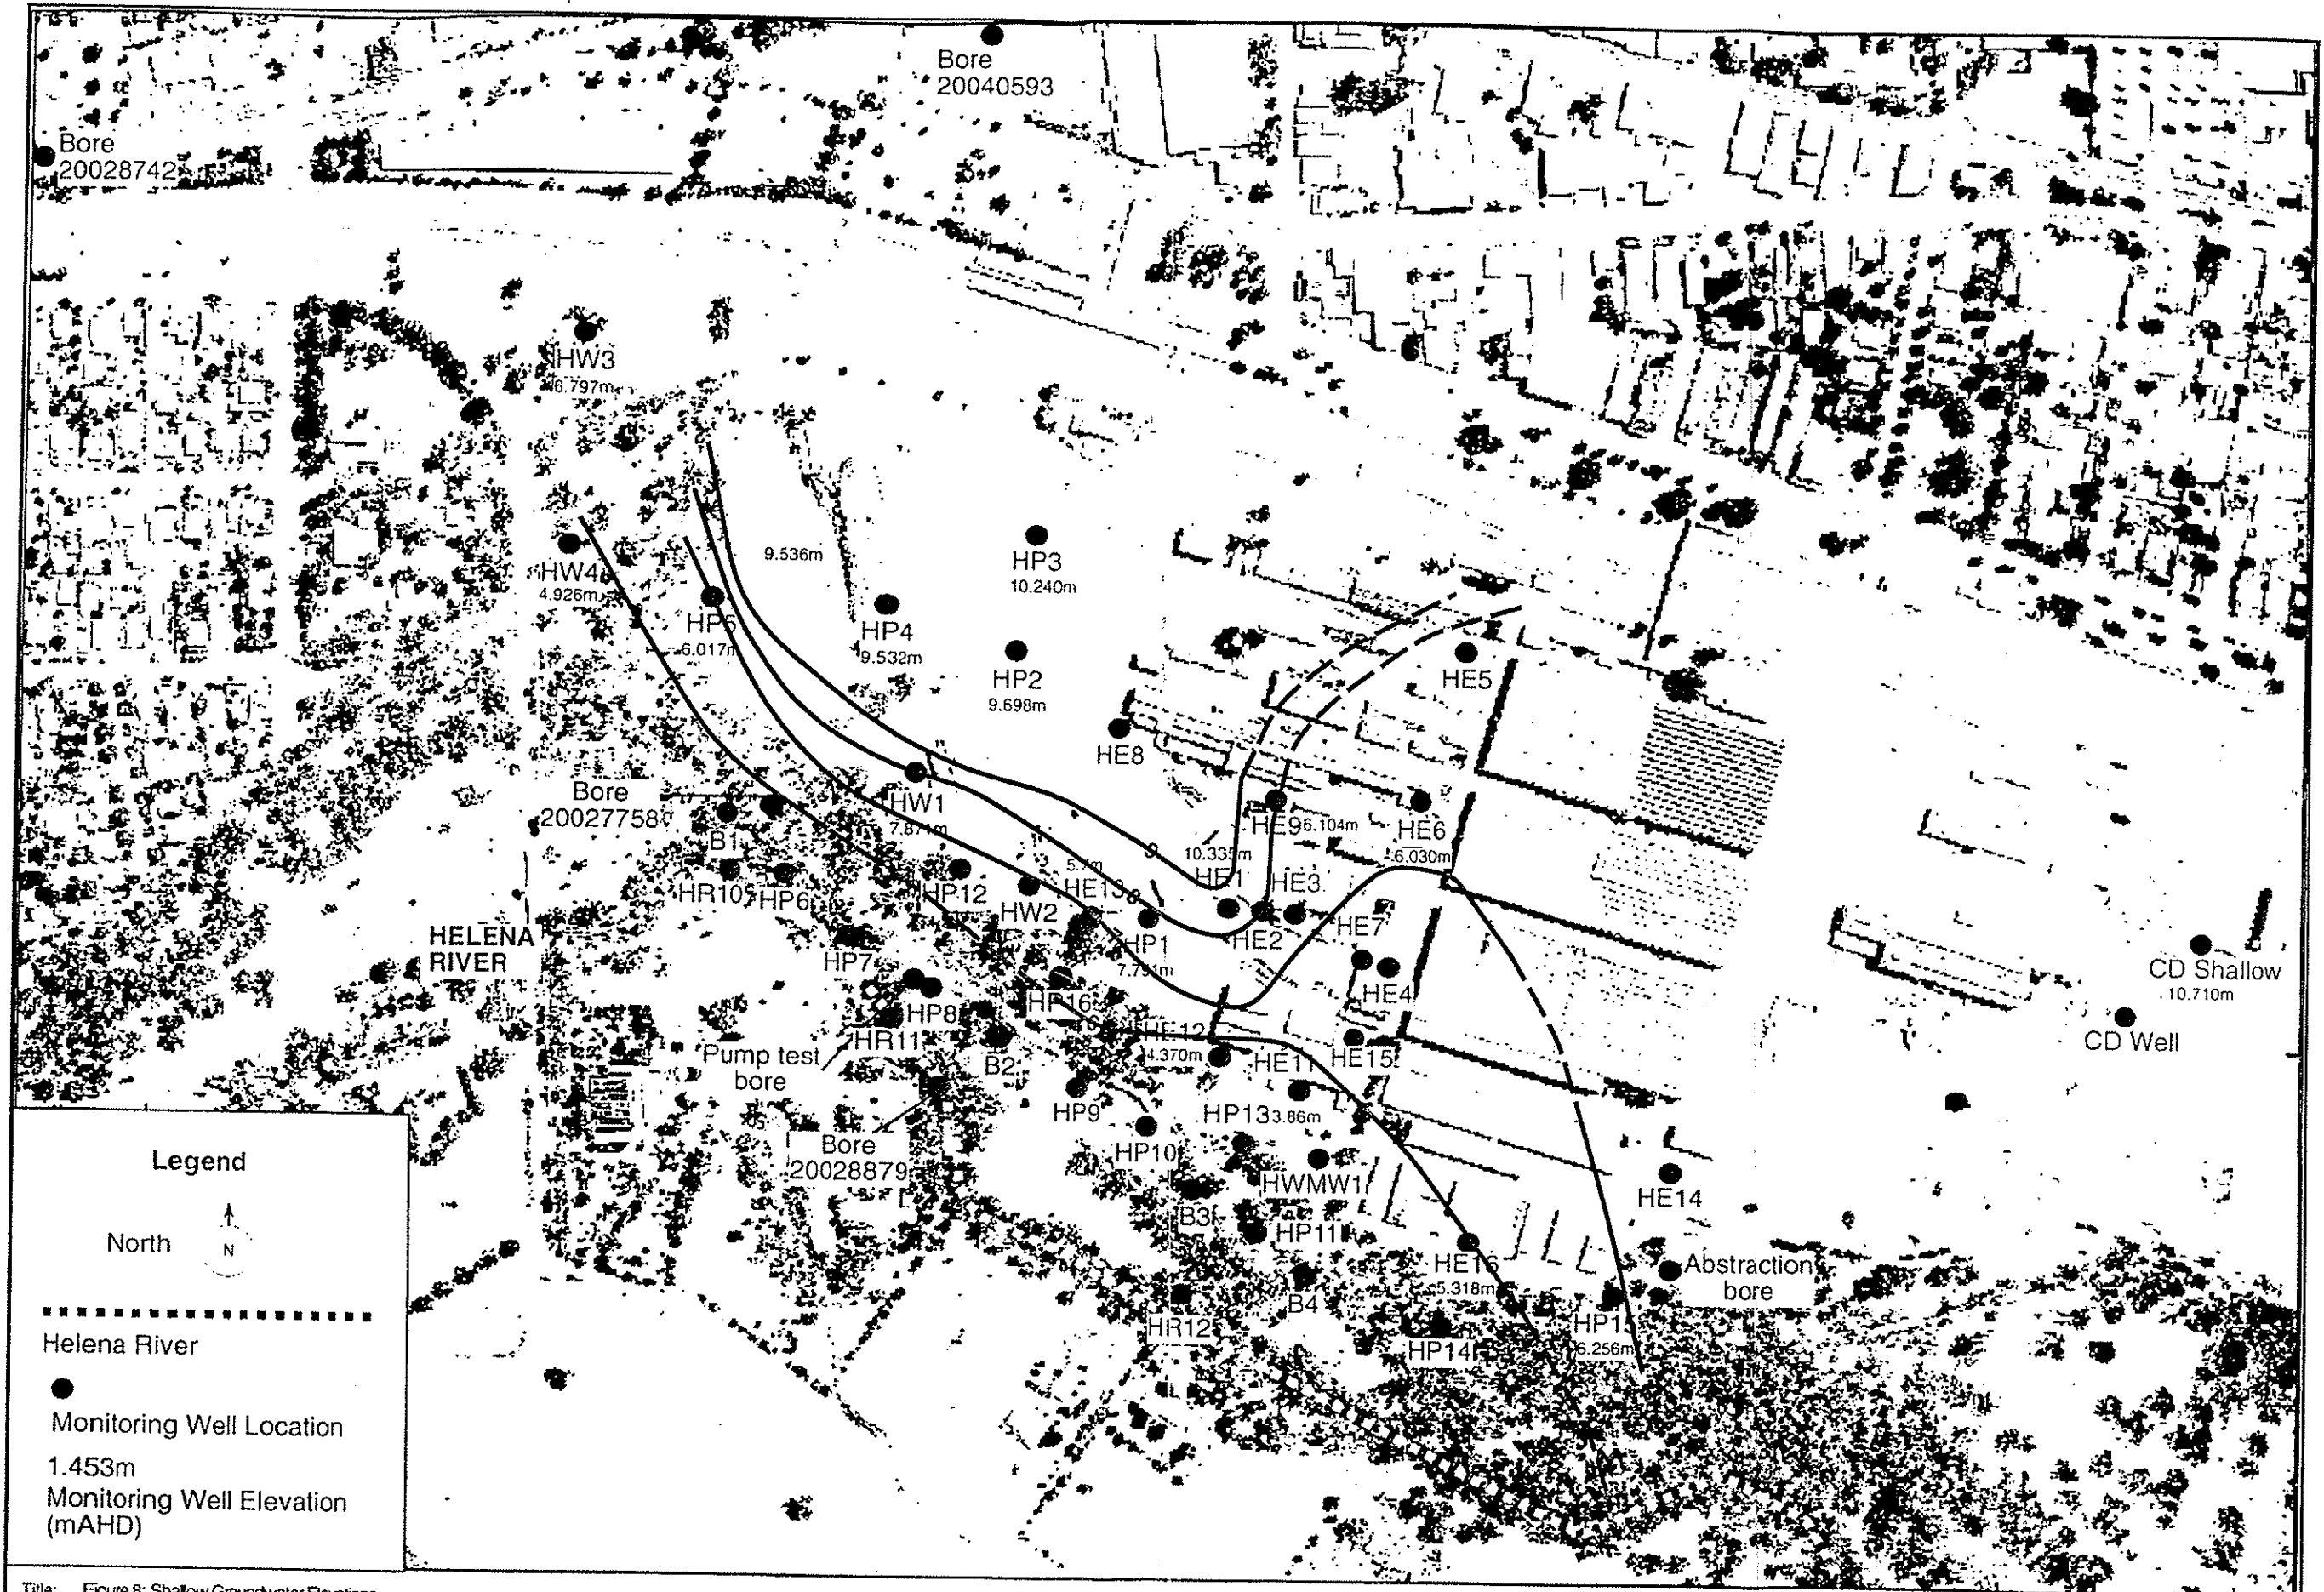
Figure 2. Approximate groundwater level contours around and to the east of the Coal Dam in the Shallow Superficials, based on water levels given in ENV(2003)⁽³⁾ (shown for each bore within this aquifer unit).

Earlier detailed investigation of the hydrogeology of the dam by Dames and Moore (1997)⁽⁷⁾, suggested groundwater mounding around the dam which indicates that the dam was recharging groundwater. The approximate contours shown in Figure 2 here suggest some mounding to the southeast.

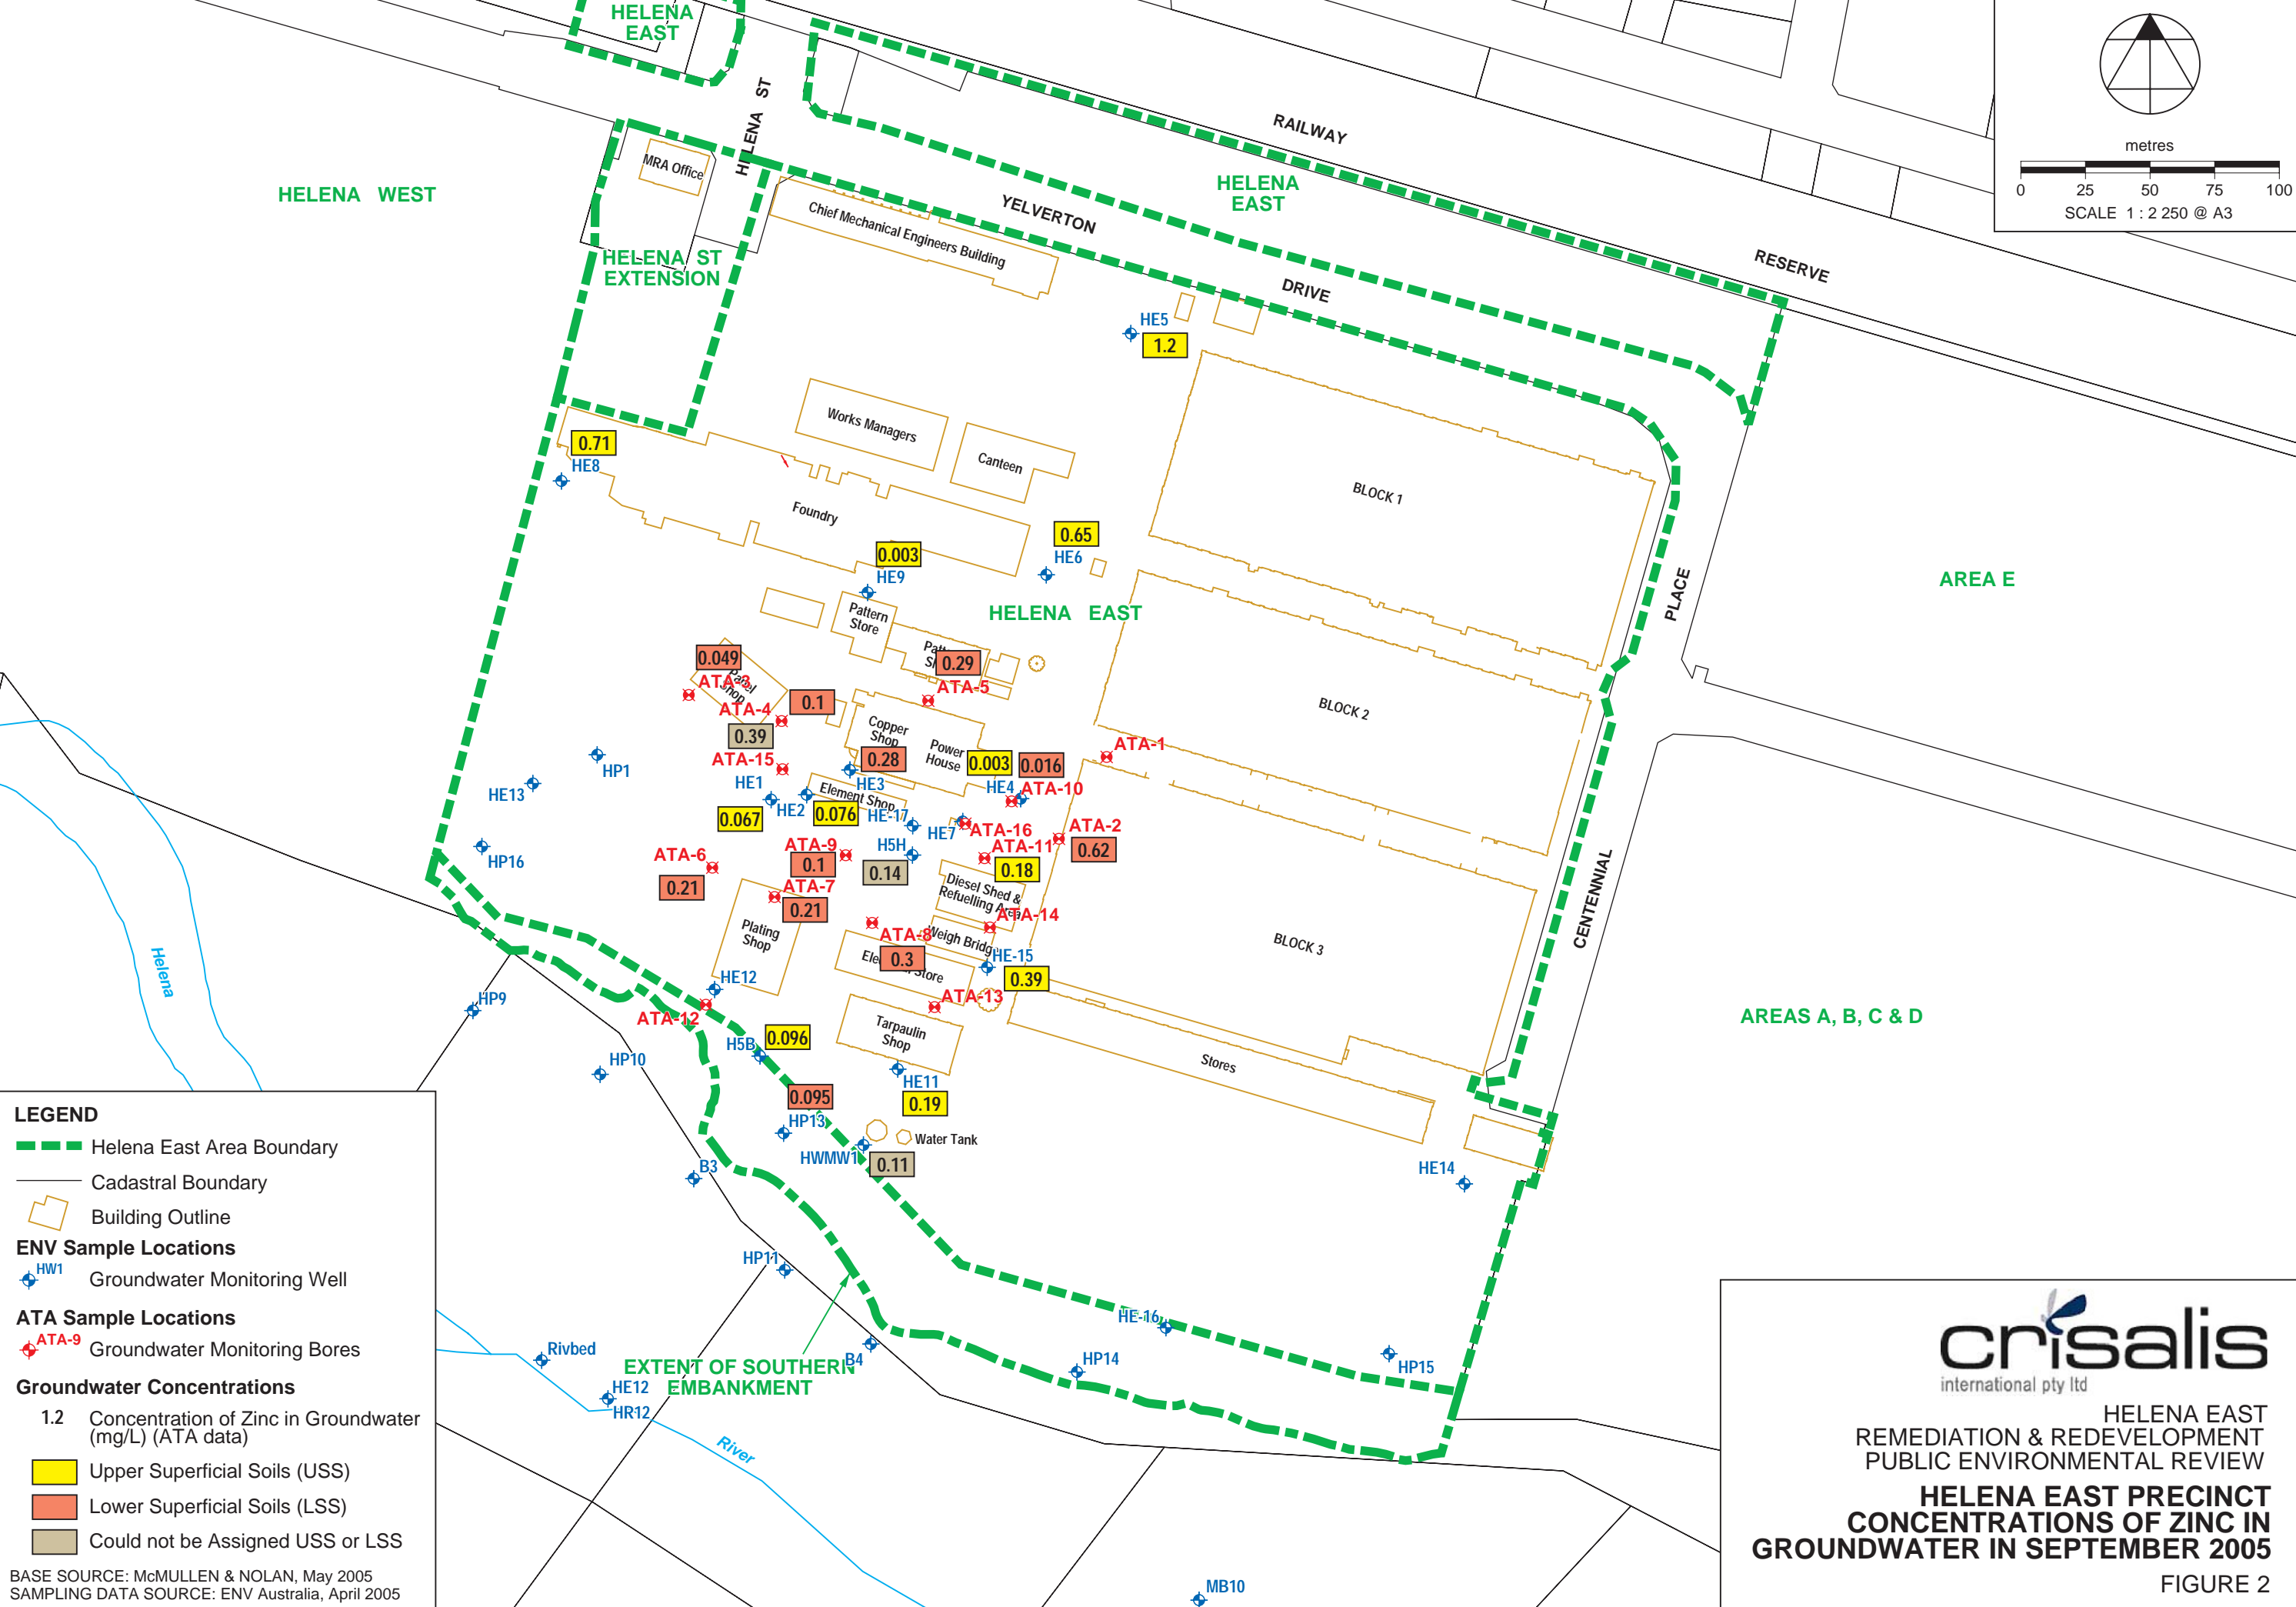
Groundwater concentrations exceeding freshwater criteria for zinc particularly, and a much lesser extent for nickel, are apparent in Figure 10a in the PER (ATA, 2006) and summarized here in Figure 2. These are mostly associated with the main area of contaminated soil, with multiple sources such as the Copper shop, Plating shop etc within the central southern region of the site. There is some possible contamination associated with the Foundry (bores HE6 and HE8 only) but little apparent contamination with other “source” areas. Bore HE5 in the central northern region of Helena East shows the highest groundwater concentrations of lead and copper.
