Geotechnical Assessment of Bat Caves

Mulga Downs Iron Ore Project

PSM5194-007R REV3 18 December 2024

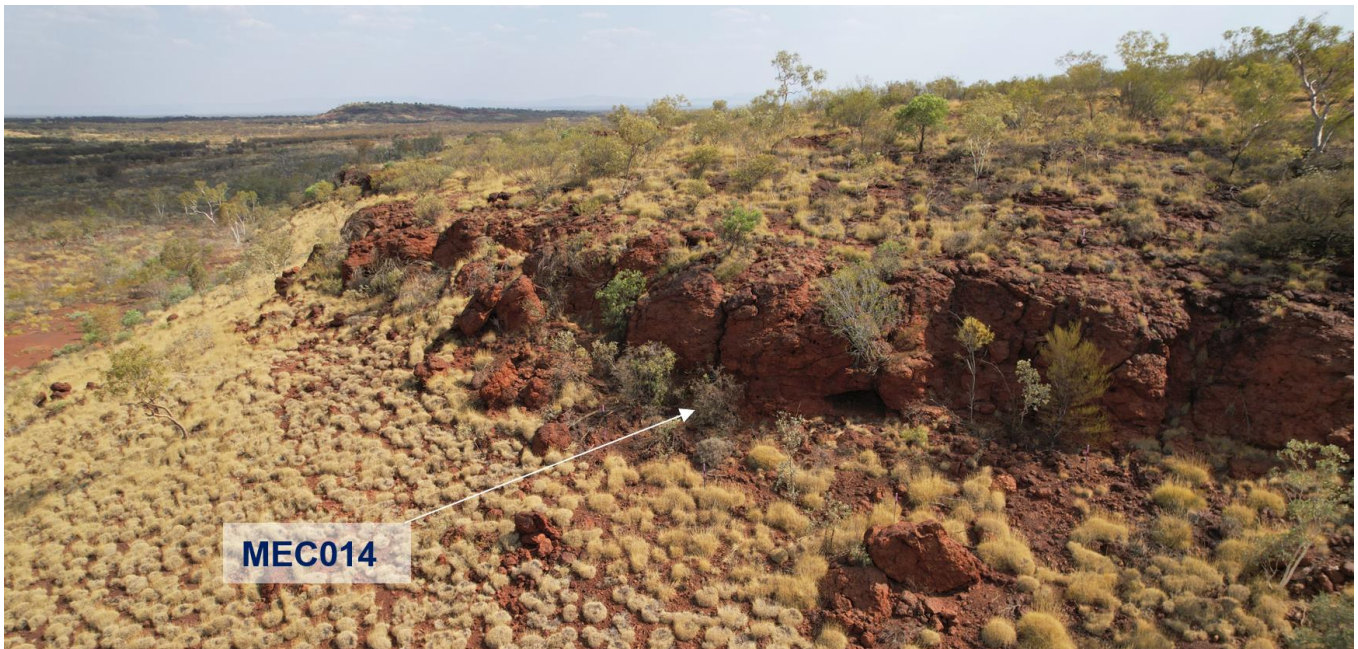
Inset 1: Aerial view showing the location of MEC014 as an example of the escarpment and setting. The escarpment is approximately 6 m high.

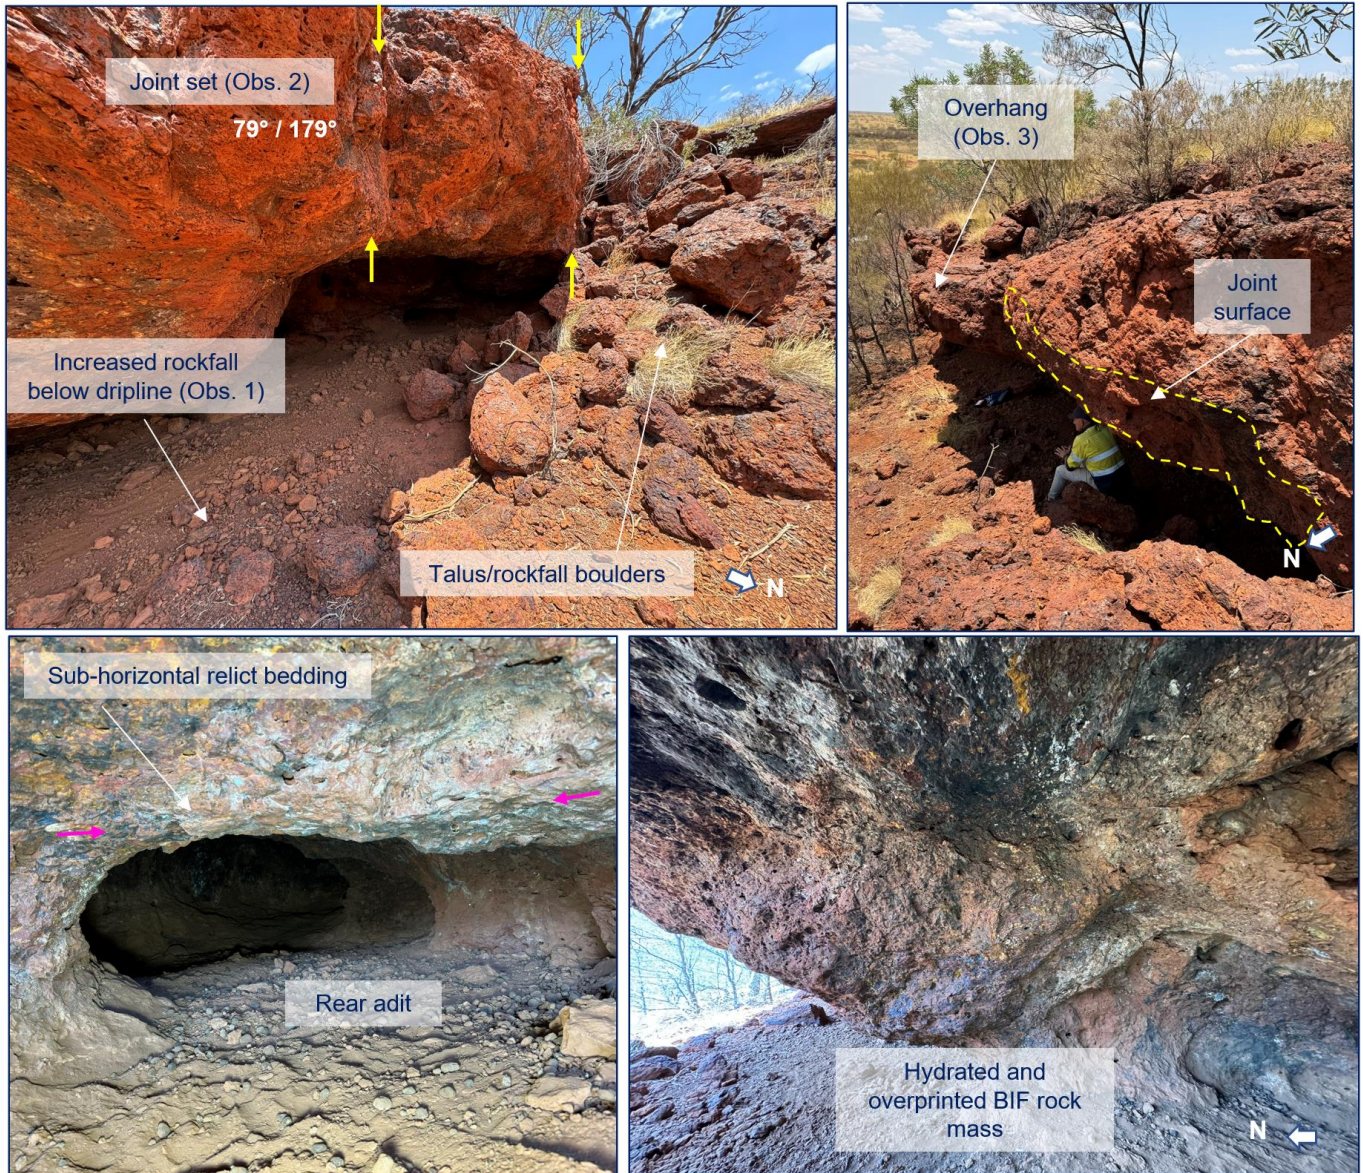
Inset 2: Engineering geological observations of cave MEC042.

- The joint set appears to control the western extent of the cave, evidenced by the planar sub-vertical shape of the dripline shown in Inset 2
- Rockfall debris appears to increase towards the cave entrance (Obs. 1, Inset 2). Most of the rockfall product observed on the ground does not appear to have detached from any specific identified structure
 - BIF blocks in front of the entrance have highly irregular surfaces, reflecting the degree of hydration and fabric overprinting in the rock mass
 - Measured blocks within the cave are 50 to 500 mm in size.
- No loose or hanging blocks were observed in the roof or cave walls.

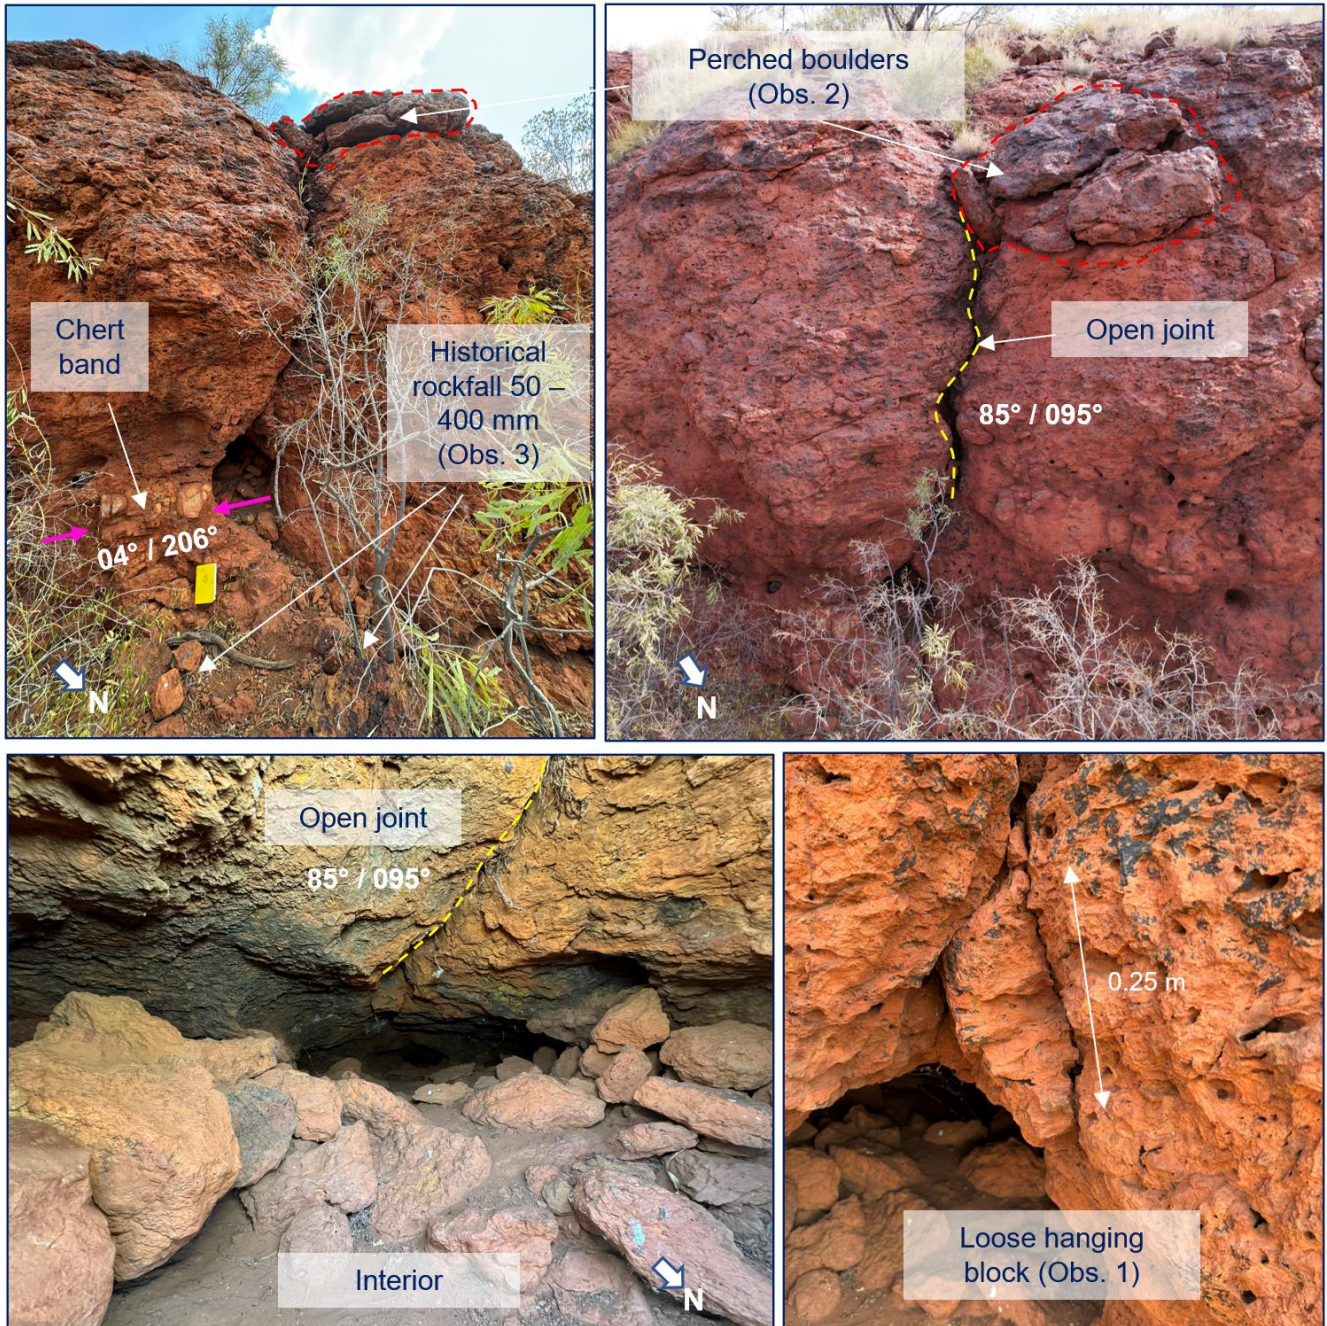
Inset 3: Engineering geological observations of cave MEC014.

- A 250 mm wide hanging BIF block was observed in the dripline of the cave and is bounded by an open fracture and the sub-vertical controlling joint (Obs. 1, Inset 3)

- Multiple perched and wedged boulders were observed at the top of the bedrock escarpment, approximately 4 m above the cave entrance (Obs. 2, Inset 3)
- Rockfall fragments ranging between 50 to 400 mm were observed on the floor immediately outside the cave entrance (Obs. 3, Inset 3)
 - The rockfall debris generally have a blocky shape, and some surfaces show evidence of detachment from bedding partings.
- A fresh BIF cobble was observed to be inserted into a large vugh in the outcrop. The HPPL and Banjima Traditional Owner representatives indicated that this was probably evidence of anthropogenic use of the cave. It is also possible that the unusually high amount of BIF rock debris just inside the cave was part of a walled niche.

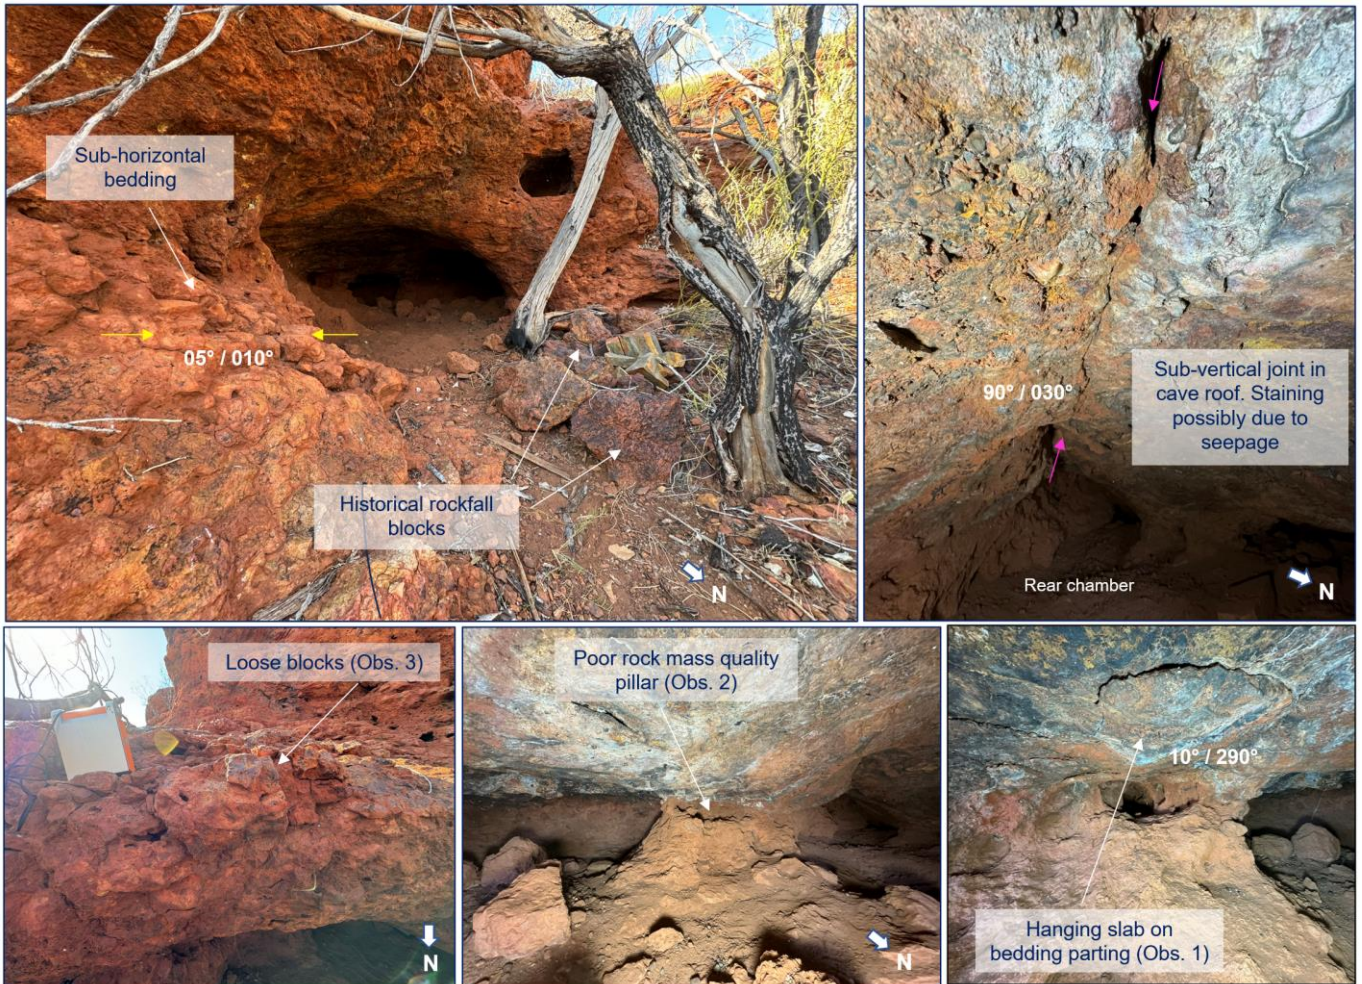
- A loose hanging BIF slab on an open bedding parting was observed on the eastern side of the main chamber roof, (Obs. 1, Inset 4)
- A susceptible rock pillar of poor rock mass quality and inferred low rock strength, was observed on the eastern side of the rear chamber (Obs. 2, Inset 4)

- A cluster of loose 50 to 200 mm BIF fragments was observed in the dripline above the cave entrance (Obs. 3, Inset 4)
 - Given the small size of the blocks in this area (typically < 200 mm), any rockfall would not be expected to restrict access to the cave for either bats or personnel.

Inset 4: Engineering geological observations of cave MEC013.
Top Left: Cave entrance viewed towards the southwest. **Top Right:** Sub-vertical joint intersecting the roof of the rear chamber. Note iron oxide staining on the roof proximal to the joint. **Bottom Left:** Loose blocks observed in the dripline above the cave entrance. **Bottom Middle:** Poor rock mass quality pillar located on the eastern side of the rear chamber. **Bottom Right:** Hanging slab in main chamber roof, on open bedding.

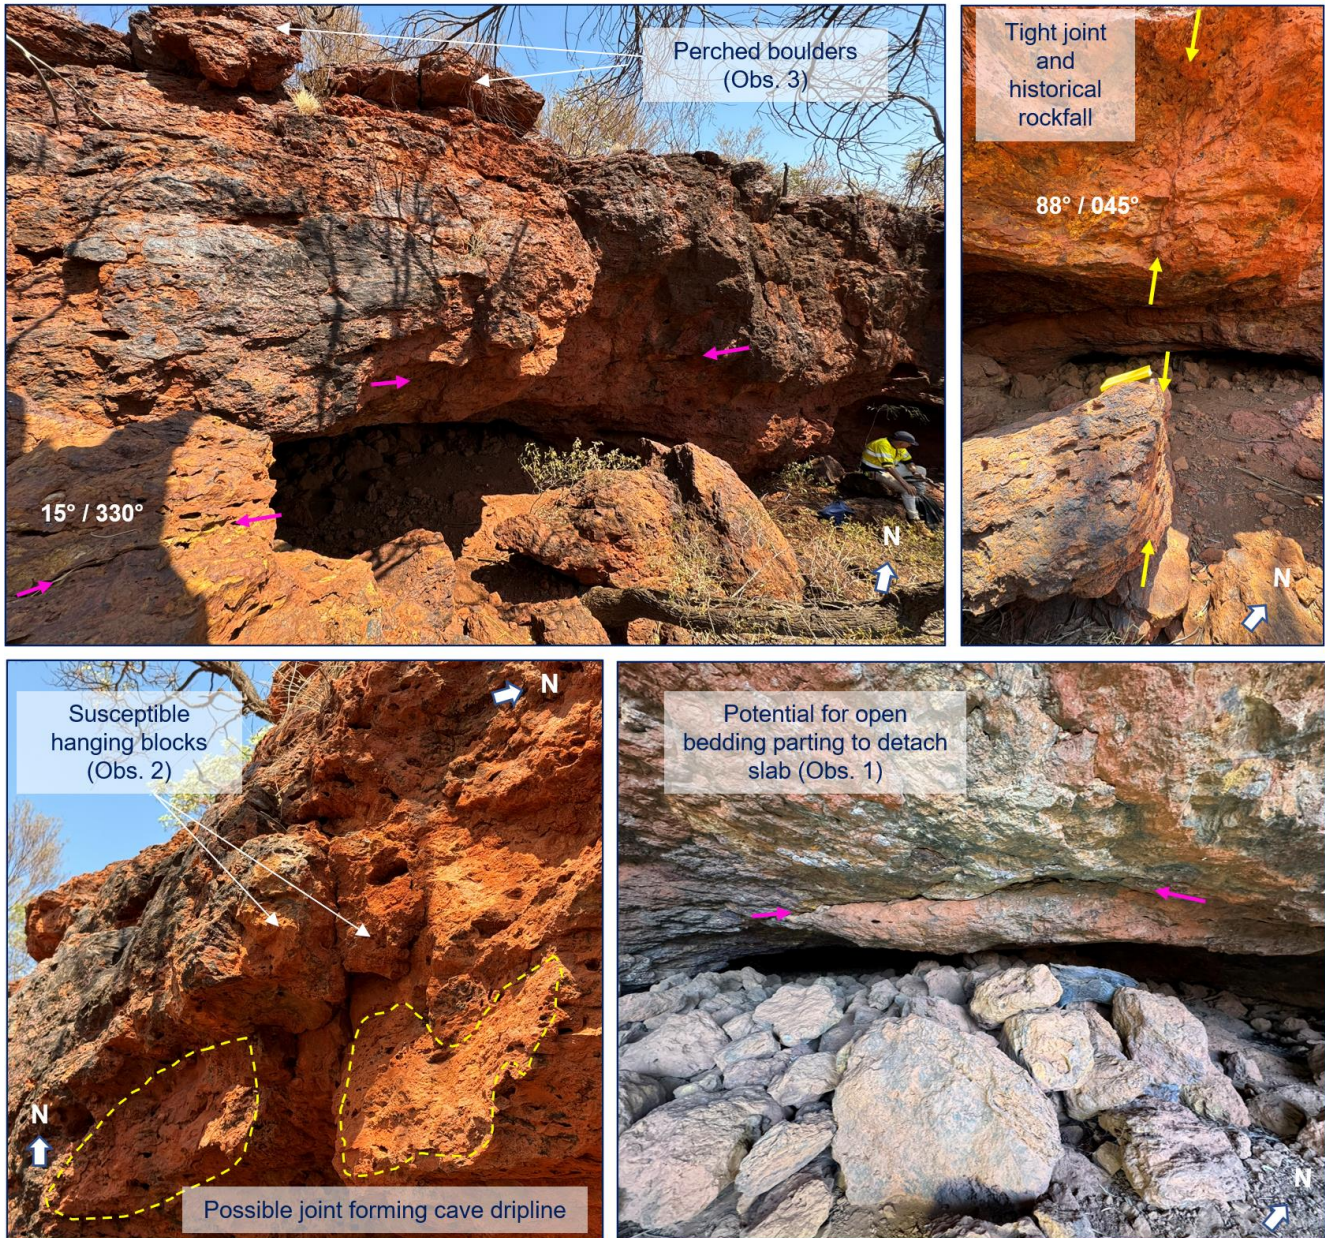
Inset 5: Engineering geological observations of cave MEC012.

- A single bedding parting, open up to 5 mm, occurs in the roof between the main overhang and rear chamber. The parting bounds a large slab of BIF (Obs. 1, Inset 5) which may be susceptible to blasting induced vibrations
- Detachment from bedding appears to be a common rockfall mechanism in MEC012, with large tabular blocks up to 4 m wide observed on the cave floor
 - Some rockfall blocks show evidence of detachment from bedding and the steep northeast dipping joint set, Inset 5, which may act as a side release plane.
- Loose hanging blocks up to 0.35 m wide occur in the dripline immediately above the cave entrance (Obs. 2, Inset 5)
- Two perched boulders were observed at the top of the BIF escarpment and may be susceptible to mining induced vibrations (Obs. 3, Inset 5).

Top Left: The cave entrance viewed to the north showing rock fall debris at entrance, sub-horizontal bedding, and perched boulders atop the escarpment. **Top Right:** Cave entrance showing sub-vertical joint set and release of a historical block from the cross-cutting joint. **Bottom Left:** Loose hanging blocks in cave dripline and inferred joint surfaces oriented sub-parallel to the strike of cave entrance. **Bottom Right:** Cave interior and open bedding parting above BIF slab.

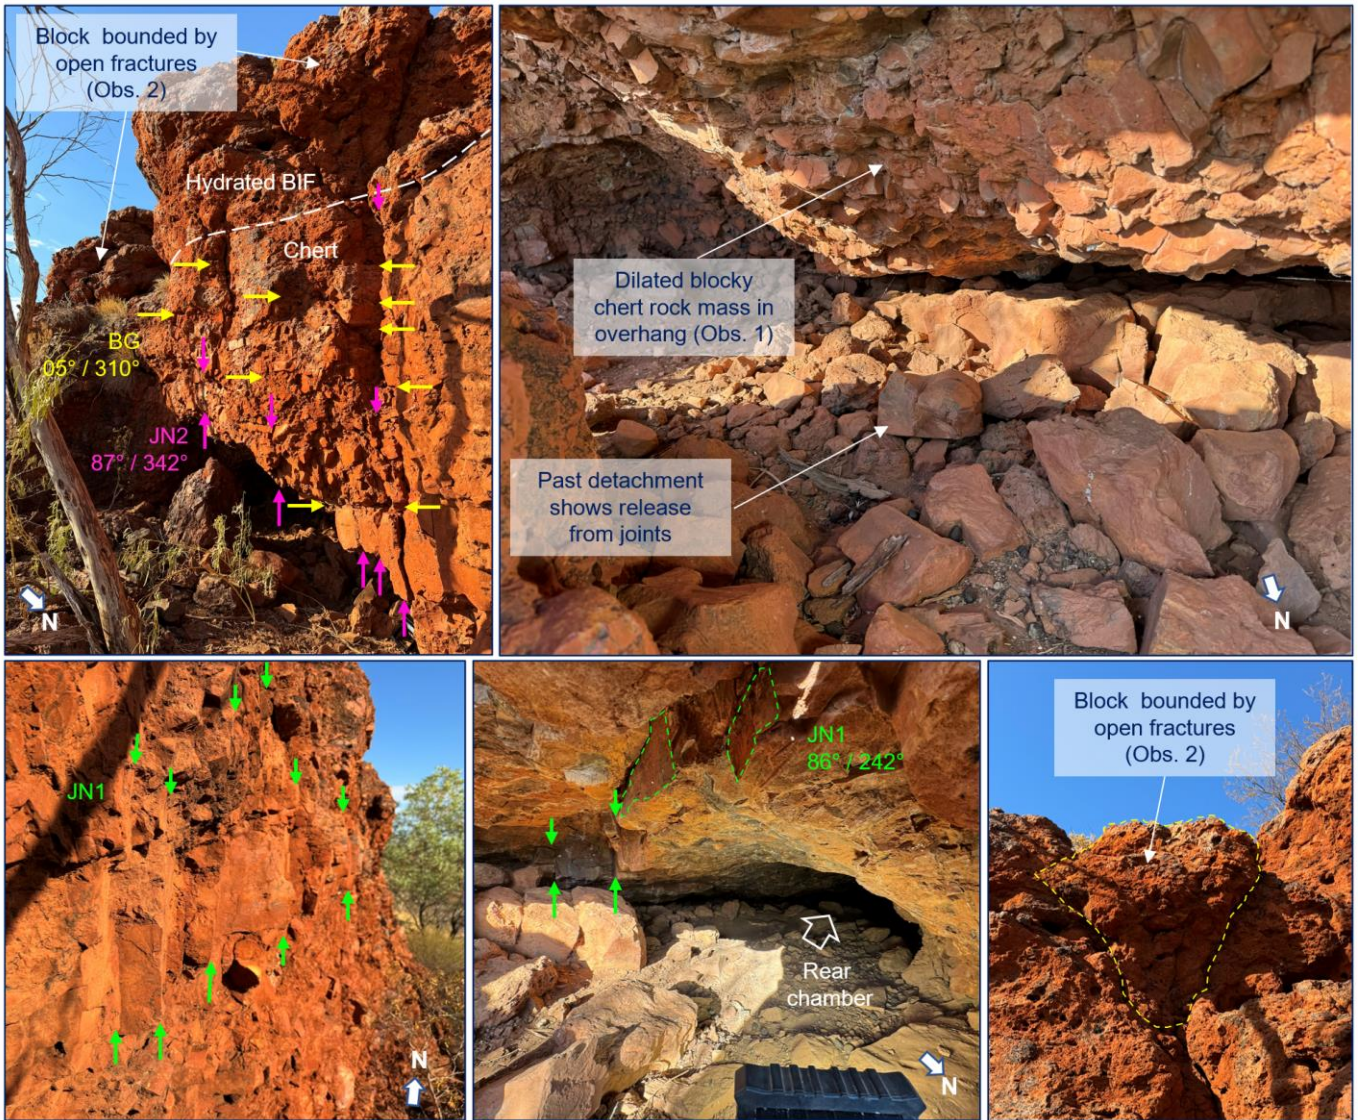
- Dilated, loose blocky chert rock mass was observed in some areas of the dripline and in the roof of the overhang (Obs. 1, Inset 6). There appears to be an increased potential for rockfall in these areas as evidenced by past detached blocks on the ground, Inset 6
- Hanging blocks bounded by non-systematic open fractures were identified in the BIF escarpment above the cave entrance (Obs. 2, Inset 6).

Inset 6: Engineering geological observations of cave MEC074.
Top Left: Cave entrance viewed towards the southwest, showing hanging blocks in dripline. **Top Right:** Interior of overhang showing past rockfall product and dilated chert rock mass in the cave roof. **Bottom Left:** Joint set 1 controlling dripline formation, viewed towards the north. **Bottom Middle:** Access point to rear chamber showing orientation of joint set 1 planes. **Bottom Right:** Susceptible hanging block above cave entrance bounded by open fractures.

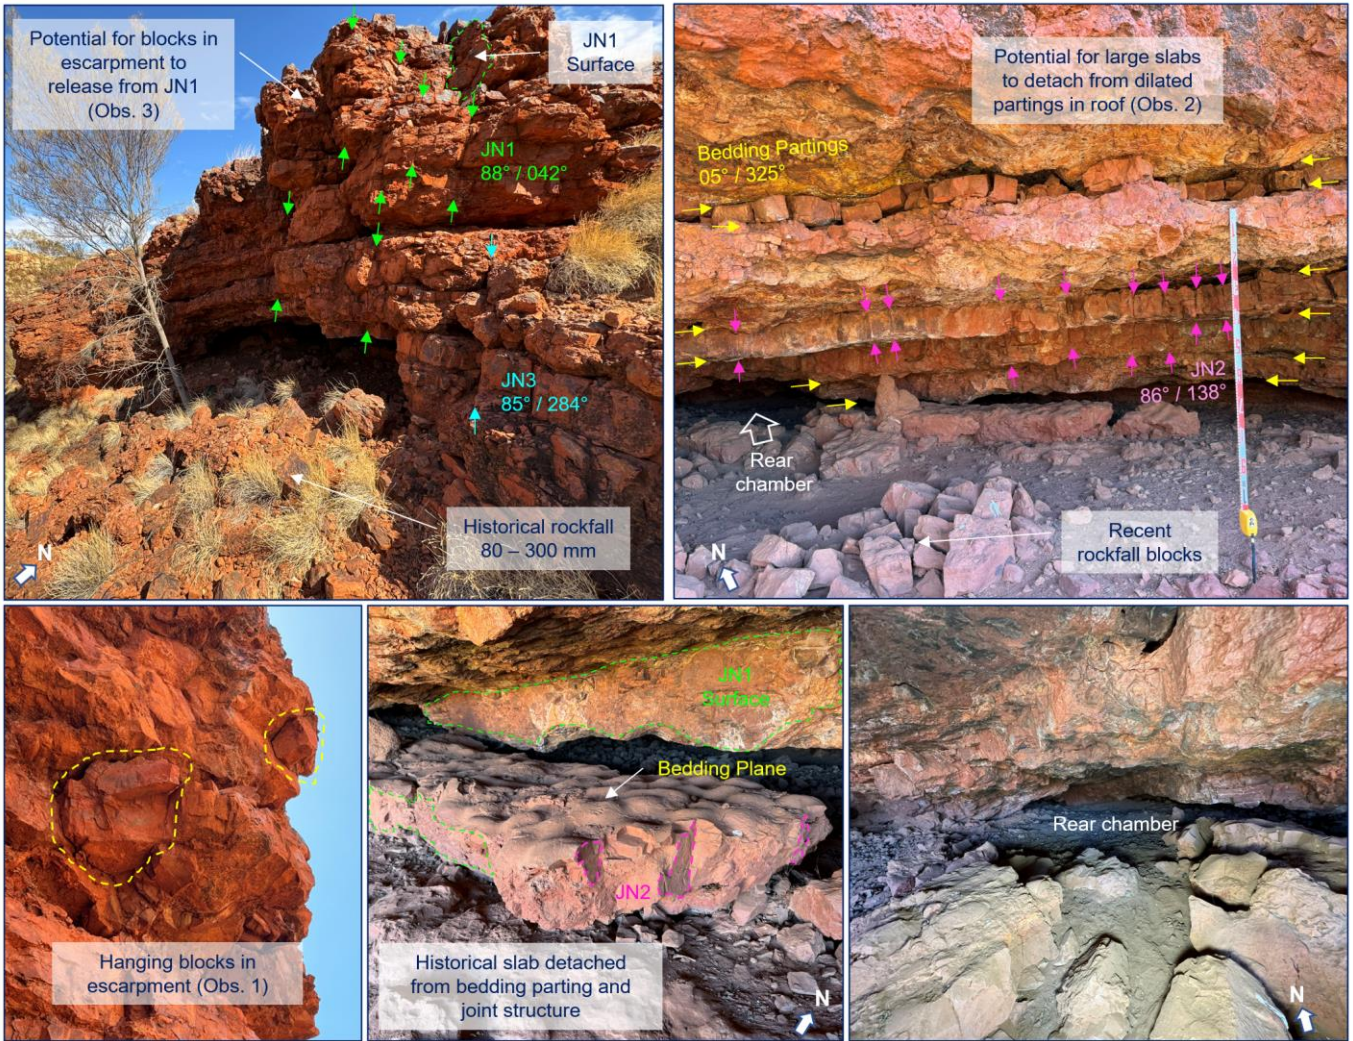
Inset 7: Engineering geological observations of cave MEC065.

- Hanging blocks bounded by open joints or non-systematic fractures occur in the dripline above the cave entrance (Obs. 1, Inset 7)
- There is potential for large slabs of chert and hydrated BIF to detach from dilated bedding partings and joints in the main chamber roof (Obs. 2, Inset 7). This mechanism is evidenced by past rockfall product on the cave floor, Inset 7. These features appear relatively highly susceptible to vibration induced damage
- In the escarpment above the cave, there is potential for blocks to release from Joint set 1 (Obs. 3, Inset 7). This presents a rockfall hazard at the cave entrance.

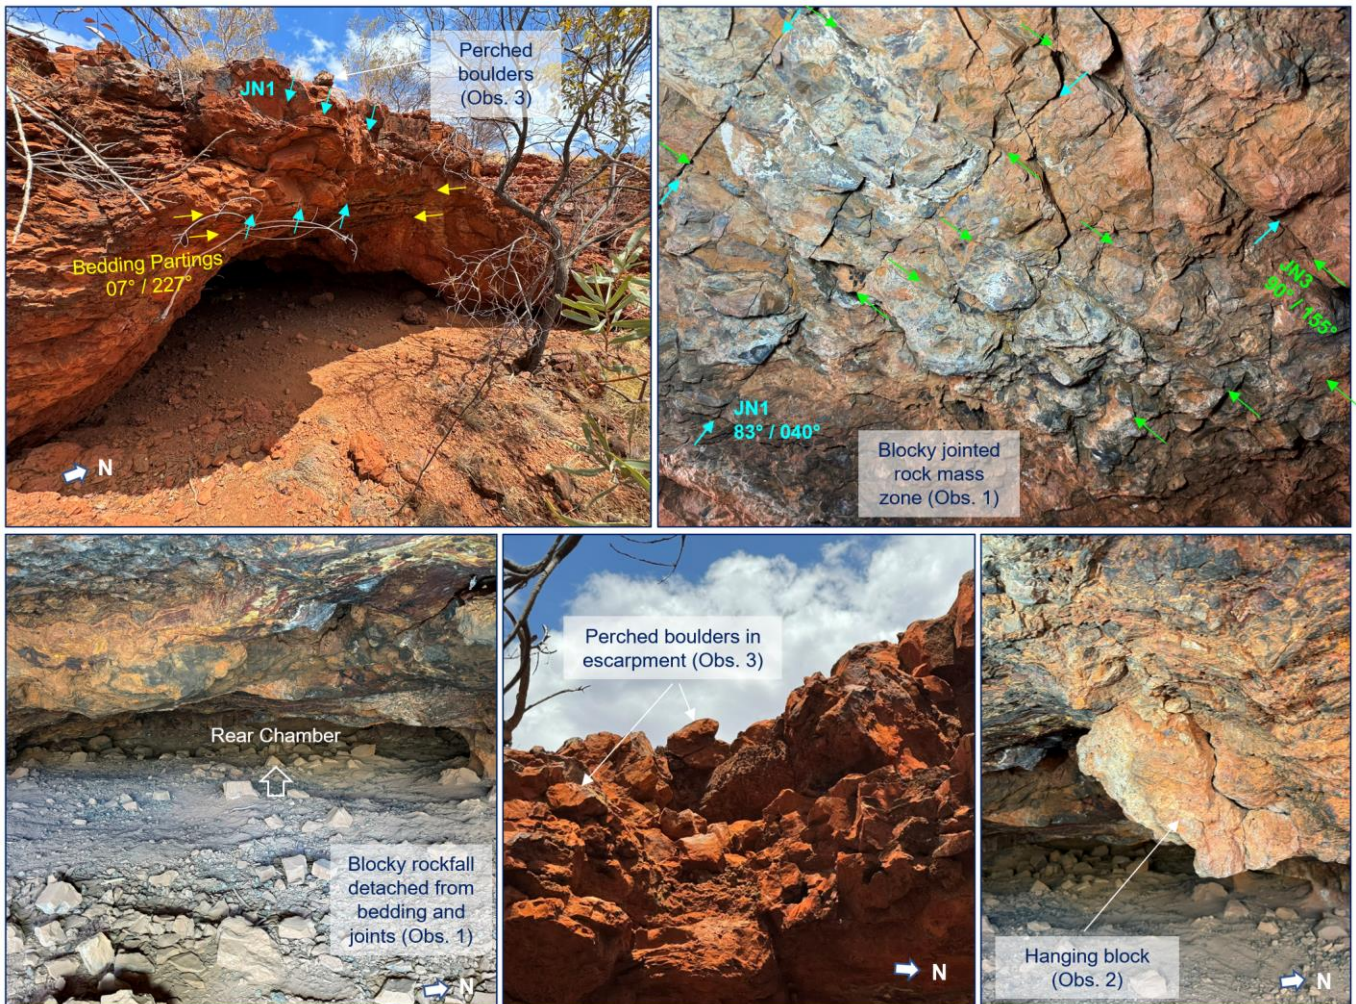
- A zone of blocky, jointed rock mass was observed in the roof of the cave interior (Obs. 1, Inset 8). The area is limited to where joint set 3 is visible, resulting in multiple intersecting sub-vertical joint sets, Inset 8)
- Two hanging blocks bounded by open fractures were observed on the interior of the cave (Obs.2, Inset 8)
- Multiple perched boulders are situated in the escarpment above the cave entrance (Obs. 3, Inset 8).

Inset 8: Engineering geological observations of cave MEC007.
Top Left: Cave entrance viewed towards the northwest. **Top Right:** Area of blocky, jointed rock mass, showing intersections of joint set 1 and joint set 3. **Bottom Left:** Rear chamber viewed towards the west, showing past rockfall debris on the cave floor. **Bottom Middle:** Perched boulders in the escarpment above the cave entrance. **Bottom Right:** Identified hanging block in the cave roof bounded by open fractures.

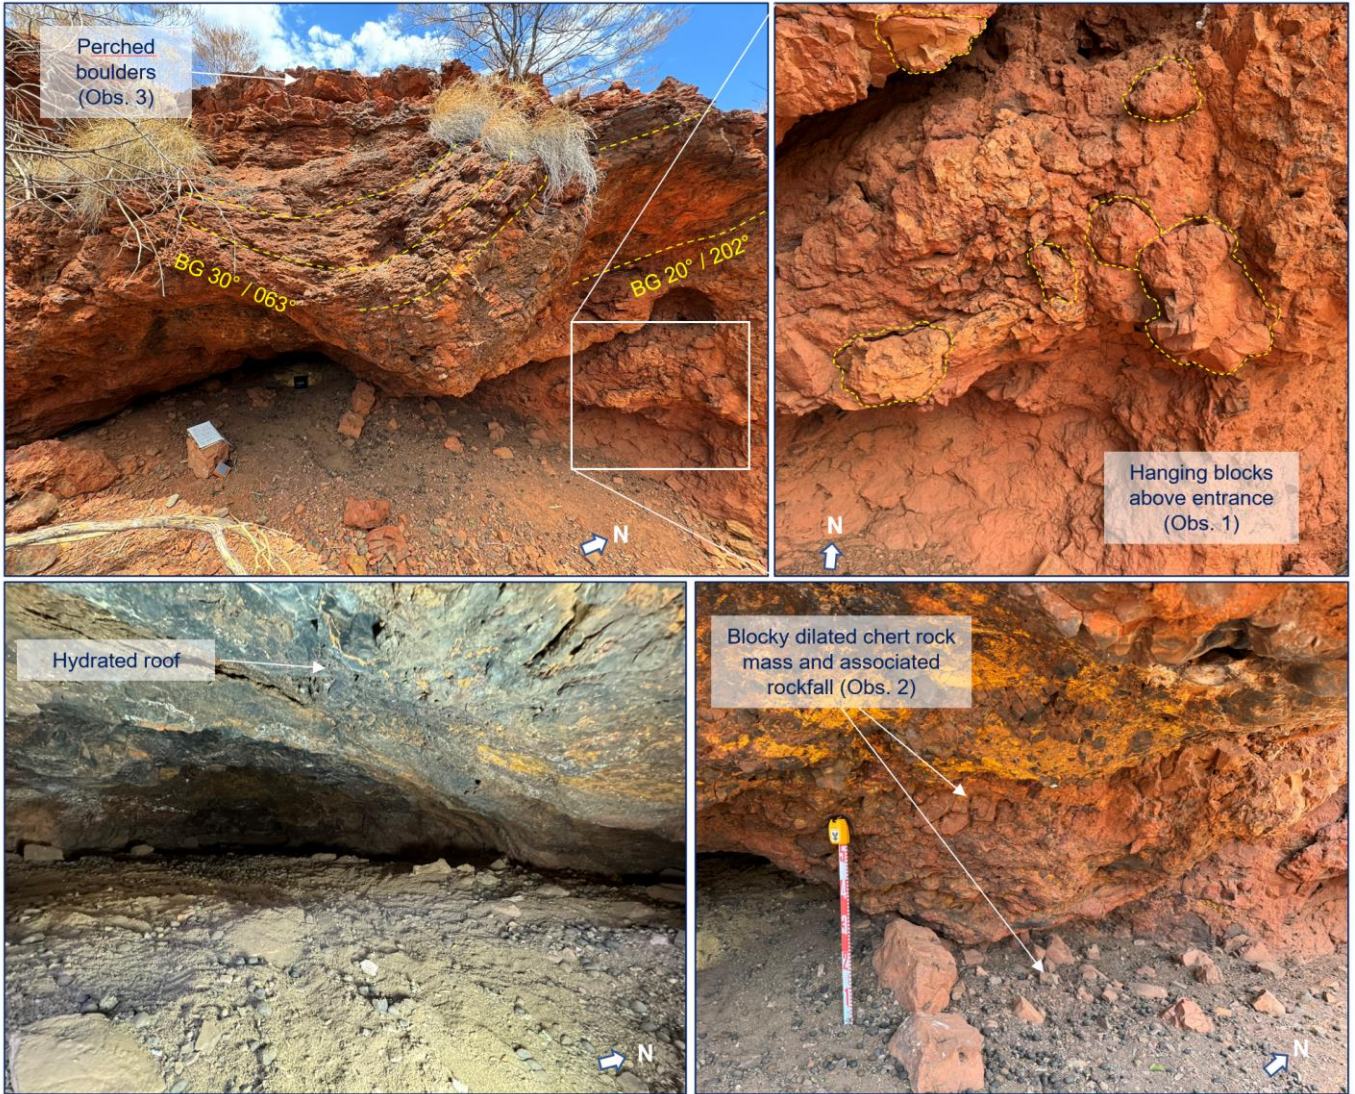
- Loose hanging blocks were identified in the overhang (Obs. 1, Inset 9)
- Blocky dilated chert rock mass was observed in the lower part of the overhang, with detached blocky to tabular chert fragments observed on the floor below (Obs. 2, Inset 9)
- Perched boulders were identified in the escarpment above the overhang (Obs. 3, Inset 9). These boulders have the potential to fall down the escarpment and over the dripline.

Inset 9: Engineering geological observations of cave MEC033.
Top Left: Cave entrance viewed towards the west, showing variable bedding orientation and perched boulders in the escarpment above the entrance. **Top Right:** Loose hanging blocks identified around the entrance. **Bottom Left:** Cave interior viewed towards the east showing stained roof as a result of water seepage into the cave. **Bottom Right:** Area of blocky, dilated chert rock mass at the cave entrance, and associated rockfall debris below.

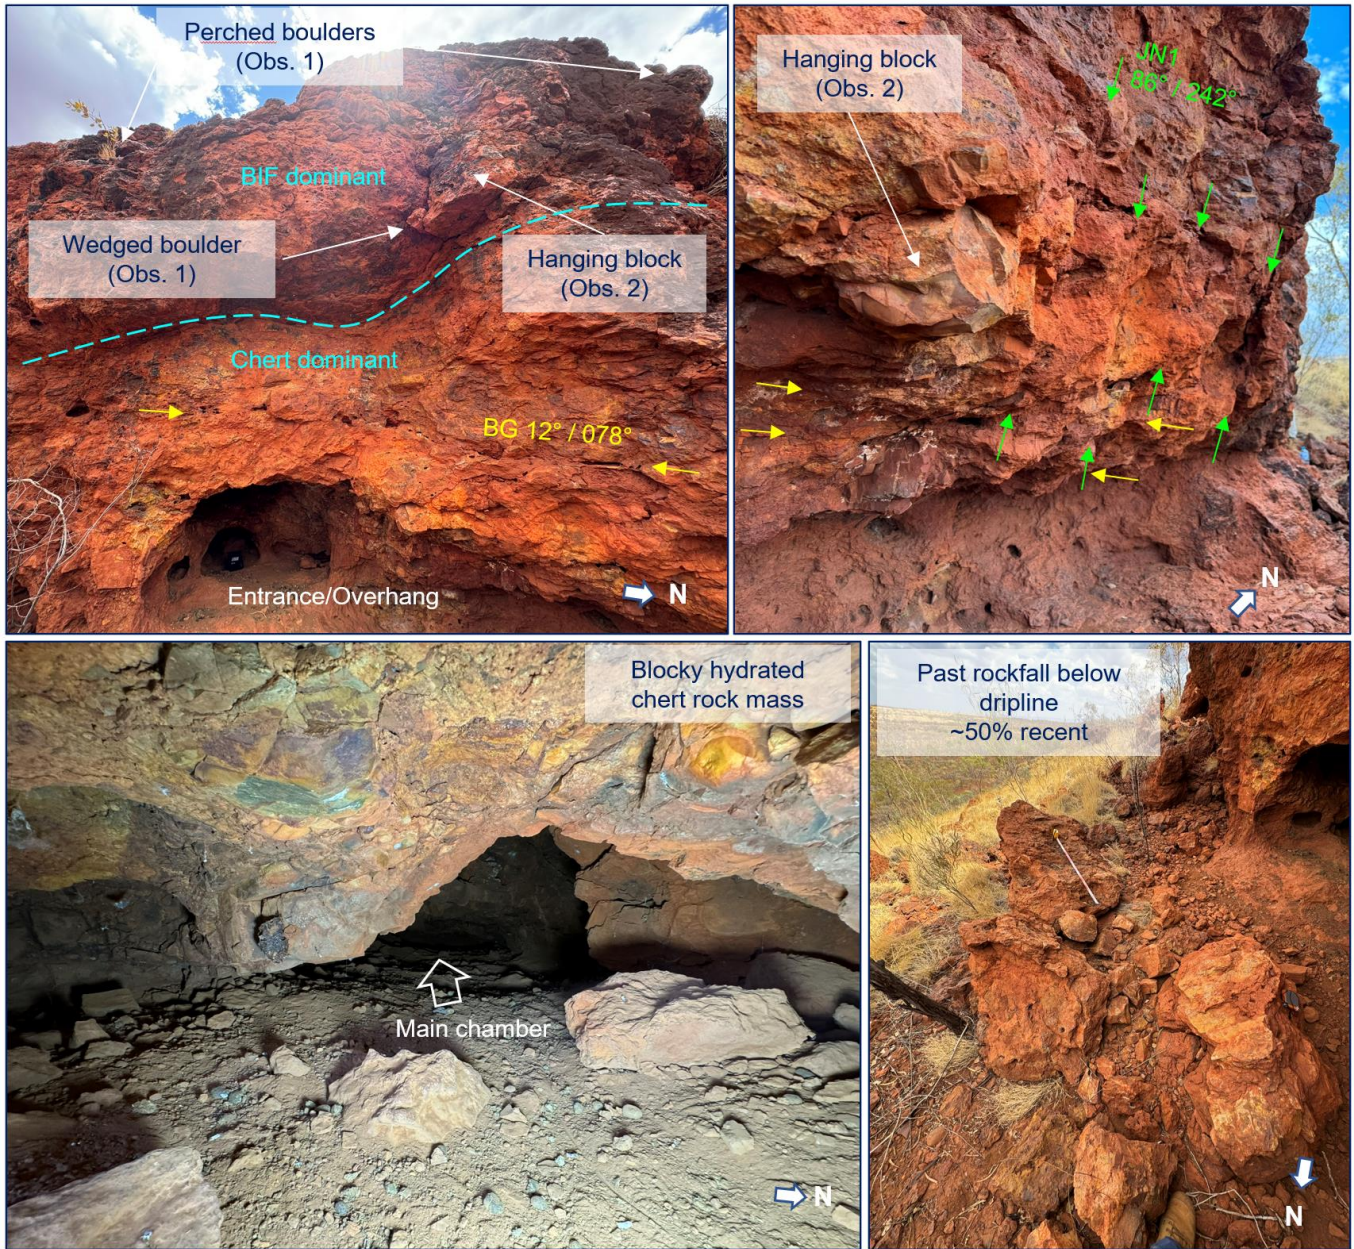
Inset 10: Engineering geological observations of cave MEC073.

Based on the orientations of bedding and the observed joint sets, it is kinematically possible for blocks to detach from the cave roof and overhang, however, no specific susceptible blocks were observed, given that the defects are typically tight.

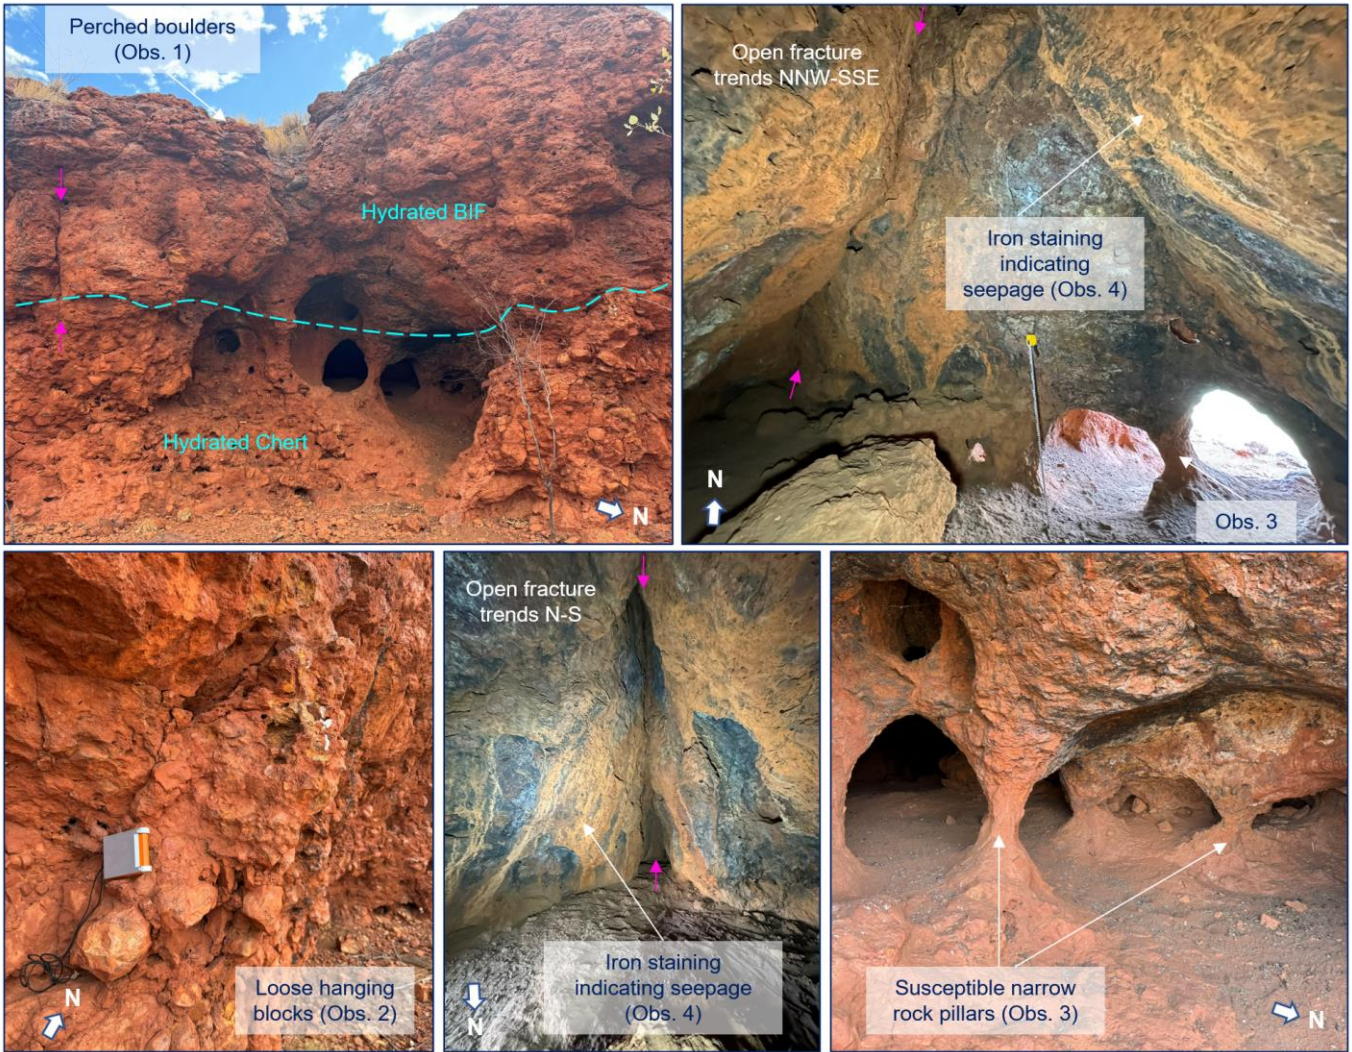
Inset 11: Engineering geological observations of cave MEC039.

- Boulders perched on the edge of the escarpment above the cave entrance (Obs. 1, Inset 11)
- Multiple hanging blocks bounded by non-systematic, dilated fractures in the cave dripline (Obs. 2, Inset 11)
- Narrow rock pillars located at the entrance to the interior chamber may be susceptible to damage or collapse from blast induced vibrations (Obs. 3, Inset 11). The pillars occur at the interface between the chert and overlying BIF
- Seepage into the cave was observed to occur along the north to north-northwest trending fracture inside the cave, evidenced by considerable iron staining (Obs. 4, Inset 11).

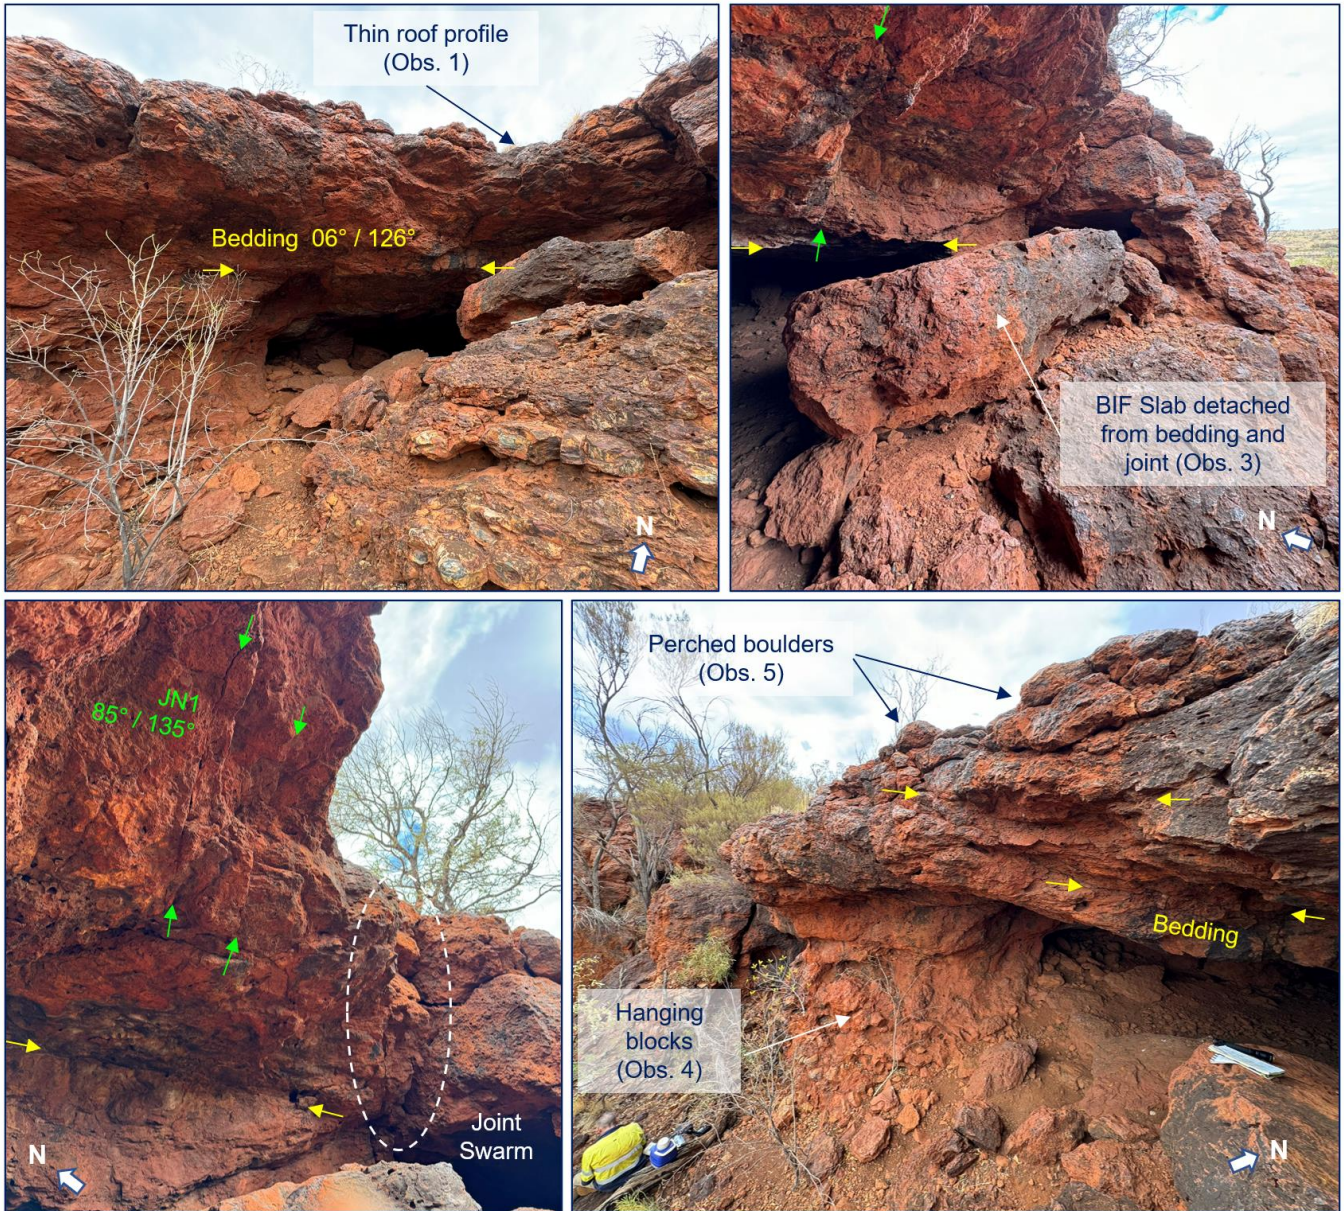
- A thin roof profile (measured 1 to 2 m thick above the entrance) in combination with the cave's wide span increases the susceptibility to collapse (Obs. 1, Inset 12)
- A pillar of poorer rock mass is situated at the back of the main chamber, and may be susceptible to cracking (Obs. 2, Inset 13)
- There is potential for blocks to detach from bedding partings in the cave roof or overhang where crosscut by a sub-vertical joint set (Obs. 3, Inset 12). This mechanism is evidenced by past tabular rockfall below the entrance
- Loose hanging blocks were identified in the escarpment around the entrance (Obs. 4, Inset 12). No hanging blocks were identified on the interior
- Perched boulders situated in the escarpment above the cave have the potential to fall across the entrance (Obs. 5, Inset 12).

Inset 12: Engineering geological observations of cave MEC016 (MIB-MD13-043) exterior.
Top Left: Cave entrance viewed towards the north. **Top Right:** Large BIF slab detached from bedding parting and joints in the overhang. **Bottom Left:** Eastern side of the cave entrance showing joint set 1 orientation in the overhang, and joint swarm location. **Bottom Right:** Cave entrance viewed towards the west showing perched boulders in the escarpment above entrance, and sub-horizontal bedding orientation.

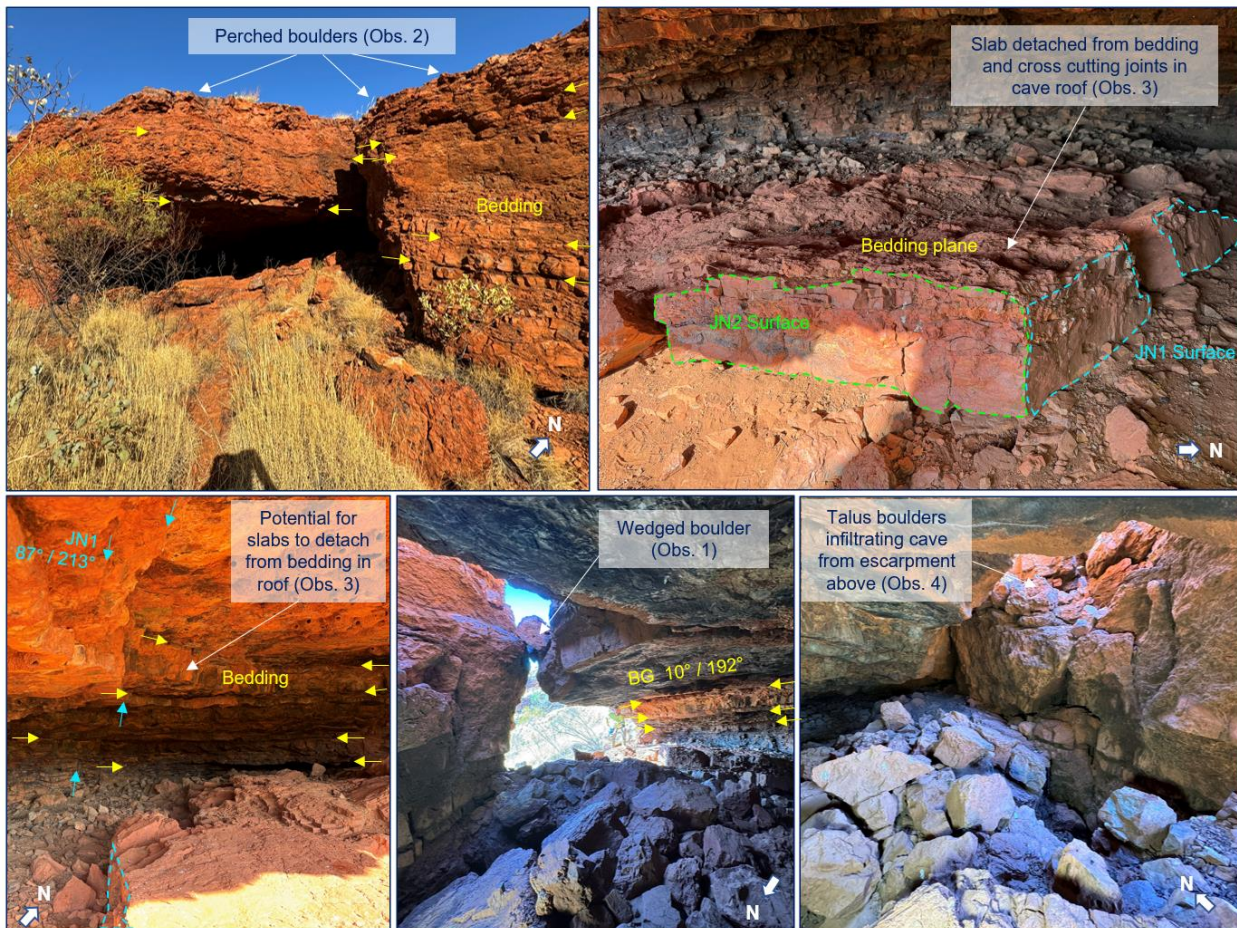
Inset 14: Engineering geological observations of cave MEC063.

- Wedged boulders were observed on the eastern side of the cave, in the gap between the cave dripline and eastern escarpment (Obs. 1, Inset 14)
- Perched boulders are situated atop the escarpment above the cave entrance (Obs. 2, Inset 14)
- There is potential for large slabs of hydrated BIF and chert to detach from dilated bedding partings and joints in the cave roof (Obs. 3, Inset 14)
- Talus boulders from the escarpment above the cave were observed to have fallen through the gap between the cave dripline and eastern escarpment edge (Obs. 4, Inset 14).
