Geotechnical Assessment of Bat Caves

Mulga Downs Iron Ore Project

PSM5194-007R REV3 18 December 2024

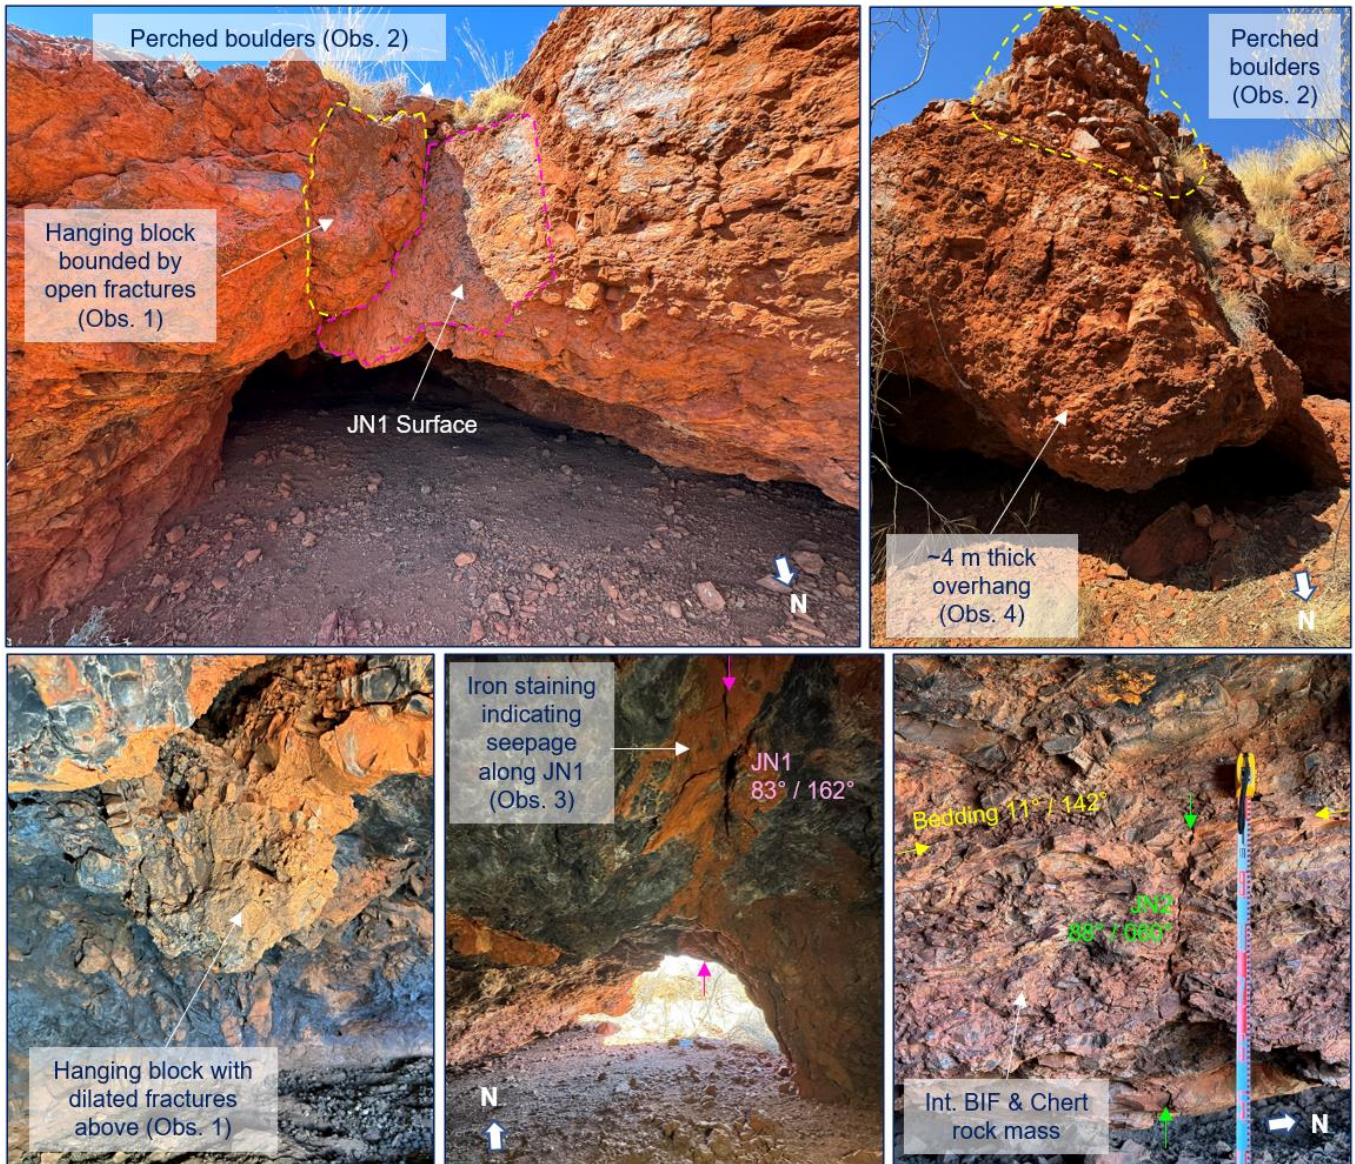
Inset 15: Engineering geological observations of cave MEC062.

- Hanging blocks were observed on the cave exterior and interior (Obs. 1, Inset 15). A large hanging block situated immediately above the entrance is bounded by joint set 1 and other open fractures, Inset 15
- Multiple perched boulders up to 0.6 m in width were observed on the escarpment above the cave entrance (Obs. 2, Inset 15)
- Water seepage into the cave was inferred along a dilated fracture in the cave roof, which is partially aligned along joint set 1 (Obs. 3, Inset 15). Seepage was evidenced by iron staining of the wall rock either side of the fracture, Inset 15
- The overhanging escarpment on the western side of the cave entrance is up to 4 m thick. Due to the orientation of joint set 2, there is potential for the substantial overhang to detach from the sub-vertical structure (Obs. 4, Inset 15).

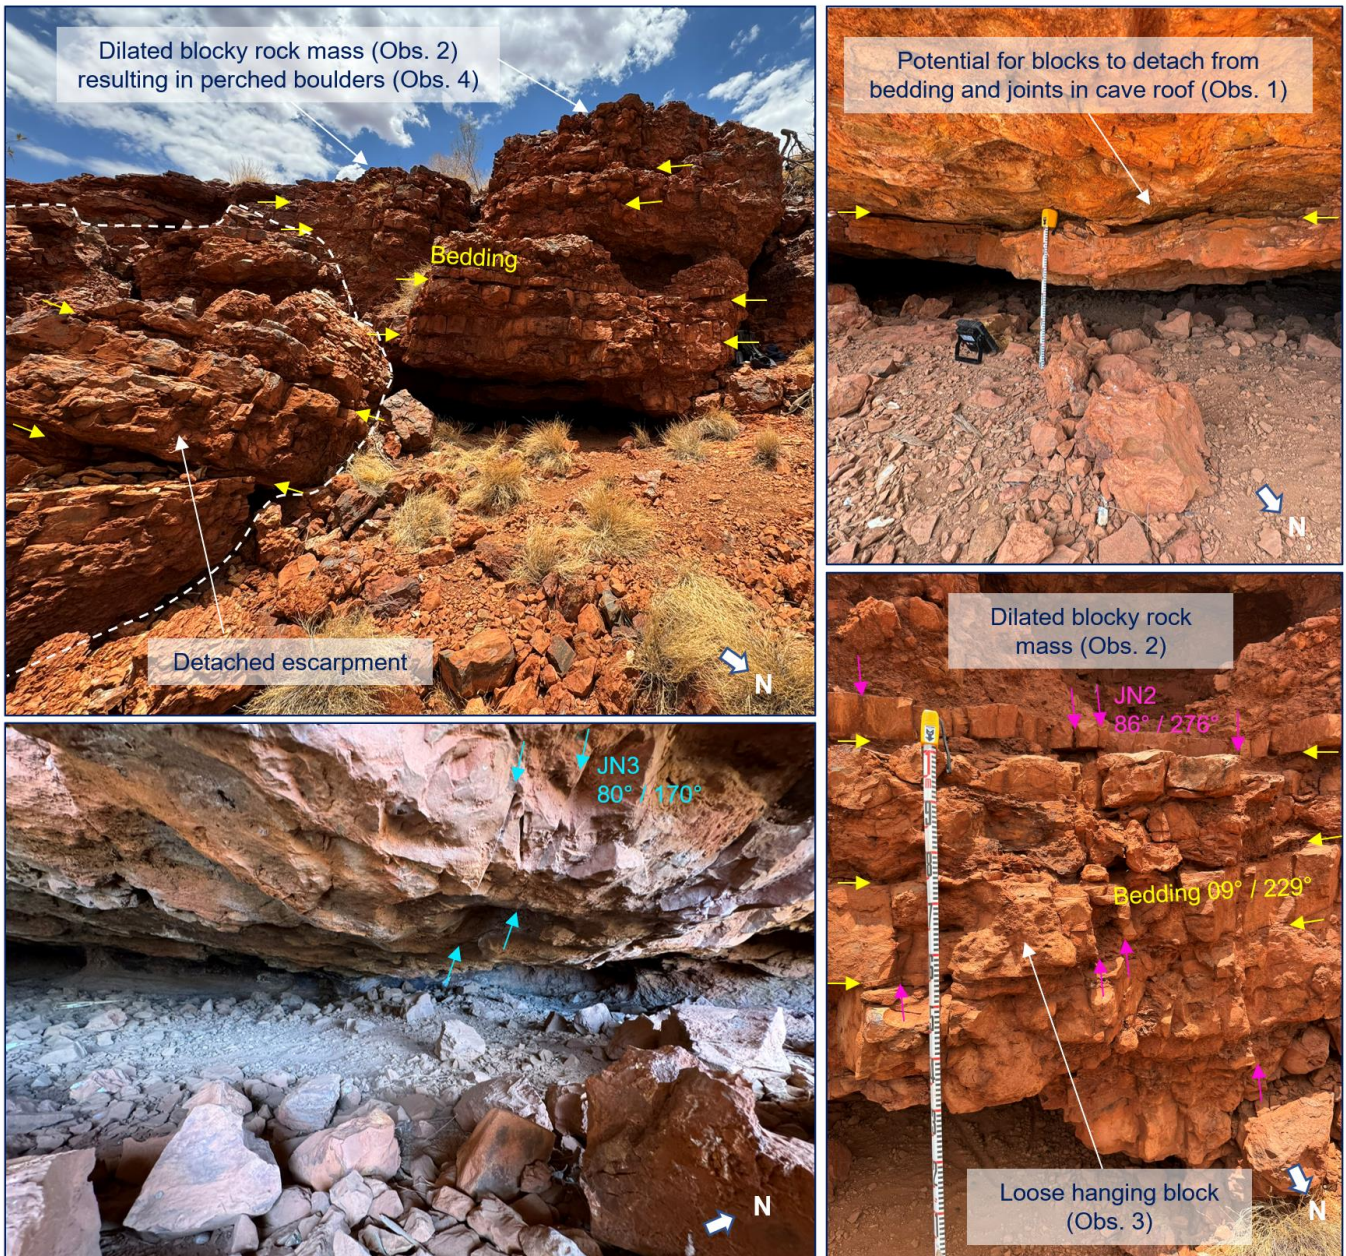
Inset 17: Engineering geological observations of cave MEC060.

- There is potential for slabs of hydrated BIF and chert to detach from bedding and/or joints in the cave roof (Obs. 2, Inset 17)
- The rock mass in the escarpment is loose and dilated in parts (Obs. 2, Inset 17). This is a potential source for future rockfall as evidenced by past rockfall product on the cave exterior
- Hanging blocks bounded by dilated bedding partings and joints were observed in the dripline above the cave entrance (Obs. 3, Inset 17)
- Perched boulders were observed along the top of the escarpment in which the cave is hosted (Obs. 4, Inset 17). Some tabular boulders appear to have become detached due to continual weathering of the dilated blocky rock mass.

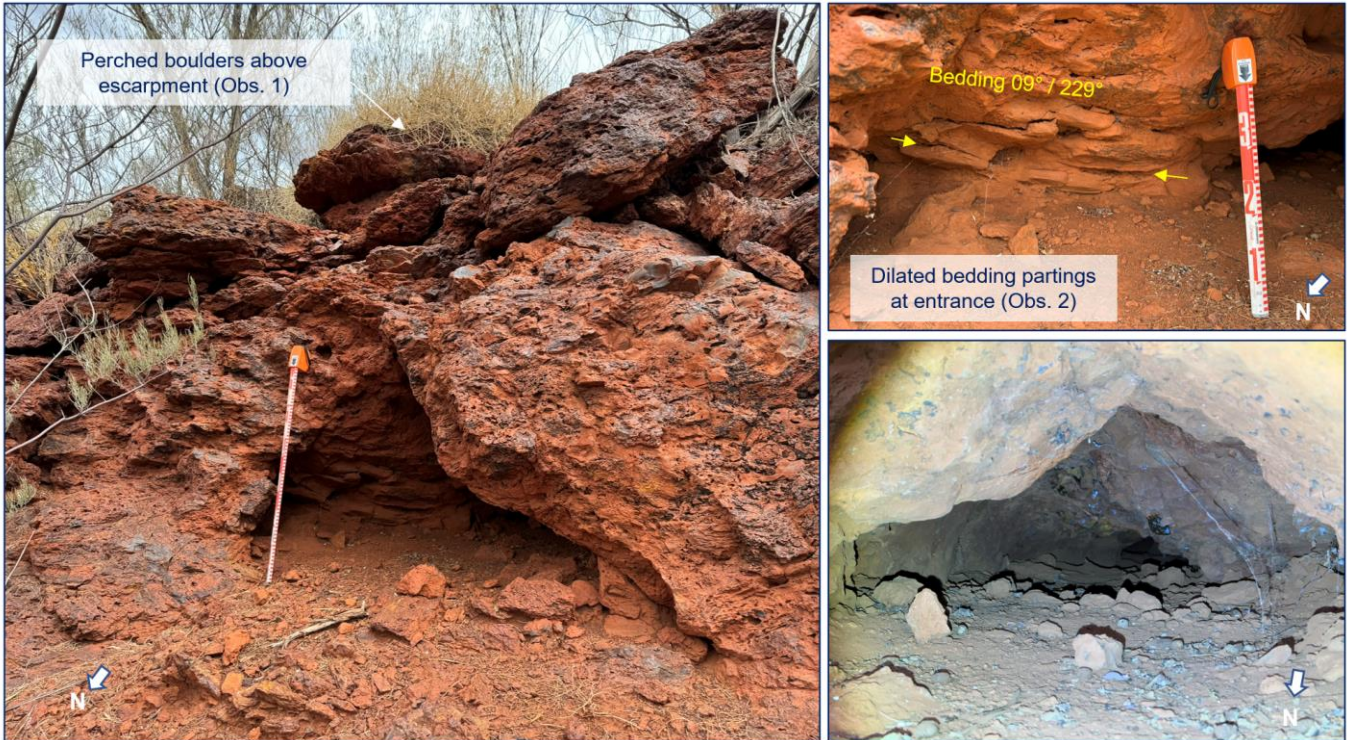
- Perched boulders are situated above the cave entrance (Obs. 1, Inset 18)
- There is potential for blocks to detach from bedding where partings are developed around the entrance, Obs. 2, Inset 18. If blocks detach they do not appear likely to restrict access to the cave for bats.

Inset 18: Engineering geological observations of cave MEC072.
Left: Cave entrance viewed towards the southeast showing perched boulders above the escarpment.
Top Right: Bedding partings observed inside the cave entrance. **Bottom Right:** Cave interior viewed towards the south.

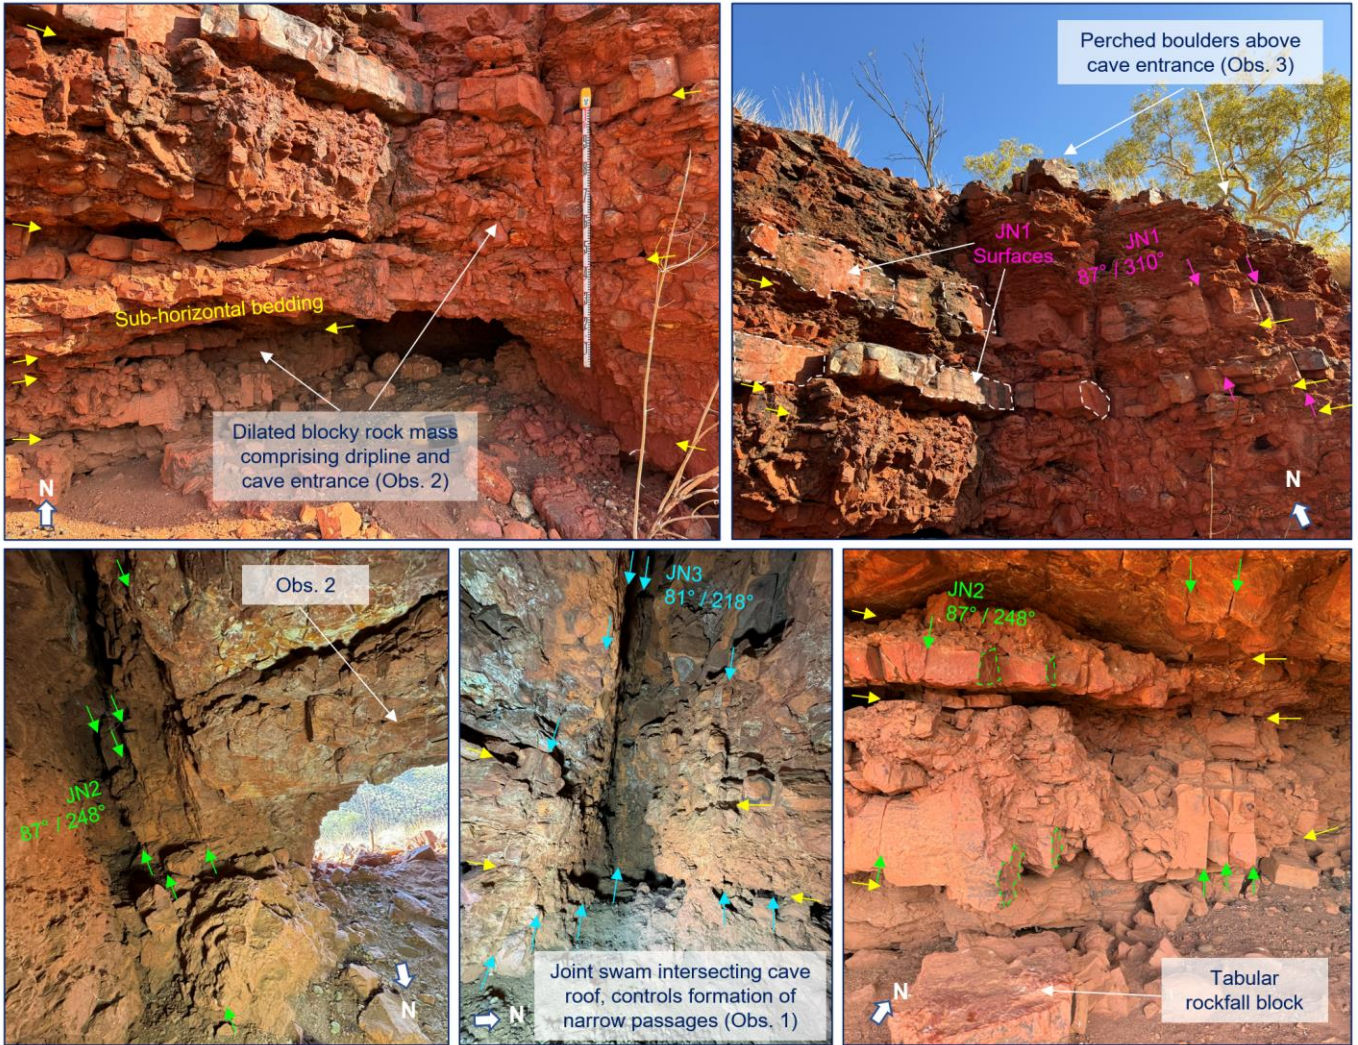
- A dilated joint swarm along joint set 3 orientation was interpreted to control cave development at the back of the interior chamber (Obs. 1, Inset 19)
- Loose, dilated, blocky rock mass was observed in the escarpment above and adjacent to the cave, and also in areas around the cave entrance (Obs.2, Inset 19)
- Perched boulders situated atop the escarpment (Obs. 3, Inset 19).

Inset 19: Engineering geological observations of cave MEC049.
Top Left: Cave entrance viewed towards the north showing dilated blocky rock mass comprising the escarpment, and dilated bedding partings. **Top Right:** Escarpment above the cave entrance showing joint set 1 orientation and perched boulders situated on the escarpment edge. **Bottom Left:** Cave interior viewed towards the south showing joint set 2 orientation and dilated blocky rock mass in roof. **Bottom Middle:** Back of cave interior viewed towards the west, showing joint set 3 orientation and associated high roof profile. **Bottom Right:** Cave interior viewed from the entrance showing dilated joint set 2 structures and detached tabular block.

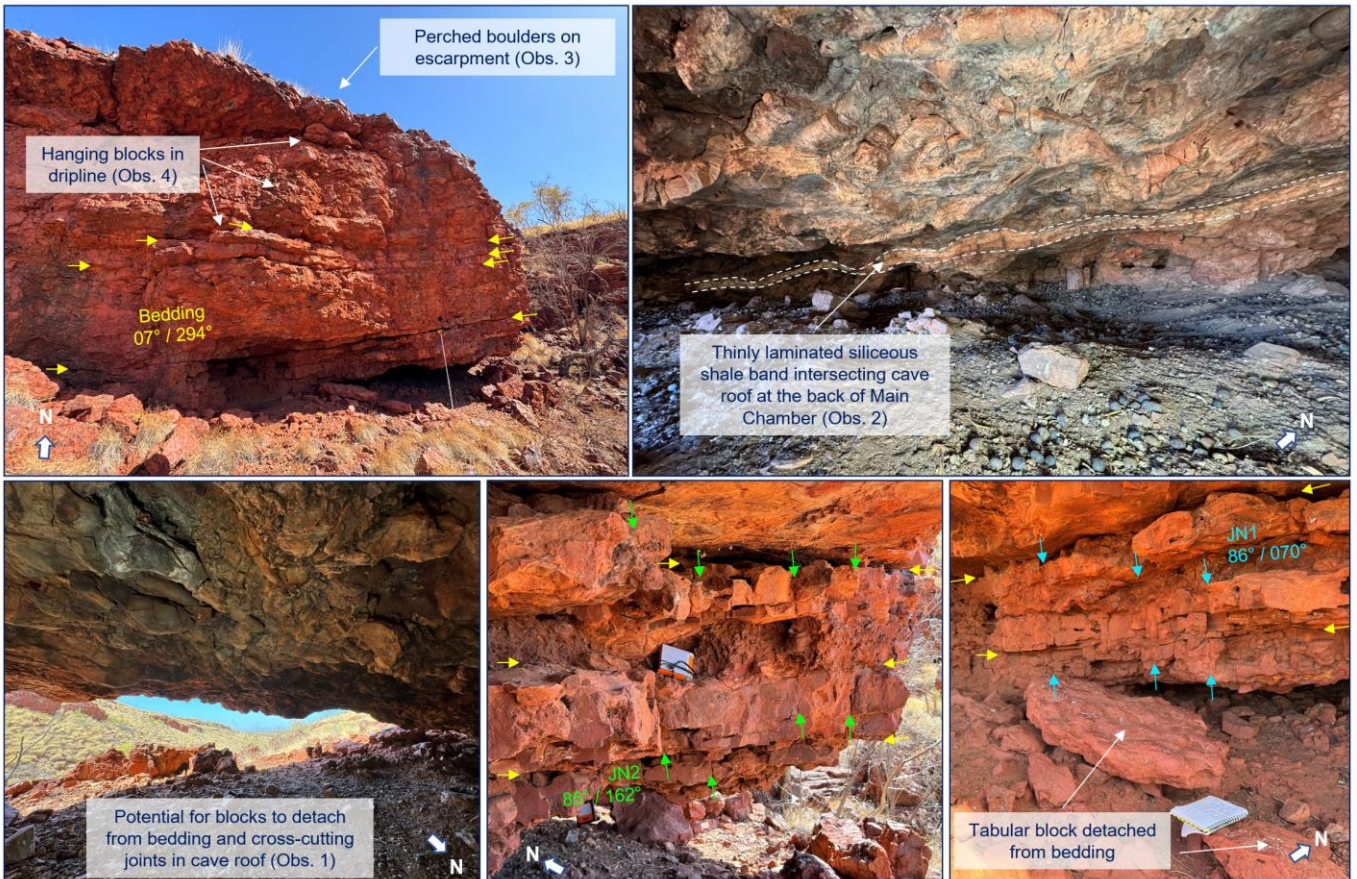
Inset 20: Engineering geological observations of cave MEC003.

- There is potential for blocks of rock to detach from bedding partings and joints in the cave roof, evidenced by past rockfall debris throughout the main chamber and below the dripline (Obs. 1, Inset 20)
- A thinly laminated siliceous shale band was observed to intersect the roof of the main chamber (Obs. 2, Inset 20). Although the laminations are intact, blocks below the shale band may be susceptible to detachment from the lower strength band
- Loose hanging blocks up to 0.8 m wide were observed on the southern side the escarpment (Obs. 3, Inset 20). The hanging blocks are bounded by dilated joints or non-systematic fractures
- Perched boulders situated in the escarpment above the cave have the potential to fall across the entrance (Obs. 4, Inset 20).

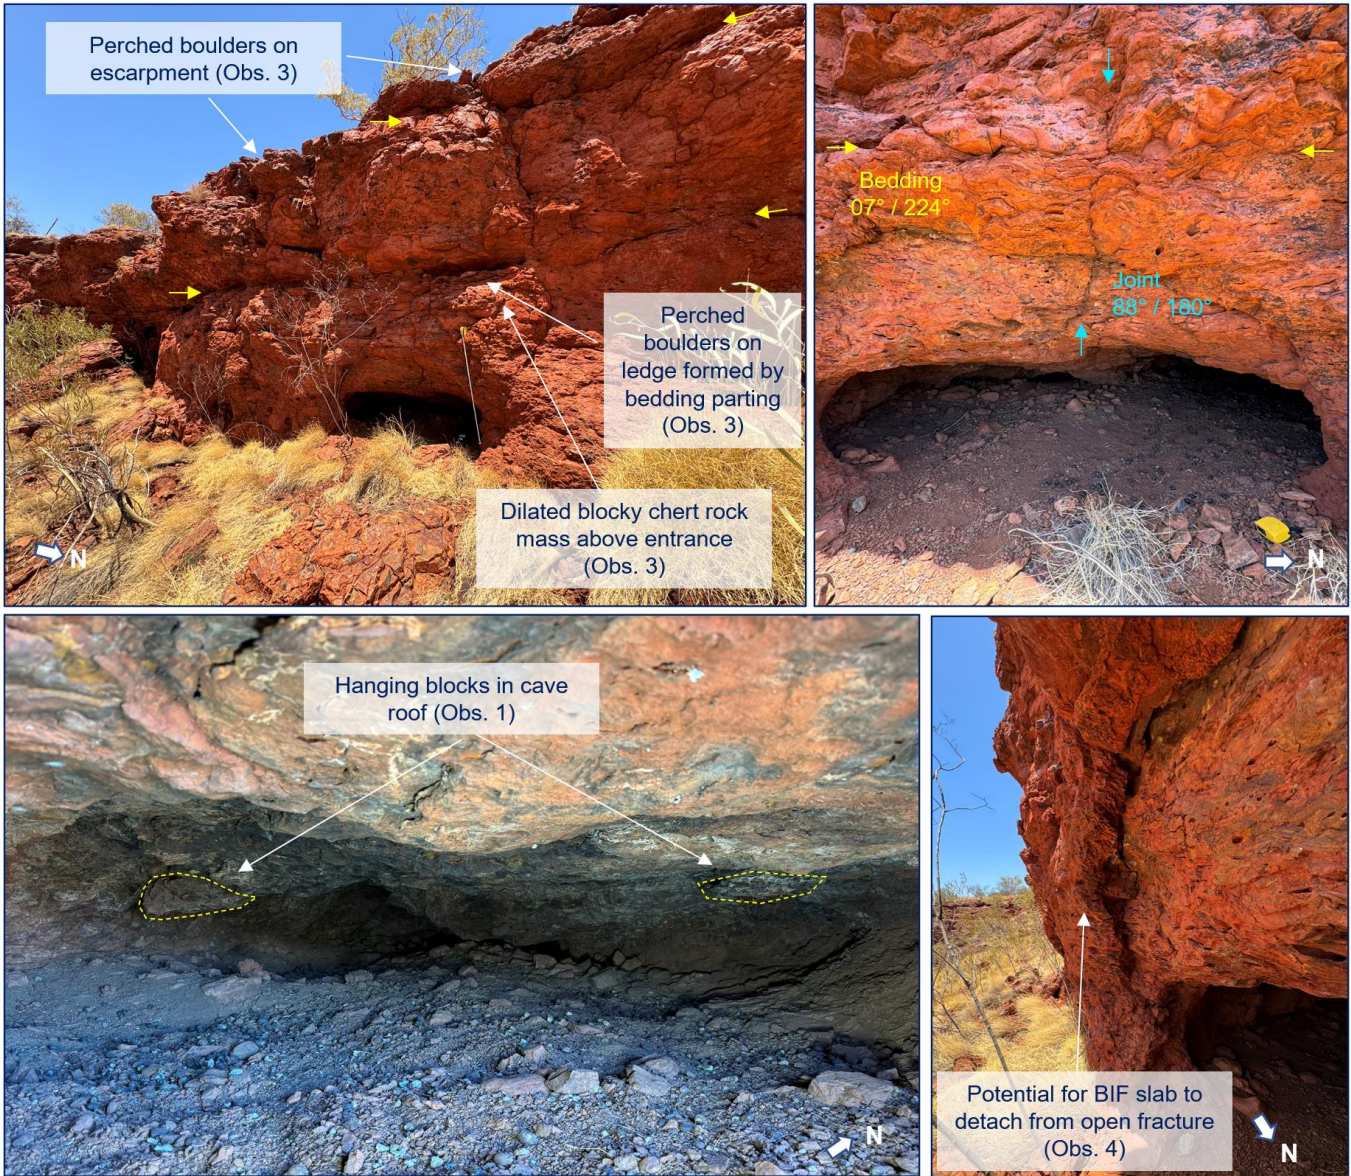
Inset 21: Engineering geological observations of cave MEC025.

- Hanging blocks bounded by open fractures were observed in the cave roof (Obs. 1, Inset 21)
- Blocky chert bands occur in the escarpment above the cave entrance (Obs. 2, Inset 21) and have the potential to release blocks from the escarpment
- Perched boulders were observed along the top of the escarpment above the cave entrance (Obs. 3, Inset 21)
- A large BIF slab is bounded by an open fracture on the southern side of the cave entrance (Obs. 4, Inset 21).

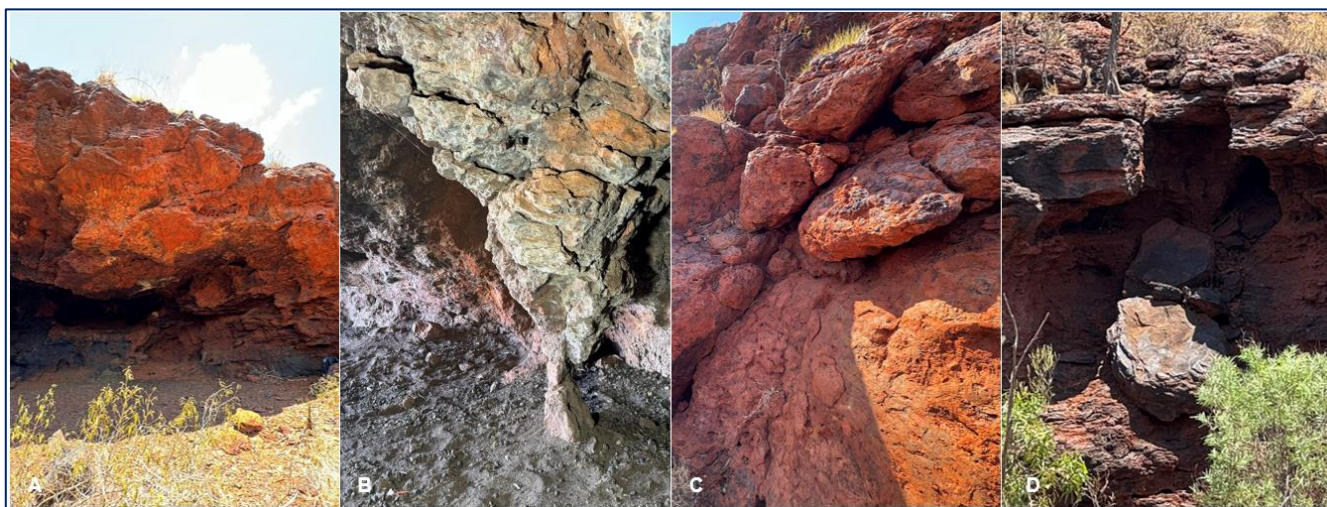
Inset 22: Examples of susceptible features observed at Mulga Downs cave sites. A) Cave formed on structure (bedding). **B)** Hanging blocks bounded by open defects. **C)** Perched boulders. **D)** Sub-vertical open joints intersecting the cave roof.
