Detailed Site Investigation for
Potential Soil and Groundwater Contamination
333 High Street/11 Montreal Street, Fremantle
Western Australia

Main Roads WA

Report Number: 1430/489/DSI/AH/02082013					
Status	Rev	Date	Prepared	Checked	Authorised
Final	1	Sept 2013	AH	CK	AR

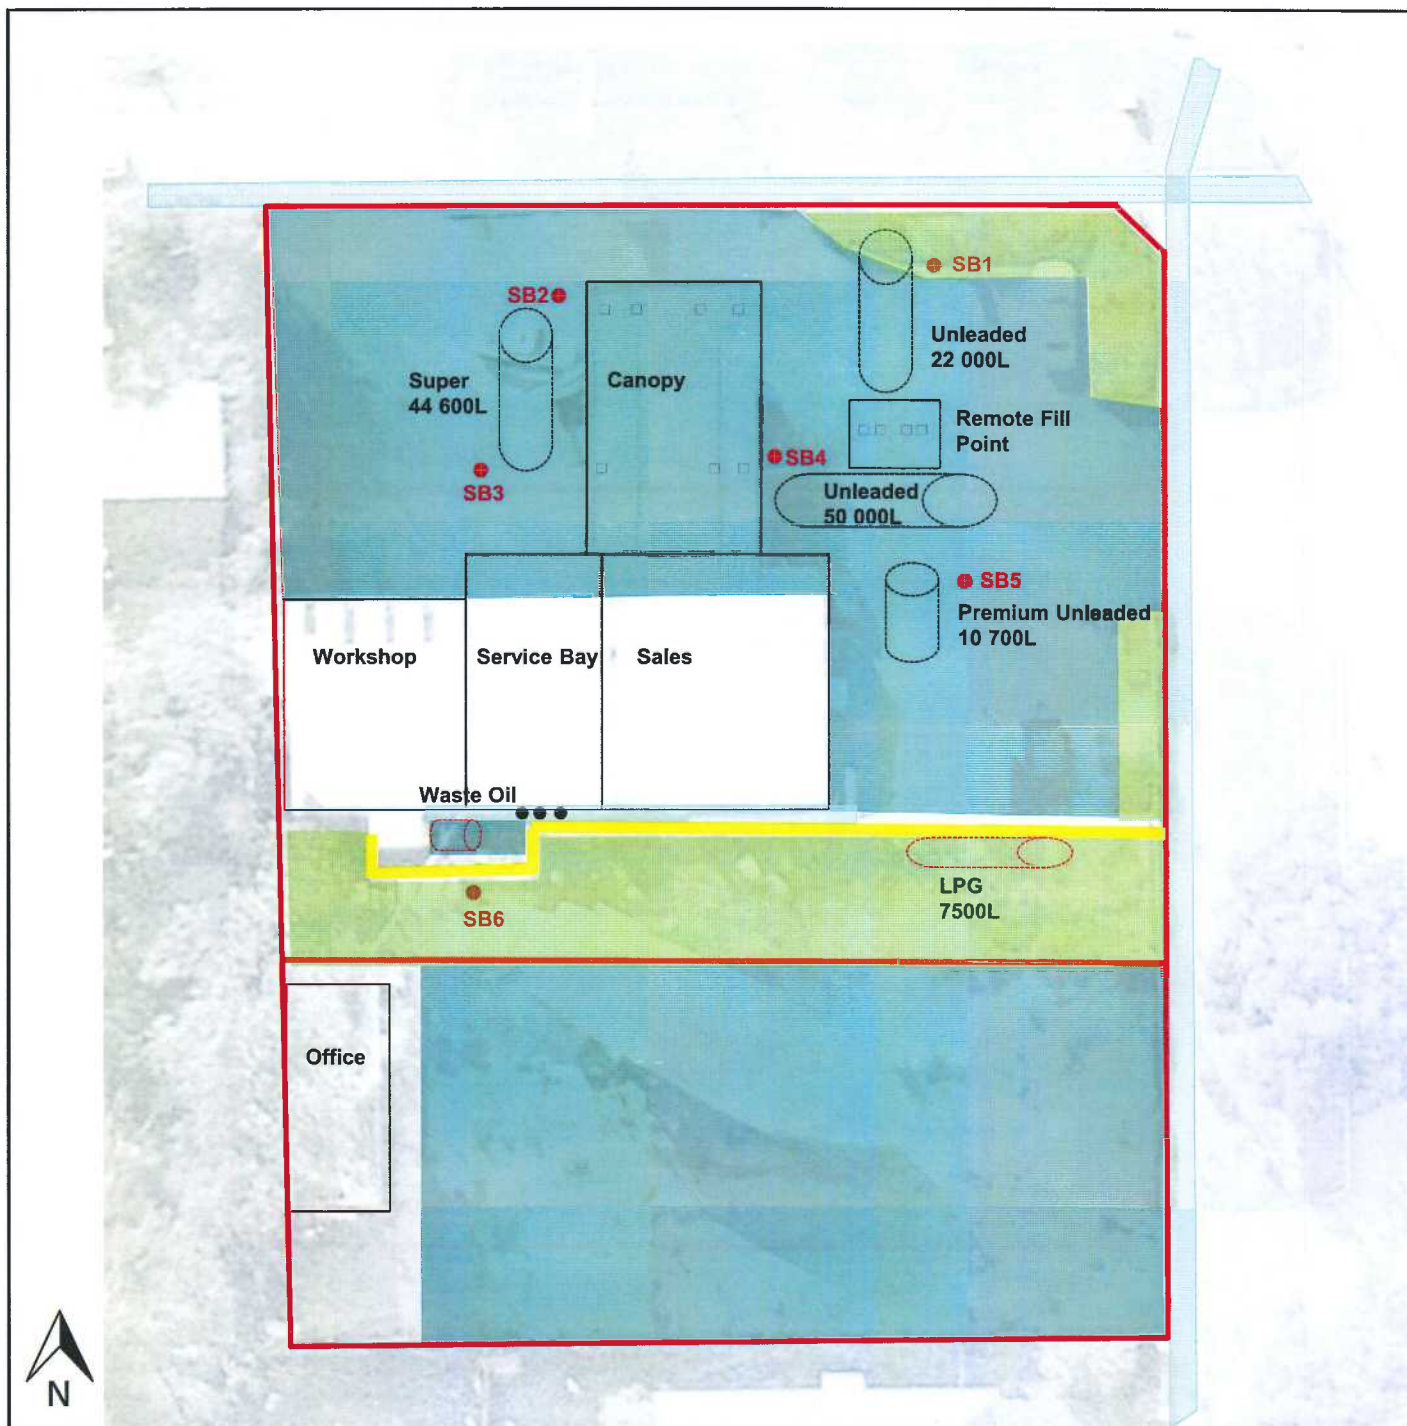
DRAWING No:
Figure 3

The Site layout is shown in Figure 3, Appendix A. Photographic plates of the Site are shown in Appendix C. The Site is approximately rectangular in shape. The northern section of the Site is occupied by a drive through coffee shop, dry cleaning drop-off and a mechanical workshop (Plates 1-3). It is largely covered with bitumen with minor landscaped areas. A building is present in the centre of the western portion of the Site which is occupied by the three business and a small building located under the canopy utilised by the drive-through coffee business. A narrow path is present behind the building (Plates 4).
