DESKTOP GEOTECHNICAL ASSESSMENT FOR PREFEASIBILITY STUDY

Blacksmith Lease, Pilbara Iron Ore Project

Report Number. 097641461-034-R-Rev0

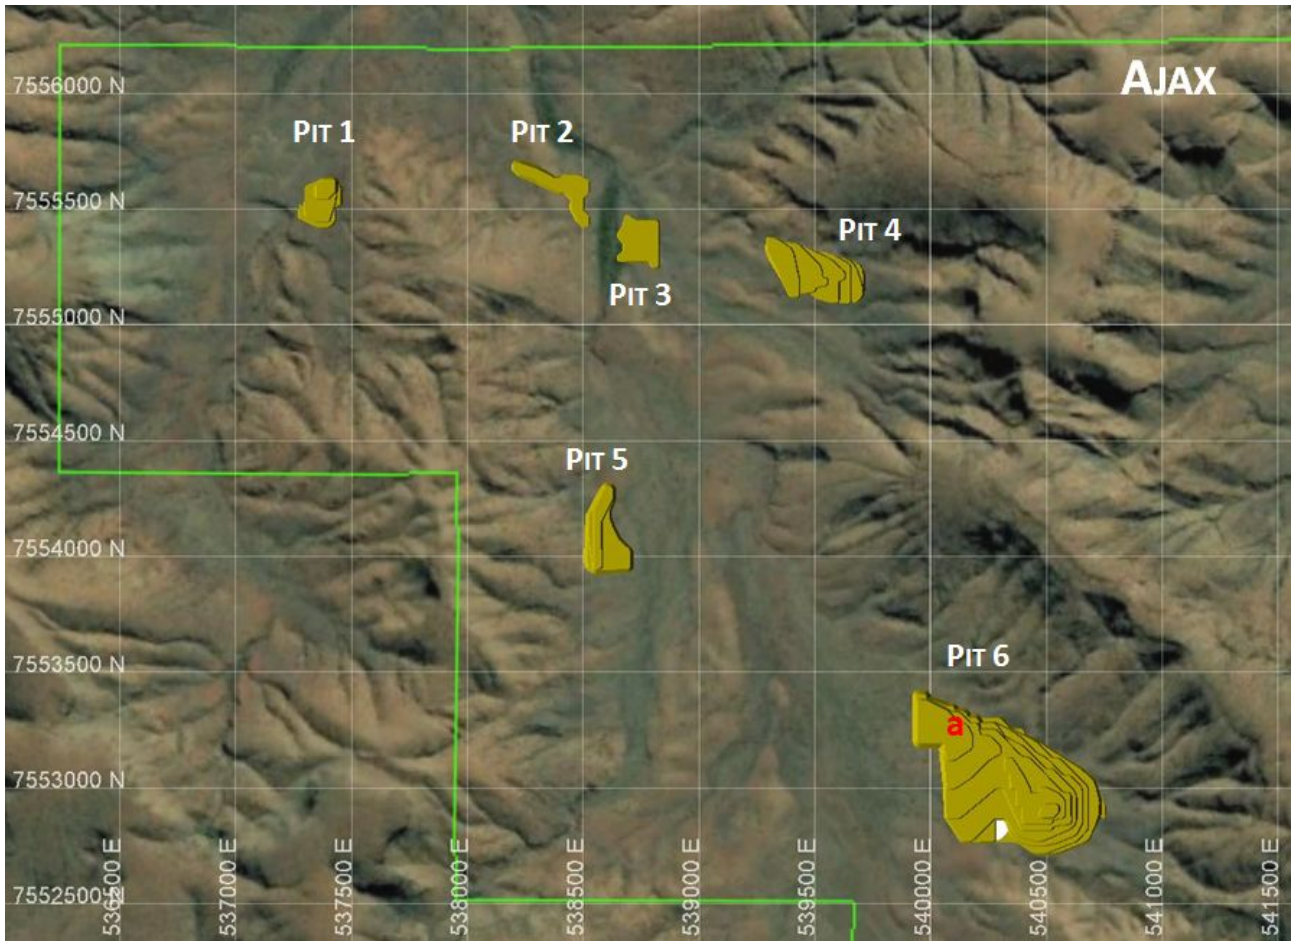
Figure 5: Ajax Pits, highlighting areas of geotechnical risk (refer to Table 1)

Area	Description	Geotechnical Risk	Risk Management
a	17 m (vertical height) undulating slope at a 45 degree angle striking for 170 m	Instability caused by the convex shape of the slope	Change design – straighten slope or make slightly concave
	natural slope at 12 degrees immediately north-east of the pit, large catchment	potential flooding

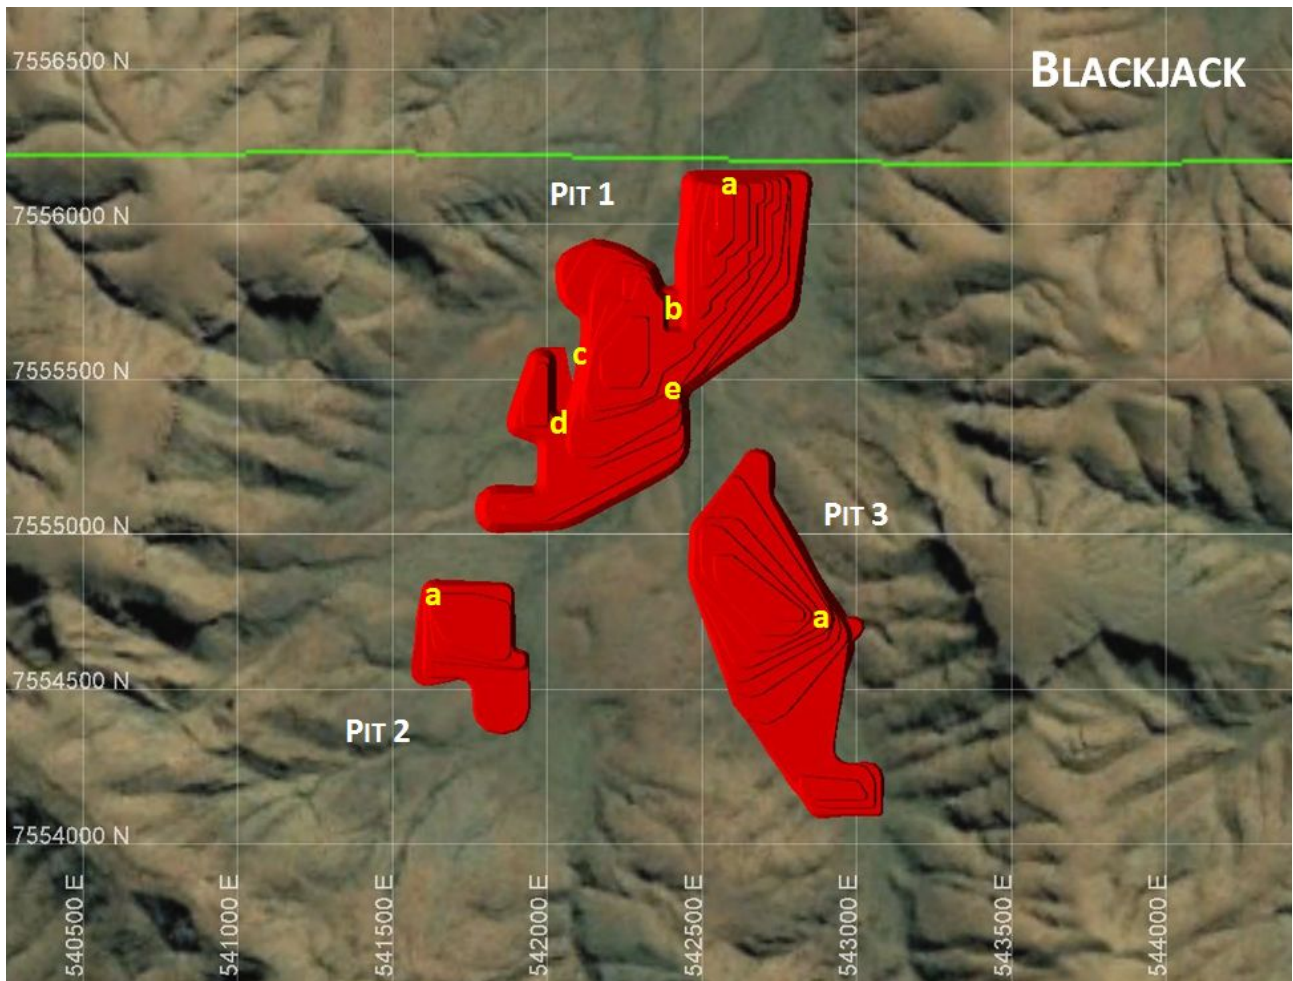
Figure 6: Ajax Pits, highlighting areas of geotechnical risk (refer to Table 2, Table 3 and Table 4)

Area	Description	Geotechnical Risk	Risk Management
a	52 m (vertical height) slope at 45 degrees with no benches. Crest is 30 m from lease boundary	Instability could pose risk to equipment/personnel below	Either step in a bench or flatten slope angle
b	42 m (vertical height) slope at 45 degrees flanking a bullnose. The front of the bullnose is stepped with benches of 16 m (max. vertical height) and berm widths of 30 m (minimum).	Instability could pose risk to equipment/personnel below	Remove or reduce bullnose
c	47 m (vertical height) slope at 45 degrees with no benches	Instability could pose risk to equipment/personnel below	Either step in a bench or flatten slope angle
d	24 m (vertical height) bullnose at a 45 degree slope angle	Instability caused by the convex shape of the slope	Either step in a bench or flatten slope angle
e	40 m (vertical height) convex slope at a 45 degree angle	Instability caused by the convex shape of the slope	Either step in a bench or flatten slope angle

Area	Description	Geotechnical Risk	Risk Management
a	23 m (vertical height) slope at a 45 degree angle in the north-west corner of the pit	Instability could pose risk to equipment/personnel below	Either step in a bench or flatten slope angle

Area	Description	Geotechnical Risk	Risk Management
a	40 m (vertical height) slope at a 45 degree angle	Instability could pose risk to equipment/personnel below	Either step in a bench or flatten slope angle

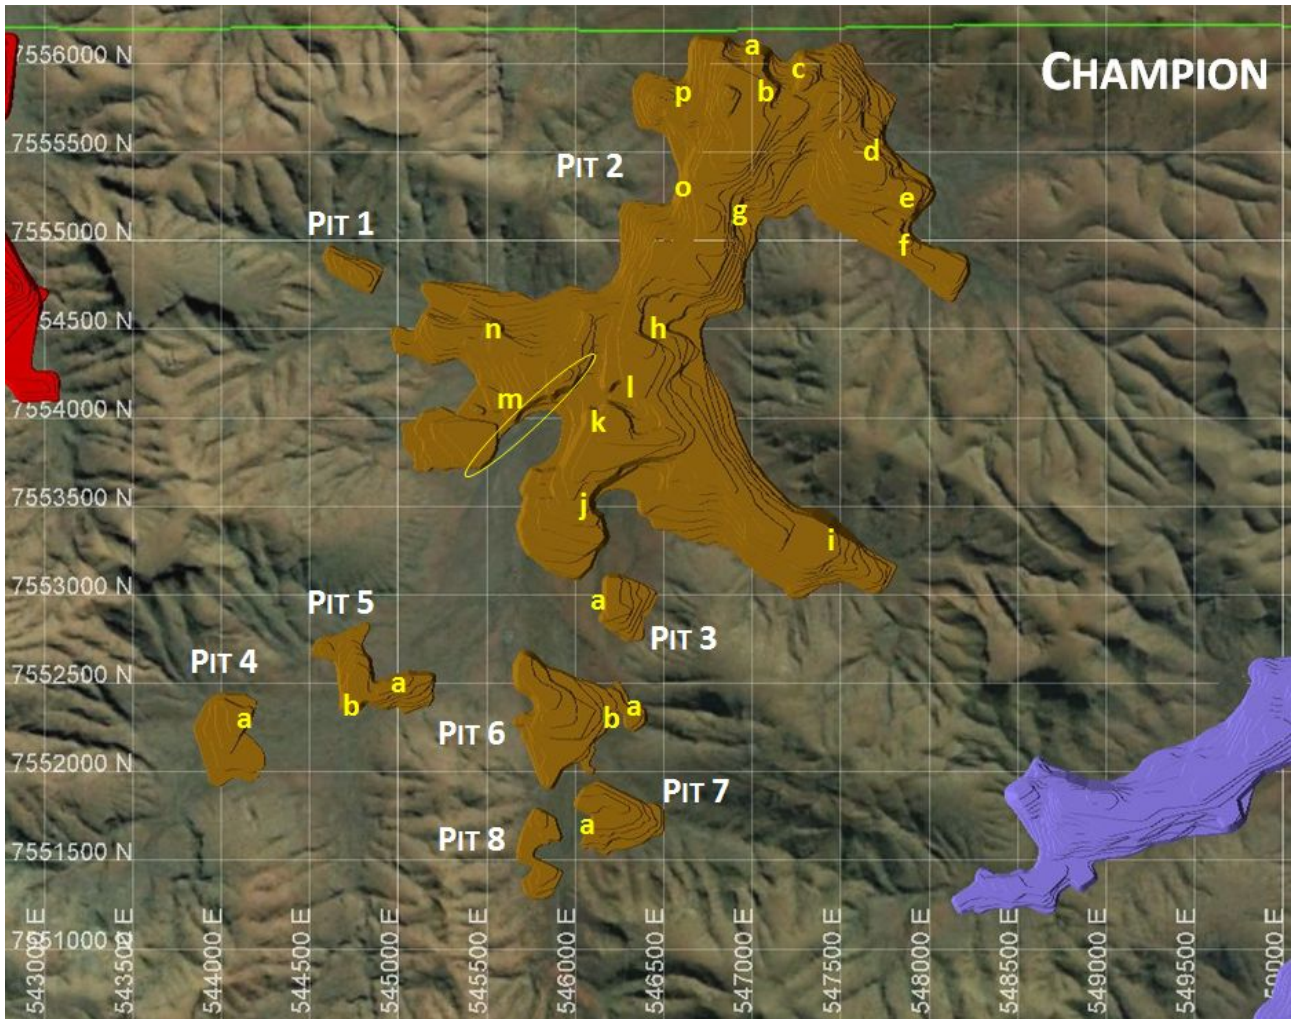
Figure 7: Champion Pits, highlighting areas of geotechnical risk (refer to Table 5, Table 6, Table 7, Table 8, Table 9, Table 10 and Table 11)

Area	Description	Geotechnical Risk	Risk Management
a	22 m (vertical height) slope at a 45 degree angle	Instability could pose risk to equipment/personnel below	Either step in a bench or flatten slope angle

Area	Description	Geotechnical Risk	Risk Management
a	57 m (vertical height) concave slope at a 45 degree angle	Instability could pose risk to equipment/personnel below	Either step in a bench or flatten slope angle
b	36 m (vertical height) convex slope at a 45 degree angle	Instability caused by the convex shape of the slope	Either step in a bench or flatten slope angle
c	36 m (vertical height) slope at a 45 degree angle	Instability could pose risk to equipment/personnel below	Either step in a bench or flatten slope angle
d	Two 18 m (vertical height) slightly convex slopes at 45 degree angles	Instability caused by the convex shape of the slope	Acceptance of risk? And procedural management
e	45 m (vertical height) slope at a 45 degree angle	Instability could pose risk to equipment/personnel below	Either step in a bench or flatten slope angle
f	18 m (vertical height) convex slope at a 45 degree angle	Instability caused by the convex shape of the slope	Acceptance of risk? And procedural management

g	24 m (vertical height) slightly convex slope at a 45 degree angle	Instability caused by the convex shape of the slope	Either step in a bench or flatten slope angle, Acceptance of risk and procedural management?
h	18 m (vertical height) convex slope at a 45 degree angle	Instability caused by the convex shape of the slope	Acceptance of risk? And procedural management
i	72 m (vertical height) slope at a 45 degree angle with a natural slope at a 20 degree angle above it	Instability could pose risk to equipment/personnel below	Either step in a bench or flatten slope angle
j	42 m (vertical height) convex slope at a 45 degree angle	Instability caused by the convex shape of the slope	Either step in a bench or flatten slope angle
k	24 m (vertical height) convex slope at a 45 degree angle	Instability caused by the convex shape of the slope	Either step in a bench or flatten slope angle, acceptance of risk? And procedural management

l	24 m (vertical height) convex slope at a 45 degree angle	Instability caused by the convex shape of the slope	Either step in a bench or flatten slope angle, acceptance of risk? And procedural management
m	36 m (vertical height) undulating slope at a 45 degree angle striking for 440 m	Instability caused by the convex shape of the slope	Change design – straighten slope or make slightly concave. Drilling may be required
n	36 m (vertical height) slope at a 45 degree angle	Instability could pose risk to equipment/personnel below	Either step in a bench or flatten slope angle
o	54 m (vertical height) slightly convex slope at a 45 degree angle	Instability caused by the convex shape of the slope	Either step in a bench or flatten slope angle
p	18 m (vertical height) convex slope at a 45 degree angle	Instability caused by the convex shape of the slope	Either step in a bench or flatten slope angle, acceptance of risk? And procedural management

Area	Description	Geotechnical Risk	Risk Management
a	27 m (vertical height) slope at a 45 degree angle	Instability could pose risk to equipment/personnel below	Either step in a bench or flatten slope angle

Area	Description	Geotechnical Risk	Risk Management
a	22 m (vertical height) slope at a 45 degree angle	Instability could pose risk to equipment/personnel below	Either step in a bench or flatten slope angle, acceptance of risk? And procedural management

Area	Description	Geotechnical Risk	Risk Management
a	31 m (vertical height) slope at a 45 degree angle	Instability could pose risk to equipment/personnel below	Either step in a bench or flatten slope angle
b	28 m (vertical height) convex slope at a 45 degree angle

Area	Description	Geotechnical Risk	Risk Management
a	21 m (vertical height) convex slope at a 45 degree angle	Instability caused by the convex shape of the slope	Either step in a bench or flatten slope angle, acceptance of risk? And procedural management
b	12 m (vertical height) convex slope at a 45 degree angle	Instability caused by the convex shape of the slope	Acceptance of risk? And procedural management

Area	Description	Geotechnical Risk	Risk Management
a	18 m (vertical height) convex slope at a 45 degree angle	Instability caused by the convex shape of the slope	Acceptance of risk? And procedural management

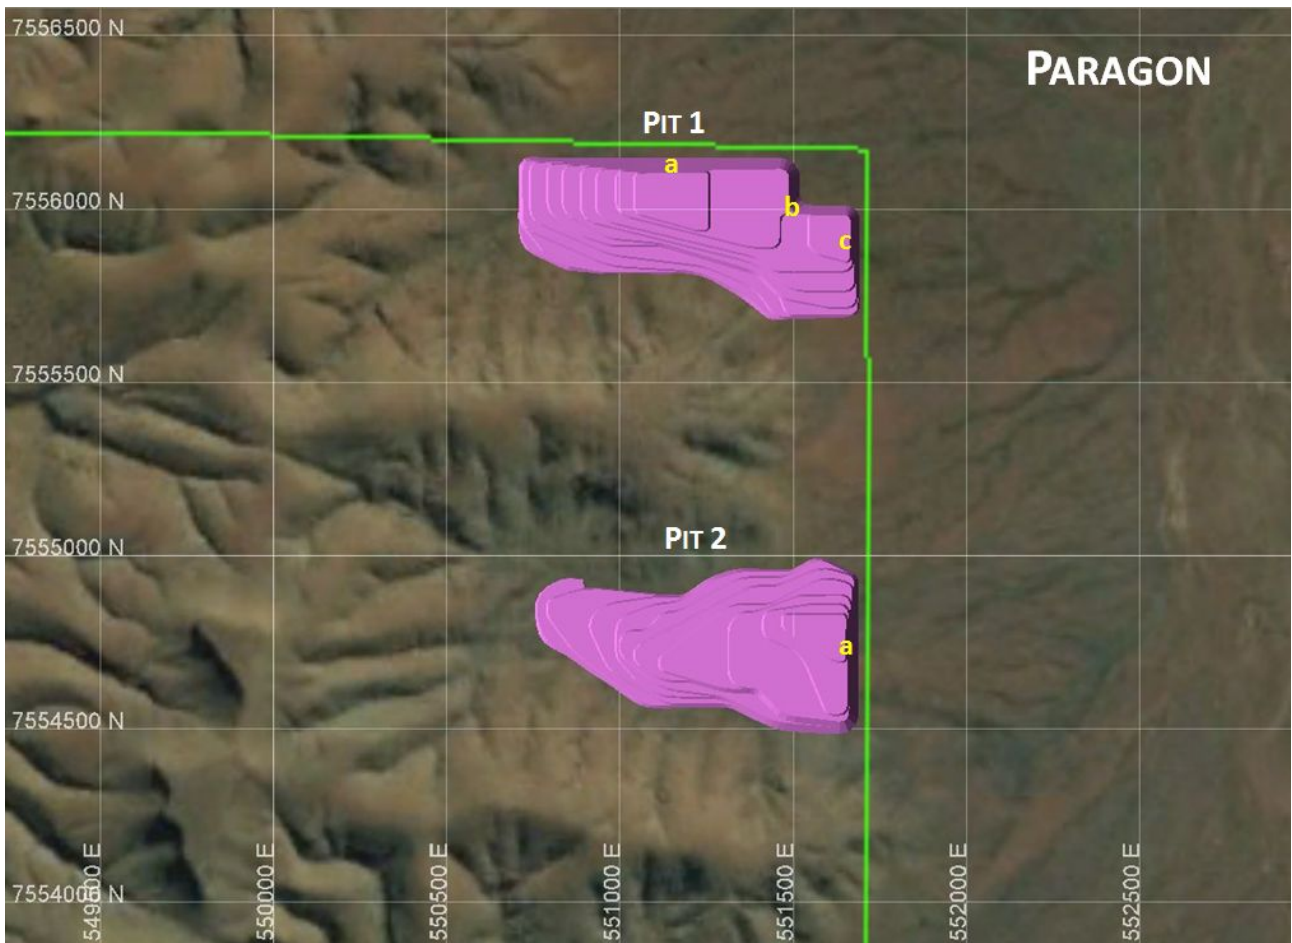
Figure 8: Paragon Pits, highlighting areas of geotechnical risk (refer to Table 12 and Table 13)

Area	Description	Geotechnical Risk	Risk Management
a	44 m (vertical height) slope at 45 degrees with no benches. Crest is 30 m from lease boundary	Instability could pose risk to equipment/personnel below	Either step in a bench or flatten slope angle
b	25 m (vertical height) bullnose at a 45 degree slope angle on the flanks and a 32 degree slope angle at the front	Instability caused by the convex shape of the slope	Either step in a bench or flatten slope angle
c	27 m (vertical height) slope at a 45 degree angle with the crest 19 m from the lease boundary	Instability could pose risk to equipment/personnel below	Either step in a bench or flatten slope angle

Area	Description	Geotechnical Risk	Risk Management
a	36 m (vertical height) slope at a 45 degree angle with the crest 26 m from the lease boundary	Instability could pose risk to equipment/personnel below	Either step in a bench or flatten slope angle

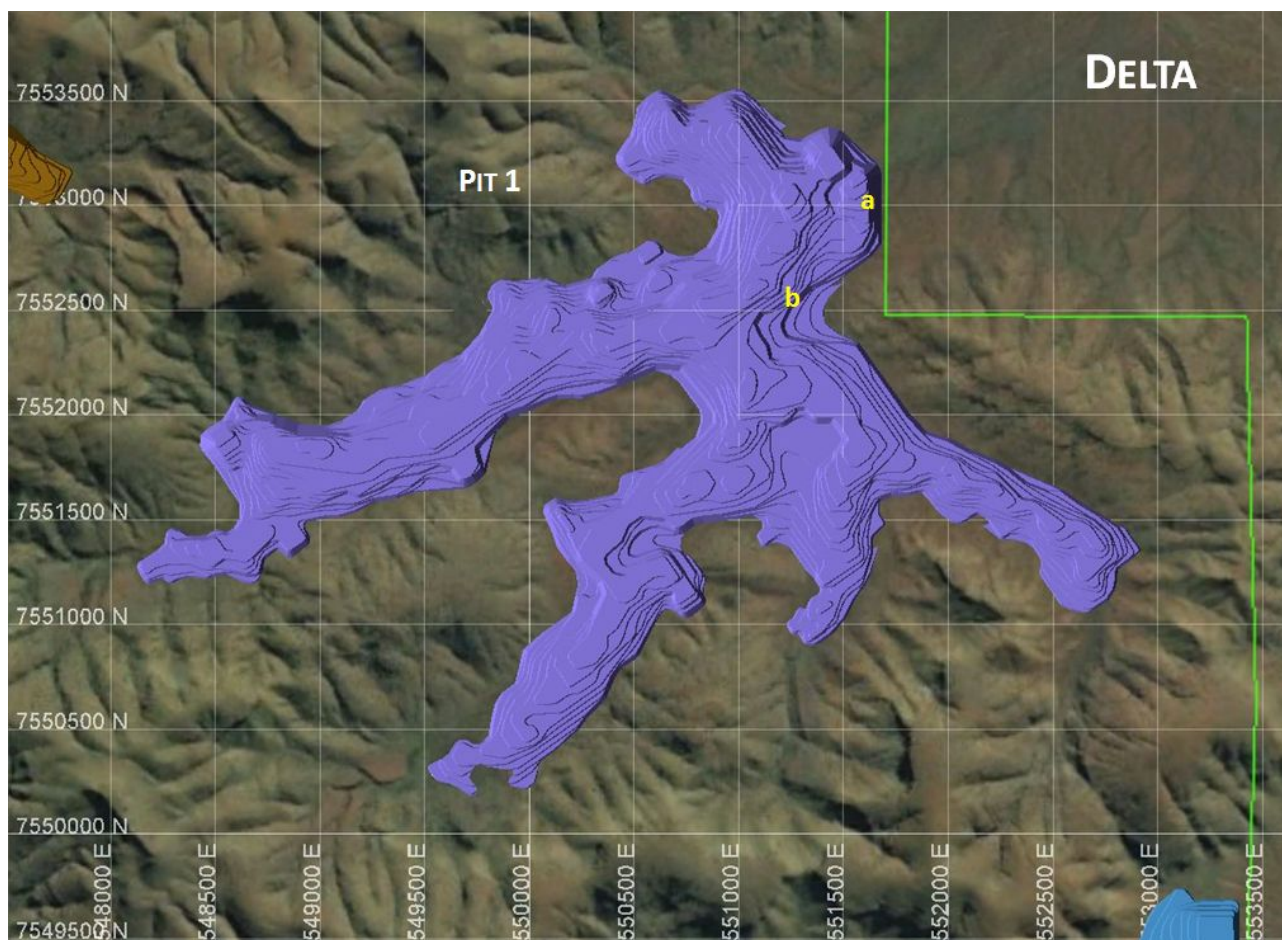
Figure 9: Delta Pit, highlighting areas of geotechnical risk (refer to Table 14)

Area	Description	Geotechnical Risk	Risk Management
a	75 m (vertical height) slope at a 45 degree angle	Instability could pose risk to equipment/personnel below	Either step in a bench or flatten slope angle
b	30 m (vertical height) slightly convex slope at a 45 degree angle	Instability could pose risk to equipment/personnel below	Either step in a bench or flatten slope angle

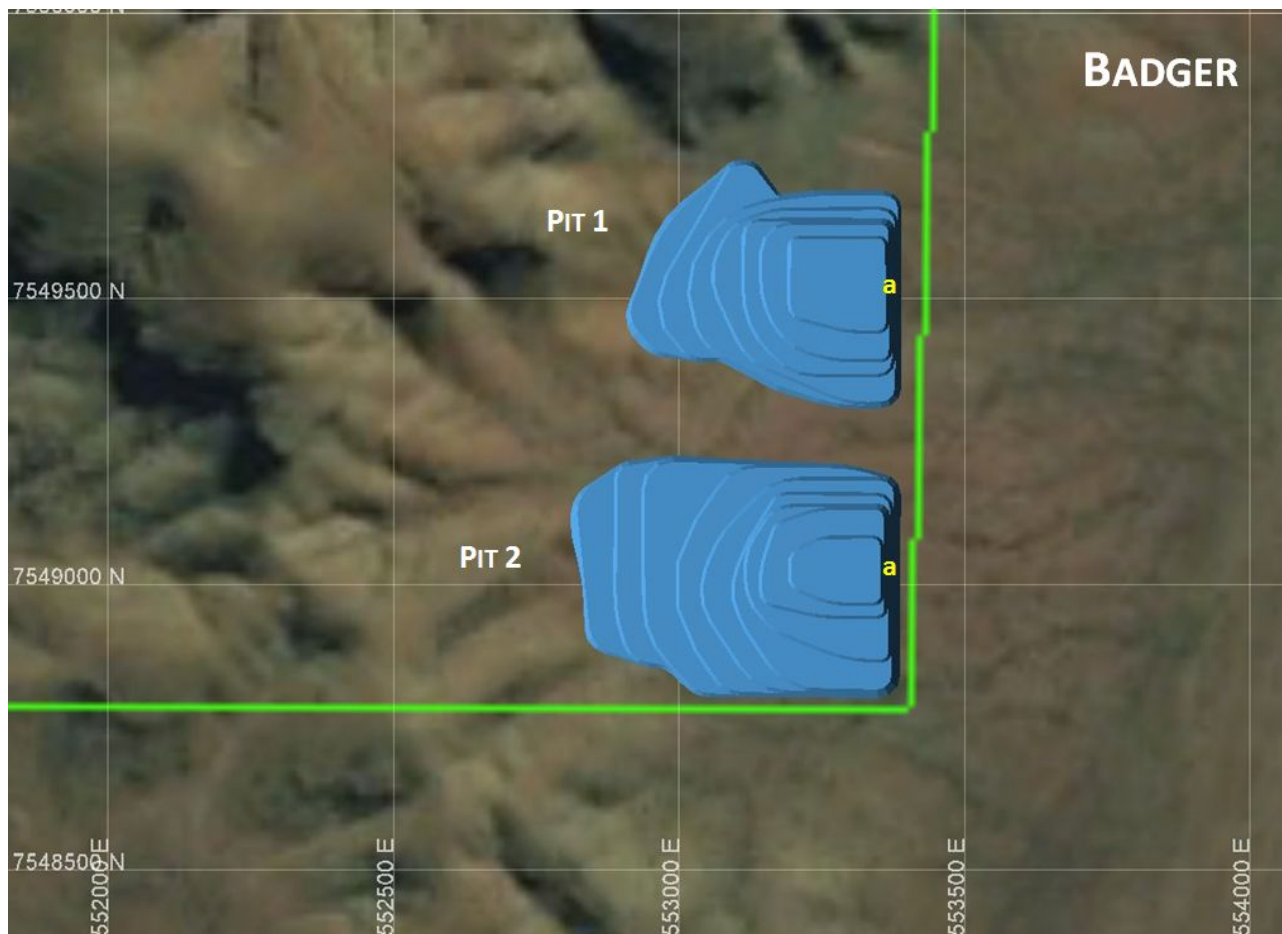
Figure 10: Badger Pits, highlighting areas of geotechnical risk (refer to Table 15 and Table 16)

Area	Description	Geotechnical Risk	Risk Management
a	27 m (vertical height) slope at a 45 degree angle with the crest 31 m from the lease boundary	Instability could pose risk to equipment/personnel below	Either step in a bench or flatten slope angle

Area	Description	Geotechnical Risk	Risk Management
a	34 m (vertical height) slope at a 45 degree angle with the crest 20 m from the lease boundary	Instability could pose risk to equipment/personnel below	Either step in a bench or flatten slope angle
	Southern edge of pit 20 m from lease boundary

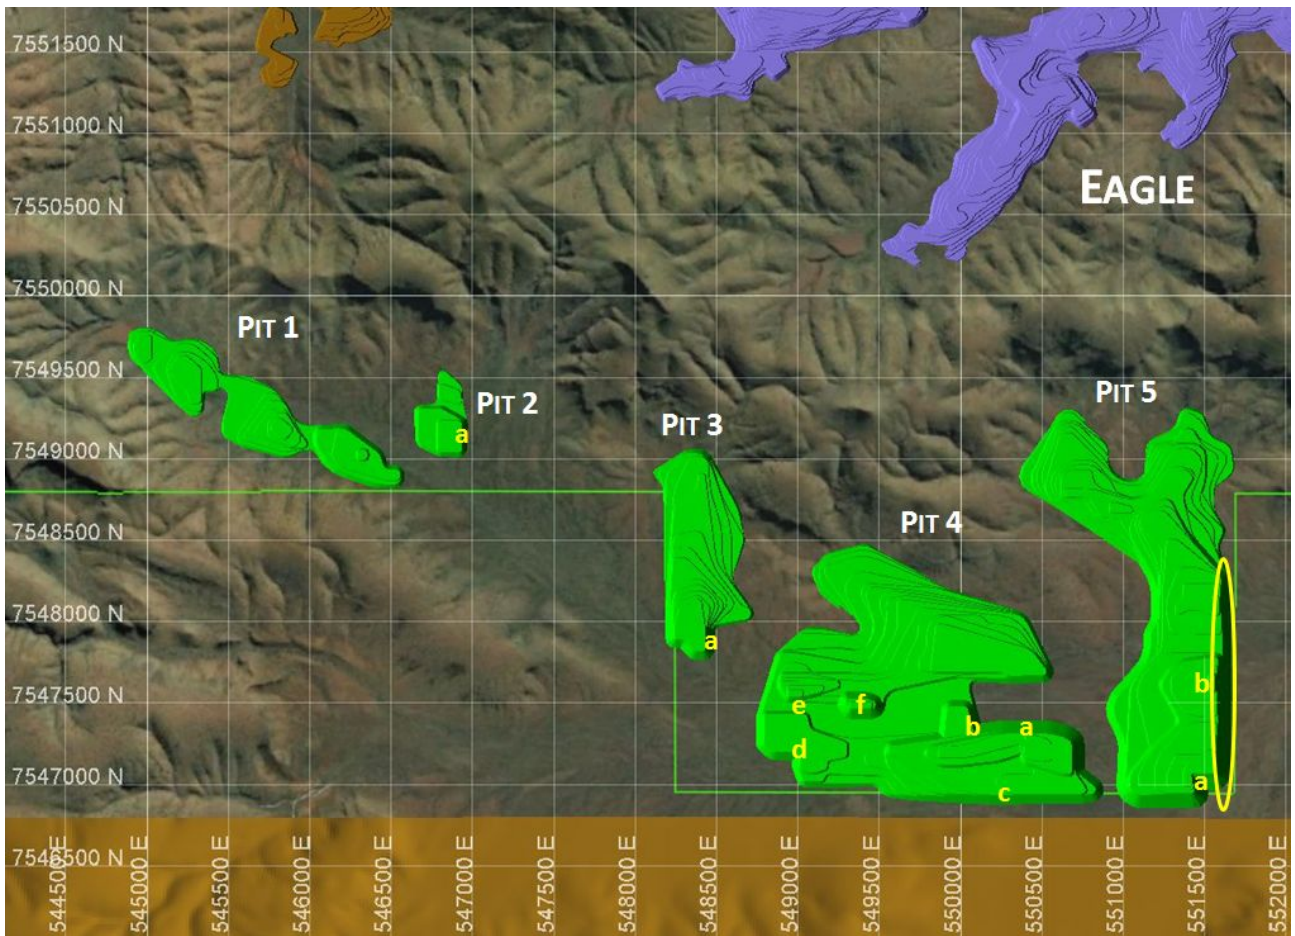
Figure 11: Eagle Pits, highlighting areas of geotechnical risk (refer to Table 17, Table 18, Table 19, Table 20 and Table 21)

Area	Description	Geotechnical Risk	Risk Management
	Southern edge of pit is 20 m from lease boundary

Area	Description	Geotechnical Risk	Risk Management
a	32 m (vertical height) slope at a 45 degree angle	Instability could pose risk to equipment/personnel below	Either step in a bench or flatten slope angle

Area	Description	Geotechnical Risk	Risk Management
a	57 m (vertical height) slope at a 45 degree angle	Instability could pose risk to equipment/personnel below	Either step in a bench or flatten slope angle
	Western edge of pit approximately 56 m outside of lease area

Area	Description	Geotechnical Risk	Risk Management
a	88 m (vertical height) slope at a 45 degree angle	Instability could pose risk to equipment/personnel below	Either step in a bench or flatten slope angle
b	55 m (vertical height) convex slope (bullnose) at a 45 degree angle	Instability caused by the convex shape of the slope	Either step in a bench or flatten slope angle
c	65 m (vertical height) slope at a 45 degree angle	Instability could pose risk to equipment/personnel below	Either step in a bench or flatten slope angle
d	48 m (vertical height) convex slope (bullnose) at a 45 degree angle	Instability caused by the convex shape of the slope	Either step in a bench or flatten slope angle
e	40 m (vertical height) slope at a 45 degree angle	Instability could pose risk to equipment/personnel below	Either step in a bench or flatten slope angle
f	65 m (vertical height) slope at a 45 degree angle	Instability could pose risk to equipment/personnel below	Either step in a bench or flatten slope angle

Southern edge of pit is 60 m outside lease boundary

Area	Description	Geotechnical Risk	Risk Management
a	100 m (vertical height) convex slope (bullnose) at a 45 degree angle	Instability caused by the convex shape of the slope	Either step in a bench or flatten slope angle
b	60-90 m (vertical height) slope at a 45 degree angle striking for 1.2 km along the eastern margin of the pit	Instability caused by the convex shape of the slope	Change design – straighten slope or make slightly concave. Drilling may be required
	Southern edge of pit is 90 m outside lease boundary		
	Eastern edge of pit is 16 m from lease boundary
