WATER FLOW IN MULGA AREAS ADJOINING FORTESCUE MARSH

Report of observations from field trials undertaken for
Fortescue Metals Group Limited

C Muller
January 2005

C Muller Consulting Pty Ltd

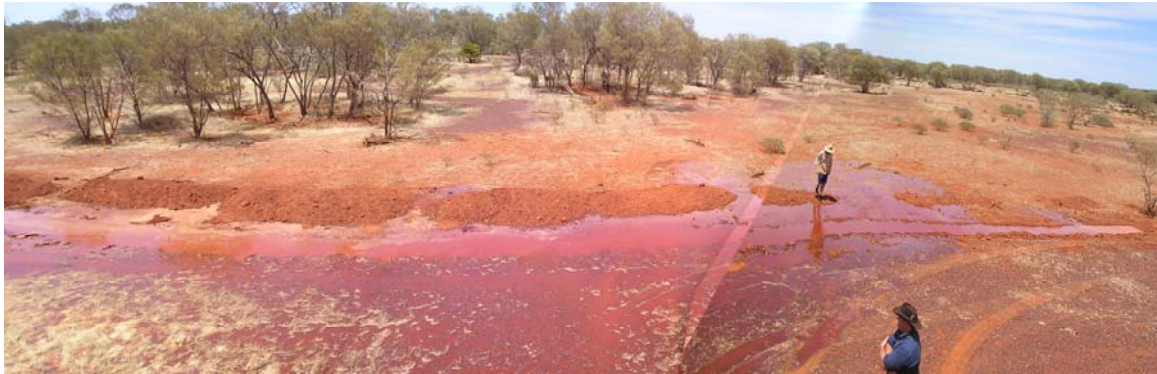
Both spreader ditches successfully spread water at higher flow rates (Figure 8. 9a and 9b), with a higher flow at slight depressions along the ditch sill. However at less than peak flow rates there was strong preferential discharge to one or two lower points only, with flow ceasing at other points. Thus, unless the culvert is running at near capacity, the spreader ditch

will relocate the water to this lowest point, but not spread it out. This will be exacerbated if there is any erosion at these discharge points.

Fig 8: Spreader ditch with bund on down slope side. Note the breaks in the bund in the centre and left of the picture have been affected by cattle trampling, with the one in the centre of the picture completely closed.

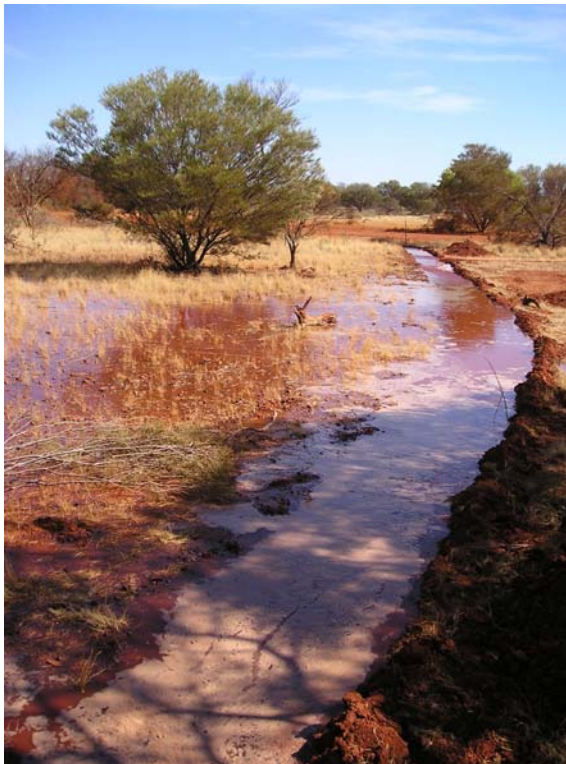
Fig 9a: Unconfined channel. Flow rate 21.5 l/sec. Ditch overflows at multiple points.

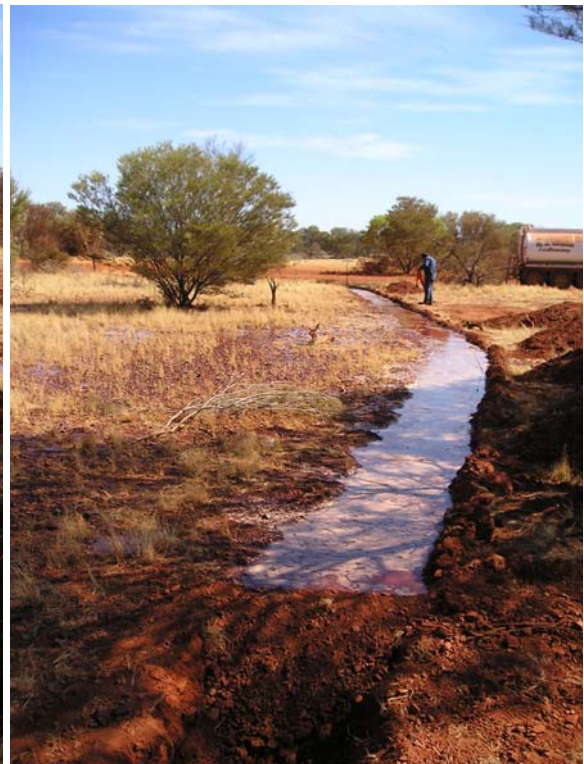
Fig 9b: Reduced flow. Discharge at low point only.

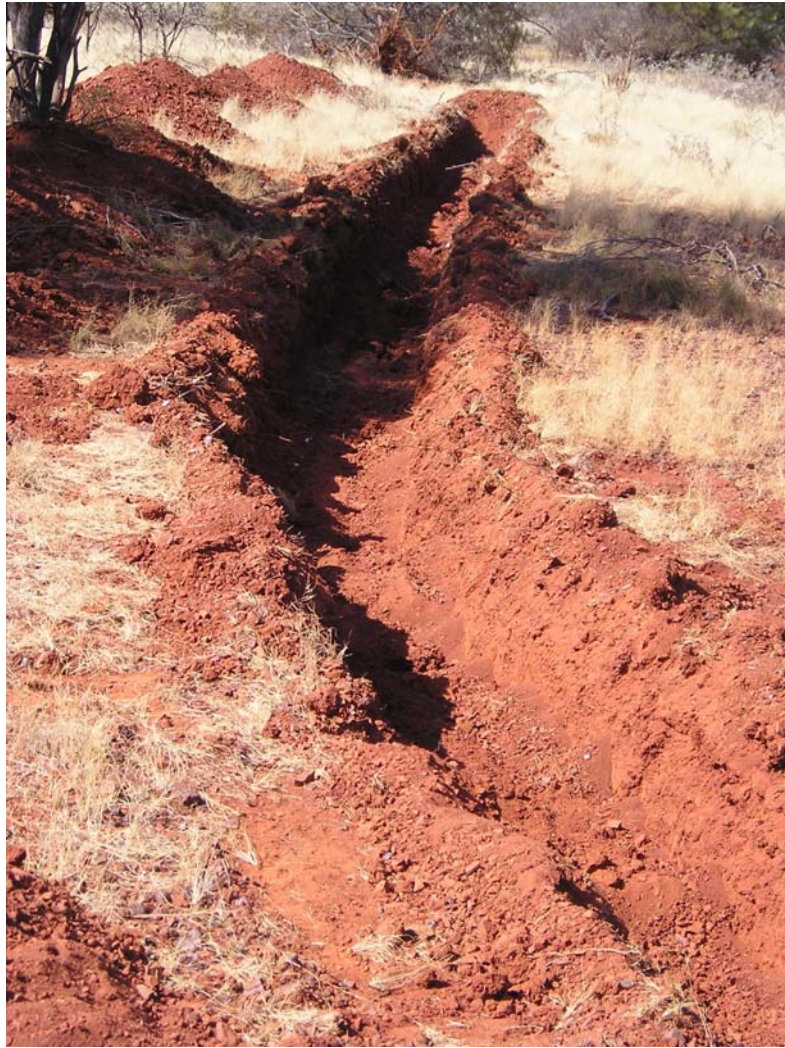
It is difficult/impossible to establish the sill exactly level. Whilst the survey line was pegged to within 5mm, there is inevitable disturbance during construction. Care was taken to leave the down slope side of the lower channel undisturbed. Spill from the backhoe was removed by hand along the down slope side of the “unconfined” ditch.(Figure 8). Despite this, there was preferential discharge (Fig 10).

Fig 10: Minimal disturbance of natural surface to retain level. Spill removed by hand.

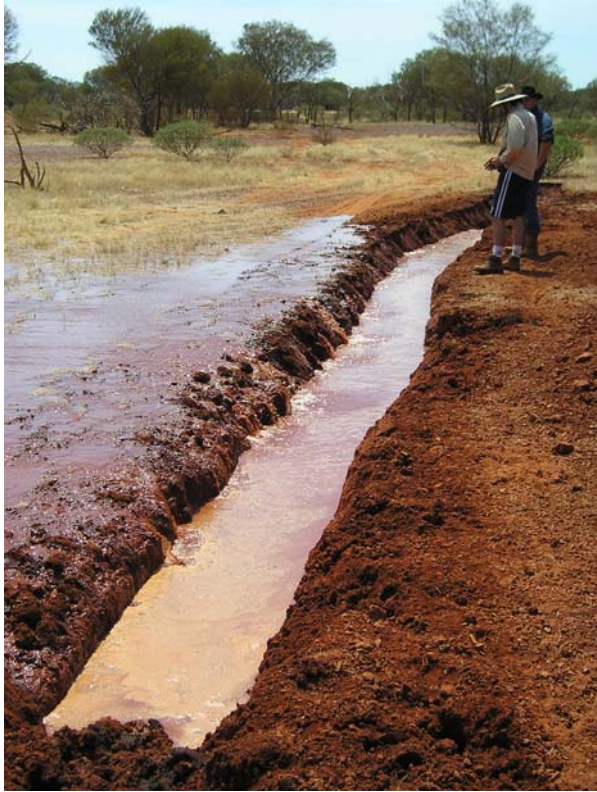
Maintenance of spreader ditches is likely to be a major issue. The upslope (culvert) side of the ditch is susceptible to erosion as it fills (Figure 11) and rock armour may be required.

Fig 11: Ditch edge may need armouring to prevent erosion.

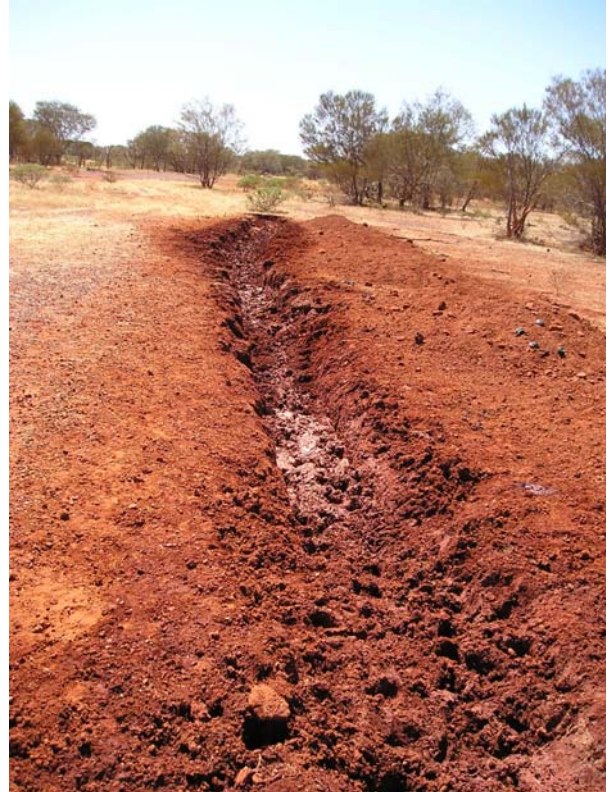
Cattle are also likely to cause major maintenance issues. In the short period between the mounds being constructed and the trial, cattle had trampled the mounds below the spreader ditch, effectively closing two of the openings, even with no water in the ditch. Within 24 hours of the ditch being filled, cattle had trampled both the ditch and the mounds (Figure 12). The problem was probably exacerbated in this case as the surrounding country was dry, and it may be less of a problem during a natural flooding event, however, as the ditches will retain water for a longer period, they will still be a “watering hole”, and attract cattle.

Fig 12: Cattle damage 24 hours after filling.

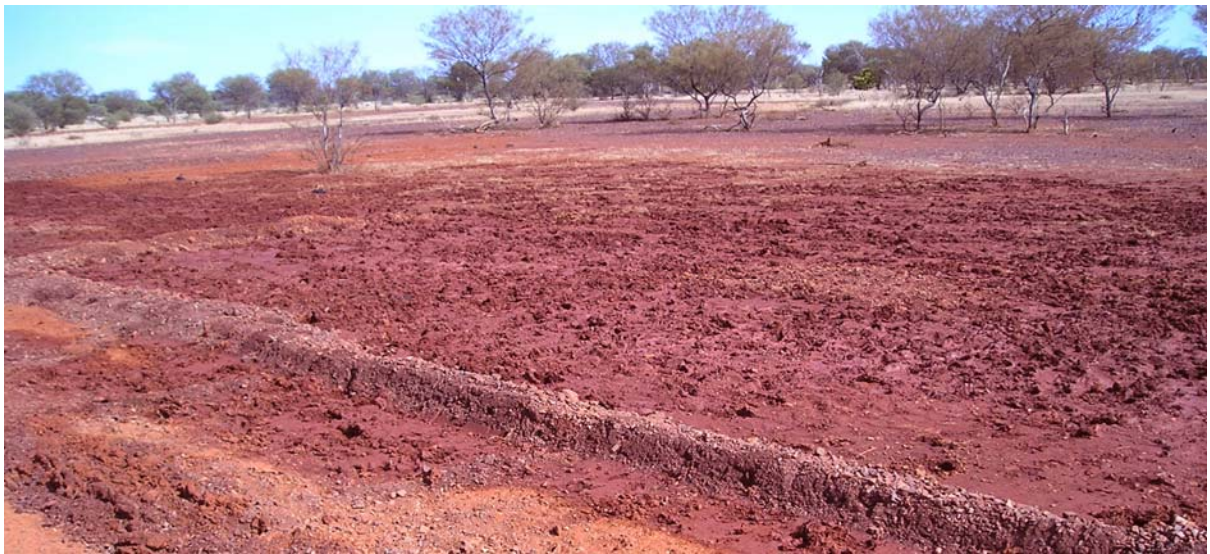
The adjoining levee bank trial also retained water and attracted cattle, but suffered little/no damage (figure 13) during the course of this trial. Maintenance would undoubtedly be required in the longer term.

Fig 13: Cattle trampling did not materially affect the levee bank.

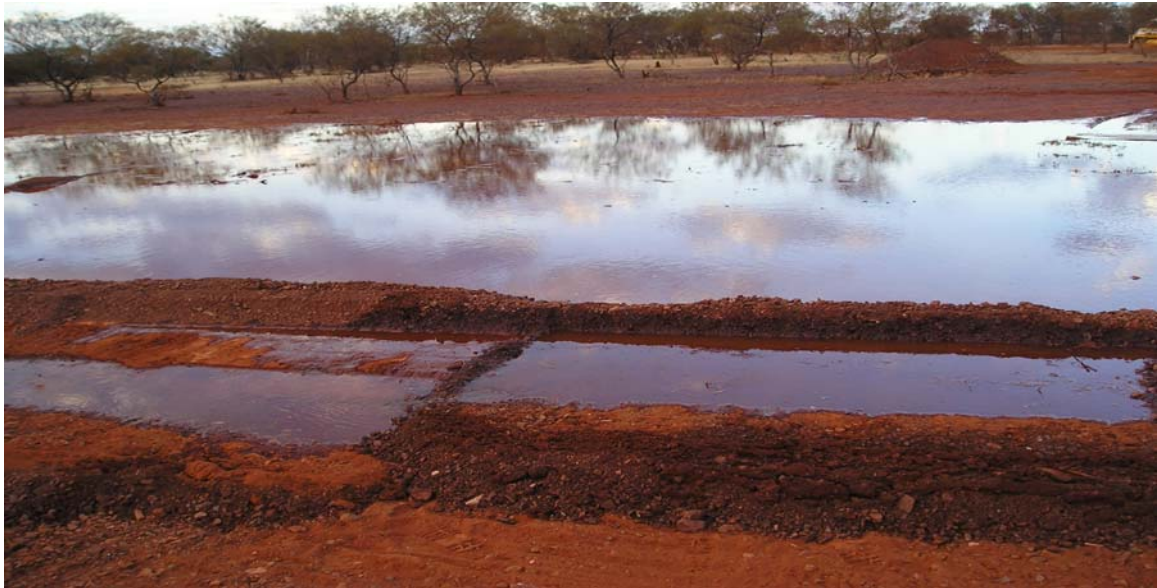
The levee spread water successfully (figures 5a and 5b) but did not allow water to pass as constructed. The levee banks at both sites were modified to make them narrower. They were not uniform, and the variation provided some indication as to the requirements for successful permeability. (Figures 14 and 15). The levee at the “top” site (Figure 15) was constructed quickly by tipping from a loader bucket. The resultant levee is far from uniform, but successfully passed water at a number of points along its length, sufficient to ensure effective

Fig 14: "E20 Levee". This had a high proportion of very fine material, and insufficient permeability, and it is likely it would have eventually over-topped with sufficient water. Effective at spreading the water.

This trial was limited by the material available. The preferred material would be ballast size crushed rock. Due to the limitations of the pumps, the trial could not test the stability of the narrow levee to a full discharge event. In practice it may be necessary to confine the section of levee in the culvert discharge area with wire mesh (gabions or reno mattresses).

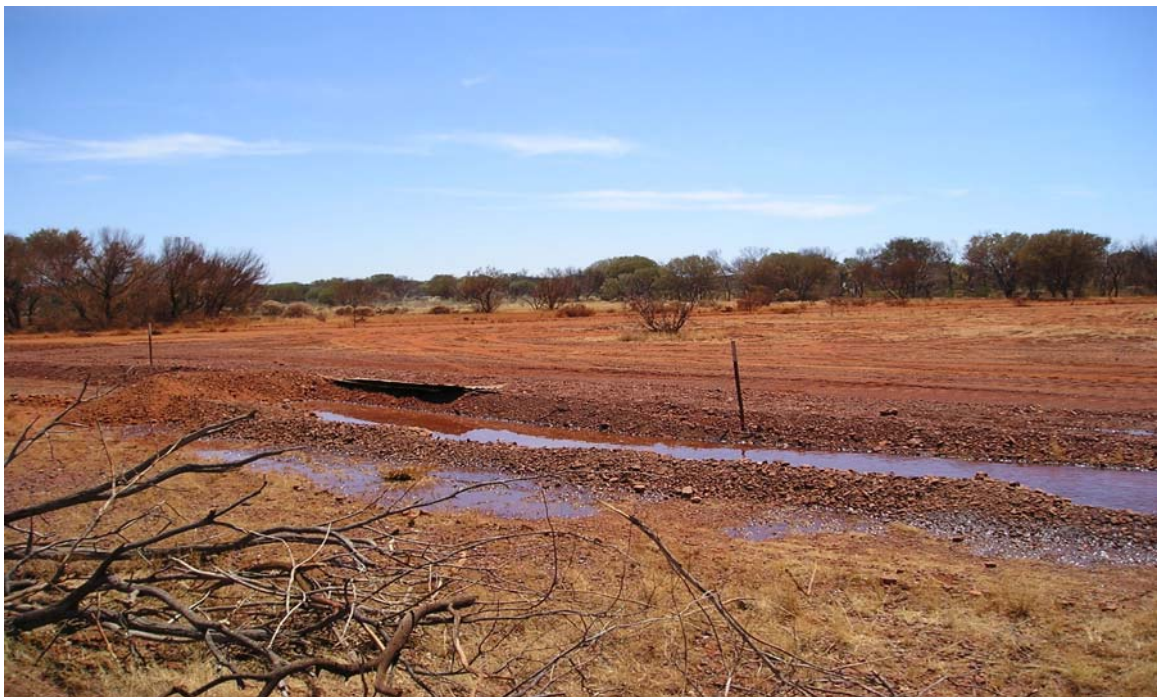
Fig 15: "Top" levee. The front levee was constructed quickly with a loader. The original levee in the rear was too wide and consolidated for the purpose. Permeability was not uniform, but the levee leaked in sufficient places that continuous sheet flow was quickly established.

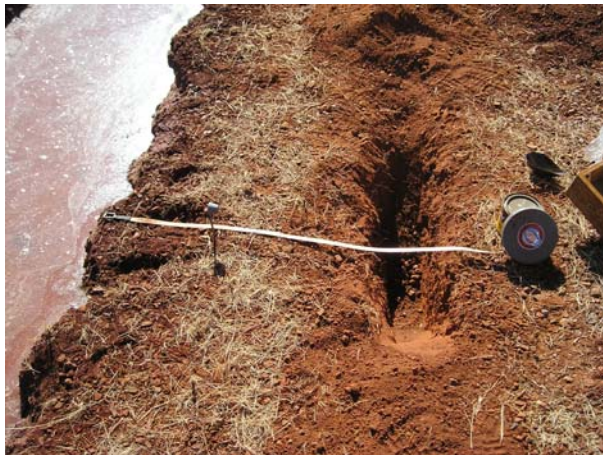
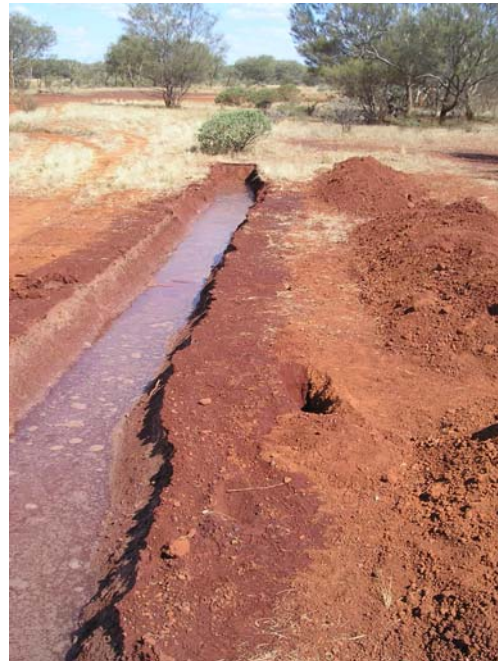
In 24 hours, the maximum progress of subsurface flow from a spreader ditch was 900mm, and therefore is not a significant contributor to water spread.

Fig 16: Penetration after 16 hrs (above) and 24 hours (right)

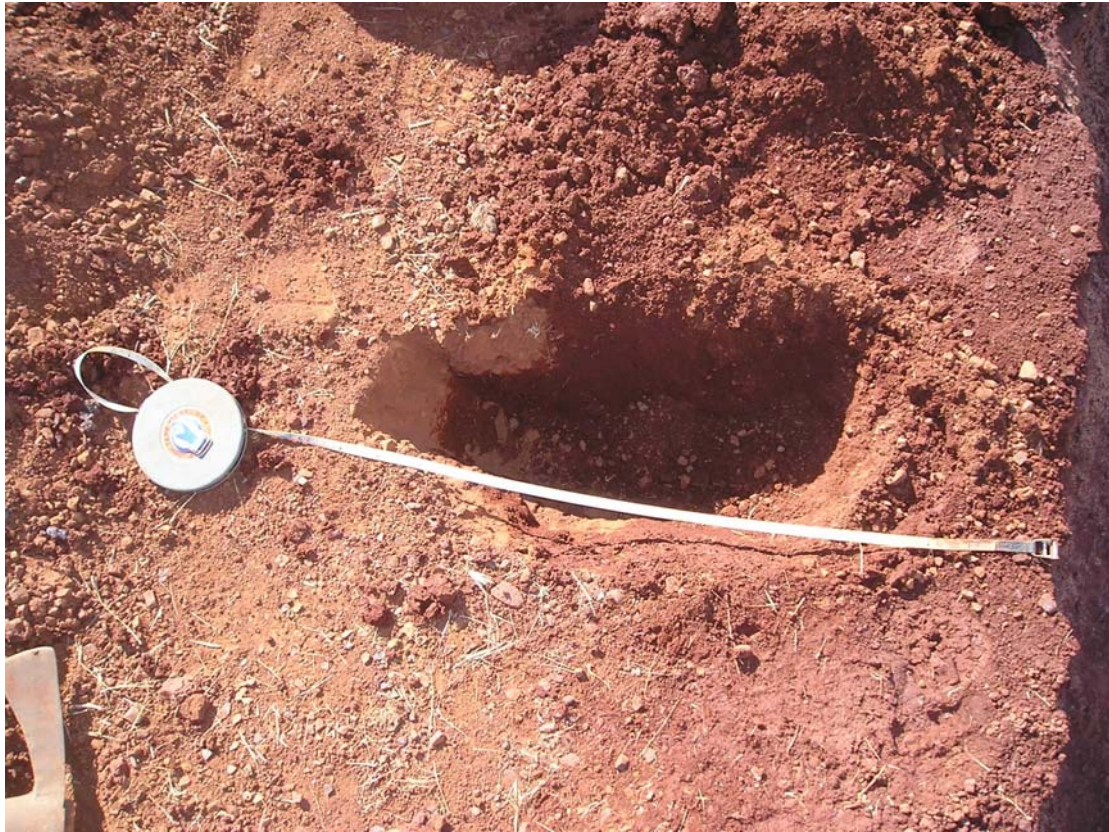
There was no noticeable increase in moisture content ahead of the obvious colour change. The measured moisture content 2 cm ahead of the obvious boundary was 4.3%, and immediately behind the boundary 16+%.

Fig 17: Extent of lateral moisture movement through the soil in 24 hours. Maximum movement was approximately 150mm below the surface. Moisture content 2cm to the left of the obvious boundary was 4.3%.
