updated
screening and
rehabilitation program

Red Hill Quarry

March 2007

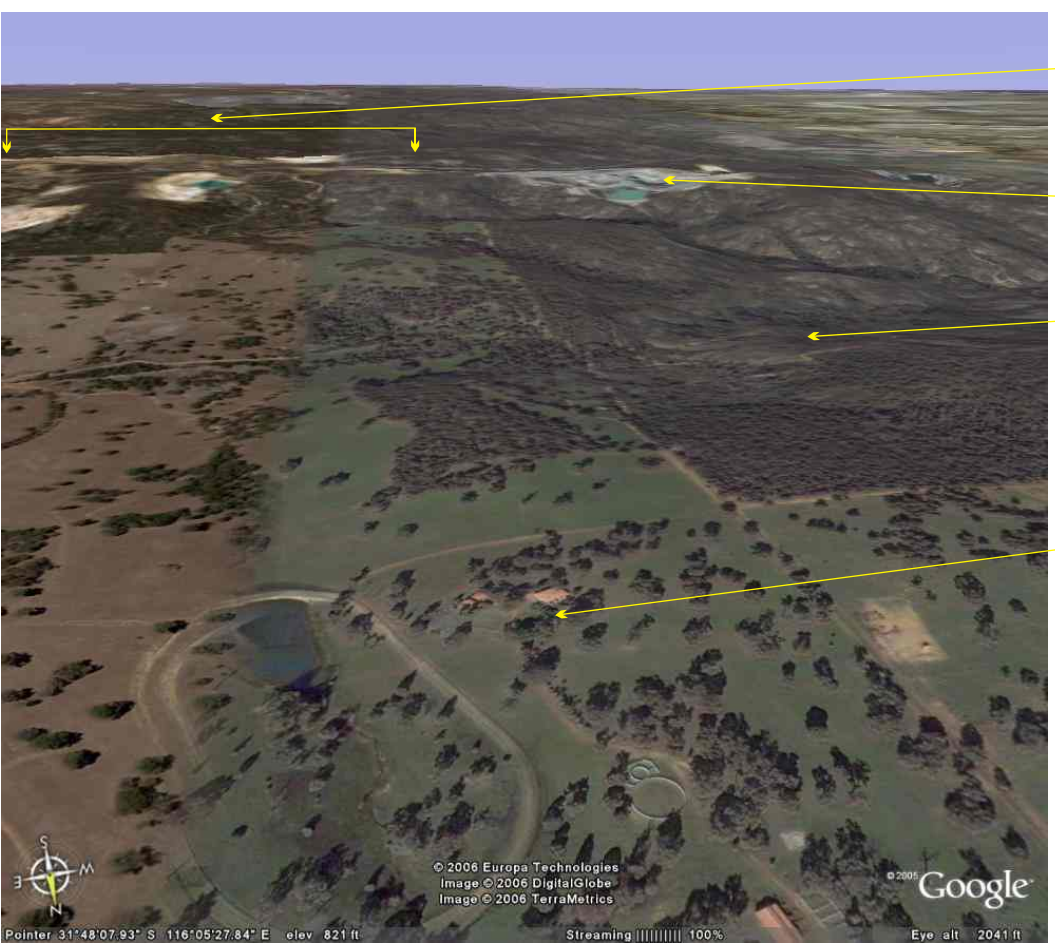
- Midland Brick pits
- Red Hill pit
- Buffer owned by Hanson Construction Materials
- The pit is not visible from this dwelling

VIEW FROM LOT 250

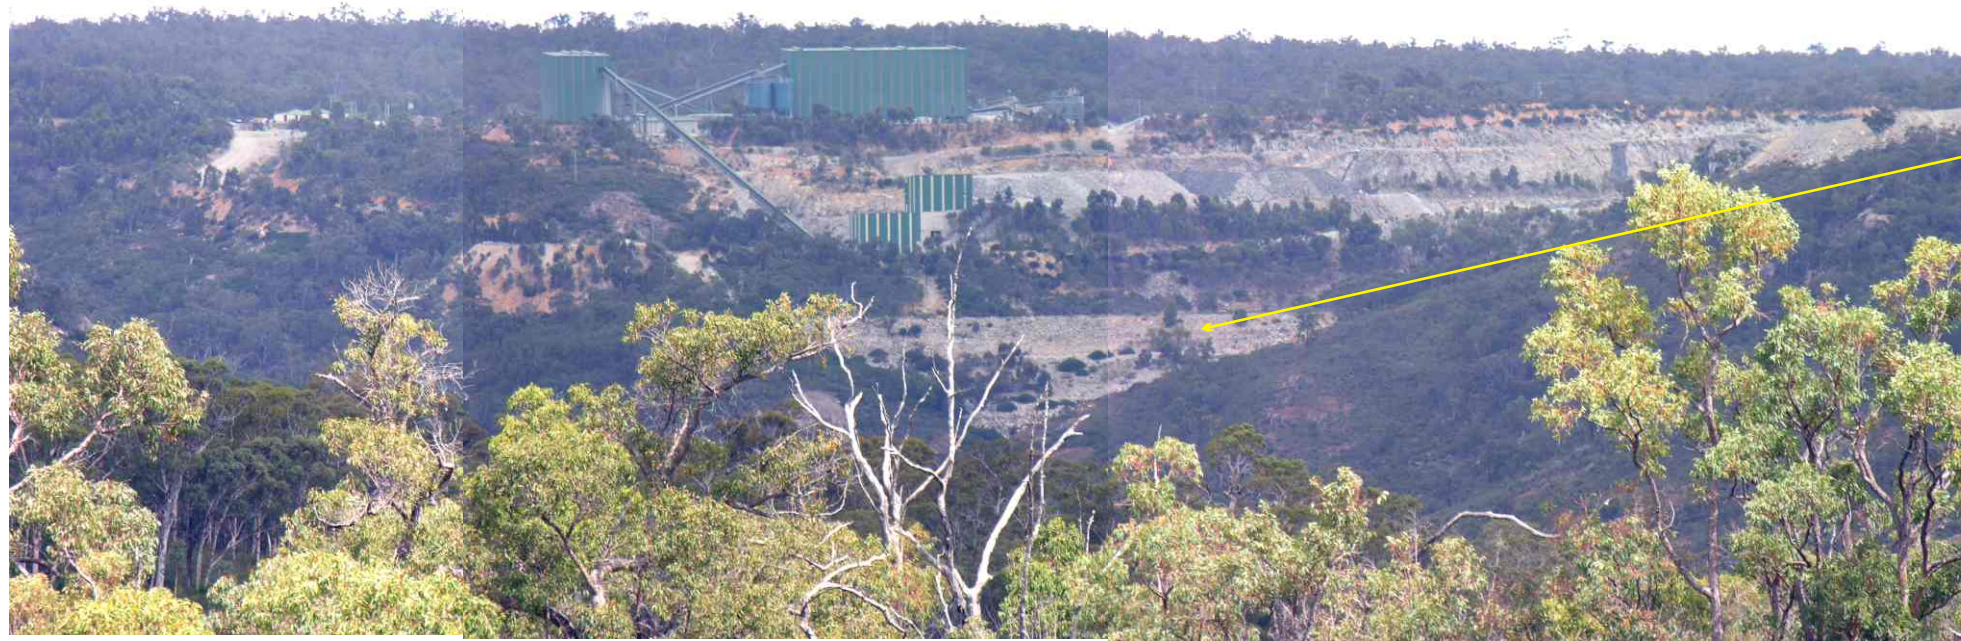
Figure 7 View from northern side of Susannah Brook in November 2006. The photo is at the same scale as the one above taken in December 2006

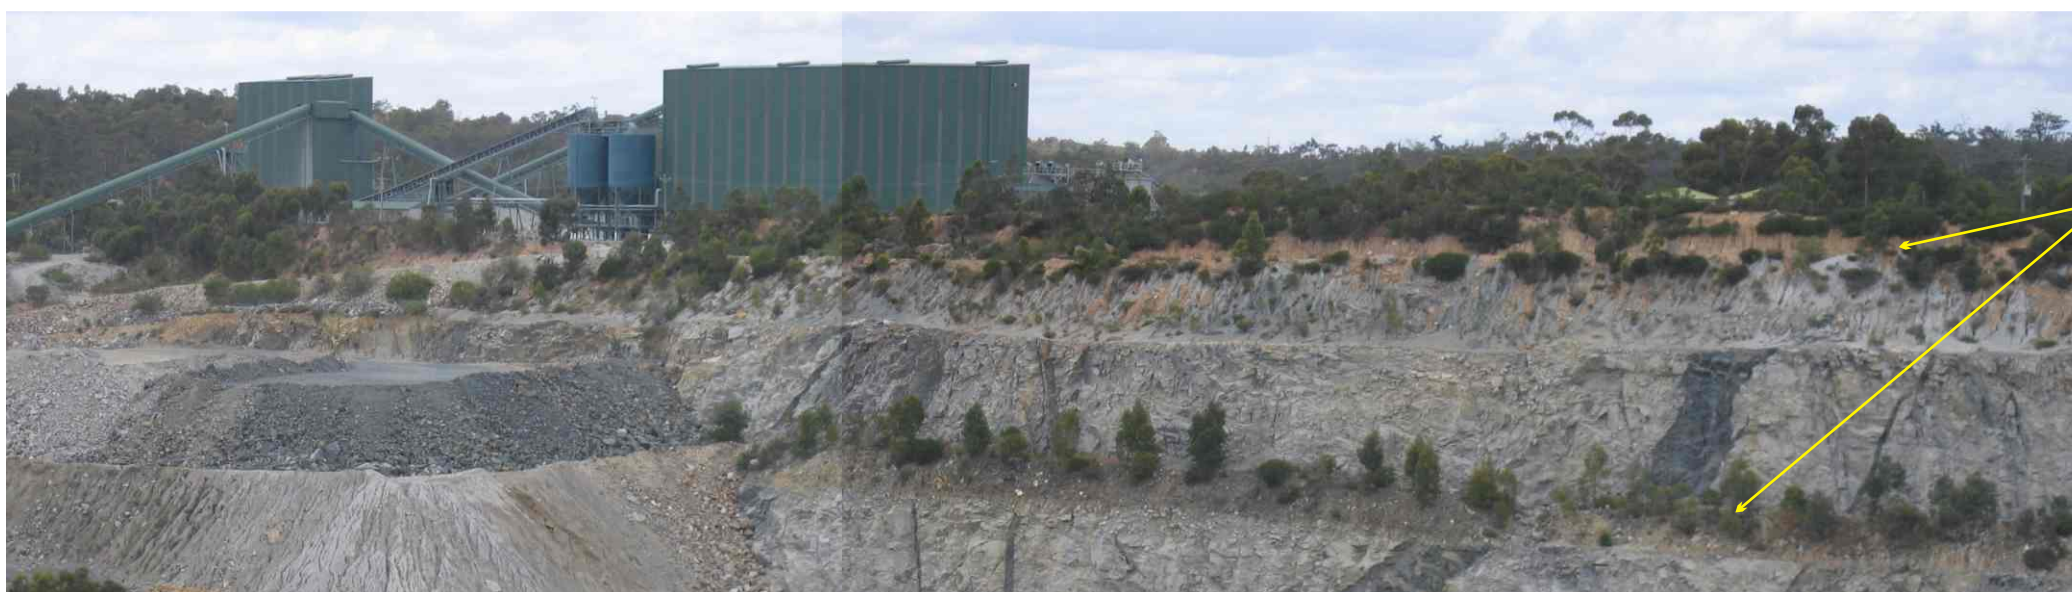
Rehabilitation of upper benches

Figure 8 Southern face of the pit showing rehabilitation of the upper benches

6. It should be noted that for dumps and batters, some of the ground preparation is not possible for certain safety reasons such as backfilling benches. See Figure 8.
7. Dump and batter slopes are constructed with a mixture of rock in the core, to assist slope stability, with a covering of overburden.
8. Slopes should be left rough and not smoothed or compacted, both of which increase surface water runoff. Batter slopes left rough enable easy access for rehabilitation and provide sufficient undulations and depressions to catch seeds and assist in water penetration.

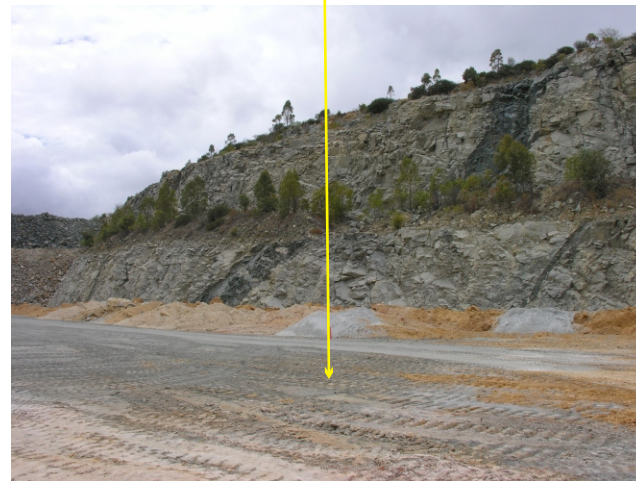
Interim revegetation of the south eastern face that will be backfilled and rehabilitated

To be vegetated in 2007

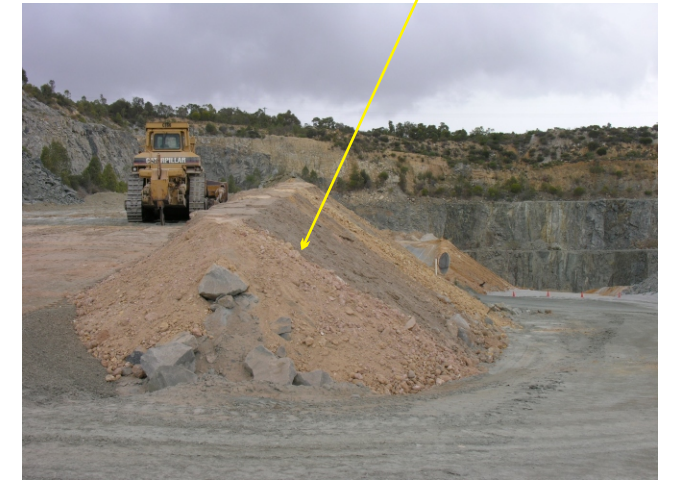
Construction of benches to enable backfill of the south eastern face

BACKFILL OF THE SOUTH EASTERN FACE AND CONCEPT TIMING OF REHABILITATION HANSON CONSTRUCTION MATERIALS RED HILL QUARRY

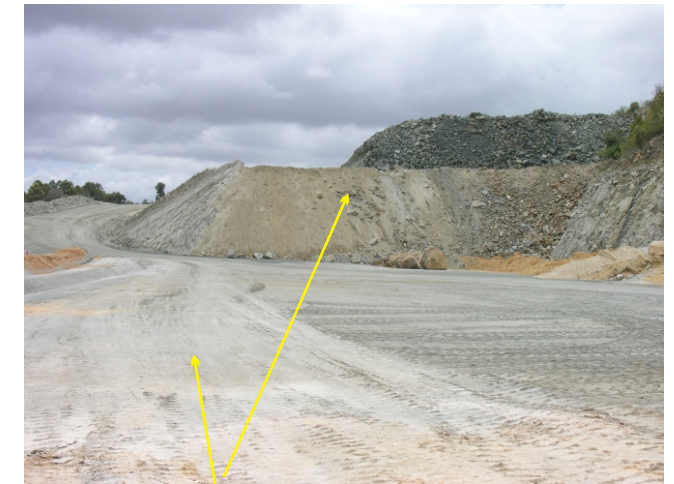
Construction of benches to enable backfill of the south eastern face To be covered by overburden and vegetate, to screen the diorite stockpile.

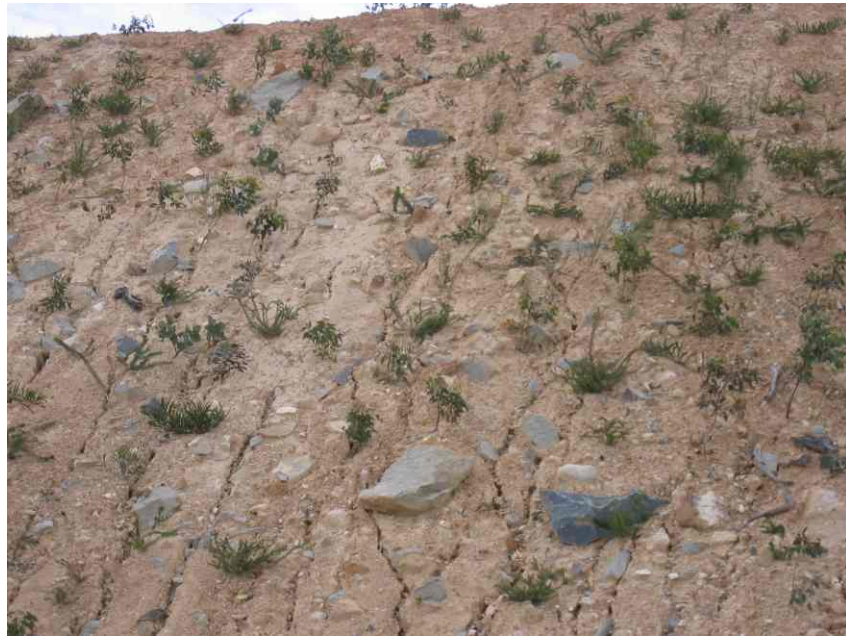
Figure 3 Year 2005 rehabilitation in hardened ground. Mainly tube plants

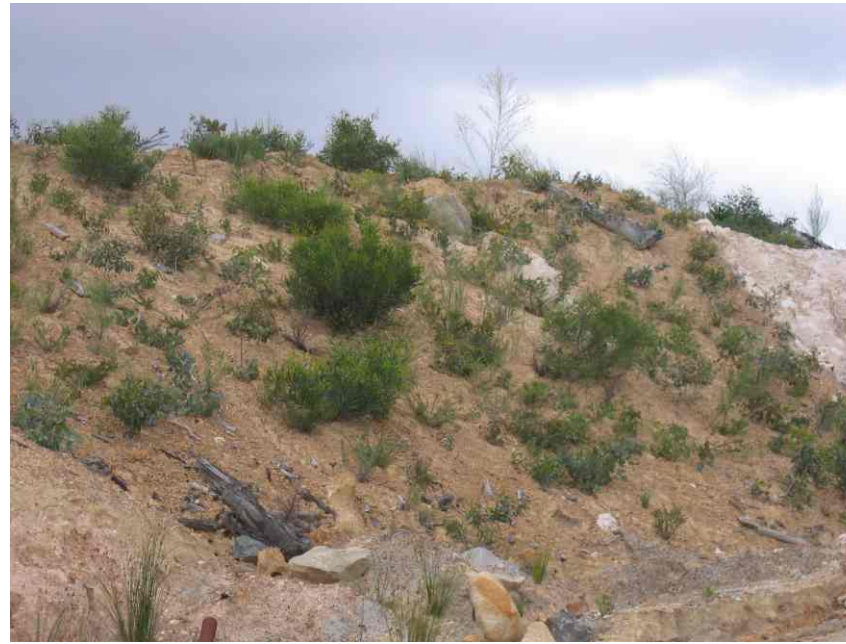
Figure 4 Year 2005 rehabilitation in softer ground. Tube plants and seed

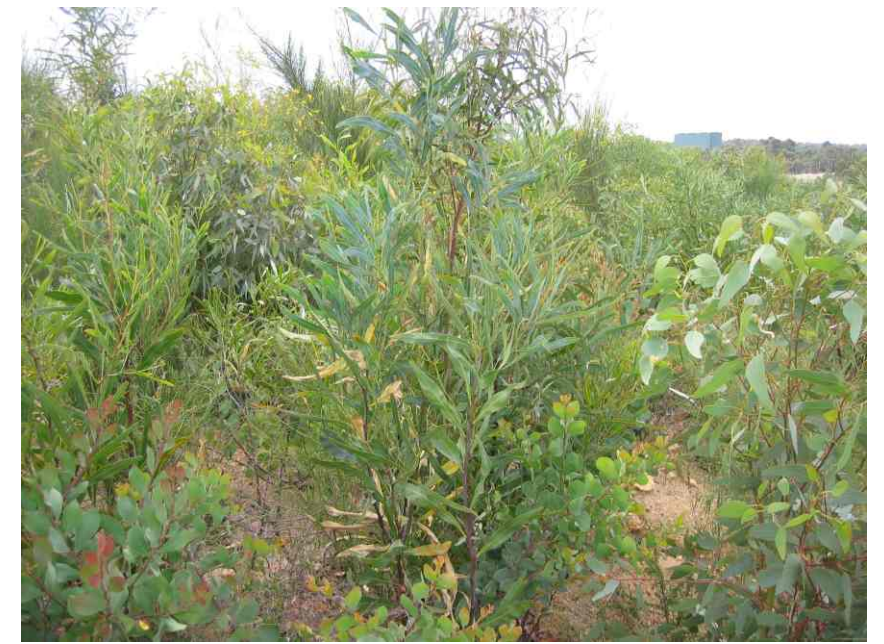
Figure 5 2004 - 2005 rehabilitation on the overburden dump. Note high lateral cover.

However on the newer rehabilitation (2003 – 2005) on the overburden dump, where growth conditions were good, using the changed rehabilitation methods resulted in an average number of species of 2.5 per m² of shrubs and trees. See Appendix 1.

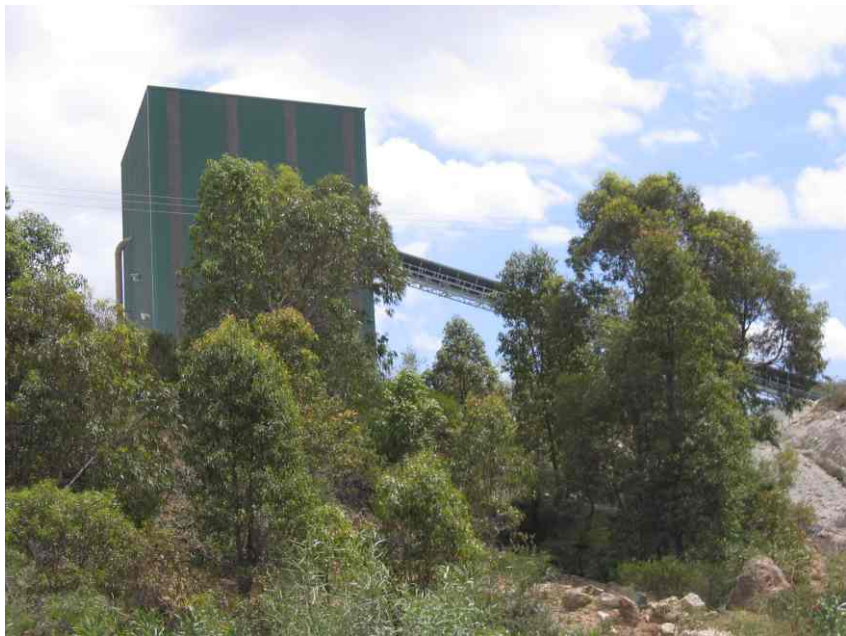
Figure 6 Sample Area 4 vegetation. Whilst not thick, it provides good lateral screening

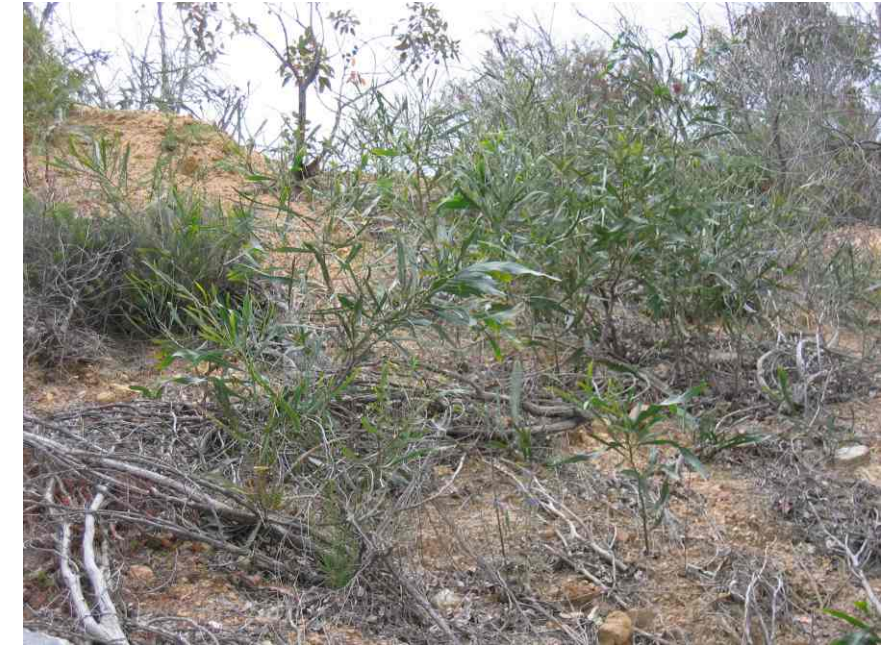
Figure 8 Sample Area 2, showing germination and regrowth of *Acacia saligna*

Some of the shorter lived species such as *Acacia saligna* have died but have been replaced by seedlings, ensuring that the rehabilitation is self sustaining.

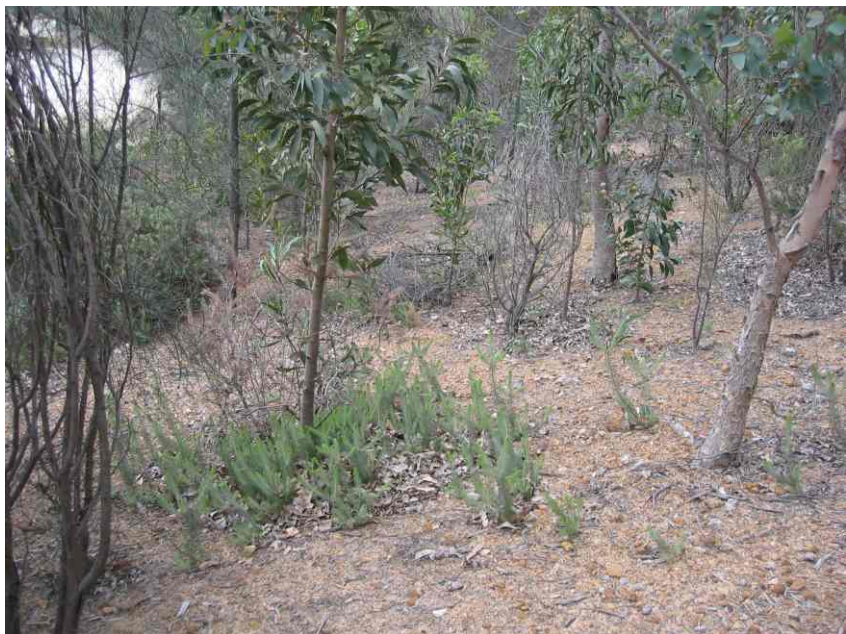
Figure 9 Self seeding and germination of *Calothamnus quadrifidus* in Sample Area 1
Note that whilst the vegetation is not dense lateral screening is provided in the distance

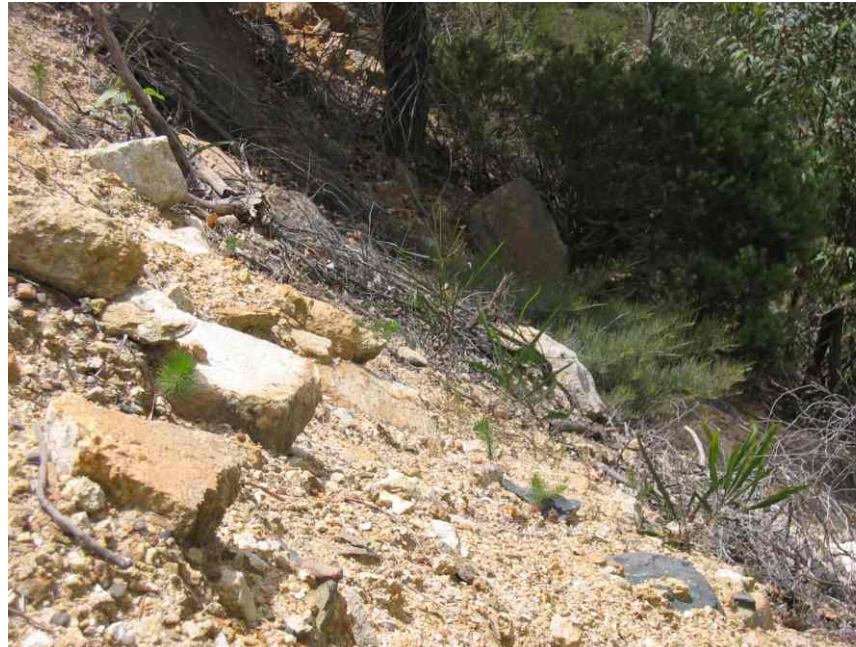
Figure 10 Self seeding and germination on bare area of Sample Area 3

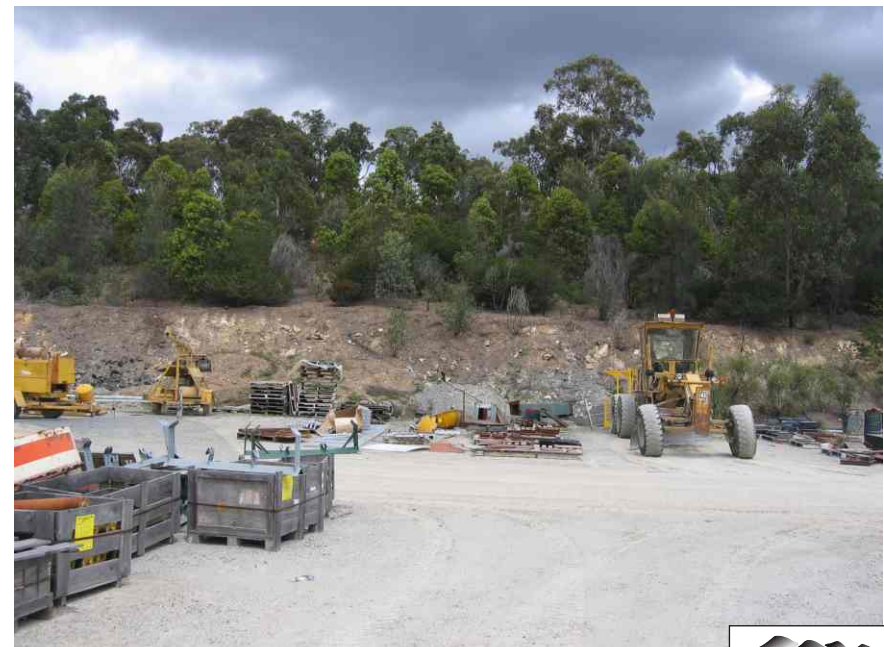
Figure 11 Lateral view of Area 1 rehabilitation. Compare to Figure 12
