# Fortescue Metals Group

## Cave 13 Lateral Extent and Structural Assessment

March 2015

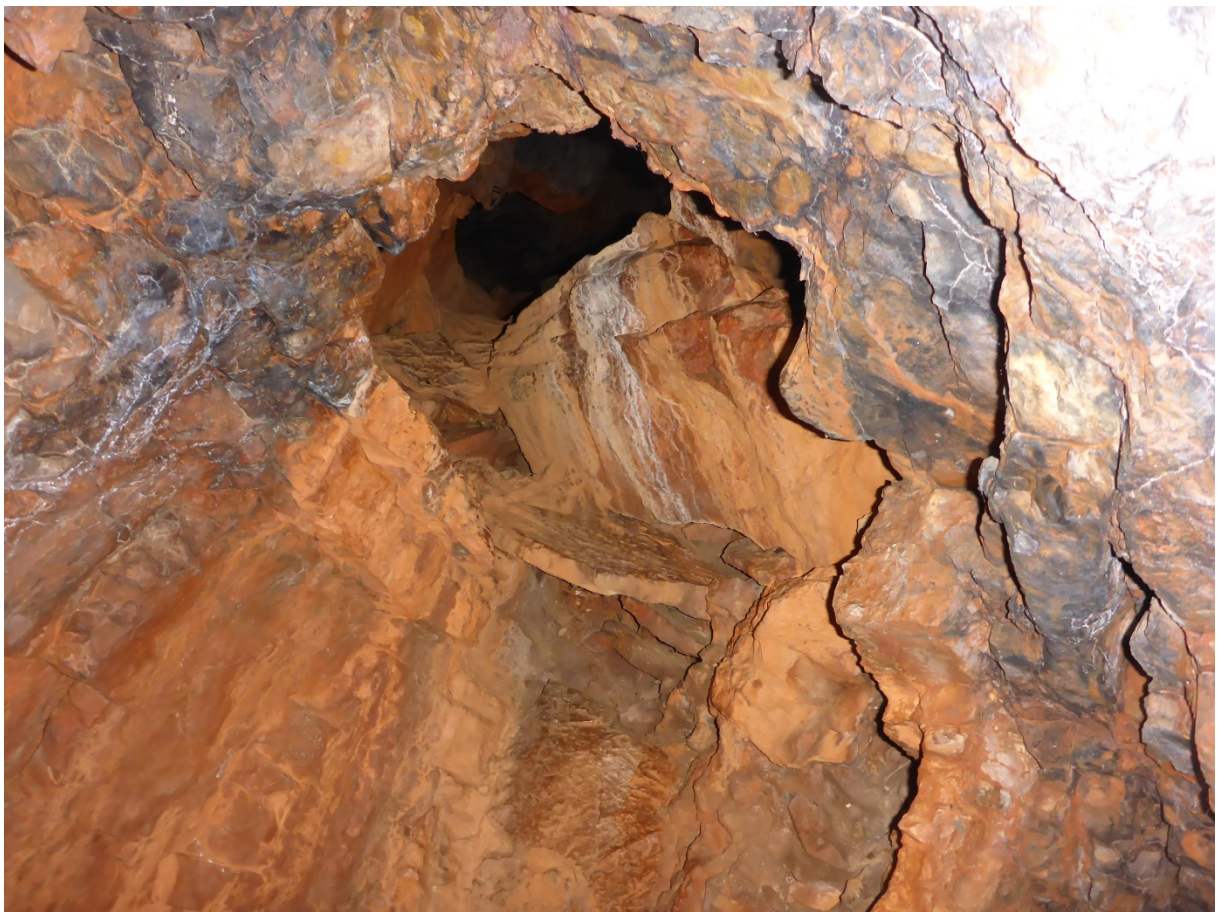
Plate 1 Looking up the 45° inclined passage to the upper chamber (field of view ~1 m).

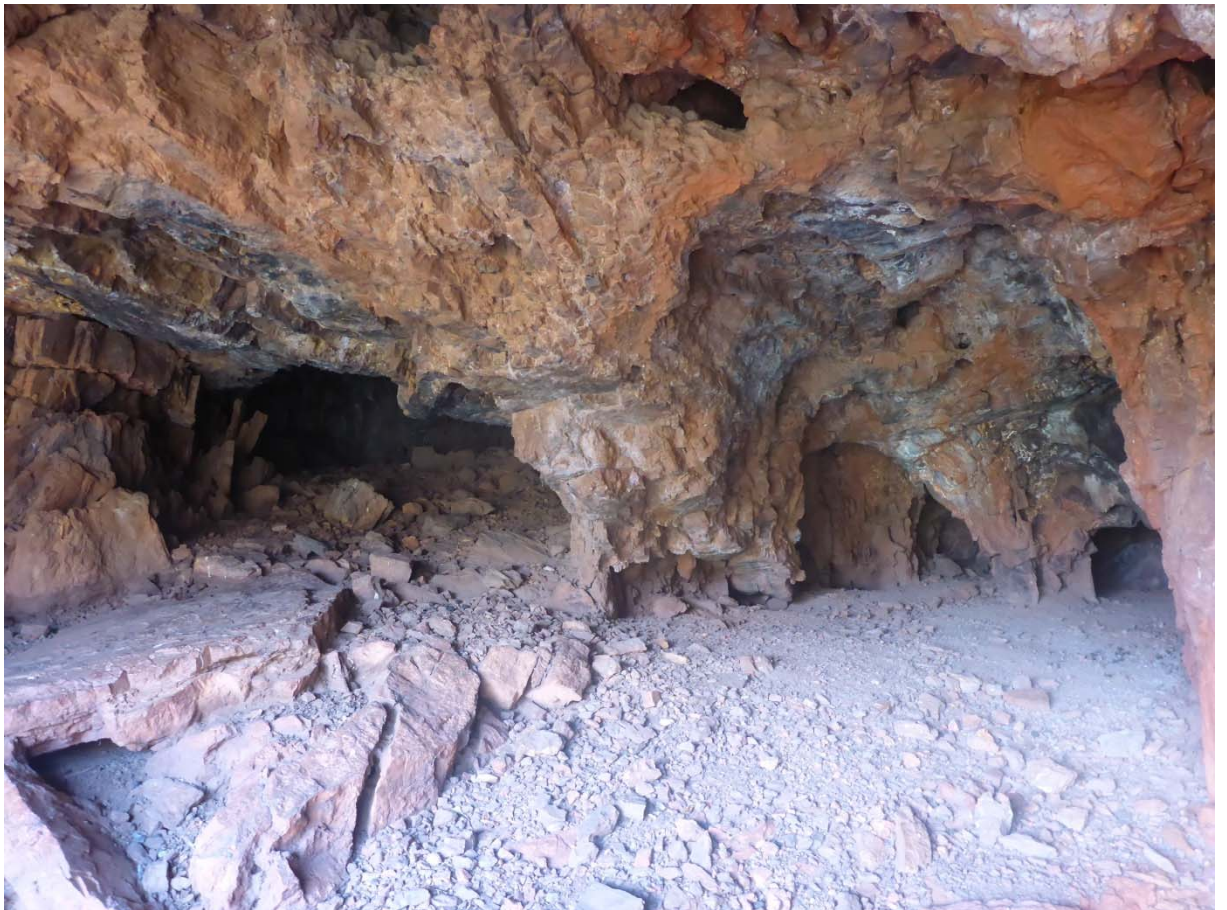
The majority of Cave 13 is lit at least partially by daylight (Plate 4), with some twilight zones located within the side chambers of the central passage, and in the lower portion of the eastern most passage. The upper chamber in the eastern most passage is within the dark zone of the cave.

Plate 4 View south into the eastern most passage (right) and central passage (field of view ~6 m).

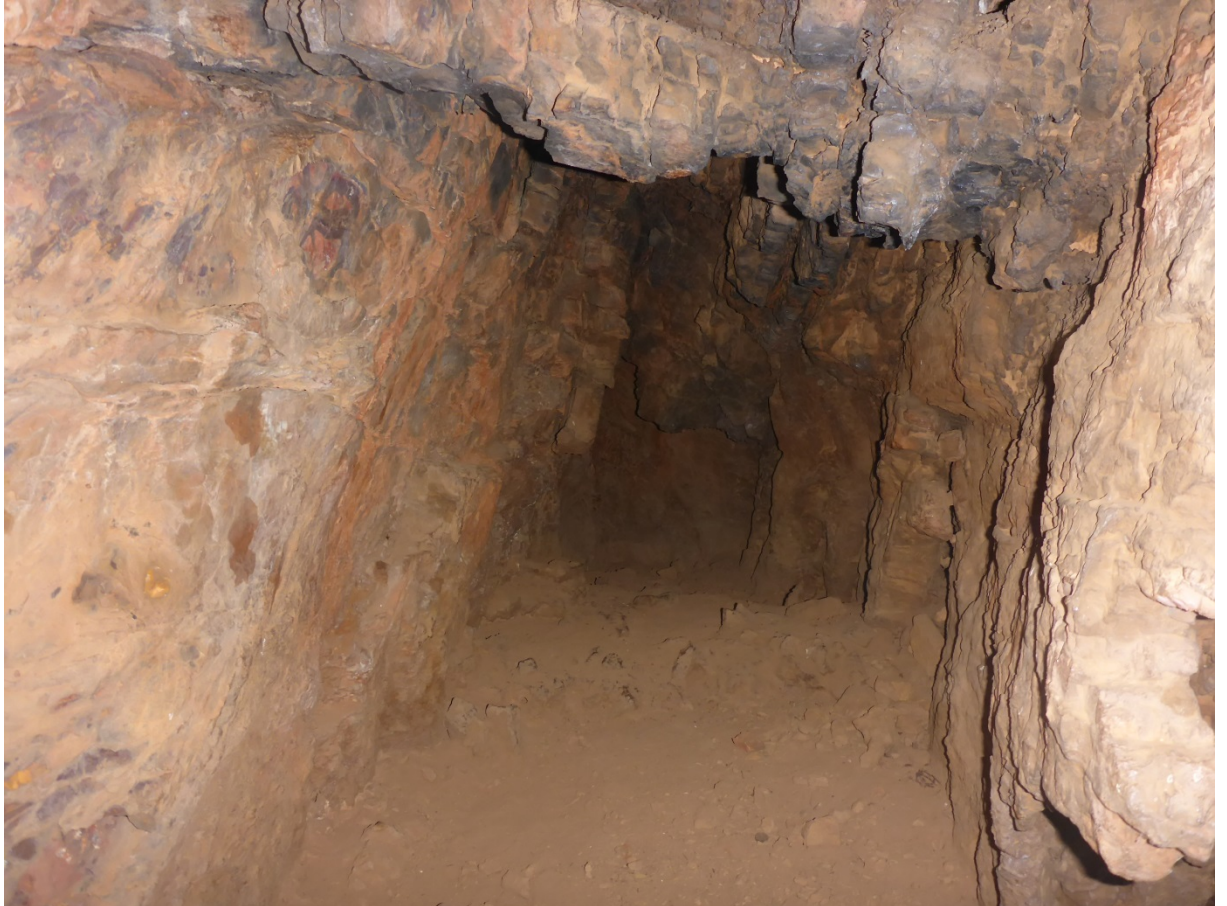
The cave ceiling is generally low (less than 1.2 m) and bedding within the cave varies from nearly horizontal to near vertical. The dramatic changes in bedding dip and strike suggest the bedrock is heavily folded and micro-faulted, thus while individual chambers and passages may be parallel to localised bedding (Plate 5), the cave as a whole cannot be considered to be bedding plane controlled. All the avens (blind vertical shafts) observed within Cave 13 showed a strong association with vertically bedded ironstone.

Plate 5 Bedding controlled side passage (field of view ~1 m)

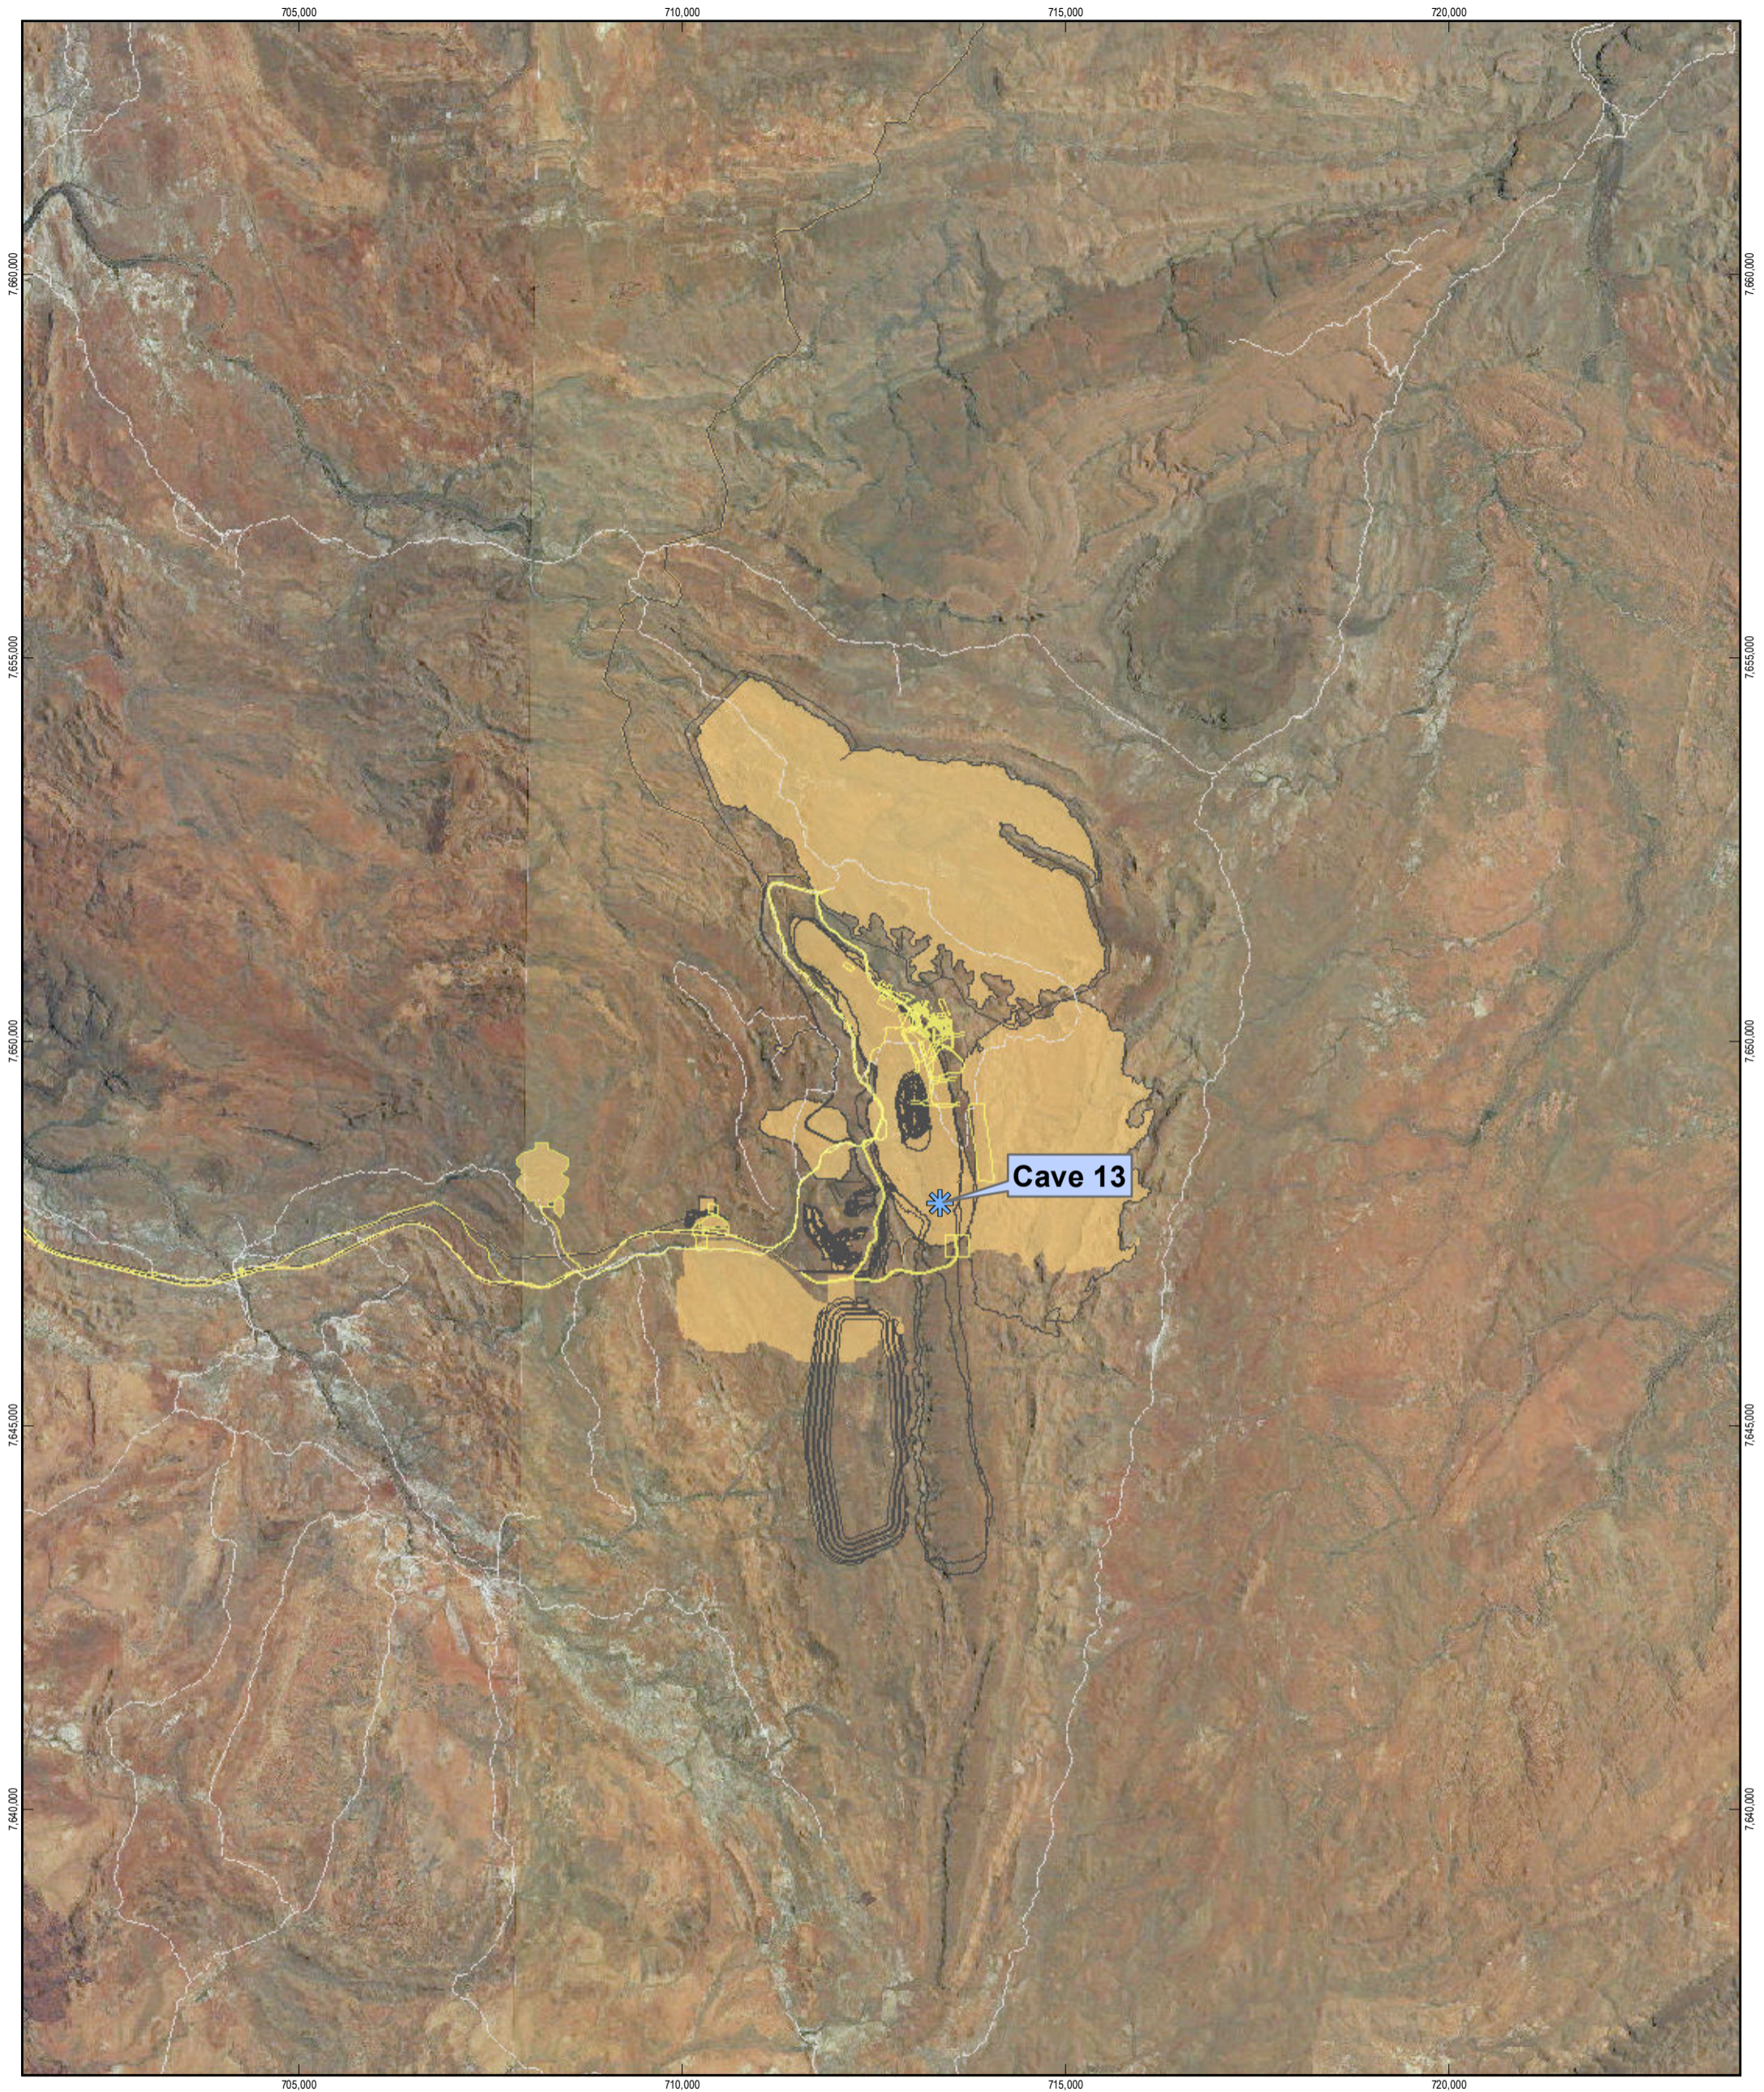
**Figure 2**

Cave 13 is located on the southern side of a gully and has a 5 m wide opening that divides into three separate passages (Figure 2). The passage to the far right (western most edge) is 7 m in length and completely lit by daylight. The central passage is approximately 16 m in length, with several small side chambers sloping gently upwards into the hillside behind. The passage on the far left (eastern most passage) leads into a 1 m high chamber with a 45° inclined passage approximately 2 m high heading to the east (Plate 1). This inclined passage is approximately 1 m wide and leads into an elevated chamber 6 m wide and 3.5 m deep, and up to 2.5 m high in the central area. This elevated chamber has formed partially through roof decay. There is no evidence for any water activity within this chamber for an extended time period.

**Location of Cave 13 at North Star Mine Site**
