**CLIENT** Iron Bridge Operations Pty Ltd  
**JOB NUMBER** 114185.10

**JOB NAME** North Star Magnetite Project  
**JOB LOCATION** Pilbara, WA

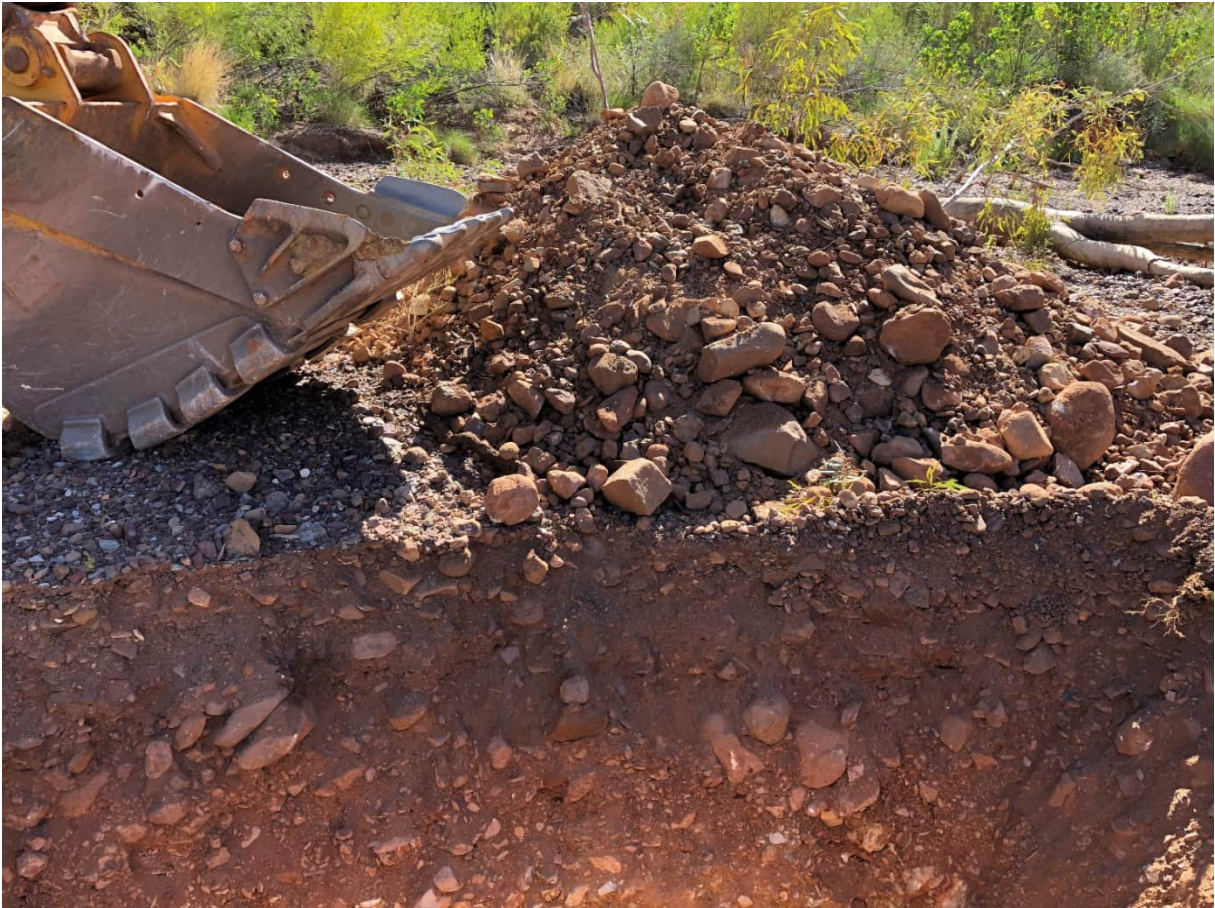
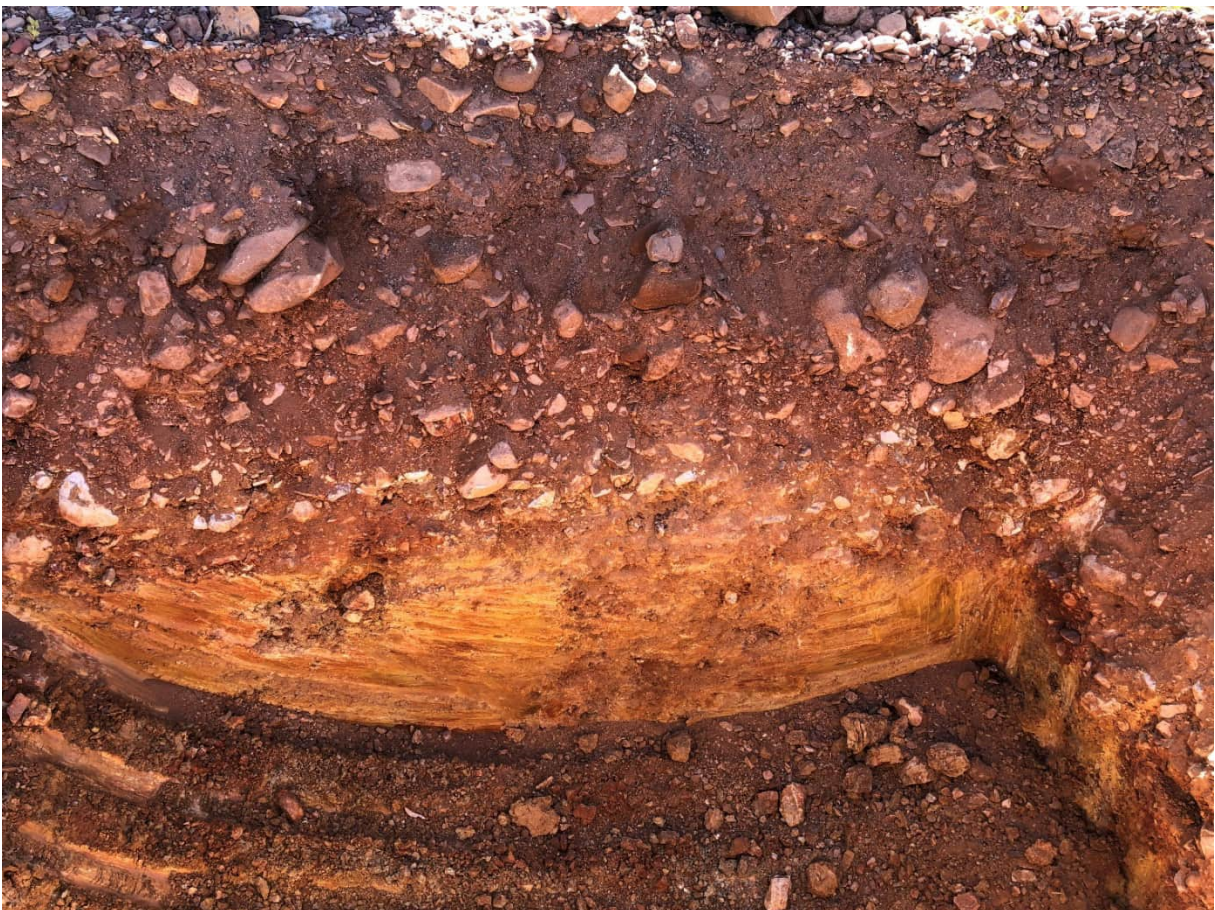
TP2A-R19

GP-GC	<b>TOPSOIL: GRAVEL</b> Medium dense, fine to coarse gravel, red brown, with sand, clay and rootlets, dry.			
					GP-GC	<b>SHALE</b> Extremely weathered, cleaved/laminated, grey and red brown. Excavated As : GRAVEL: Very dense/dense, fine to coarse, grey, red brown, with sand and clay fines, dry

<b>SHALE</b> Highly weathered, grey and pale grey, cleaved / laminated and closely fractured, very low / low strength, dry.			
			1.5

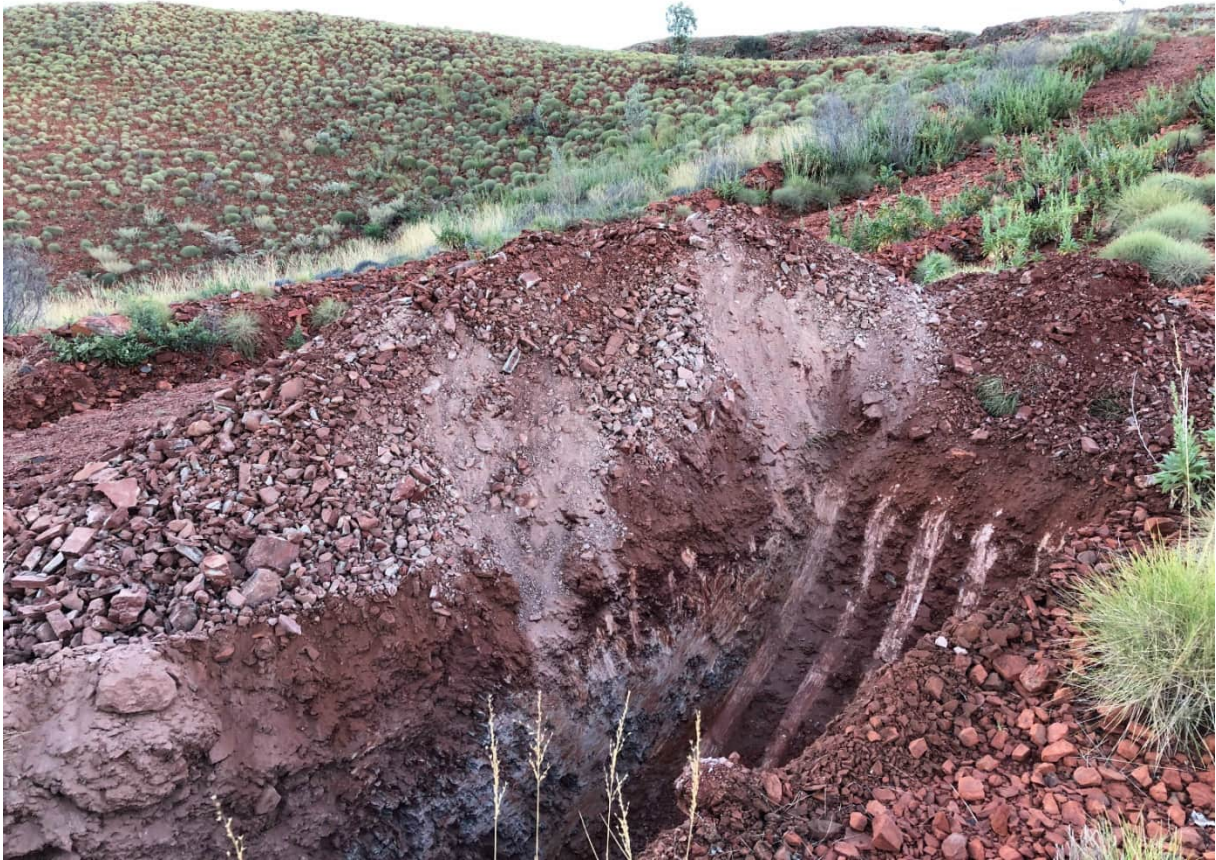
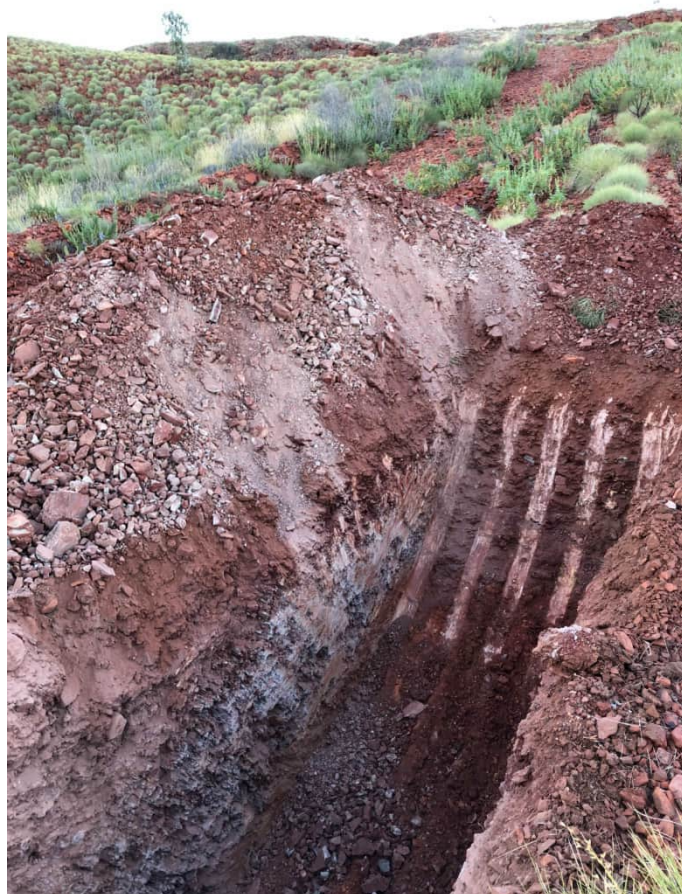
TP2A-R20

<b>SILTSTONE</b> Highly weathered, grey and pale grey, thinly bedded 30 - 100 mm layers, closely fractured, low strength, dry.			
						becoming medium strength			
not encountered			1.5

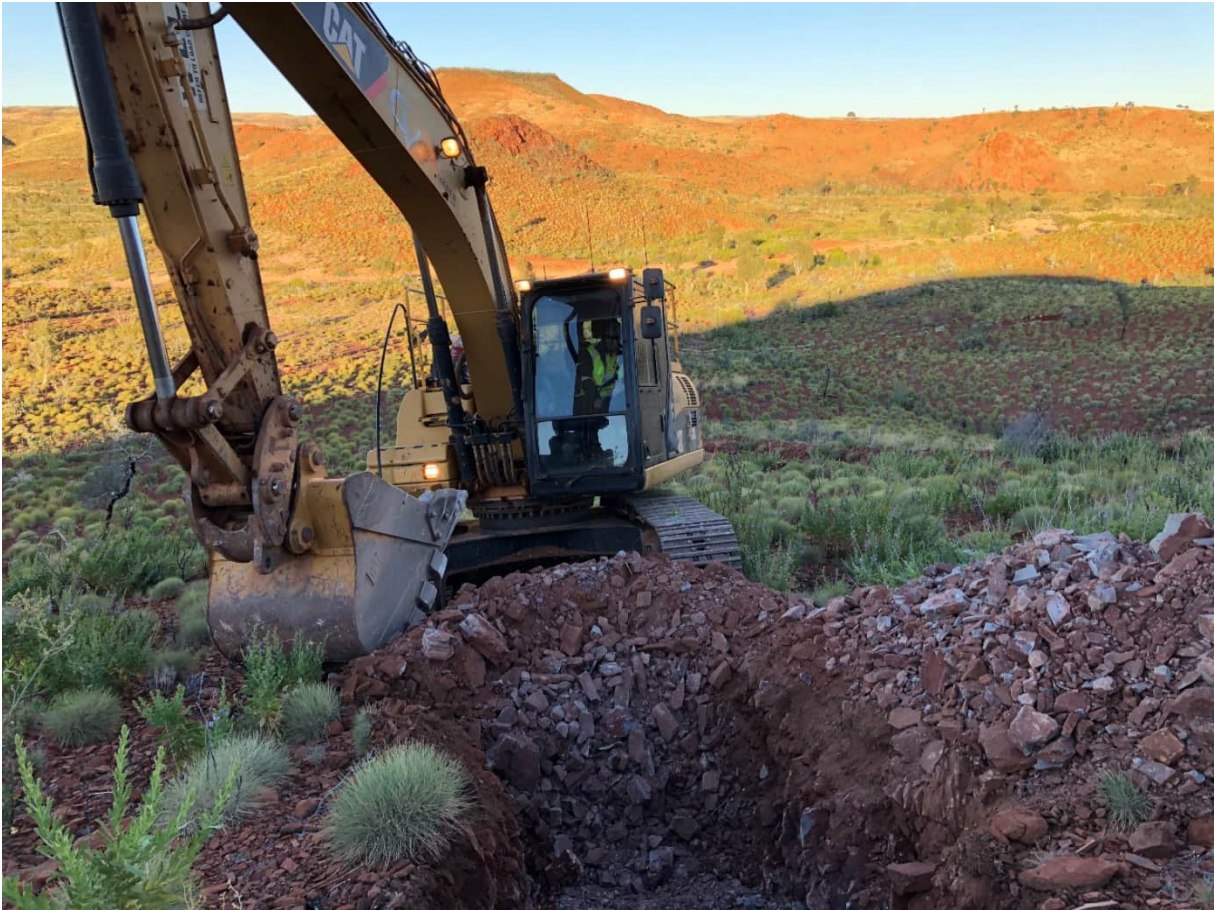
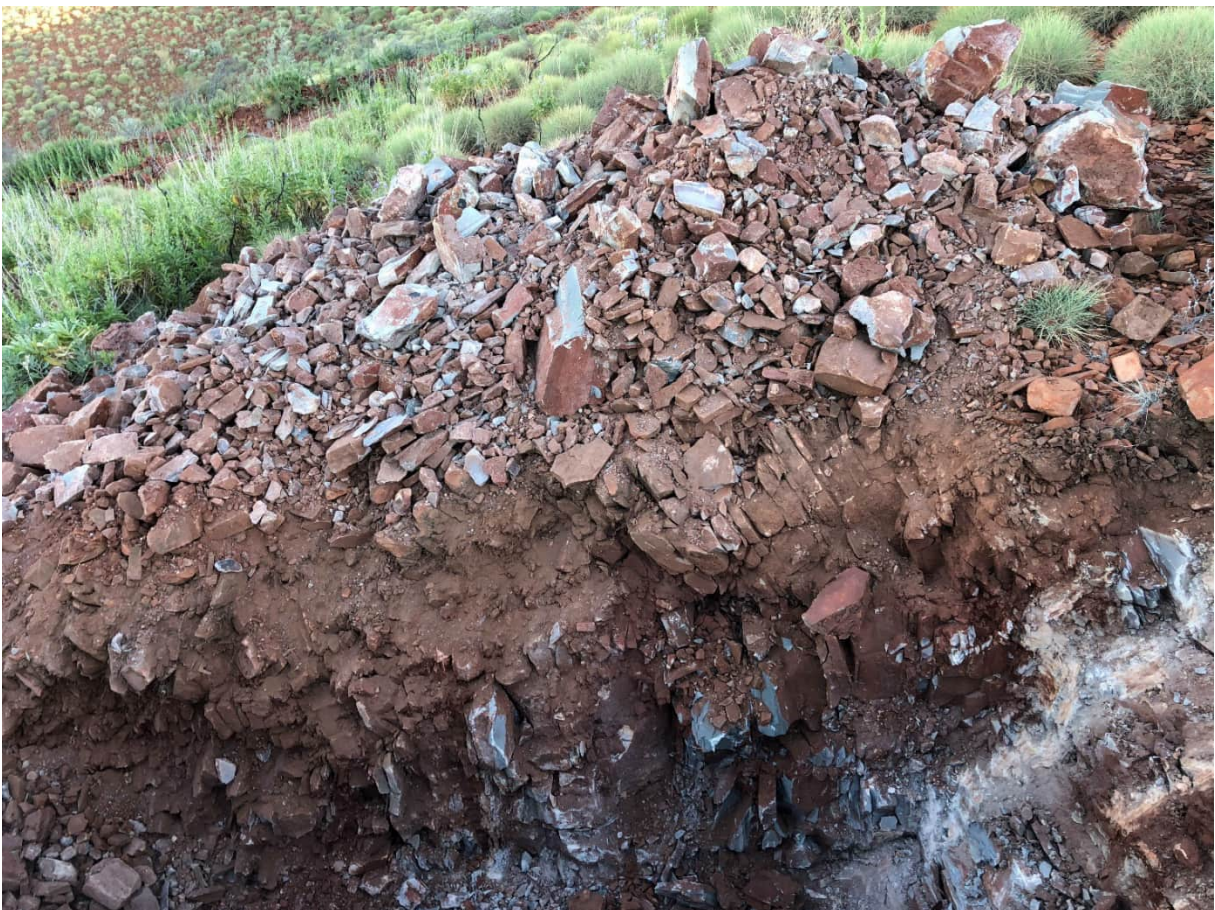
TP2A-R21

<b>SHALE</b> Extremely weathered. Excavated as: Clayey GRAVEL: Dense, fine to coarse, tabular, red brown and grey, with sand, dry/moist

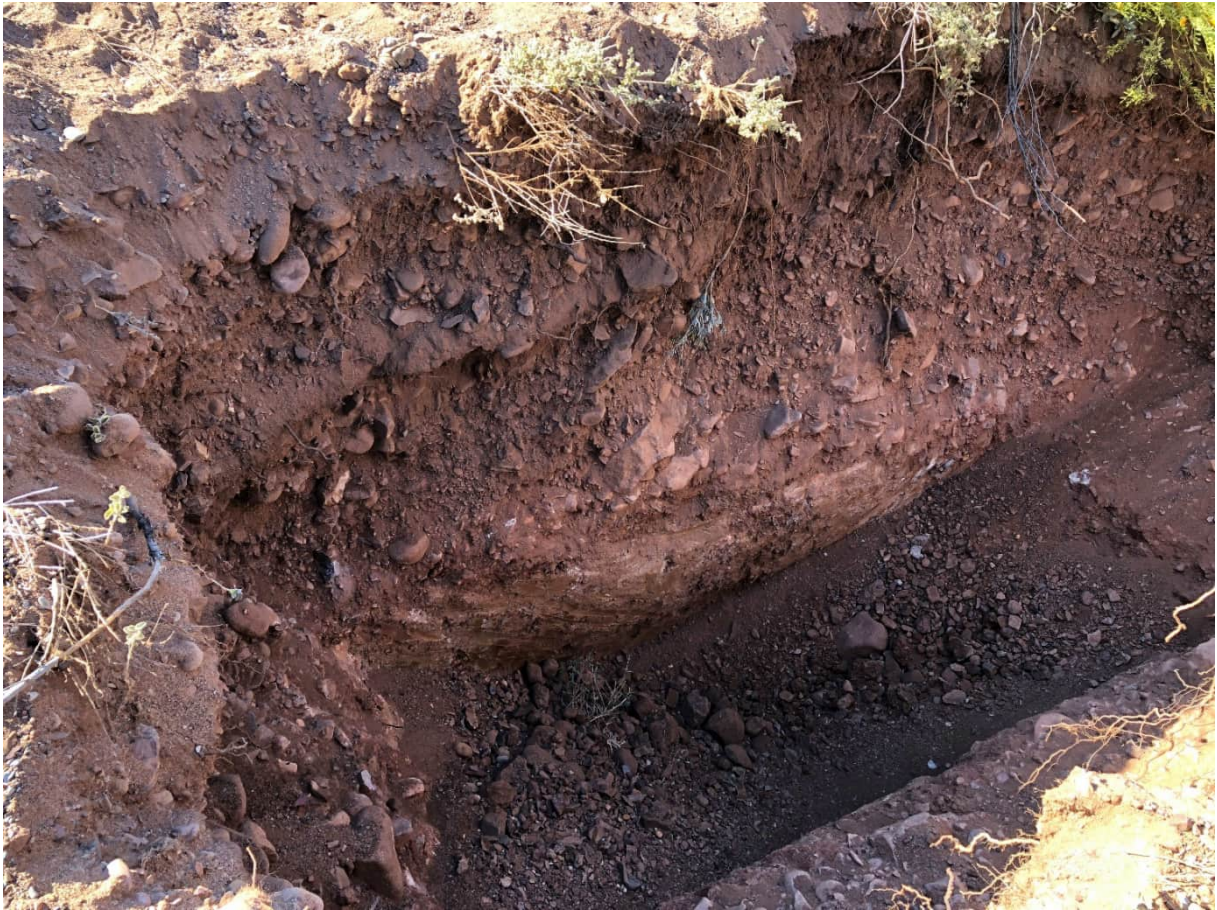
TP2A-R22

<b>SILTSTONE</b> Extremely / highly weathered, red brown and grey, laminated, very low/low strength.			
			3.0 3.5 4.0 4.5			Test pit TP2A-R23 terminated at 2.7m Bucket refusal - hard excavation

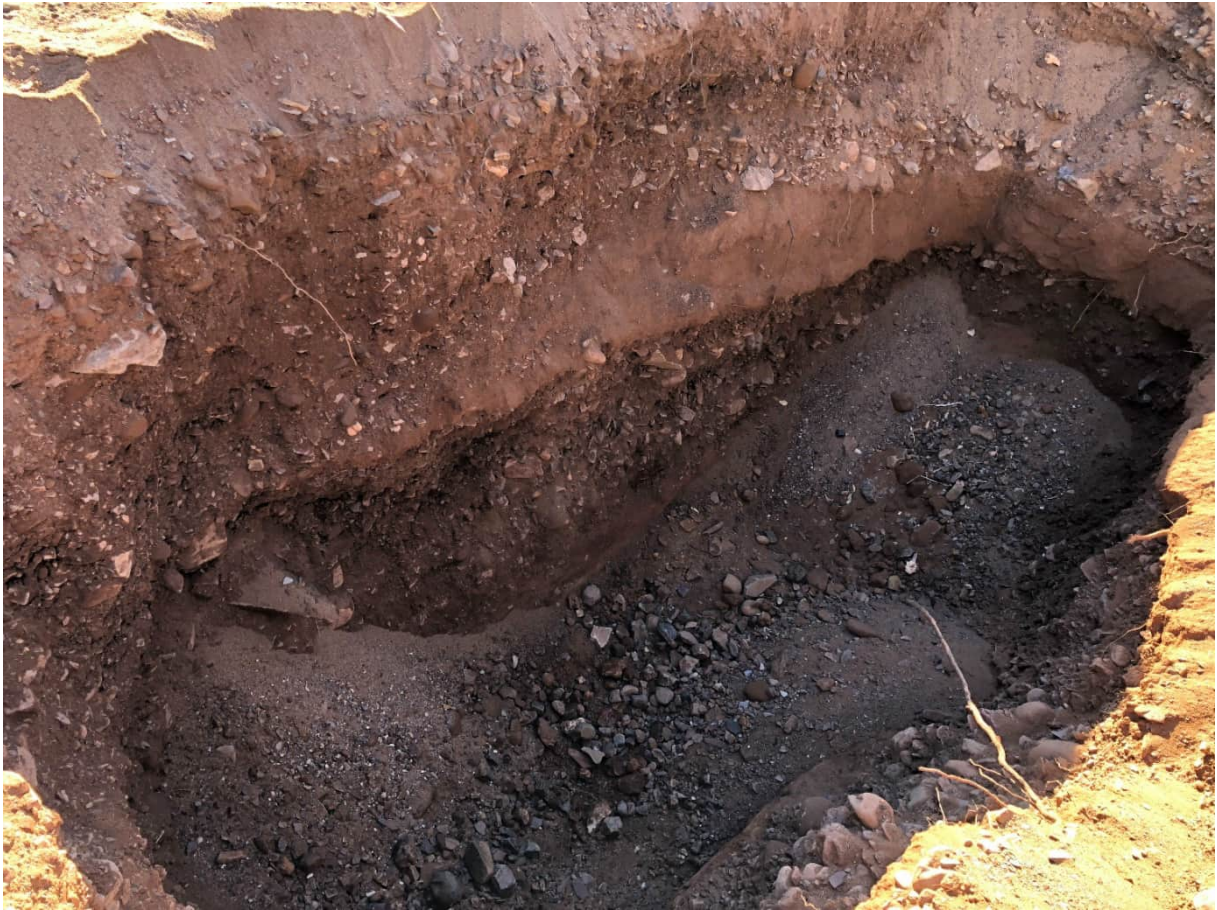
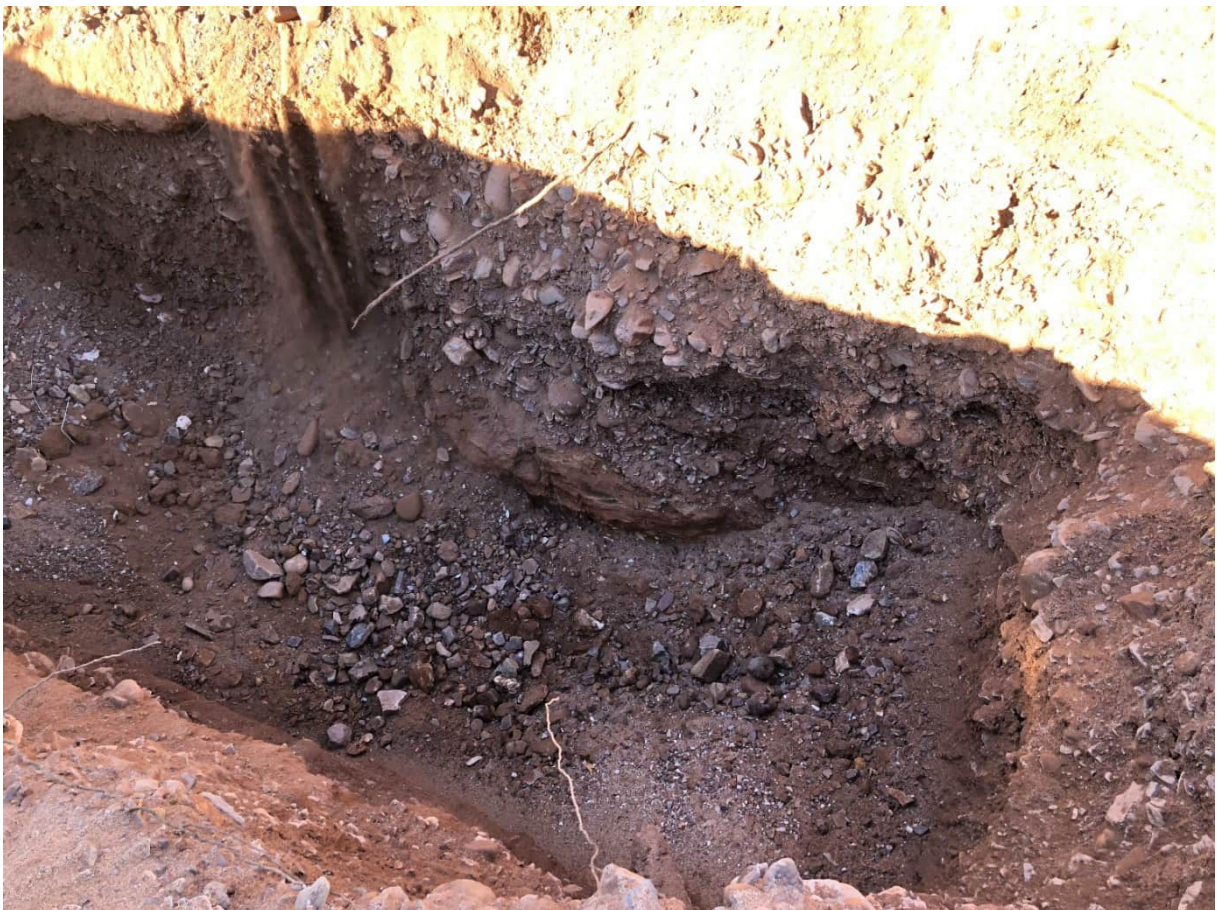
TP2A-R23

<b>SANDSTONE</b> Highly weathered, green-grey with red oxide staining, medium texture, closely jointed, low/medium strength, wet.			
			3.0 3.5 4.0 4.5			Test pit TP2A-R24 terminated at 2.8m Bucket refusal - hard excavation

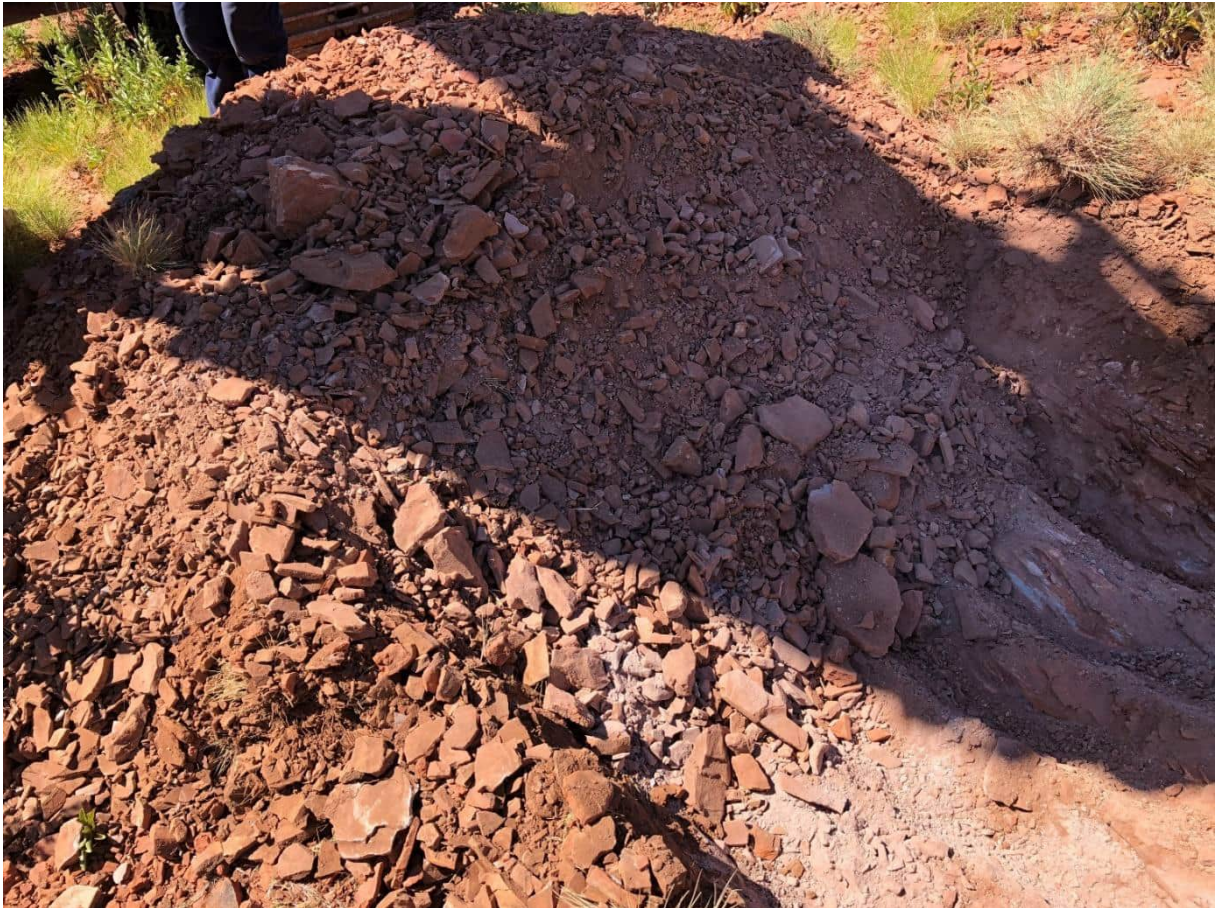
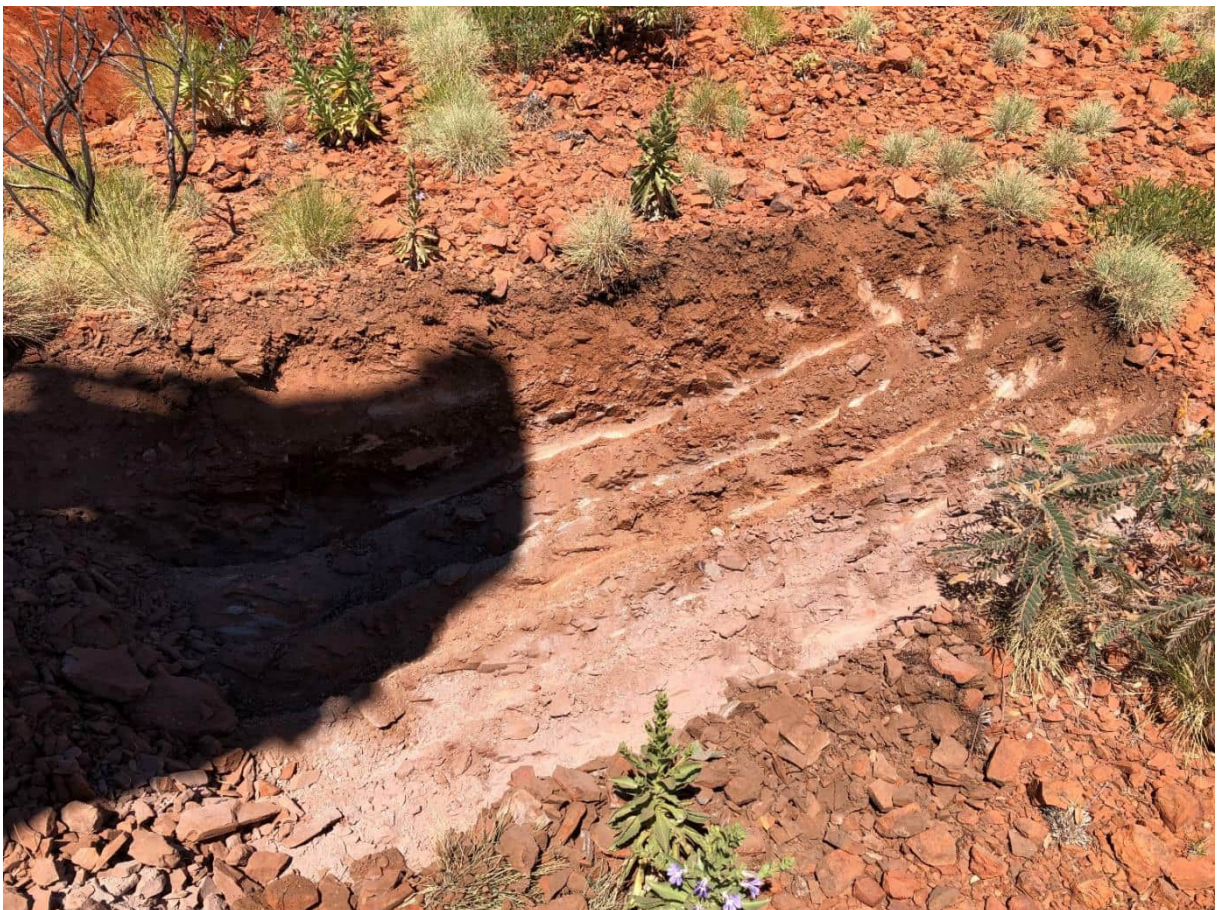
GP-GC	<b>TOPSOIL: GRAVEL</b> Medium dense, fine to coarse gravel, red brown, with sand, clay and rootlets, dry.			
					GP-GC	<b>SHALE</b> Extremely weathered. Excavated As : Very dense/dense, fine to coarse tabular GRAVEL, grey and red brown, dry			
						<b>SHALE</b> Highly weathered, grey, laminated, subvertical cleavage/bedding, very low to low strength. Test pit TP2A-T20 terminated at 0.6m Bucket refusal - hard excavation			
			1.0						
			1.5						
			2.0						
			2.5						
			3.0						
			3.5						
			4.0						
			4.5

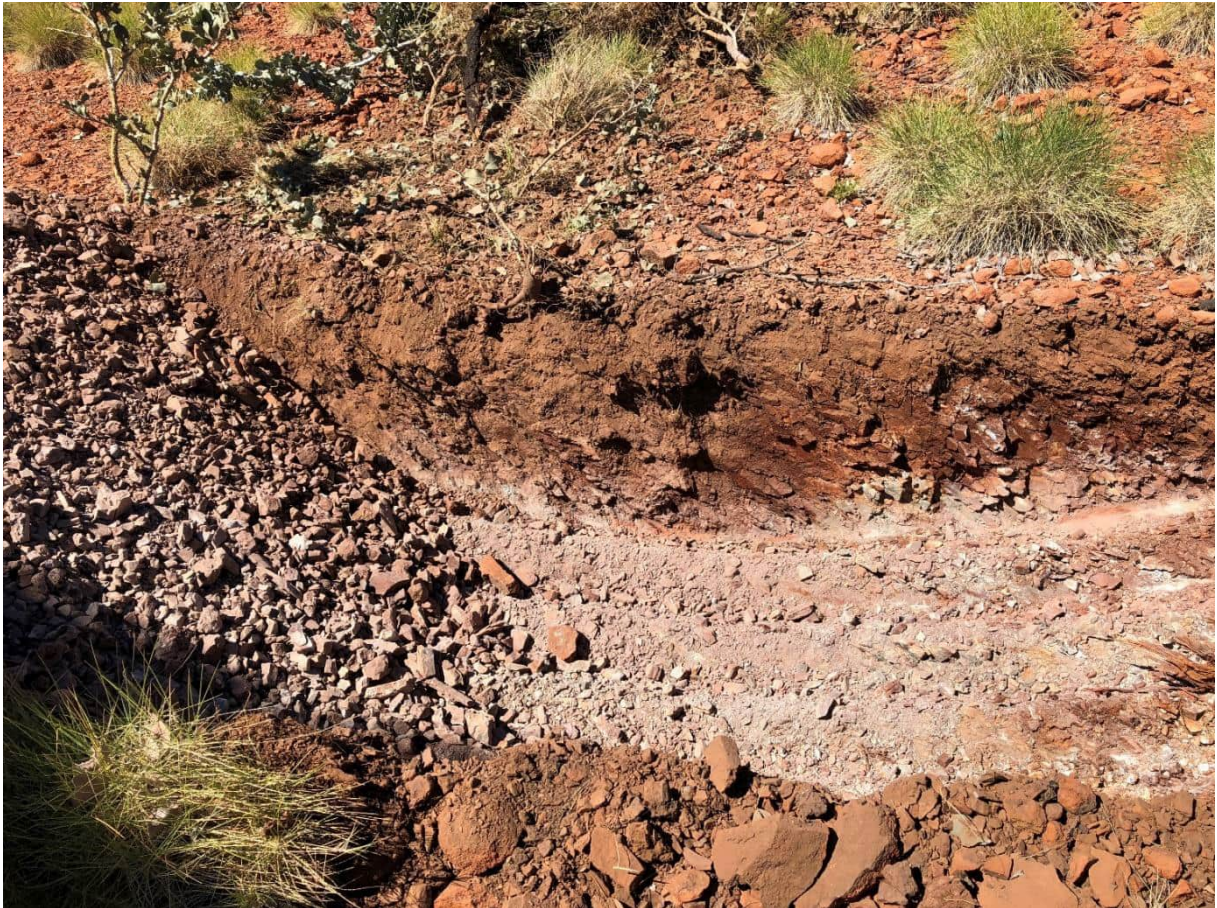
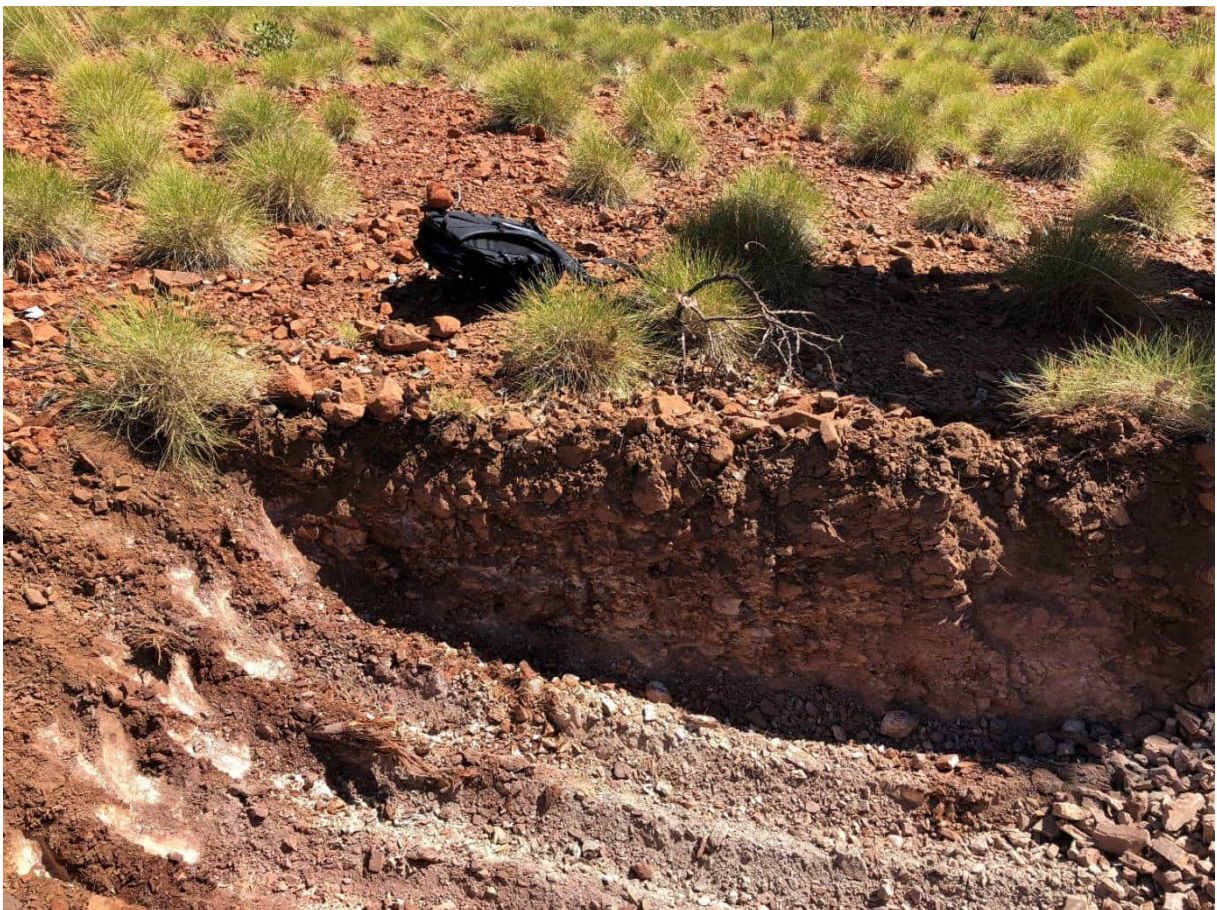
GP-GC GP-GC	<b>TOPSOIL: GRAVEL</b> Medium dense, fine to coarse gravel, red brown, with sand, clay and trace rootlets, dry. <b>SHALE</b> Extremely weathered. Excavated As : Very dense/dense, fine to coarse tabular GRAVEL, grey and red brown, dry			
			1.0			<b>SHALE</b> Highly weathered, grey, laminated, subvertical cleavage/bedding, very low to low strength, dry. Test pit TP2A-T21 terminated at 0.6m Bucket refusal - hard excavation

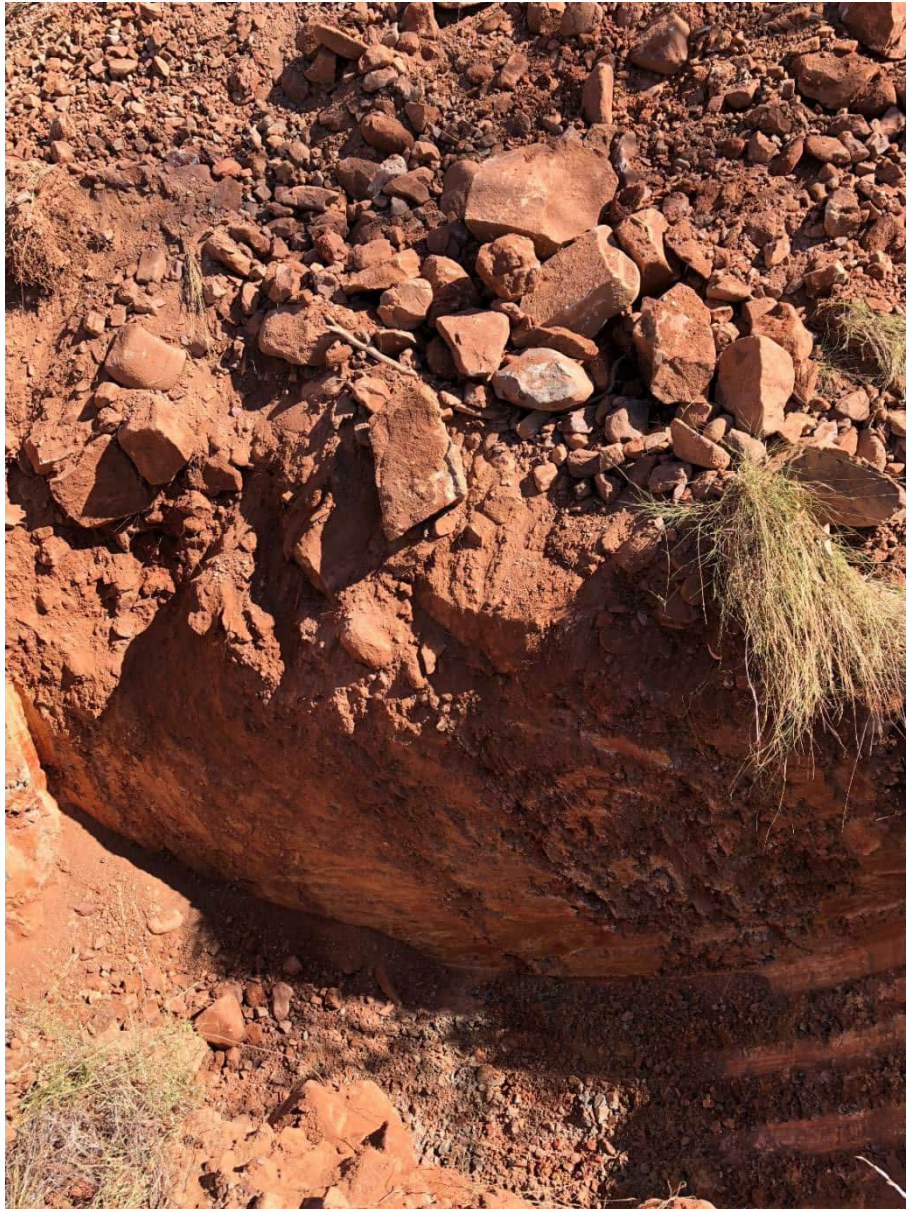
TP2A-T23

<b>COBBLES &amp; BOULDERS with Gravel</b> Medium dense, rounded to subrounded cobbles and boulders to 0.6 m diameter of sandstone, ironstone and dolerite, grey, red and brown, with gravel, trace sand and silt, dry (Alluvium).			
			1.0			GP <b>SHALE</b> Extremely weathered. Excavated As : Very dense/dense, fine to coarse tabular GRAVEL, red brown, trace sand and silt, dry/moist. Bedding / cleavage 40 - 50 dip to north.			
			1.5

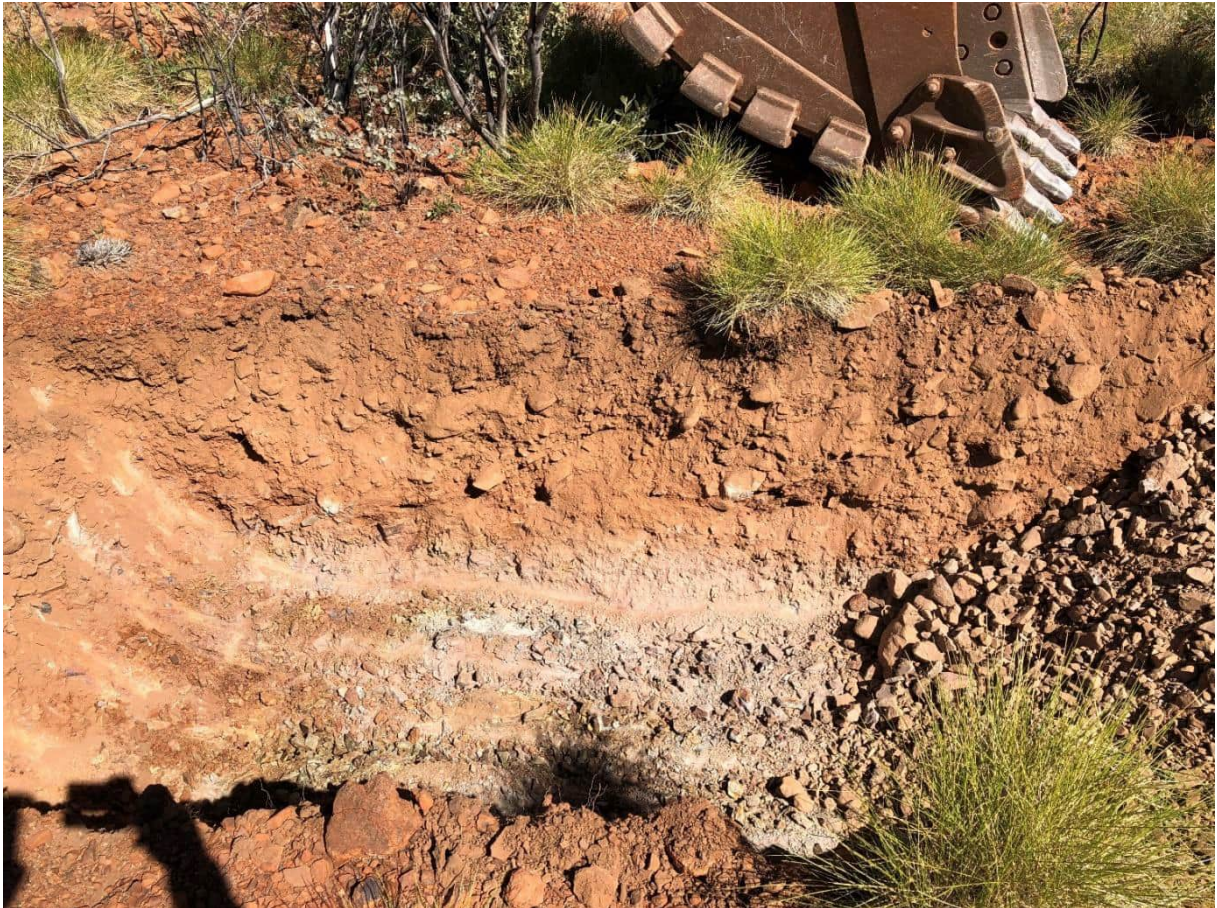
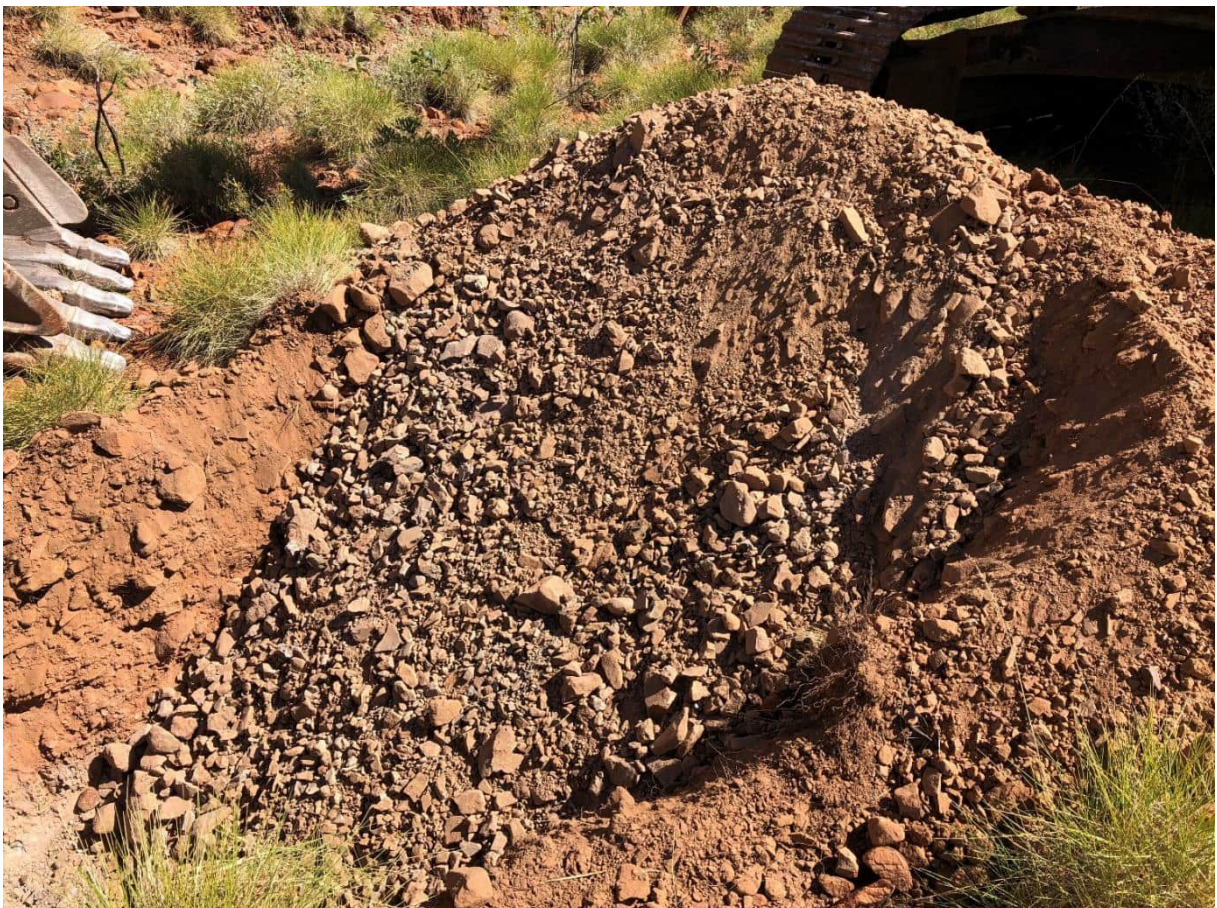
GP-GC	<b>TOPSOIL: GRAVEL</b> Medium dense, fine to coarse gravel, red brown, with sand, clay and rootlets, dry.			
					GP-GC	<b>GRAVEL</b> Loose, fine to coarse, tabular shale gravel, red brown with sand and clay fines, dry (Colluvium)			
					GP-GC	<b>SILTSTONE/SHALE</b> Extremely weathered. Excavated As : Very dense/dense, fine to coarse tabular GRAVEL, red brown, dry

<b>SILTSTONE/SHALE</b> Highly weathered, grey, laminated, subvertical cleavage/bedding, very low to low strength.			
			1.5			Test pit TP2A-T24 terminated at 1m Bucket refusal - hard excavation

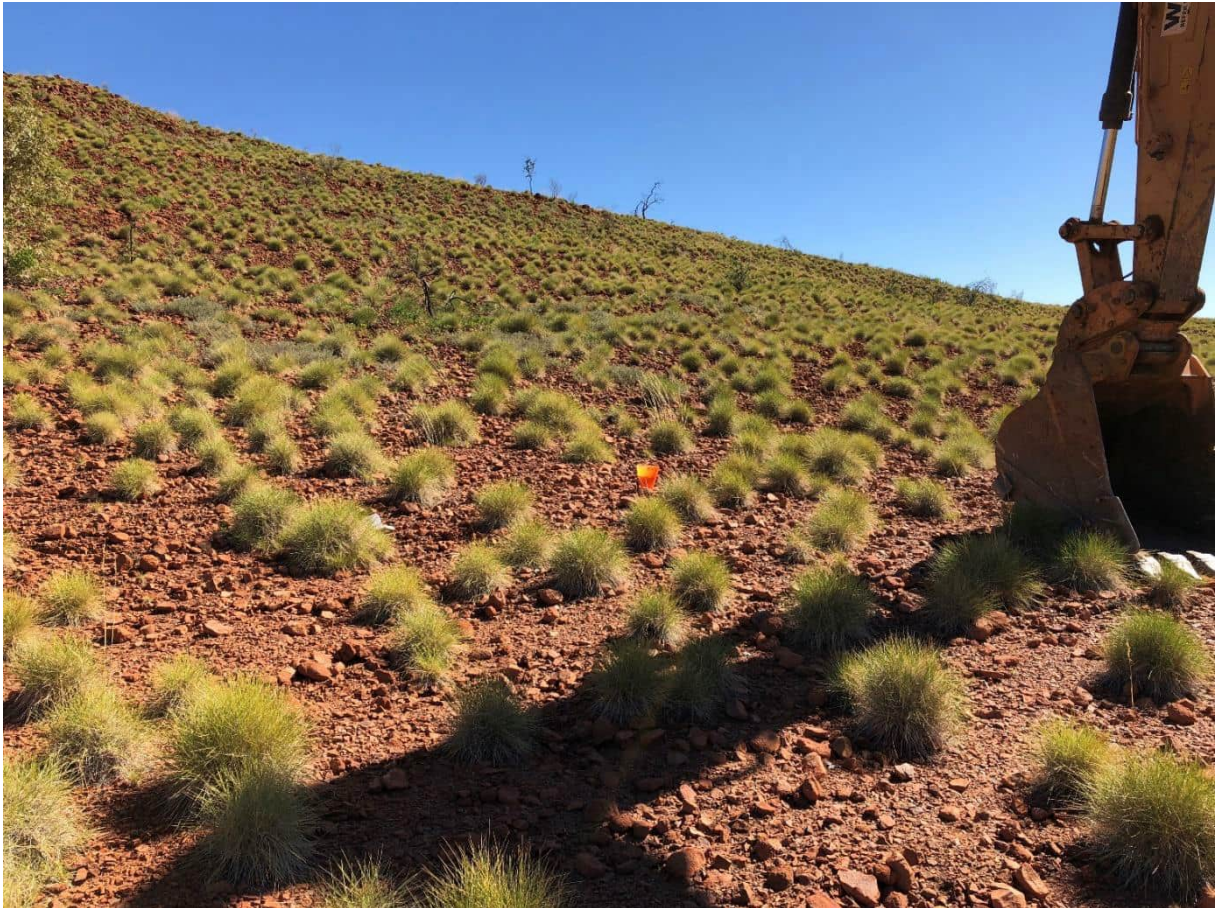
GP-GM	<b>TOPSOIL: GRAVEL</b> Medium dense, fine to coarse gravel, red brown, with sand, silt and rootlets, dry.			
					GP-GC	<b>SHALE</b> Extremely weathered. Excavated As : Very dense/dense, fine to coarse tabular, grey, red brown, trace sand and silt, dry/moist.			
			1.0			<b>SHALE</b> Highly weathered, grey / white, laminated / cleaved with 70 - 80 degree dip, with siltstone banding, very low to low strength, dry			
			1.5						
			2.0						
			2.5						
			3.0						
			3.5						
			4.0						
			4.5						
						Test pit TP2A-T25 terminated at 0.7m Bucket refusal - hard excavation

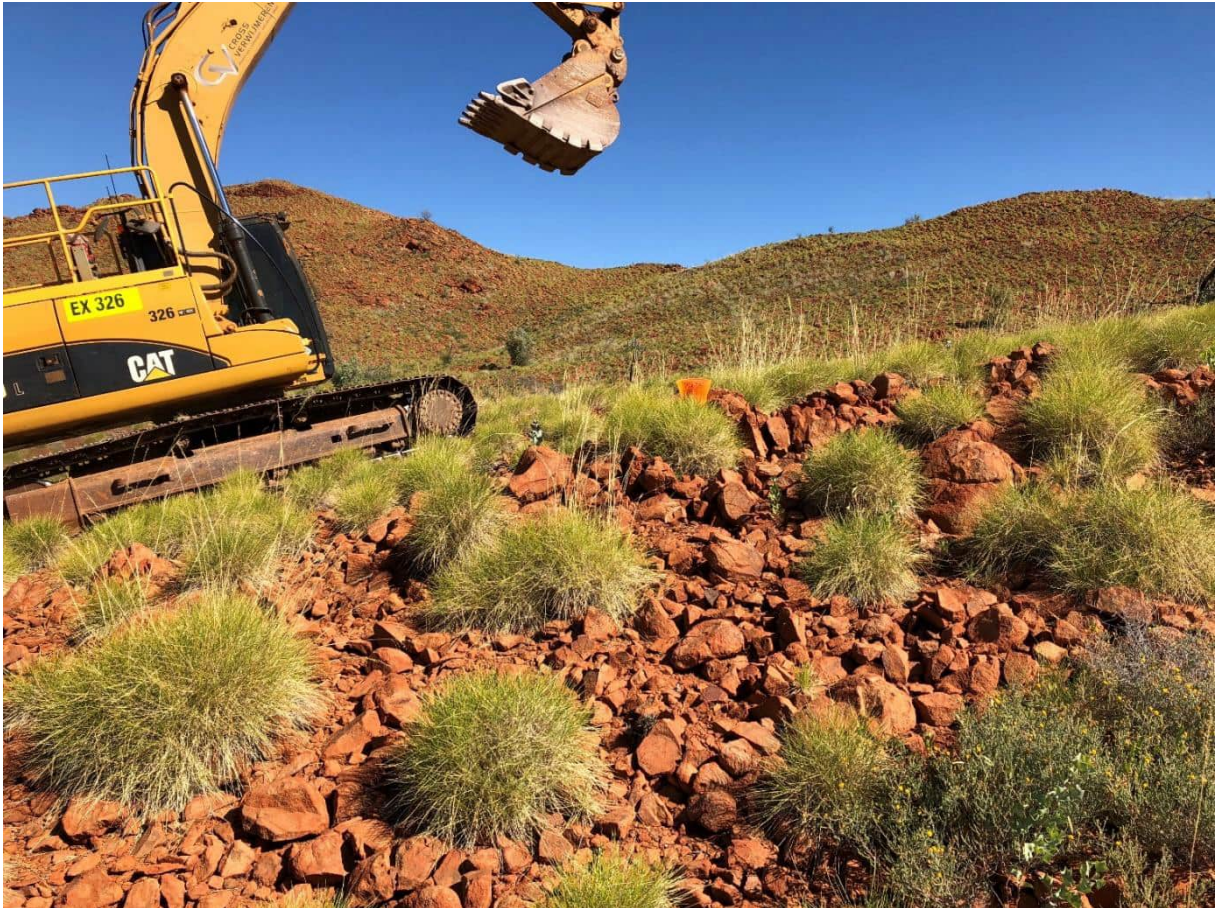
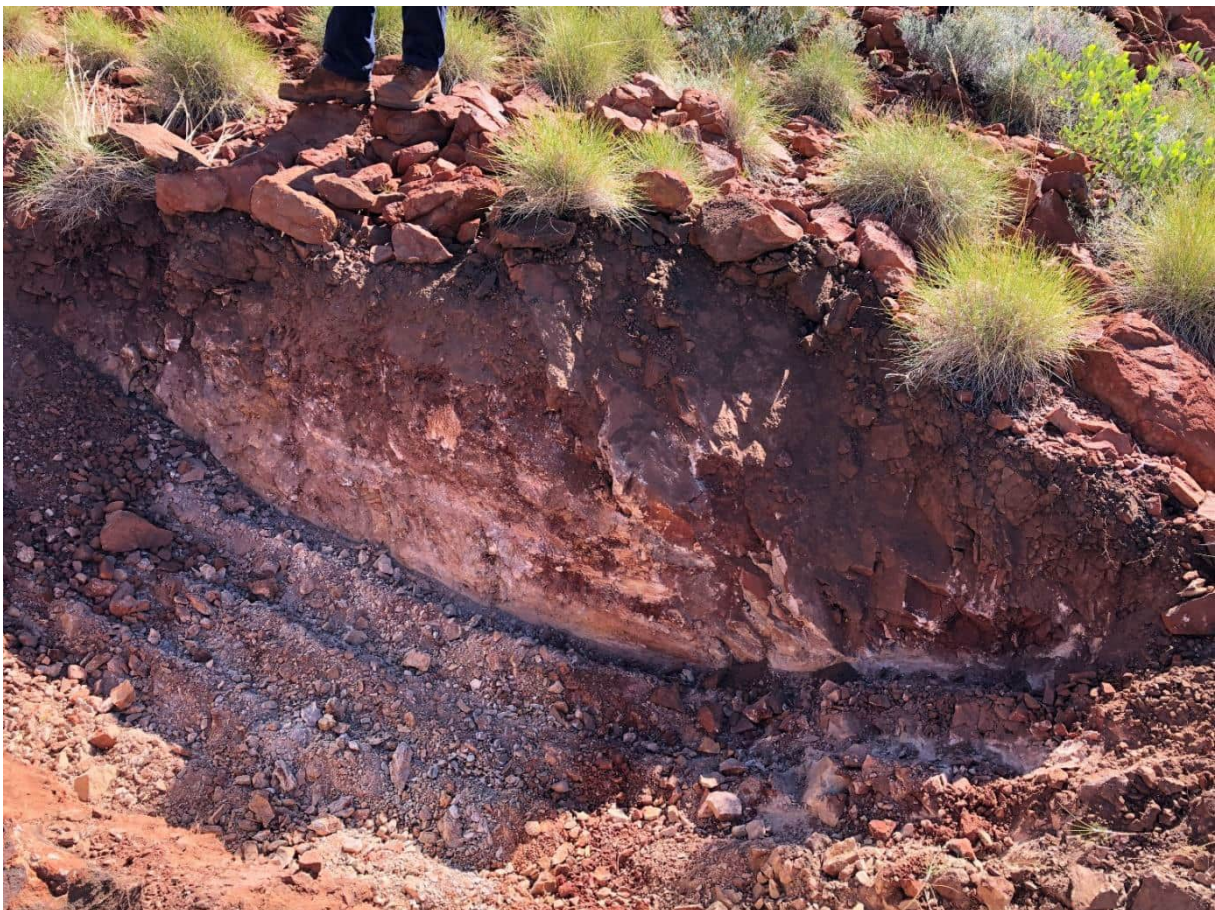
TP2A-T26

GP-GC	<b>GRAVEL</b> Loose, fine to coarse, tabular shale gravel, red brown with sand and clay fines, dry (Colluvium)			
			0.5

GP	<b>SHALE</b> Extremely weathered. Excavated As : Very dense/dense, fine to coarse tabular GRAVEL, grey, red brown, trace sand and silt, dry/moist.

<b>SHALE</b> Highly weathered, grey / white, laminated / cleaved with subvertical dip, subvertical cleavage/bedding, very low to low strength (dry).

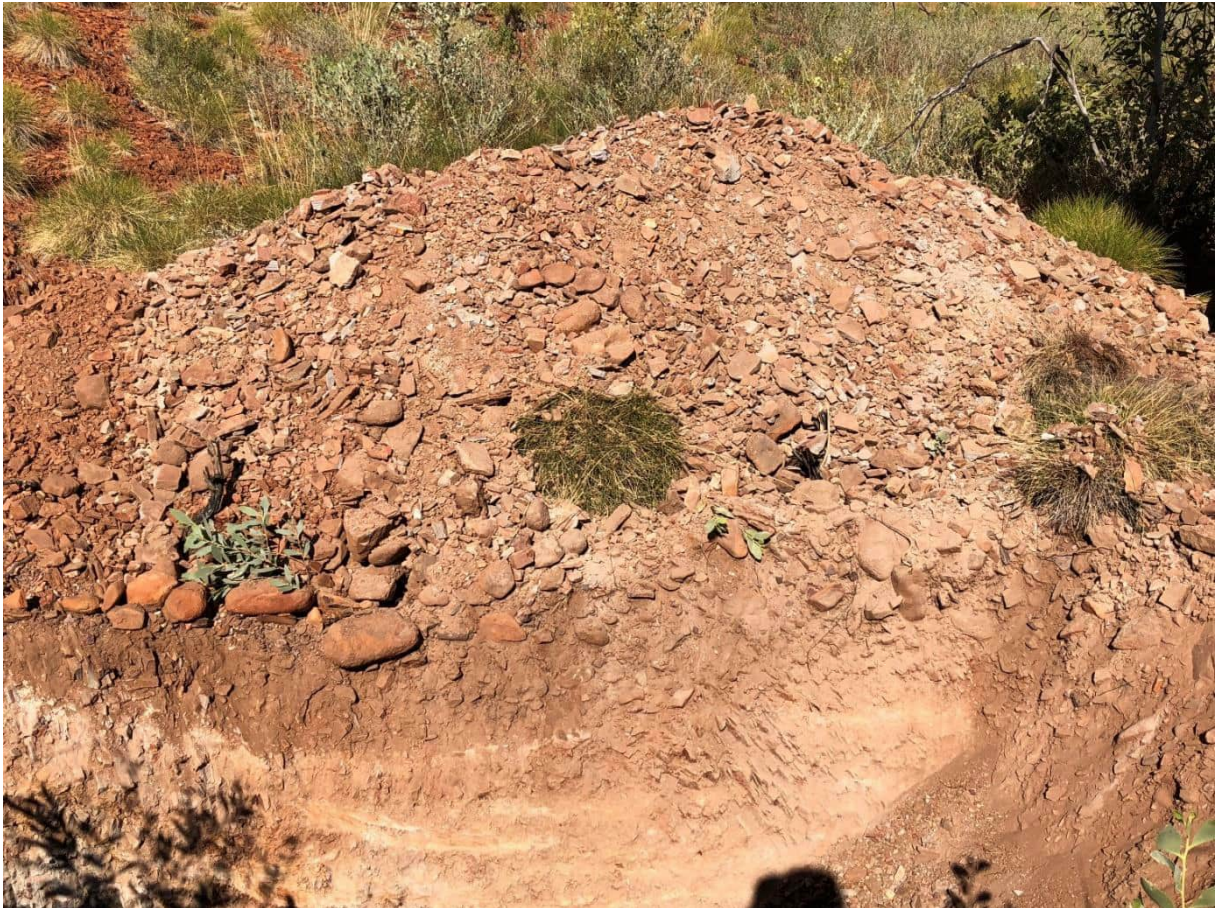
GP-GC GP-GC	<p><b>TOPSOIL: GRAVEL</b> Medium dense, fine to coarse gravel, red brown, with sand, clay and rootlets, dry.</p> <p><b>COBBLES</b> Medium dense, rounded to subrounded of sandstone, ironstone and dolerite, grey, red and brown, with boulders to 0.6 m dia, gravel, trace sand and silt, dry/moist (Alluvium)</p> <p><b>SILTSTONE/SHALE</b> Extremely / highly weathered, grey, laminated, subvertical cleavage/bedding, extremely low to low strength, dry.</p>			
			1.5 2.0 2.5 3.0 3.5 4.0 4.5			<p>Test pit TP2A-T27 terminated at 1.2m Bucket refusal - hard excavation</p>
