**CLIENT** Iron Bridge Operations Pty Ltd  
**JOB NUMBER** 114185.10

**JOB NAME** North Star Magnetite Project  
**JOB LOCATION** Pilbara, WA

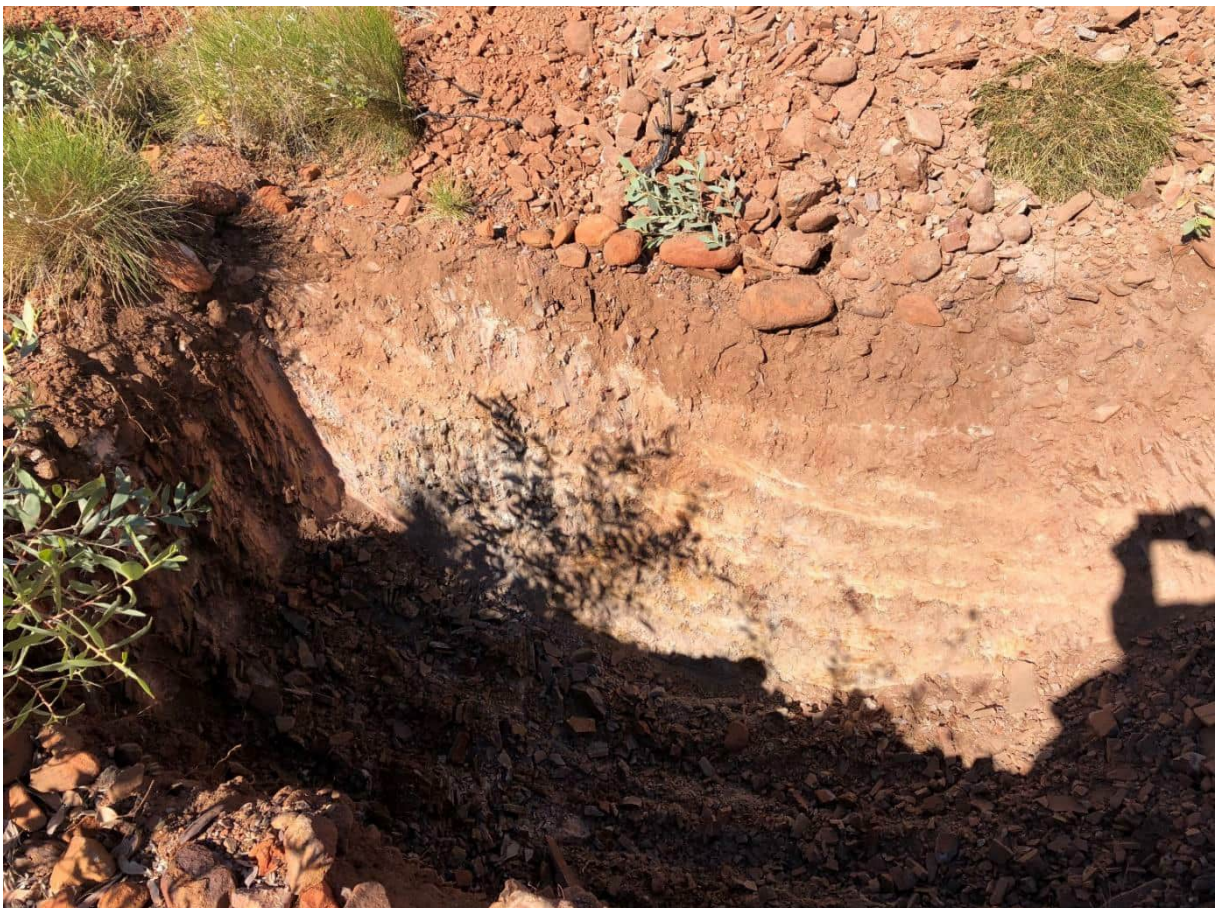
GP-GC GP-GC	<p><b>TOPSOIL: GRAVEL</b> Medium dense, fine to coarse gravel, red brown, with sand, clay and rootlets, dry.</p> <p><b>COBBLES</b> Medium dense, rounded to subrounded of sandstone, ironstone and dolerite, grey, red and brown, with boulders to 0.6 m dia, gravel, trace sand and silt, dry/moist (Alluvium)</p> <p><b>SILTSTONE/SHALE</b> Extremely / highly weathered, grey, laminated, subvertical cleavage/bedding, extremely low to low strength, dry.</p>			
			1.5 2.0 2.5 3.0 3.5 4.0 4.5			<p>Test pit TP2A-T27 terminated at 1.2m Bucket refusal - hard excavation</p>

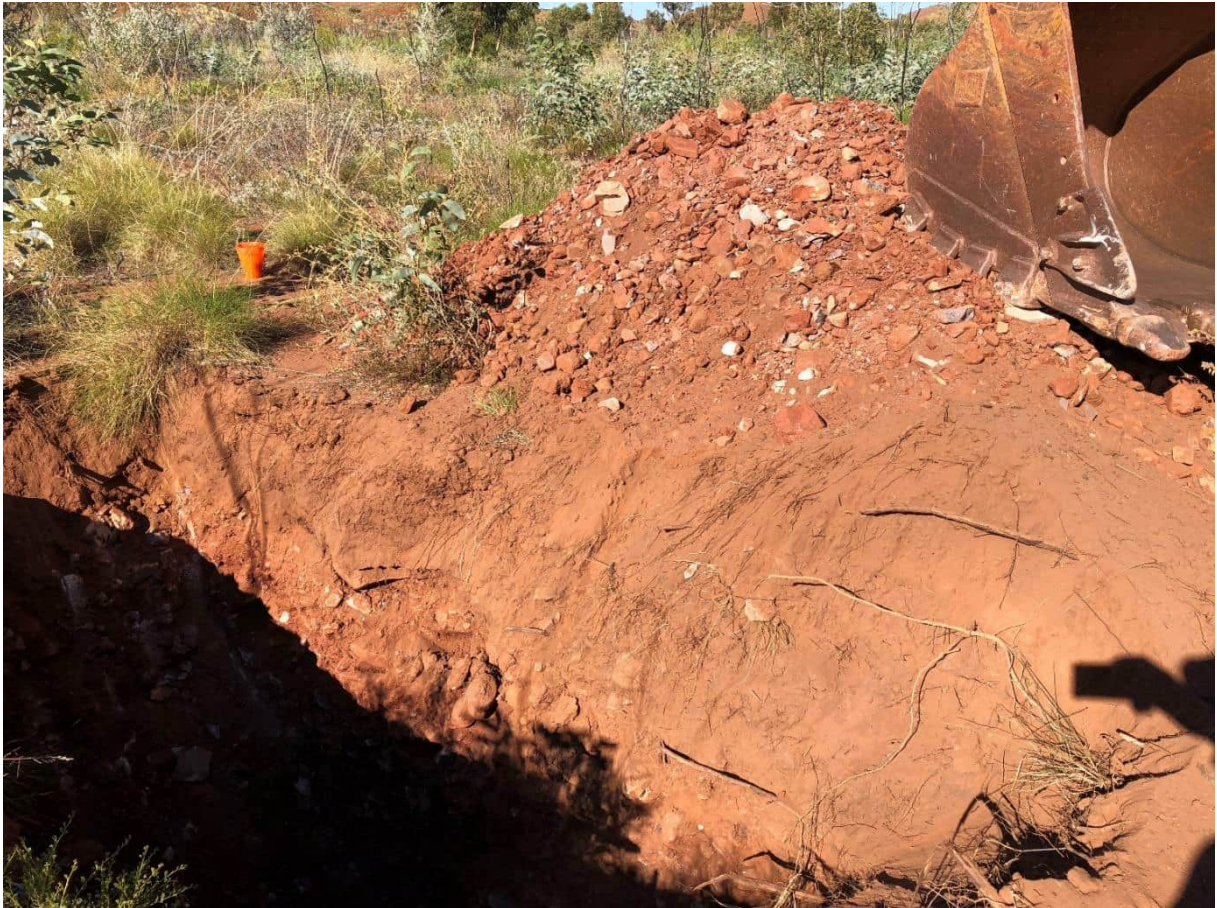
GP	<b>MIXTURE OF COBBLES/BOULDERS with Gravel</b> Medium dense/dense, rounded to subrounded of sandstone, ironstone and dolerite, grey, red and brown, clast supported with boulders to 0.5 m dia, with gravel, trace sand and silt, dry/moist (Alluvium)			
			2.5			Test pit TP2A-T29 terminated at 2.6m Bucket refusal - hard excavation			
			3.0						
			3.5						
			4.0						
			4.5

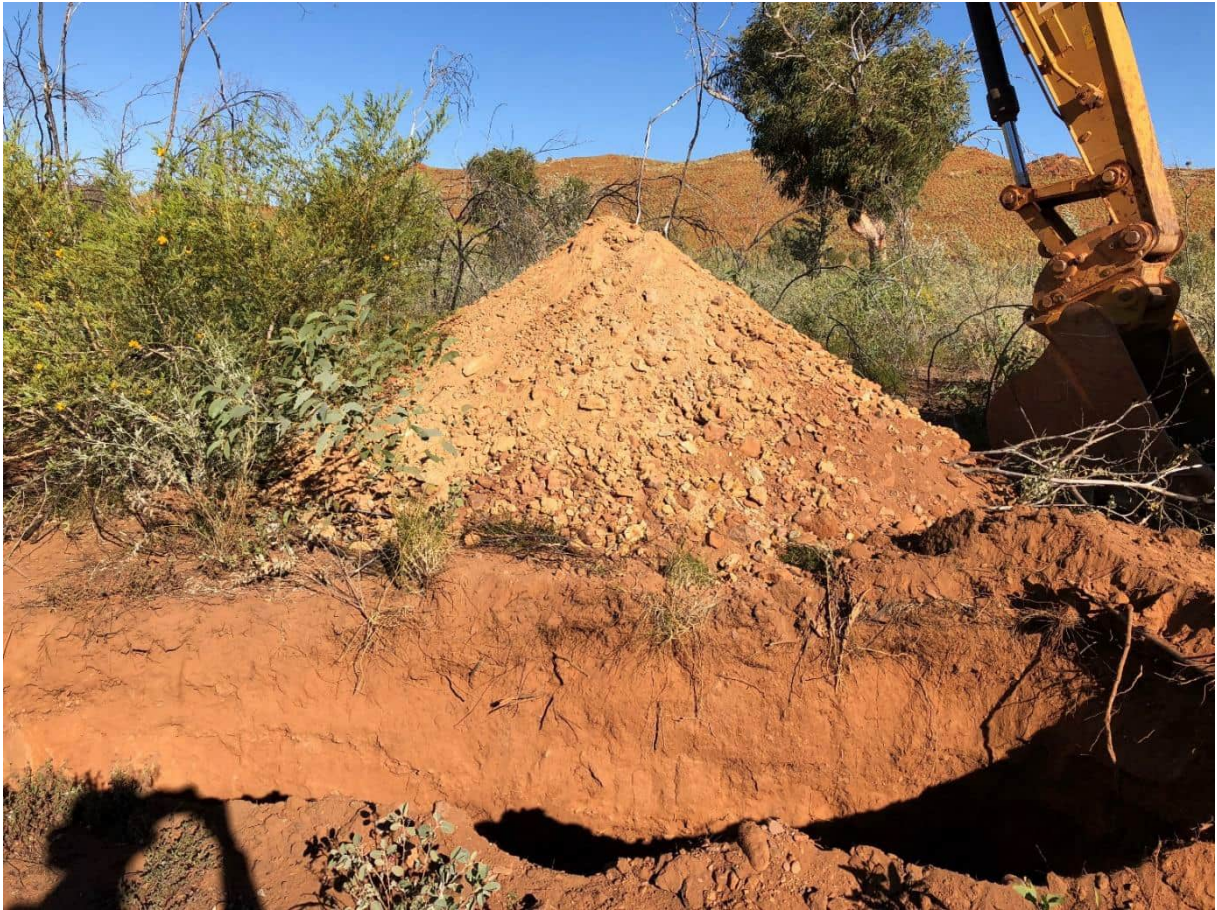
SM	<b>TOPSOIL: SILTY SAND</b> Loose, fine and medium, brown, trace roots, dry.			
			0.5		GP-GM	<b>GRAVEL</b> Medium dense, fine to coarse gravel of sandstone, ironstone, with cobbles, sand and silt, dry (Alluvium)			
			1.0						
			1.5						
			2.0		GP-GM	<b>SANDSTONE</b> Extremely weathered, pale yellow and red brown extremely low strength. Recovered as Sandy GRAVEL with silt, dry.			
			2.5			Test pit TP2A-T30 terminated at 2.4m Bucket refusal - hard excavation			
			3.0						
			3.5						
			4.0						
			4.5

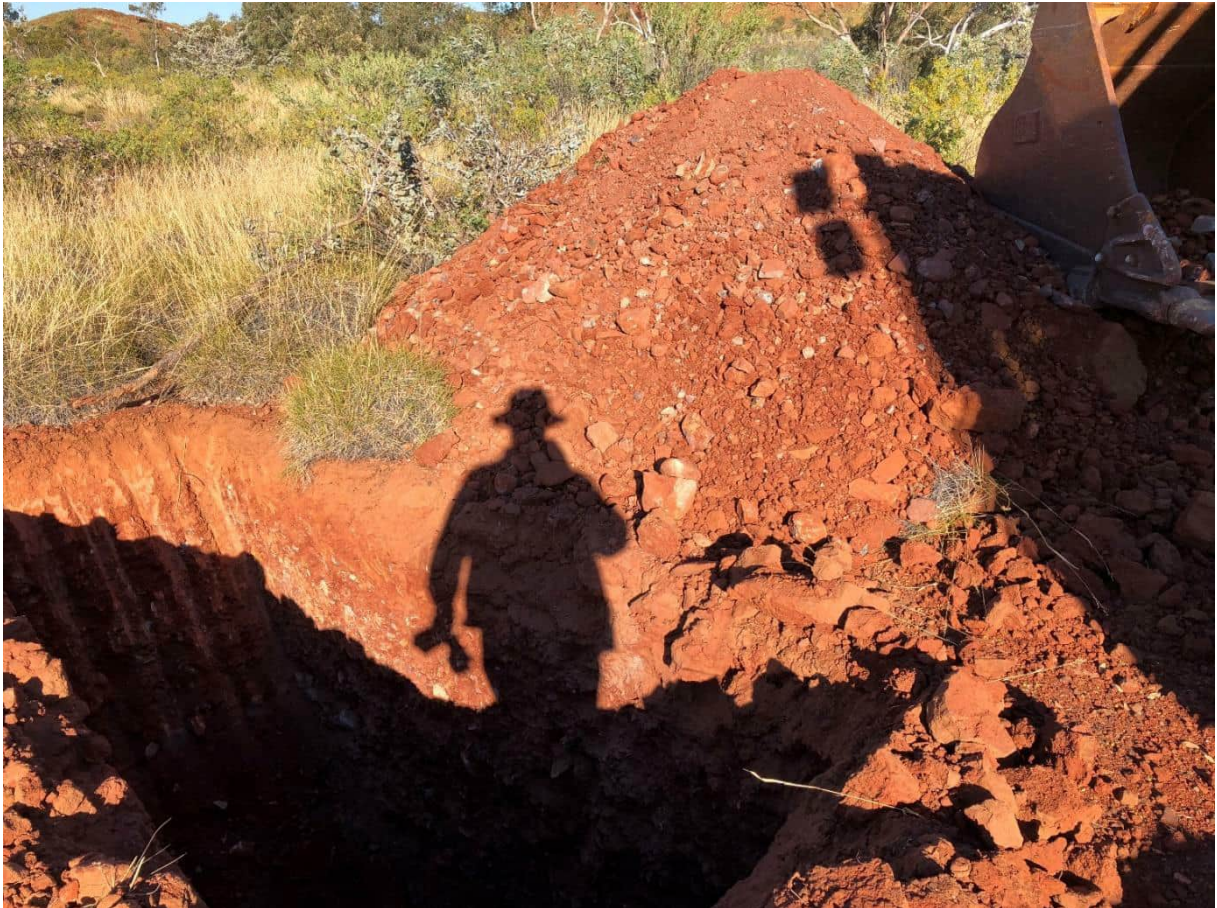
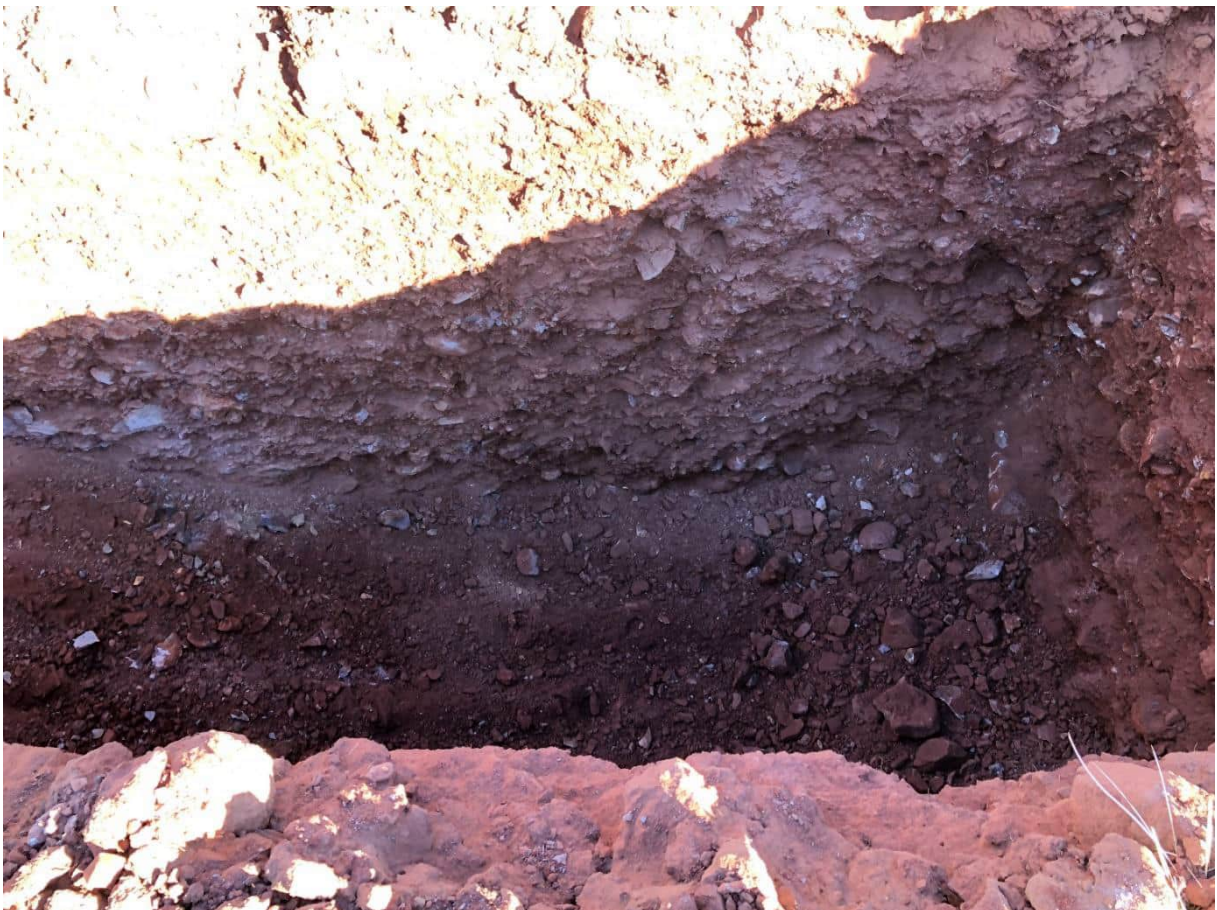
GP-GM	<b>TOPSOIL: GRAVEL</b> Medium dense, fine to coarse gravel, red brown, with sand, silt trace rootlets, dry.			
			2.5 3.0 3.5 4.0 4.5			Test pit TP2A-T32 terminated at 2.3m Bucket refusal - hard excavation

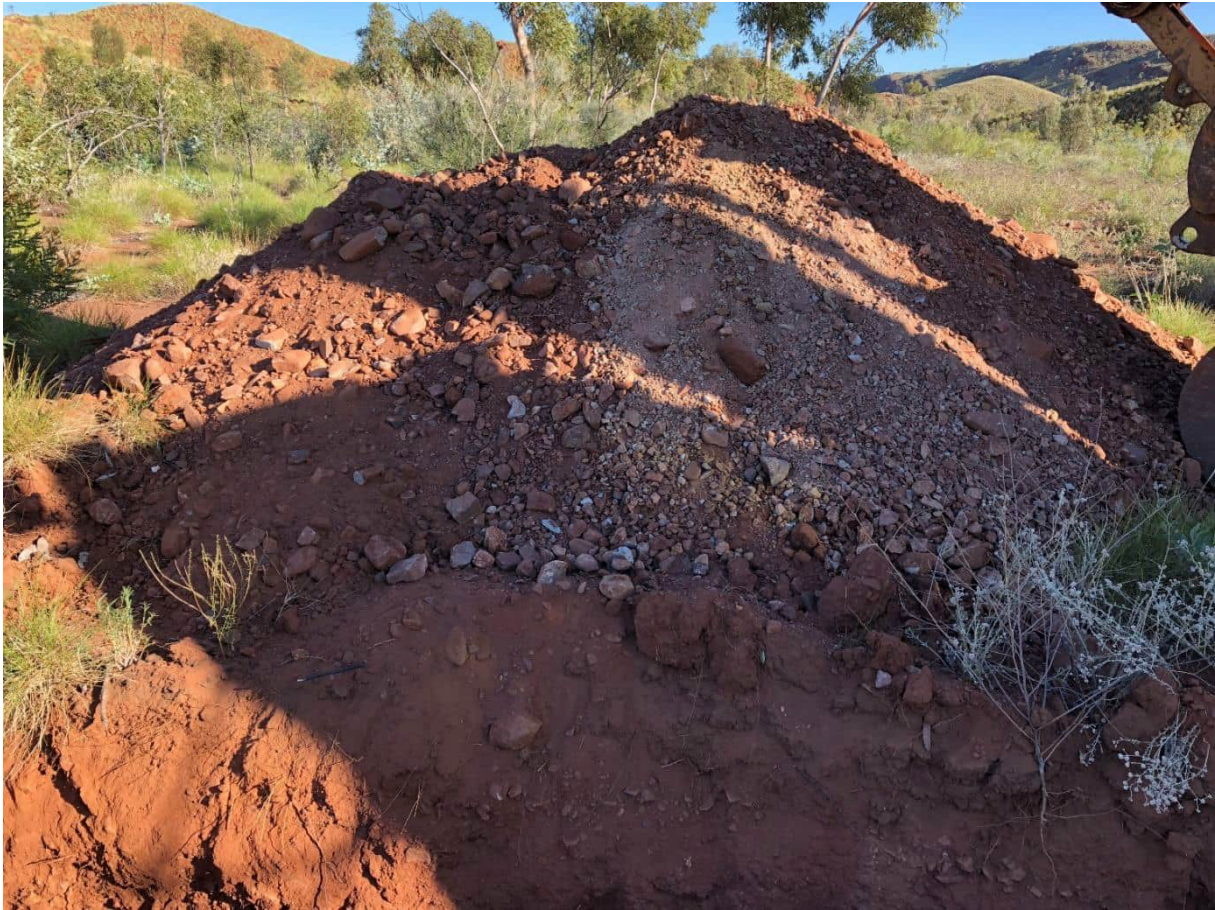
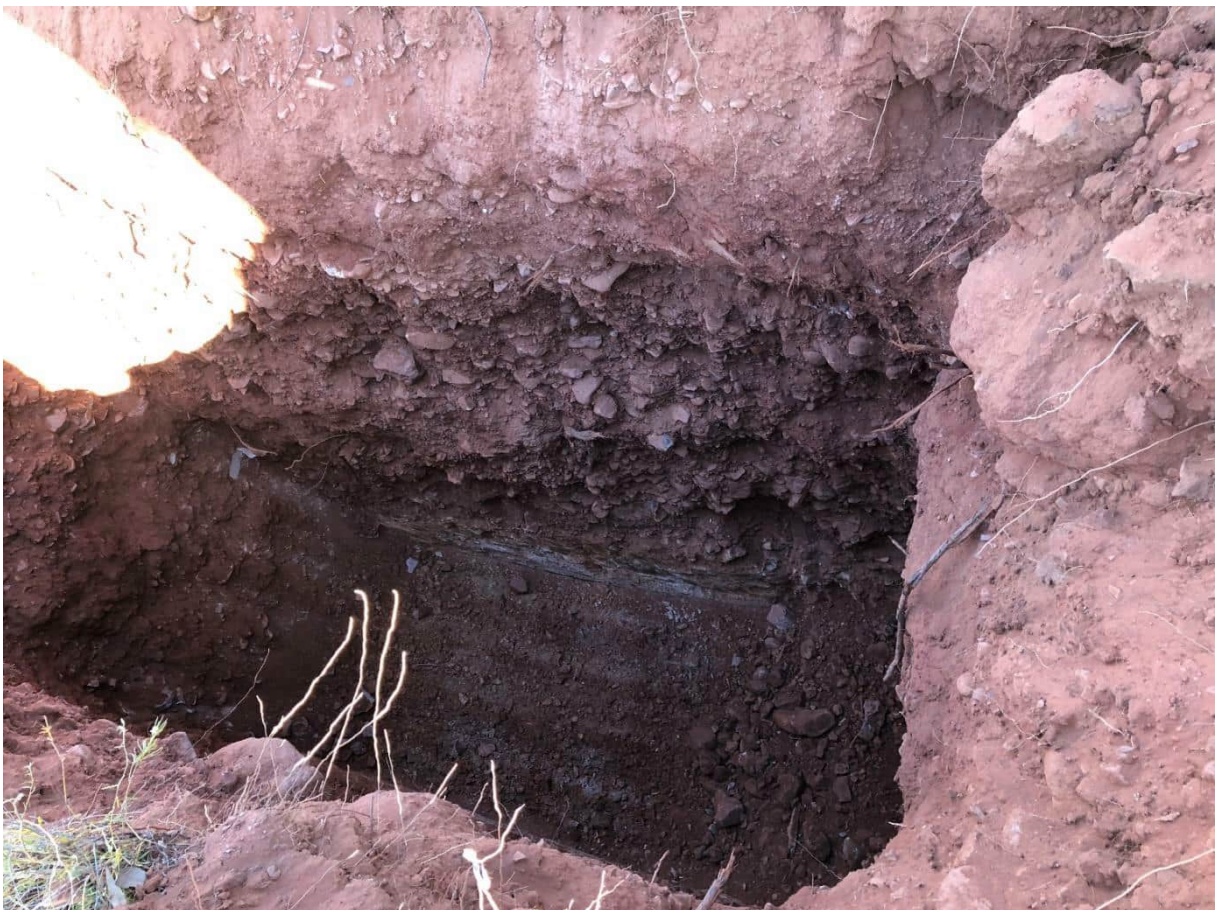
TP2A-T34

SM	<b>TOPSOIL: SILTY SAND</b> Loose, fine to coarse, red brown, with roots, dry

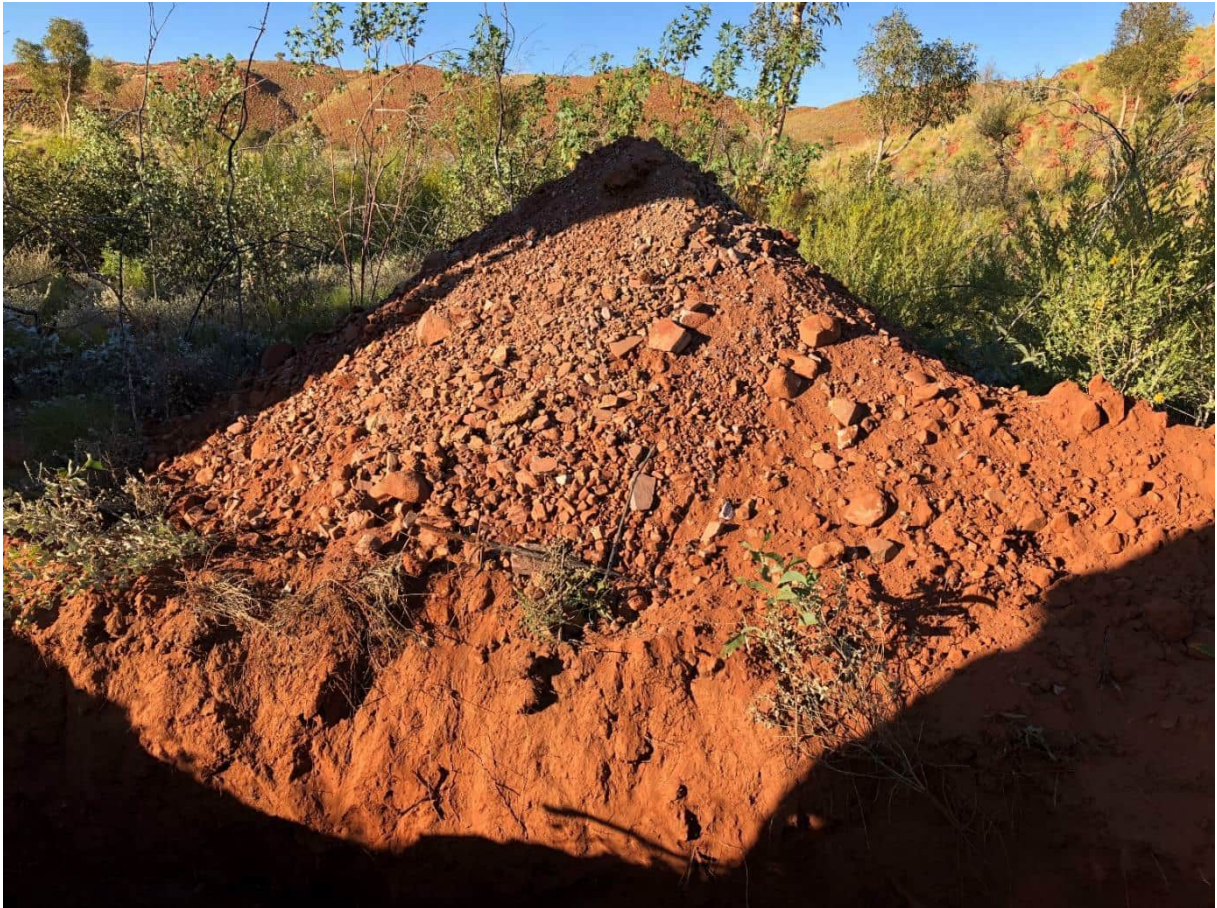
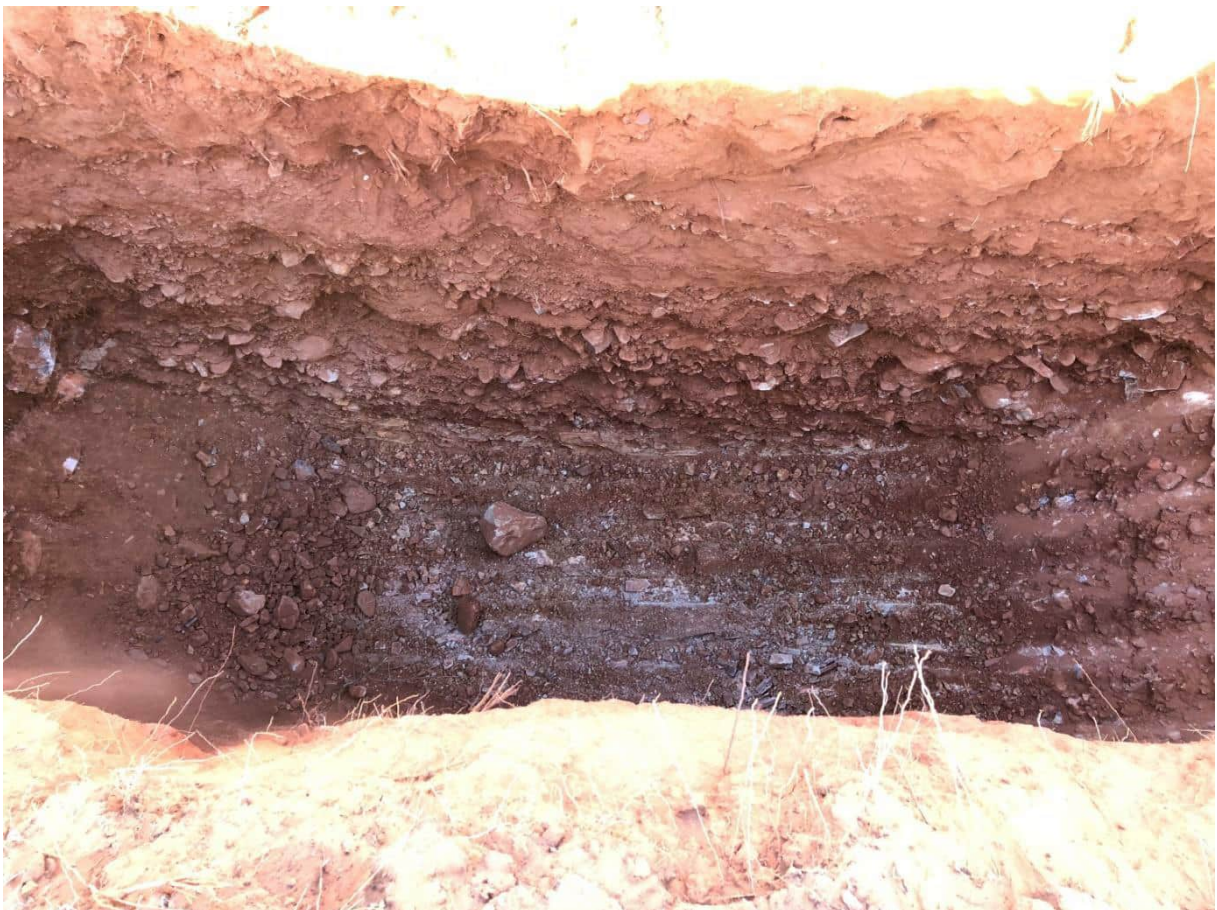
<b>SHALE/SILTSTONE</b> Extremely to highly weathered, grey, thin interbedded shale and siltstone layers, extremely low / very low strength, dry Test pit TP2A-T35 terminated at 2.8m Bucket refusal - hard excavation

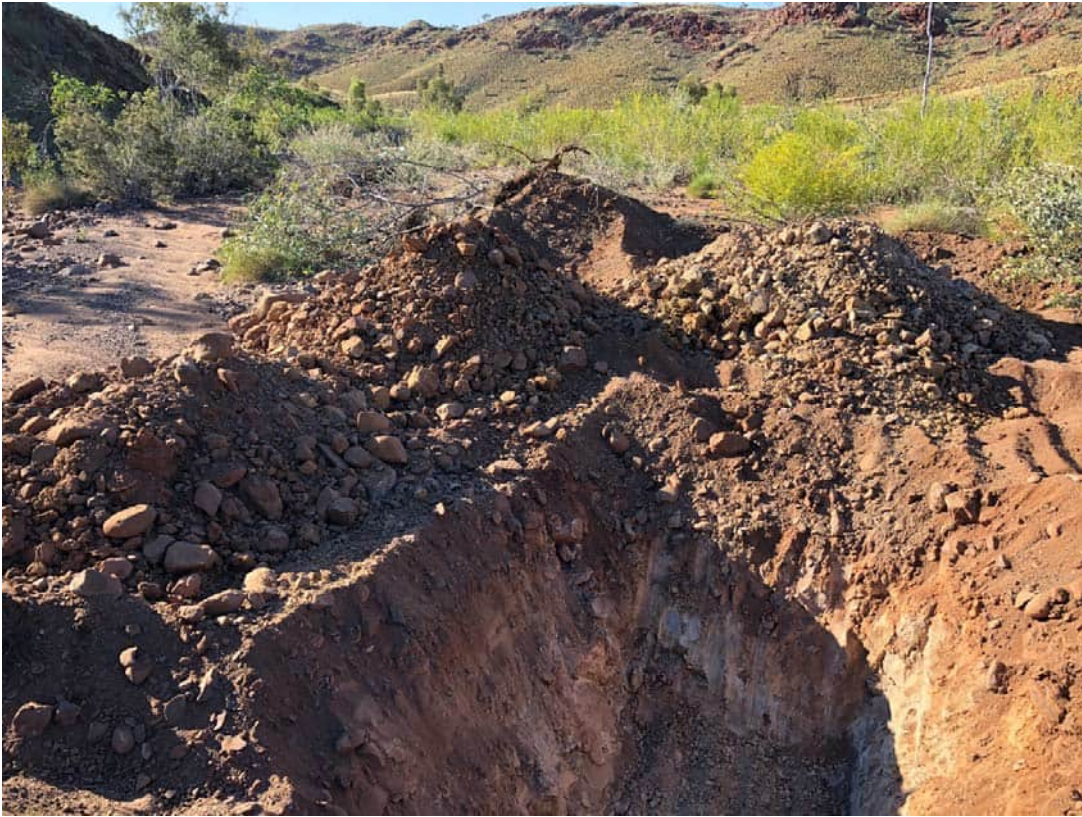
<b>SANDSTONE</b> Highly weathered, grey with minor red brown staining, fine and medium grained, massive, low / medium strength.			
			2.0			Test pit TP2A-T37 terminated at 1.9m Bucket refusal - hard excavation			
			2.5						
			3.0						
			3.5						
			4.0						
			4.5

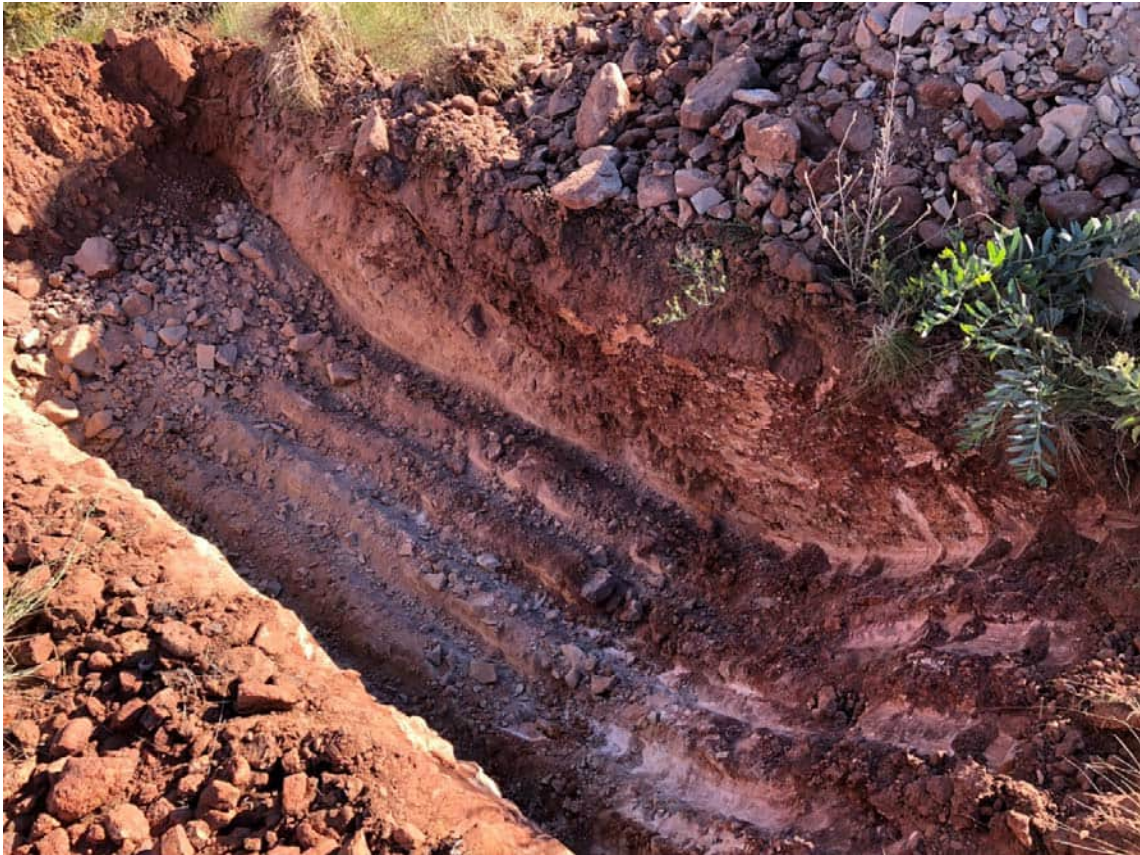
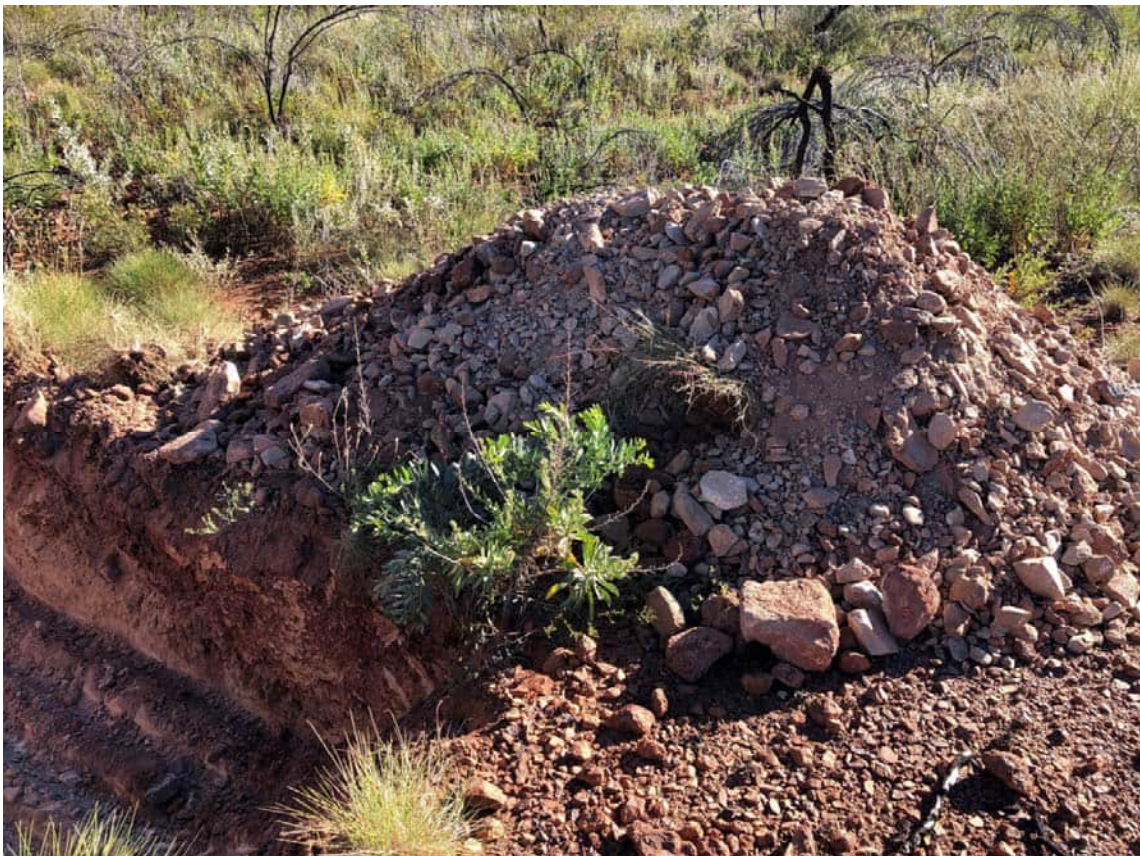
1.0			<b>SANDSTONE</b> Highly weathered, fine and medium grained, massive/faintly laminated, grey and pale grey, low /medium strength, dry.			
			1.5			Test pit TP2A-T38 terminated at 1.2m Bucket refusal - hard excavation

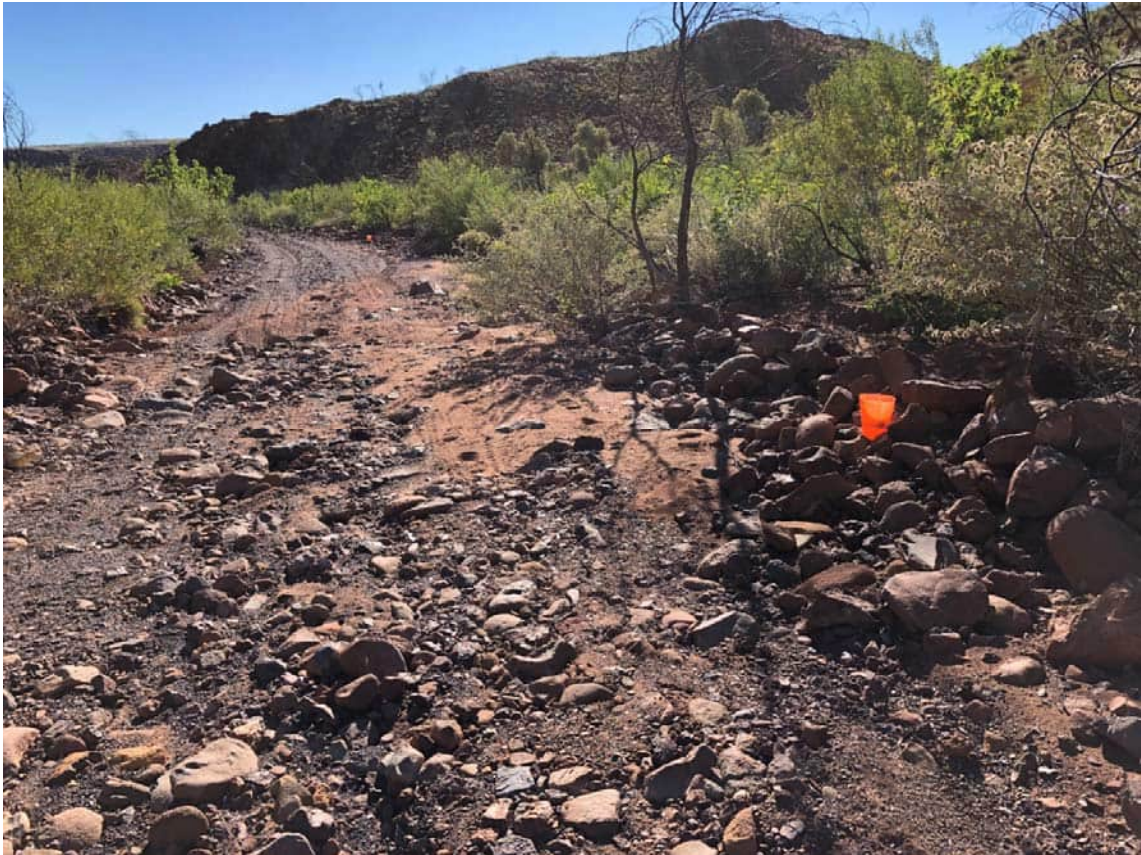
TP2A-T39

<b>SANDSTONE</b> Extremely to highly weathered, medium and coarse grained, massive/faintly laminated, grey and pale grey, very low /low strength, dry.  becoming low to medium strength

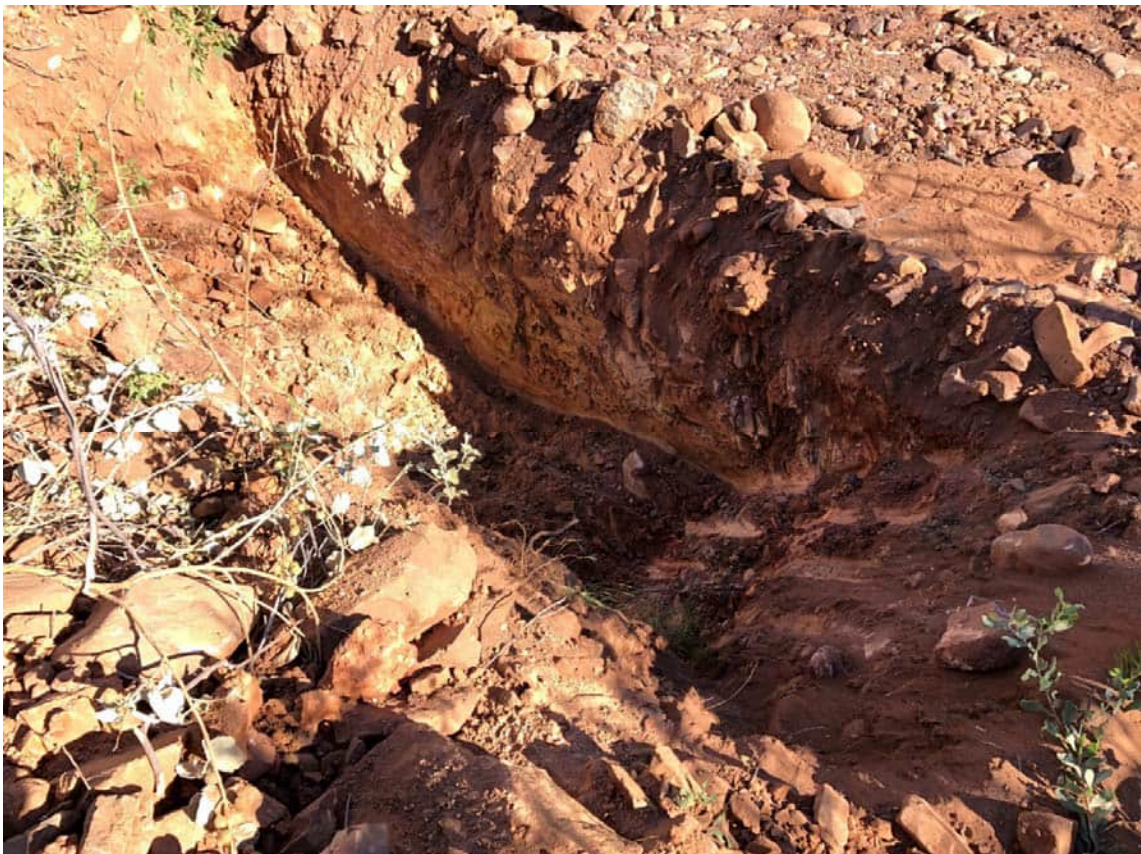
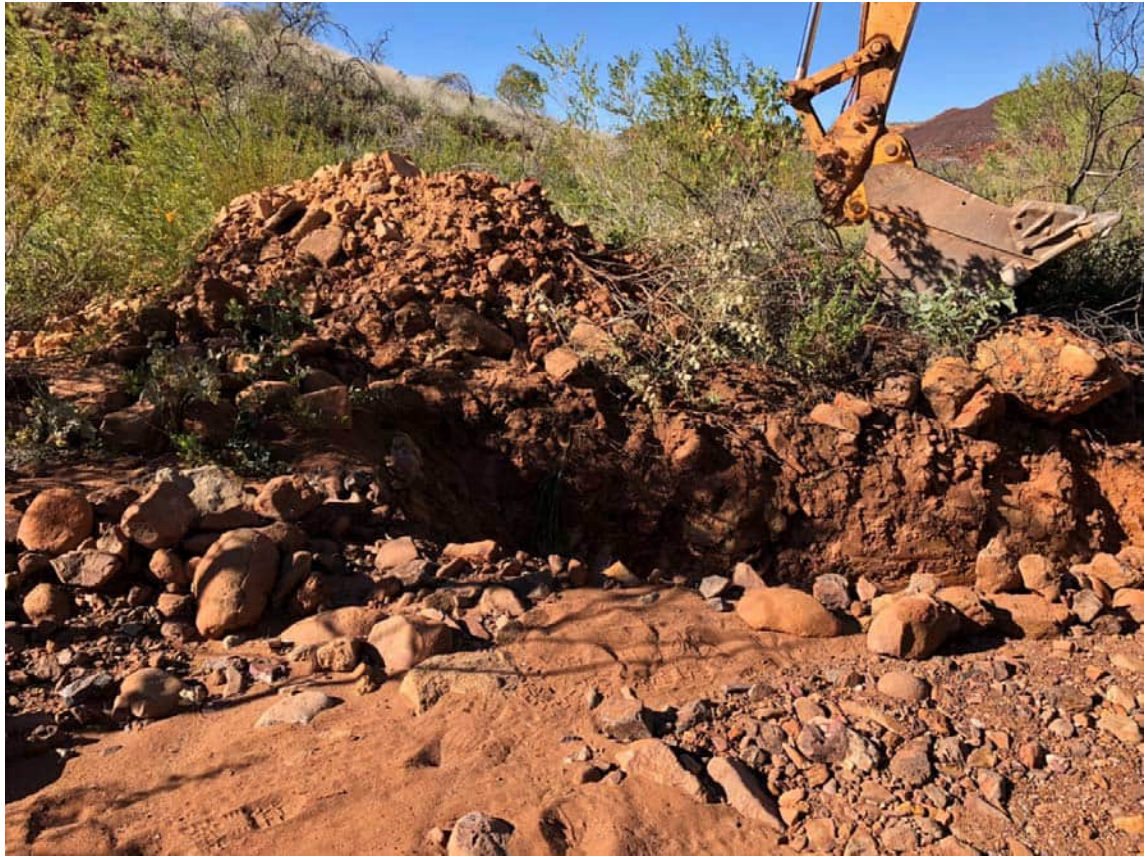
TP2A-T39

<b>SHALE</b> Extremely weathered, thinly bedded, brown and red brown. Excavated As: GRAVEL: Very dense/dense, fine to coarse, grey, red brown, with cobbles, sand and clay fines, dry/moist.

<b>SHALE</b> Extremely to highly weathered, medium and coarse grained, massive/faintly laminated, grey and pale grey, very low /low strength, dry.

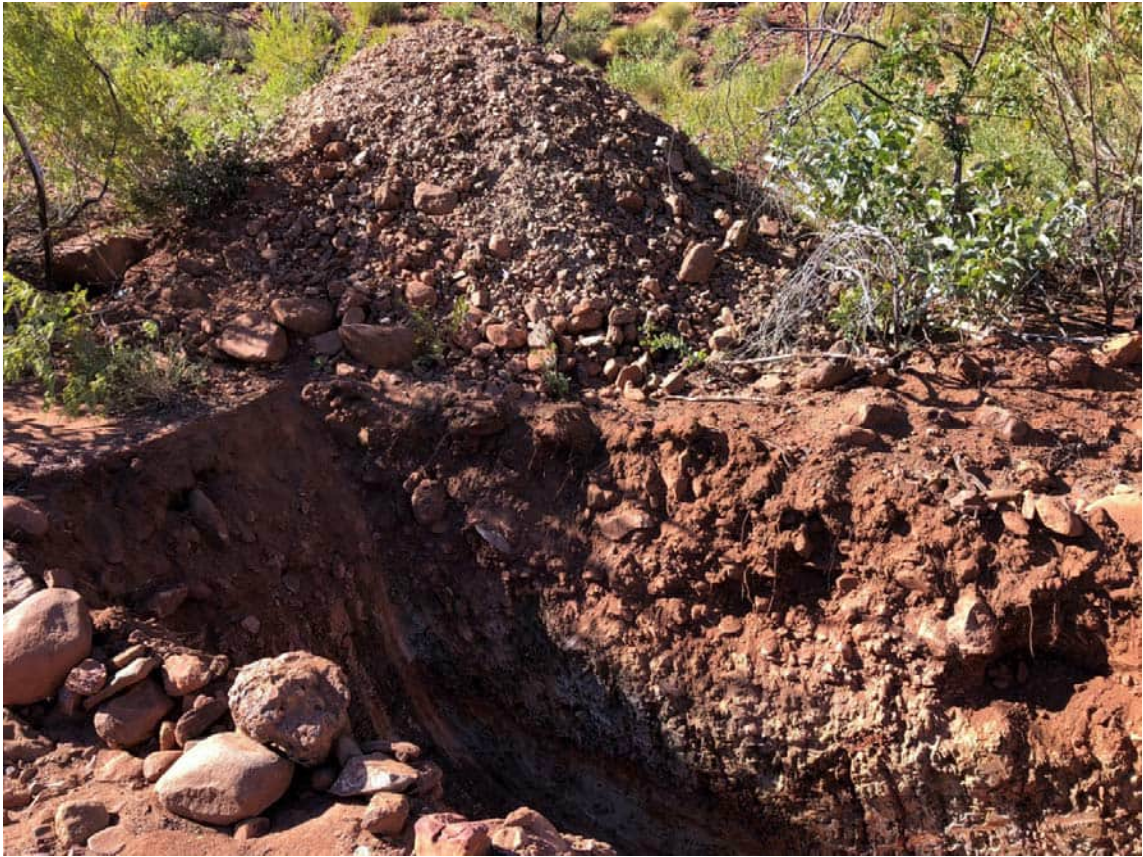
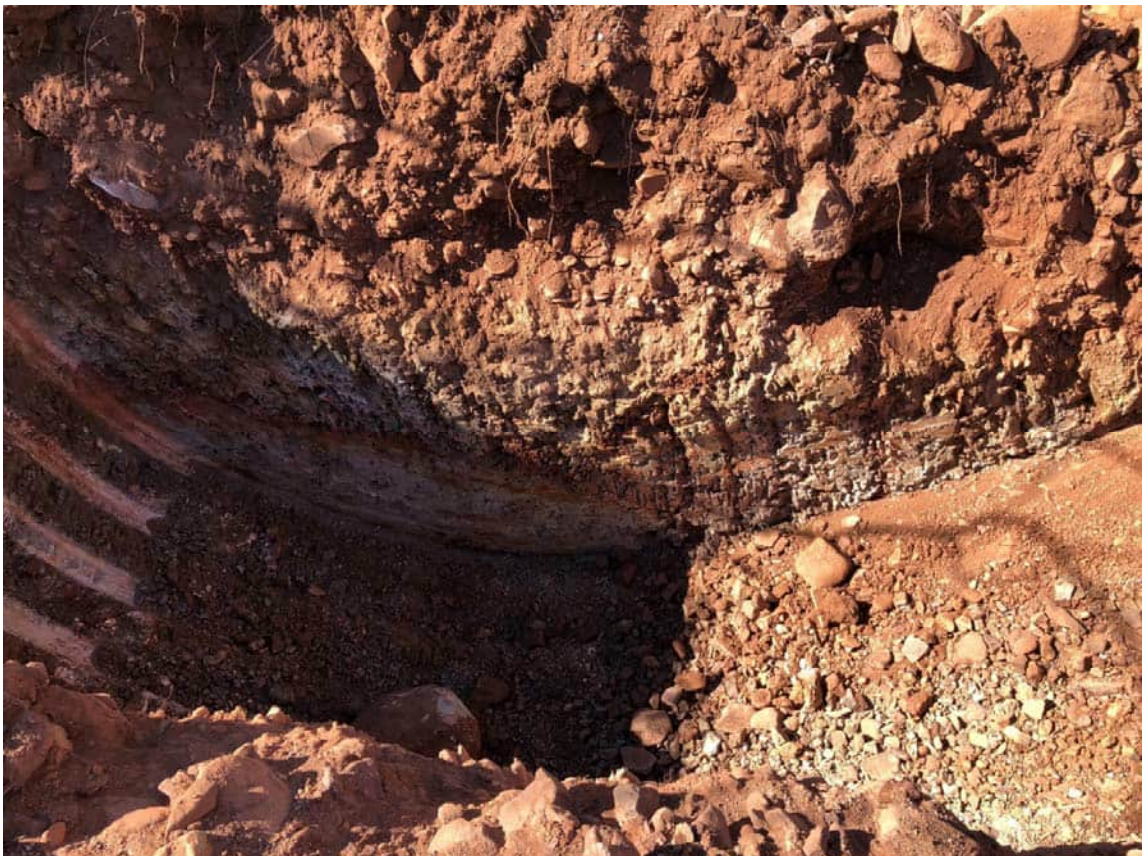
TP2A-T40

<b>SHALE</b> Extremely weathered, thinly bedded, brown and red brown. Excavated As: GRAVEL: Very dense/dense, fine to coarse, tabular, grey, red brown, sand and clay fines, dry/moist.

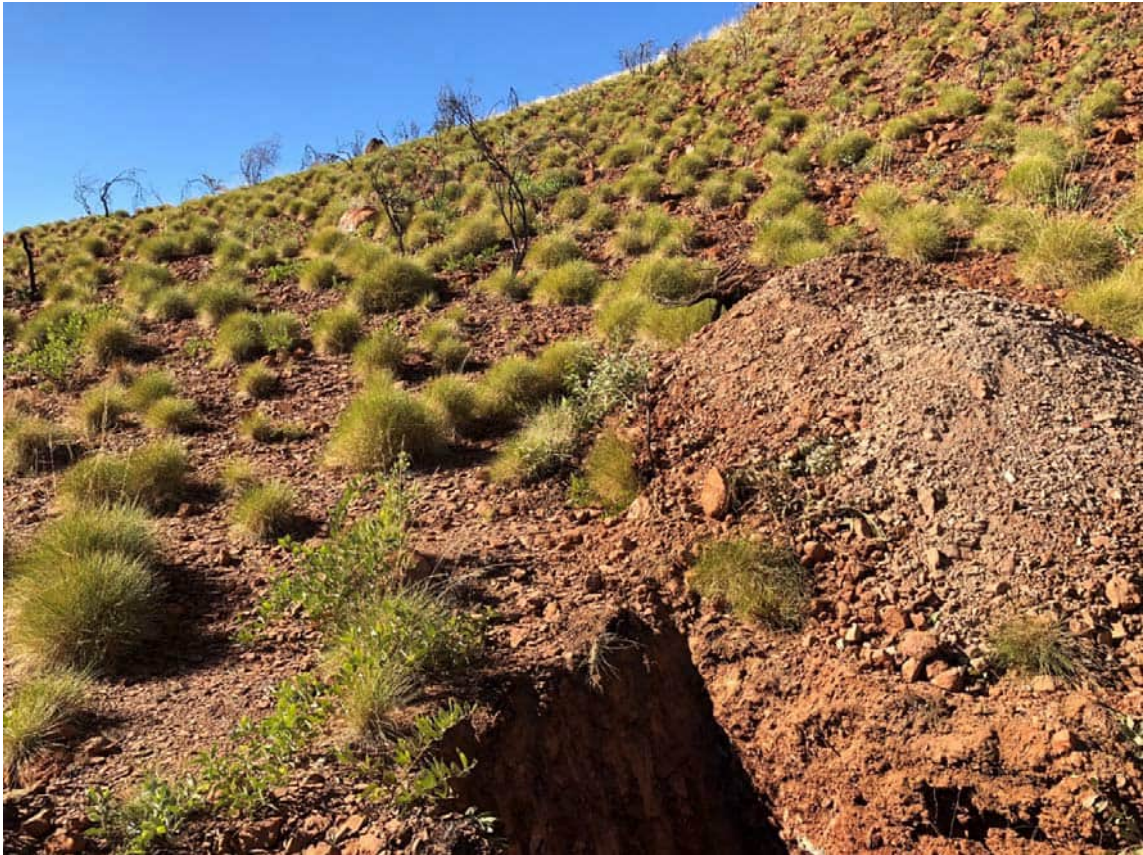
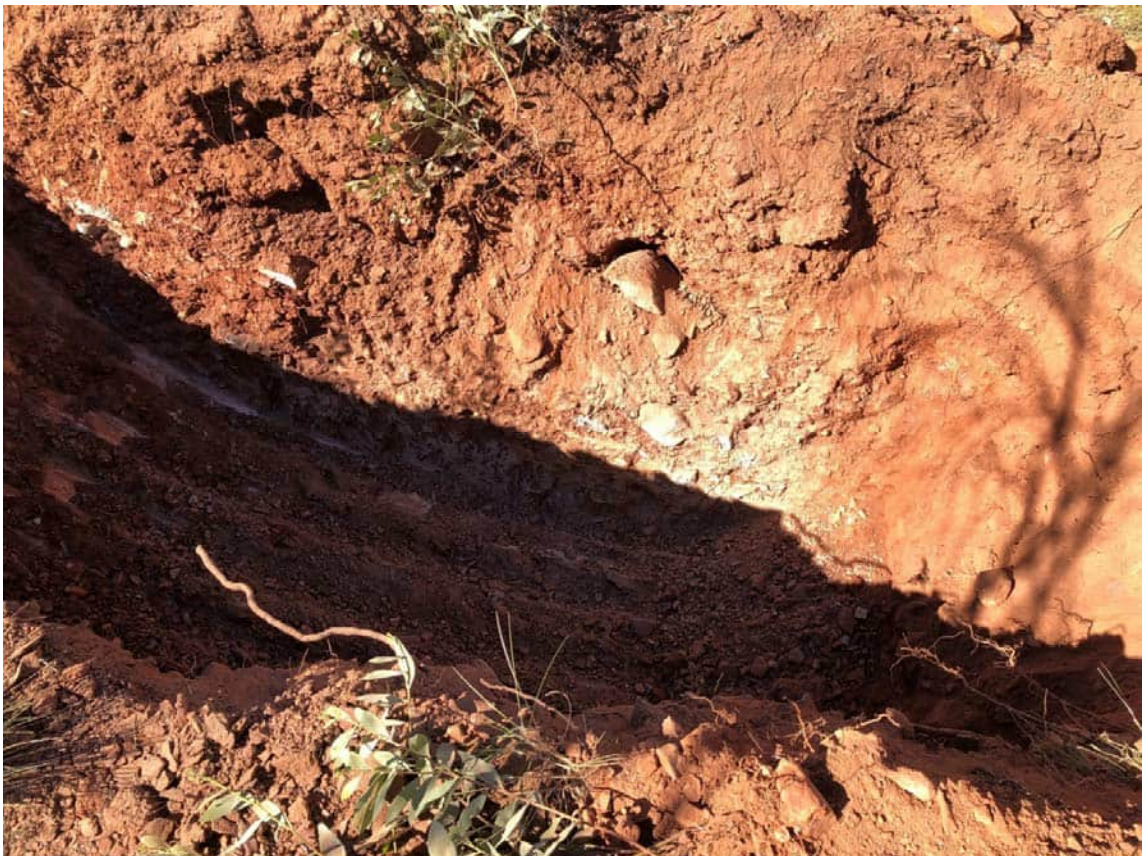
TP2A-T41

GP-GC	Sandy GRAVEL Loose, fine to coarse, gravel, red brown, fine to coarse sand, with silt fines, dry (Colluvium)			
					GP-GC	SHALE Extremely weathered. Excavated As : Very dense/dense, fine to coarse GRAVEL, grey, red brown, with sand and clay fines, dry			
						SHALE Highly weathered, grey and white, thinly interbedded, subvertical dip, subvertical cleavage/bedding, very low / low strength, dry Test pit TP2A-T42 terminated at 0.5m Bucket refusal - hard excavation			
			1.0						
			1.5						
			2.0						
			2.5						
			3.0						
			3.5						
			4.0						
			4.5

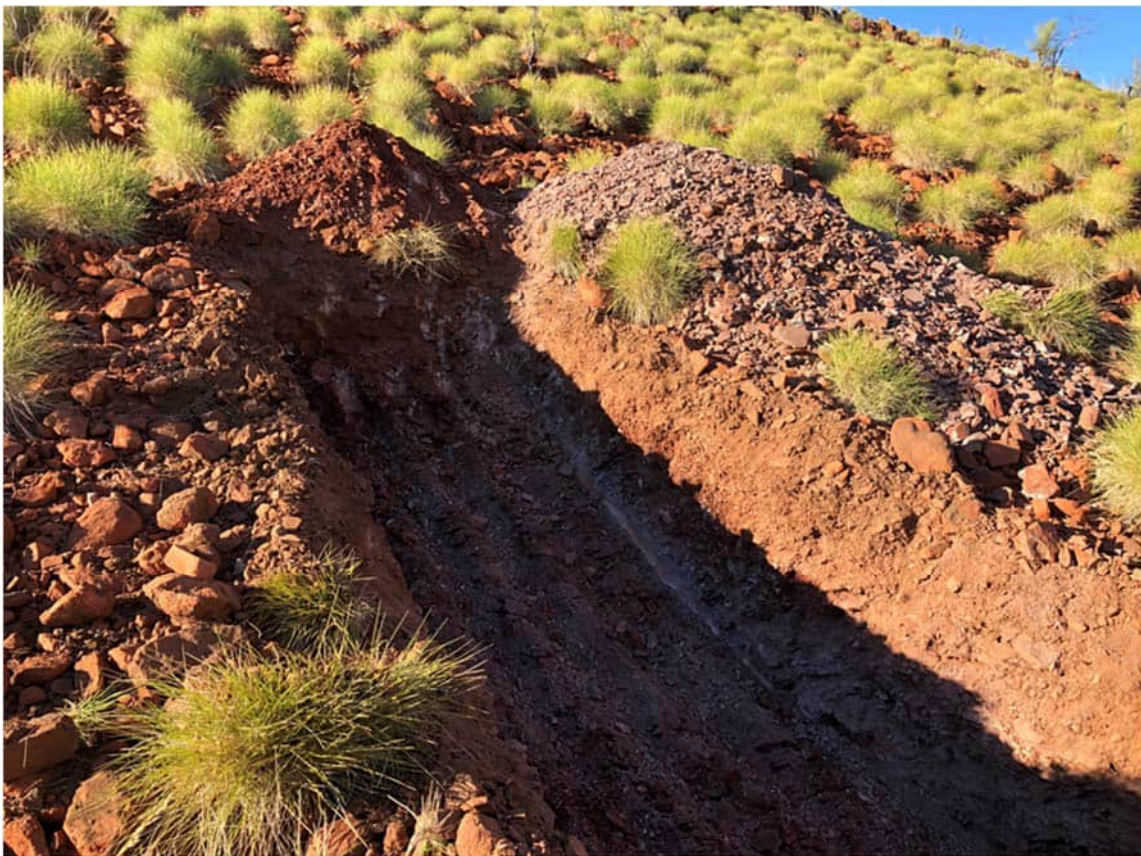
TP2A-T42

GP-GC GP-GC	<b>TOPSOIL: GRAVEL</b> Medium dense, fine to coarse gravel, red brown, with sand, clay and rootlets, dry.			
						<b>GRAVEL</b> Loose, fine to coarse, gravel, red brown, fine to coarse sand, with silt fines, dry (Colluvium)
