**CLIENT** Iron Bridge Operations Pty Ltd  
**JOB NUMBER** 114185.10

**JOB NAME** North Star Magnetite Project  
**JOB LOCATION** Pilbara, WA

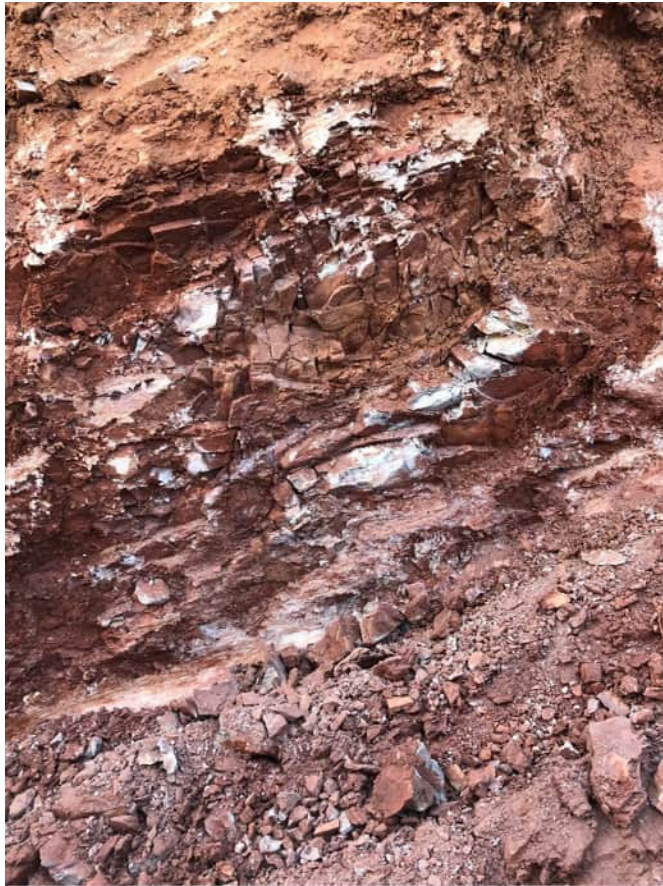
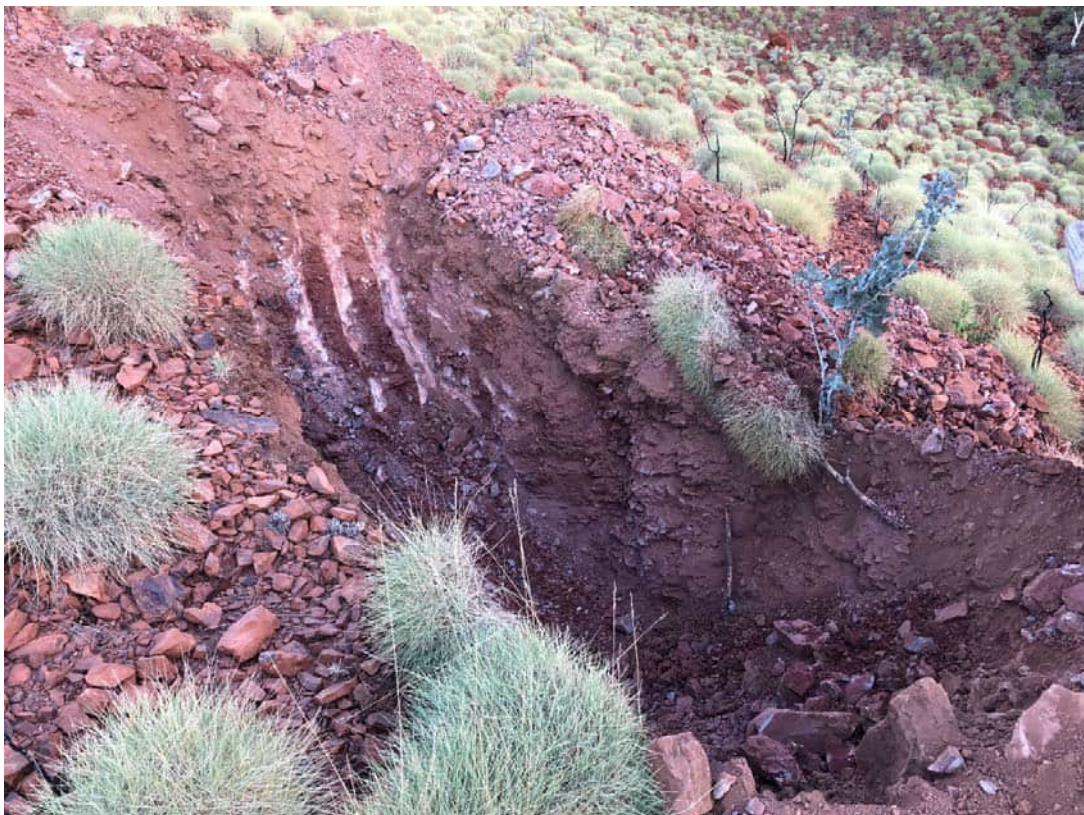
TP2A-T43

GP-GC	<b>TOPSOIL: GRAVEL</b> Medium dense, fine to coarse gravel, red brown, with sand, clay and rootlets, dry.			
					GP-GC	<b>SHALE/SILTSTONE</b> Extremely weathered. Excavated As : Very dense/dense, fine to coarse GRAVEL, grey, red brown, with sand and clay fines, dry			
						<b>SHALE/SILTSTONE</b> Highly weathered, grey brown, thinly interbedded shale and siltstone layers (20 mm - 30 mm thickness), very low / low strength, dry Test pit TP2A-T44 terminated at 0.5m Bucket refusal - hard excavation			
			1.0						
			1.5						
			2.0						
			2.5						
			3.0						
			3.5						
			4.0						
			4.5

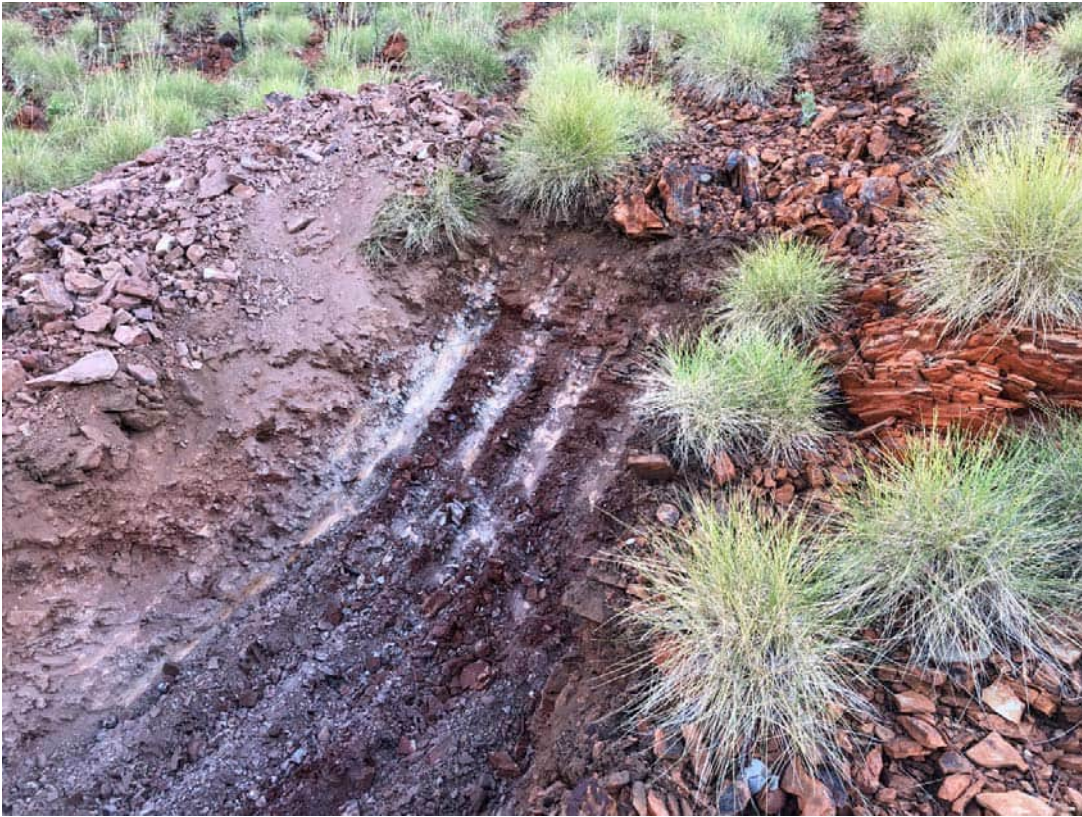
TP2A-T44

GP-GM	<b>TOPSOIL: GRAVEL</b> Medium dense, fine to coarse gravel, red brown, with sand, silt and rootlets, dry. <b>SANDSTONE</b> Extremely weathered, pale grey with red oxide staining, close vertical jointing. Excavated as COBBLES with gravel and sand, dry			
			0.5			<b>SANDSTONE</b> Highly weathered, pale grey with red oxide staining, medium and coarse, close vertical jointing, low / medium strength, dry Test pit TP2A-T45 terminated at 0.5m Bucket refusal - hard excavation			
			1.0						
			1.5						
			2.0						
			2.5						
			3.0						
			3.5						
			4.0						
			4.5

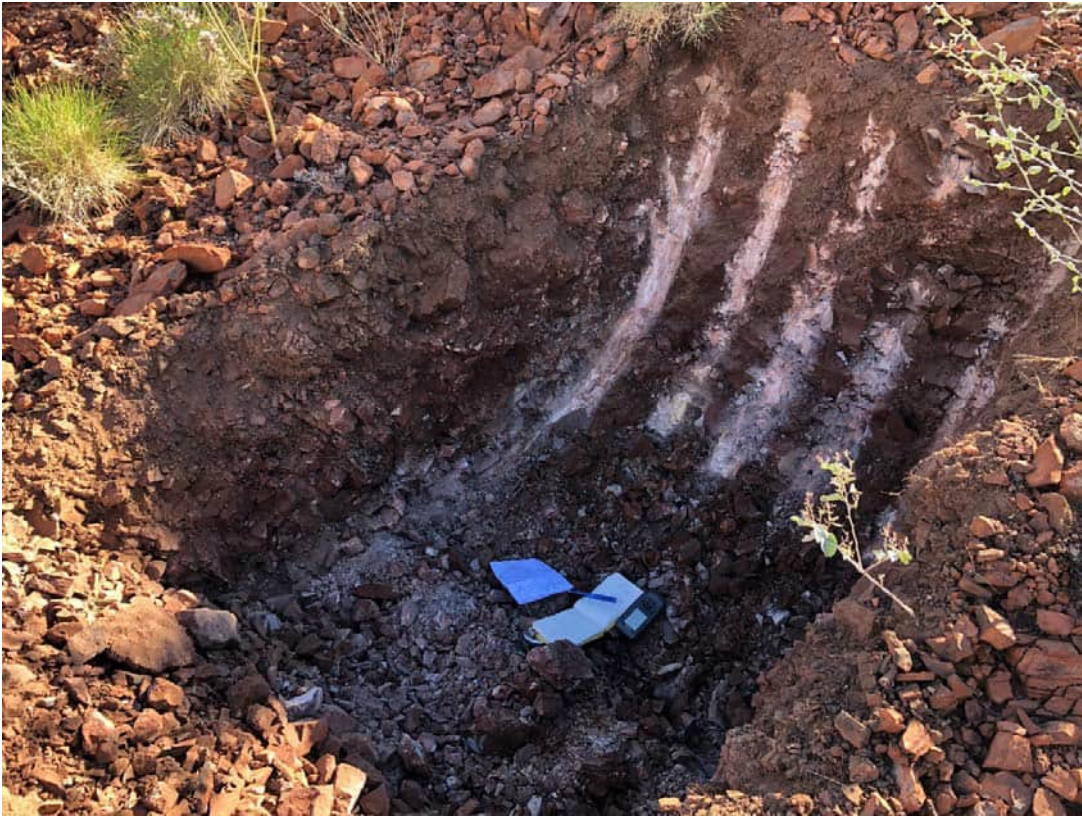
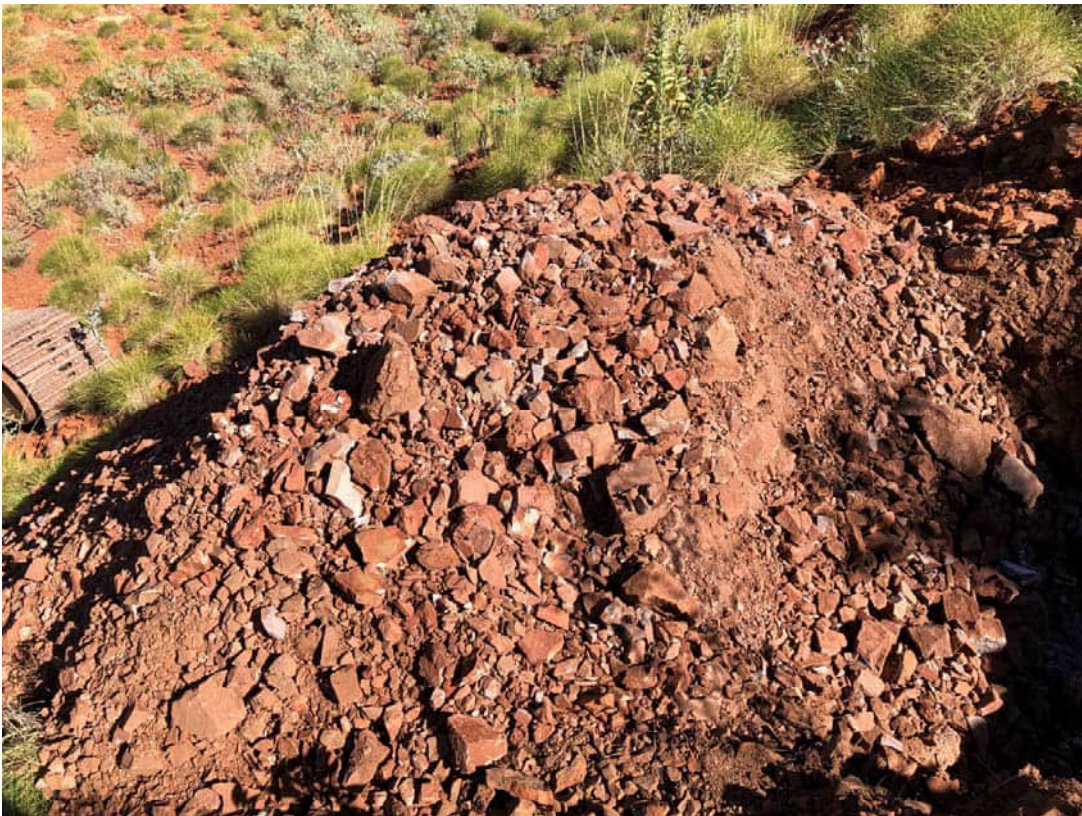
TP2A-T46

GP-GM	<b>GRAVEL</b> Loose, fine to coarse, grey brown with sand and silt fines, dry (Colluvium)			
			0.5

<b>SANDSTONE</b> Highly weathered, green-grey, medium and coarse grained, closely jointed, medium strength, dry. (Very hard to excavate).

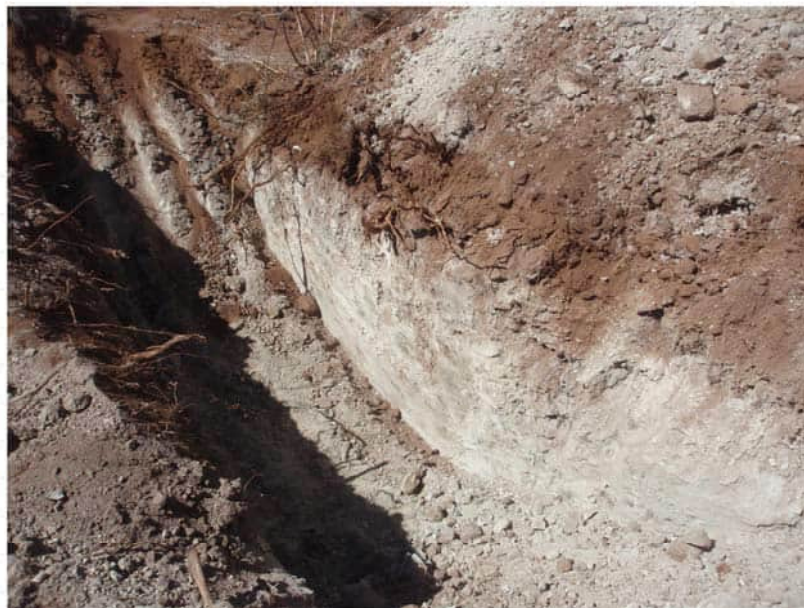
Sketch & Other Observations

CL-CI	TOPSOIL, Silty SAND, fine to medium grained, rounded sand brown grey with organics and rootlets	M	D - VD		
			276.85	0.5				Sandy CLAY low to medium plasticity, white grey, with 20% medium to coarse grained, sub-angular sand, recovered as cobbles and coarse gravels extremely to completely weathered rock				
			1.0	275.80				TEST PIT DISCONTINUED @ 1.20 m STABLE REFUSAL BACKFILLED				
			1.5									
			2.0									
			2.5									
			3.0									
			3.5									
			4.0									
			4.5									
			5.0

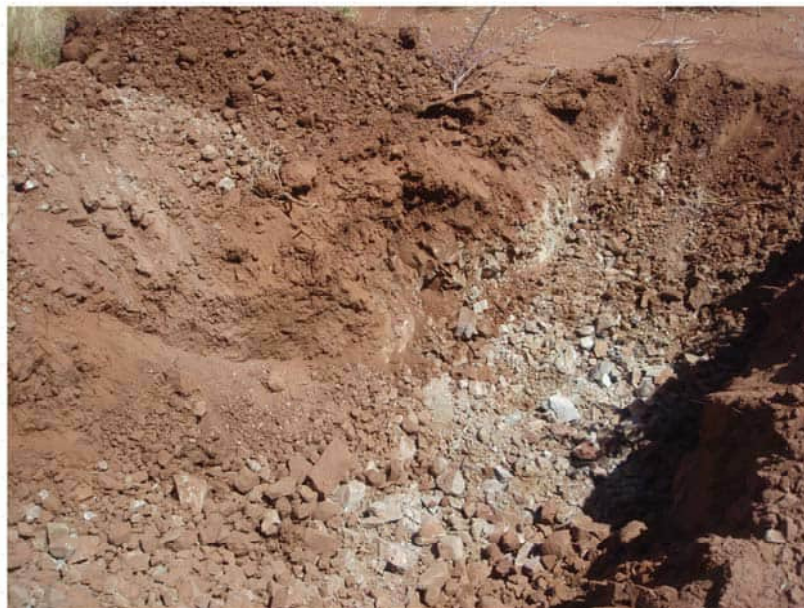
Sketch & Other Observations

GP		GRAVEL fine to coarse grained, grey white, extremely to completely weathered sandstone	D	L	VD
			0.5	284.40				TEST PIT DISCONTINUED @ 0.60 m STABLE REFUSAL BACKFILLED				
			1.0									
			1.5									
			2.0									
			2.5									
			3.0									
			3.5									
			4.0									
			4.5									
			5.0

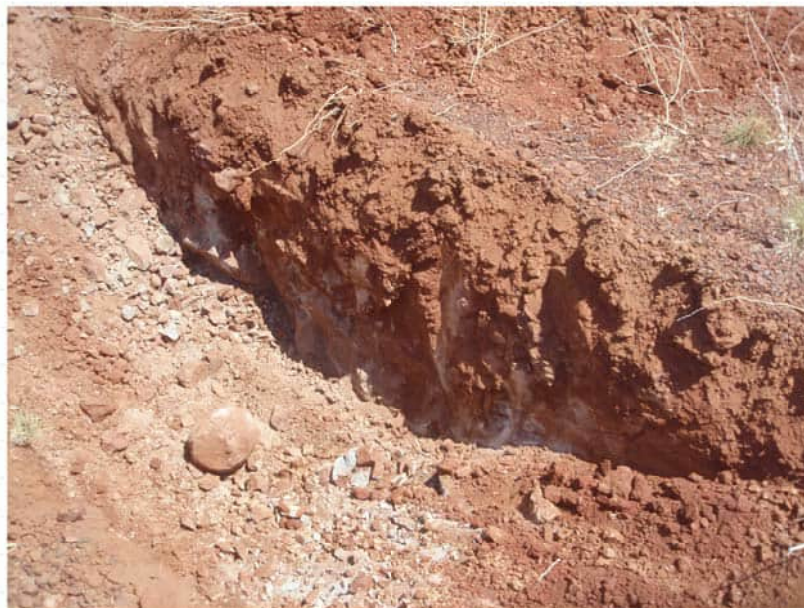
Sketch & Other Observations

1.0	292.90				TEST PIT DISCONTINUED @ 1.10 m STABLE REFUSAL BACKFILLED				
			1.5									
			2.0									
			2.5									
			3.0									
			3.5									
			4.0									
			4.5									
			5.0

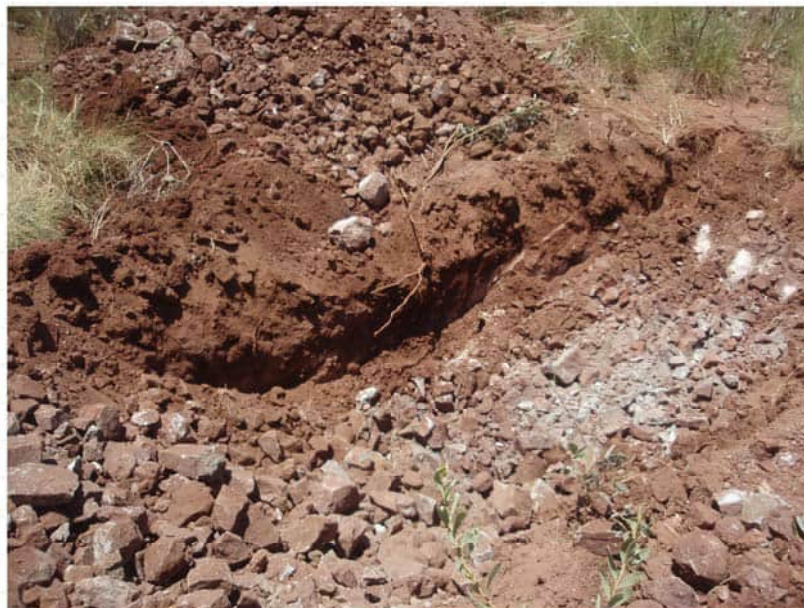
**Sketch & Other Observations**

Excavation			Sampling			Field Material Description						
METHOD	EXCAVATION RESISTANCE	WATER	DEPTH (metres)	DEPTH RL	SAMPLE OR FIELD TEST	RECOVERED GRAPHIC LOG	USCS SYMBOL	SOIL/ROCK MATERIAL DESCRIPTION	MOISTURE CONDITION	CONSISTENCY	DENSITY	STRUCTURE AND ADDITIONAL OBSERVATIONS
			0.0	288.00			SC	Clayey SAND medium to coarse grained, sub-angular, brown, with 10 -15% low Pl clay, trace gravel				
			0.20	287.80			GP					
			0.5	287.40				GRAVEL fine to coarse grained, sub-angular, grey white, extremely to completely weathered sandstone				
			1.0					TEST PIT DISCONTINUED @ 0.60 m				
			1.5					STABLE				
			2.0					REFUSAL				
			2.5					BACKFILLED				
			3.0									
			3.5									
			4.0									
			4.5									
			5.0

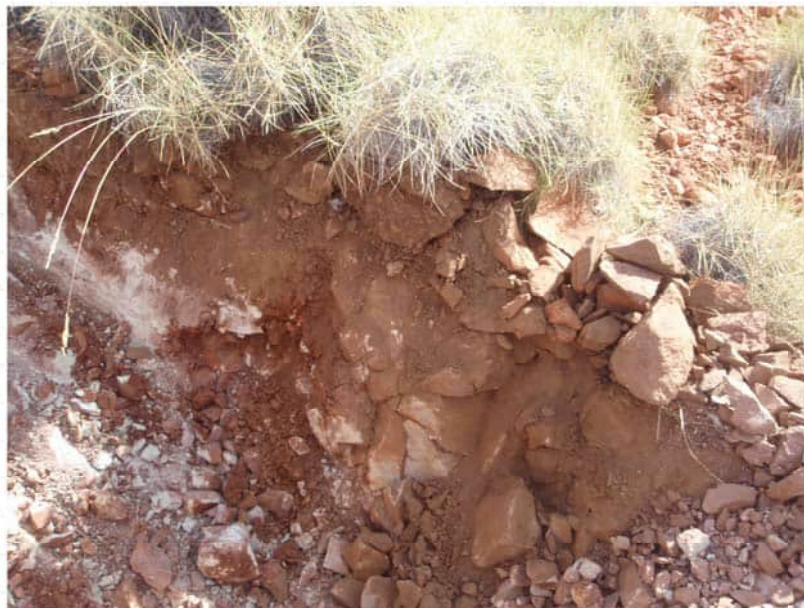
**Sketch & Other Observations**

Excavation				Sampling			Field Material Description					
METHOD	EXCAVATION RESISTANCE	WATER	DEPTH (metres)	DEPTH RL	SAMPLE OR FIELD TEST	RECOVERED GRAPHIC LOG	USCS SYMBOL	SOIL/ROCK MATERIAL DESCRIPTION	MOISTURE CONDITION	CONSISTENCY	DENSITY	STRUCTURE AND ADDITIONAL OBSERVATIONS
			0.0	259.00			GP	Gravelly COBBLES sub-angular, red brown, with coarse grained, sub-angular to sub-rounded gravel, trace sand	D	D - VD		
			0.5	258.60				TEST PIT DISCONTINUED @ 0.40 m STABLE REFUSAL BACKFILLED				
			1.0									
			1.5									
			2.0									
			2.5									
			3.0									
			3.5									
			4.0									
			4.5									
			5.0

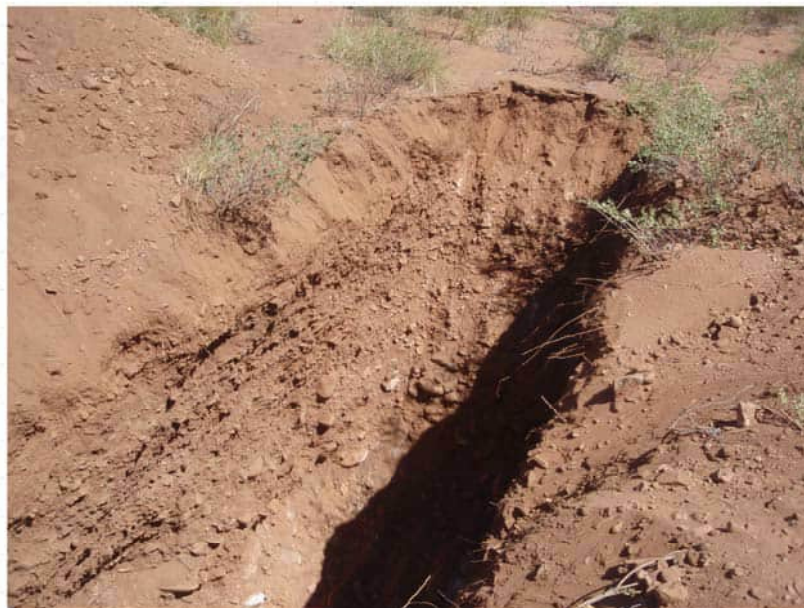
Sketch & Other Observations

GP	TOPSOIL, Gravelly SAND, 70 - 80% fine to coarse grained sand, with some fine sub-rounded gravel (20 - 25%)	D	MD		
			0.15	250.85				Sandy GRAVEL fine to coarse grained, sub-rounded, 40 - 50%, red brown, with 30 - 40% fine to coarse grained, rounded sand				
			0.5									
			1.0	1.30								
			1.5	249.70			GP	with some boulders and cobbles		D - VD		
			2.0									
			2.5	248.90				TEST PIT DISCONTINUED @ 2.10 m STABLE REFUSAL BACKFILLED				
			3.0									
			3.5									
			4.0									
			4.5									
			5.0

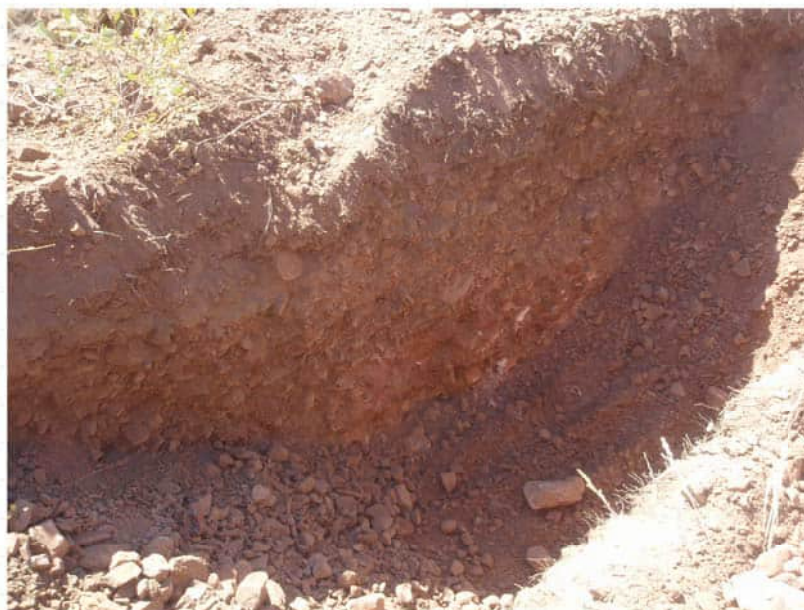
**Sketch & Other Observations**

Excavation			Sampling		Field Material Description							
METHOD	EXCAVATION RESISTANCE	WATER	DEPTH (metres)	DEPTH RL	SAMPLE OR FIELD TEST	RECOVERED GRAPHIC LOG	USCS SYMBOL	SOIL/ROCK MATERIAL DESCRIPTION	MOISTURE CONDITION	CONSISTENCY	DENSITY	STRUCTURE AND ADDITIONAL OBSERVATIONS
			0.0	0.15				TOPSOIL, Silty GRAVEL, with some root fibres				
			0.15	253.85			GW	GRAVEL fine to coarse grained, sub-rounded, 80 - 90%, grey brown, with some cobbles, and trace fine, sub-rounded sand				
			0.5	0.70			GW	less than 5% red, low to medium PI clay				
			0.70	253.30								
			1.0									
			1.5	252.70				TEST PIT DISCONTINUED @ 1.30 m STABLE REFUSAL BACKFILLED				
			2.0									
			2.5									
			3.0									
			3.5									
			4.0									
			4.5									
			5.0

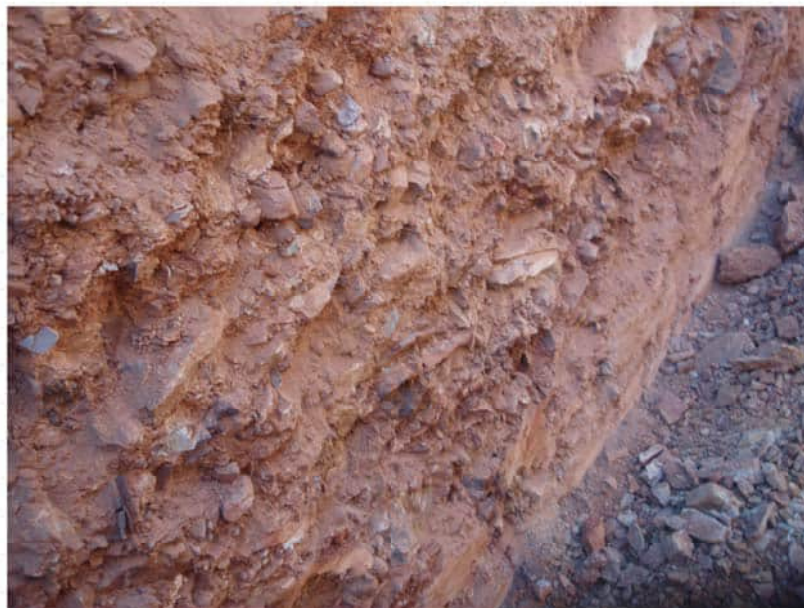
**Sketch & Other Observations**

GC	Clayey GRAVEL fine to coarse grained, sub-angular, 60 -70%, red with yellow, green and grey, with 20% high PI, moderately cemented clay				
			1.5	259.60				TEST PIT DISCONTINUED @ 1.40 m STABLE REFUSAL BACKFILLED

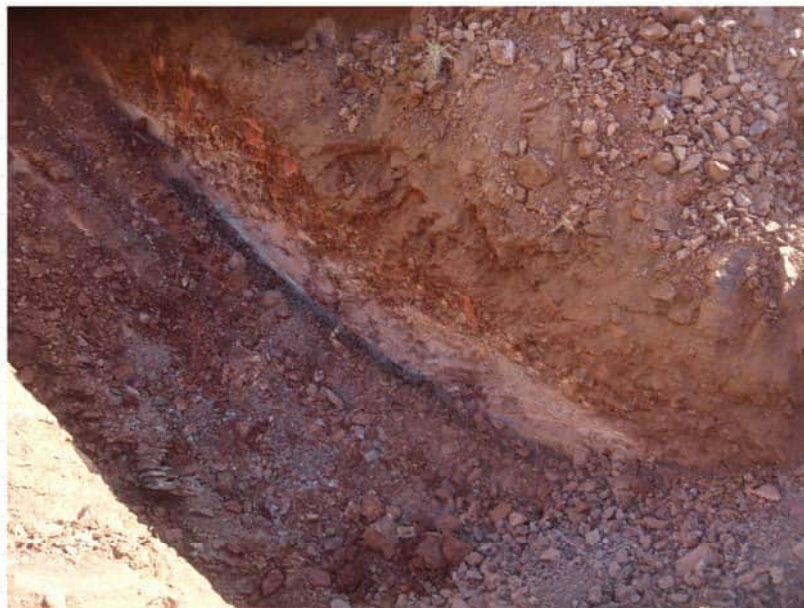
**Sketch & Other Observations**

GC	TOPSOIL, trace root fibres				
			0.60	267.40			GP	GRAVEL fine to coarse grained, angular, pale red brown, with 20 -30% medium to high PI clay				
			1.0	267.10				GRAVEL coarse grained, angular, grey red, trace high PI clay, with some cobbles, increasing cobbles with depth				
								TEST PIT DISCONTINUED @ 0.90 m STABLE REFUSAL BACKFILLED				
			1.5									
			2.0									
			2.5									
			3.0									
			3.5									
			4.0									
			4.5									
			5.0

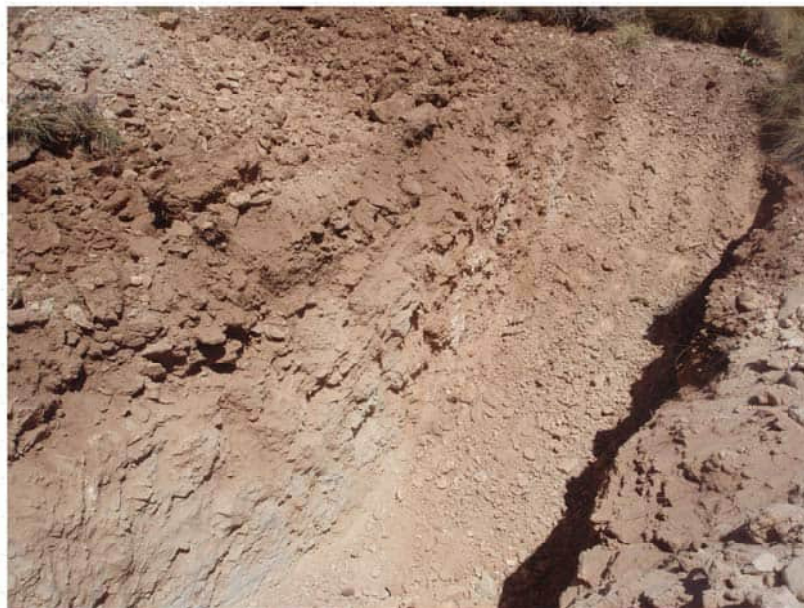
Sketch & Other Observations

GP	TOPSOIL, Sandy GRAVEL, medium grained, sub-angular, red brown gravel with fine to coarse grained, sub-angular to sub-rounded sand (40%)  GRAVEL medium to coarse grained, angular, pale grey brown, with 10% low to medium Pl clay, and 10 - 15% sub rounded, fine, well cemented sand. (sandstone)	D	D - VD		
			1.5	249.70				TEST PIT DISCONTINUED @ 1.30 m STABLE REFUSAL BACKFILLED

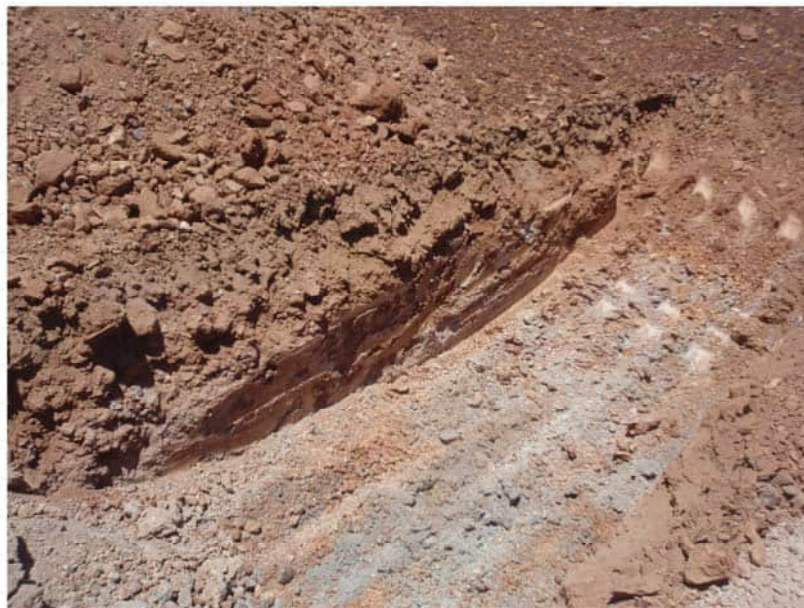
Sketch & Other Observations

GC	TOPSOIL, trace rootlets Clayey GRAVEL fine grained, pale red brown, with 20 - 30% low to medium PI clay	D	MD		
			0.5		TP-23 0.6-0.8 BDS 0.60 m					Vst	H	
			1.0	251.20				TEST PIT DISCONTINUED @ 0.80 m STABLE REFUSAL BACKFILLED				
			1.5									
			2.0									
			2.5									
			3.0									
			3.5									
			4.0									
			4.5									
			5.0

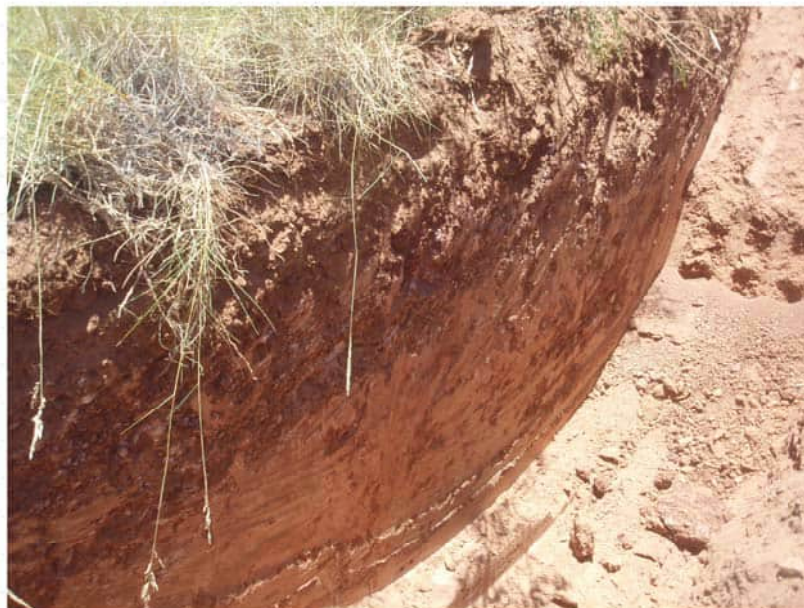
**Sketch & Other Observations**

Excavation			Sampling	Field Material Description								
METHOD	EXCAVATION RESISTANCE	WATER	DEPTH (metres)	DEPTH RL	SAMPLE OR FIELD TEST	RECOVERED GRAPHIC LOG	USCS SYMBOL	SOIL/ROCK MATERIAL DESCRIPTION	MOISTURE CONDITION	CONSISTENCY	DENSITY	STRUCTURE AND ADDITIONAL OBSERVATIONS
			0.0					TOPSOIL, rootlets to 150 mm depth				
			0.15	248.85	TP-24 0.15-0.5 BDS 0.15 m	[Hand-drawn graphic log showing soil layers with symbols for gravel and clay]	GC	Clayey GRAVEL fine to medium grained, sub-angular, red, with 30 - 40% low to medium PI clay				MD
			0.50	248.50	TP-24 0.5-1.9 BDS 0.50 m		GC	Clayey GRAVEL fine to coarse grained, sub-rounded, pale red, with low PI clay				D
			1.0									
			1.5									
			2.0	247.10				TEST PIT DISCONTINUED @ 1.90 m STABLE REFUSAL BACKFILLED				
			2.5									
			3.0									
			3.5									
			4.0									
			4.5									
			5.0

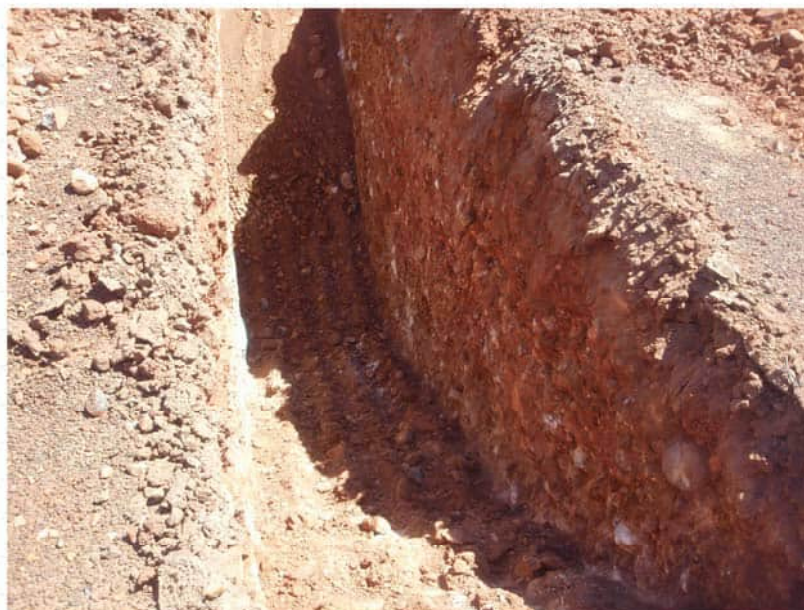
Sketch & Other Observations

GP	COBBLES				MD D
			2.44.80	244.80				TEST PIT DISCONTINUED @ 2.20 m STABLE REFUSAL BACKFILLED				M D-VD

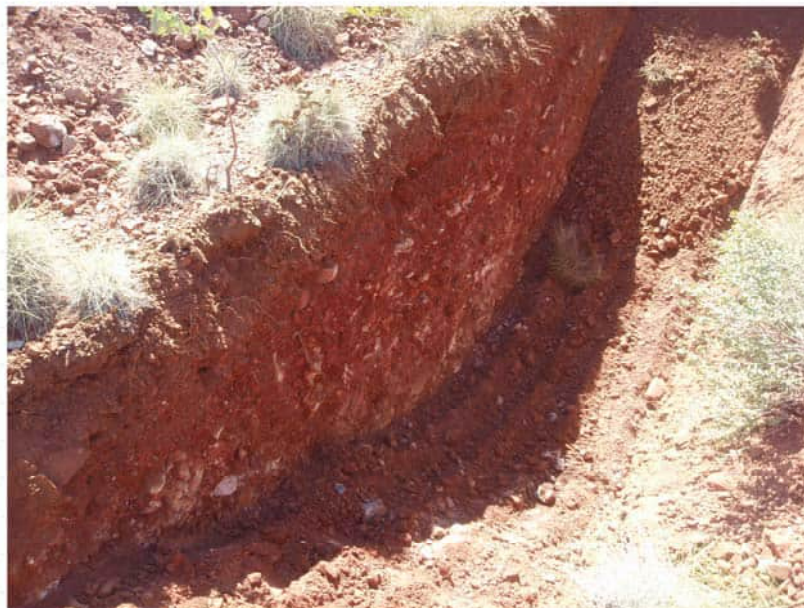
Sketch & Other Observations

GRAVEL fine to coarse grained, sub-rounded to sub-angular, dark red, trace medium PI clay, trace cobbles		MD		
			0.70	246.30				GW	COBBLES with fine grained gravel		D	
			1.0									
			1.5	245.50				TEST PIT DISCONTINUED @ 1.50 m STABLE REFUSAL BACKFILLED				
			2.0									
			2.5									
			3.0									
			3.5									
			4.0									
			4.5									
			5.0

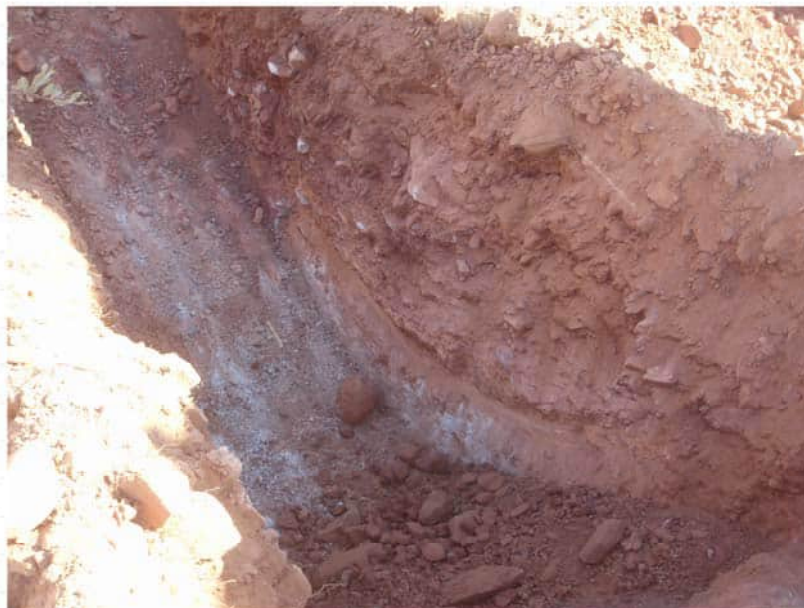
**Sketch & Other Observations**

Excavation			Sampling		Field Material Description							
METHOD	EXCAVATION RESISTANCE	WATER	DEPTH (metres)	DEPTH RL	SAMPLE OR FIELD TEST	RECOVERED GRAPHIC LOG	USCS SYMBOL	SOIL/ROCK MATERIAL DESCRIPTION	MOISTURE CONDITION	CONSISTENCY	DENSITY	STRUCTURE AND ADDITIONAL OBSERVATIONS
			0.0	244.85				TOPSOIL				
			0.15					GRAVEL with cobbles fine to coarse grained, sub-rounded, red brown, with 30 - 40% cobbles, with some medium PI clay				
			0.5									
			0.90		TP-27 0.9-1.6 BDS 0.90 m			GRAVEL fine to coarse grained, sub-angular to angular, pale brown and white grey, with some fine grained sand, moderately cemented				
			1.0	244.10								
			1.5									
			1.60	243.40				TEST PIT DISCONTINUED @ 1.60 m STABLE REFUSAL BACKFILLED				
			2.0									
			2.5									
			3.0									
			3.5									
			4.0									
			4.5									
			5.0

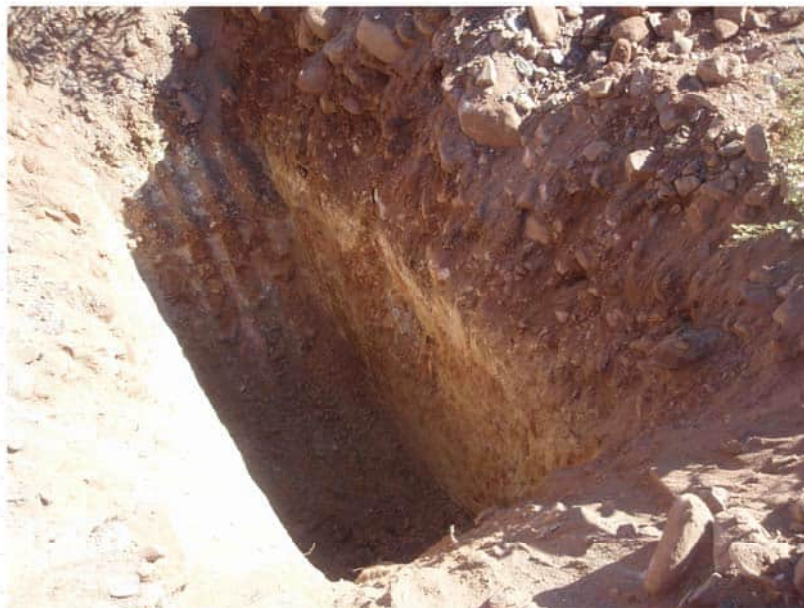
Sketch & Other Observations

2.5	241.50				TEST PIT DISCONTINUED @ 2.50 m STABLE REFUSAL BACKFILLED				
			3.0									
			3.5									
			4.0									
			4.5									
			5.0

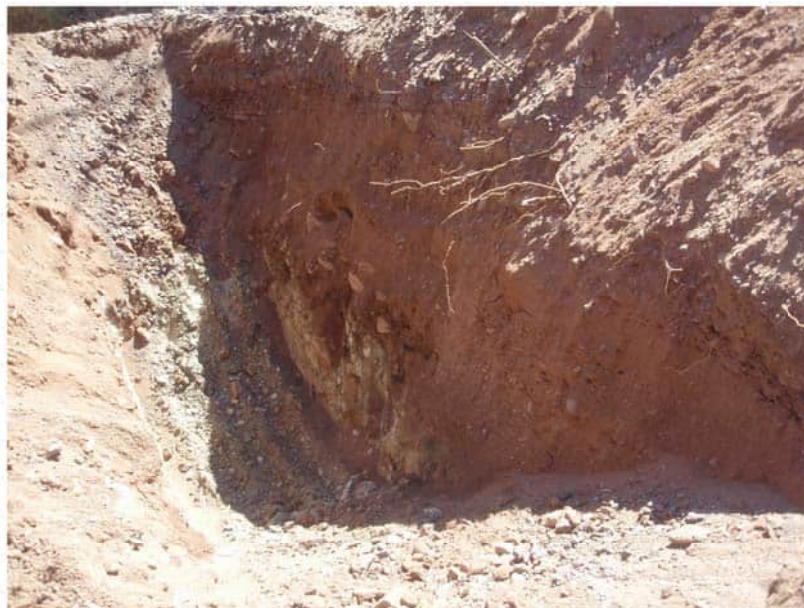
**Sketch & Other Observations**

GW	Sandy Clayey GRAVEL fine to coarse grained, sub-rounded to sub-angular, pale yellow red brown, with 10 - 20% low to medium PI clay, and fine grained, rounded sand				pit left open for 1.5 hrs water ingress at 1.3 m depth with small pool at bottom of pit
			2.0	242.10				TEST PIT DISCONTINUED @ 1.90 m STABLE REFUSAL BACKFILLED

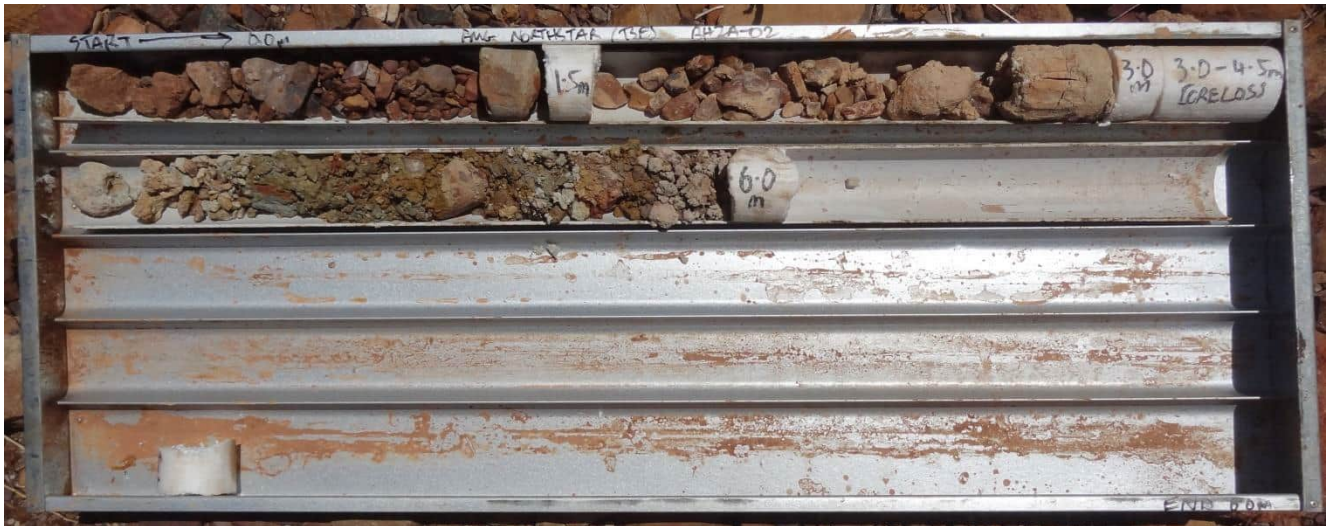
**BH2A-02 (0.0 - 6.0 m)**

<b>SANDSTONE</b> Extremely weathered, grey, red brown and yellow brown, fine to coarse grained, very low strength	EW												Highly fractured, with yellow and pale brown clay infill, from 5.4 m to 6.0 m

238	7		Drill hole terminated due to sand collapsing around the drill string causing reduced torque and jamming the barrel BH2A-02 terminated at 6m													
				237	8															
				236	9

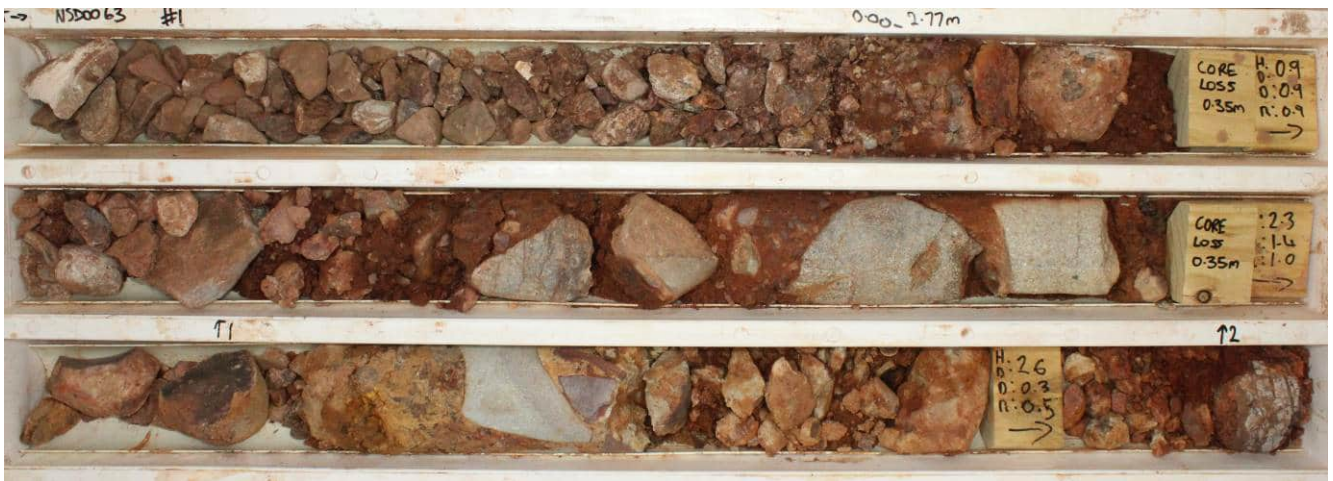
BH2A\_11 - 0.00 - 2.77 m

<b>SILTSTONE</b> Highly weathered, grey / dark grey with red brown staining, subvertical laminations/bedding, medium and high strength	HW									1.1 - 4.86 m siltstone fractures mostly irregular, rough and tight. Surfaces stained or with minor silt infill.
		93	0	260	3

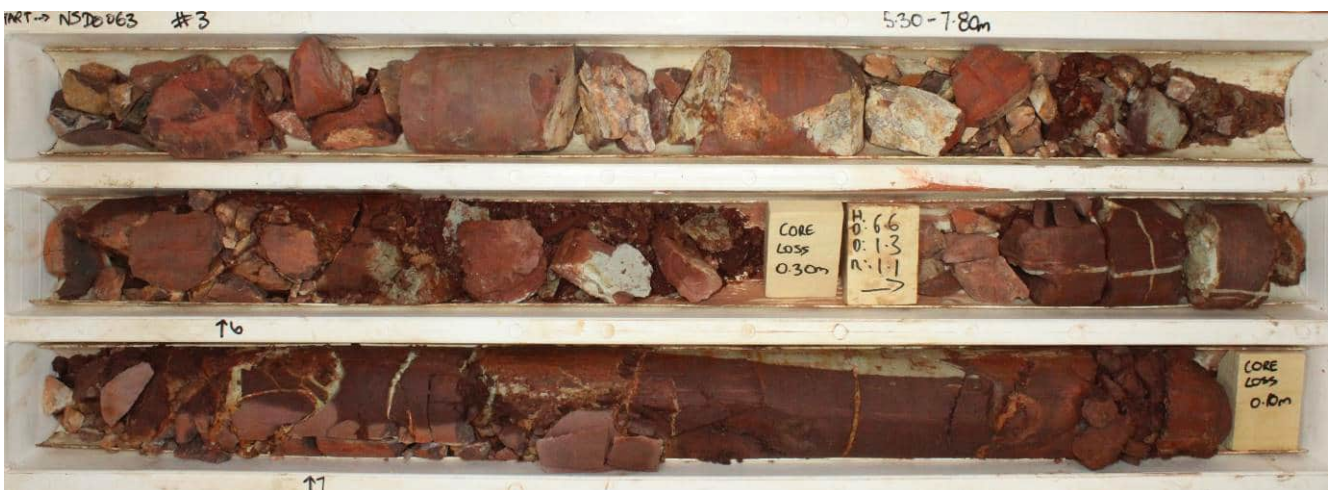
BH2A\_11 - 5.30 - 7.80 m

<b>SILTSTONE</b> Highly weathered, dark grey, grey and purple, subvertical laminations/bedding, medium and high strength										5.6 - 5.80 m fractures in siltstone mostly subhorizontal, irregular, rough with no infill. Sample 5.70 - 6.06 m UCS 134.7 MPa. Shear Failure 5.9 m laminations 15-20°
		100	67	256	7

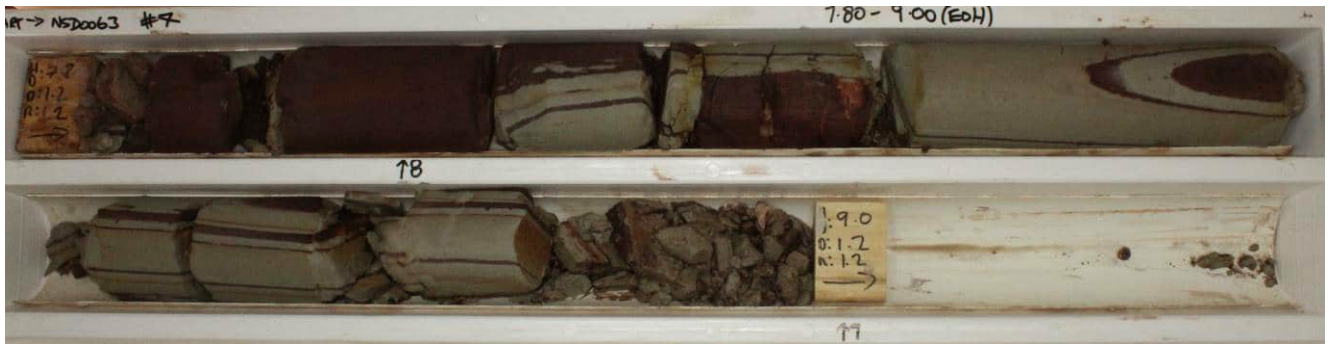
BH2A\_11 - 7.80 - 9.00 m

<b>SILTSTONE</b>	SW									7.45 m white vein, tight.

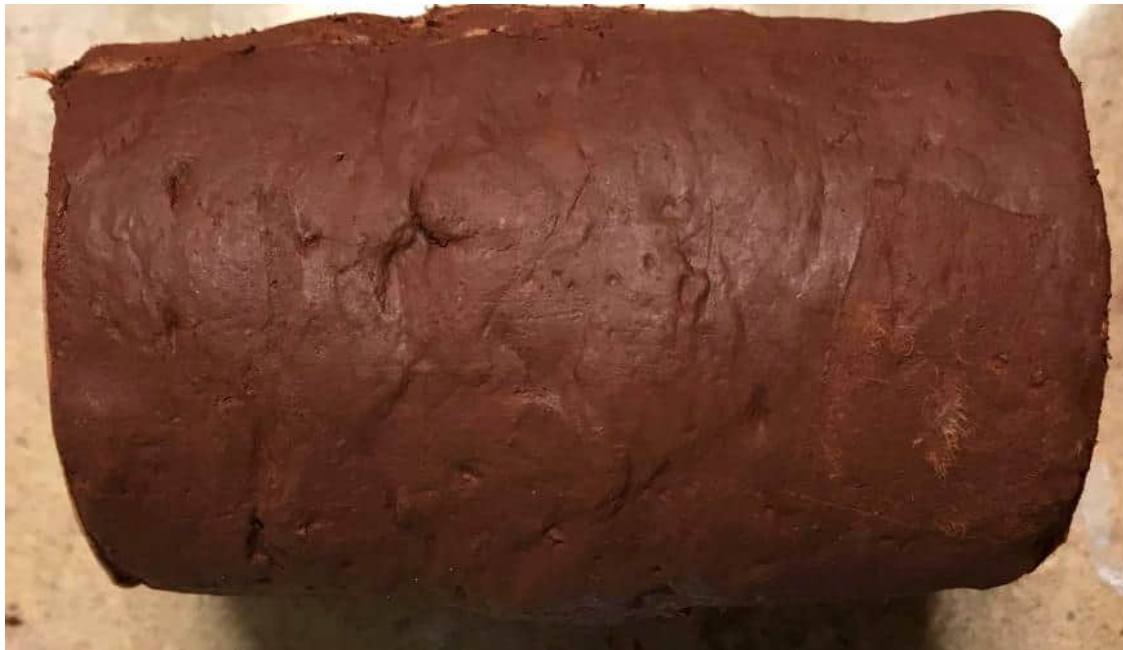
**Failure Mode: Bulging Failure**

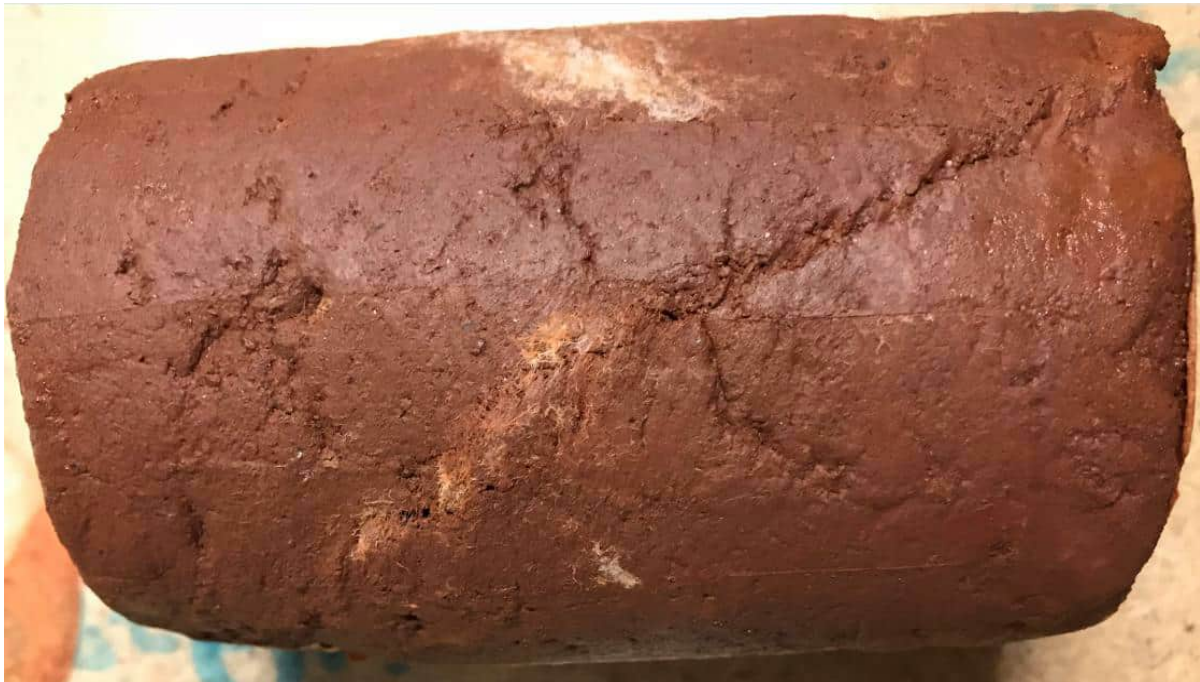
Failure Mode: Shear Failure to Vertical @ 35.2°

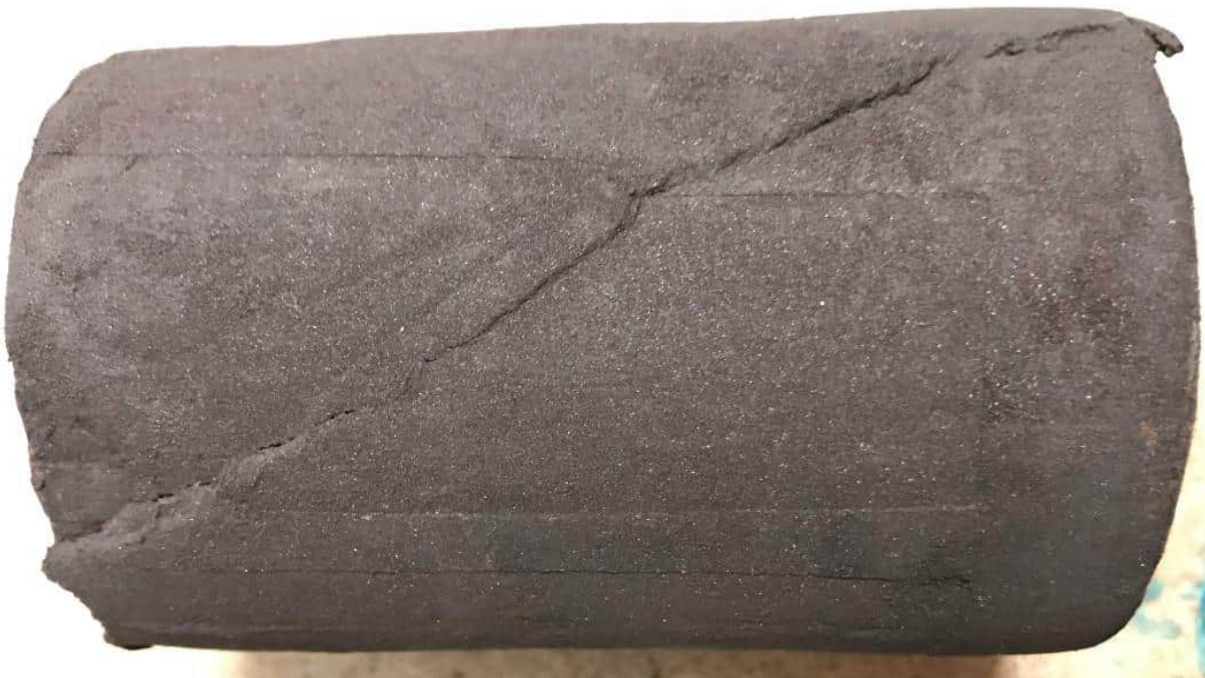
**Failure Mode: Shear Failure Angle @ 38.1°**

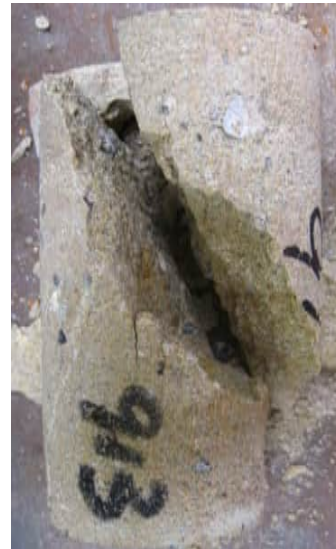
After Test

<b>UCS (MPa)</b>	8.17	<b>Bedding Angle (deg)</b>	N/A
<b>Failure Angle (deg)</b>	28.6

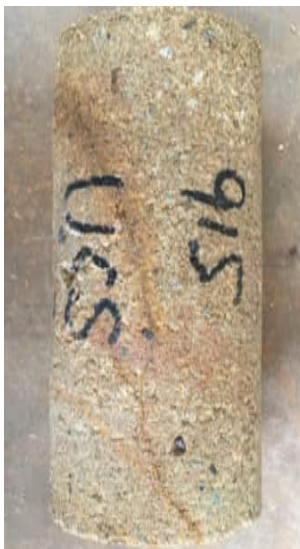
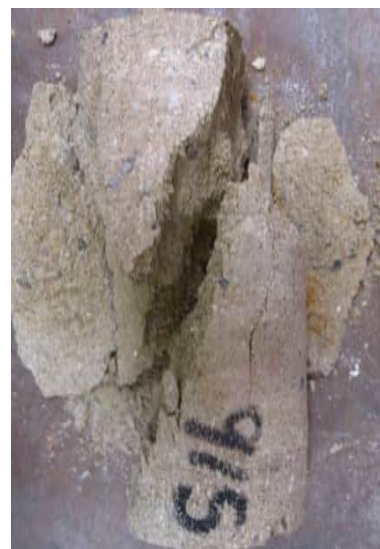
Before Test

Client:	Liquid Labs Pty Ltd	Date Tested:	06/02/2018
Project:	North Star Magnetite	EP Lab Job Number:	LLABS
Client ID:	BH2A-03	Lab:	EPLAB
Lab ID:	LLS18_915_UCS		
Depth (m):	11.10 - 11.25	Room Temperature at Test:	19°C
Tested by:	Phil	Sample Description:	-
Checked by:	Phil		
		* <b>Testing Temperature:</b>	N/A
<b>Length/Diameter Ratio:</b>	2.53	<b>Bulk Density (t/m<sup>3</sup>):</b>	2.50
<b>Correction Applied:</b>	N	<b>Moisture Content (%):</b>	2.17
<b>Failure Mode:</b>	Shear Failure		
<b>Length (mm):</b>	153.11	<b>Loading Rate (mm/min):</b>	0.05
<b>Diameter (mm):</b>	60.60

<b>UCS (MPa)</b>	10.44	<b>Bedding Angle (deg)</b>	N/A
<b>Failure Angle (deg)</b>	29.1

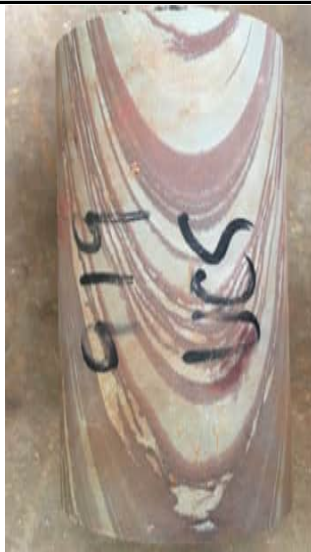
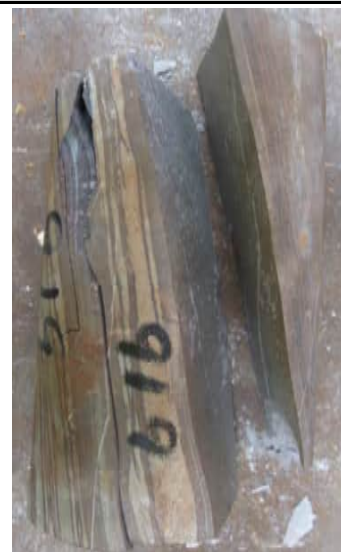
Before Test

Client:	Liquid Labs Pty Ltd	Date Tested:	06/02/2018
Project:	North Star Magnetite	EP Lab Job Number:	LLABS
Client ID:	BH2A-04	Lab:	EPLAB
Lab ID:	LLS18_919_UCS		
Depth (m):	6.60 - 6.90	Room Temperature at Test:	19°C
Tested by:	Phil	Sample Description:	-
Checked by:	Phil		
		* <b>Testing Temperature:</b>	N/A
<b>Length/Diameter Ratio:</b>	2.03	<b>Bulk Density (t/m<sup>3</sup>):</b>	2.49
<b>Correction Applied:</b>	N	<b>Moisture Content (%):</b>	0.00
<b>Failure Mode:</b>	Shear Failure		
<b>Length (mm):</b>	124.28	<b>Loading Rate (mm/min):</b>	0.05
<b>Diameter (mm):</b>	61.20

<b>UCS (MPa)</b>	8.02	<b>Bedding Angle (deg)</b>	15.6
<b>Failure Angle (deg)</b>	15.6

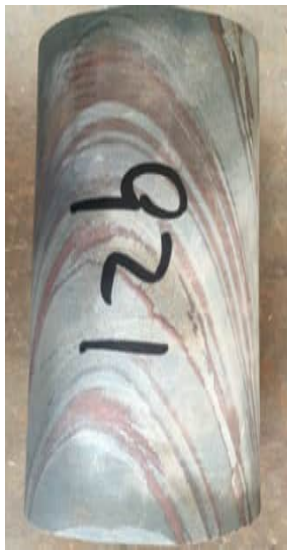
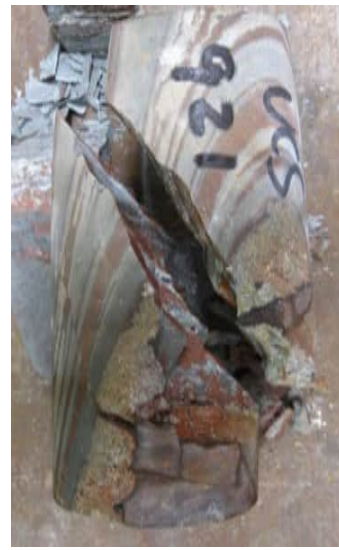
Before Test

Client:	Liquid Labs Pty Ltd	Date Tested:	06/02/2018
Project:	North Star Magnetite	EP Lab Job Number:	LLABS
Client ID:	BH2A-04	Lab:	EPLAB
Lab ID:	LLS18_921_UCS		
Depth (m):	13.70 - 13.90	Room Temperature at Test:	19°C
Tested by:	Phil	Sample Description:	-
Checked by:	Phil		
		* <b>Testing Temperature:</b>	N/A
<b>Length/Diameter Ratio:</b>	2.28	<b>Bulk Density (t/m<sup>3</sup>):</b>	2.60
<b>Correction Applied:</b>	N	<b>Moisture Content (%):</b>	0.00
<b>Failure Mode:</b>	Shear Failure		
<b>Length (mm):</b>	139.95	<b>Loading Rate (mm/min):</b>	0.05
<b>Diameter (mm):</b>	61.38

<b>UCS (MPa)</b>	27.81	<b>Bedding Angle (deg)</b>	17.6
<b>Failure Angle (deg)</b>	29.5
