**CLIENT** Iron Bridge Operations Pty Ltd  
**JOB NUMBER** 114185.10

**JOB NAME** North Star Magnetite Project  
**JOB LOCATION** Pilbara, WA

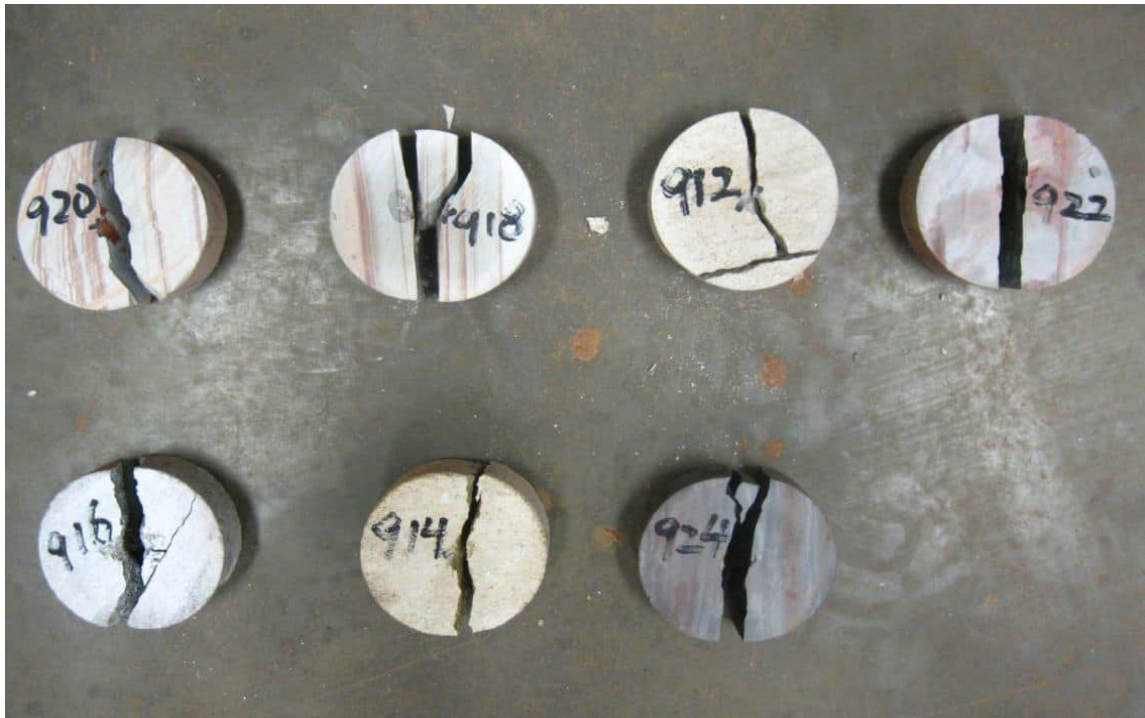
### PHOTO POST TESTING

Stored and Tested the Sample as received

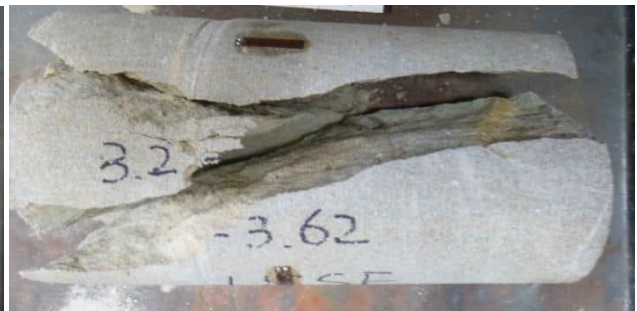
Post Test Photo

Failure Angle to Vertical: 25.7° Intact Rock

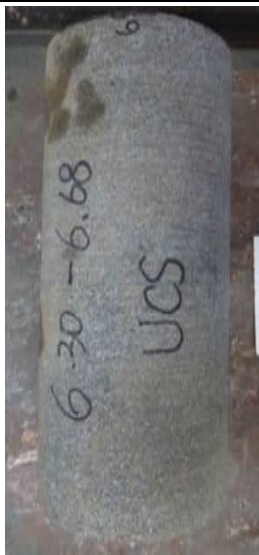
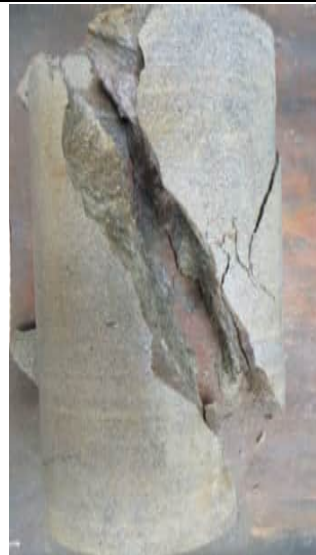
Before Test

Client:	Liquid Labs WA	Date Tested:	30/09/2018
Project:	Iron Bridge North Star TSF	EP Lab Job Number:	LLABS
Client ID:	BH2A 02A	Lab:	EPLAB
Lab ID:	BH2A_02A_1_UCS		
Depth (m):	6.30 - 6.68	Room Temperature at Test:	19°C
Tested by:	Phil	Sample Description:	-
Checked by:	Phil		
		* <b>Testing Temperature:</b>	N/A
<b>Length/Diameter Ratio:</b>	2.41	<b>Bulk Density (t/m<sup>3</sup>):</b>	2.60
<b>Correction Applied:</b>	N	<b>Moisture Content (%):</b>	0.00
<b>Failure Mode:</b>	Shear Failure		
<b>Length (mm):</b>	199.78	<b>Loading Rate (mm/min):</b>	0.05
<b>Diameter (mm):</b>	82.92

<b>UCS (MPa)</b>	60.74	<b>Bedding Angle (deg)</b>	N/A
<b>Failure Angle (deg)</b>	25.9

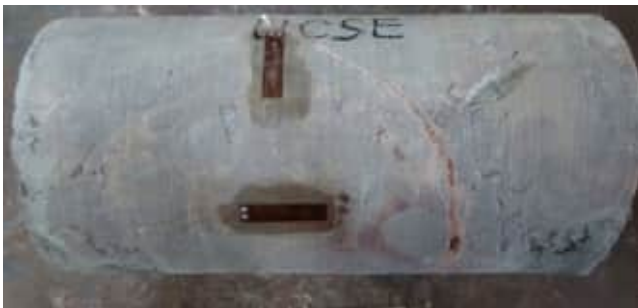
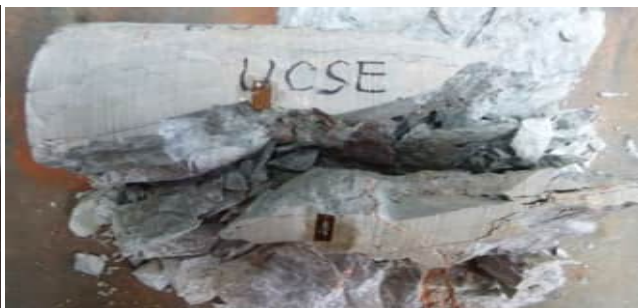
**Failure Angle to Vertical: 27.8° along structure**

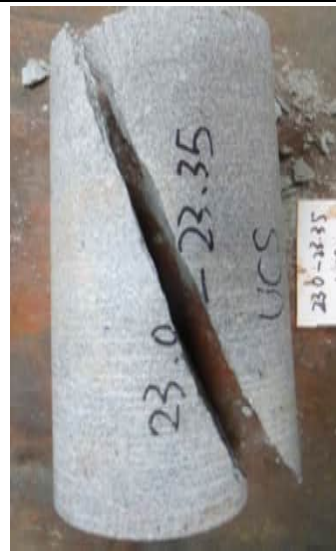
After Test

<b>UCS (MPa)</b>	79.88	<b>Bedding Angle (deg)</b>	N/A
<b>Failure Angle (deg)</b>	22.9

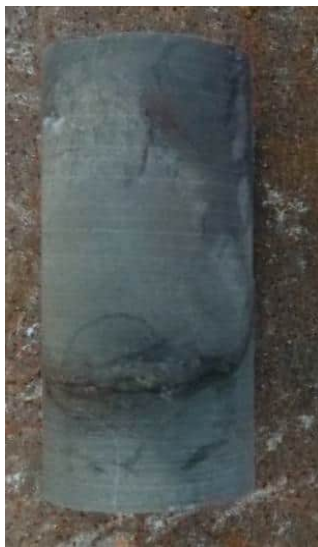
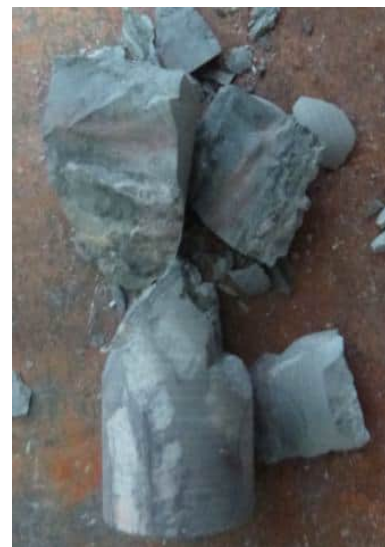
Before Test

Client:	Liquid Labs WA	Date Tested:	30/09/2018
Project:	Iron Bridge North Star TSF	EP Lab Job Number:	LLABS
Client ID:	BH2A 12	Lab:	EPLAB
Lab ID:	BH2A_12_1_UCS		
Depth (m):	5.70 - 6.06	Room Temperature at Test:	19°C
Tested by:		Sample Description:	-
Checked by:	Phil		
<b>Length/Diameter Ratio:</b>	2.22	<b>* Testing Temperature:</b>	N/A
<b>Correction Applied:</b>	N	<b>Bulk Density (t/m<sup>3</sup>):</b>	2.44
<b>Failure Mode:</b>	Shear Failure	<b>Moisture Content (%):</b>	0.00
<b>Length (mm):</b>	36.11	<b>Loading Rate (mm/min):</b>	0.05
<b>Diameter (mm):</b>	16.27

<b>UCS (MPa)</b>	134.68	<b>Bedding Angle (deg)</b>	N/A
<b>Failure Angle (deg)</b>	28.5

**Notes:** *Sample subcored* Accredited for compliance with ISO/IEC 17025

<b>SILTSTONE</b> Highly weathered, dark grey, grey and purple, subvertical laminations/bedding, medium and high strength										5.6 - 5.80 m fractures in siltstone mostly subhorizontal, irregular, rough with no infill. Sample 5.70 - 6.06 m UCS 134.7 MPa. Shear Failure 5.9 m laminations 15-20°
		100	67	256	7

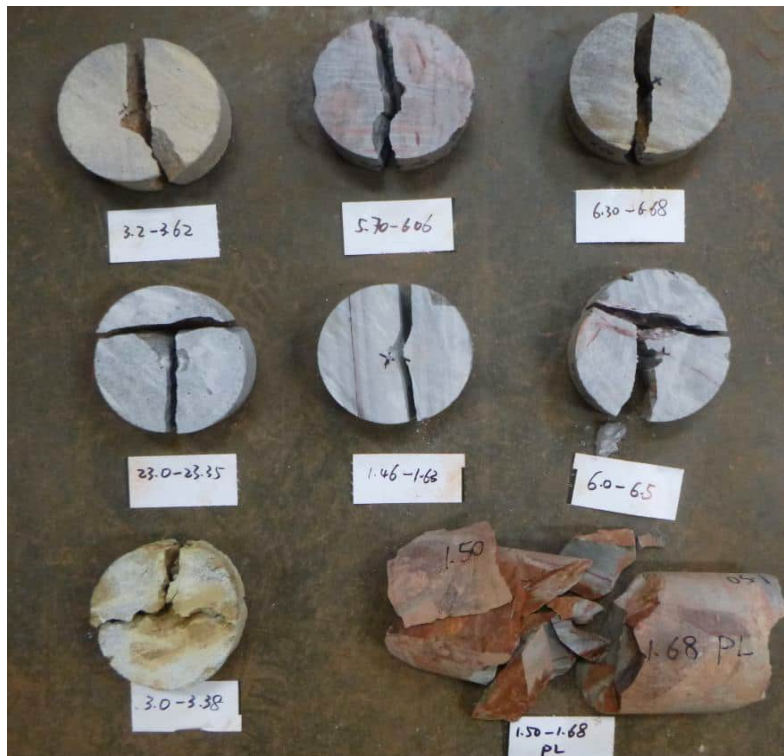
## PHOTO POST TESTING

Stored and Tested the Sample as received
