Evaluating the environmental condition of Weeli Wolli Creek

Supporting technical report

Evaluation program report series
March 2018

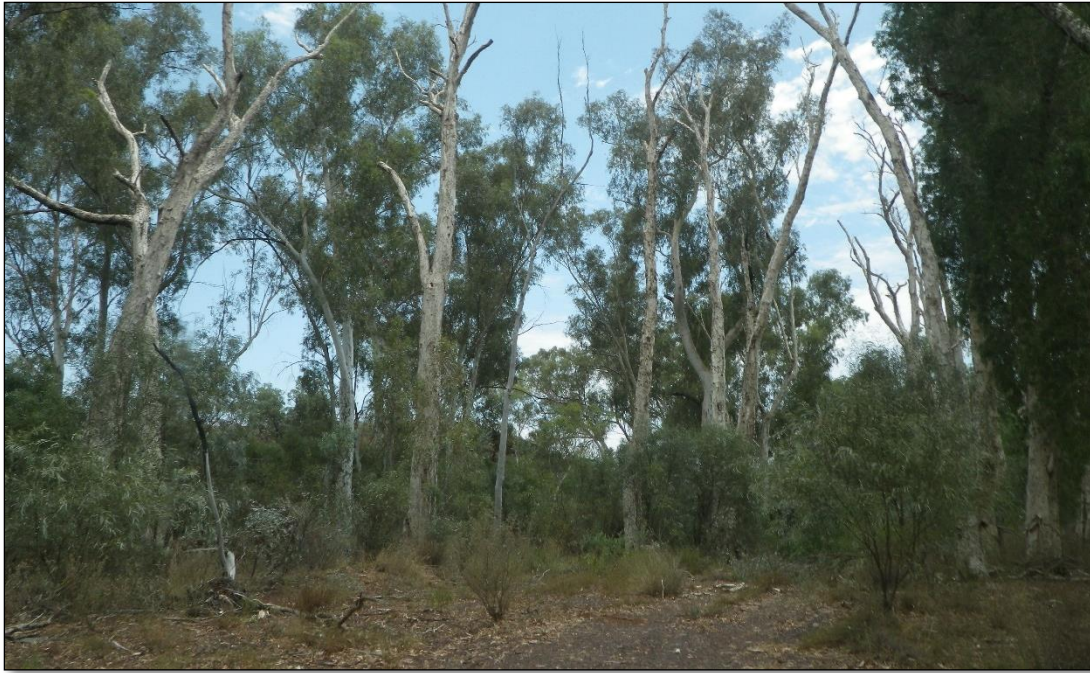
Figure 9: Mortality and decline (with some recovery) of *Melaleuca argentea* trees (photo taken November 2015)

- In contrast, a severe decline in foliage cover and some mortality was observed in *Melaleuca argentea* in 2013 on the western side of the creek (**Figure 9**). This was likely due to water from spur irrigation failing to disperse over the whole creek profile. The issue was managed through the extension of an irrigation spur to the affected side of the creek and there have been some signs of recovery. Based on the response of *Melaleuca argentea* to drawdown in an area where it was not being reached by spur irrigation, the persistence of this obligate phreatophyte within the irrigated area suggests that this species is not resilient to drawdown in this area and spur irrigation is an important ongoing measure.

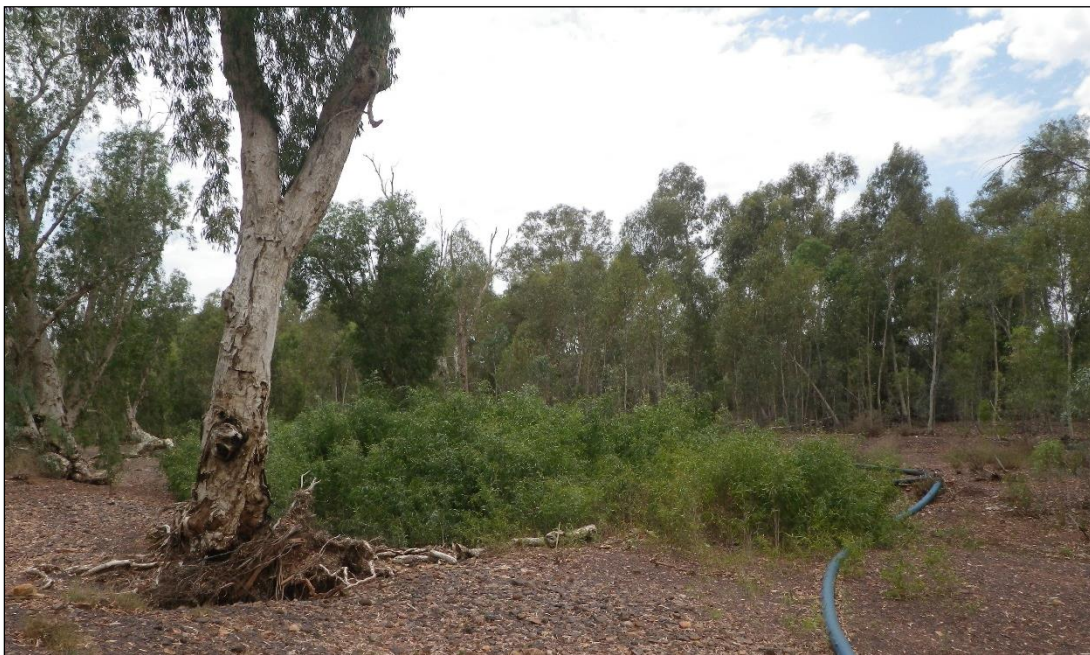
Figure 10: Proliferation of *Melaleuca argentea* seedlings around spur outlet

- An outcome of spur irrigation which does not appear to have been predicted through EIA was the proliferation of *Melaleuca argentea* seedlings around the spur outlets and permanent pools (**Figure 10**). Seedlings in this species establish only with plentiful surface or near-surface water (McLean 2014). The consistent levels of the pools and accessibility of surface water (which would likely have fluctuated seasonally pre-mining) has allowed the seedlings to persist and thrive, potentially to the exclusion of other flora species and changing pool-edge habitats.

A proliferation of opportunistic species downstream of the discharges was predicted through EIA. This prediction has been borne out as *Melaleuca argentea* seedlings and small trees have proliferated in some areas downstream of the discharge where permanent water is now available. It is not known what effect this may be having on other species in these areas. It is also unknown whether other opportunistic species have responded in a similar way.
