Evaluation program report

Evaluating the environmental condition of Weeli Wolli Creek

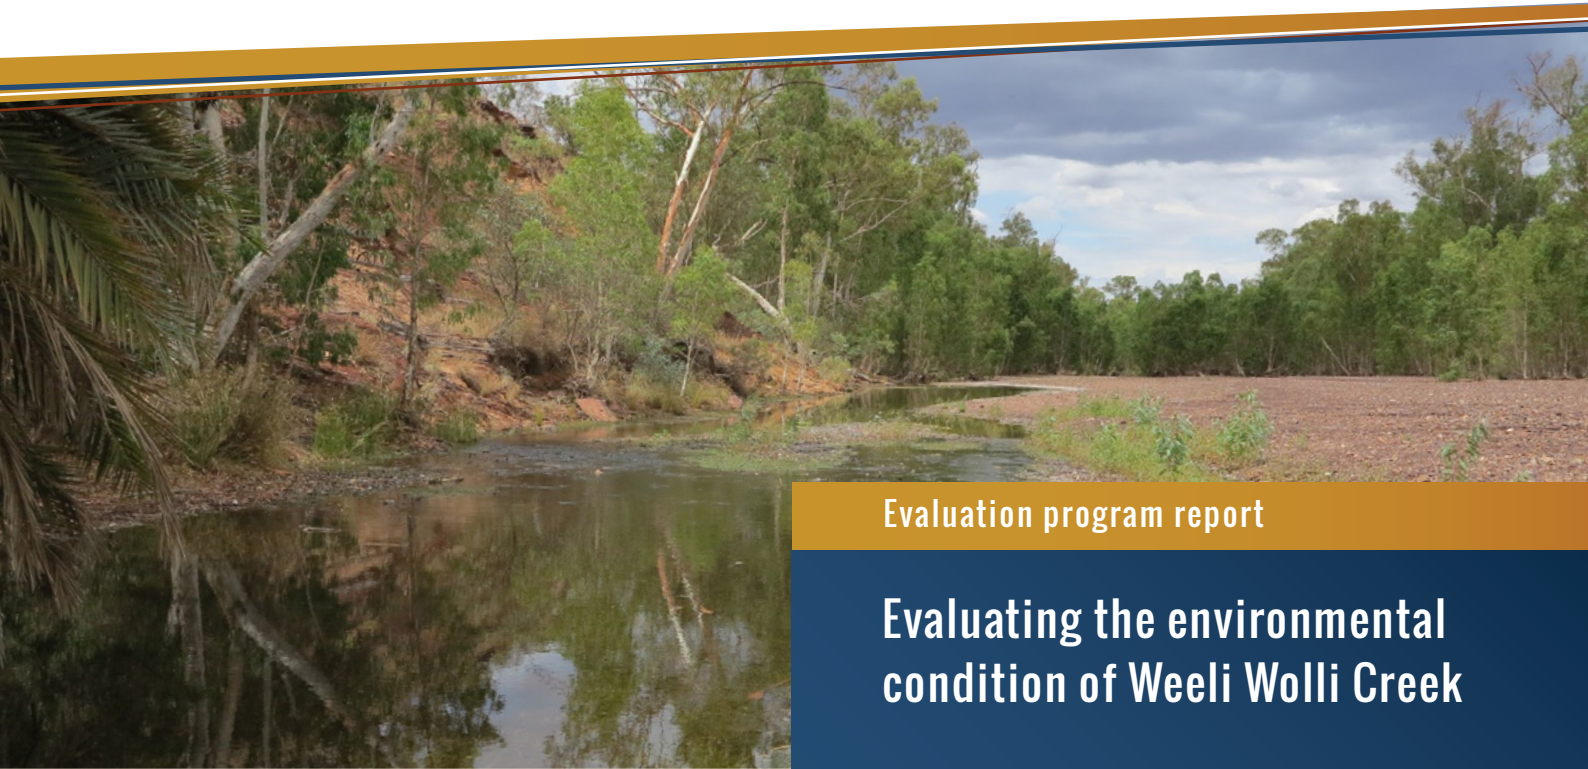
The Weeli Wolli Creek system in the central Hamersley Range area of the East Pilbara (Figure 1) has high environmental value.

The Weeli Wolli Creek catchment contains extensive iron ore deposits and increasing numbers of mining proposals in various stages of development (Figure 1). Activities from operating mines place pressure on the creek and have the potential to cause cumulative impacts.

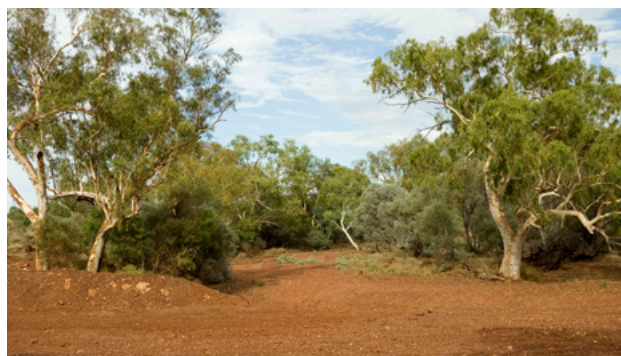
Upstream of spring at creek crossing (2006)

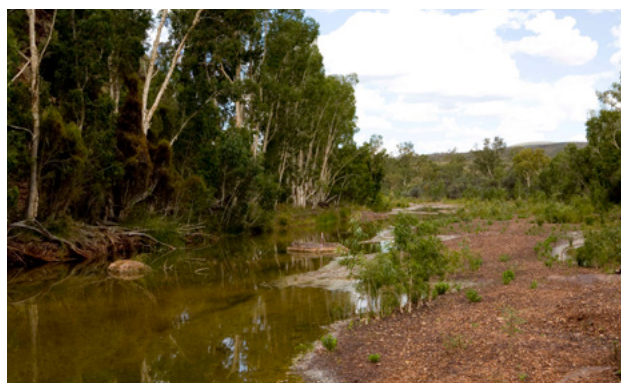
Pool downstream of springs (2006)

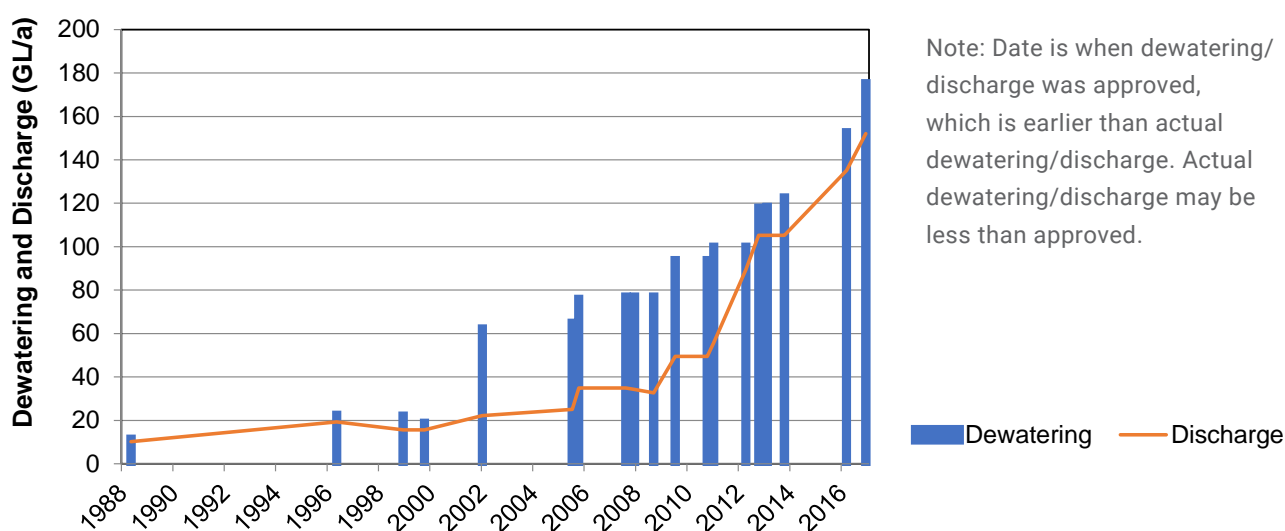
Figure 4: Approved dewatering and discharge

Once mining started, some companies reported that dewatering (and discharge) requirements were higher than predicted during the EPA's assessment. Some companies have also expanded or extended their mining operations. The approved annual dewatering and discharge for all operating mines in the Weeli Wolli catchment as at 2016 was more than 15 times what was approved with the first mine in 1988 (Figure 4).

The EPA notes that predictions of dewatering and discharge requirements increased over time for some mining operations, but the increase in impacts on Weeli Wolli Creek was predicted to be either no change or negligible. All of the assessment reports from 1996 onwards raised cumulative impacts as an issue. Some assessment reports, particularly recent reports, explicitly stated that groundwater modelling included impacts from other proposals.

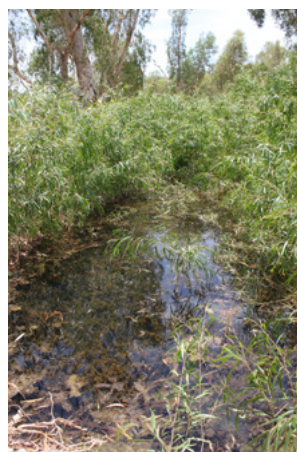
To counteract the potential impacts from a decrease in groundwater levels, surplus dewater has been discharged to irrigate the area of the spring to sustain the surface expression of water at the spring and sustain pools. Water levels, not spring flow, have been maintained.

Irrigation at the spring (2015)

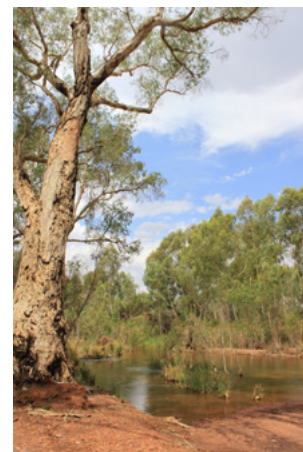
Further downstream, there is a cumulative effect from the discharge of dewater from multiple mining operations, which have extended the distance of permanent flow. This is as predicted.

Permanent flow downstream of the spring (2015)

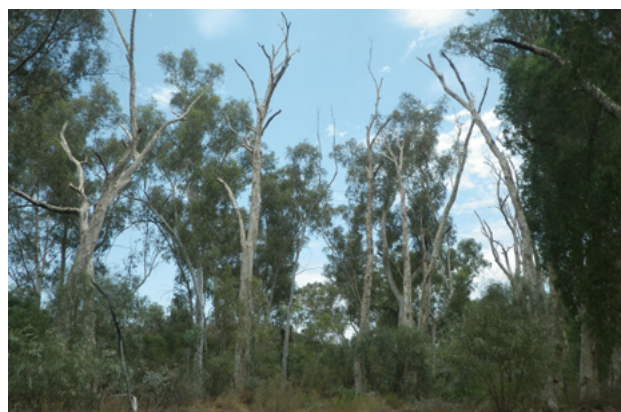
- There has been some decline in the health of Silver Cadjeput trees and some deaths. It was originally predicted that irrigation would maintain groundwater levels beneath the creek and prevent this impact. The mitigation didn't work as predicted, and this impact is now being managed through direct irrigation of the affected areas and there appears to be some improvement.
- After an initial decline, River Red Gum and Coolibah trees appear to have adapted better than predicted to no access to groundwater, when surface water availability is maintained.

Decline in health of Silver Cadjeput upstream of spring (2015)

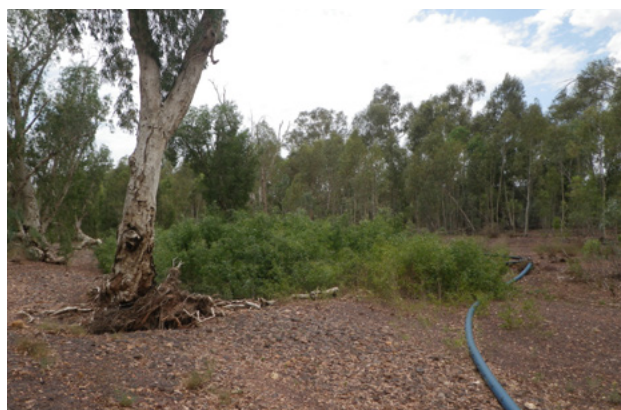
- Silver Cadjeput seedlings and small trees in some areas have increased due to permanent water availability. An increase in opportunistic species was predicted.

Increase in Silver Cadjeput seedlings downstream of spring (2015)
