Robe Mesa Project

Native Vegetation Clearing Permit (NVCP) Application

Supporting Document (Rev 2)

December 2024

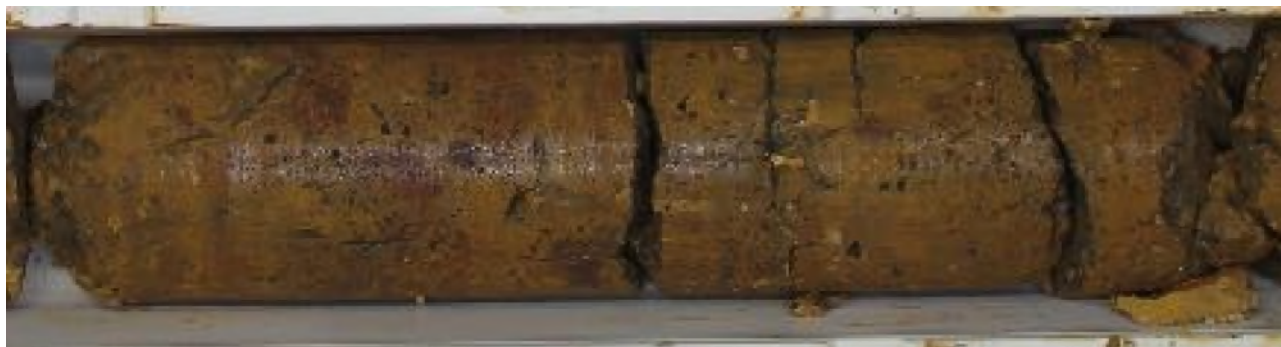
Figure 3.38: Diamond core of CID-upper layer depicting vugs and fractures (CZR 2023)

A detailed assessment of troglifauna habitat has been modelled by CZR (2023), building on similar work by API Management (APIM), for the West Pilbara Iron Ore Project (WPIOP) Stage 1 Deposits (APIM 2015) and with technical assistance from Red Hill Resources.
