# Round Hill Project Landform Assessment

**HanRoy Limited**

29 July 2025

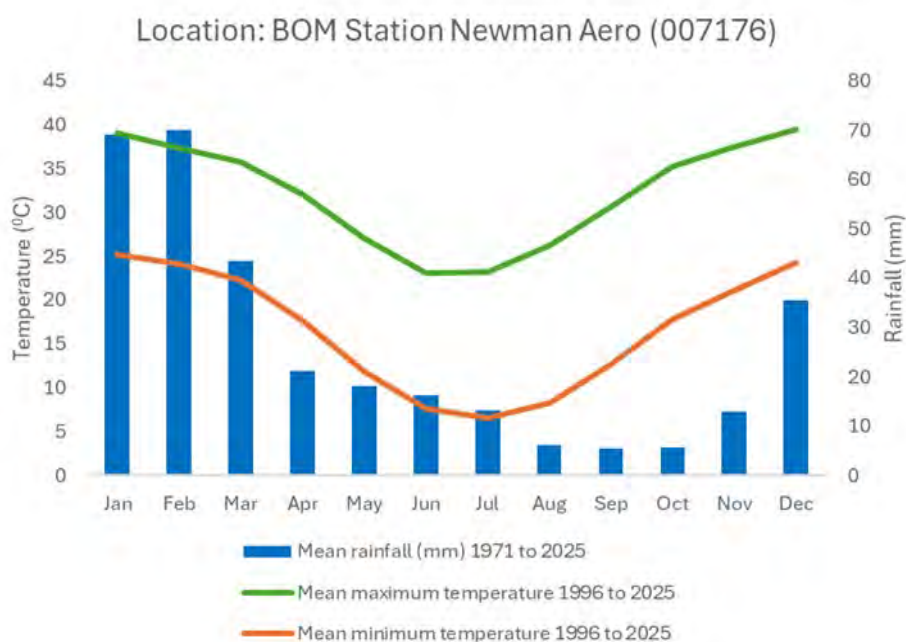
Figure 3: Mean monthly rainfall with monthly mean maximum and minimum temperatures as recorded at the Newman Airport weather station

The climate in the survey area is characterised as having very hot summers and mild dry winters (BOM, 2025). The closest weather station is located at the Newman Airport, approximately 80 km southwest of the Project. Mean annual maximum temperatures range from 39.4°C in December to 23.1°C in June (Figure 3). Mean minimum temperatures range from 6.5°C in July to 25.2°C in January (BOM, 2025).

Rainfall in the region is highly variable and unpredictable, however more than half of the annual rainfall occurs between December and March. The survey area is also subject to tropical cyclones, generally between January and April, which are associated with destructive winds and large rainfall events. The mean annual rainfall is approximately 320 mm (BOM, 2025). The mean number of days of rain in a year is 41.6 (BOM, 2025).

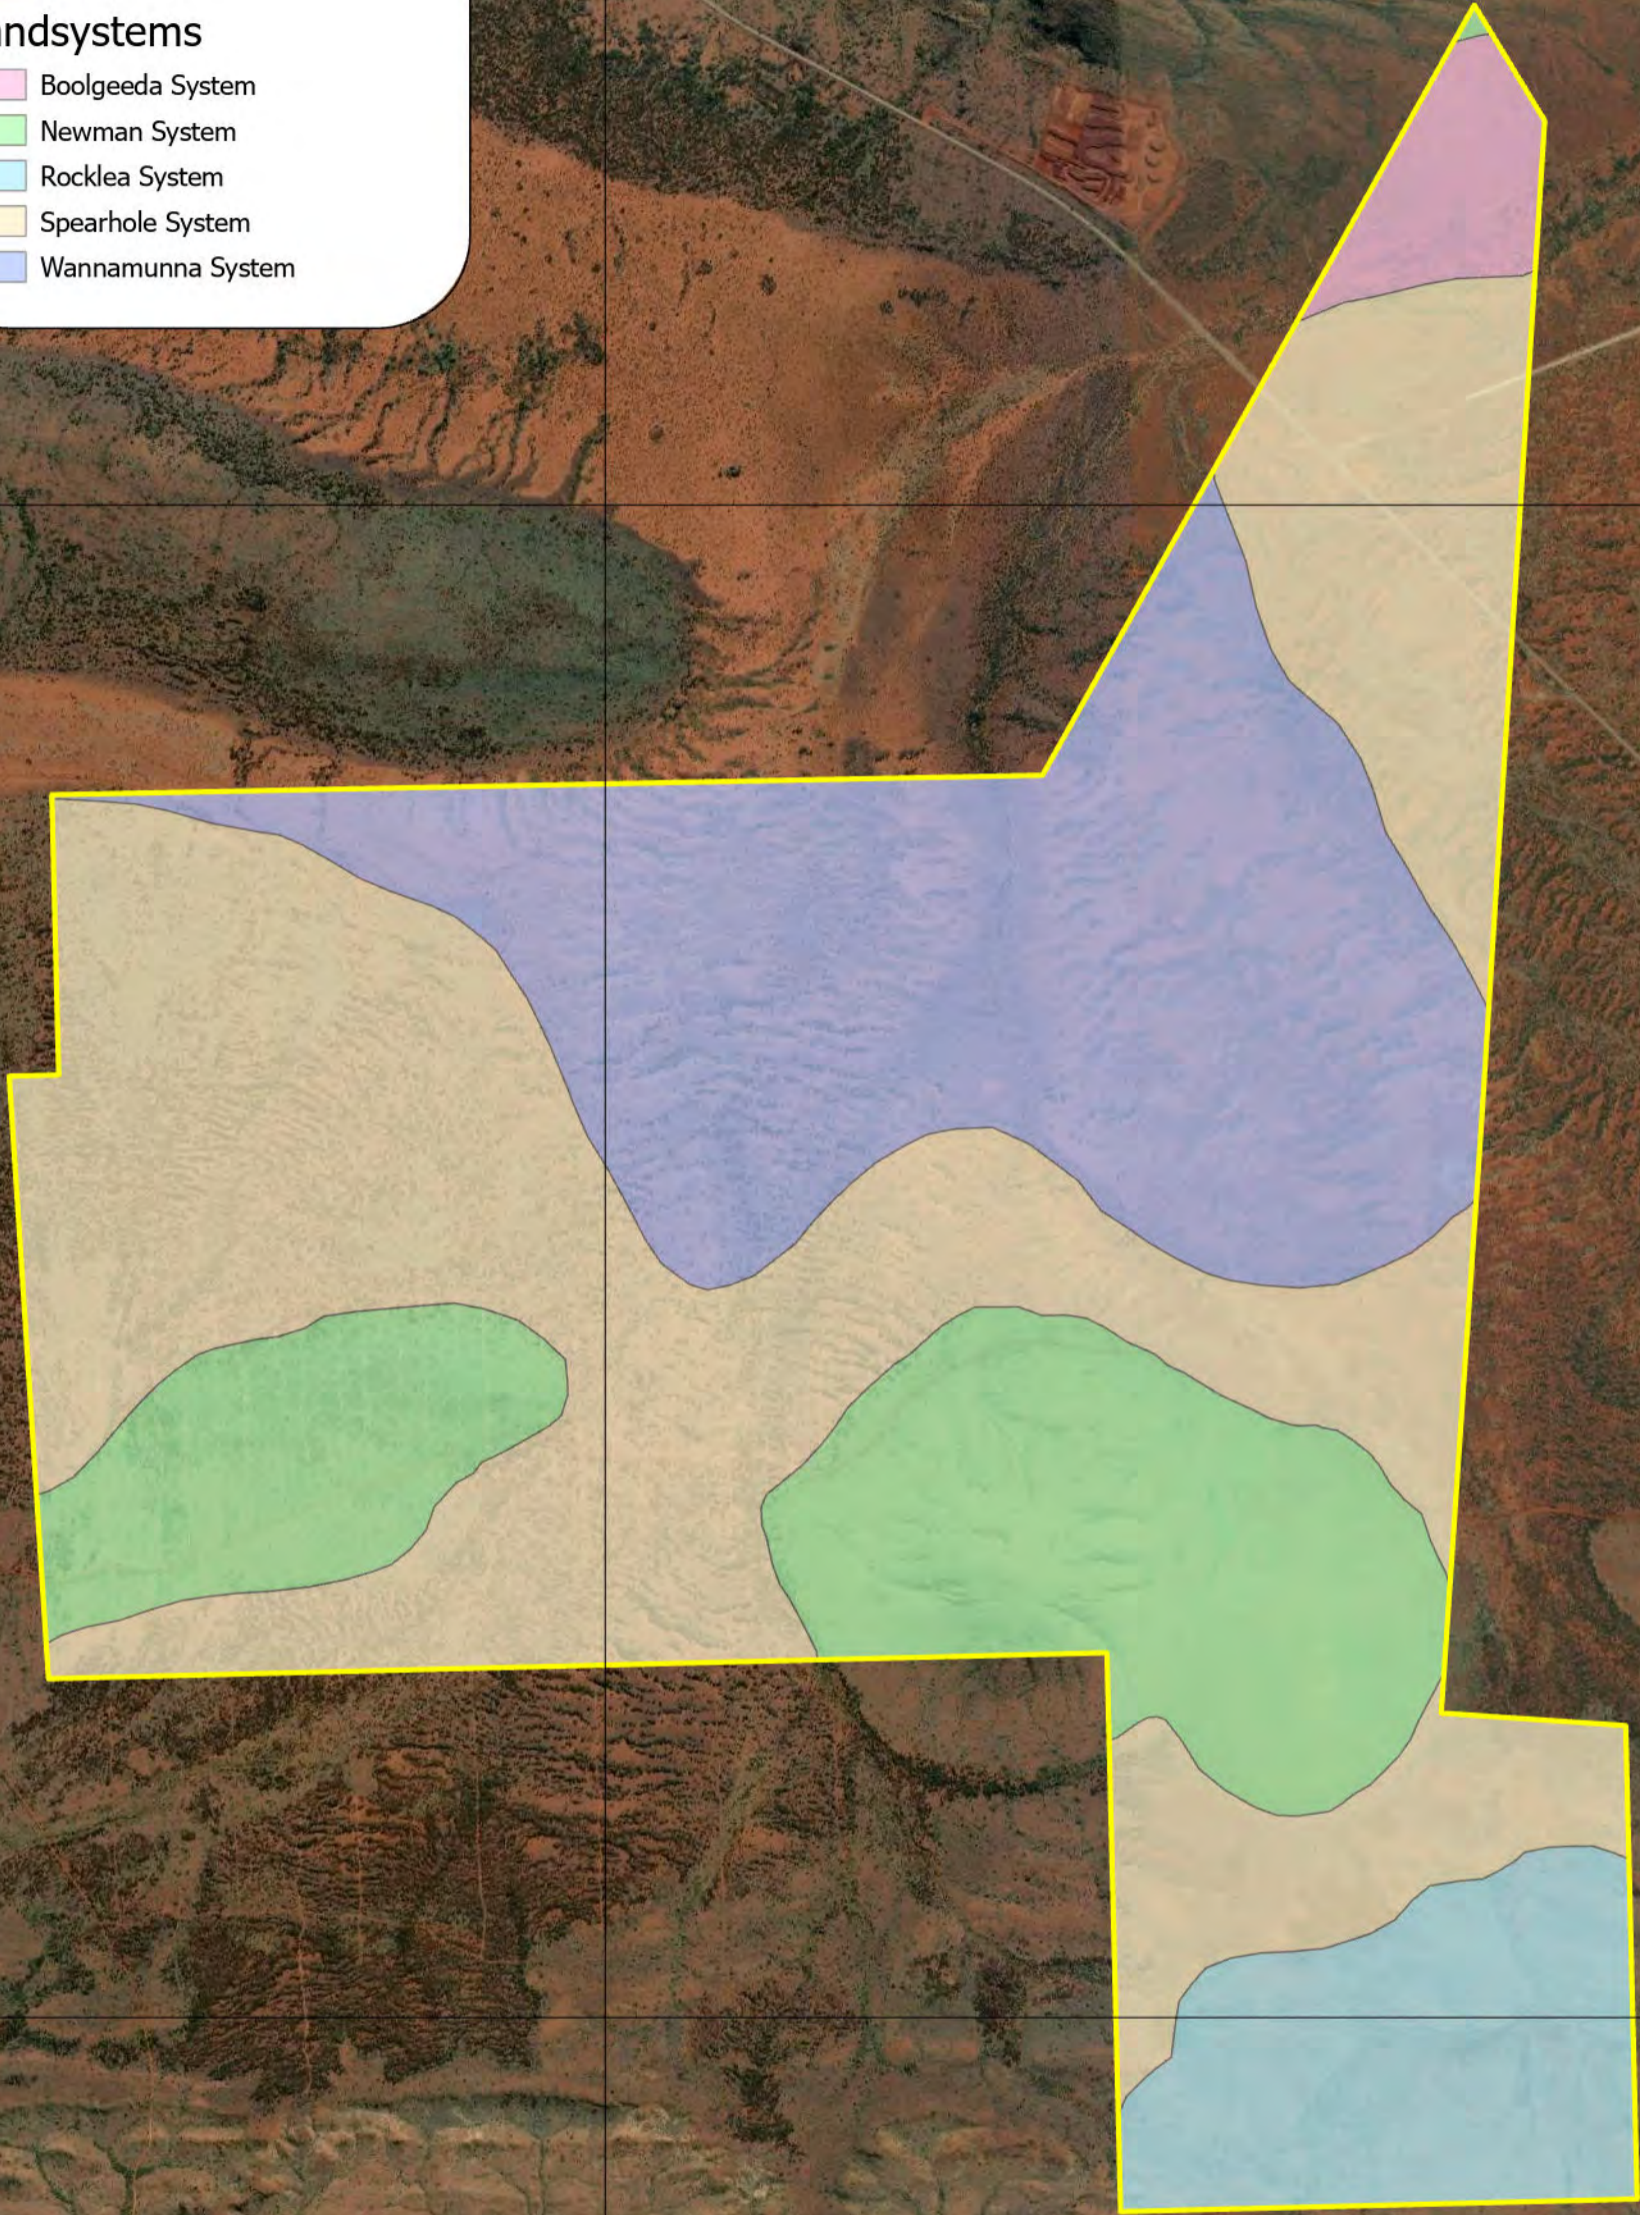
Figure 5

Land systems of the survey area

Land systems of the Pilbara region were mapped in 2004 (van Vreeswyk, Leighton, Payne, & Hennig, 2004). There are five land systems represented within the survey area (Figure 5). The approximate total area of each land system in the region, area of land system within the survey area, percentage of each regional land system within the survey area and the percentage of the survey area represented by each land system, is detailed in Table 1. Table 2 describes the major landform features and soils present within each land system within the survey area.

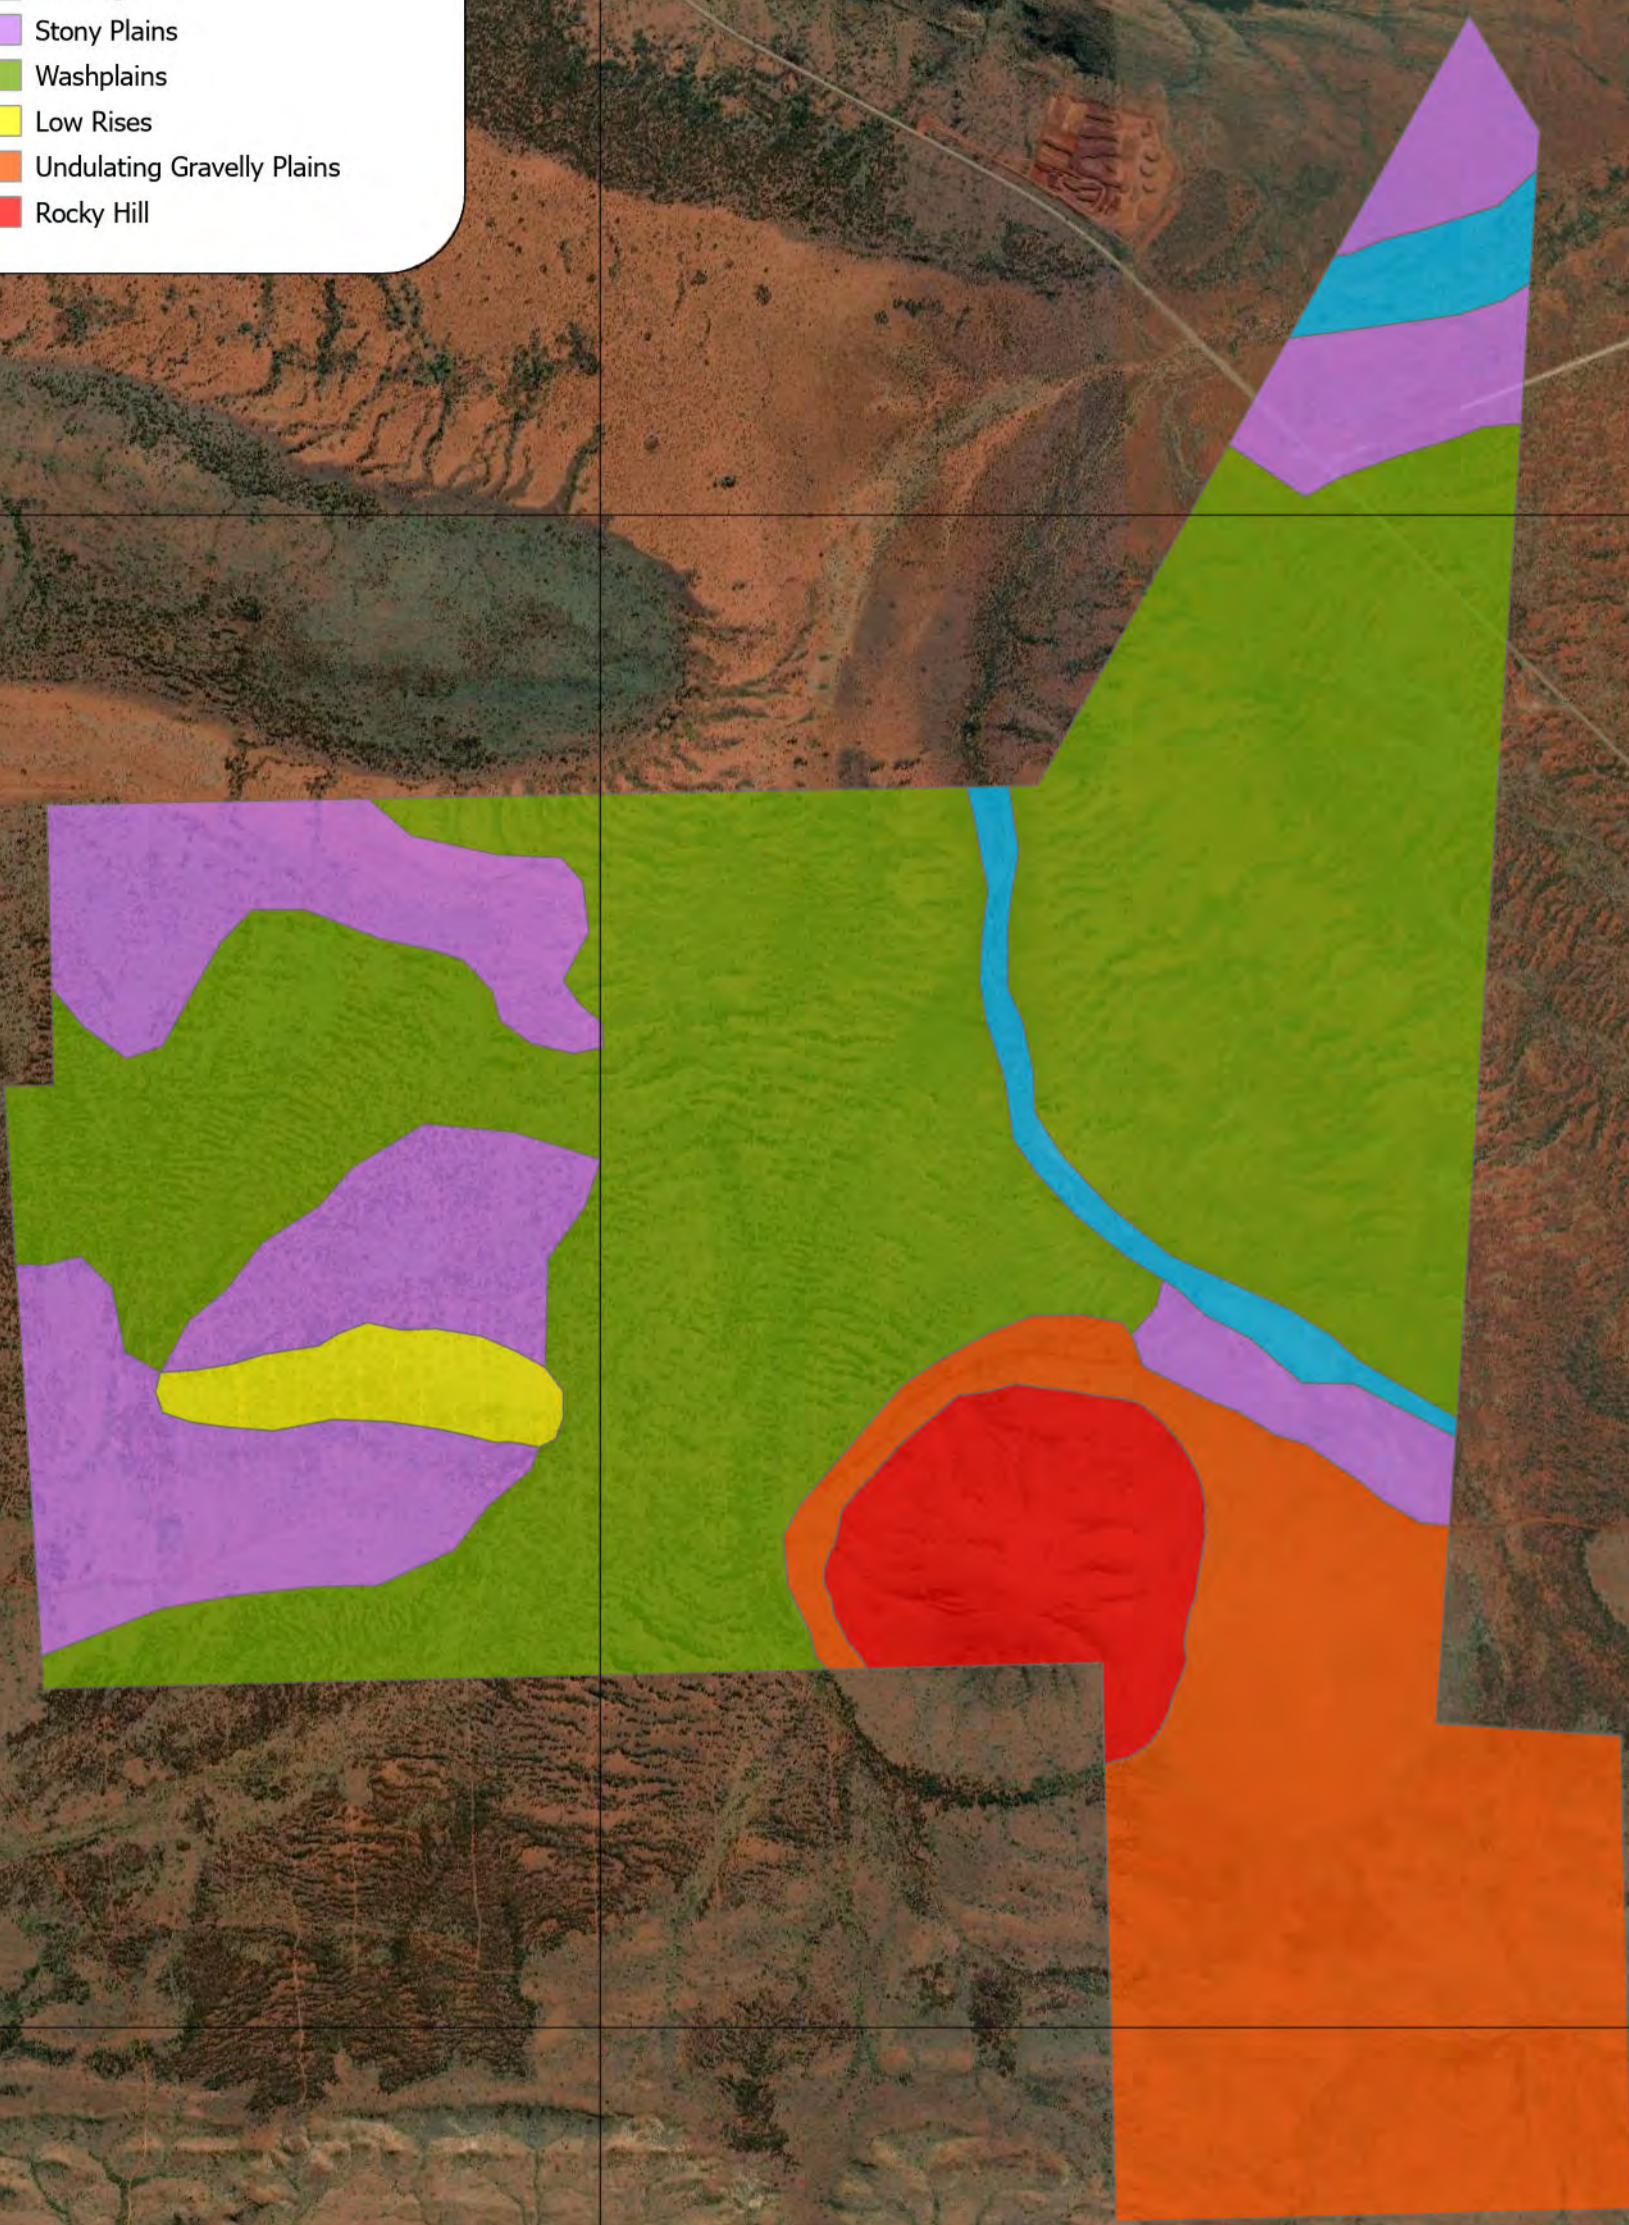
Figure 10

Landforms of the survey area

The observation points assessed during the field survey are presented in Figure 9. The landforms identified during the field survey are listed below, with their approximate extent within the survey area detailed in Figure 10. Field observations and photos of each of the landforms is included in Appendix A. The extent, condition/integrity, geology, morphology and environmental values of each landform are summarised in Table 7.

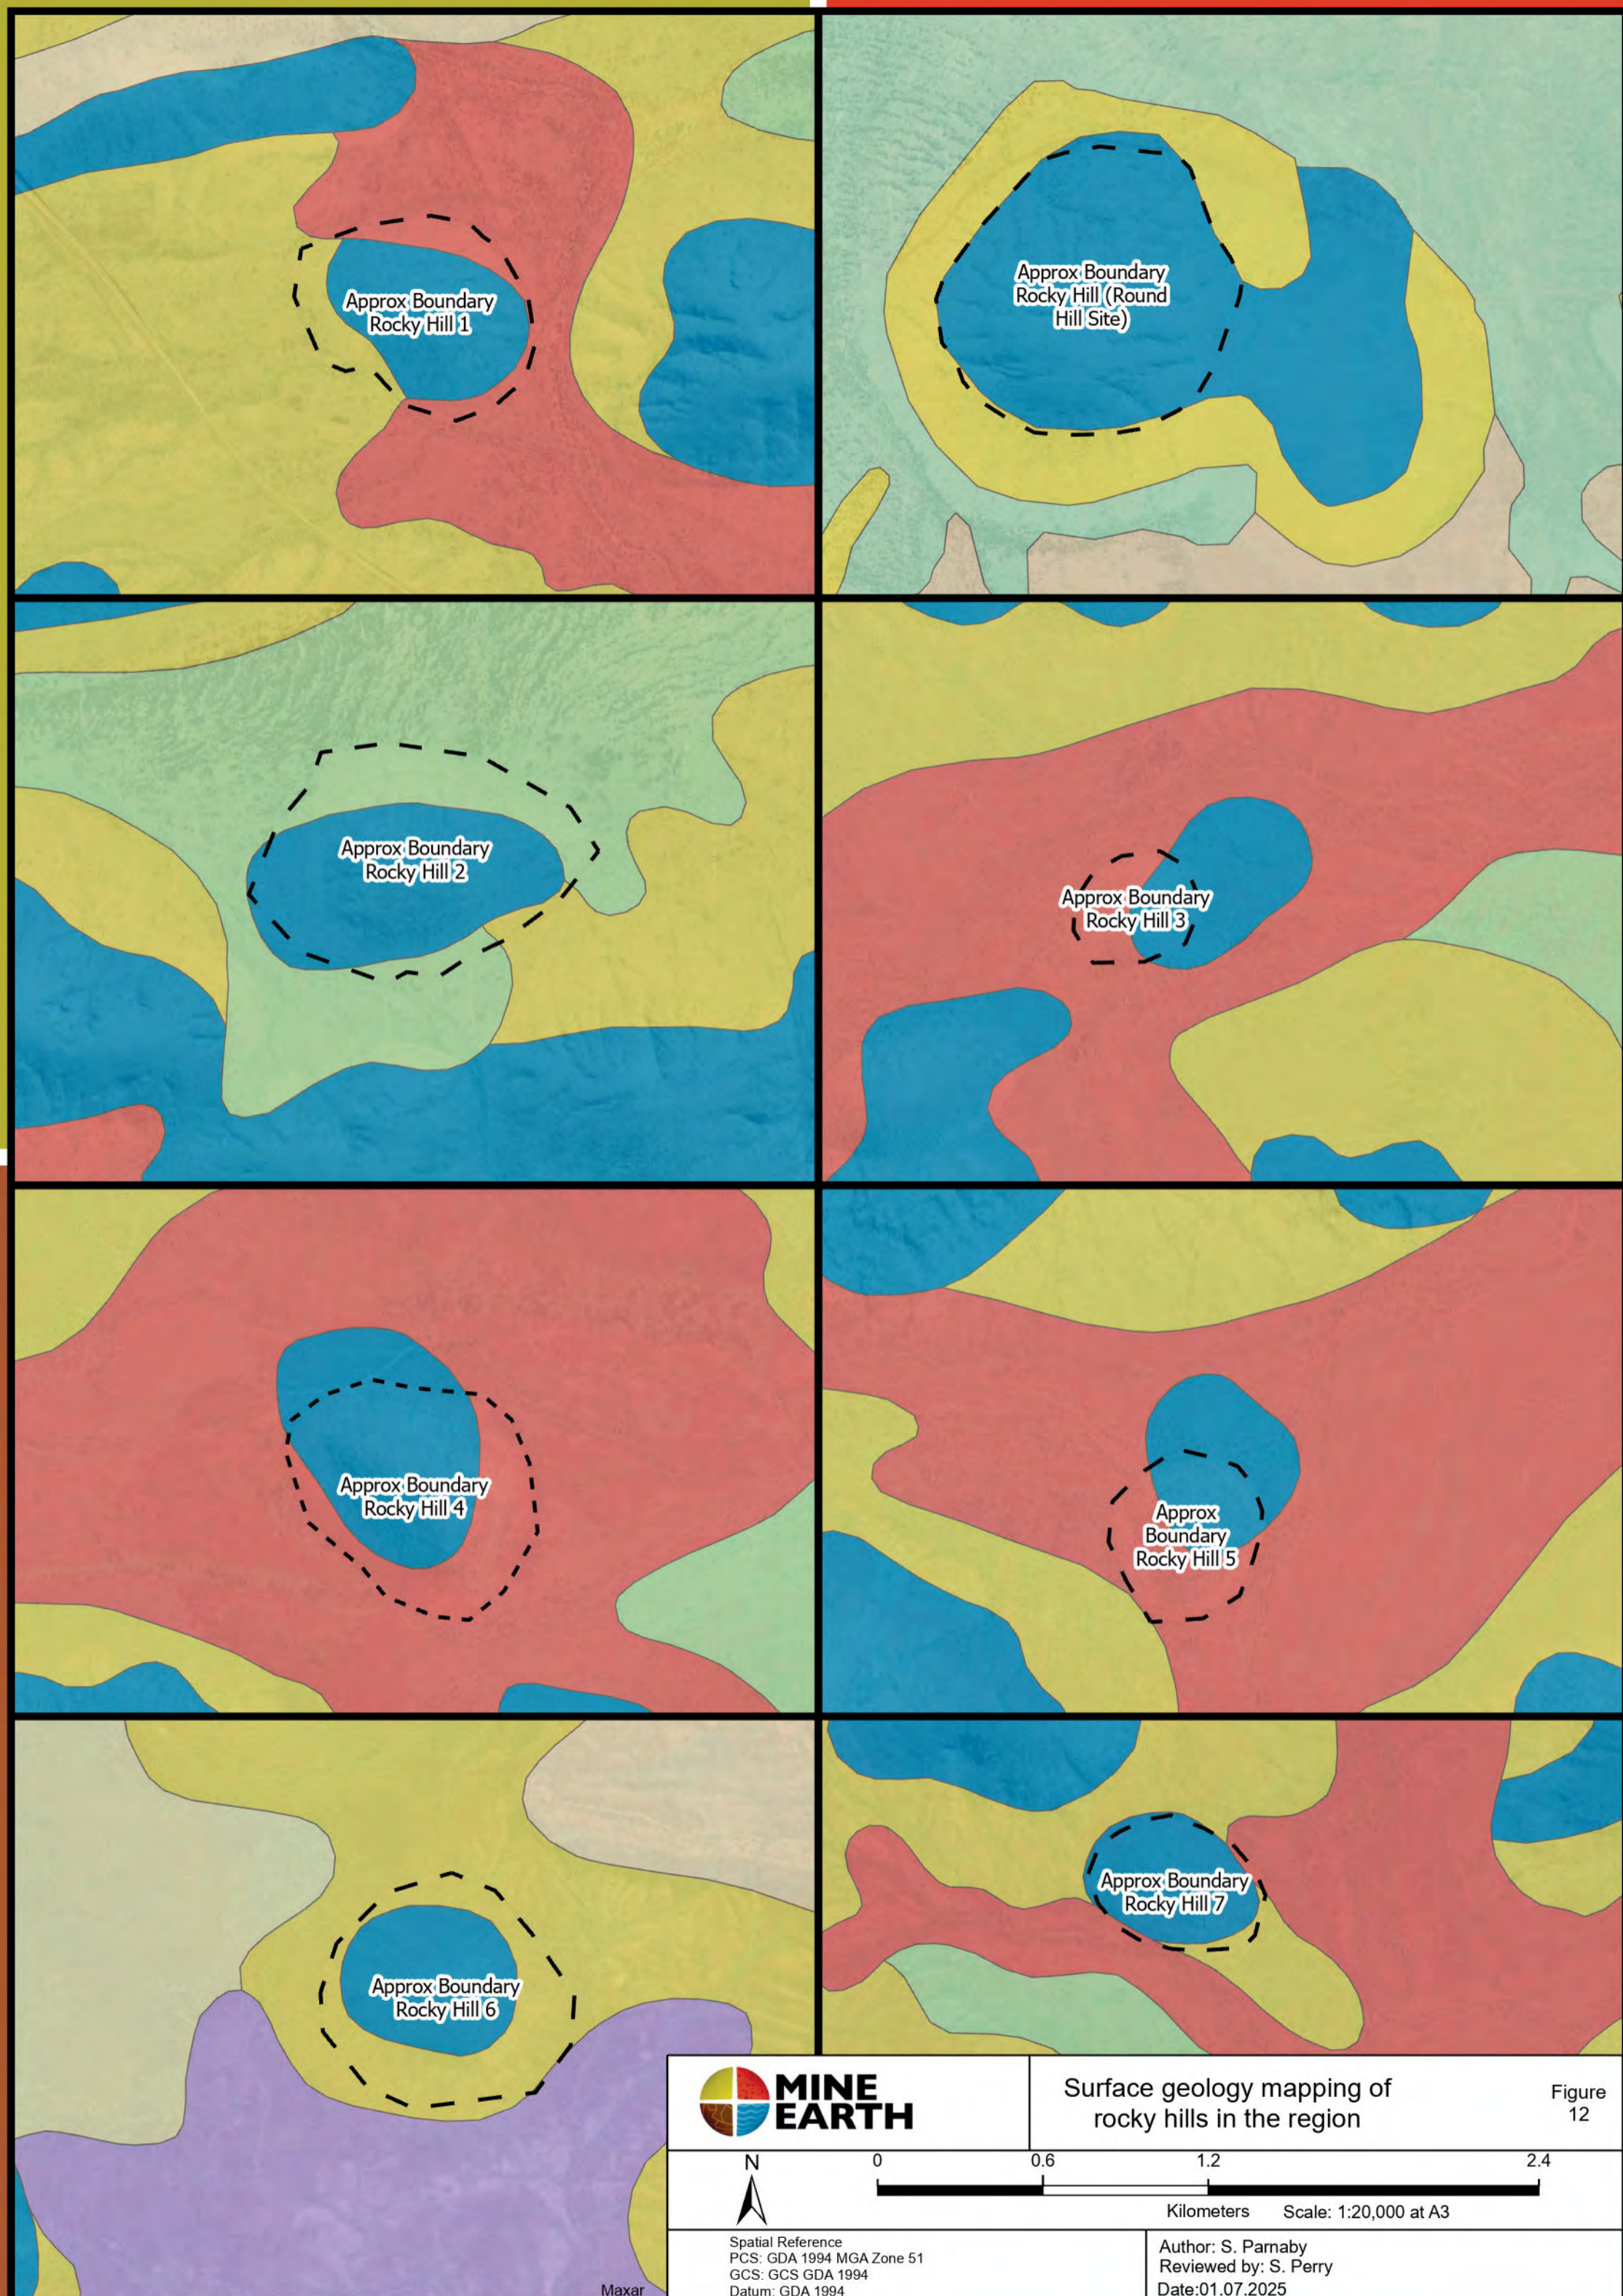
Surface geology mapping of rocky hills in the region

Seven other rocky hill landforms with the above characteristics were identified within the region as outlined in Figure 11. Visual comparisons of the surface geology and land systems for the rocky hills are shown in Figure 12 and Figure 13. It should be noted that the surface geology and land systems shown are based on broad scale regional mapping. Elevation of the rocky hills examined ranged between approximately 1,430m (AHD) and 1,778m (AHD) and the hills ranged between approximately 14 ha and 75 ha in area.

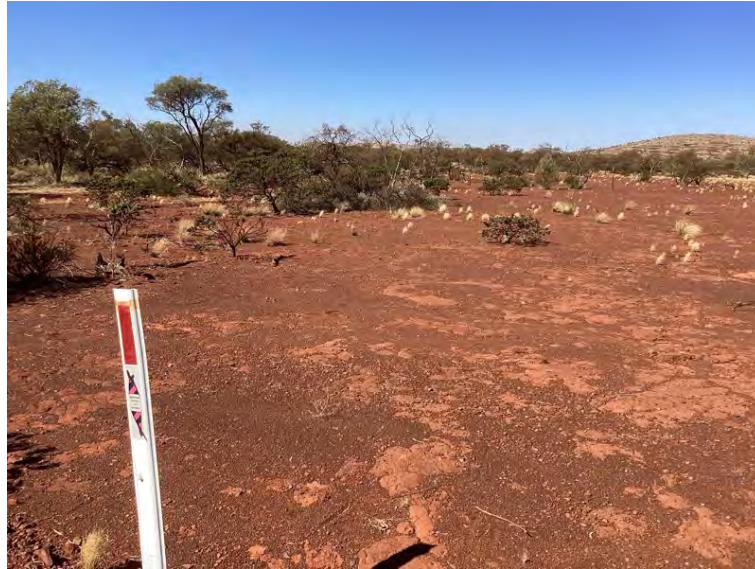
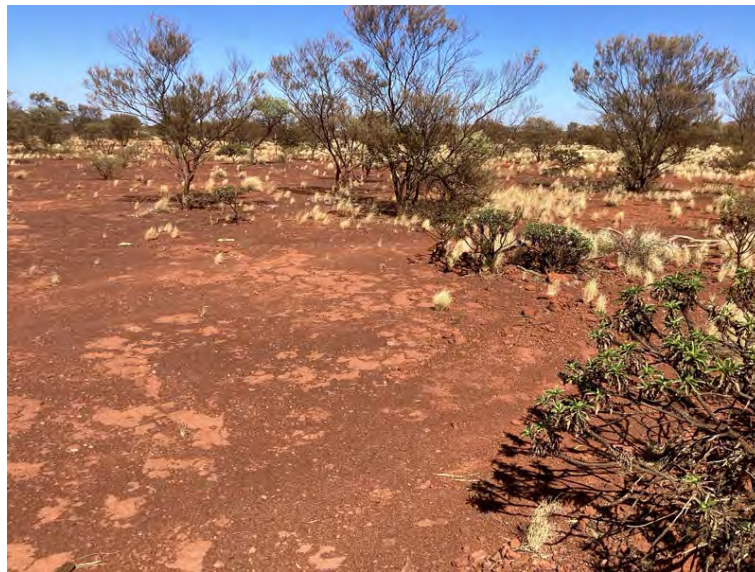
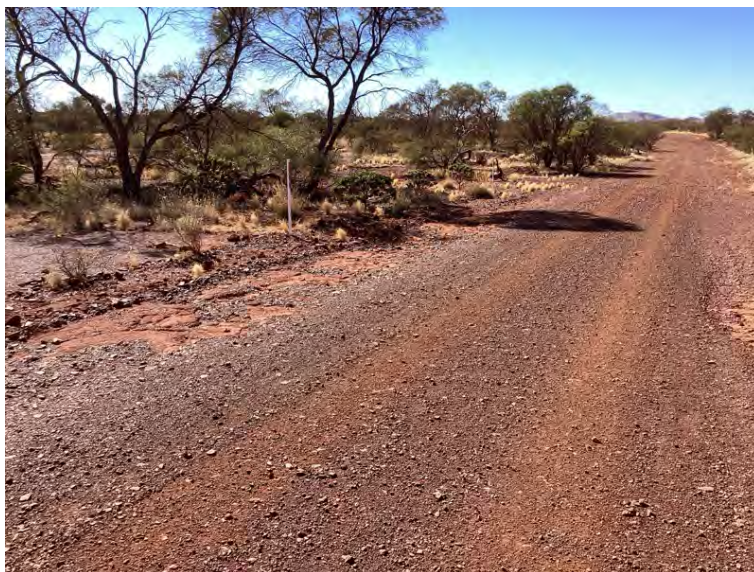
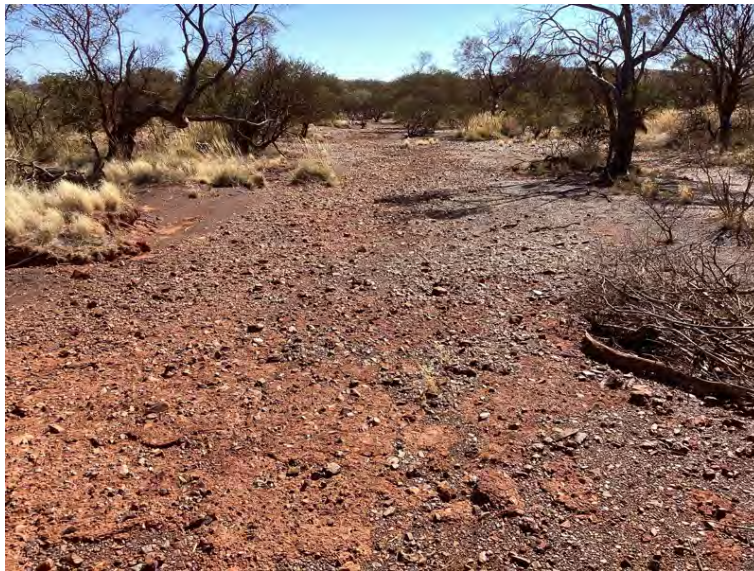
Cryptogammic gravelly plain with sparse mulga and buffel grass, with other shrubs present. Heritage area with low to flat relief. Drainage channel or floor nearby with fringing vegetation. Moderate condition and may be disturbed by cattle historically. Plate 6 and 7 are of the channel nearby.

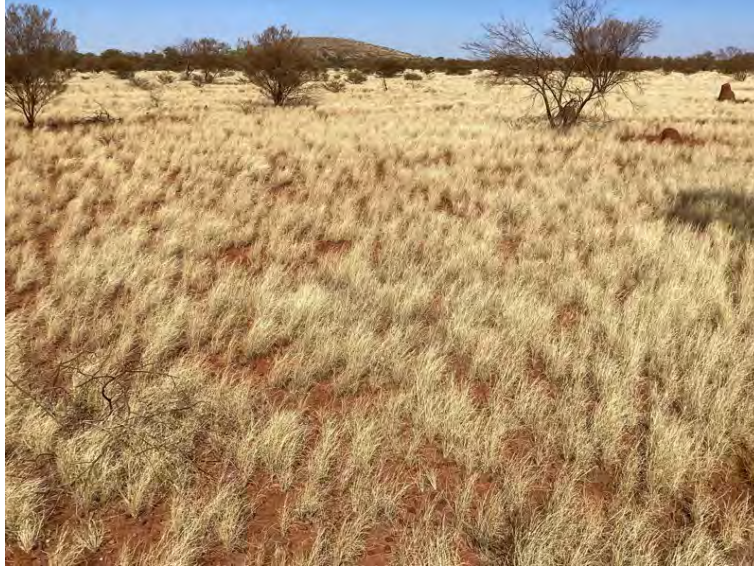
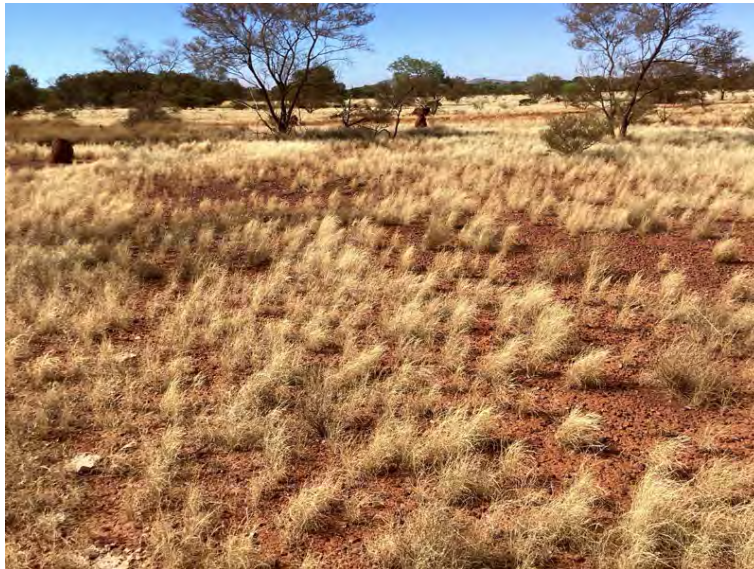
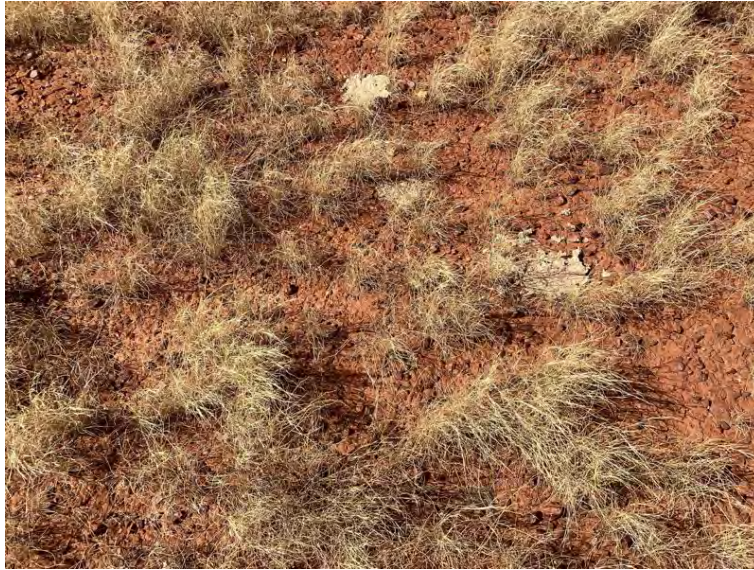
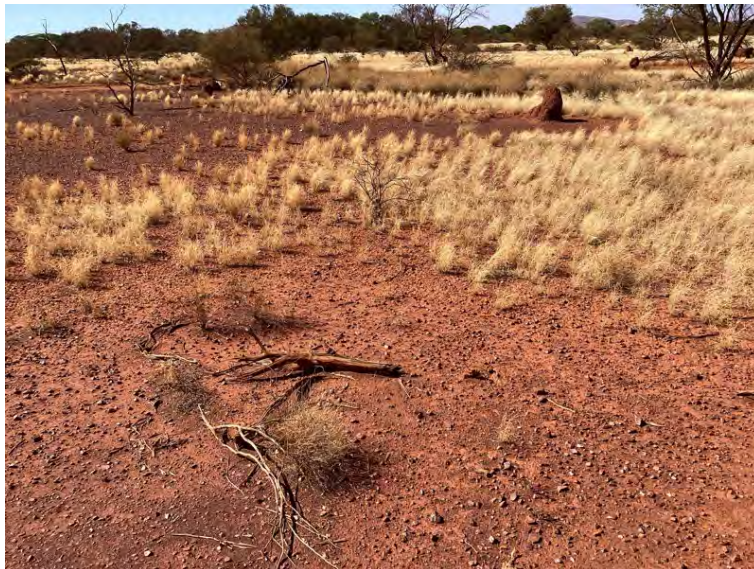
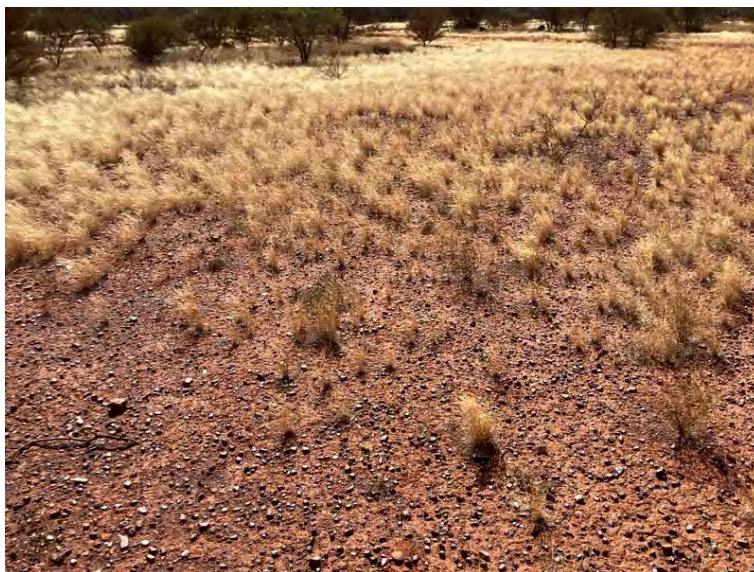
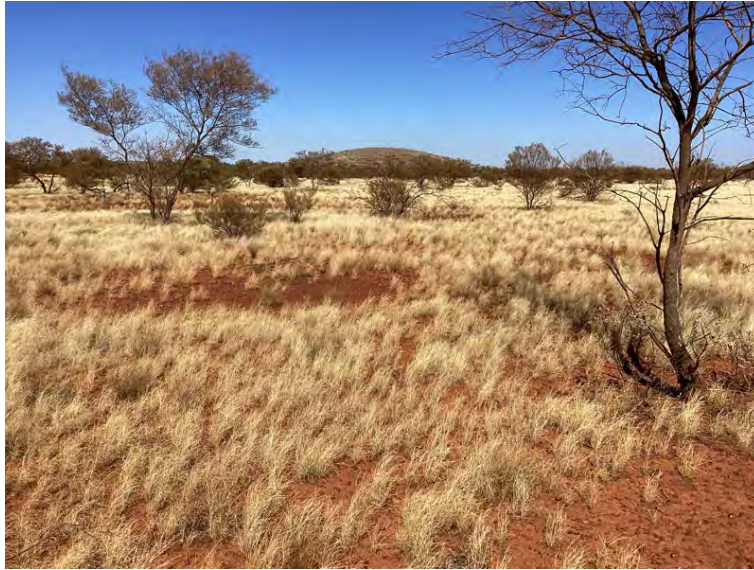
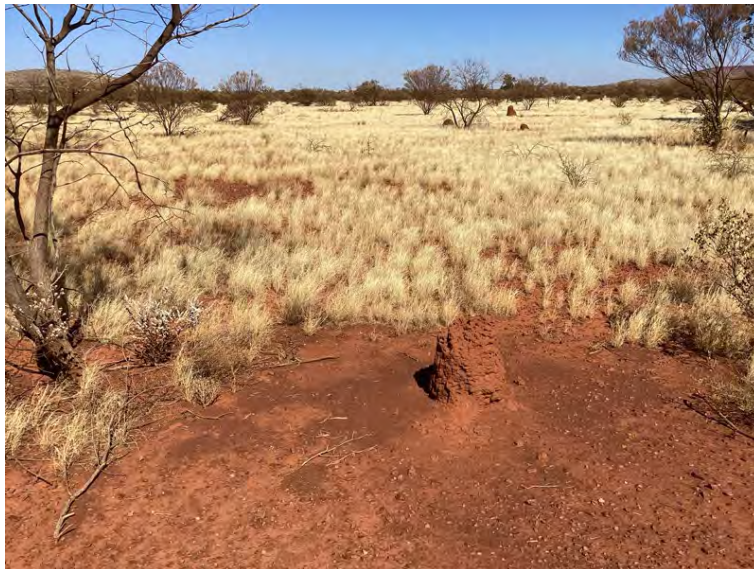
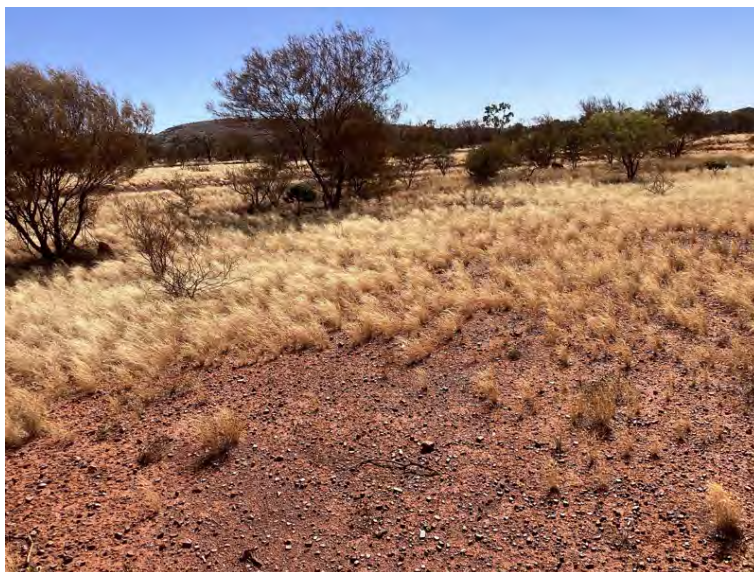
Similar to sites 1 and 16. Sparse mulga and other trees with short buffel and other grasses. Historically impacted by cattle and presents a loamy cryptogamic crust in most places. Lag of stones is sparse and small in size, this area is north of the round hill.

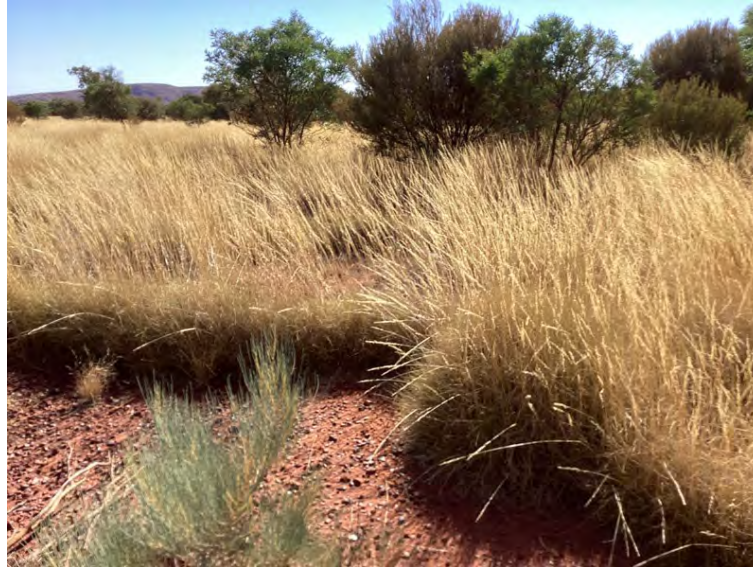
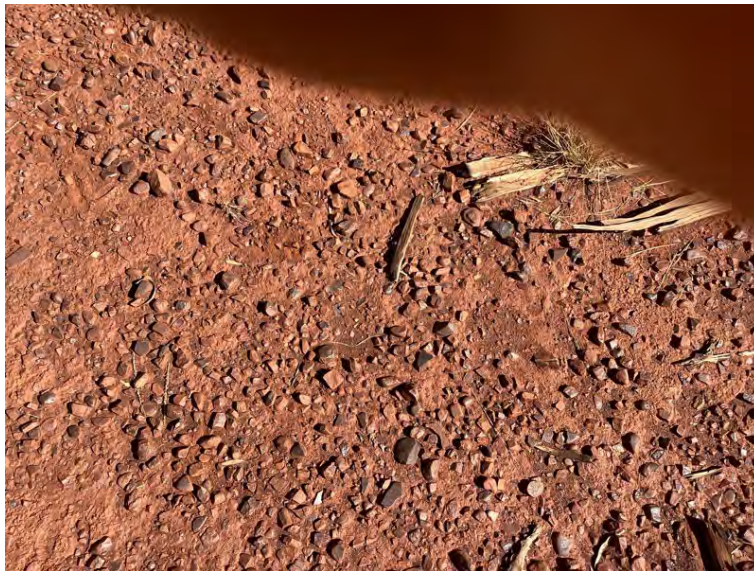
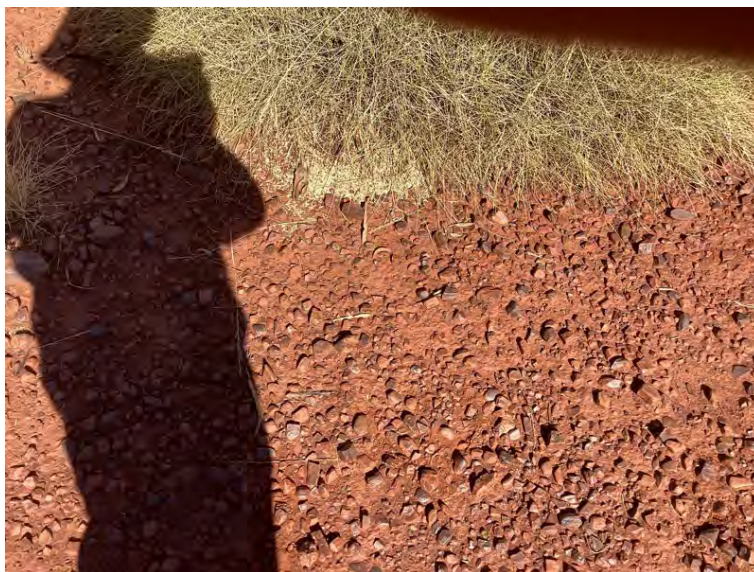
Stony spinifex plain with stony coarse fragments as a lag and cryptogams on the surface. Above wash plain (slight elevation difference was observed but probably still a plain). Mulga, eucalyptus and other trees with very dense spinifex.

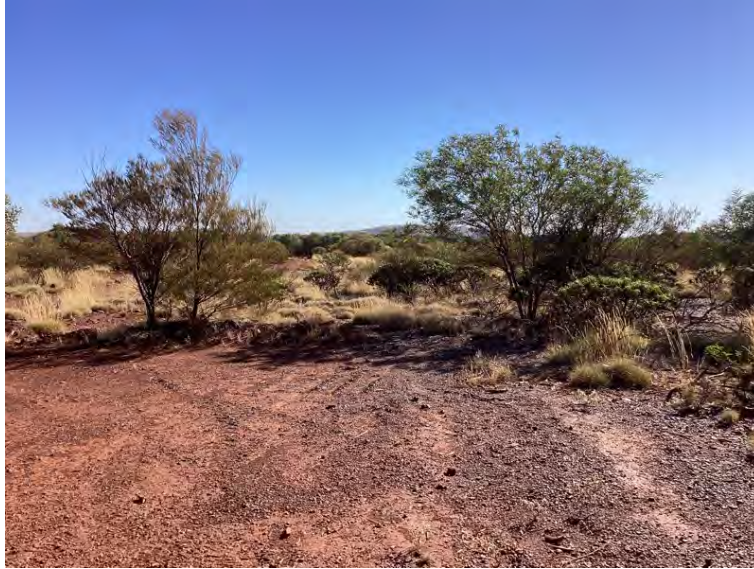
**Plate 21**

Slightly sloping plain. Spinifex dominant with Eucalyptus, mulga and other shrubs in open woodland. Slightly above wash plain and may be lower footslopes from RD05, which is a part of the Newman landsystem. This area is in good condition but with some exploration disturbance.

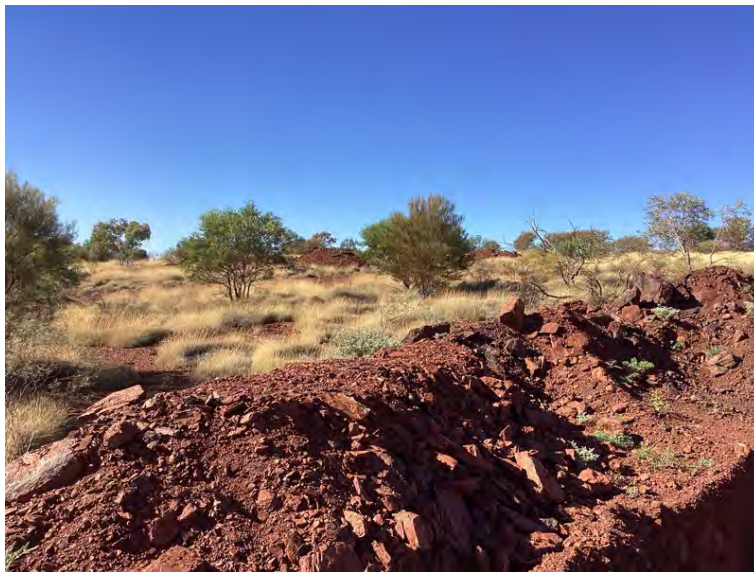
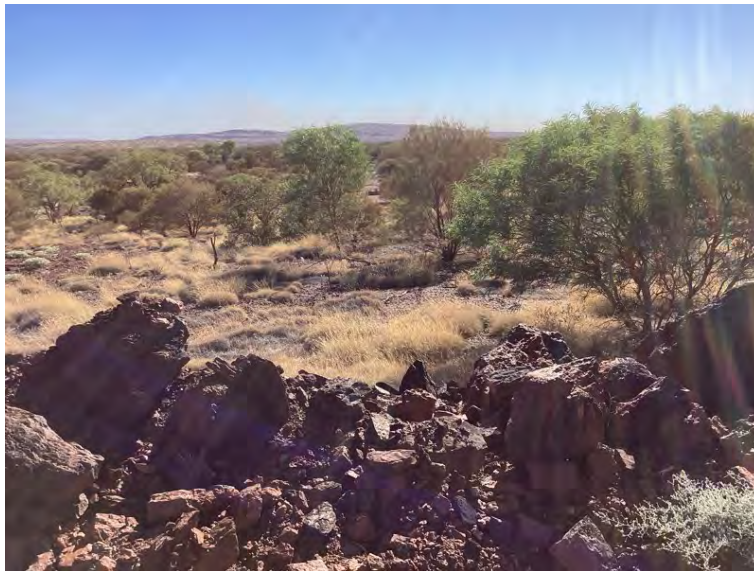
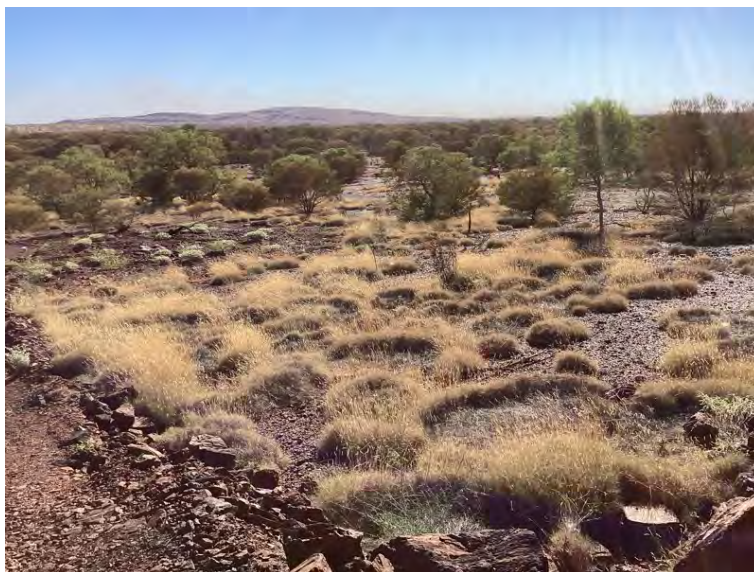
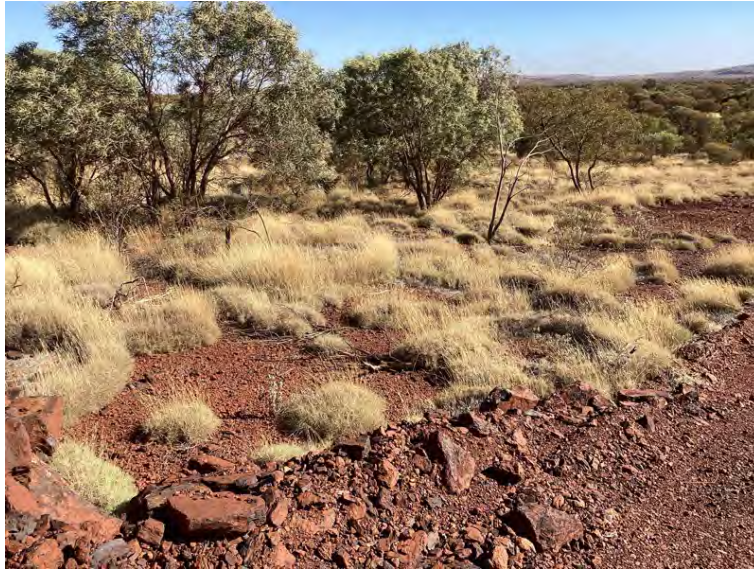
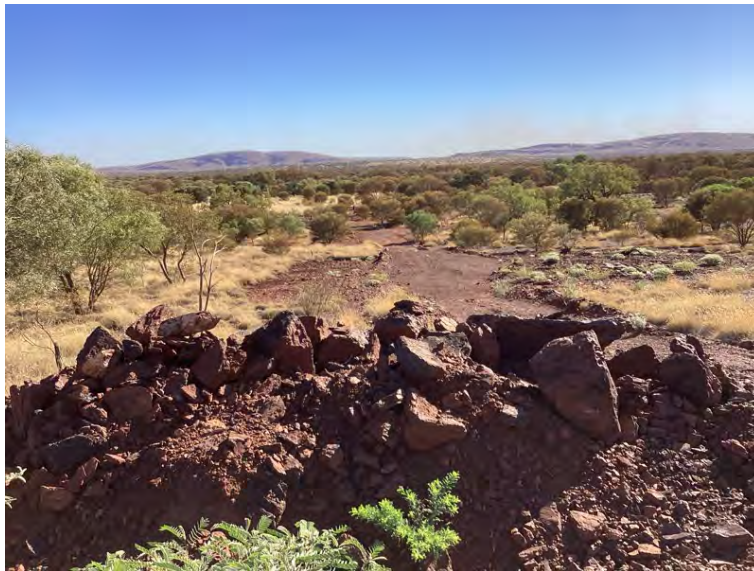
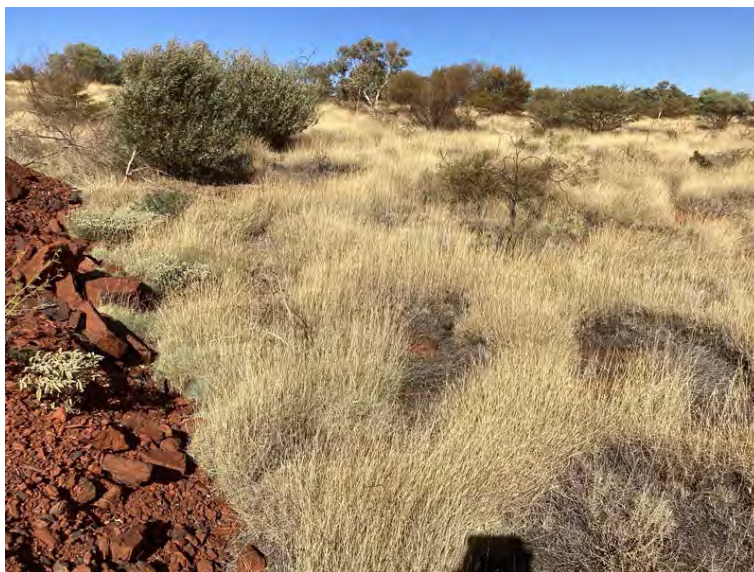
Mid-sized discrete slope with a mild slope angle. Spinifex dominated tops also with sparse mulga. Pad shows potentially BIF material. A stony surface lag and some weeds were found to be present. Mild slope angle. Good condition except for exploration disturbance. Another rise was observed in the distance to the north.
