# Round Hill Project Landform Assessment

**HanRoy Limited**

29 July 2025

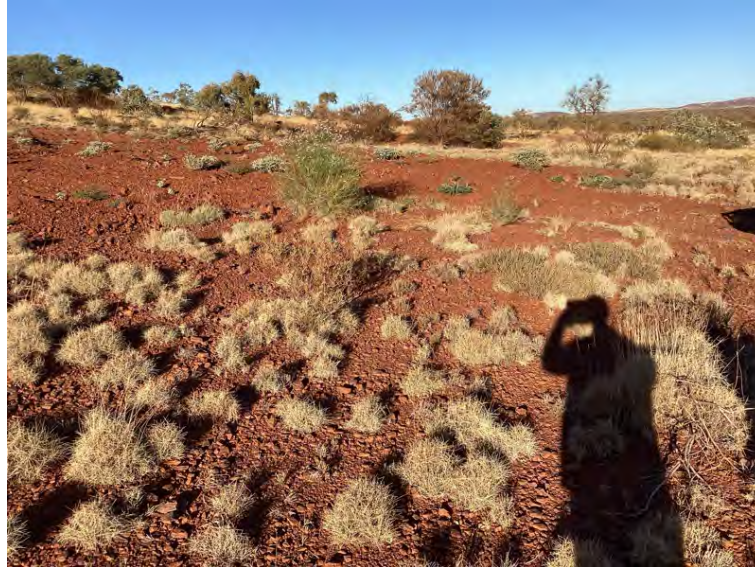
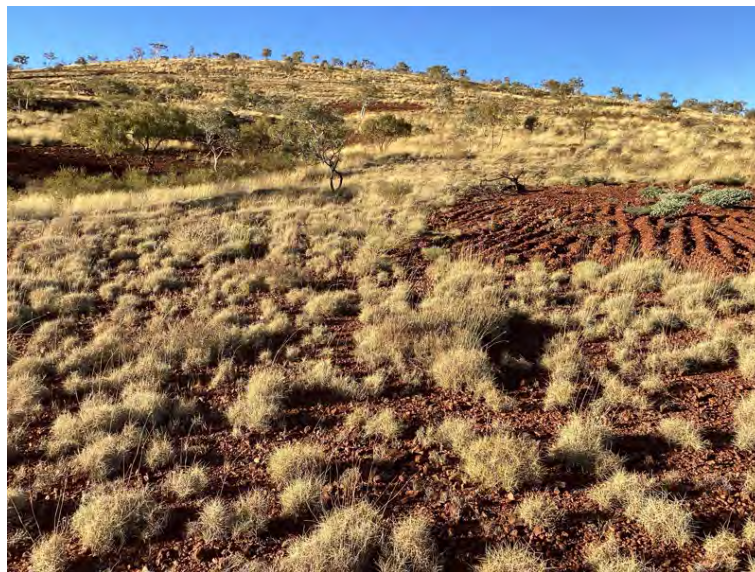
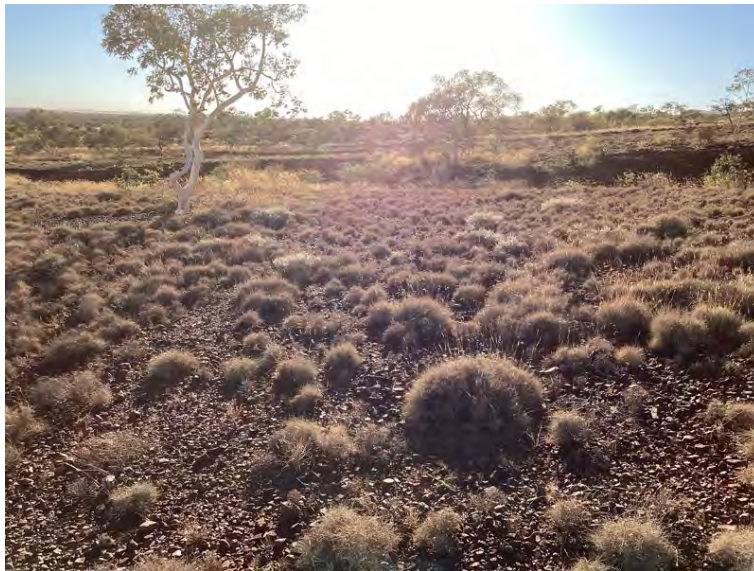
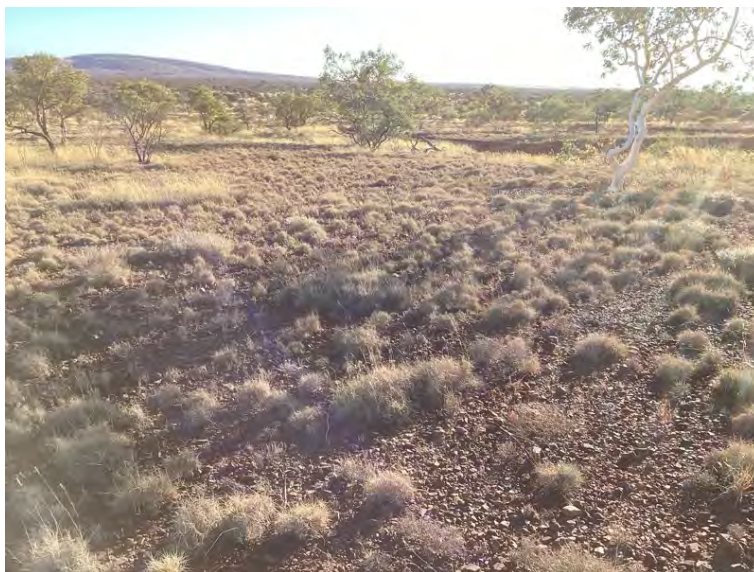
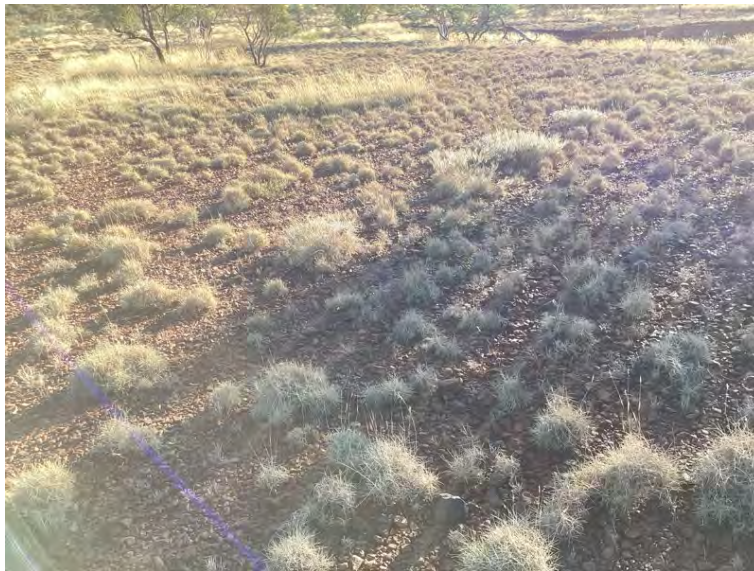
Lower slopes of the round hill. Possess a larger coarse fraction. Spinifex dominates with some Eucalyptus and mulga trees. This site is near a drainage line of the hill and above the wash plain area. Rehabilitation areas nearby, site is in good condition except for presence of some weeds.

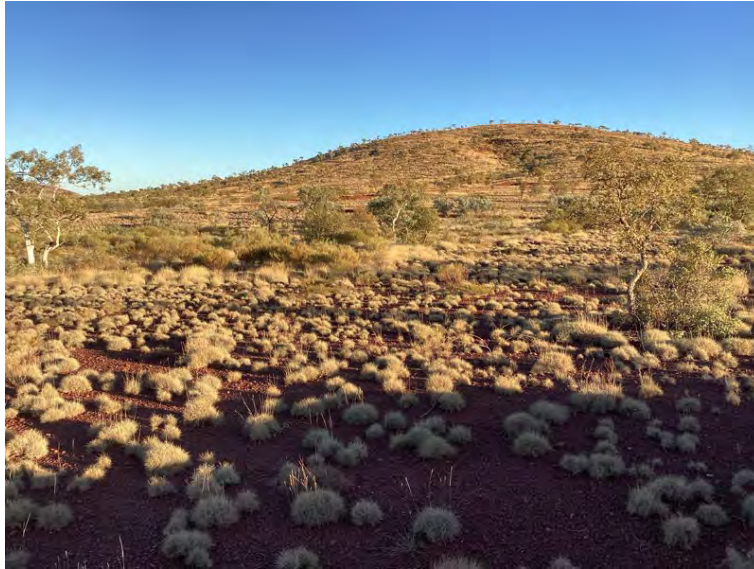
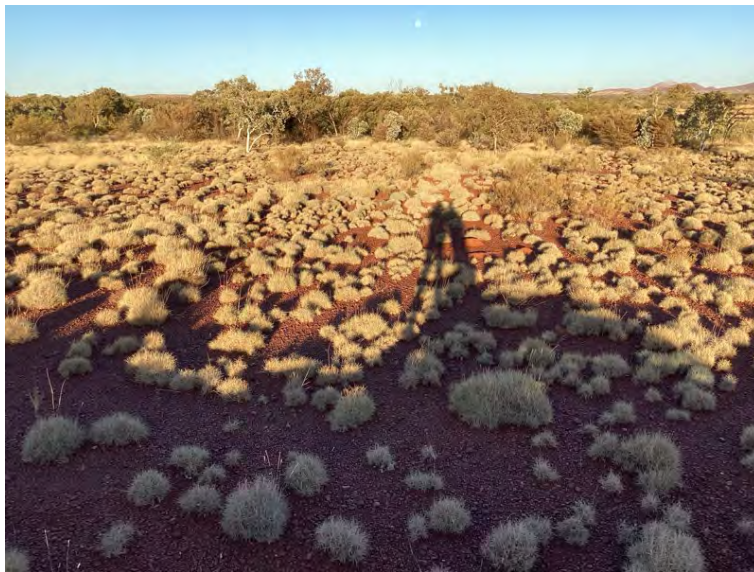
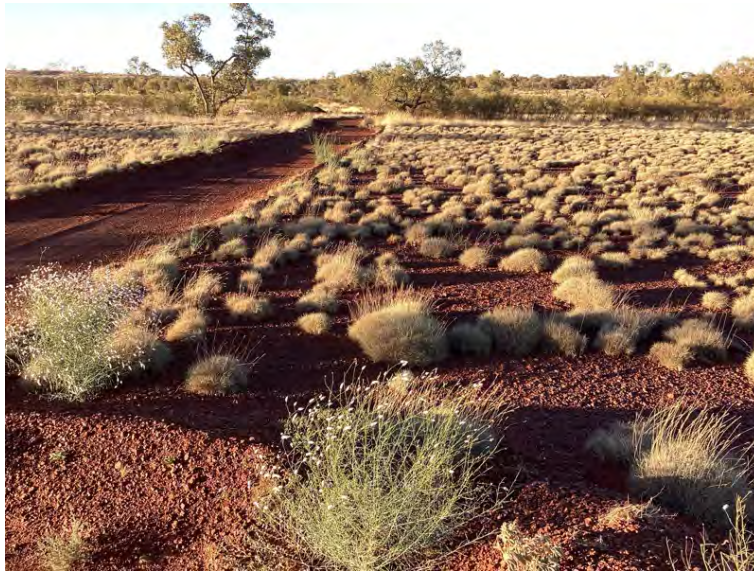
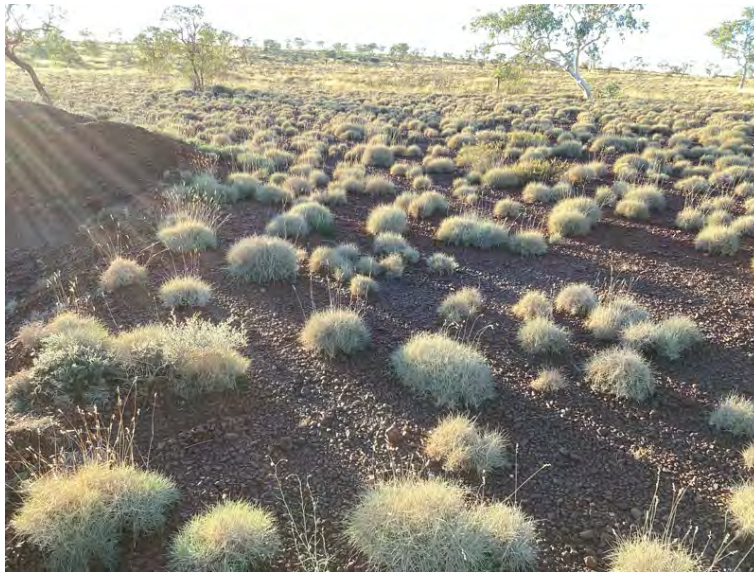
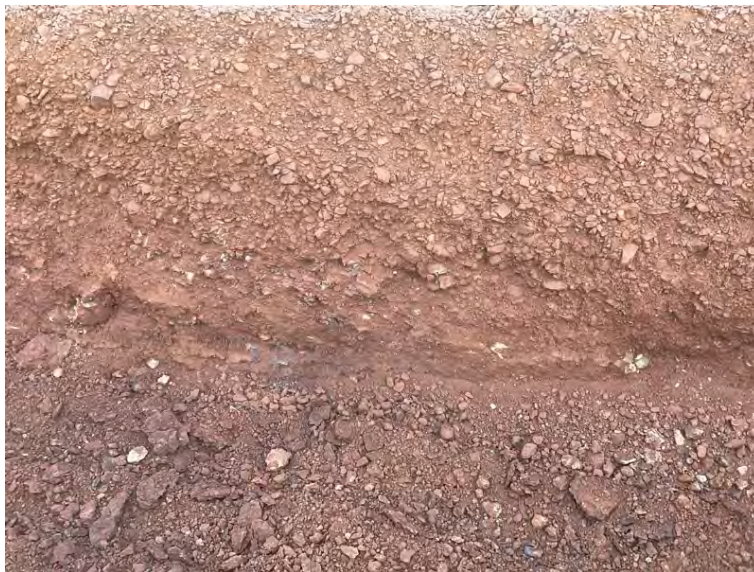
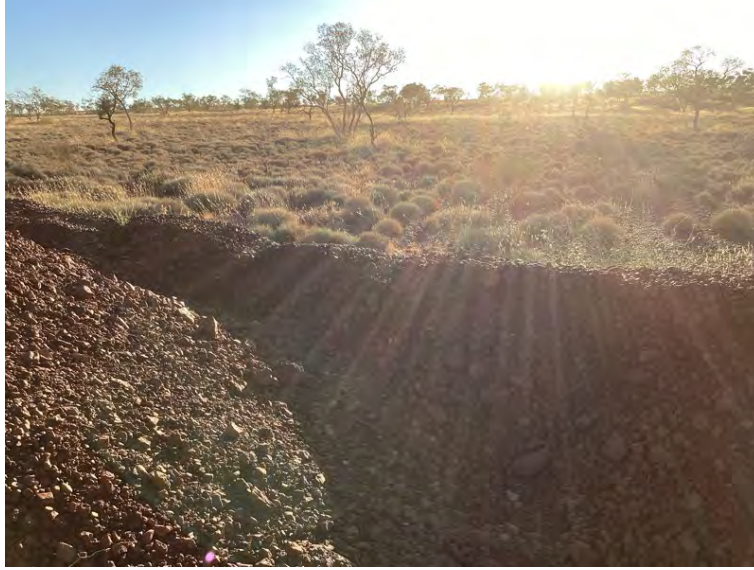
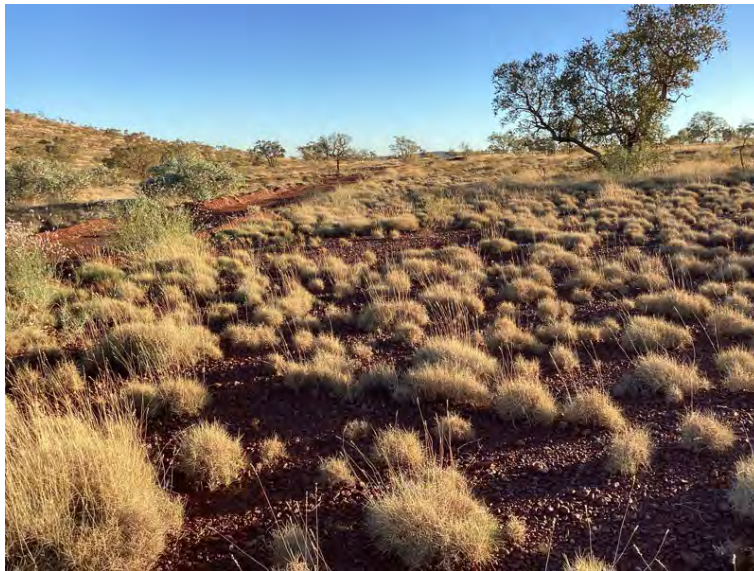
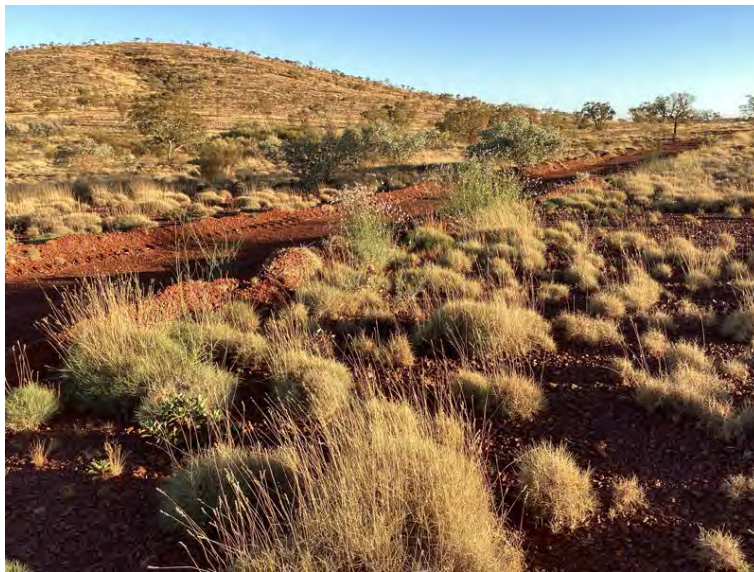
South-east of the round hill. Hill has moderate slope angle, domed top, defined drainage courses, concentrated at the hill's base. Vegetation is mostly eucalyptus and spinifex. This area is defined by stony undulating plains with low rises around the hill, there was a stony surface of larger coarse fragments.

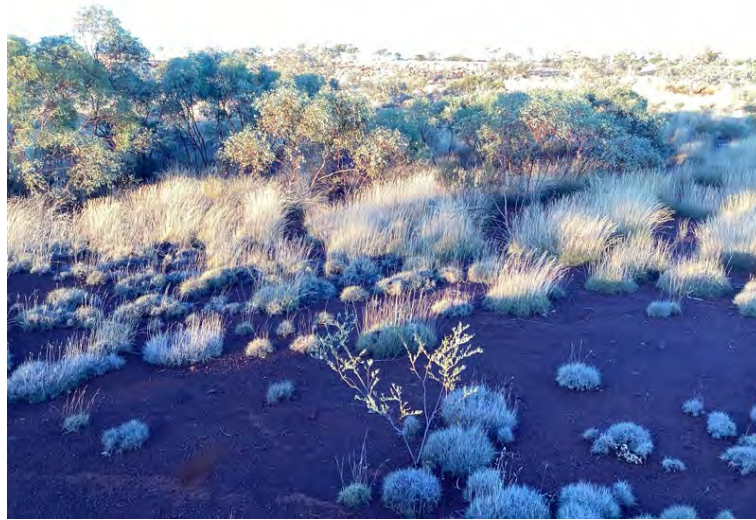
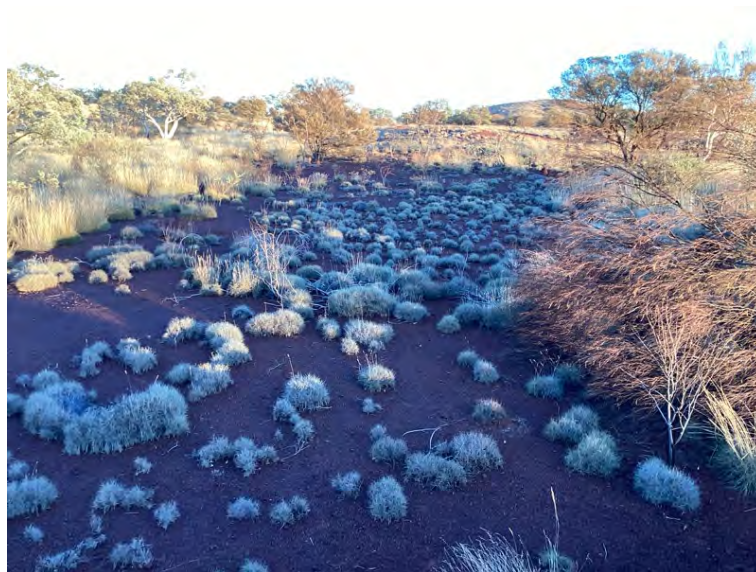
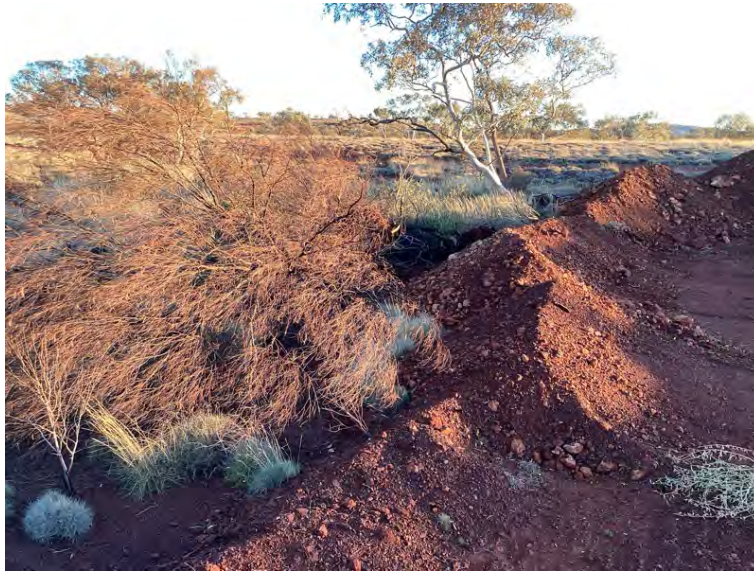
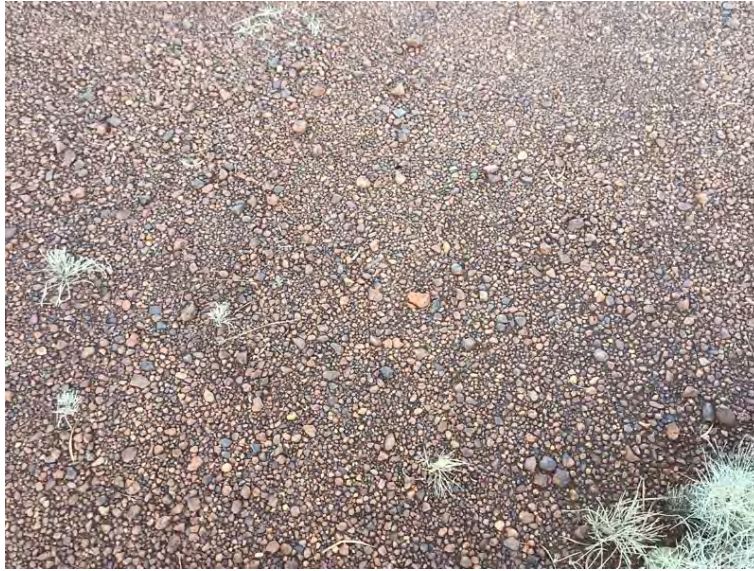
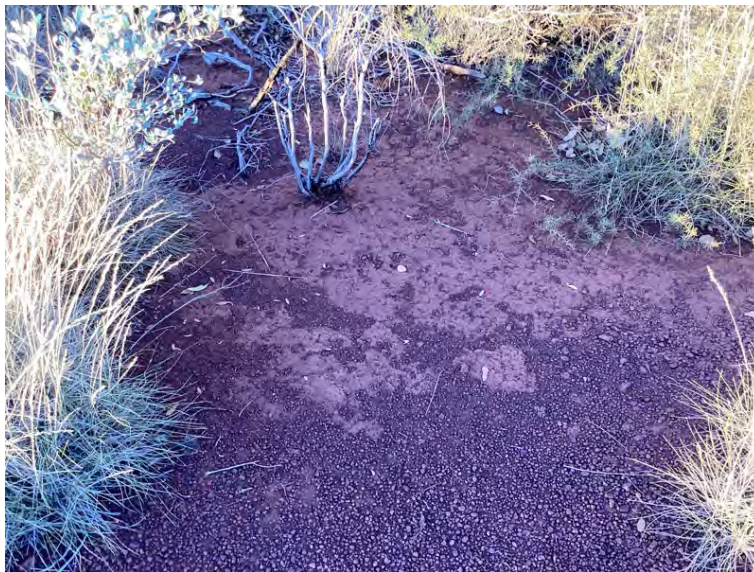
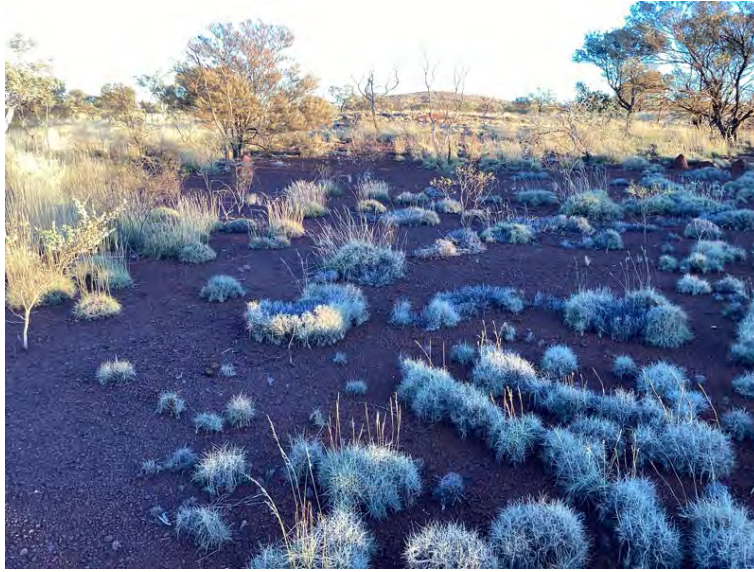
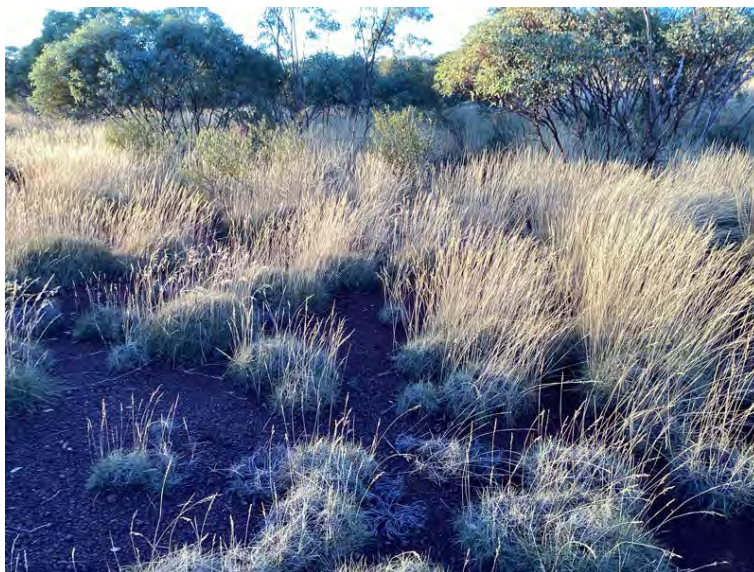
Stony spinifex plain with low rises and open woodland. There were stony surface soils and drainage floors between rises. Cryptogams present, with mature mulga. Good condition and integrity.

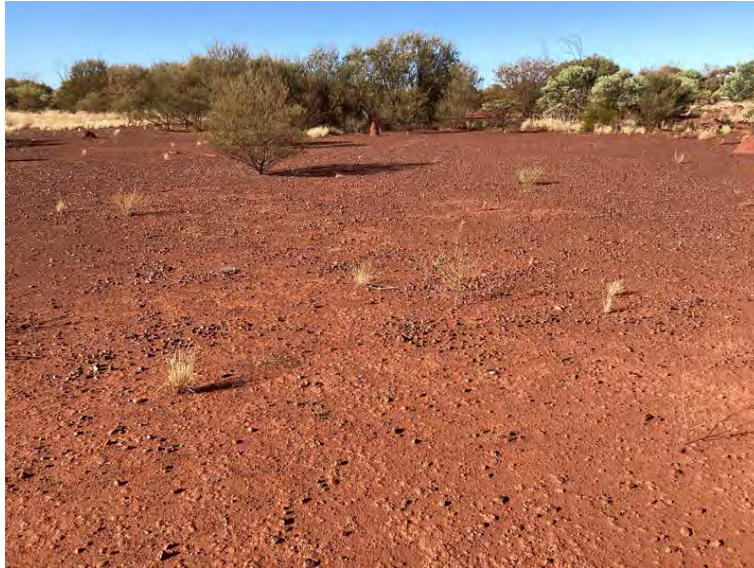
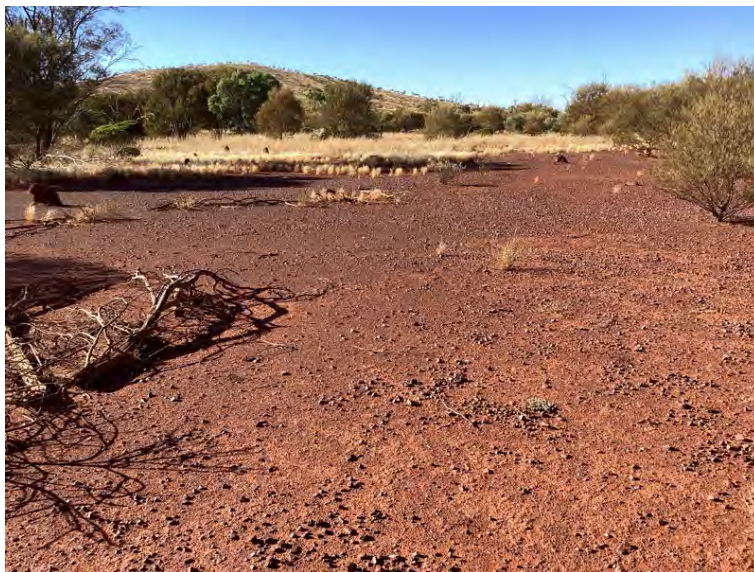
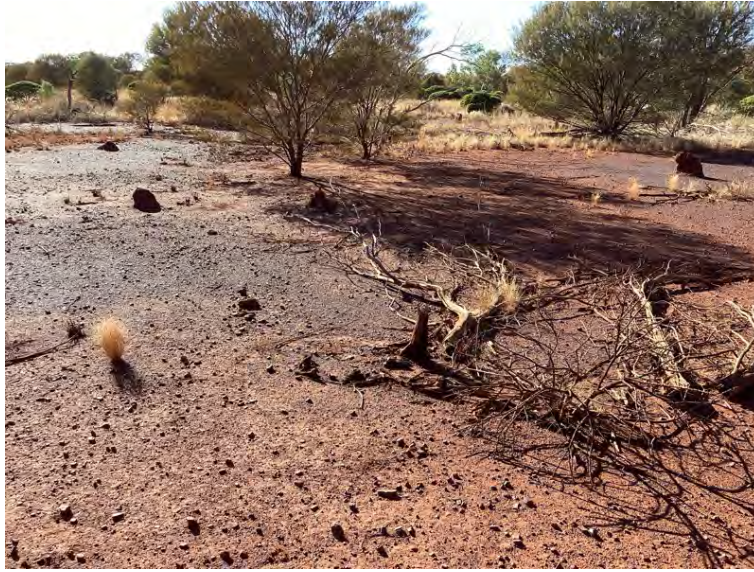
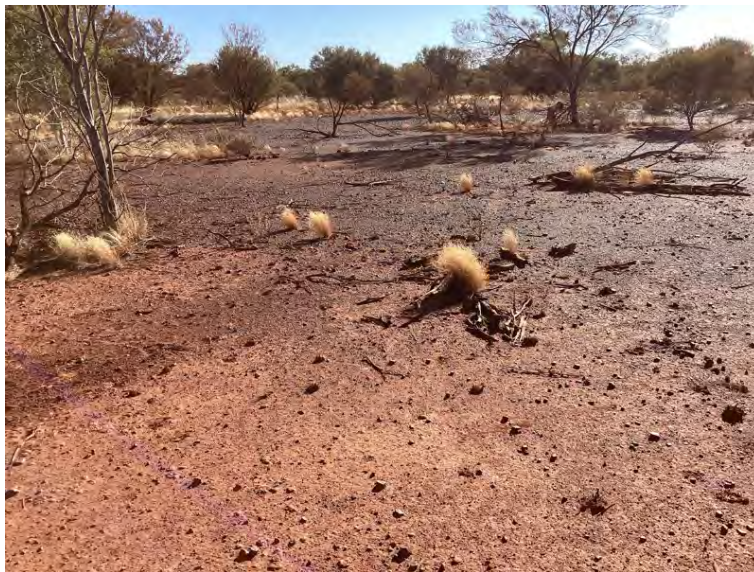
Wash plain area where Mulga and spinifex dominate. Lower coarse frag percentage and size was noted. Generally flat and non-undulating. Some sparse buffel grass and cattle disturbance present.

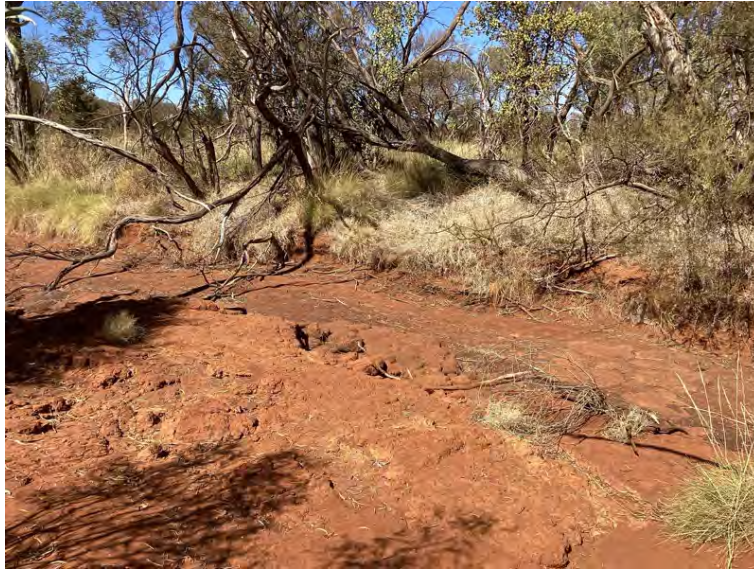
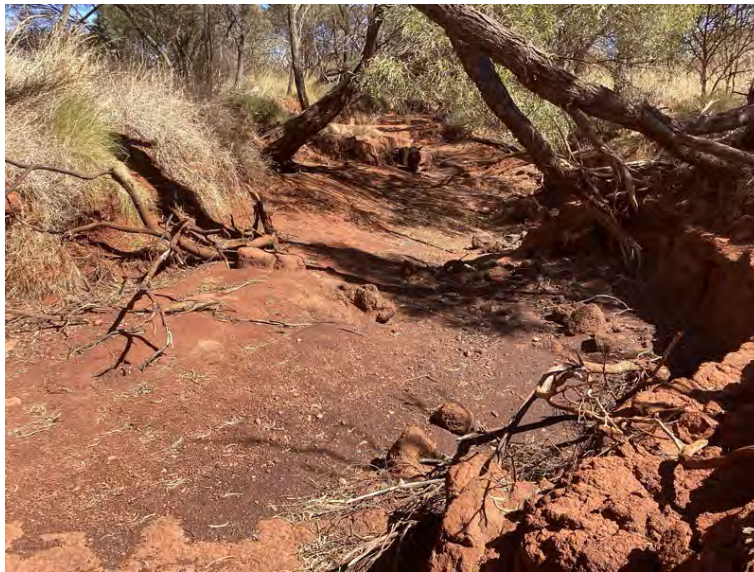
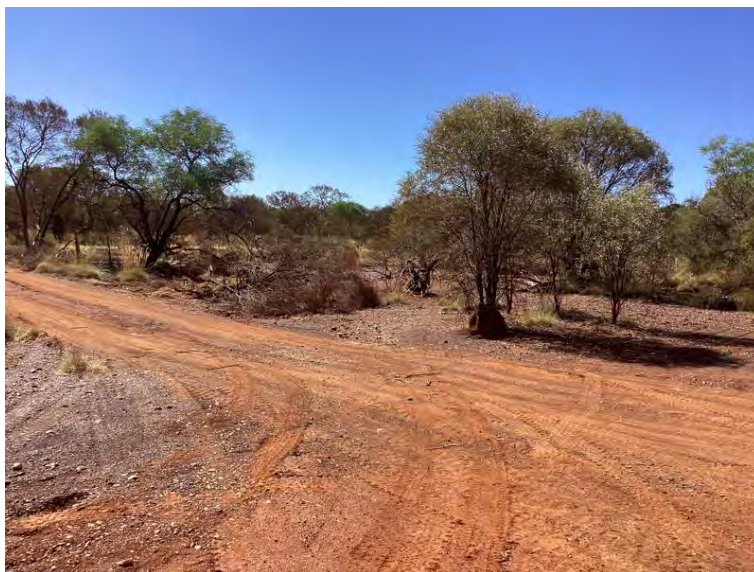
Flat sandy plain, cryptogams, adjacent to drainage channel, semi open woodland, outcropping rocks near drainage channel, good condition, signs of flooding. Exploration disturbance nearby.

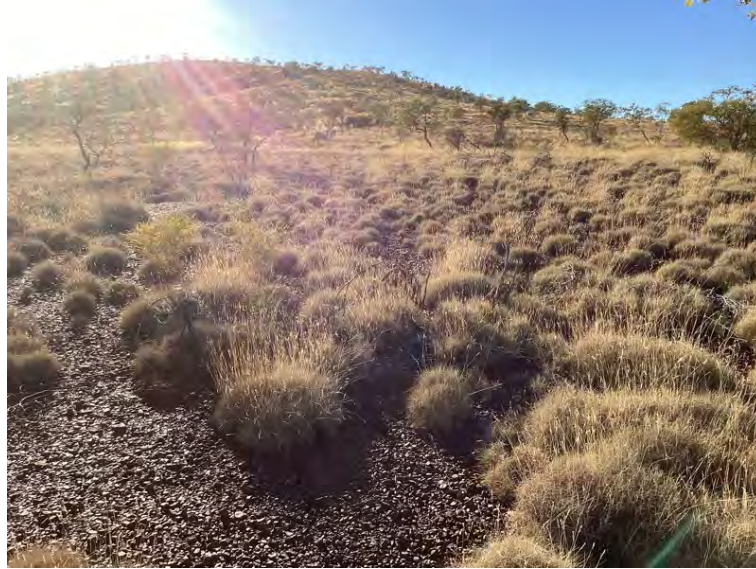
**Plate 73**

Base of round hill where spinifex dominates above, a vegetation transition zone where there is thicker open woodland of Mulga and Eucalyptus in the washplains. Larger coarse frag and drainage into wash plain evident.

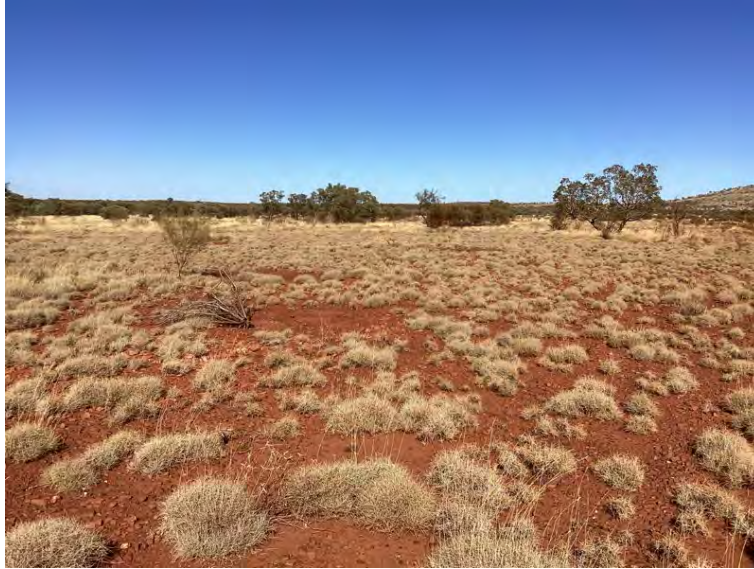
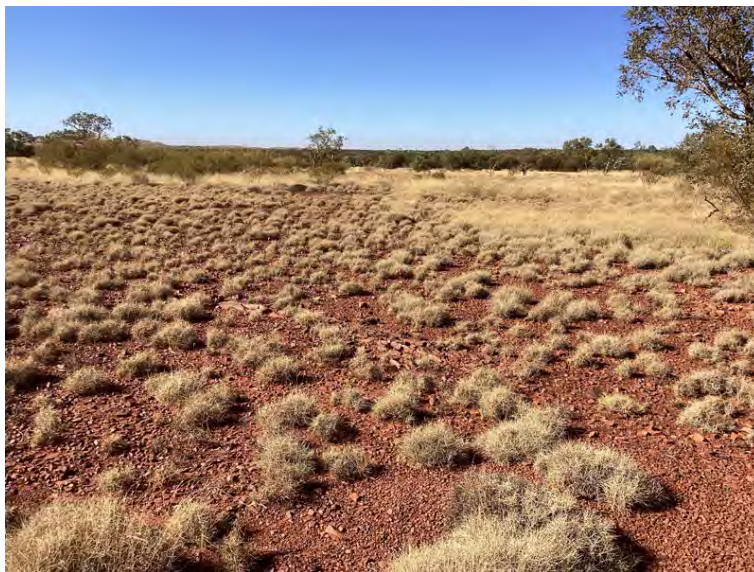
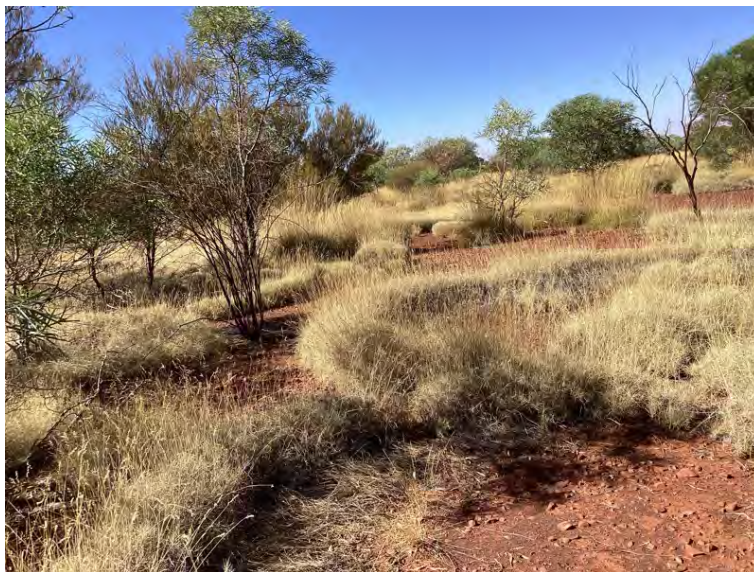
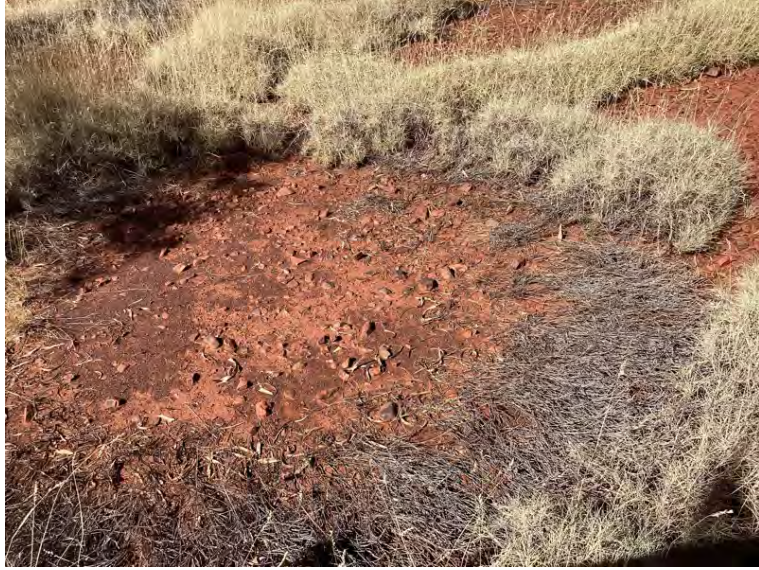
Upland flat stony plain, outcropping rock, cryptogams present, mid-sized abundant coarse fragment lag of moderate to large size, spinifex dominant with adjacent sparse mulga. Dormant pebble mound, and the area is in good condition with minimal disturbance. Possibly top of a low relief rise.

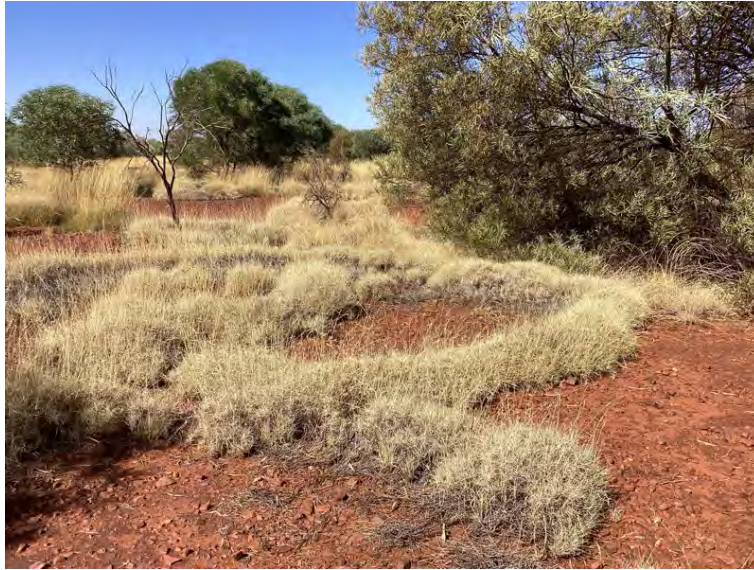
**Plate 85**

Similar to RD03 in morphology and vegetation, cryptogams with mature vegetation, semi open woodland. Unable to exit vehicle due to heritage restrictions.

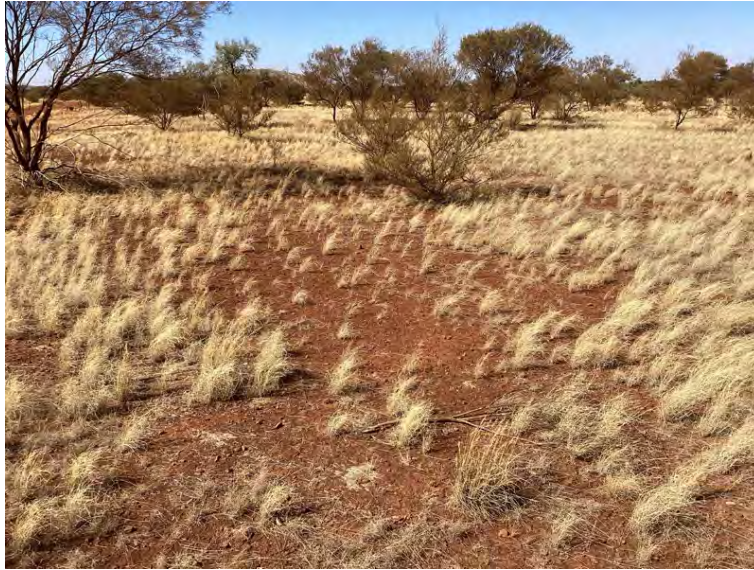
**Plate 88**

Sparse mulga woodland with open buffel grassland plain. This area has been disturbed by cattle. Low rise to south and north with a loamy crust surface compacted by cattle, cryptogams present.

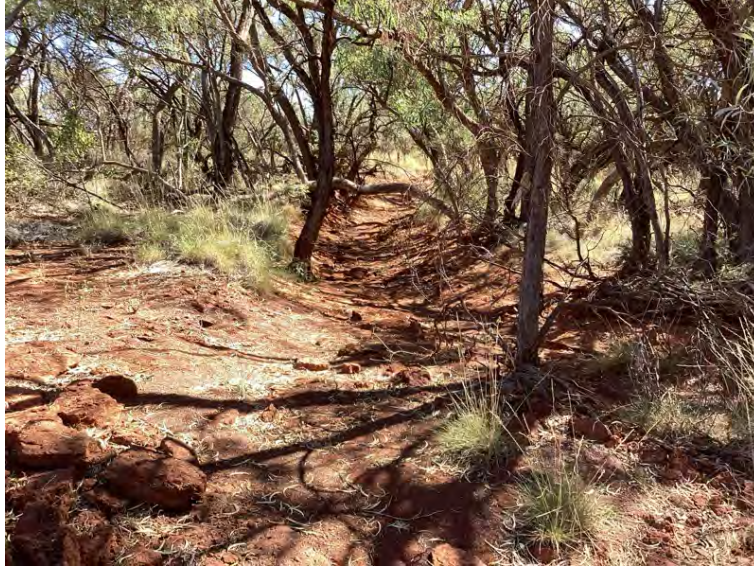
**Plate 95**

Distinct drainage channel on the side of the road. Dense mulga and other fringing vegetation present, along with outcropping rock. This area is adjacent to woodlands and plains. There are visible signs of flooding as well as cattle disturbance.

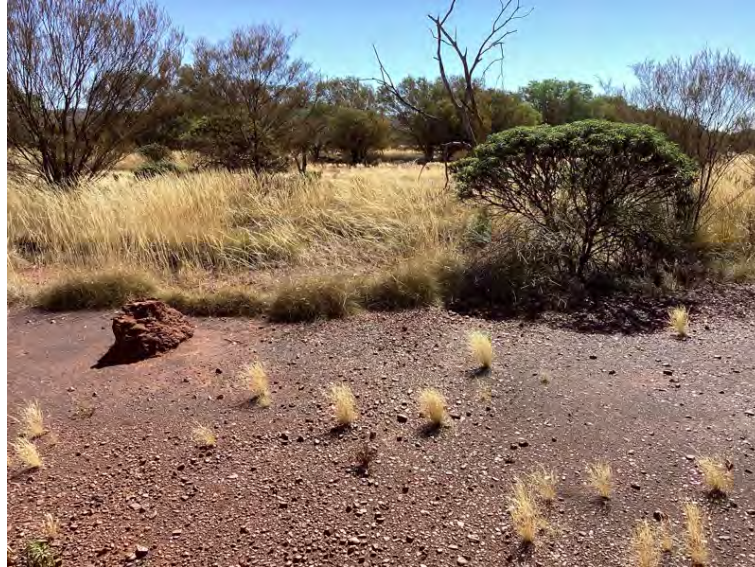
**Plate 102**

RD16. Grassy plain with pockets of open woodland and cryptogammic crust in places. Relief of the area is flat to slightly sloped with a gravelly to stony surface lag. Cattle disturbance evident and sandy in some areas.
