Yanchep Rail Extension

Geotechnical Investigation Report

301012-02366-SS-REP-0001

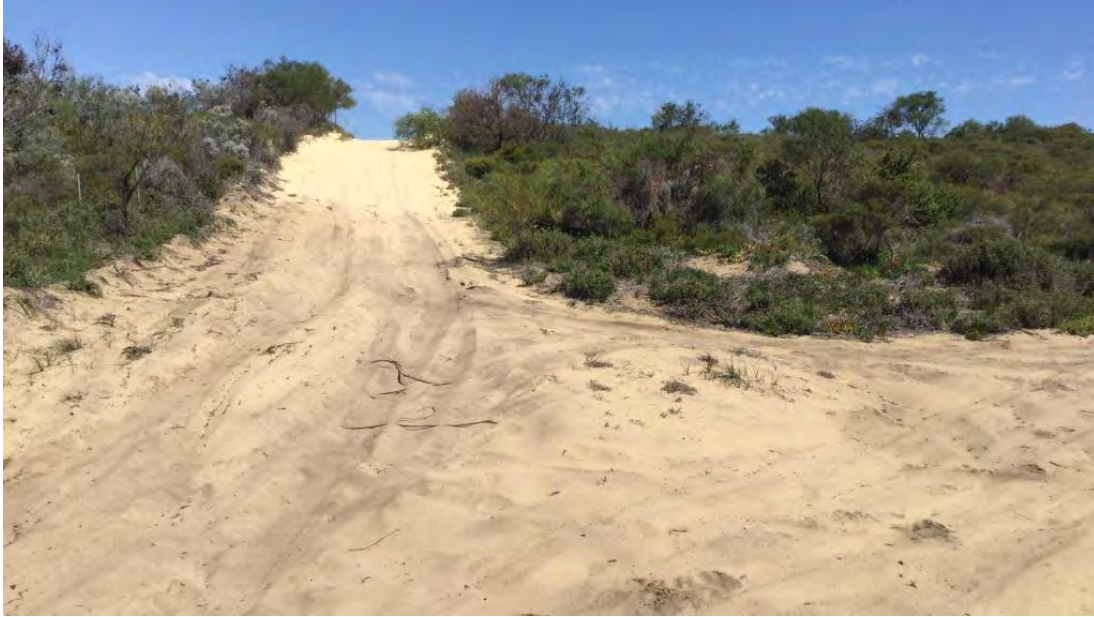
Figure 5-1: Safety Bay Sand ('lighter-coloured') forming crest of narrow dune, underlain by Tamala Sand

5-1). Outcrops of Tamala Limestone 'caprock' are also often evident near the boundary between these different coloured sand bodies (Figure 5-2).

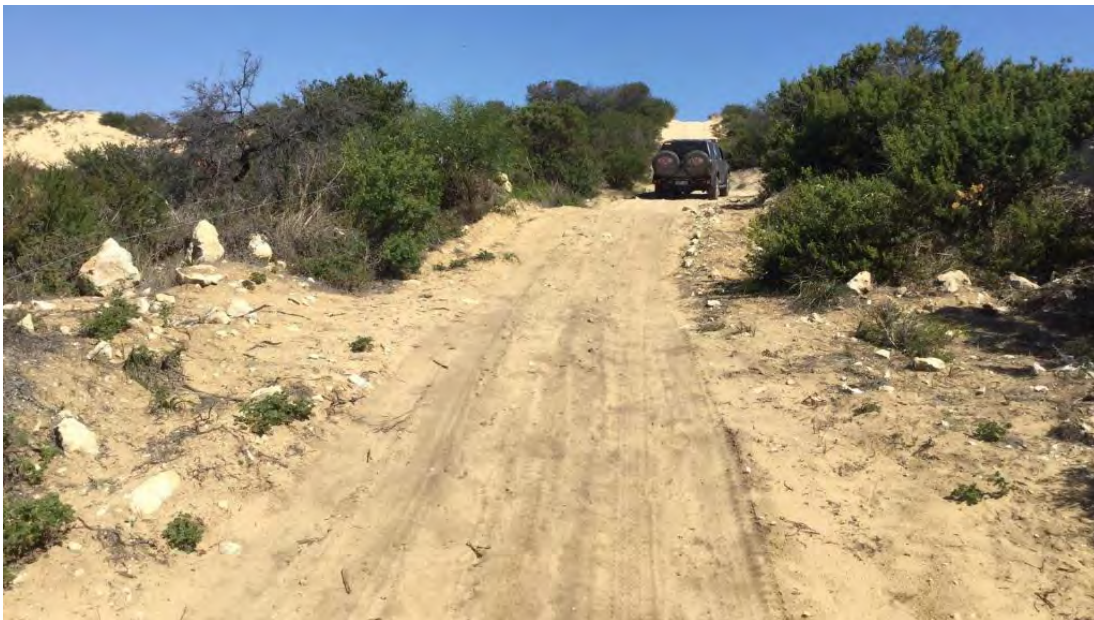
Figure 5-2: Tamala Limestone outcrop near the boundary (approximate position of vehicle) between Tamala Sand and overlying Safety Bay Sand, which forms the narrow dune crest in the background

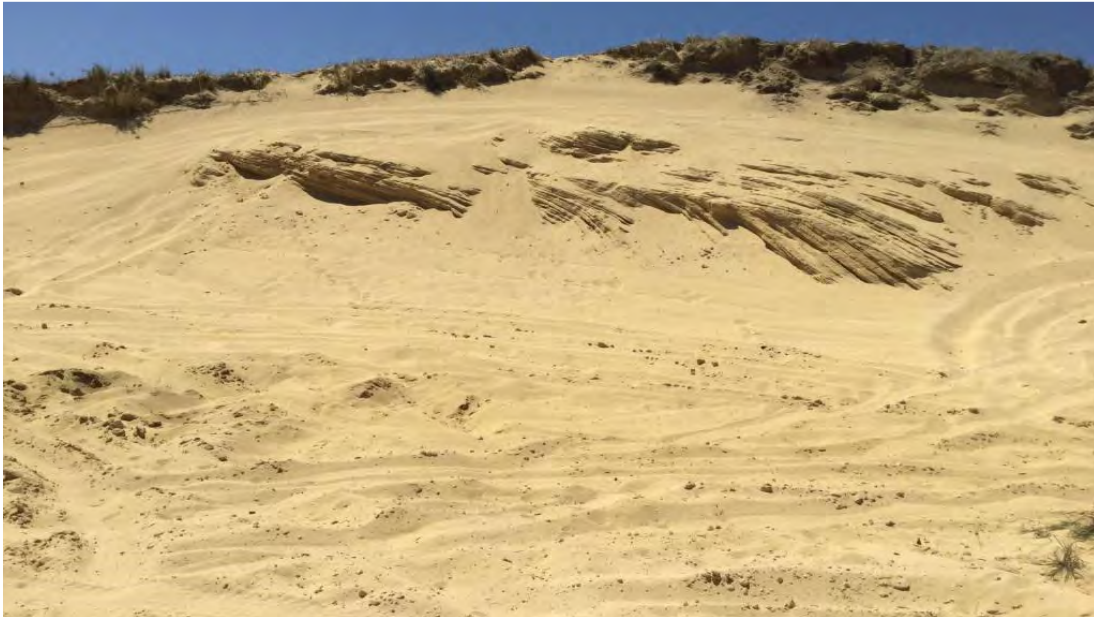
Figure 5-3: LS4 (Cemented Safety Bay Sand) exposed as subcrop in cutting, exhibiting planar cross-bedding typical of aeolianites

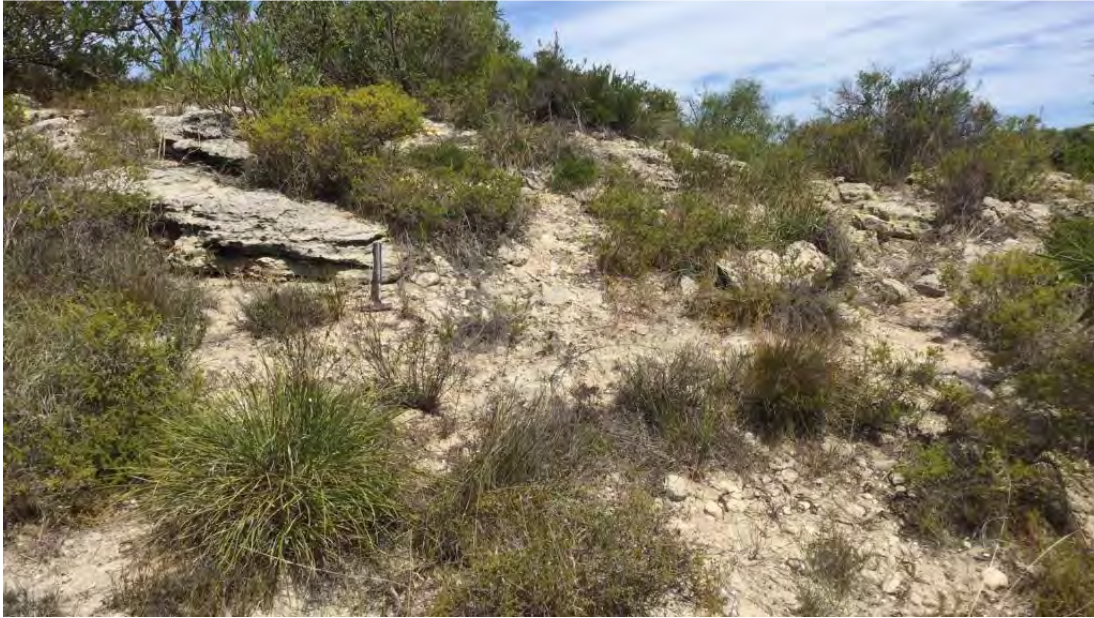
Figure 5-4: LS4 (Cemented Safety Bay Sand) outcropping near dune crest, exhibiting planar cross-bedding features overprinted by small-scale solution features

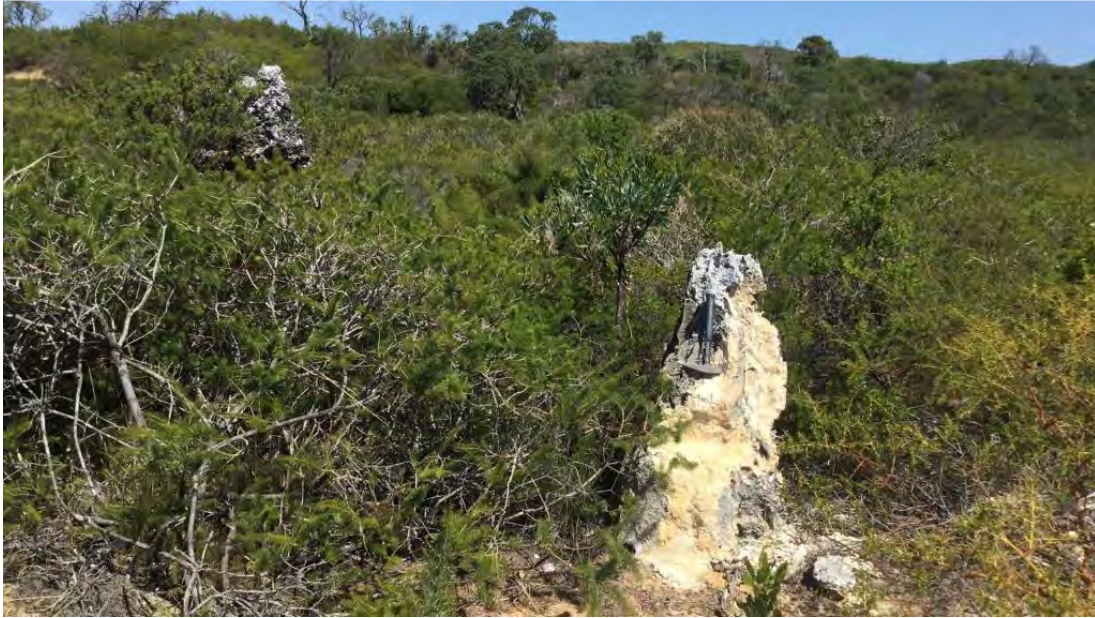
Figure 5-5: Pinnacles of Tamala Limestone outcropping above the surrounding landscape

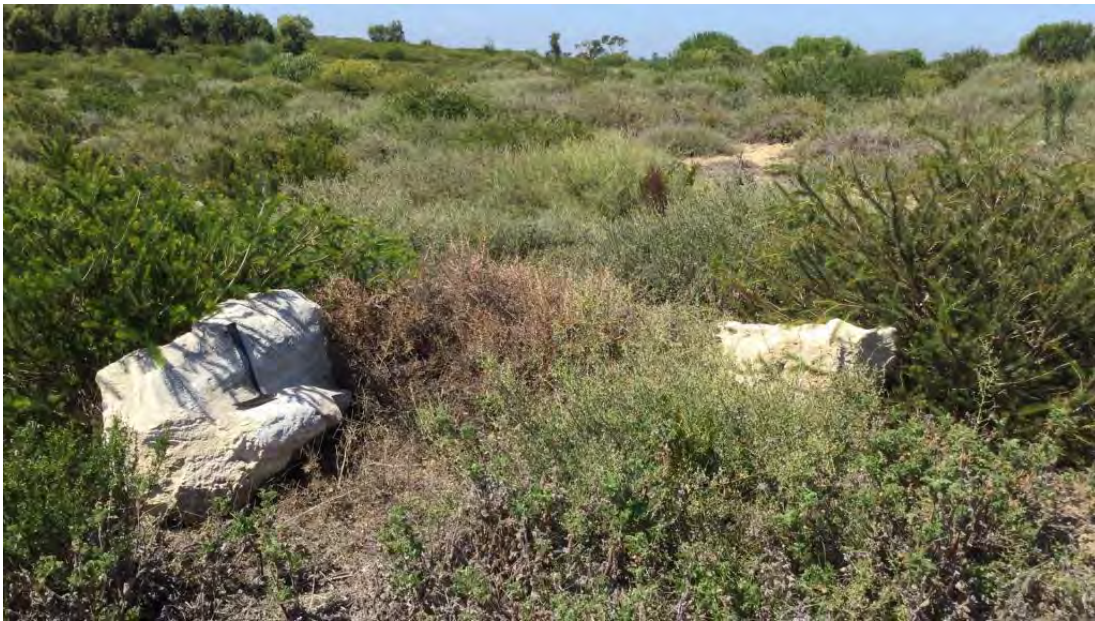
Figure 5-6: Topped pinnacles of Tamala Limestone in area of historical clearing

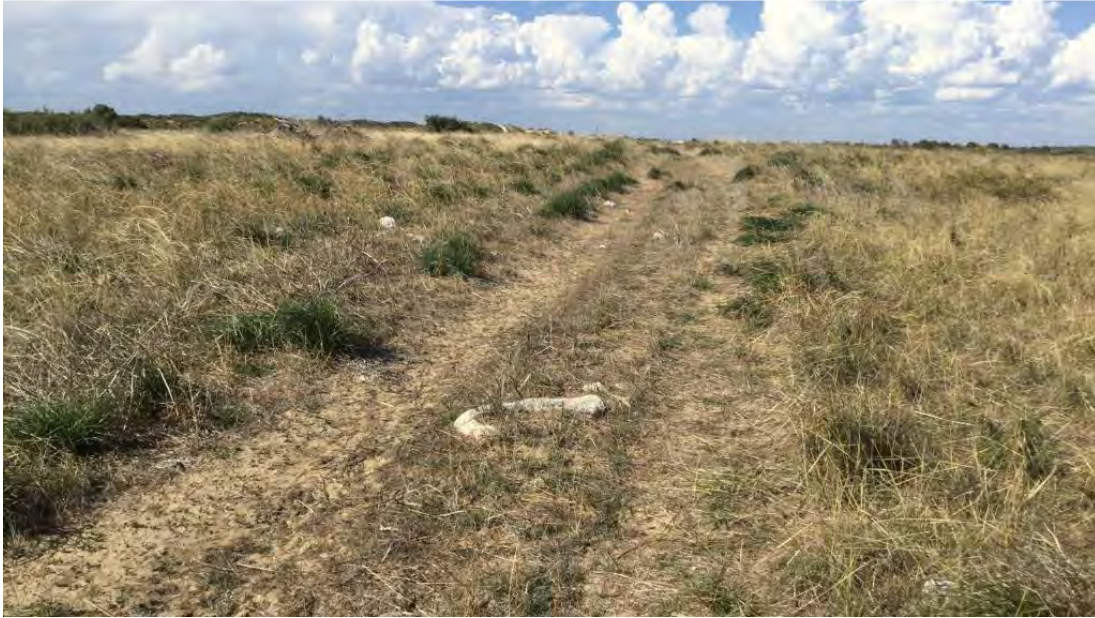
Figure 5-7: Minor surface outcrop of Tamala Limestone indicative of potential buried 'caprock' pinnacles

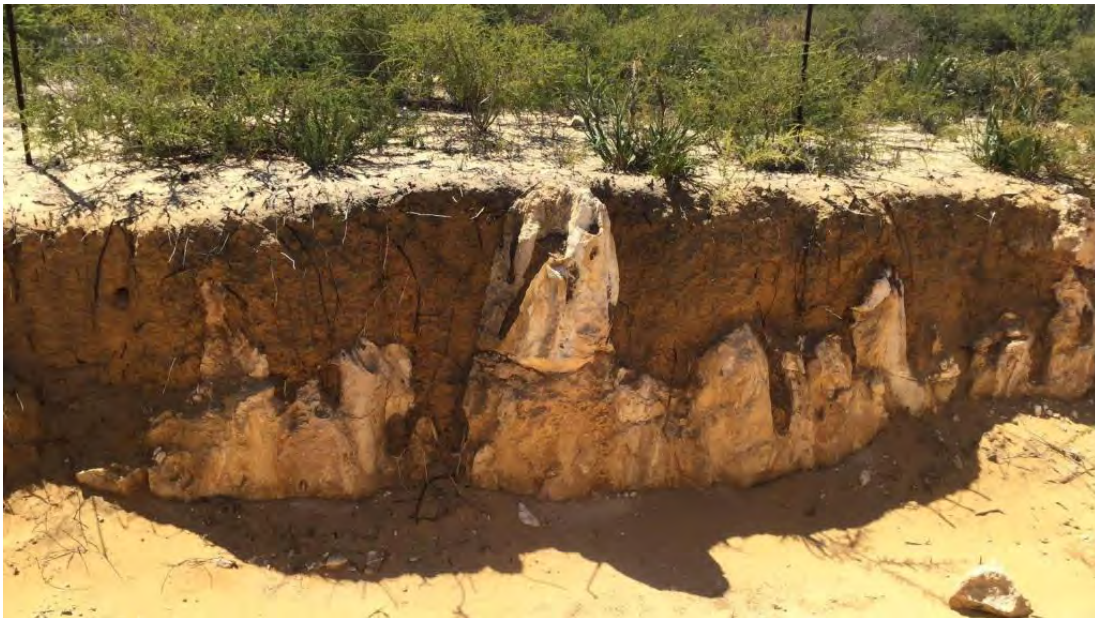
Figure 5-8: Buried pinnacles of Tamala Limestone with sub-vertical solution features ('solution pipes') exposed in excavation and overlain by Tamala Sand

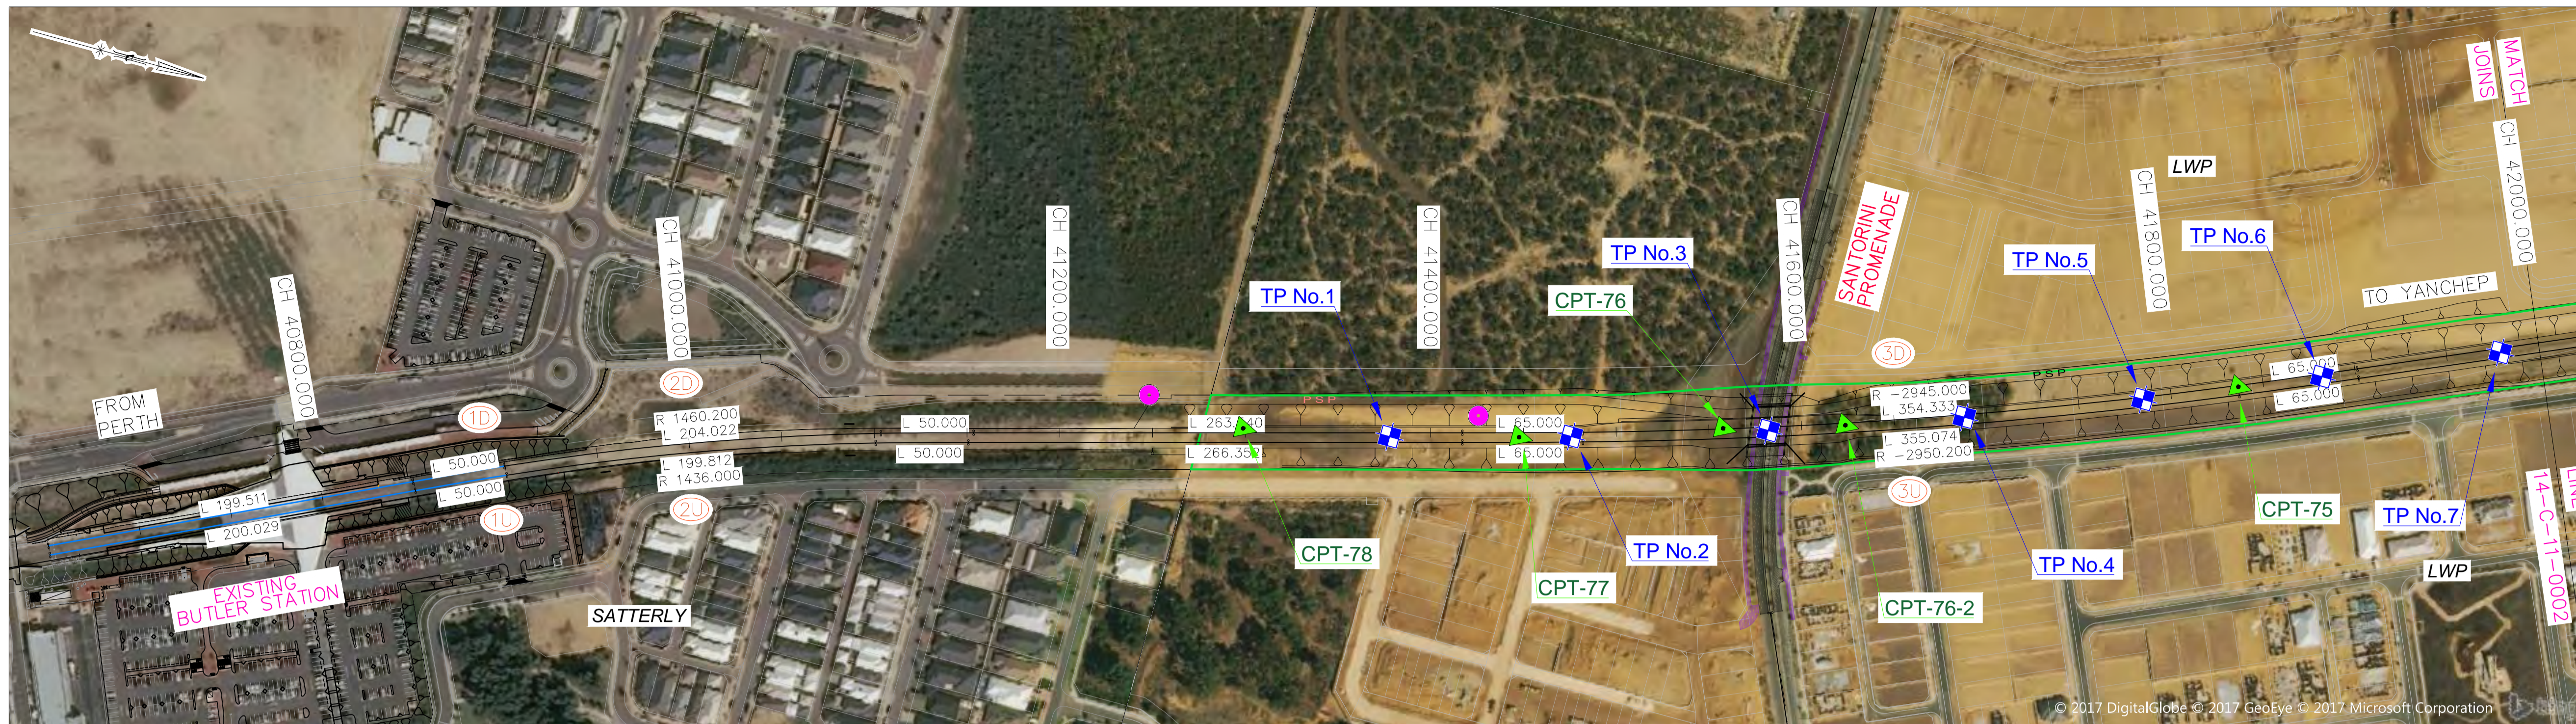
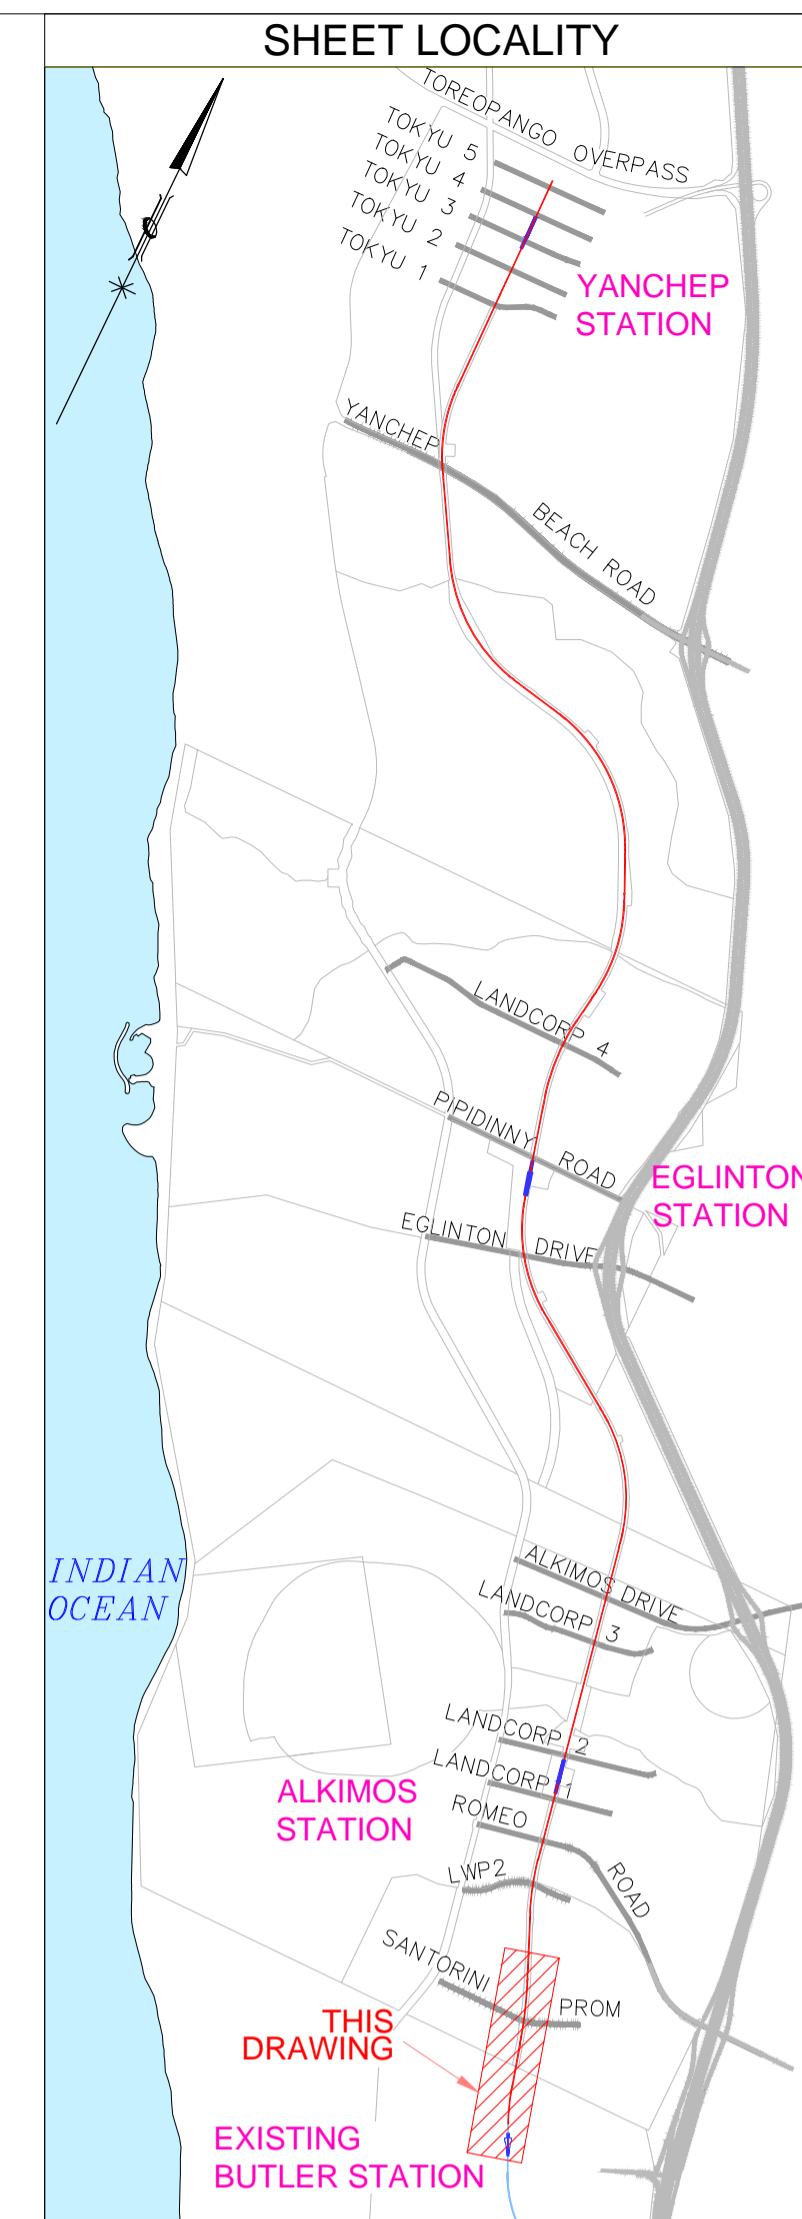
Appendix A Engineering Geological Long- Section

Datum R.L. 23m	40800.000	40820.000	40840.000	40860.000	40880.000	40900.000	40915.995	40920.000	40940.000	40960.000	40980.000	41000.000	41020.000	41040.000	41060.000	41080.000	41100.000	41120.000	41140.000	41160.000	41180.000	41200.000	41220.000	41240.000	41260.000	41280.000	41300.000	41320.000	41340.000	41360.000	41380.000	41400.000	41420.000	41440.000	41460.000	41480.000	41500.000	41520.000	41540.000	41560.000	41580.000	41600.000	41620.000	41638.128	41640.000	41660.000	41680.000	41700.000	41720.000	41730.236	41740.000	41760.000	41780.000	41800.000	41820.000	41840.000	41860.000	41880.000	41900.000	41919.020	41920.000	41940.000	41960.000	41980.000	42000.000

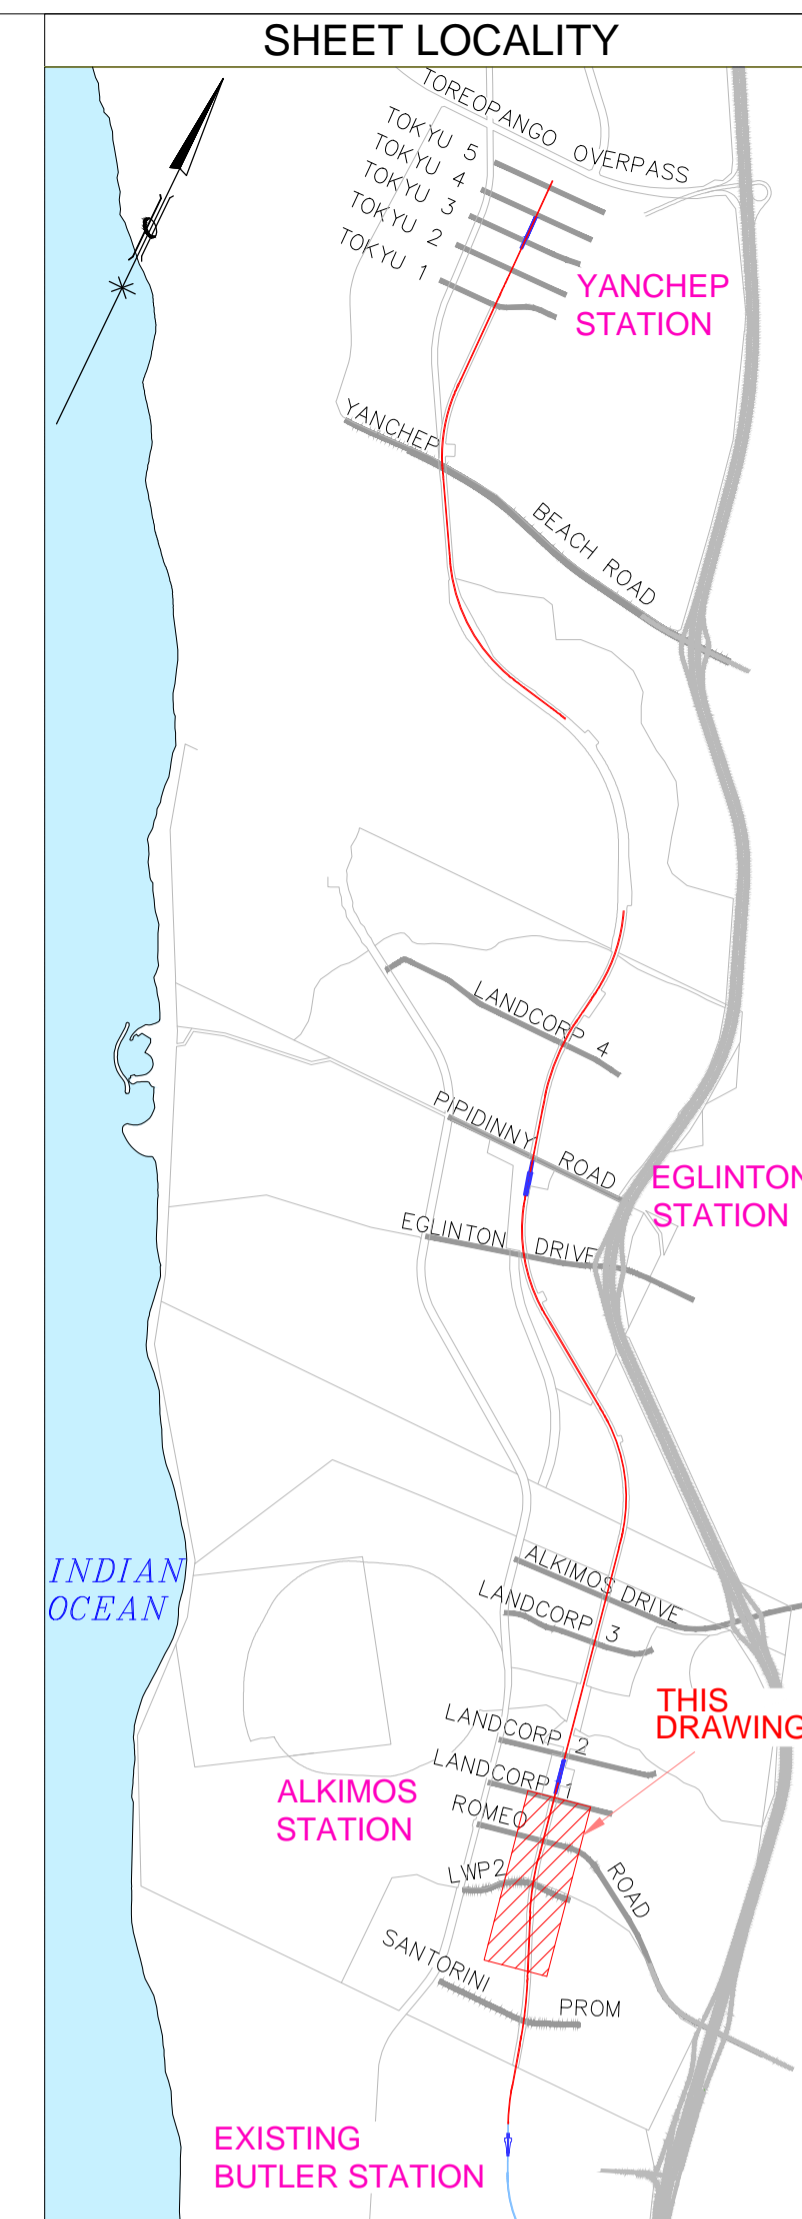
DRG No _____ LONG-SECTION - SHEET 2 of 15 REV 0

PASSENGER DOWN MAIN LOW RAIL LEVEL	42000.000	47.514	47.749	42014.755	47.188	47.703	42020.000	47.082	47.680	42040.000	46.503	47.565	42060.000	46.013	47.402	42080.000	45.577	47.193	42100.000	45.453	46.936	42110.490	45.438	46.782	42120.000	45.517	46.637	42140.000	45.620	46.333	42160.000	45.977	46.028	42180.000	46.424	45.723	42200.000	47.030	45.418	42202.227	47.096	45.384	42220.000	47.664	45.104	42239.411	48.040	44.776	42260.000	48.920	44.404	42276.595	49.776	44.088	42280.000	49.951	44.020	42300.000	53.587	43.627	42320.000	52.795	43.234	42340.000	51.283	42.841	42360.000	50.127	42.448	42380.000	50.902	42.055	42400.000	48.918	41.662	42420.000	47.631	41.269	42440.000	46.234	40.876	42460.000	45.035	40.483	42480.000	44.047	40.090	42500.000	43.251	39.697	42520.000	47.003	39.305	42540.000	50.721	38.912	42560.000	45.438	38.519	42570.349	43.342	38.315	42580.000	41.899	38.130	42590.000	40.000	37.777	42600.000	40.221	36.956	42666.808	40.432	36.886	42680.000	40.962	36.754	42700.000	43.000	36.554	42720.000	40.981	36.354	42740.000	37.658	36.154	42760.000	37.979	35.954	42780.000	39.097	35.754	42800.000	39.451	35.554	42820.000	39.585	35.354	42840.000	38.967	35.154	42860.000	39.455	34.954	42880.000	42.327	34.754	42900.000	42.850	34.554	42920.000	42.457	34.354	42940.000	41.655	34.154	42960.000	41.000	33.954	42980.000	40.000	33.754	43000.000	39.796	33.554

EXISTING SURVEY LEVEL	42000.000	47.514	47.749	42014.755	47.188	47.703	42020.000	47.082	47.680	42040.000	46.503	47.565	42060.000	46.013	47.402	42080.000	45.577	47.193	42100.000	45.453	46.936	42110.490	45.438	46.782	42120.000	45.517	46.637	42140.000	45.620	46.333	42160.000	45.977	46.028	42180.000	46.424	45.723	42200.000	47.030	45.418	42202.227	47.096	45.384	42220.000	47.664	45.104	42239.411	48.040	44.776	42260.000	48.920	44.404	42276.595	49.776	44.088	42280.000	49.951	44.020	42300.000	53.587	43.627	42320.000	52.795	43.234	42340.000	51.283	42.841	42360.000	50.127	42.448	42380.000	50.902	42.055	42400.000	48.918	41.662	42420.000	47.631	41.269	42440.000	46.234	40.876	42460.000	45.035	40.483	42480.000	44.047	40.090	42500.000	43.251	39.697	42520.000	47.003	39.305	42540.000	50.721	38.912	42560.000	45.438	38.519	42570.349	43.342	38.315	42580.000	41.899	38.130	42590.000	40.000	37.777	42600.000	40.221	36.956	42666.808	40.432	36.886	42680.000	40.962	36.754	42700.000	43.000	36.554	42720.000	40.981	36.354	42740.000	37.658	36.154	42760.000	37.979	35.954	42780.000	39.097	35.754	42800.000	39.451	35.554	42820.000	39.585	35.354	42840.000	38.967	35.154	42860.000	39.455	34.954	42880.000	42.327	34.754	42900.000	42.850	34.554	42920.000	42.457	34.354	42940.000	41.655	34.154	42960.000	41.000	33.954	42980.000	40.000	33.754	43000.000	39.796	33.554

**PUBLIC TRANSPORT AUTHORITY
YANCHEP RAIL EXTENSION
ENGINEERING GEOLOGICAL MODEL**

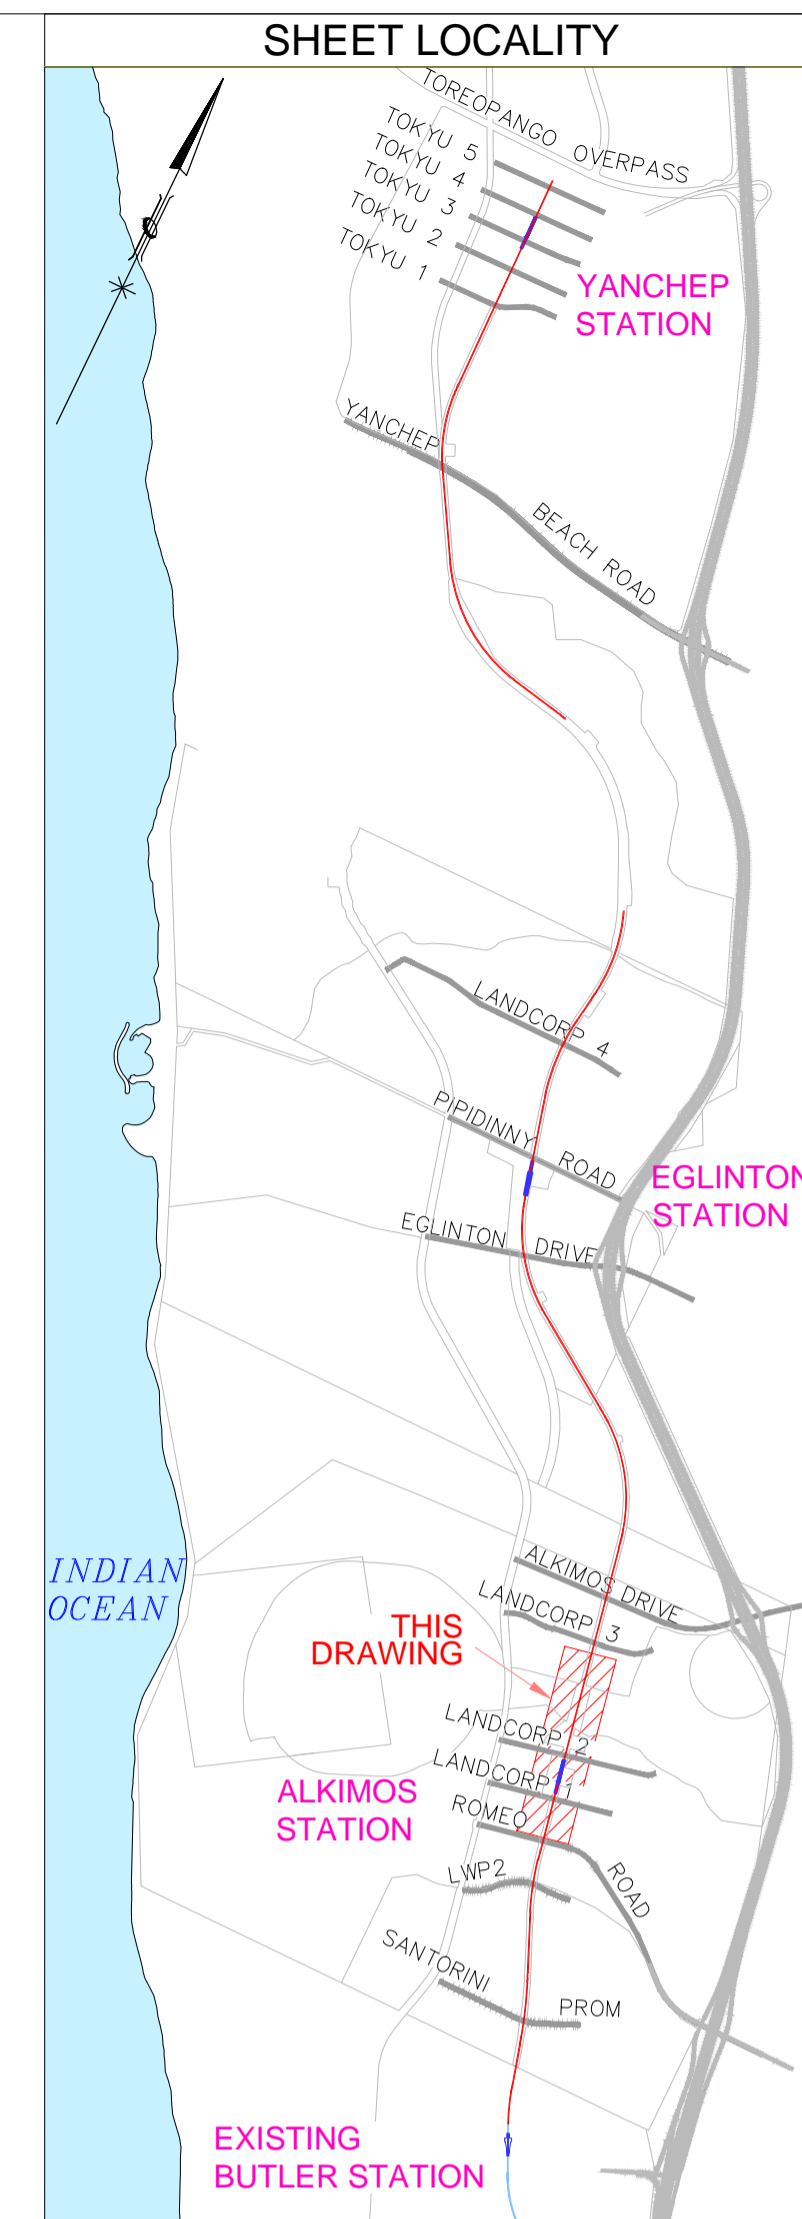
Datum R.L. 14m	33.554	33.354	33.154	32.954	32.754	32.554	32.354	32.154	31.954	31.754	31.554	31.354	31.154	30.954	30.754	30.554	30.354	30.154	29.954	29.754	29.554	29.354	29.154	28.954	28.754	28.554	28.354	28.154	27.954	27.754	27.554	27.354	27.154	26.954	26.754	26.554	26.354	26.154	25.954	25.754	25.554	25.354	25.157	24.957	24.757	24.557	24.357	24.157	23.957	23.757	23.557	23.357	23.157	22.957	22.757	22.557	22.357	22.157	21.957	21.757	21.557	21.357	21.157	20.957	20.757	20.557	20.357	20.157	19.957	19.757	19.557	19.357	19.157	18.957	18.757	18.557	18.357	18.157	17.957	17.757	17.557	17.357	17.157	16.957	16.757	16.557	16.357	16.157	15.957	15.757	15.557	15.357	15.157	14.957	14.757	14.557	14.357	14.157	13.957	13.757	13.557	13.357	13.157	12.957	12.757	12.557	12.357	12.157	11.957	11.757	11.557	11.357	11.157	10.957	10.757	10.557	10.357	10.157	9.957	9.757	9.557	9.357	9.157	8.957	8.757	8.557	8.357	8.157	7.957	7.757	7.557	7.357	7.157	6.957	6.757	6.557	6.357	6.157	5.957	5.757	5.557	5.357	5.157	4.957	4.757	4.557	4.357	4.157	3.957	3.757	3.557	3.357	3.157	2.957	2.757	2.557	2.357	2.157	1.957	1.757	1.557	1.357	1.157	0.957	0.757	0.557	0.357	0.157	0.000

PASSENGER DOWN MAIN LOW RAIL LEVEL	33.554	33.354	33.154	32.954	32.754	32.554	32.354	32.154	31.954	31.754	31.554	31.354	31.154	30.954	30.754	30.554	30.354	30.154	29.954	29.754	29.554	29.354	29.154	28.954	28.754	28.554	28.354	28.154	27.954	27.754	27.554	27.354	27.154	26.954	26.754	26.554	26.354	26.154	25.954	25.754	25.554	25.354	25.157	24.957	24.757	24.557	24.357	24.157	23.957	23.757	23.557	23.357	23.157	22.957	22.757	22.557	22.357	22.157	21.957	21.757	21.557	21.357	21.157	20.957	20.757	20.557	20.357	20.157	19.957	19.757	19.557	19.357	19.157	18.957	18.757	18.557	18.357	18.157	17.957	17.757	17.557	17.357	17.157	16.957	16.757	16.557	16.357	16.157	15.957	15.757	15.557	15.357	15.157	14.957	14.757	14.557	14.357	14.157	13.957	13.757	13.557	13.357	13.157	12.957	12.757	12.557	12.357	12.157	11.957	11.757	11.557	11.357	11.157	10.957	10.757	10.557	10.357	10.157	9.957	9.757	9.557	9.357	9.157	8.957	8.757	8.557	8.357	8.157	7.957	7.757	7.557	7.357	7.157	6.957	6.757	6.557	6.357	6.157	5.957	5.757	5.557	5.357	5.157	4.957	4.757	4.557	4.357	4.157	3.957	3.757	3.557	3.357	3.157	2.957	2.757	2.557	2.357	2.157	1.957	1.757	1.557	1.357	1.157	0.957	0.757	0.557	0.357	0.157	0.000

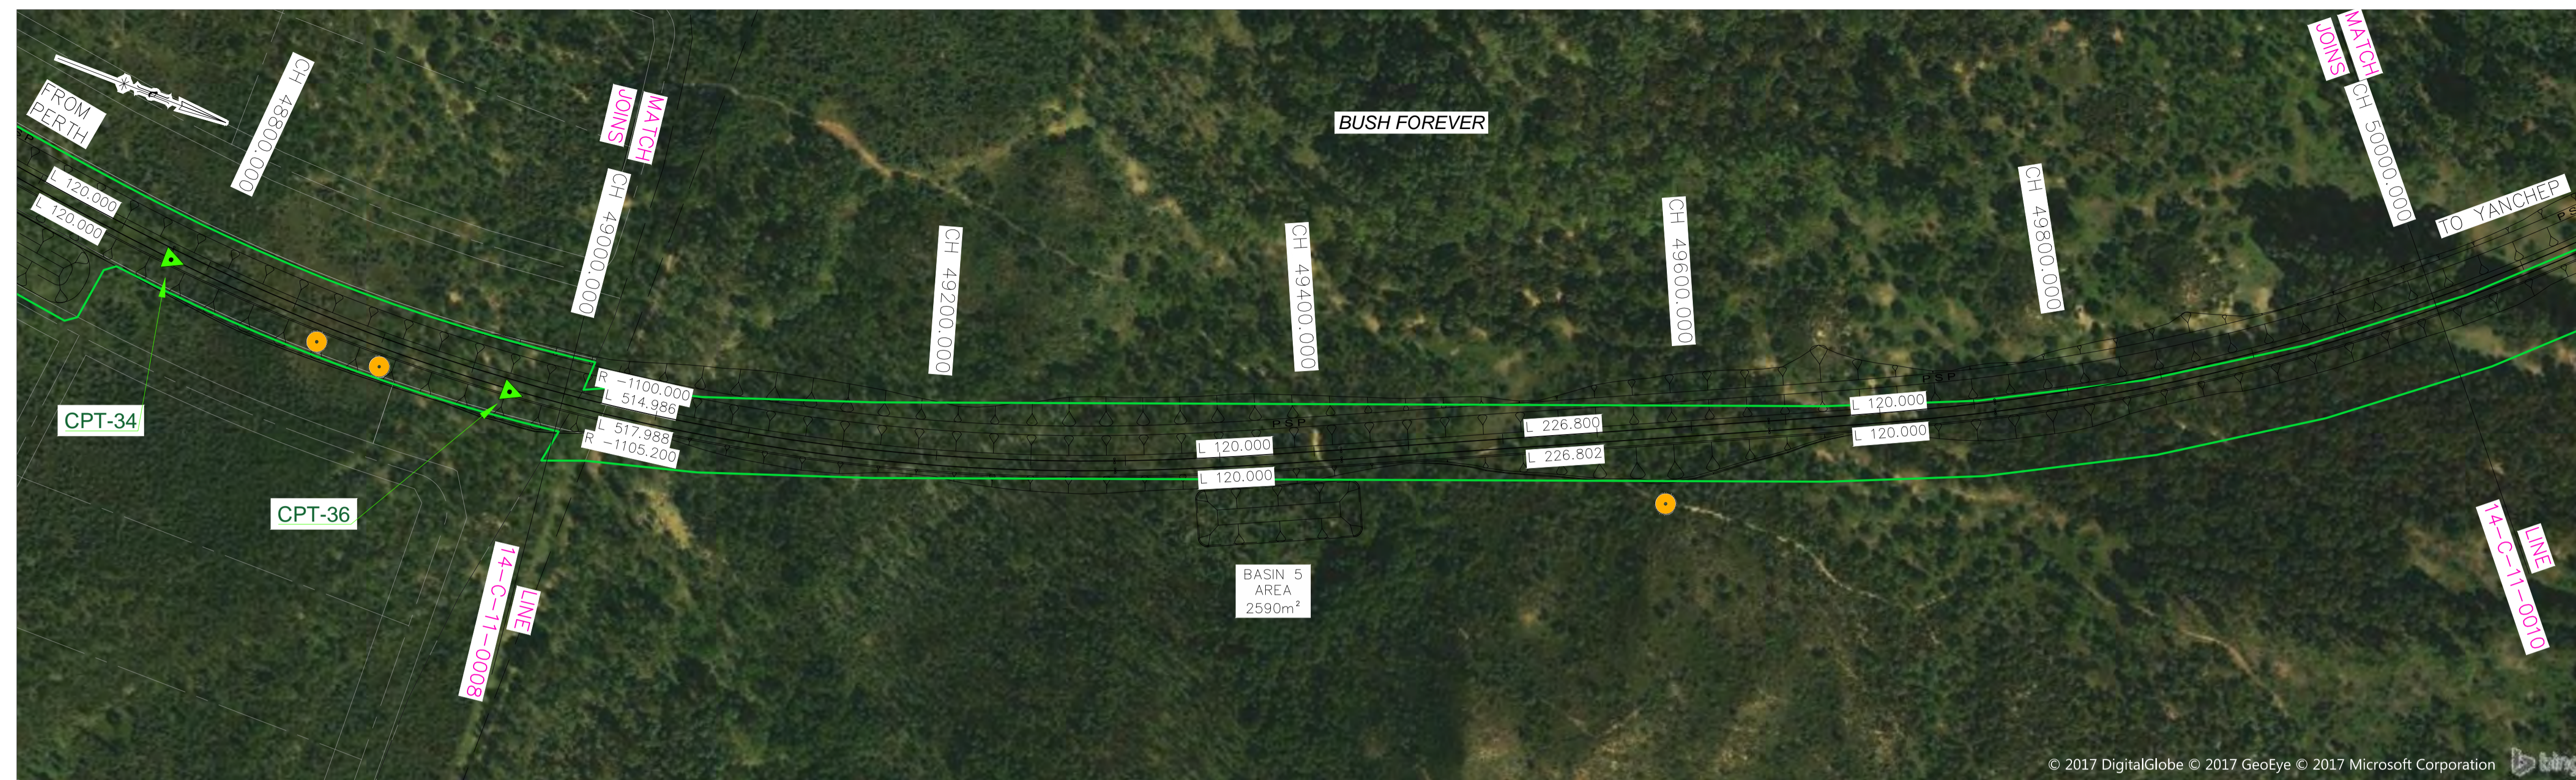
**PUBLIC TRANSPORT AUTHORITY
YANCHEP RAIL EXTENSION
ENGINEERING GEOLOGICAL MODEL**

Datum R.L. 2m

CHAINAGE	PASSENGER DOWN MAIN LOW RAIL LEVEL	EXISTING SURVEY LEVEL	PASSENGER DOWN MAIN THROUGH CHAINAGE
49000.000	18.474	21.971	49000.000
49020.000	18.131	20.260	49020.000
49040.000	17.788	17.674	49040.000
49060.000	17.445	15.582	49060.000
49080.000	17.102	14.124	49080.000
49100.000	16.759	12.888	49100.000
49120.000	16.416	12.354	49120.000
49140.000	16.073	12.000	49140.000
49160.000	15.730	12.551	49160.000
49180.000	15.387	13.352	49180.000
49200.000	15.044	13.540	49200.000
49220.000	14.701	11.960	49220.000
49240.000	14.359	10.367	49240.000
49260.000	14.016	10.070	49260.000
49280.000	13.673	9.164	49280.000
49300.000	13.330	8.728	49300.000
49320.000	12.987	9.140	49320.000
49340.000	12.644	9.062	49340.000
49360.000	12.301	8.673	49360.000
49380.000	11.958	8.215	49380.000
49400.000	11.615	8.105	49400.000
49420.000	11.272	8.529	49420.000
49440.000	10.929	9.716	49440.000
49460.000	10.586	10.714	49460.000
49480.000	10.243	11.195	49480.000
