# Katanning Gold Project

Visual Impact Assessment

Prepared for Ausgold Limited

19 August 2025

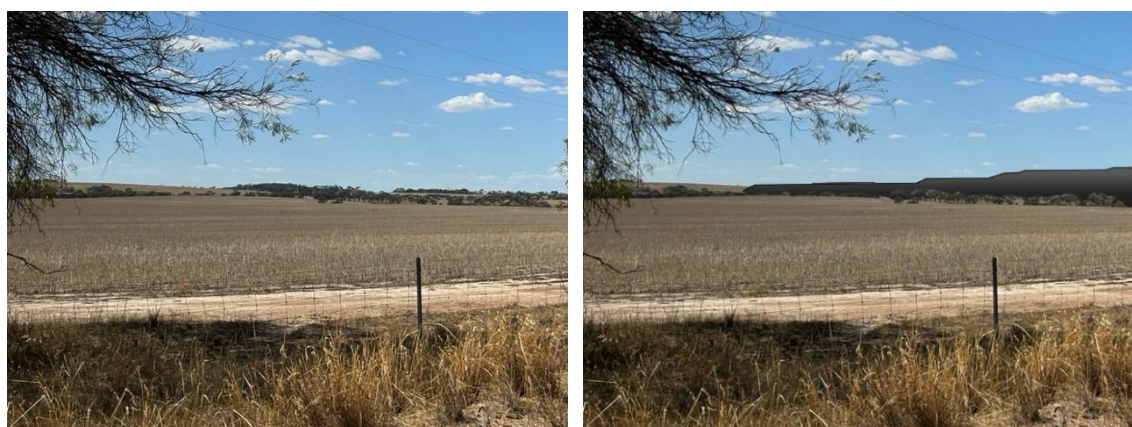
**Figure 2-3: Example Photomontage (VP02 NE)**

For the proposal, the photomontage analysis incorporated the vegetation and other screening objects (such as signs, buildings and fence lines). This allowed a realistic view of the changes to the landscape from the given observation point to be created (Figure 2-3).

If a series of photographs were taken at given observation points, these were then “stitched” together to form a panorama, and the outputs were used in the photomontage analysis. Photo editing software was then used to alter the panoramic photographs to insert the proposed landform features.

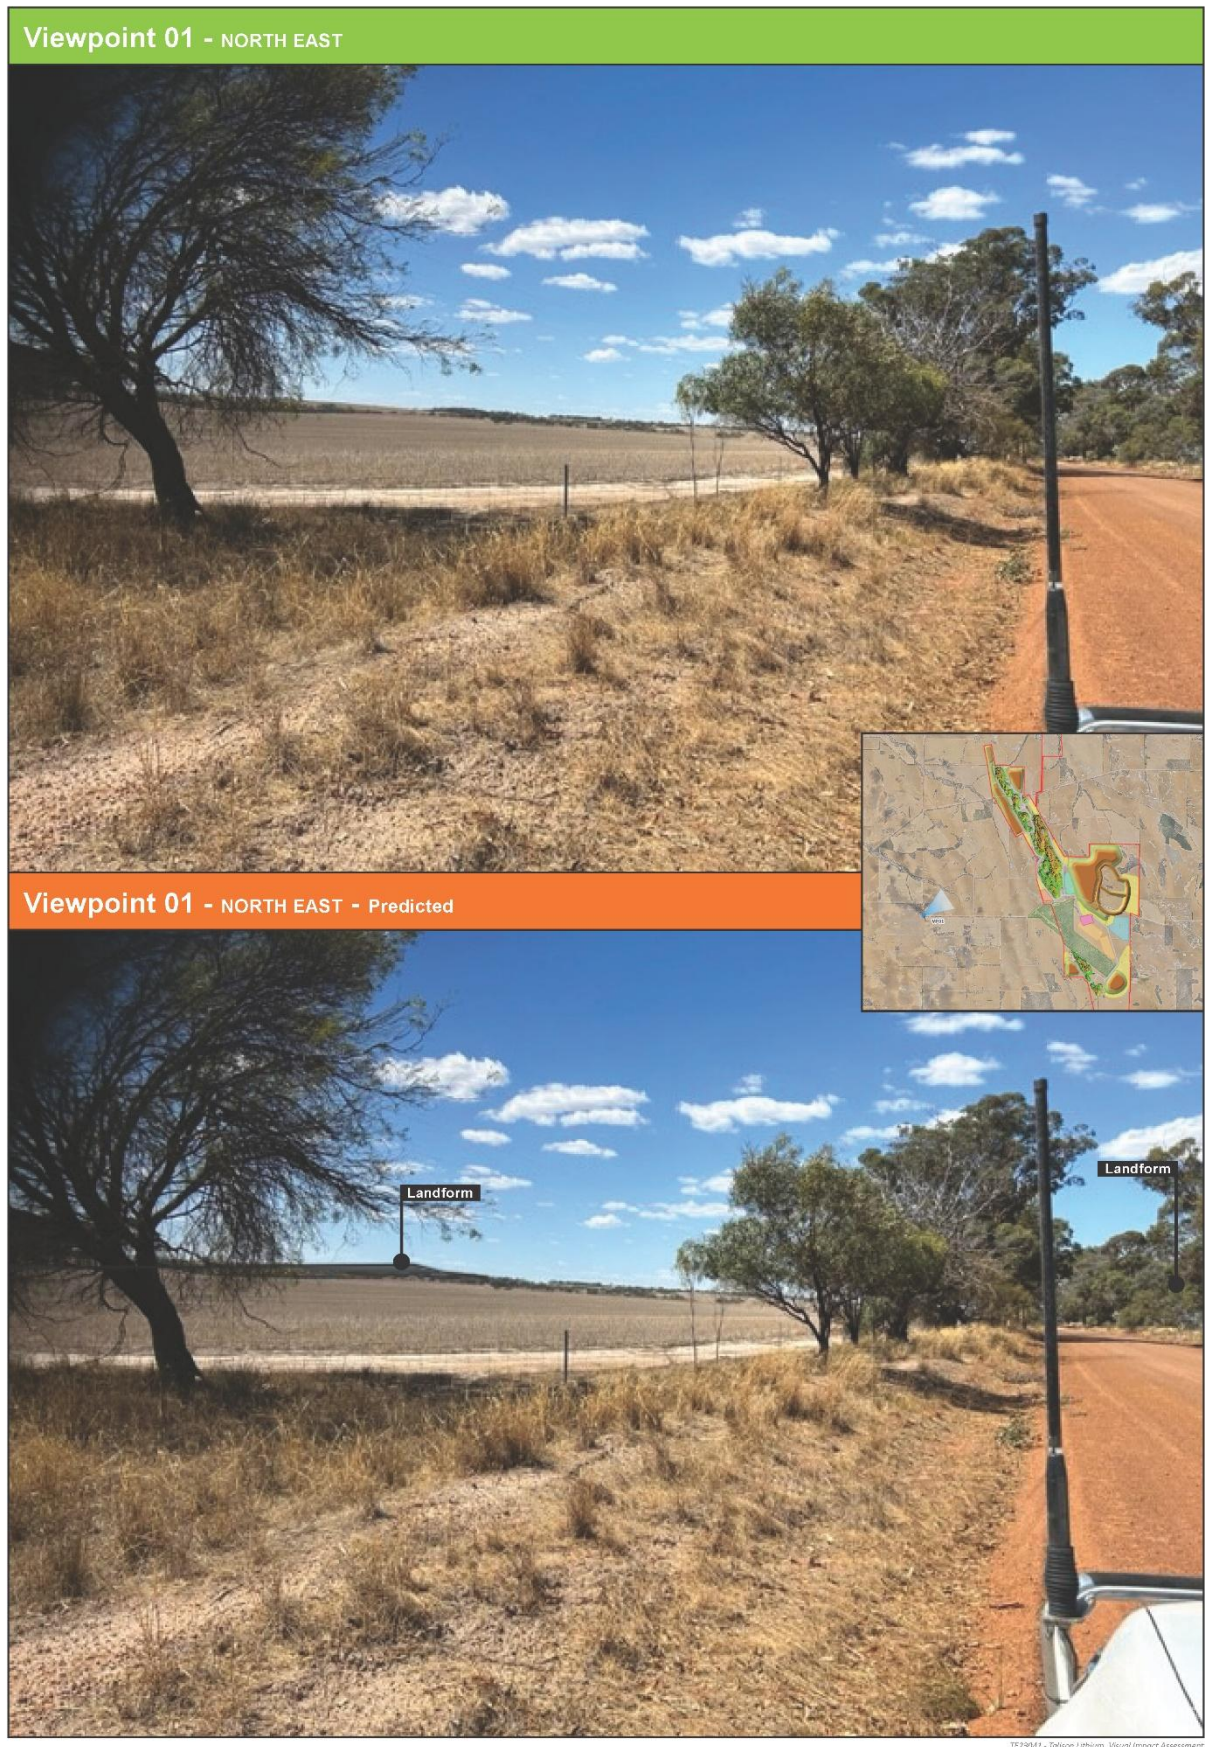
Figure 3-4: Final Photomontages (VP01 – North-North East)

Figure 3-5: Final Photomontages (VP01 – South East)

The viewshed from VP01 and VP02 is subject to minimal change and would not be considered a significant impact for the purpose of this assessment.

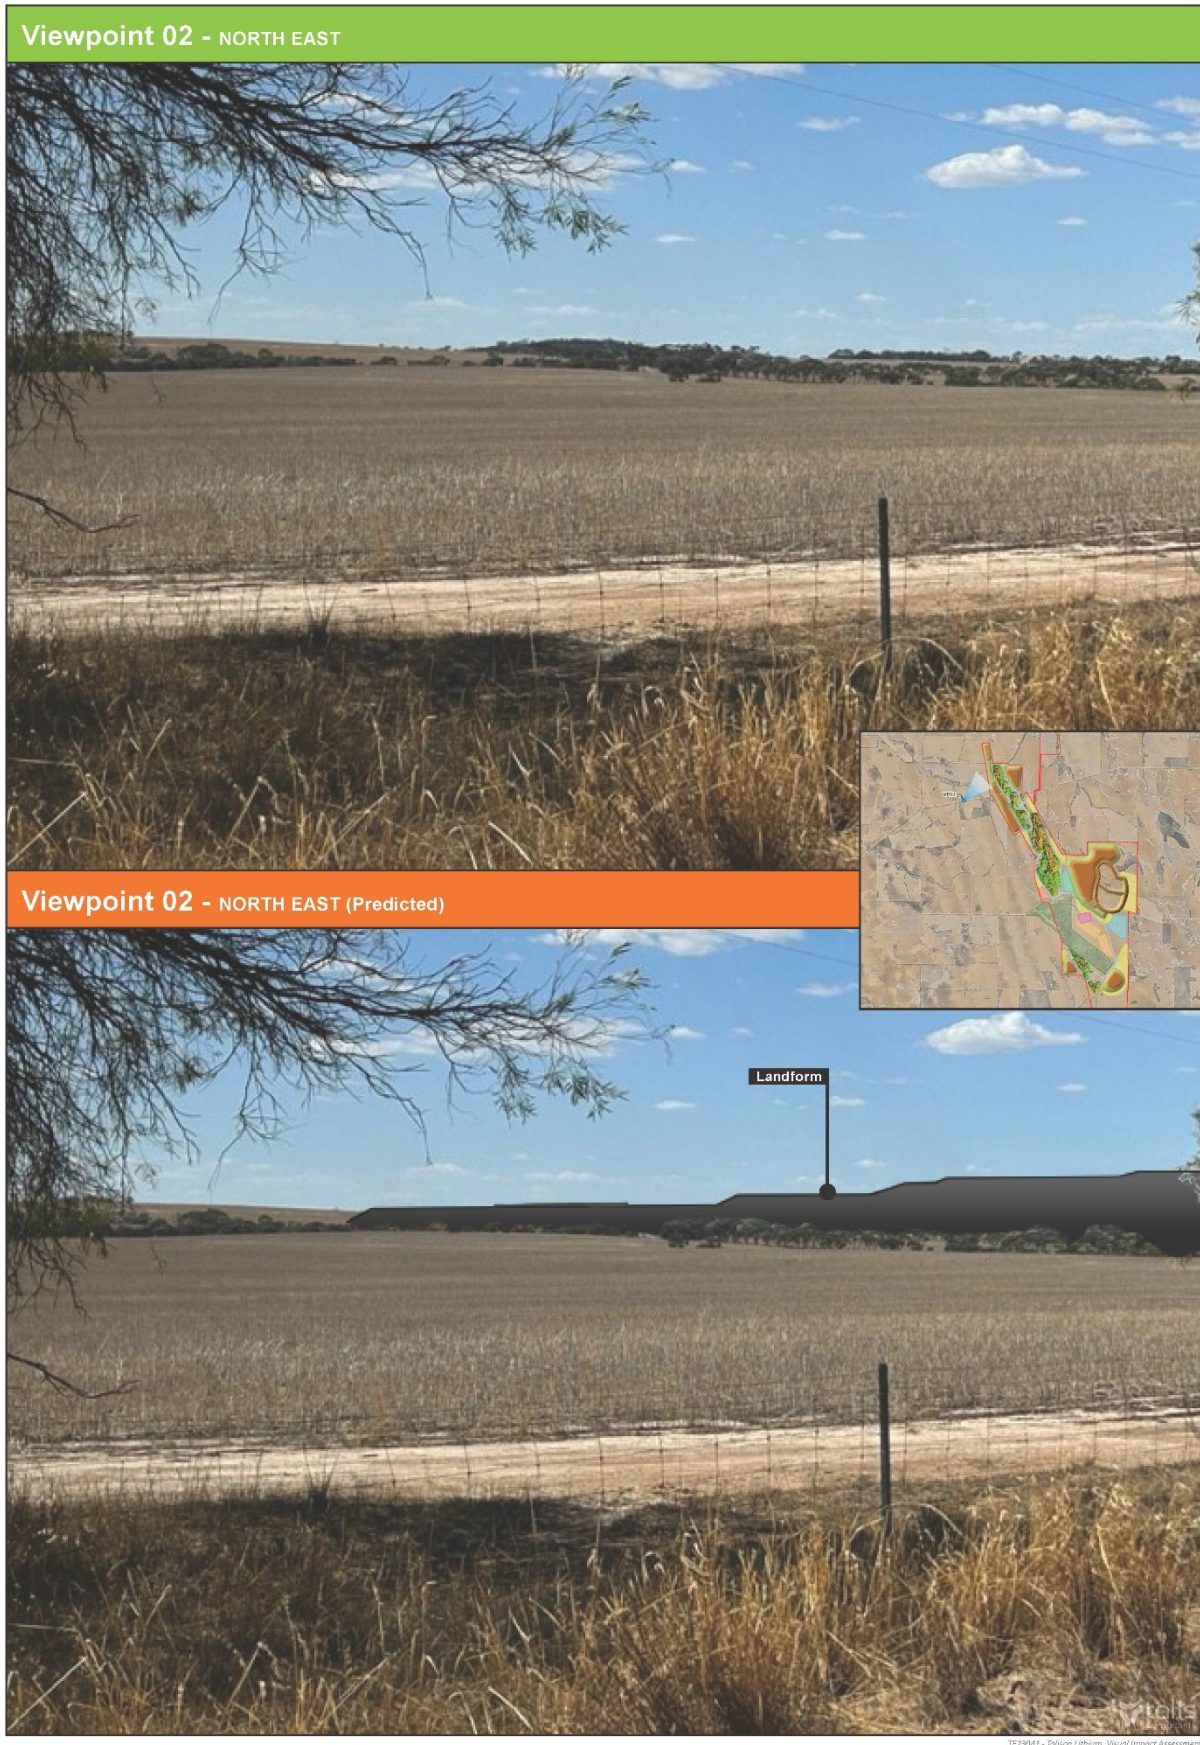
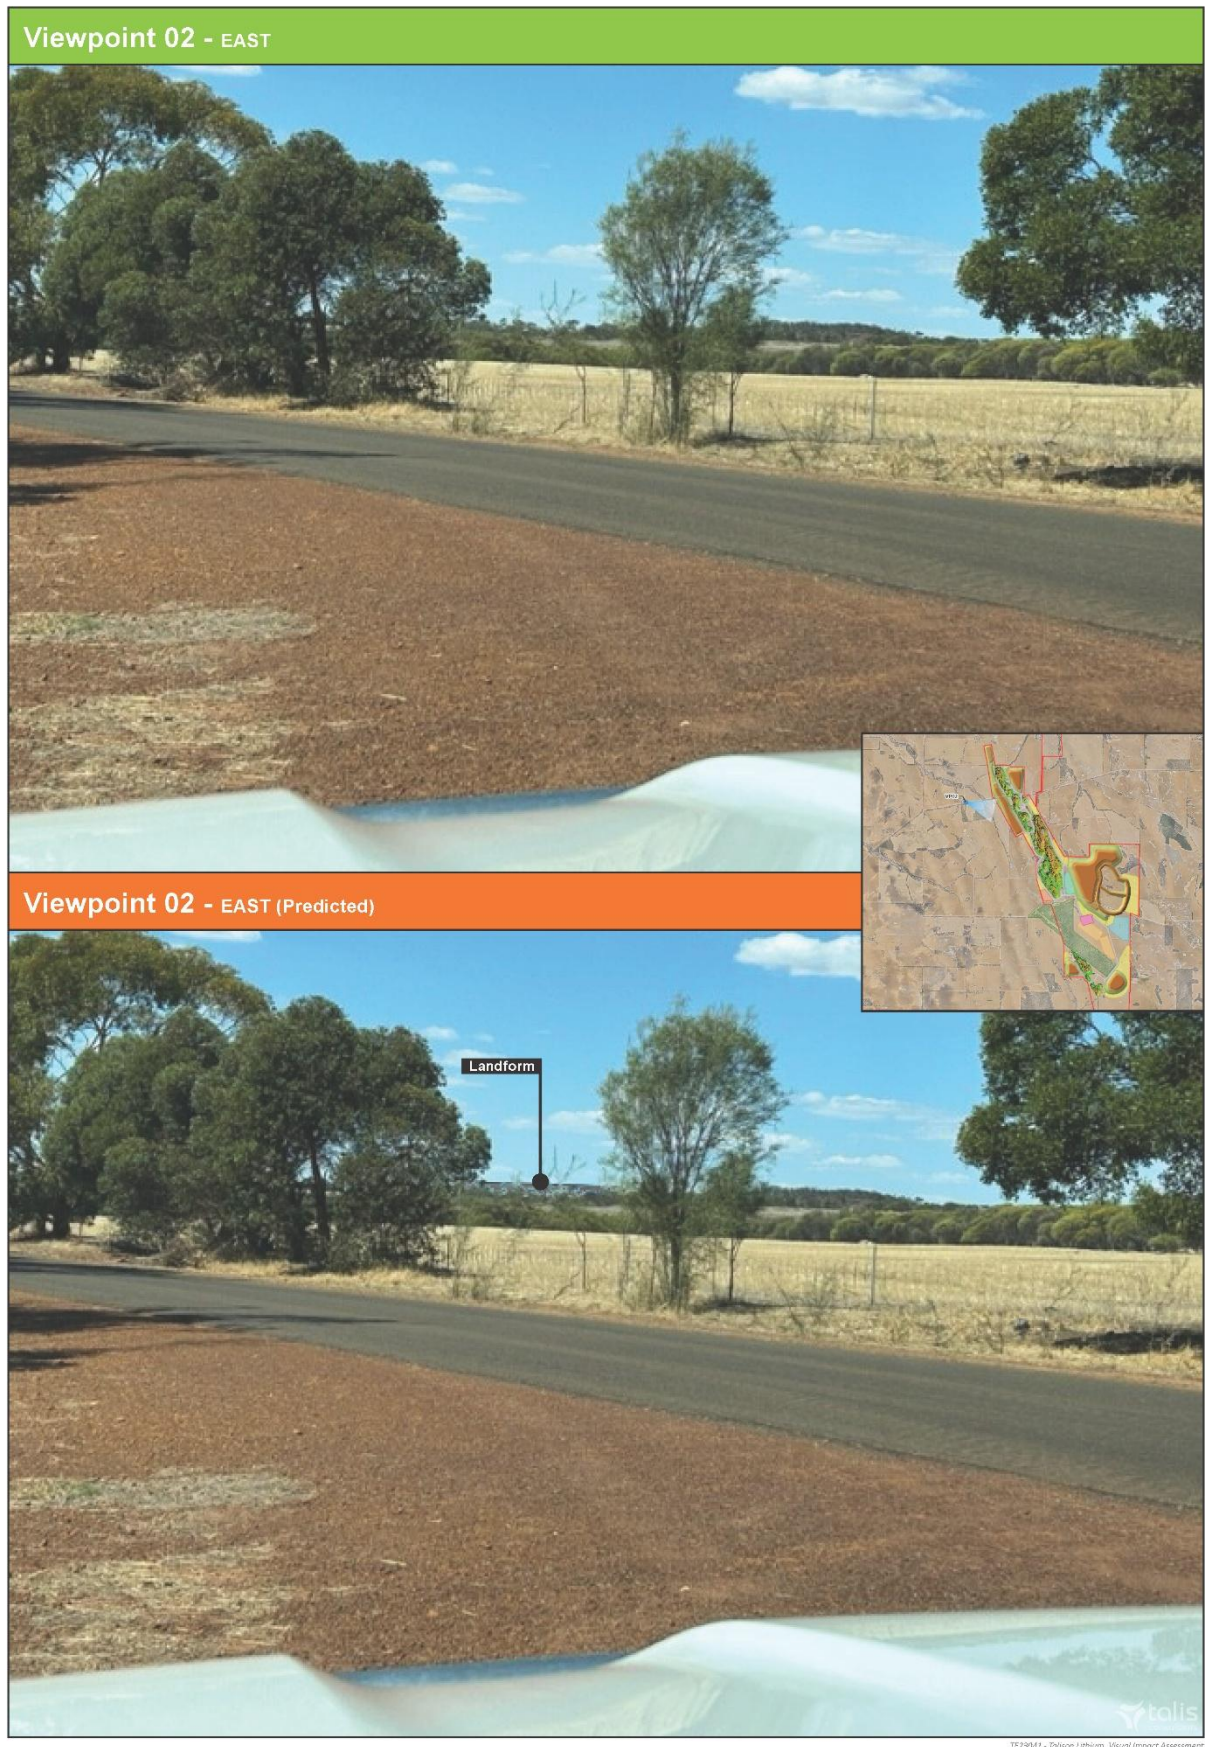
Figure 3-6: Final Photomontages (VP02 – North East)

Figure 3-7: Final Photomontages (VP02 - East)

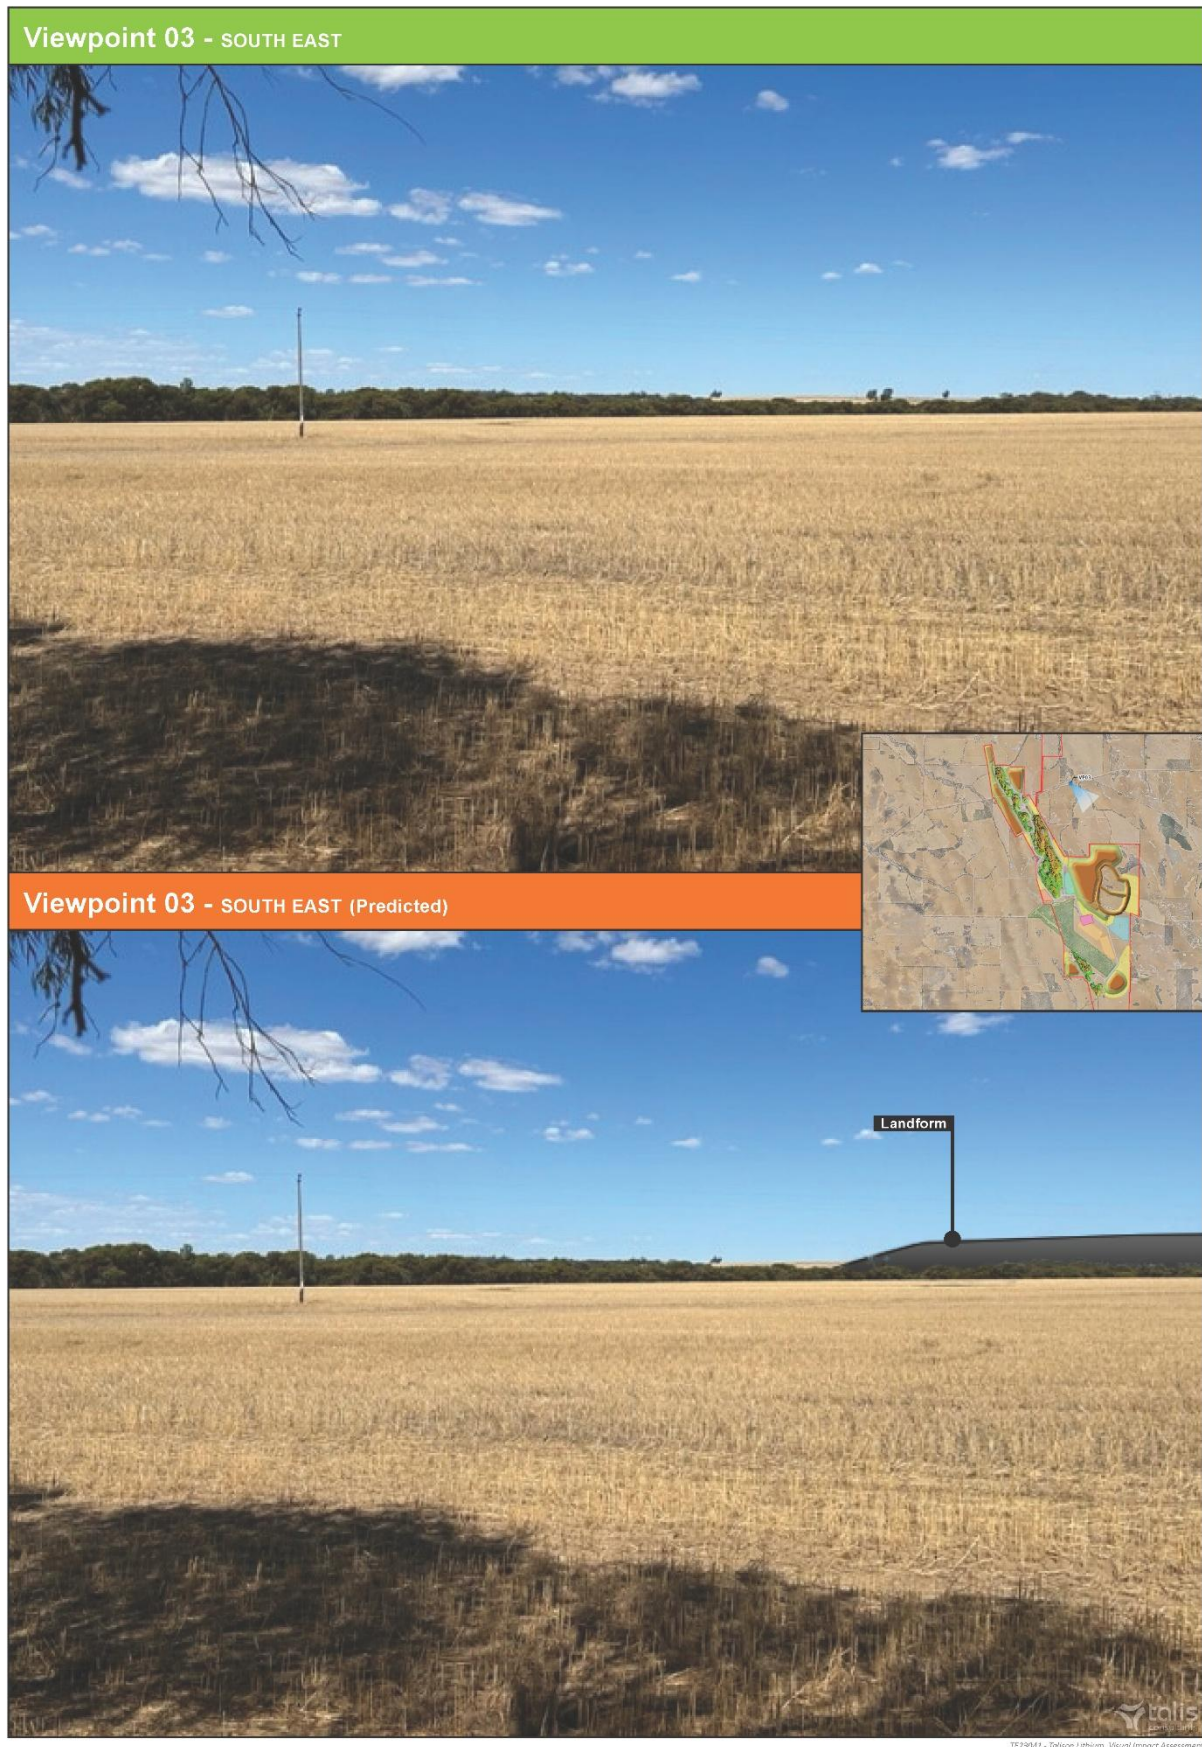
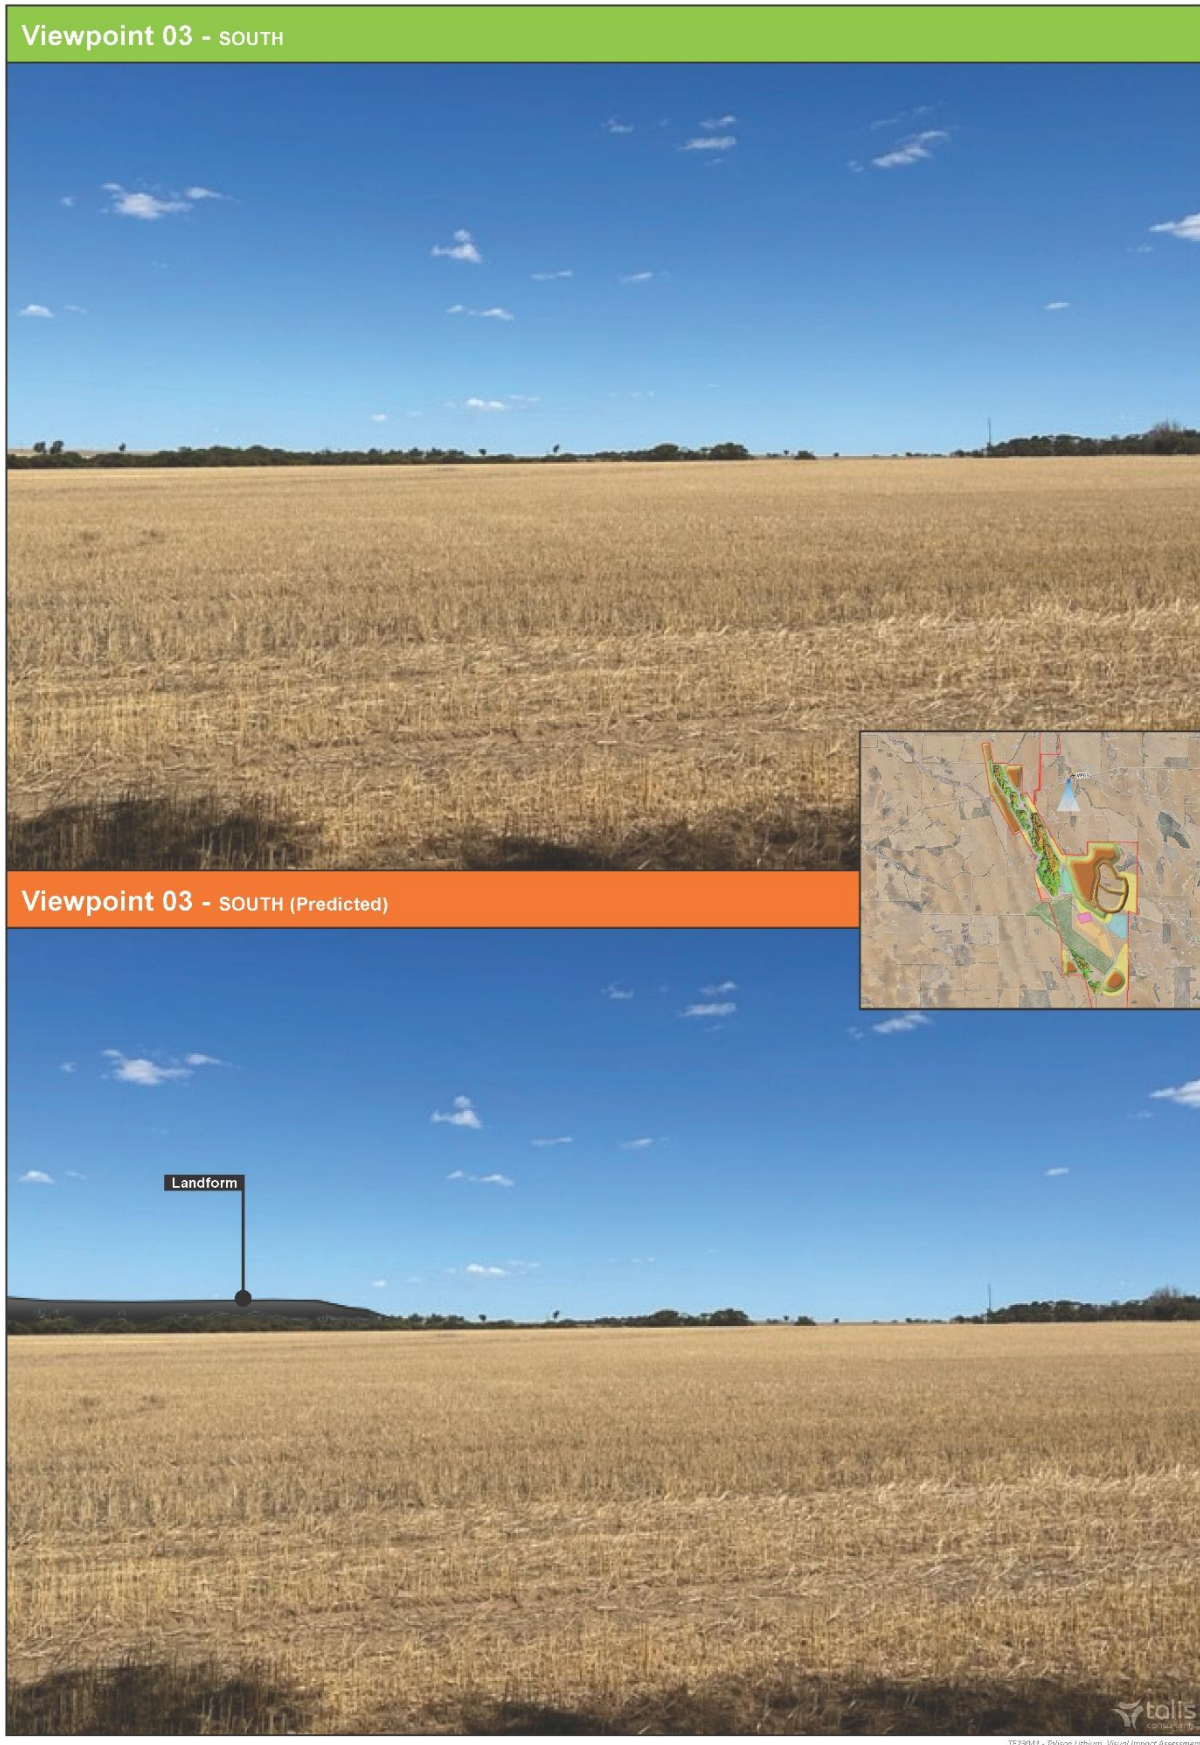
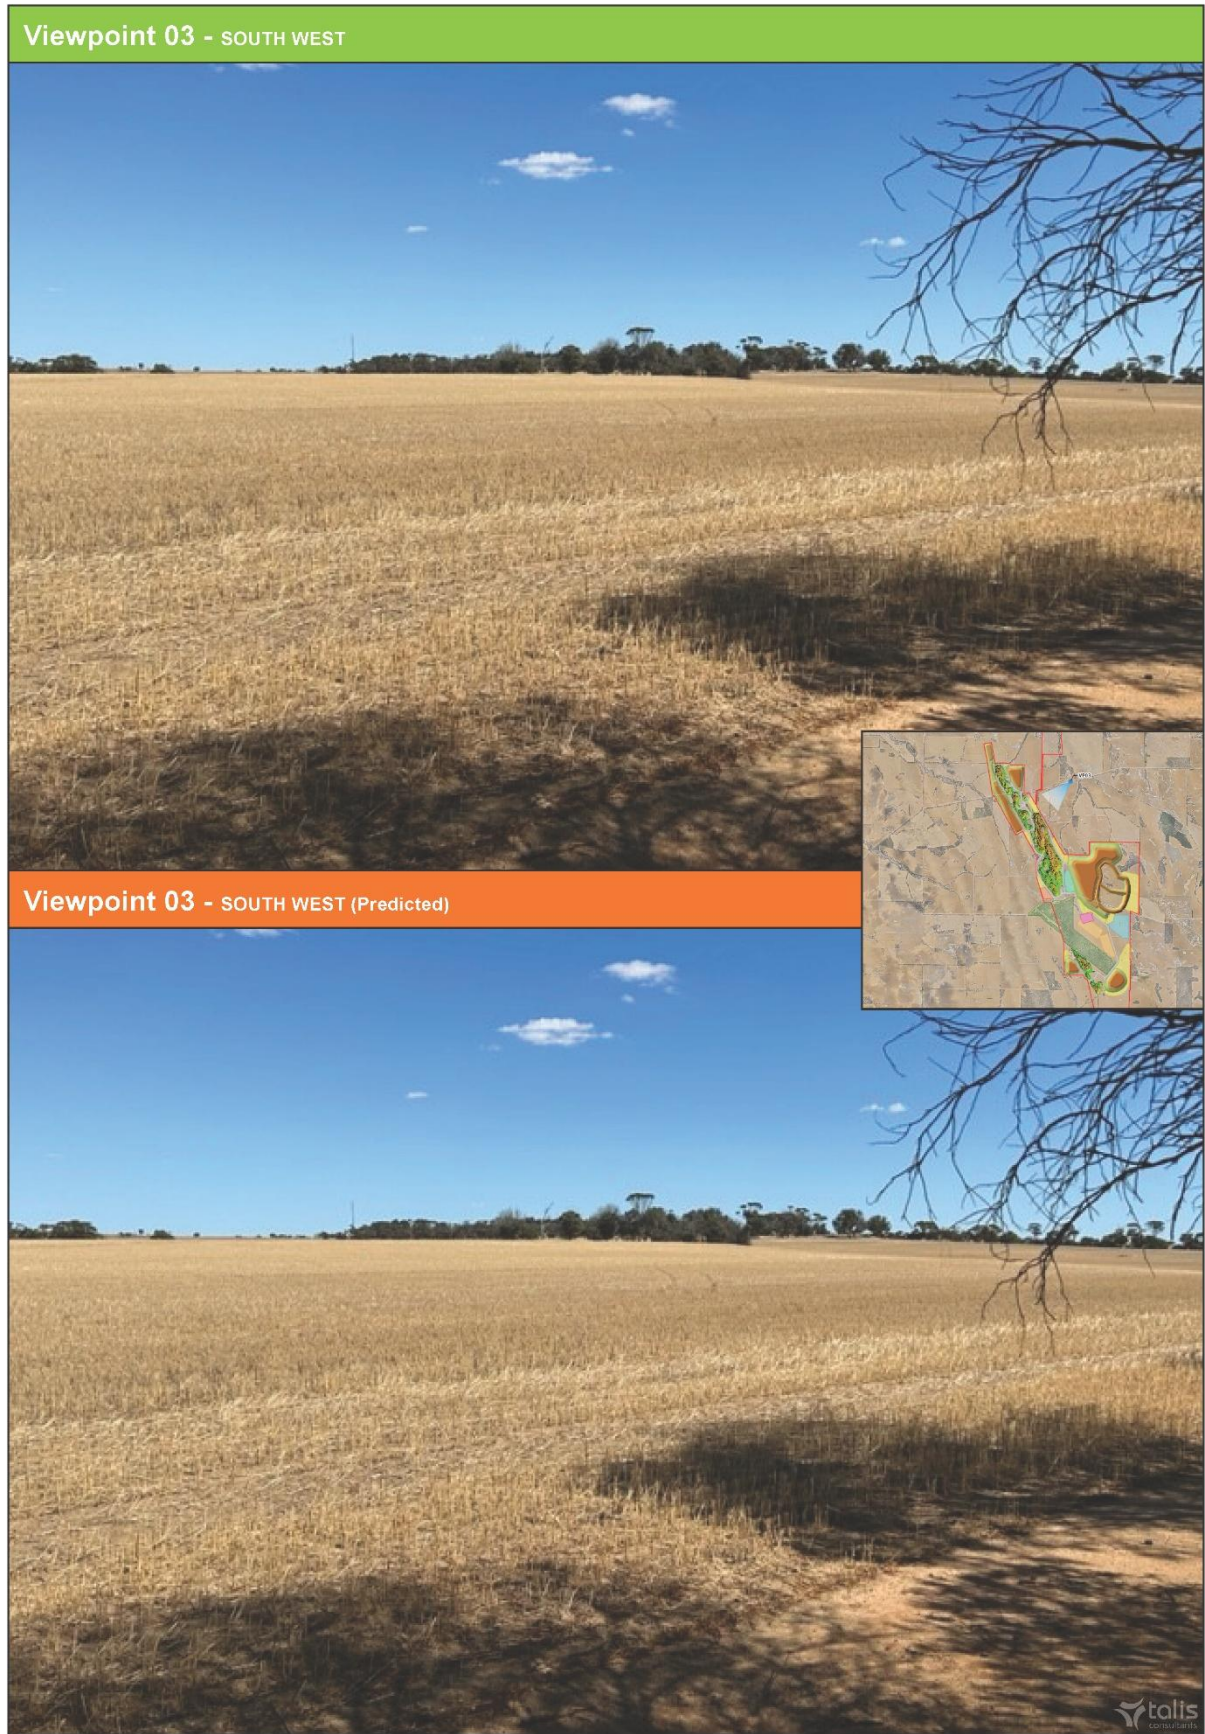
Figure 3-8: Final Photomontages (VP03 – South East)

Figure 3-9: Final Photomontages (VP03 - South)

Figure 3-10: Final Photomontages (VP03 – South West)

With respect to VP03, which is taken from Warren Road looking south, the impact is relatively limited. Further to this, the view is likely to be transient in nature (from moving vehicles) and, as such, the impact will be limited and is considered to be acceptable, although the built infrastructure (waste rock landform) will be evident.

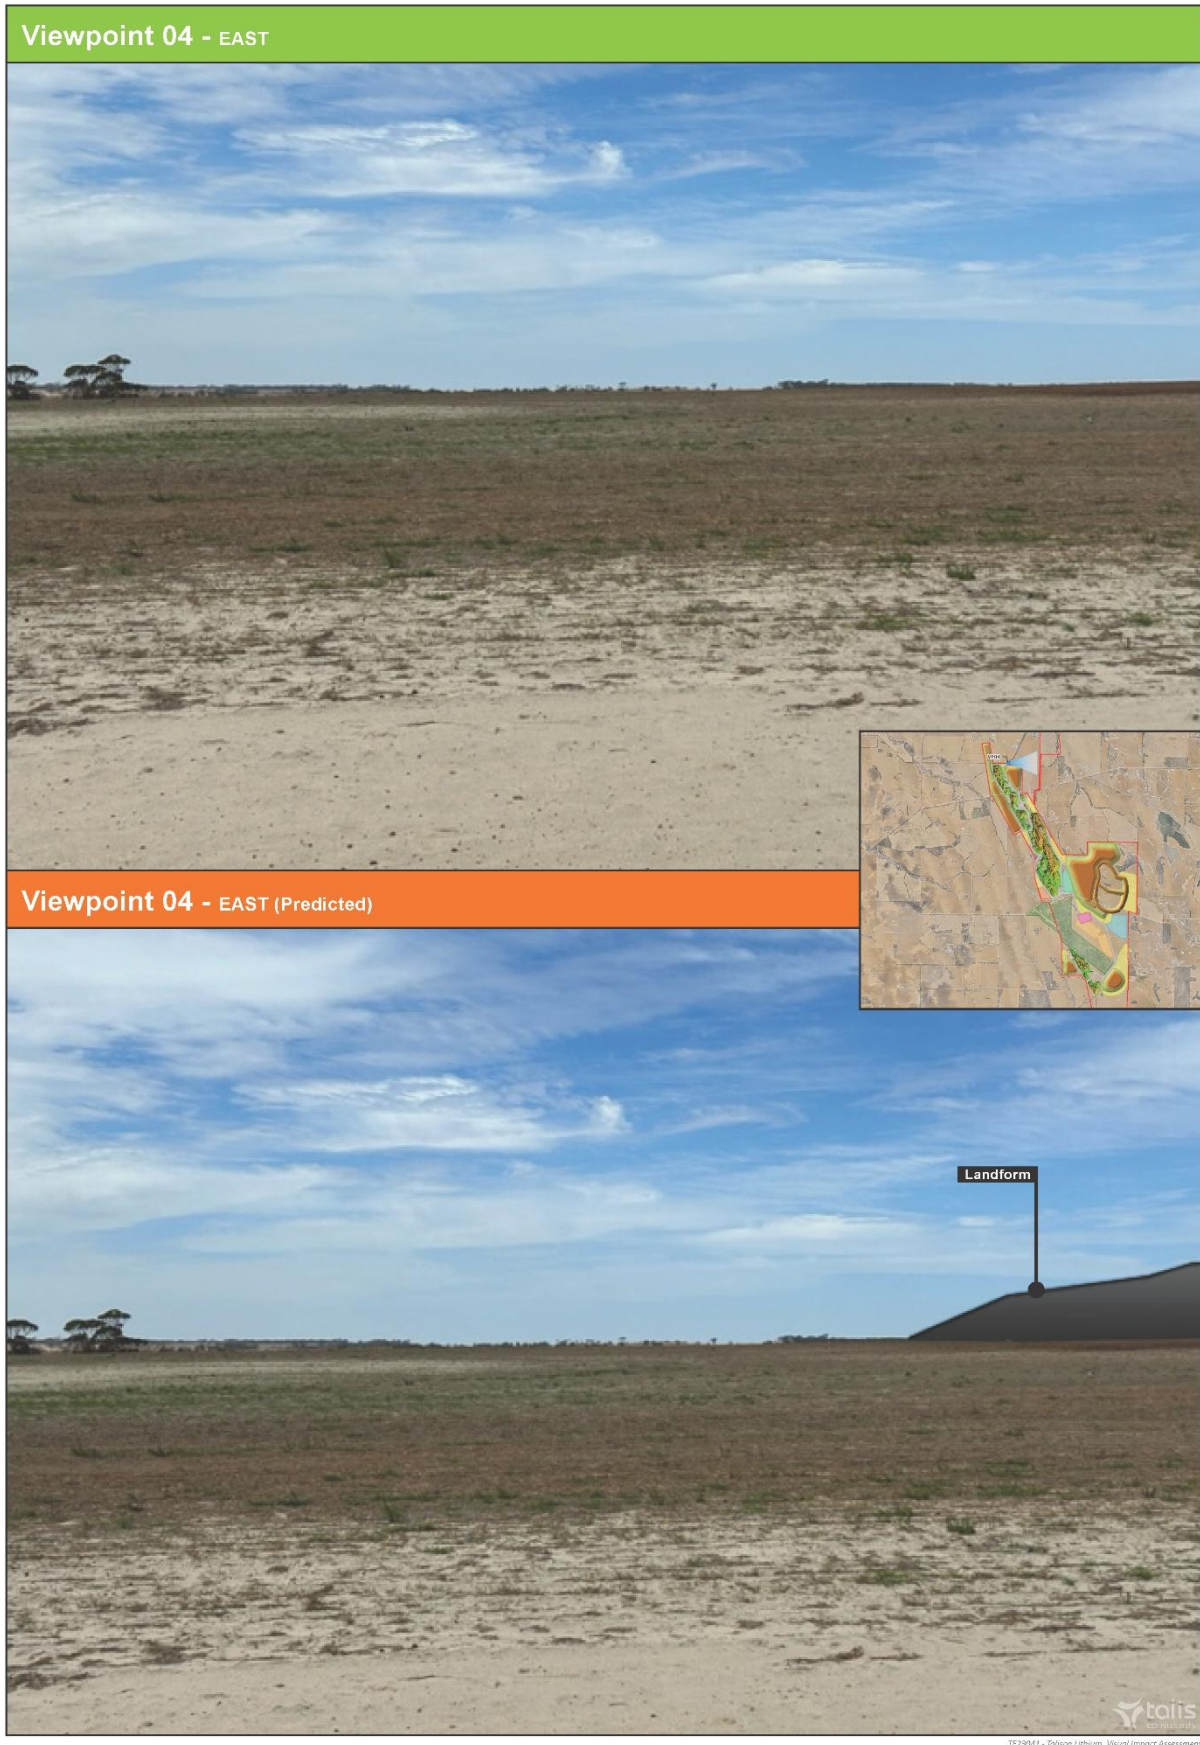
Figure 3-11: Final Photomontages (VP04 – East)

Figure 3-12: Final Photomontages (VP04 – South East)

Figure 3-13: Final Photomontages (VP04 – South West)

VP04 is located on the northern property boundary and is essentially the closest point to the infrastructure in this vicinity on West Road. There will be an obvious presence of the built infrastructure at this location, but again, this is likely to be transient in nature and can be further mitigated through appropriate vegetation screening at the boundary of the Ausgold property. Note West Road would need to be closed to the public so the viewshed would only be evident to the owner and workers on Dyabiling Holdings land near to and north of that point.
