KATANNING GOLD BASELINE SOIL ASSESSMENT

Ausgold Limited
October 2024

Project Number: 2530.23a

Report Title: Katanning Gold – Baseline Soil Assessment

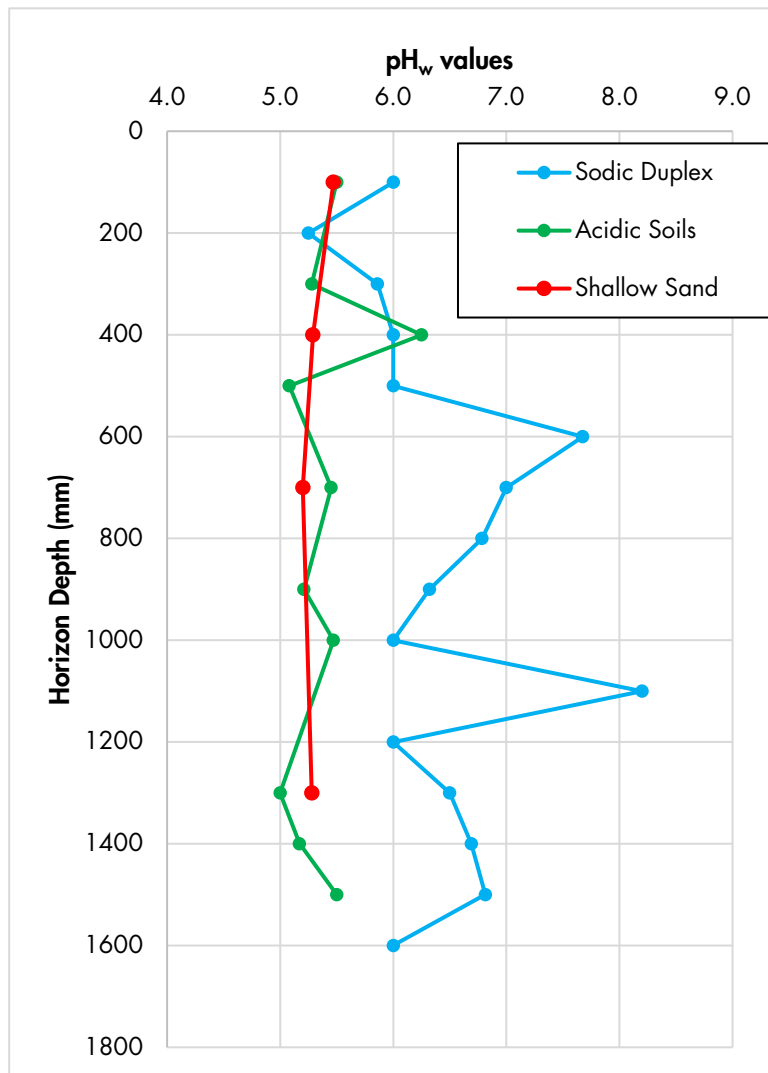
Figure 9: Median pH values throughout the observed soil profile for the SMUs.

Figure 9 below presents the median pH values throughout the observed soil profiles for each SMU.

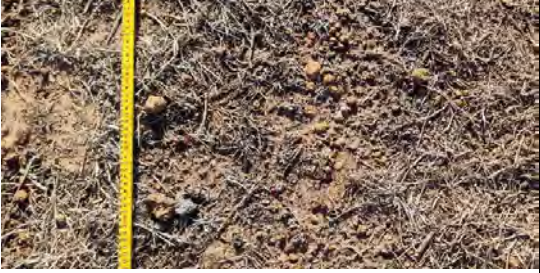
Soil Surface Condition Photo

Other Information: Higher in the landscape. Crop stubble present. Rock cover 50% 20-60mm.

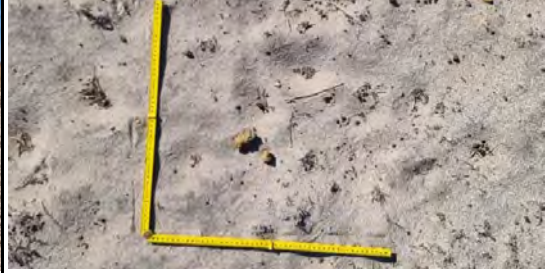
Sampled
<p>Other Information: White sand at surface. Crops not established. A few woody species established in sandy area. Rock surface cover 10% 20-60mm.</p>

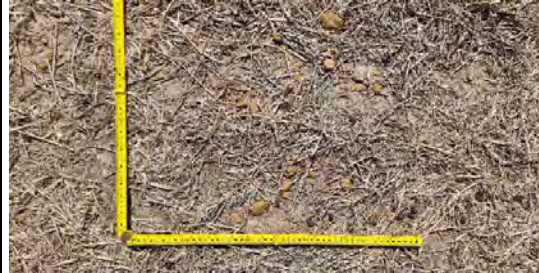
Soil Surface Condition Photo

Other Information: Ground cover is dense crop stubble. Rock cover 30% 20-60mm.		
Dominant Vegetation Photo 1			Dominant Vegetation Photo 2			Other Vegetation Photo

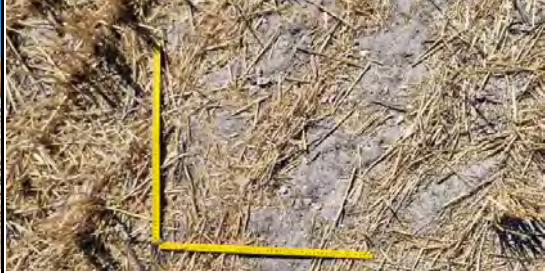
Soil Surface Condition Photo

Microrelief Type Vertical (m) Horizontal (m) Sampled
Dominant Vegetation Photo 1			Dominant Vegetation Photo 2			Other Vegetation Photo		Other Information: Quartz fragment as surface cover 10% 20-60mm.

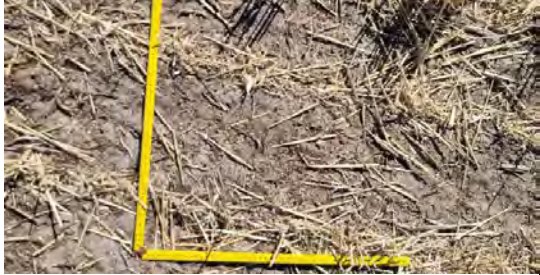
Soil Surface Condition Photo

Microrelief Type Vertical (m) Horizontal (m)
Dominant Vegetation Photo 1			Dominant Vegetation Photo 2			Other Vegetation Photo		Sampled Other Information: No surface coarse fragments.

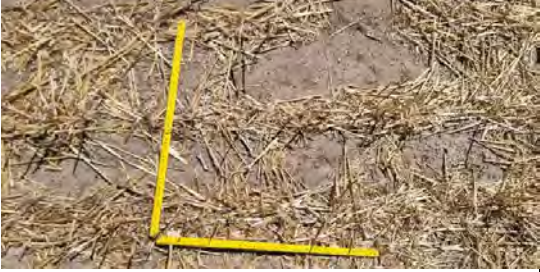
Landscape Photo (East)  			Soil Surface Condition Photo

Microrelief Type Vertical (m) Horizontal (m) Sampled		
Dominant Vegetation Photo 1			Dominant Vegetation Photo 2			Other Vegetation Photo			Other Information: 10% rock cover, 2-6mm. Adjacent to sump drain. Lower in landscape.

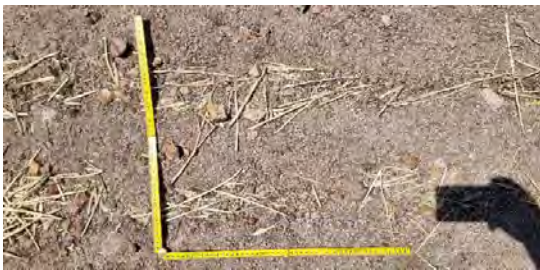
Soil Surface Condition Photo

Microrelief Type Vertical (m) Horizontal (m) Sampled		
Dominant Vegetation Photo 1		Dominant Vegetation Photo 2		Other Information: Near to crest, in between two wooded areas. Surface cover quarts and laterite of differing sizes. 20% cover 20-100mm.

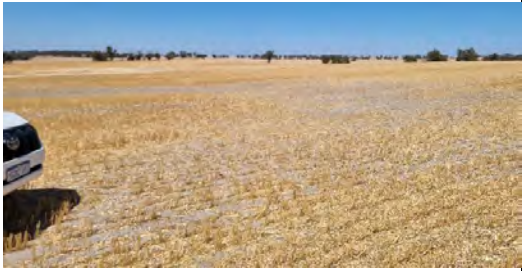
Sampled
								Other Information: Crop stubble. 5% rock cover 6-20mm.

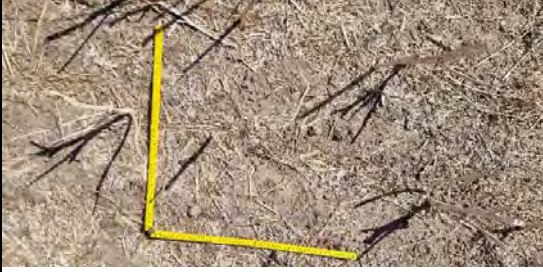
Soil Surface Condition Photo

Microrelief Type Vertical (m) Horizontal (m) Sampled	
Dominant Vegetation Photo 1			Dominant Vegetation Photo 2			Other Information: Down slope from a crest. 10% rock cover 2-6mm.

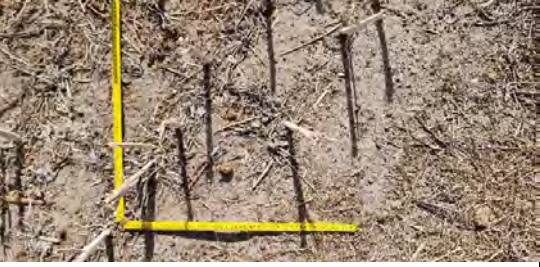
Soil Surface Condition Photo

Other Photo		Microrelief Type Vertical (m) Horizontal (m) Sampled	
Dominant Vegetation Photo 1		Dominant Vegetation Photo 2		Other Vegetation Photo		Other Information: Quartz and laterite like rocks on surface. Crop stubble. 10% rock cover 20-60mm.

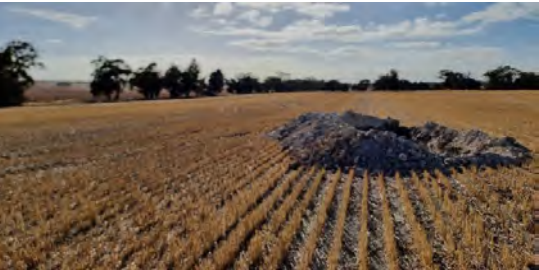
Horizontal (m)
							Sampled
							Other Information: Loose quartz rocks on surface. Rock surface cover 10%, 20-100mm.

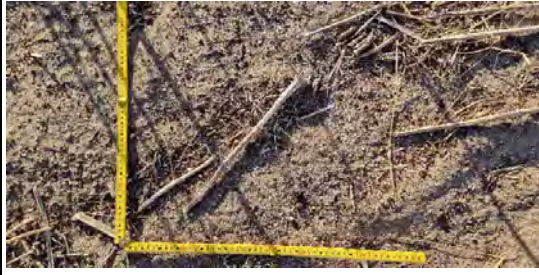
Horizontal (m)
								Sampled
								Other Information: Crop stubble remains. Rock surface cover 10% 2-6mm.

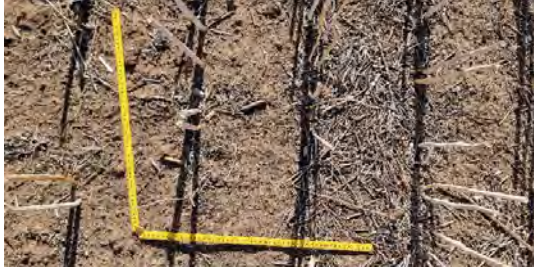
Soil Surface Condition Photo

Microrelief Type Vertical (m) Horizontal (m) Sampled
Dominant Vegetation Photo 1			Dominant Vegetation Photo 2			Other Vegetation Photo		Other Information: No rock cover Cleared rocks and trees piled nearby.

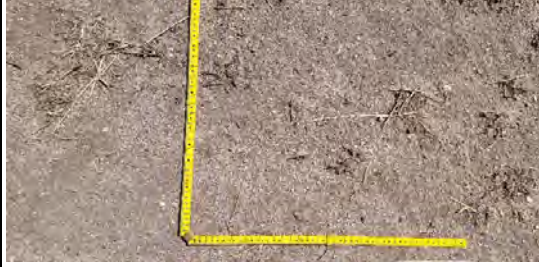
Soil Surface Condition Photo

Other Photo		Microrelief Type Vertical (m) Horizontal (m) Sampled	
Dominant Vegetation Photo 1		Dominant Vegetation Photo 2		Other Vegetation Photo		Other Information: Close to a dam. Surface cover desnse crop stubble. 10% rock cover <2mm.

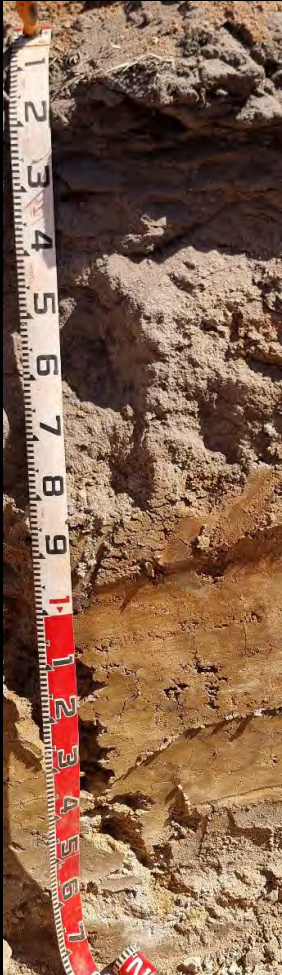
Horizon	Depth (mm)	Profile Photo	Boundary	Texture	Moist Colour	Mottle (colour, abundance)	Segregations (abundance, nature)	Coarse fragments (abundance, size)	Structure (type)	Structure (grade)	Consistence (soil water status)	Roots (abundance, size)	pH	EC (dS/m)	Depth of Sample for Lab (mm)
A11	0-200

Clear	Loamy Sand	10yr2/1	Not recorded	Not recorded	<2 % 2-6 mm	Subangular blocky	Strong	Firm (dry)	Many (25-200) Very fine (<1 mm)	5.5	0.15	50-150
A11	200-400-		Clear	Loamy Sand	10yr3/3	Not recorded	Not recorded	<2 % 2-6 mm	Subangular blocky	Strong	Firm (dry)	No roots (0) Not recorded	5.3	0.04	200-300
B1	400-800		Clear	Clayey Sand	10yr 5/3	10% grey	Not recorded	2-10 % 2-6 mm	Subangular blocky	Weak	Strong (dry)	No roots (0) Not recorded	5.5	0.03	600-700
B21	800-1150		Clear	Sandy Clay Loam	10yr 5/6	10% grey	Not recorded	<2 % 2-6 mm	Angular blocky	Moderate	Very firm (dry)	No roots (0) Not recorded	5.5	0.06	900-1000

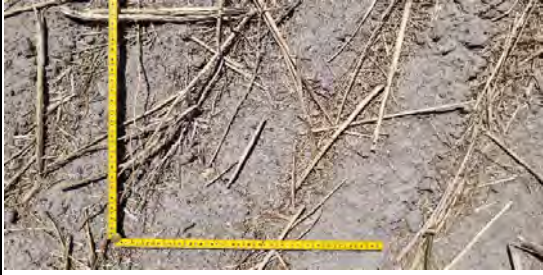
Soil Surface Condition Photo

Microrelief Type Vertical (m) Horizontal (m) Sampled	
Dominant Vegetation Photo 1		Dominant Vegetation Photo 2		Other Information: Crop stubble. Less than 5%, 2mm rock cover.

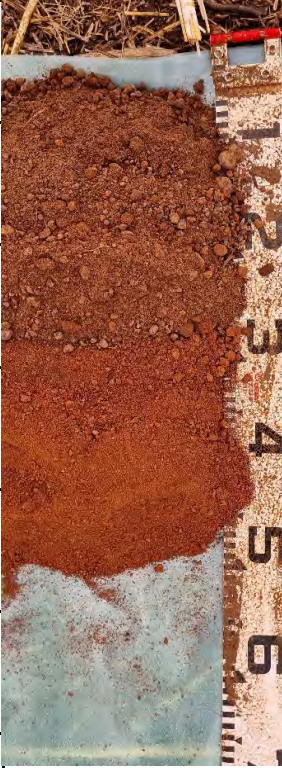
Horizon	Depth (mm)	Profile Photo	Boundary	Texture	Moist Colour	Mottle (colour, abundance)	Segregations (abundance, nature)	Coarse fragments (abundance, size)	Structure (type)	Structure (grade)	Consistence (soil water status)	Roots (abundance, size)	pH	EC (dS/m)	Depth of Sample for Lab (mm)	
A	0-200

Not recorded	Clayey Sand	5yr 3/4	Not recorded	Not recorded	10-20 % 6-20 mm	Not recorded	Not recorded	Not recorded	Not recorded	5.4	0.09	0-100	
B1	200-500		Not recorded	Light Clay	2.5yr 2/4	Not recorded	Not recorded	10-20 % 6-20 mm	Not recorded	Not recorded	Not recorded	Not recorded	6.2	0.06	300-400	
Other information:

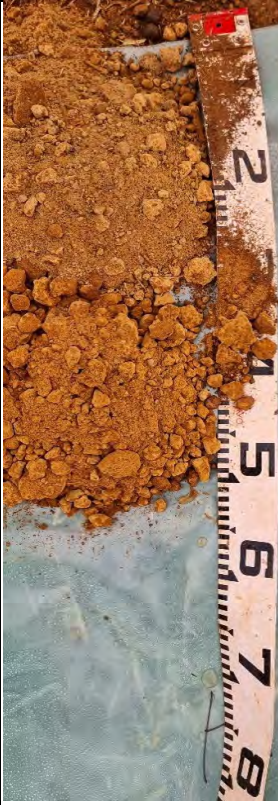
Horizon	Depth (mm)	Profile Photo	Boundary	Texture	Moist Colour	Mottle (colour, abundance)	Segregations (abundance, nature)	Coarse fragments (abundance, size)	Structure (type)	Structure (grade)	Consistence (soil water status)	Roots (abundance, size)	pH	EC (dS/m)	Depth of Sample for Lab (mm)	
A	0-200

Not recorded	Sandy Clay Loam	10yr 3/6	Not recorded	Not recorded	20-50 % 6-20 mm	Not recorded	Not recorded	Not recorded	Not recorded	5.5	0.05	0-100	
B	200-500		Not recorded	Sandy Clay Loam	7.5yr 4/4	Not recorded	Not recorded	50-90 % 20-60 mm	Not recorded	Not recorded	Not recorded	Not recorded	5.5	0.05	400-500	
Other information: <div style="height: 100px; border: 1px solid black;"></div>

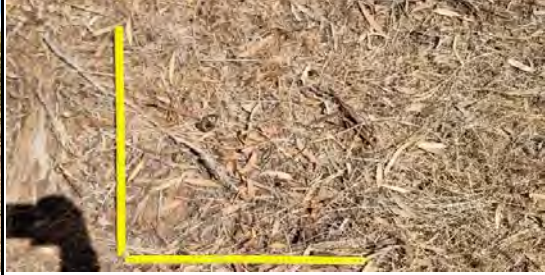
Soil Surface Condition Photo

Other Information: Road side nature strip. Groundcover leaf litter. No rock cover.

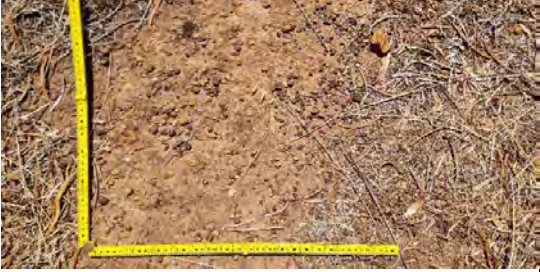
Landscape Photo (East)  			Soil Surface Condition Photo

Other Photo		Microrelief Type Vertical (m) Horizontal (m)	
Dominant Vegetation Photo 1			Dominant Vegetation Photo 2					Other Information: Roadside auger site. rock cover 20% 20mm.

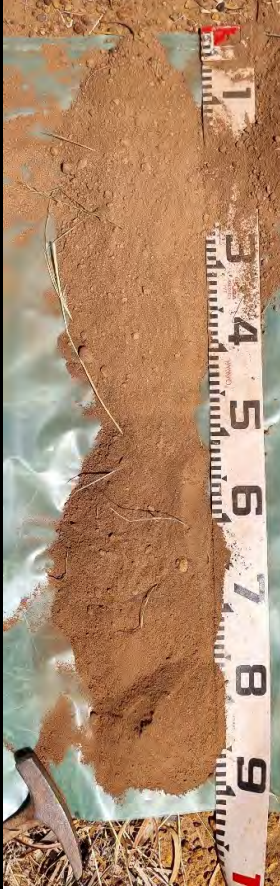
Horizon	Depth (mm)	Profile Photo	Boundary	Texture	Moist Colour	Mottle (colour, abundance)	Segregations (abundance, nature)	Coarse fragments (abundance, size)	Structure (type)	Structure (grade)	Consistence (soil water status)	Roots (abundance, size)	pH	EC (dS/m)	Depth of Sample for Lab (mm)	
A	0-200

Not recorded	Loamy Sand	5yr 3/4	Not recorded	Not recorded	10-20 % 2-6 mm	Not recorded	Not recorded	Not recorded	Not recorded	6.0	0.03	0-100	
B	200-600		Not recorded	Clayey Sand	7.5yr 2.5/3	Not recorded	Not recorded	10-20 % 6-20 mm	Not recorded	Not recorded	Not recorded	Not recorded	6.5	0.03	500-600	
B2	600-900		Not recorded	Clayey Sand	2.5yr 2.5/3	Not recorded	Not recorded	2-10 % 6-20 mm	Not recorded	Not recorded	Not recorded	Not recorded	6.5	0.07	800-900

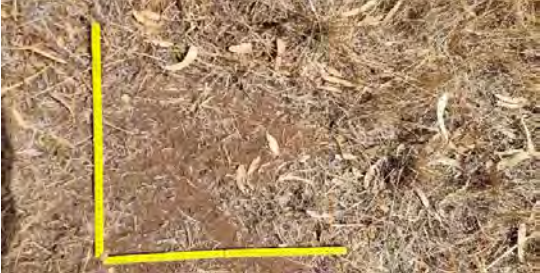
Sampled
							Other Information: Auger site off the side of the road. 100% veg cover. 10% rock cover 20mm.

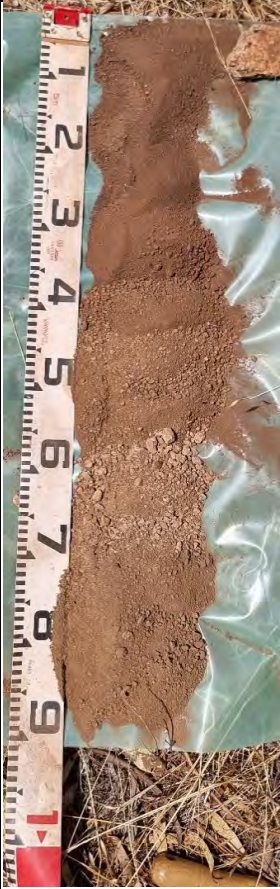
Not recorded	Loamy Sand	7.5yr 2.5/2	Not recorded	Not recorded	2-10 % 2-6 mm	Not recorded	Not recorded	Not recorded	Not recorded	6.0	0.05	0-100	
B	300-600		Not recorded	Clayey Sand	5yr 3/4	Not recorded	Not recorded	10-20 % 2-6 mm	Not recorded	Not recorded	Not recorded	Not recorded	6.0	0.03	400-500	
B2	600-900		Not recorded	Clayey Sand	5yr 3/4	Not recorded	Not recorded	20-50 % 6-20 mm	Not recorded	Not recorded	Not recorded	Not recorded	6.0	0.03	800-900	
Other information:

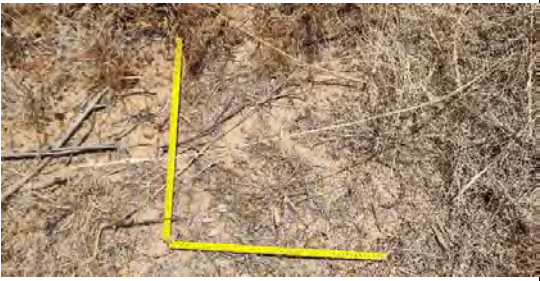
Sampled
								Other Information: Nature strip between paddock and dirt road. 10% rock cover 20mm.

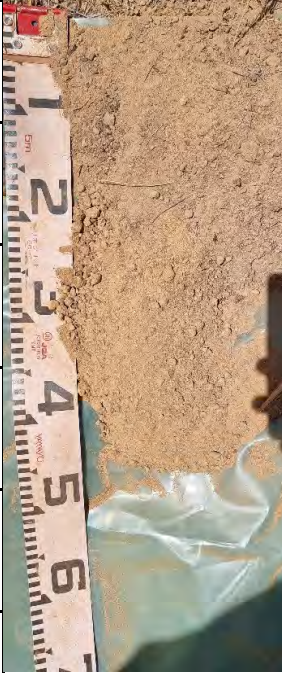
Not recorded	Sandy Clay Loam	Not recorded	10yr 4/6	Not recorded	10-20 % 6-20 mm	Not recorded	Not recorded	Not recorded	Not recorded	5.2	0.03	0-100	
B	200-500		Not recorded	Sandy Clay Loam	Not recorded	10yr 4/6	Not recorded	10-20 % 6-20 mm	Not recorded	Not recorded	Not recorded	Not recorded	5.9	0.02	300-400	
Other information:
