## Cooljarloo Mine including Cooljarloo West: Mine Closure Plan

Rev 0.1

November 2015

Tronox Management Pty Ltd on behalf of Tronox Western Australia and Yalgoo Minerals

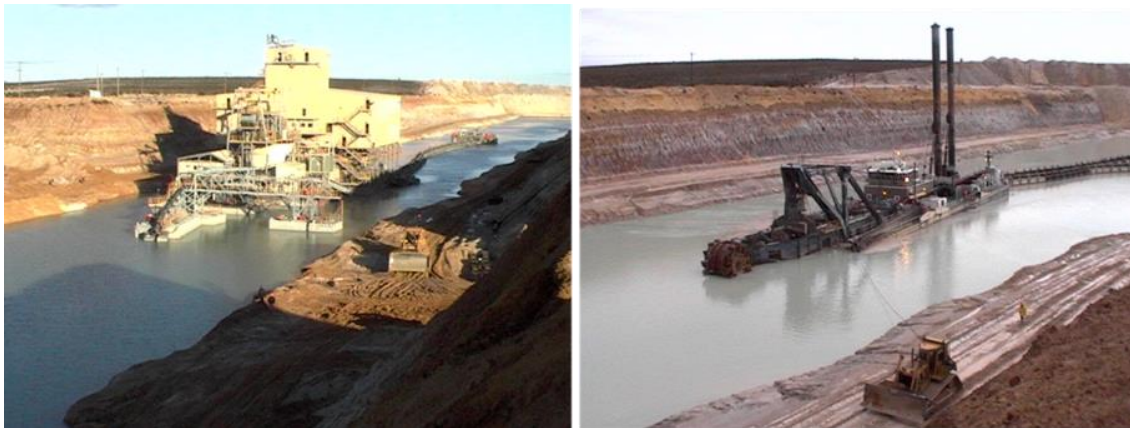
**Figure 5 Photos showing mining equipment moving through a transfer channel from the existing Cooljarloo Mine.**

Note these are similar in depth (approximately 20-30m) to the deepest sections of the channel planned for the Cooljarloo West project where approximately 80% of the channel is 10-14m deep.

This approach has been previously used at the existing Cooljarloo mine as shown in Figure 5 and will be used in the future for Cooljarloo West and other areas of mining within M268SA.

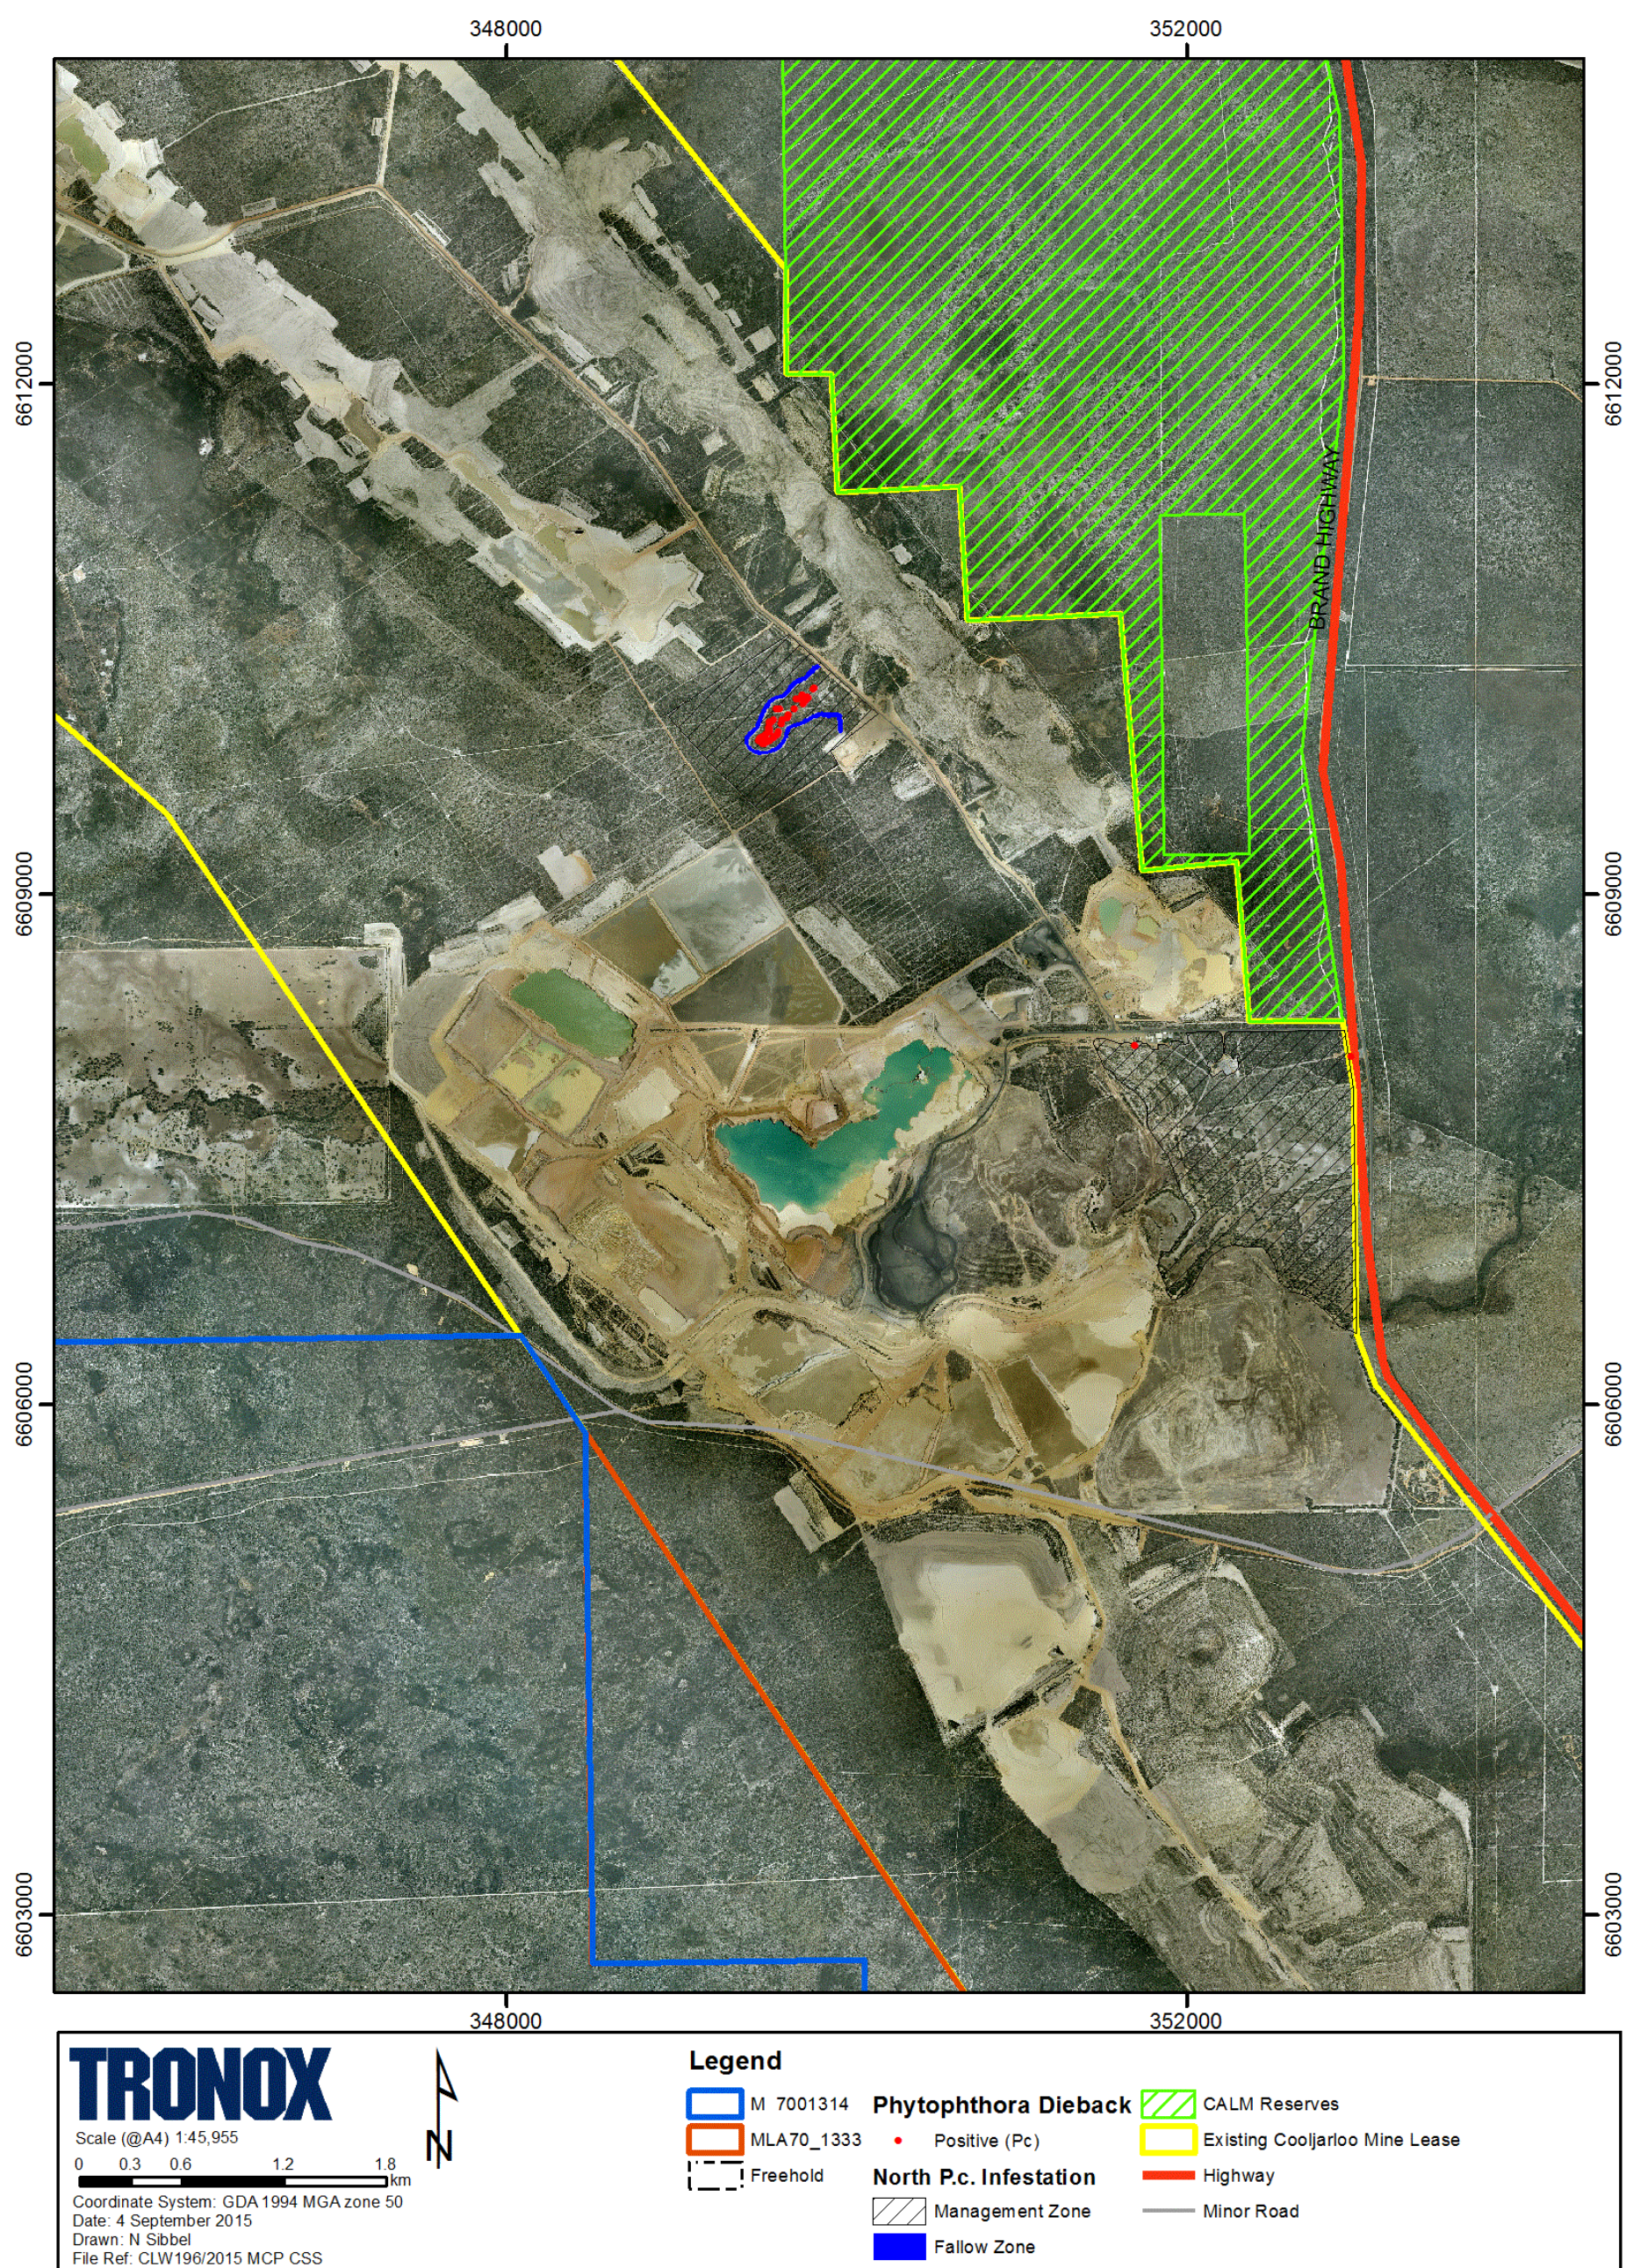
**Figure 28: *Phytophthora cinnamomi* Dieback Recoveries**

Extensive dieback surveys have been conducted at Cooljarloo since the commencement of mining including Hart, Simpsons and Associates (1998-1999); Woodman Environmental (2004) and most recently Glevan consulting (2008, 2010). A number of *Phytophthora* species have been recorded at the Cooljarloo Mine mostly in the area surrounding Mullering Farm. Of these species *Phytophthora cinnamomi* (Pc) is considered to pose the greatest risk to native vegetation communities. Many local species are susceptible to Pc and as such, the disease threatens the biodiversity values of the area. Tronox undertakes soil sampling, water baiting and regular interpretation/mapping across the lease. Figure 28 shows the recoveries of Pc recorded on site.
