Mesa J Hub Closure Plan

July 2018

Mineral Field: 08 – Ashburton

FDMS No: RTIO-HSE-0168839

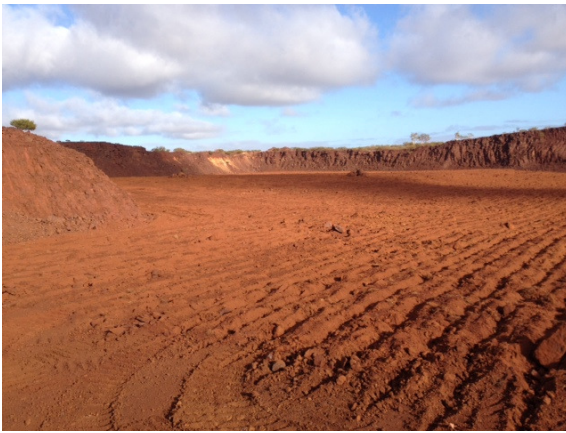
Figure 18: Progressive rehabilitation of Mesa J Pit 10 North

After rehabilitation (January 2014)

Mesa J Pit 10 was rehabilitated in 2014. The pit was ripped and seeded, with topsoil only spread on the northern area of Pit 10. Monitoring locations were installed in 2014 on both the top-soiled and non-top-soiled areas of Pit 10. Development of the rehabilitation was monitored in 2014 and 2015 (Figure 18). The rehabilitation is compared to local undisturbed reference sites. Pit 10 North has good vegetation establishment with a range of native vegetation species. Pit 10 South has limited native perennial vegetation establishment, due to both the young age of the rehabilitation and the lack of topsoil. Over time, it is expected to perform similarly well to Mesa K Pit rehabilitation (Figure 19), with differences attributed to topsoil, particularly at Pit 10 South. Buffel Grass and Birdwood Grass are present at Pit 10 North and Ruby Dock at Pit 10 South. Weeds in rehabilitation are managed under the company's *Weed Management Strategy* which has control measures such as periodic spraying and equipment hygiene procedures.

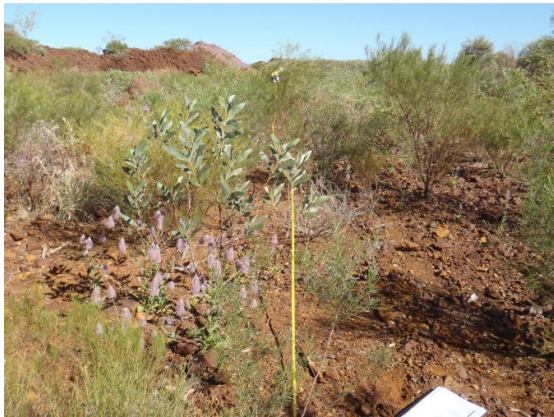
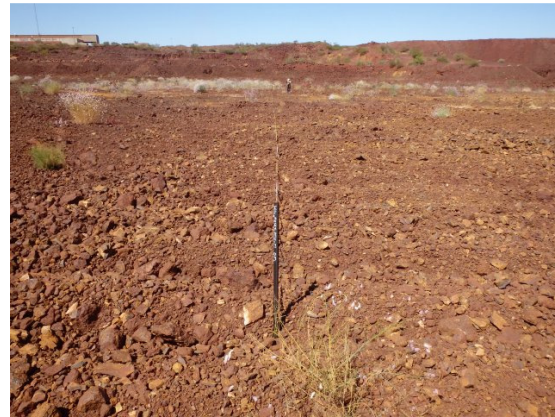
Mesa K Pit (2013 – 17 years)

Mesa J Pit 10 South (2015 – 1 year)

Figure 19: Recently completed rehabilitation of the pit floor at Pit 10 Mesa J is expected to reach similar successful rehabilitation outcomes as 17 year old rehabilitation at Mesa K.

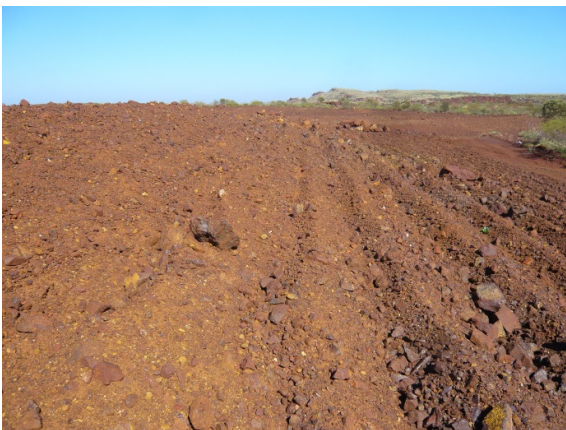
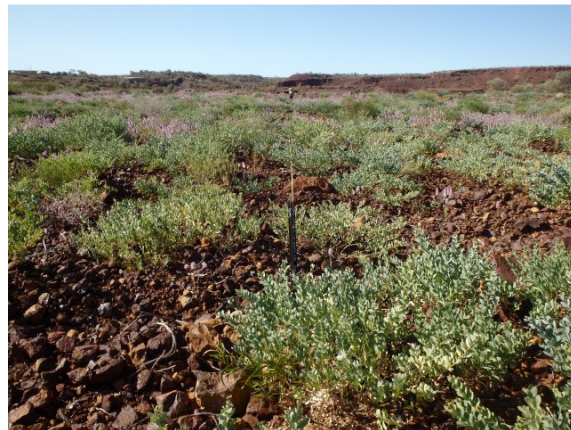
After rehabilitation (March 2014)

Monitoring (September 2015)

Figure 20: Progressive rehabilitation of the Mesa K Gravel Pit without topsoil.

The Gravel Pit at Mesa K was rehabilitated in 2013 by reshaping, ripping, and seeding. Good regrowth had occurred on the area prior to rehabilitation, so the soil and vegetation were collected and respread during rehabilitation. Monitoring locations were installed in 2014, one on the upper area and one on the lower area. These were monitored in 2014 and 2015. The rehabilitation was compared to local undisturbed reference sites. Vegetation is establishing well, with vegetation parameters comparable to the reference sites (Figure 20).

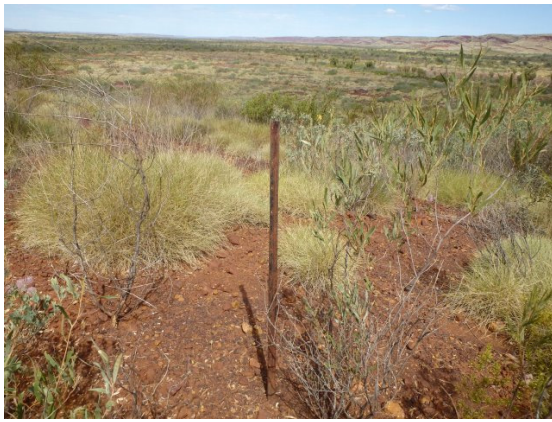
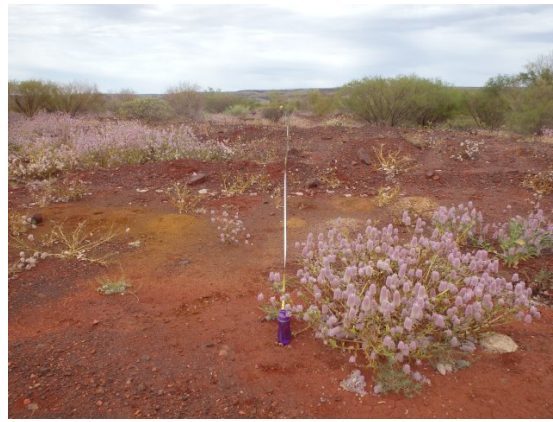
S Dump (2015 – 7 years)

T Dump (2015 – 7 years)

Figure 21: Mesa J Waste Dump rehabilitation – comparison of success utilising topsoil and subsoil

The S and T Waste Dumps at Mesa J were rehabilitated between 2004 and 2008 by reshaping, ripping, and seeding the dump slopes and tops. S Dump received topsoil, whilst T Dump received subsoil. Monitoring locations were installed in 2008, including both sloped and flat areas. Development of the rehabilitation was monitored on five occasions, the most recent of which was in 2015. The rehabilitation is compared to local undisturbed reference sites. At S Dump, vegetation cover and density had been increasing since completion, with an upper storey developing since 2010. The flat areas on top of the dump had plant density and cover plateauing in 2015, indicating the rehabilitation had completely established. T Dump also increased vegetation cover and density in the early stages, and plateaued around 2010. S Dump had higher cover and density than the compared reference sites, while T Dump had lower values (Figure 21). Minor erosion occurred on the sloped sides of both dumps; however monitoring data demonstrates it was not active and had stabilized. Buffel Grass was present at S Dump and Ruby Dock at T Dump; both are sparse and not outcompeting native vegetation. Weeds in rehabilitation are managed under the company's weed management strategy which has control measures such as periodic spraying and equipment hygiene procedures.

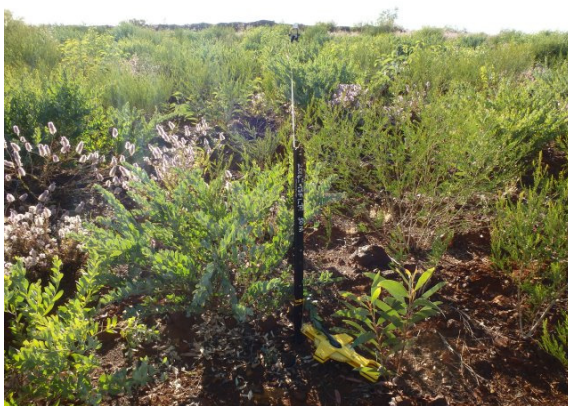
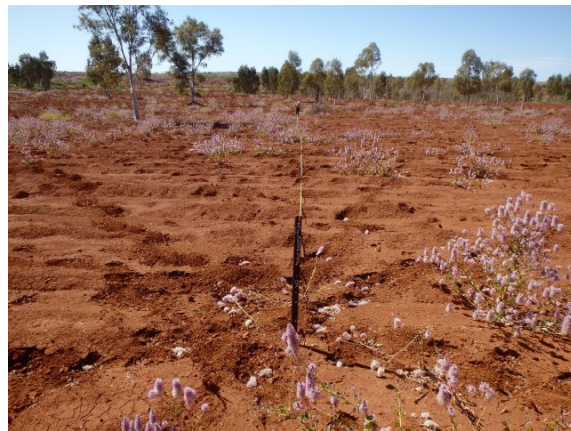
TSF1_T1 (2015 – 1 years)

TSF1_T4 (2015 – 1 years)

Figure 22: Mesa J TSF1 showing variability in vegetation establishment, although the area is still young.

Mesa J Waste Fines Storage Facility 1 (TSF1) was rehabilitated in 2014 as a trial of WFSF closure without the use of a capping layer. TSF1 was ripped and seeded, taking care to avoid large trees established in the area. Topsoil was not spread on TSF1, as growth media studies supported the surface material being suitable for vegetation growth. Monitoring locations were installed in 2014 on the upper and low-lying (periodic inundation) areas of TSF1. Development of the rehabilitation was monitored in 2014 and 2015. The rehabilitation is compared to local undisturbed reference sites. Vegetation establishment has been variable across TSF1 (Figure 22); however vegetation metrics have mostly increased since 2014. Minor subsidence has been noted, although is expected to stabilize as vegetation establishes and waste fines settle. Birdwood Grass is present in the low-lying areas and Buffel Grass in the upper areas. Ruby Dock is present across TSF1; however in general, introduced species are declining in density. Weeds in rehabilitation are managed under the company's weed management strategy which has control measures such as periodic spraying and equipment hygiene procedures.

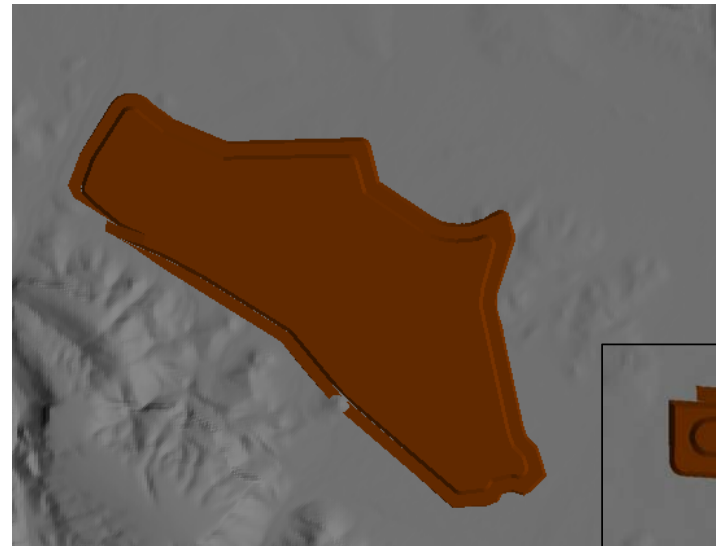
Mesa H SE Dump (Dump 3)

Waste volume	
Erodibility ranking	Moderate - High
Classification	Inert <input checked="" type="checkbox"/> Capping required at closure: PAF <input type="checkbox"/> - Fibrous minerals <input type="checkbox"/> - WFSF <input type="checkbox"/> -
Overall height (m)	20
Topsoil required (Mm³)	362,663 m ³

Rehabilitation design for the extension (inset image) will be completed prior to the next closure plan submission

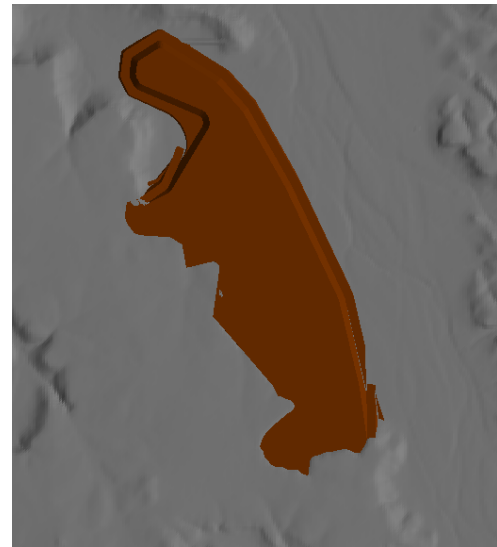
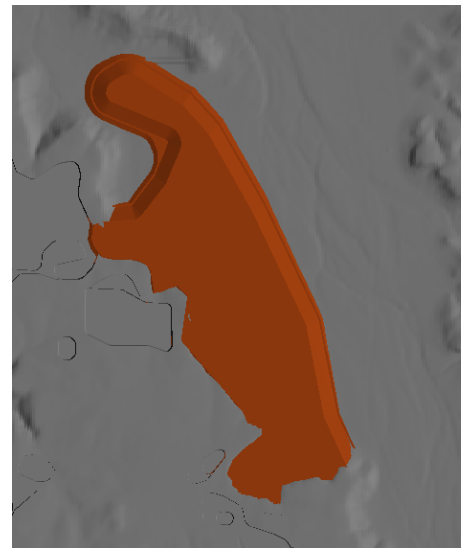
Mesa H NE Dump (Dump 4)

Waste volume	
Erodibility ranking	Moderate - High
Classification	Inert <input checked="" type="checkbox"/> Capping required at closure: PAF <input type="checkbox"/> - Fibrous minerals <input type="checkbox"/> - WFSF <input type="checkbox"/> -
Overall height (m)	30
Topsoil required (Mm³)	185,169 m ³

Capped with hydrated waste for erosion mitigation

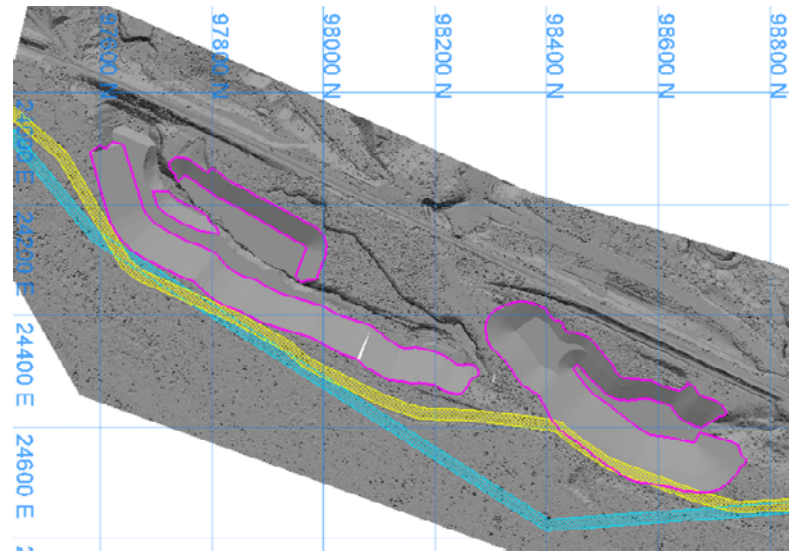
Mesa K Northern Dump

Waste volume	
Erodibility ranking	Low
Classification	Inert <input checked="" type="checkbox"/> Capping required at closure: PAF <input type="checkbox"/> - Fibrous minerals <input type="checkbox"/> - WFSF <input type="checkbox"/> -
Overall height (m)	< 35
Topsoil required (Mm³)	27, 600 m³

Comments:
 Design under review due to significant constraints
