FI Joint Venture Pty Ltd
Yogi Flora Survey

Project No. 61-37117
Revision No. A
Date 25 Mar 2019

FI Joint Venture Pty Ltd
Yogi-Magnetite Project

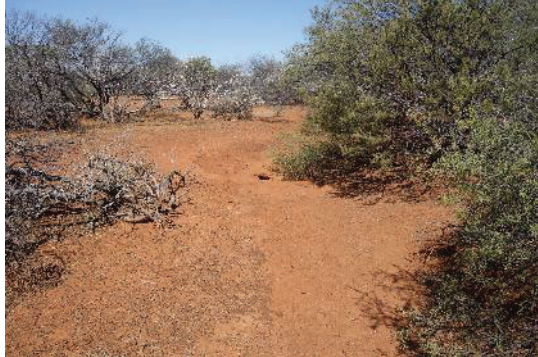
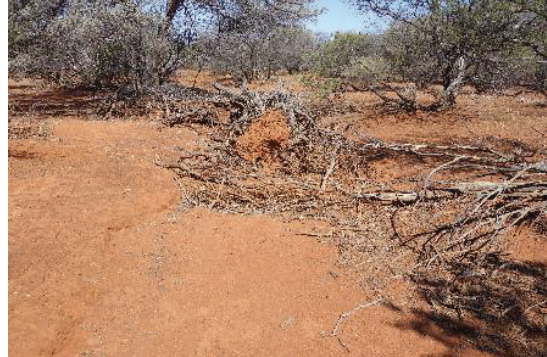
Minor channels (left) and evidence of sheetflow (right) debris in WPW upstream of mine pit.

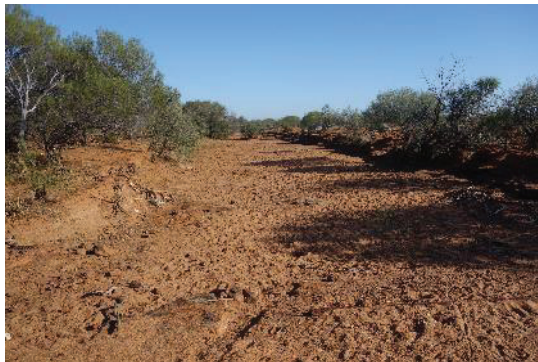
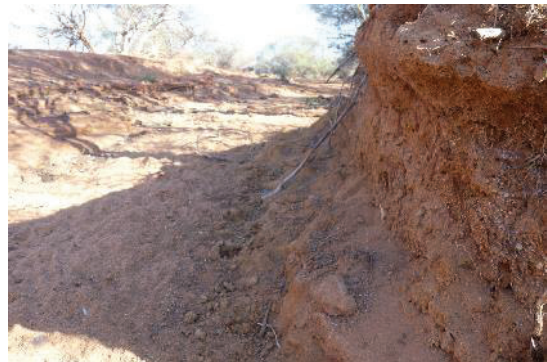
The well-defined WPW channel immediately south and downstream of proposed mine pit with evidence of granitic outcrops on the channel bed, livestock activity (left) and bank erosion (right).

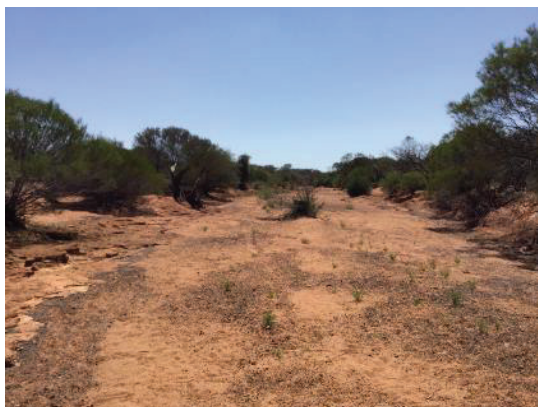
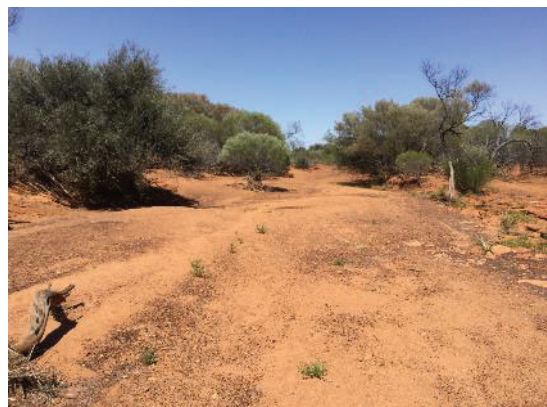
WPW further downstream of mine site exhibiting a still very well defined channel, albeit wider and shallower.

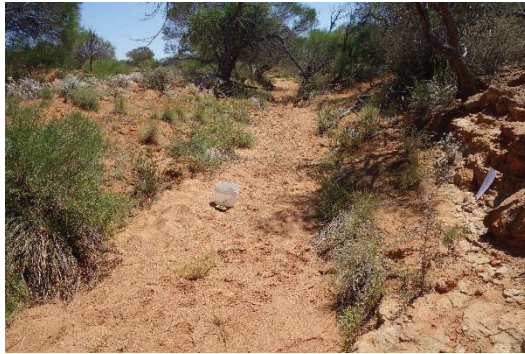
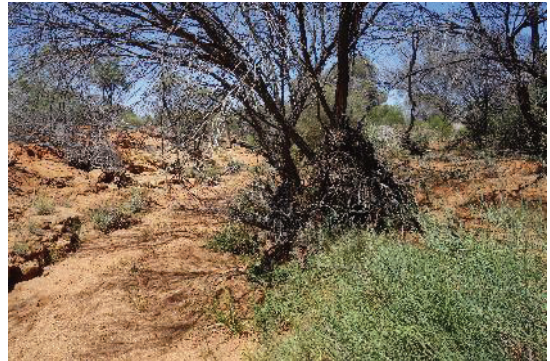
EPW upstream of mine site, directly west of inselberg, with rocky and vegetated banks (left), and evidence of debris piled high against bank vegetation (right) from significant flow events.

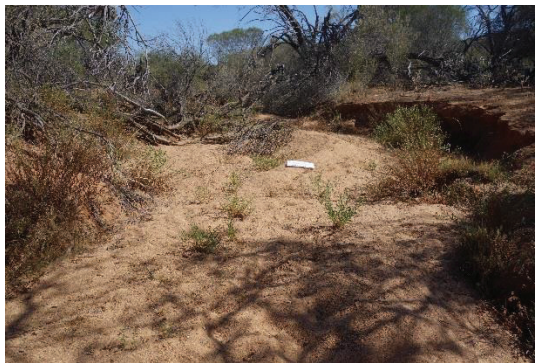
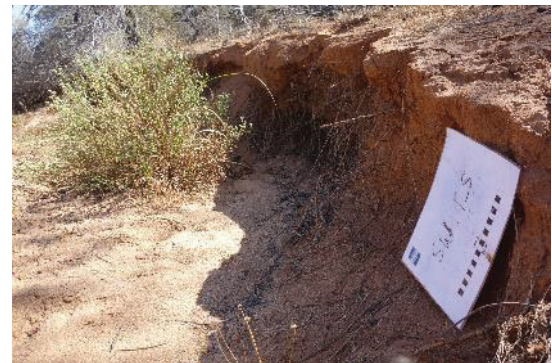
EPW at point east of proposed Guard House, showing abundant vegetation within channel bed and banks (left), and evidence of bank erosion (right)
