Appendix 39 Black Cockatoo Targeted Assessment 2023 – Willowdale

WESTERN
ENVIRONMENTAL

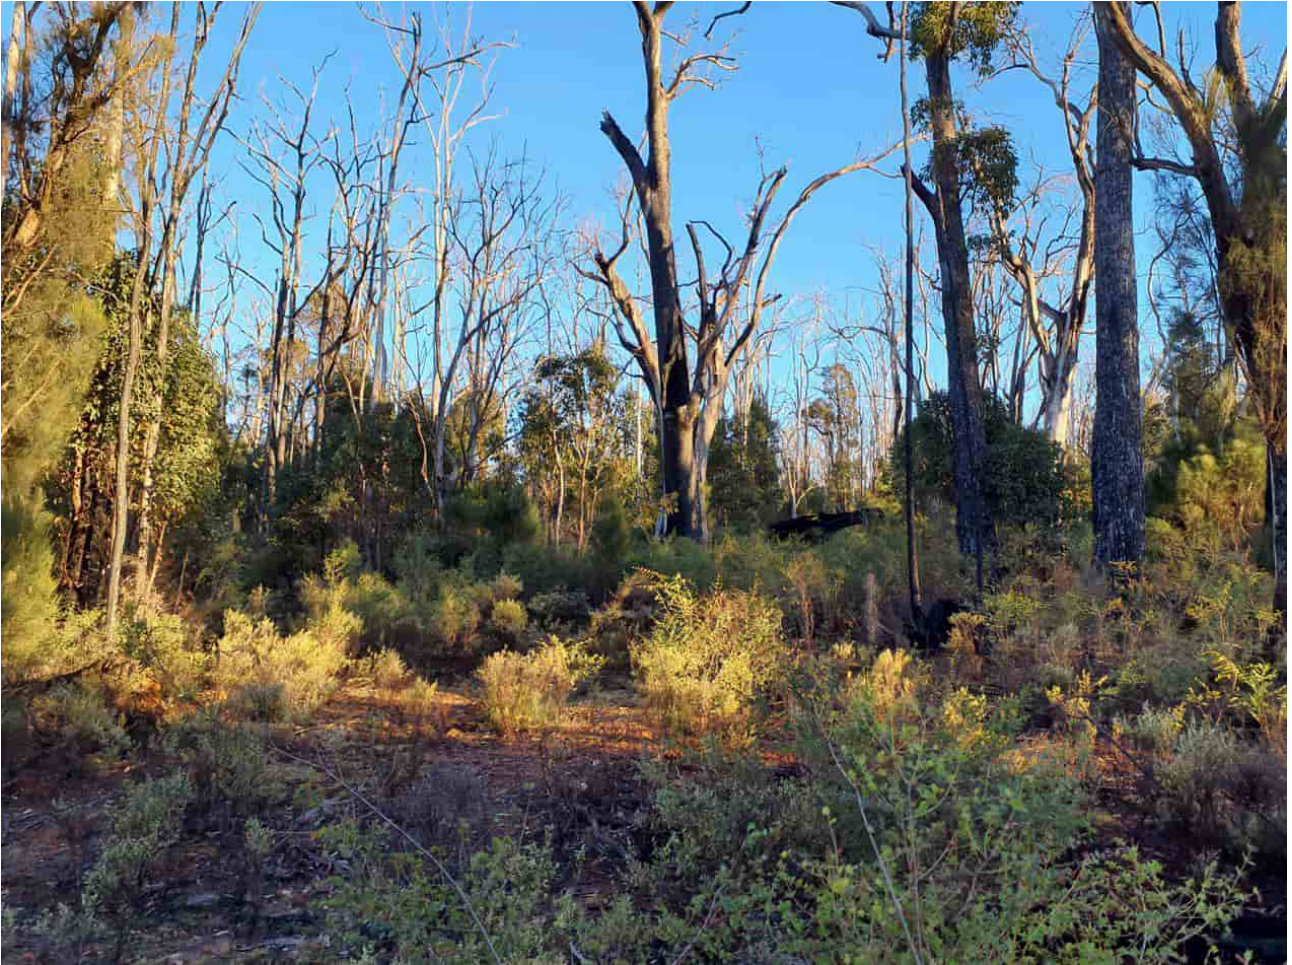
Image 02- Fire Impacted Habitat

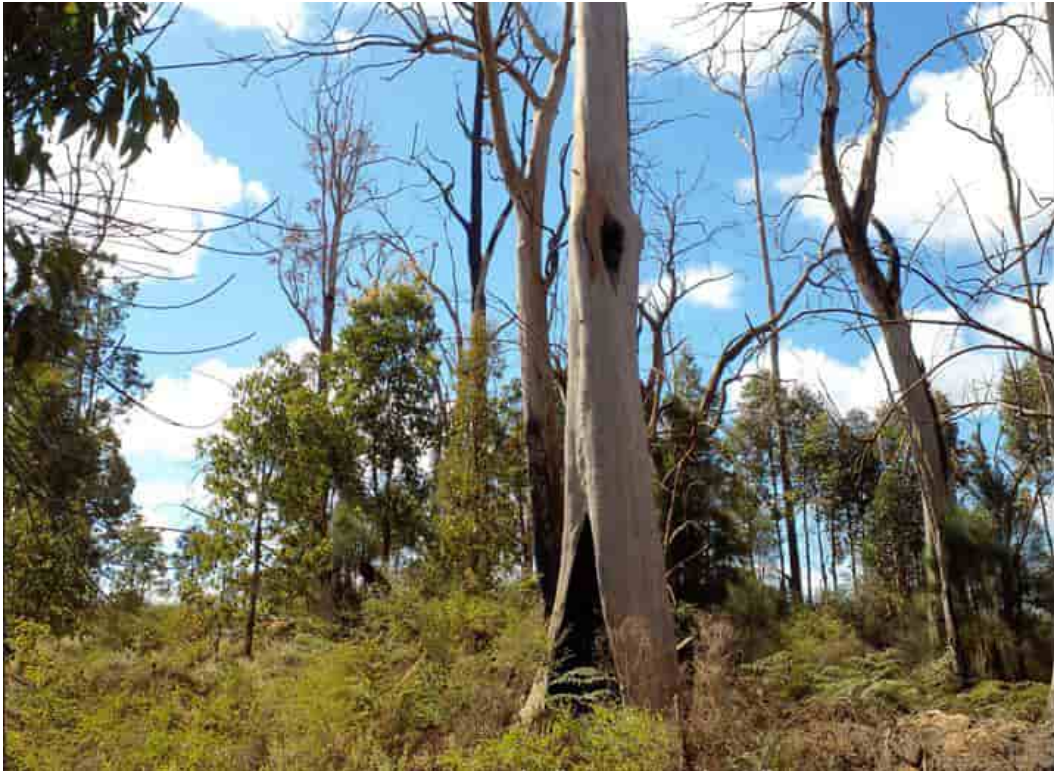
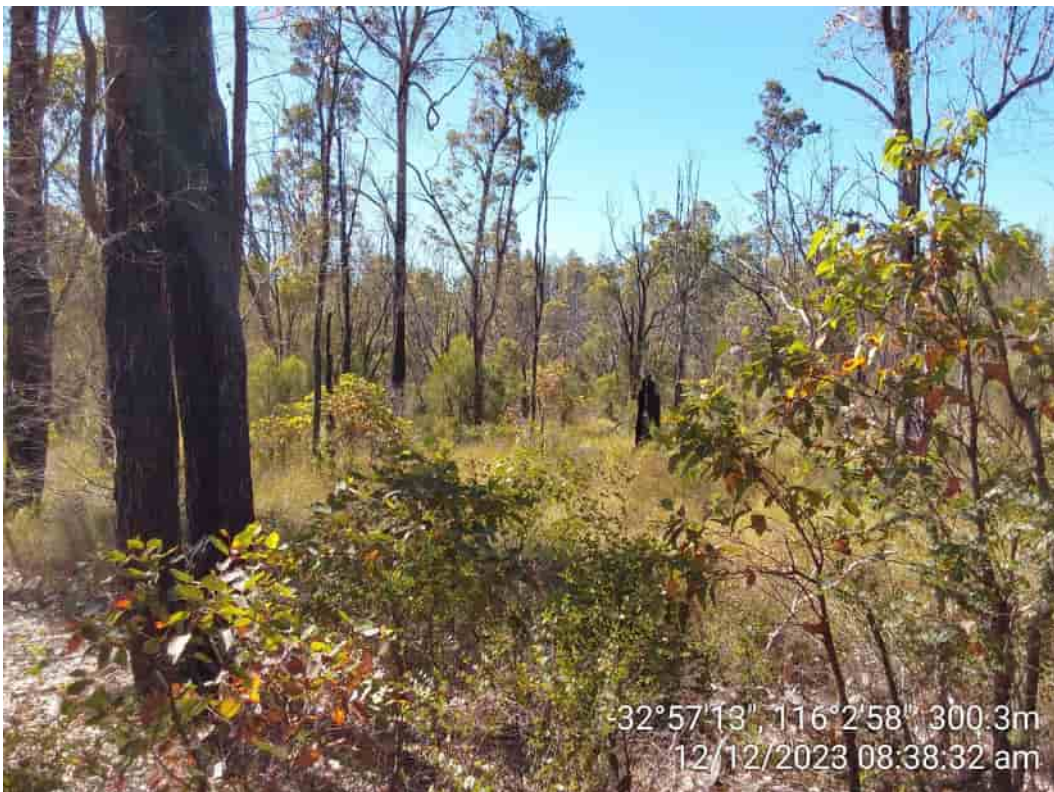
Site Condition 4-Moderate. Marri-Jarrah Forest or woodlands with 20-30% projected foliage cover; OR Marri-Jarrah Forest with 40-60% projected foliage cover but vegetation condition reduced due to tree deaths

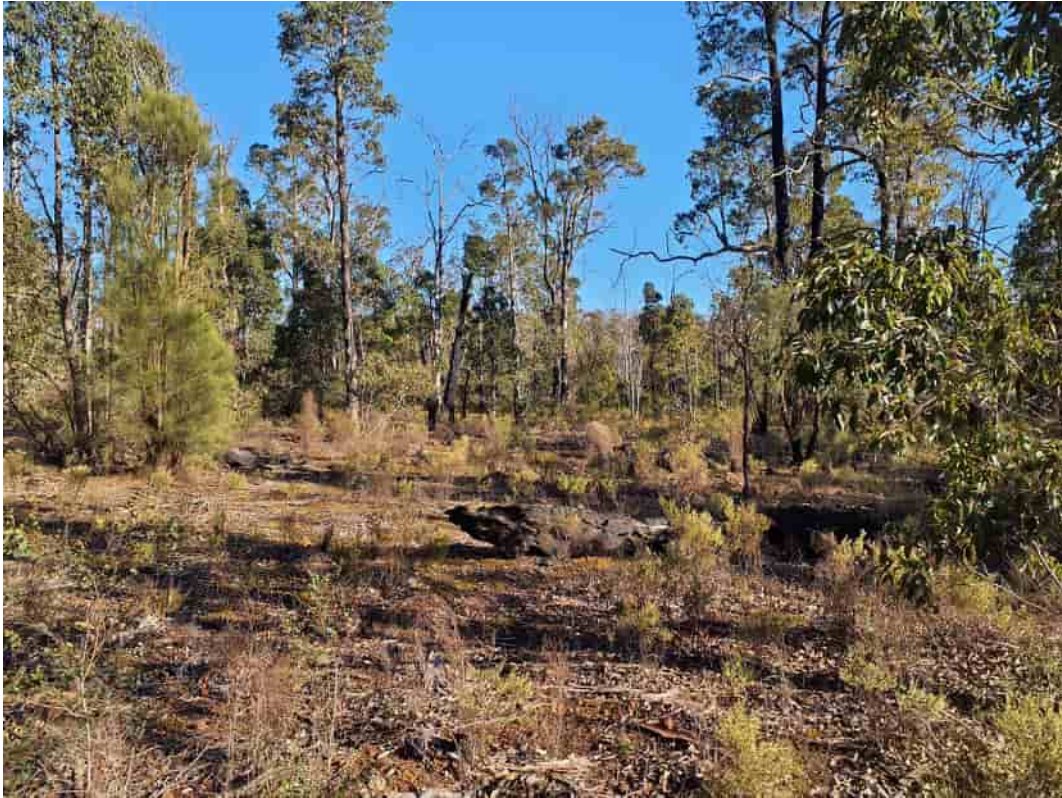
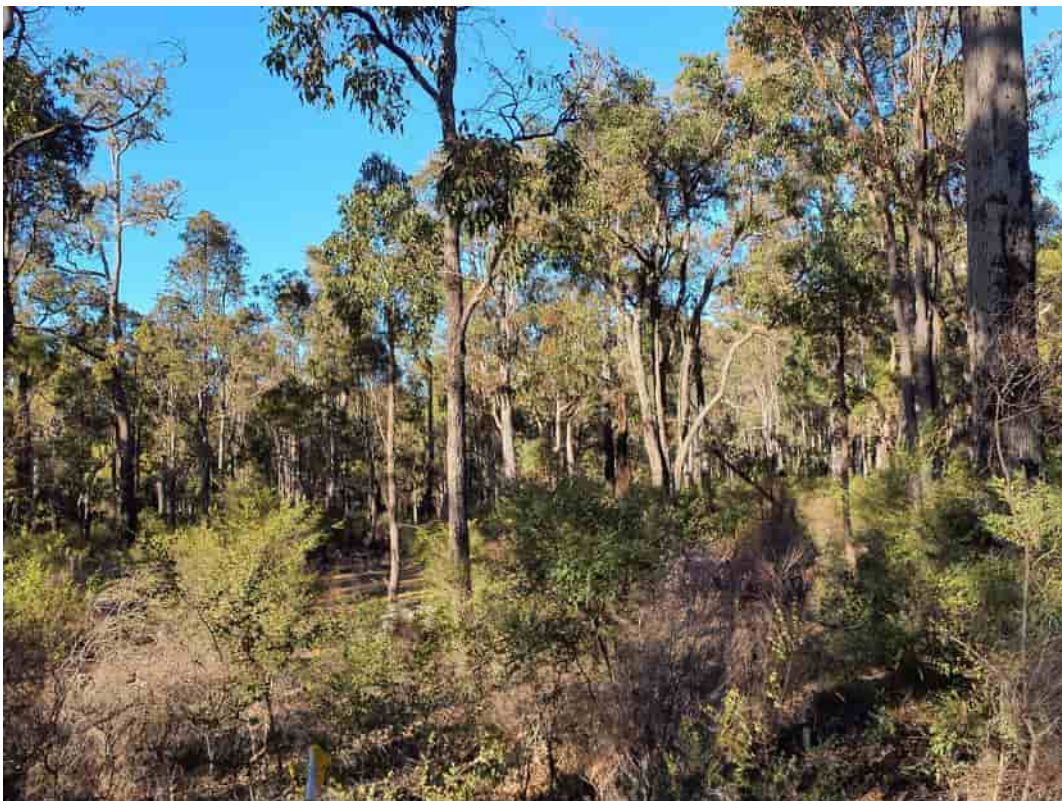
Site Condition 5- Moderate to High. Marri-Jarrah Forest or woodlands with 30-40% projected foliage cover; OR > 60% projected foliage cover but veg. condition reduced due to tree deaths (up to 20%).

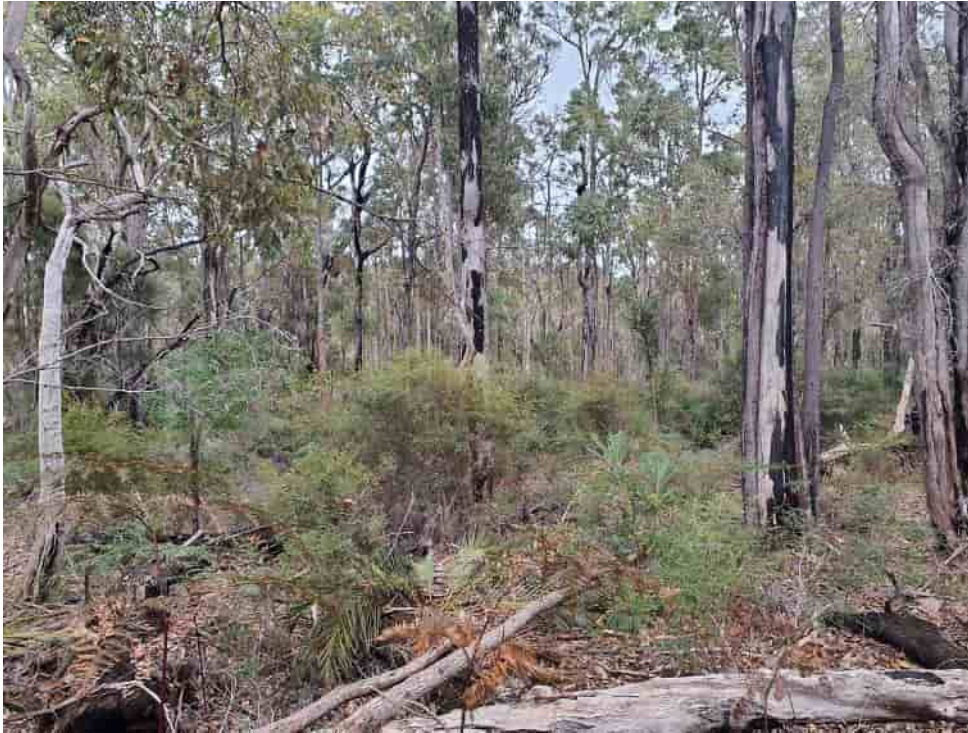
Site Condition 6-High. Marri-Jarrah Forest and woodlands with >40% projected foliage cover. Low percentage (< 10%) of tree deaths.

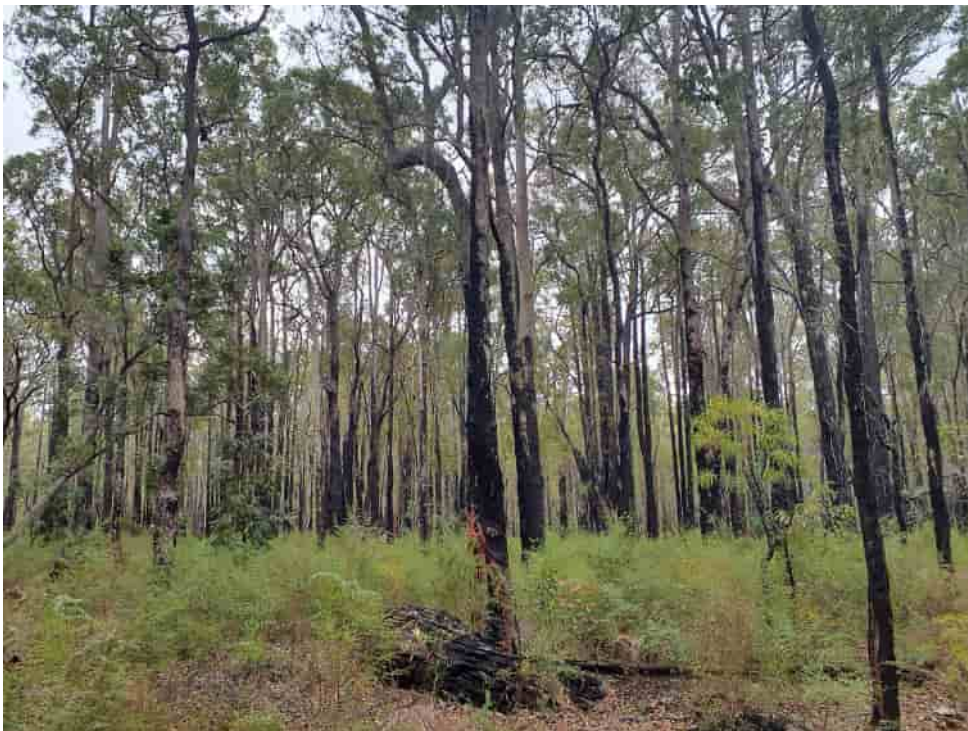
Site Condition 7- Very High. Marri-Jarrah Forest and woodlands with >50% projected foliage cover. Low percentage (< 5%) of tree deaths.

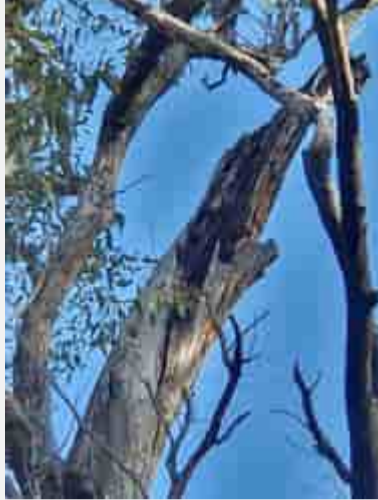
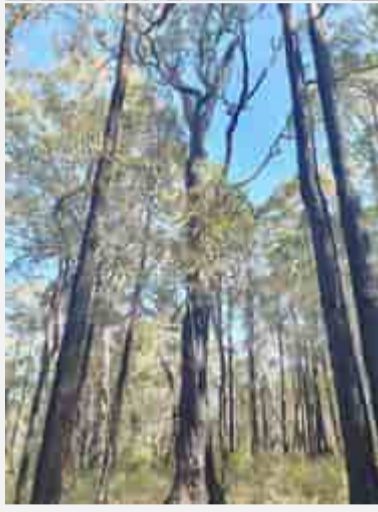
966	Marri	3	80	Tony. Mid trunk upwards facing hollow 15 cm by 25 cm. Wear marks, no chew.	414494.7872	6350949.686	   
-----	-------	---	----	--	-------------	-------------	---

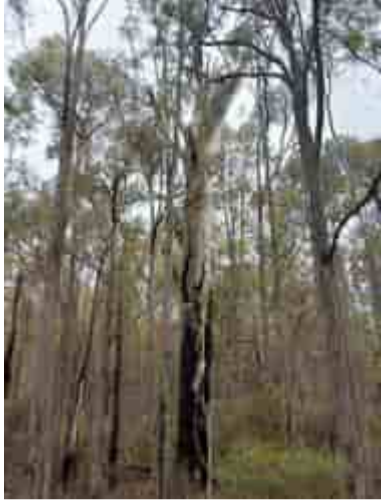
1144	Dead	3	50	Snapped off tree, potential chimney hollow, no sign of wear.	413252.6794	6351728.856

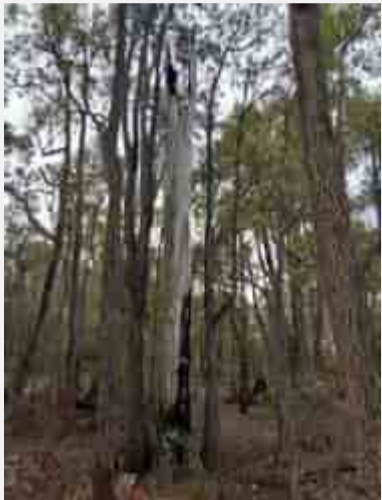
1145	Marri	3	120	Potential mid trunk hollow and spout hollow	413252.792	6351586.668

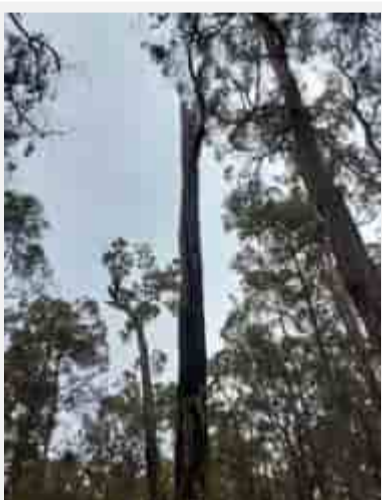
1171	Jarrah	3	70	10-15 cm mid trunk and downward facing hollows. No sign of wear.	413290.352	6351765.69

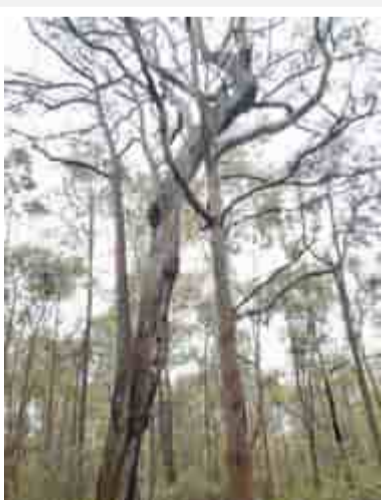
Merge Tree Number	Species	Class Bamford	DBH (cm)	Hollow Comments	Easting (AGD84/AMG zone 50)	Northing (AGD84/AMG zone 50)	Images
1194	Marri	3	90	10-15 cm spout opening present, potential hollow	413335.5787	6351730.886	 
1262	Jarrah	3	160	Tony. Three large vertical branches suit to form chimney hollows. No use evidence. Sig tree	414551.9796	6351279.822	   
1318	Dead	3	70	Has 10-15 cm openings, potential hollow	414583.4761	6350965.196	 
1326	Jarrah	3	80	Broken branches with potential hollow development and potential mid trunk hollow	414586.3238	6350750.503

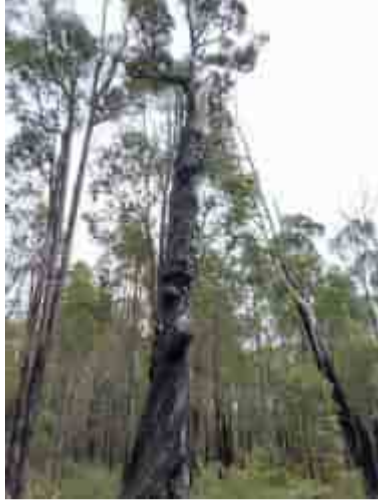
1638	Jarrah	3	110	Tony. >30cm spout hollow. Wear marks no chew. Angle and access potentially reduces likelihood. Other small hollows present	414840.8826	6350627.3

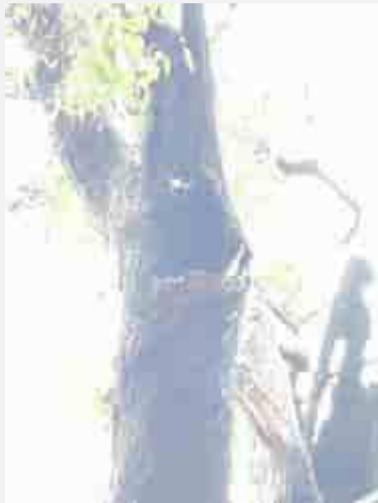
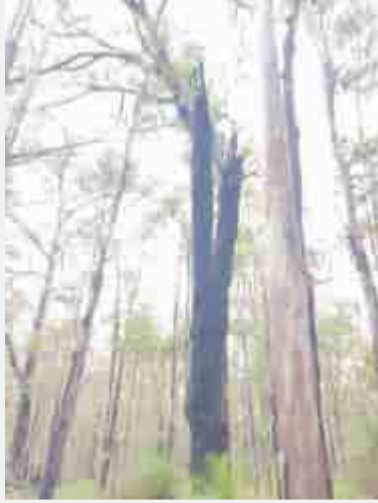
1642	Dead	3	80	Has several 10-15 cm openings, potential hollow	414852.7995	6350661.405

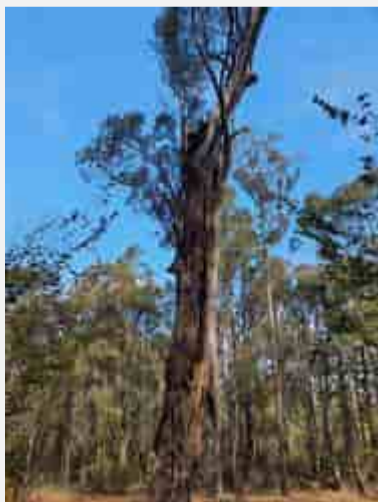
1671	Jarrah	3	160	Has several snapped off big branches, one opening is not very developed 10-	412614.1162	6351969.547

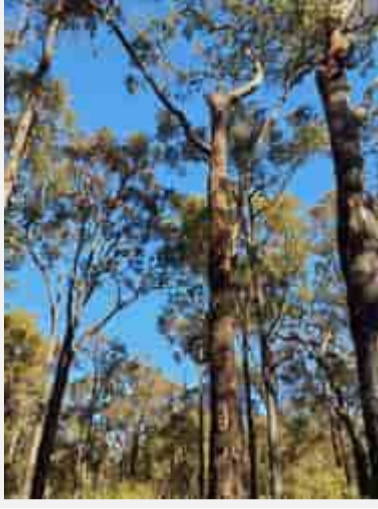
1690	Jarrah	3	70	Potential chimney hollow about 20 cm. No chew marks visible	412643.9137	6351842.806	
1752	Jarrah	3	75	One 10-15 cm mid trunk hollow. No evidence of chew marks.	412736.2571	6352157.774	
1824	Dead	3	100	Has a mid trunk hollow 10-15 cm. No chew marks.	412852.06	6351895.032	
1898	Jarrah	3	85	Has small <10 cm hollow and potential 10-15 cm hollows in broken branches up in canopy.	412982.4387	6352132.441	
1921	Jarrah	3	120	Tony. Potential chimney hollow from snapped off tree top. No visible chewing evidence present	413052.1538	6351972.002

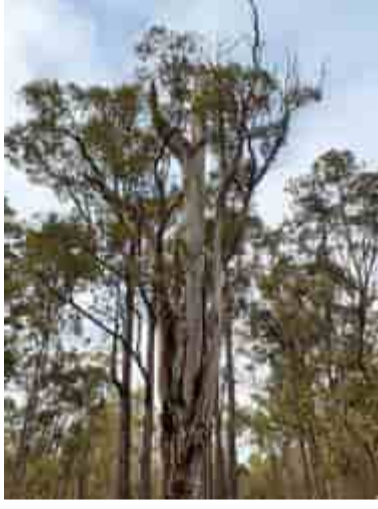
1923	Jarrah	3	100	Potential chimney hollow 20+ cm, however sides has cracks. No chew marks observed.	413066.8467	6352156.684

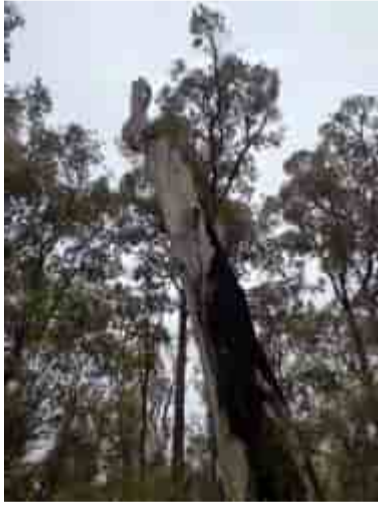
2126	Dead	3	160	Has several potential chimney hollows <20 cm. None has smooth edges, signs of wear or chew marks.	412695.5096	6352381.246

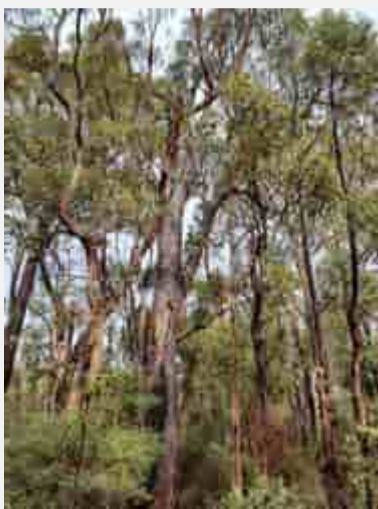
3102	Jarrah	3	50	One potential >20 cm hollow in fork, can't confirm from ground. No signs of wear. Also two undeveloped spout hollows in branches.	412786.7344	6352523.543	 
3103	Jarrah	3	50	Tony. One potential spout hollow >20 cm, upwards facing cant confirm. Also Potentially two >10 cm spout hollows, upwards facing, can't confirm.	412787.7288	6352540.53

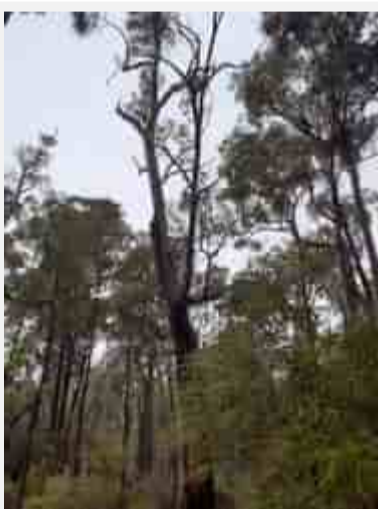
3122	Jarrah	3	160	Tony. Potential >20 cm mid trunk hollow, can't confirm firm from ground. also two undeveloped spout hollows.	412818.1745	6352527.122

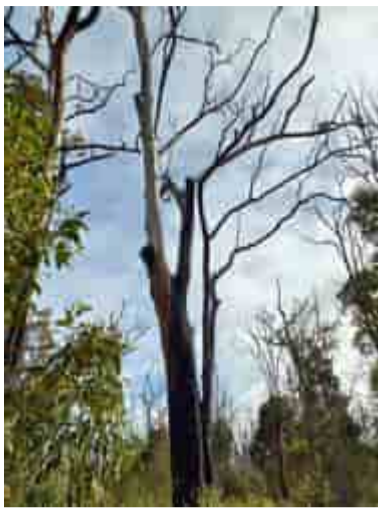
3273	Jarrah	3	55	One 15-20 cm potential mid trunk hollow and a few <10 cm hollows along the trunk.	411510.3199	6353054.649	 
3308	Jarrah	3	160	One >20 cm potential spout hollow, cannot confirm. Also potential large opening in fork, cannot confirm. Burnt out tree. Also >20 cm undeveloped and burnt out spout hollow.	411545.3984	6353107.709	 
3317	Jarrah	3	130	One >20 potential hollow in fork, can't confirm. Not signs of wear or chew marks. Also two >10 cm undeveloped chimney and spout hollows.	411551.2094	6352693.859	 
3346	Dead	3	170	Potential for chimney hollow at top of snapped burnt trunk. Can't confirm think unlikely	411596.8689	6353002.955

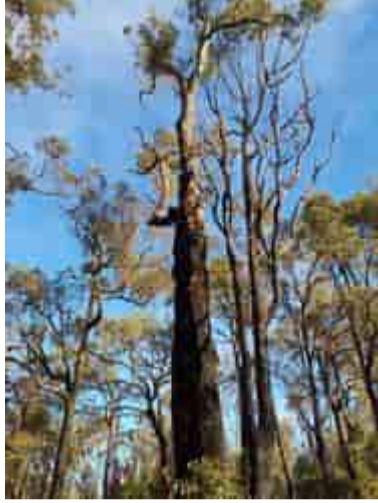
3678	Jarraah	3	110	One 15 cm sideways opening knot type hollow. 15m up in 40 cm diameter branch. Branch large enough to potentially develop chamber. Think unlikely to have suitable chamber	411122.8866	6352727.616

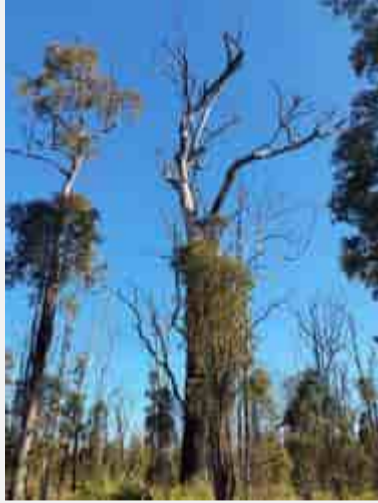
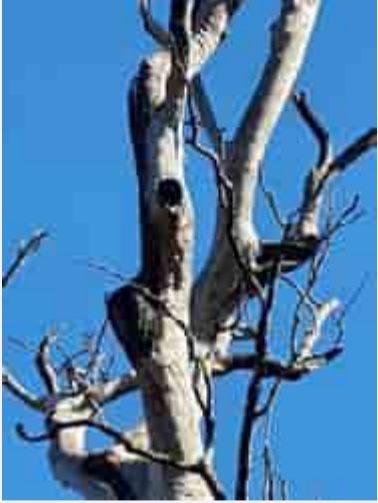
3681	Jarraah	3	95	One potential >20 cm chimney hollow about 30 m from the ground. No signs of wear and has spiky edges. Also has one broken branch with undeveloped hollow.	411125.1649	6352915.274

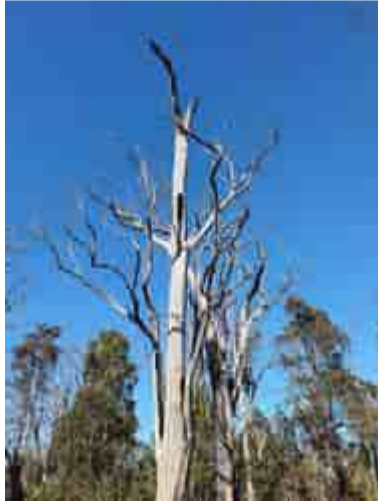
3691	Dead	3	155	Potential upwards opening hollow in fork at 13m. Entry 20cm by 25 cm. Going into main trunk. Think unlikely to have BC size chamber, can't confirm	411139.3078	6352757.613

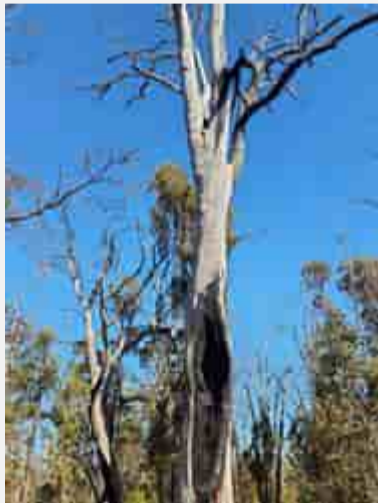
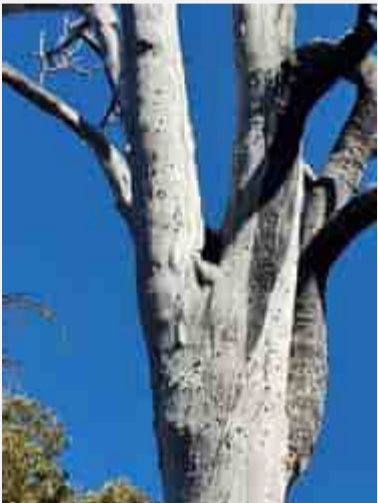
3798	Jarraah	3	75	One >20 cm potential knot hollow, however edges are very uneven and now signs of wear. about 25 m above ground.	411308.8651	6353290.285

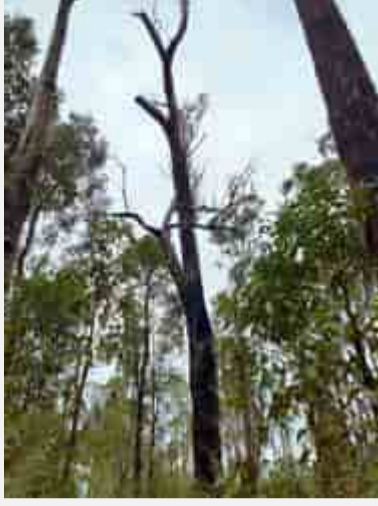
4283	Dead	3	110	Has three >10 cm potential spout hollows. One has cracks along the side and appear unstable. Also has a cup formation that appears to have sticks in it and other broken burnt out branches with undeveloped hollows	413165.6099	6354338.984

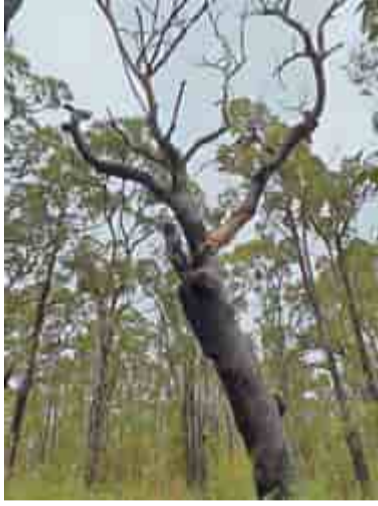
4287	Dead	3	90	Main trunk snapped at 17m. Potential for chimney hollow formation.	413166.0407	6354435.378

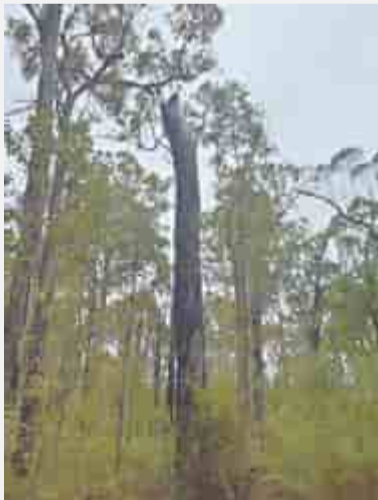
Merge Tree Number	Species	Class Bamford	DBH (cm)	Hollow Comments	Easting (AGD84/AMG zone 50)	Northing (AGD84/AMG zone 50)	Images
4342	Dead	3	70	Has two >10 cm potential spout hollows. Appear undeveloped as sides are uneven and no signs of wear, however can't confirm firm.	413186.5579	6354532.273

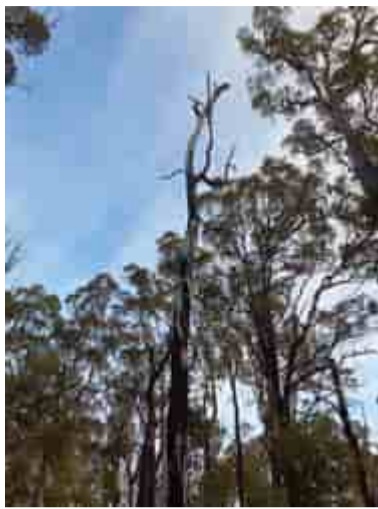
4350	Jarrah	3	150	Several large snapped upwards facing branches with potential to contain hollows. Branches of sufficient size to develop BC size hollow. Think unlikely developed.	413189.5181	6354625.533

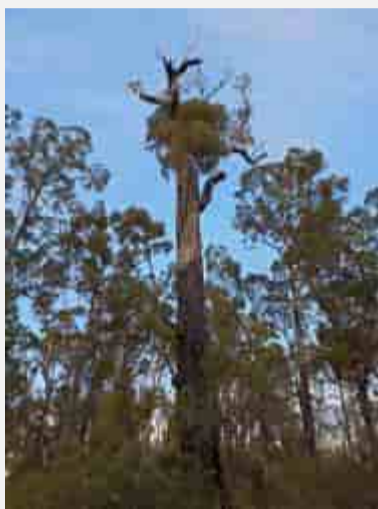
4380	Dead	3	120	One >10 cm potential spout hollow, my vision obstructed by surrounding branches and leaves so cannot confirm. Also have several broken branches in canopy with undeveloped hollows	413199.3463	6354216.08	 
4414	Jarrah	3	60	Has >20 cm potential slit hollow about 40 m above ground with potential signs of wear	413210.6312	6354497.151	 
4458	Marri	3	110	One large upwards facing branch potentially develop chimney hollow. Some stocks visible at top, think unlikely developed	413225.7639	6354175.24

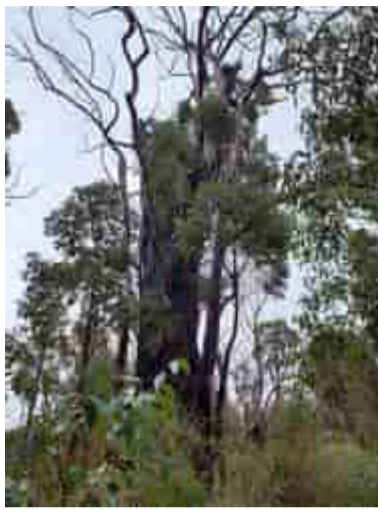
5142	Dead	3	100	Tony. Dead marri. Trunk snapped at 18m. Potential side entry hollow 40cm opening at 15m. Also Potential chimney hollow at top. Suitable size to support BC hollow	412601.0664	6355362.797	
5176	Dead	3	110	Tony. Snapped off tree at about 35 m. has potential >20 cm chimney hollow with smooth edges. No chew marks present.	412641.5251	6355483.396

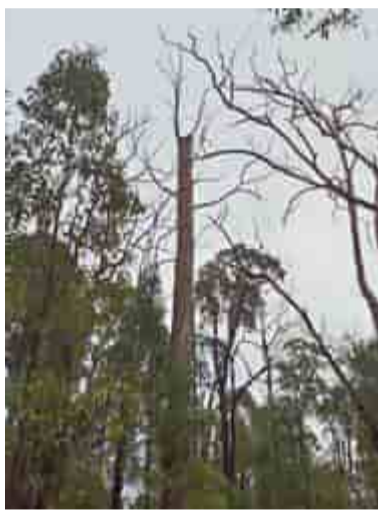
5202	Dead	3	90	Has several burnt out branches with undeveloped hollows. One appear to be >10cm spout hollow about 20 m above ground however it is has an obstructed entry	412675.9756	6355486.783

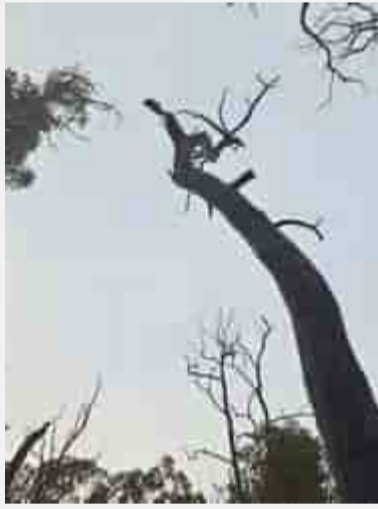
5328	Marri	3	120	Tony. Likely chimney hollow in snapped trunk at 14m. Rim smooth and narrow looking. Trunk suitable diameter to have BC hollow	412807.2034	6355213.29

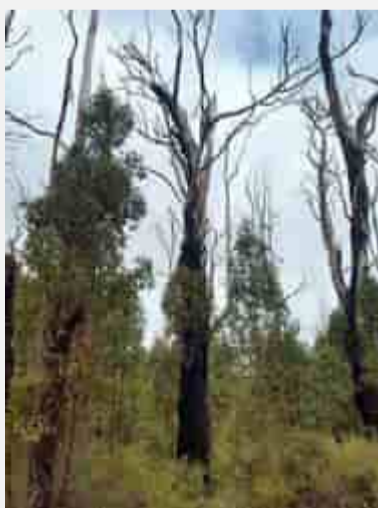
5390	Dead	3	120	One >10 cm mid branch hollow up top in the canopy about 40 m up. Has	412625.1367	6354781.346

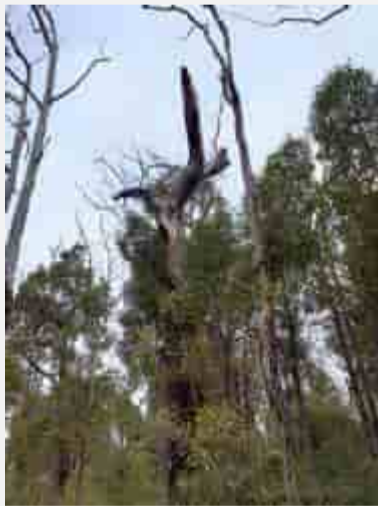
5430	Dead	3	90	Tony. Has one >20 cm spout hollow ~30 m up, smooth bottom edge. No chew marks visible. Also one broken branch appears undeveloped. Also one bid open mid trunk, obstructed by shoots.	412692.0104	6355139.285

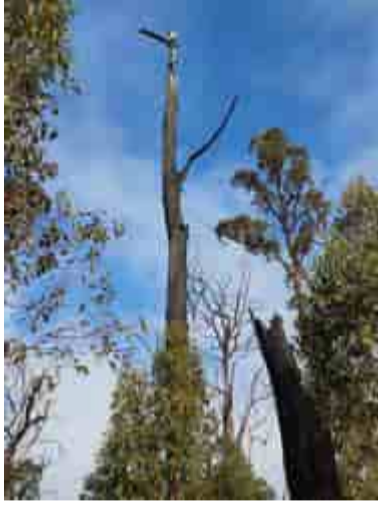
5564	Dead	3	190	One >15 cm potential knot hollow about 20 m above ground that appears to be shallow and become narrower, however cannot confirm from ground. Also have other large branches in canopy that appears undeveloped	412838.0279	6354674.81

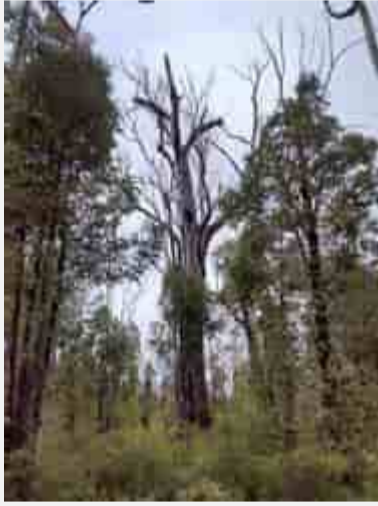
5597	Dead	3	100	Has one ~15 cm potential knot hollow that is upwards facing ~35 m above ground. Has smooth edges but can't confirm if chew marks are present. Also have broken branches in canopy with undeveloped hollows	412851.9145	6354429.892

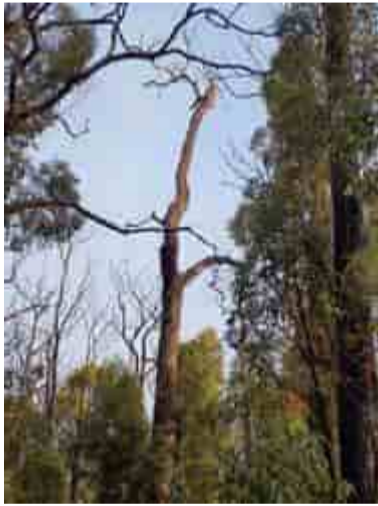
5655	Dead	3	110	Has one >10 cm potential spout hollow ~20 m above ground, slightly upwards facing so cannot confirm. It has rough edges and no visible chew marks or other signs of wear. Also have one <10 cm spout hollow and other broken branches with undeveloped hollows	412889.8701	6354456.032

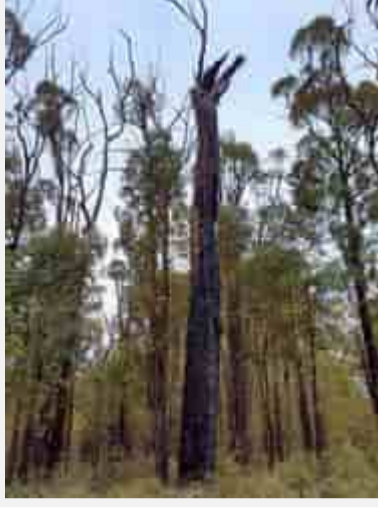
5844	Dead	3	60	Burnt and snapped off tree, potential >10 chimney hollow at ~15 m up. Also potetial >10 cm knot hollow at ~10 m.	411655.1644	6355062.744

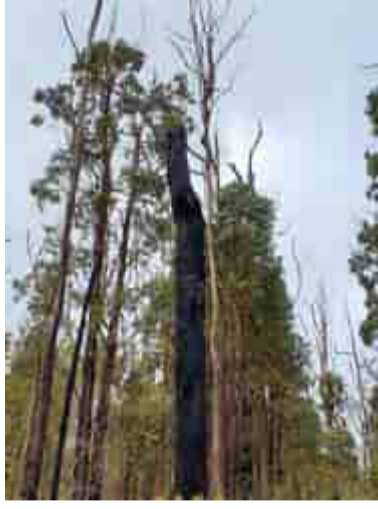
5857	Dead	3	105	One side entry hollow at 8m off ground. 40cm opening. Bottom edge looks thin with wear. Large burnt out upper branches. Potential spout hollows. Not preferred angle.	411679.9305	6354995.094

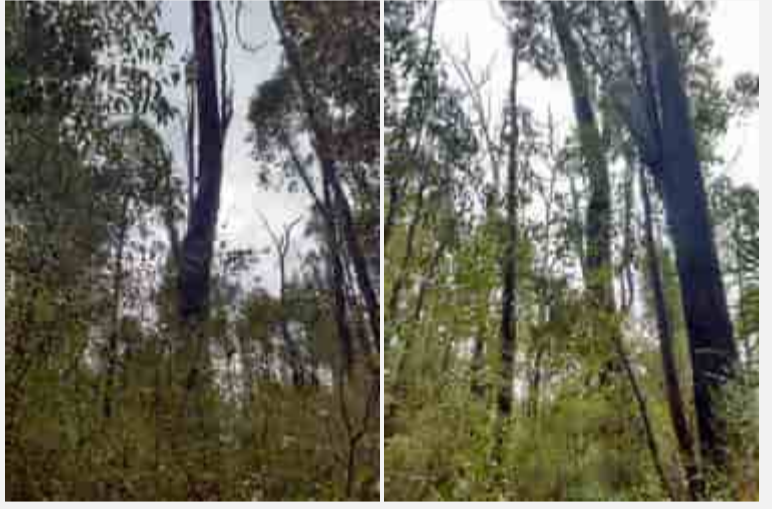
5911	Dead	3	110	Broken branches in canopy with undeveloped hollows	411753.3045	6355080.002	
5979	Dead	3	90	Dead trunk snapped at 16m. Potential for two chimney hollows at top. Can't confirm. No evidence of clear rim forming.	411834.4453	6354959.088

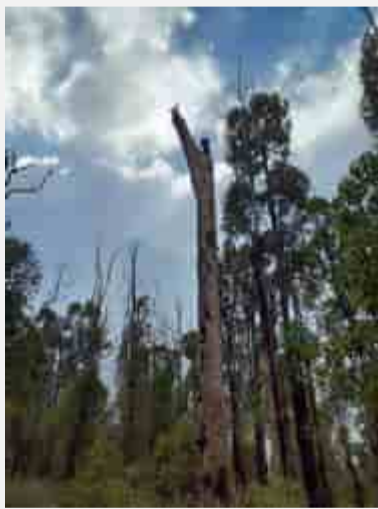
5989	Marri	3	100	One upwards opening 15cm entry knot hollow at 15m going into main trunk. Think unlikely to haave BC size chamber. Upper trunk dead with large snapped branches	411847.4197	6354919.265

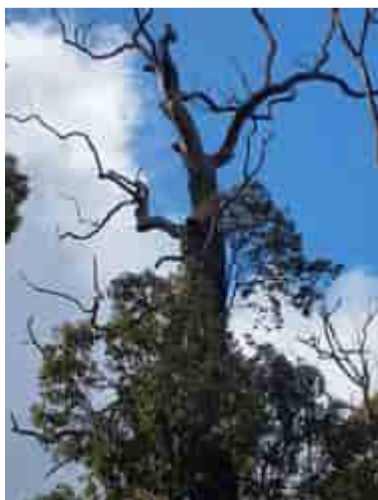
Merge Tree Number	Species	Class Bamford	DBH (cm)	Hollow Comments	Easting (AGD84/AMG zone 50)	Northing (AGD84/AMG zone 50)	Images
6069	Dead	3	120	Potential >10 cm spout hollow ~15 m up, upwards facing so cannot confirm. edges are somewhat smooth but no chew marks visible. Also broken branches at top with undeveloped hollows	412564.7814	6355071.047

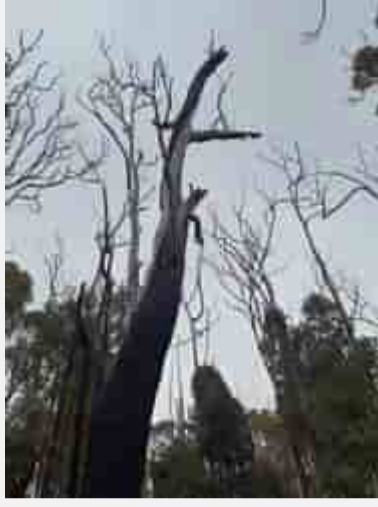
6084	Jarrah	3	100	Has one potential >10 cm hollow in fork ~30 m up. The opening travel down the trunk about 10 cm, smooth edges but no visible chew marks. Opening obstructed by minor branch and leaves. Also broken branches with undeveloped hollows	412605.8003	6355103.978

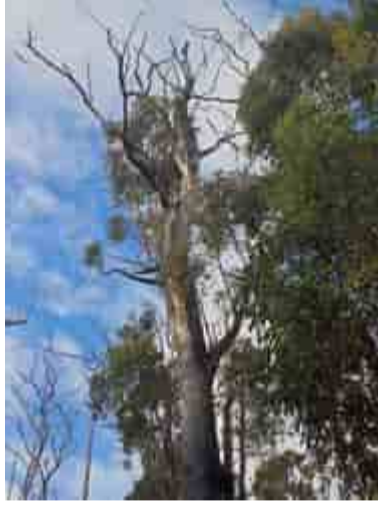
6096	Dead	3	70	Has one >10 cm mid branch hollow ~30 m up and one >10 cm knot hollow ~25 m up that is obstructed by loose bark. Also have a broken branch with undeveloped hollows	412633.0679	6355043.042

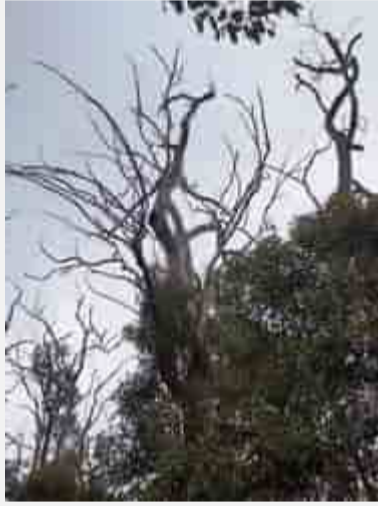
6120	Jarrah	3	130	Large dead central trunk snapped at 15m. One upwards opening hollow 25cm entry top main trunk. Also potential for two 20cm opening spout hollows. Think unlikely developed to depth	412673.1962	6354925.447

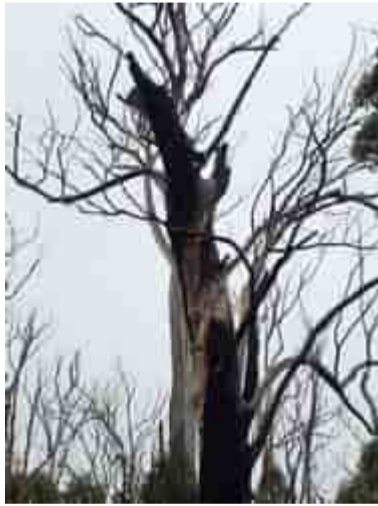
6153	Dead	3	70	Has one >10 cm potential spout hollow ~15 m up. It's burnt out can't confirm if present. smooth edges but no visible chew marks	412735.8675	6355051.648

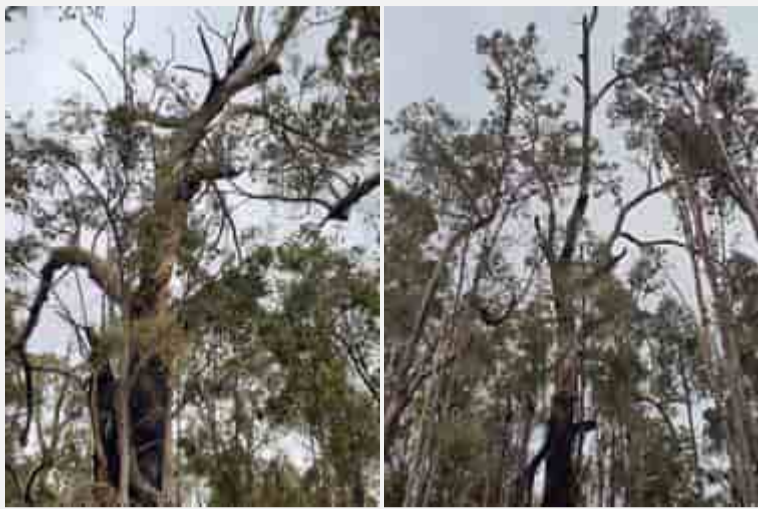
6501	Dead	3	80	Has one potential >10 cm spout hollow 15-20 m up, upwards facing and can't confirm from ground. It has rough edges and no signs of wear. Also several undeveloped hollows from broken branches.	413955.4982	6348889.289

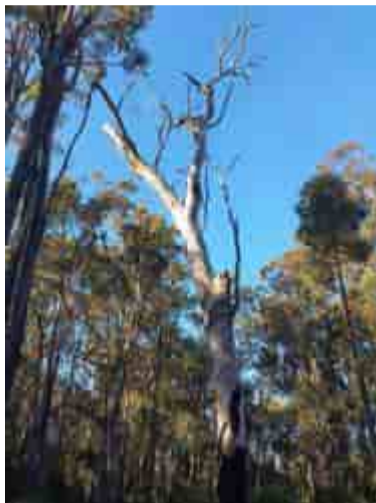
6502	Dead	3	175	Has three >20 cm potential spout hollow up top in canopy approx 20 m up. No signs of wear or chew marks, all have rough edges.	413989.0769	6348915.749

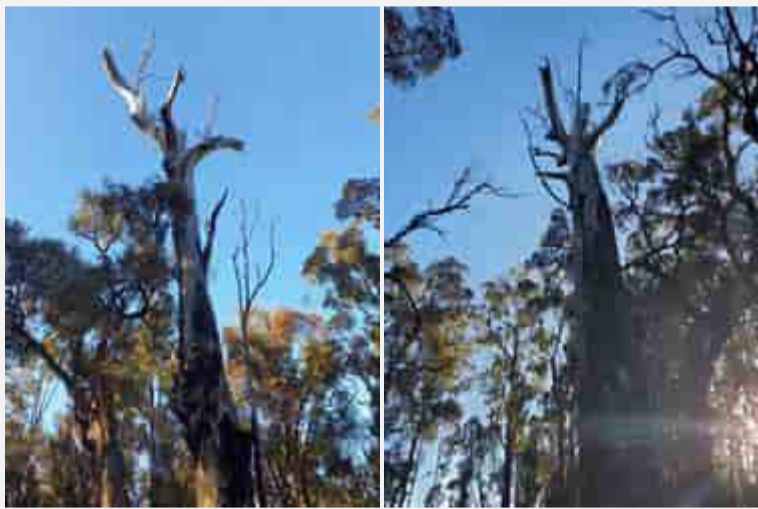
6579	Jarrah	3	160	One 10cm upward facing entry in dead side branch at 18m. Branch diameter is 30 cm. Think highly unlikely forming BC size chamber.	412932.3815	6350739.773

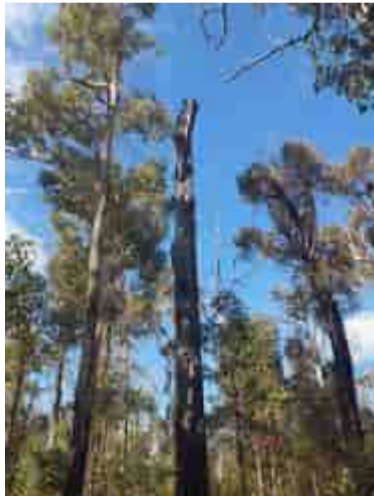
7503	Dead	3	70	Snapped off tree at 20-25 m. pote tialy >20 cm chimney hollow. Rough edges nut can't co firm from ground.	415794.057	6354312.521

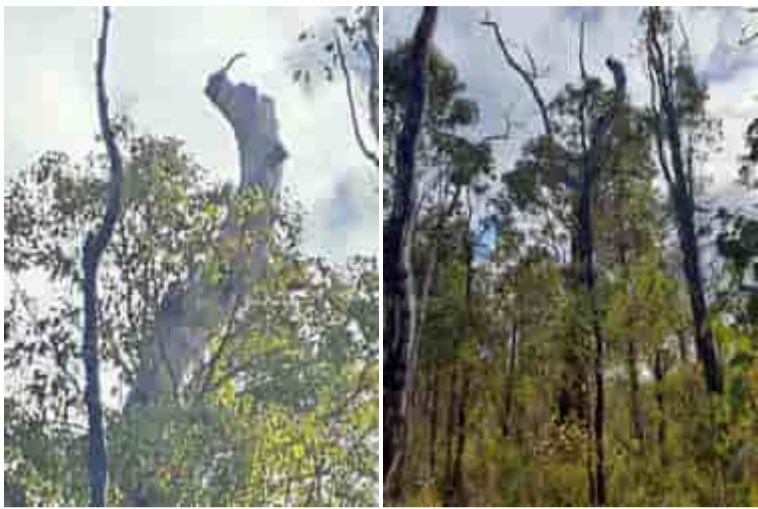
7808	Marri	3	90	Dead central trunk. Snapped at 10m. Potential chimney hollow in 40cm diameter top. Edge of rim looks thin but jagged. Should be checked from top	416023.0452	6354766.769

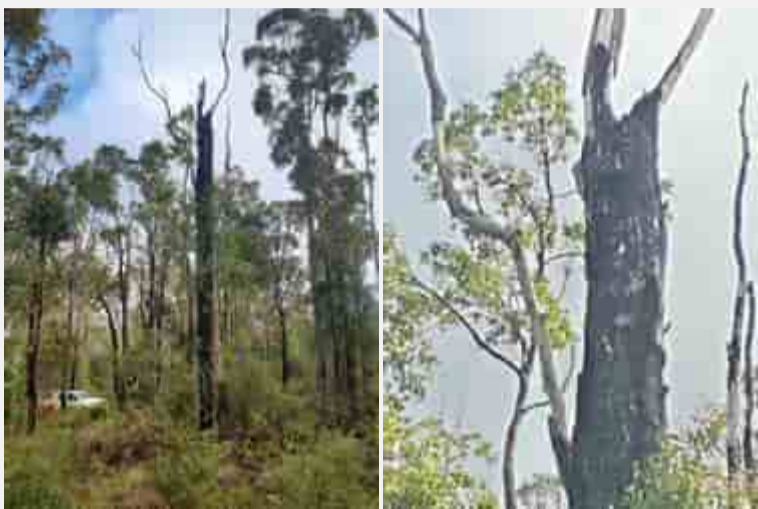
7844	Jarrah	3	100	One potential >10 cm slit hollow along a branch in canopy, can't confirm if developed depth. Also two >10 cm broken branches with hollows	416095.4501	6354882.908

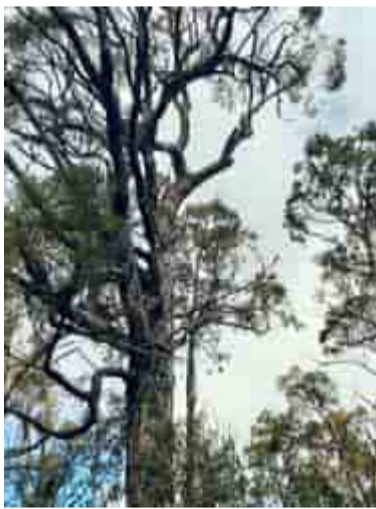
7850	Dead	3	120	One >10 cm potential spout hollow ~30 m up, can't confirm. One <10 cm knot hollow ~20 m up. One large undeveloped knot hollow from broken branch at ~25 m	416108.8225	6354854.394

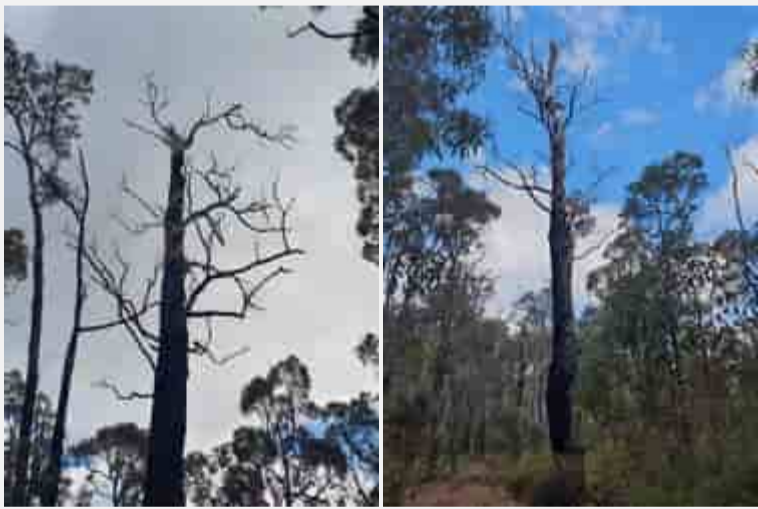
7851	Dead	3	100	Has two larger broken branches that are burnt out. One has a crack along the side. The other can potentially be a spout hollow, can't confirm from ground.	416110.073	6354899.96

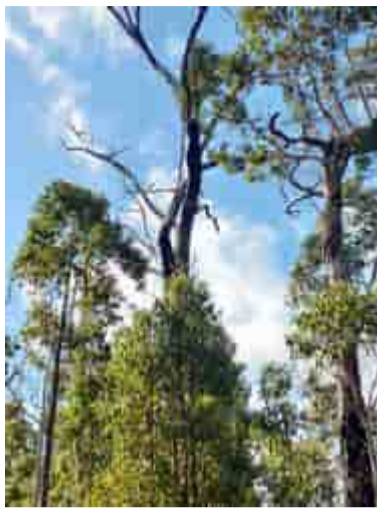
7964	Marri	3	95	Tony. 40cm side entry hollow opening at 10m in damaged main trunk. Rim of hollow smoothed off and we'll defined. Can see back of hollow angle forward. Potential not developed to depth.	416472.8923	6352433.706

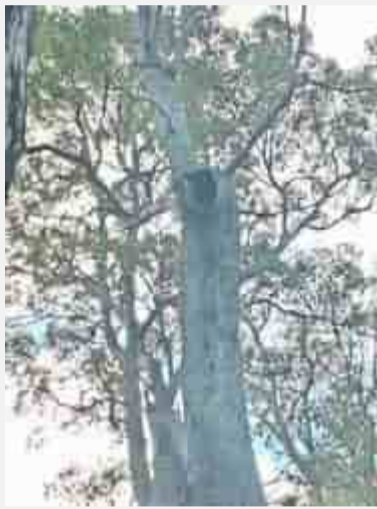
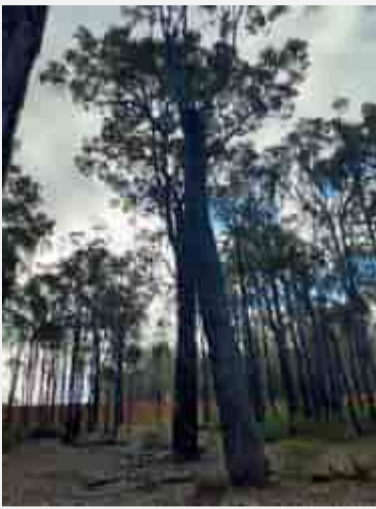
7967	Marri	3	90	. Tony. Main trunk old break at 10m. 50cm diameter chimney type opening present. Edges of hollow are thin with vertical cracks and parts where edge of hollow has broken. Potential to be too open to be suitable.	416478.1277	6352439.14

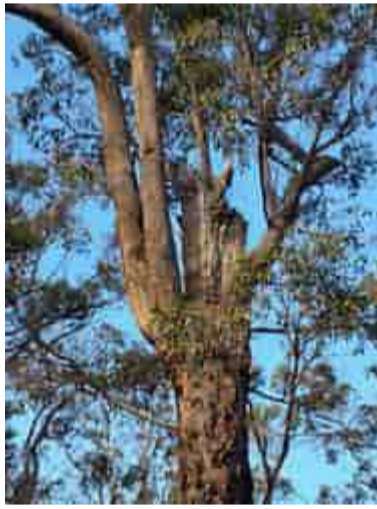
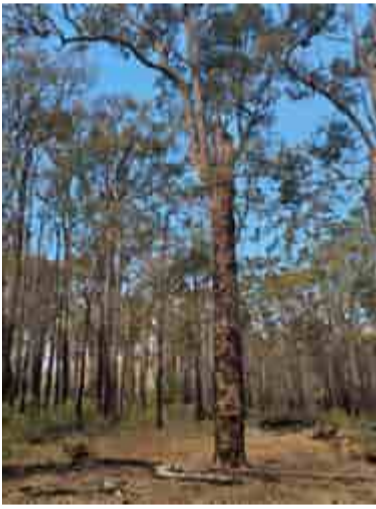
7989	Jarrah	3	115	One well defined 20cm side entry hollow in main trunk at 15m. Edges rounded and smooth. Potential for upwards facing hollows in two large snapped off branches	416515.2279	6355306.907

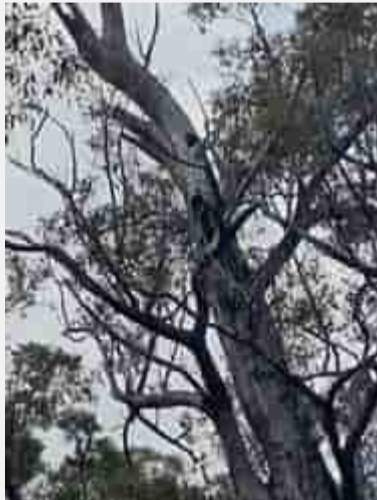
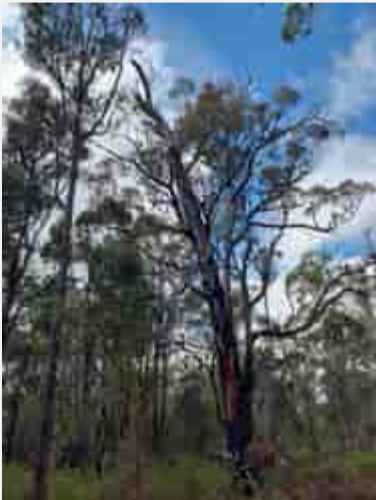
Merge Tree Number	Species	Class Bamford	DBH (cm)	Hollow Comments	Easting (AGD84/AMG zone 50)	Northing (AGD84/AMG zone 50)	Images
8025	Dead	3	70	Potential chimney hollow 40cm diameter branch. Rim is thin. Think unlikely developed hollow but can't confirm	416579.0215	6355241.372	
8036	Jarrah	3	110	Mallee with 110 cm DBH Has one >10 cm knot hollow 10-15 m up. Smooth edges but can't confirm from ground. Trunk with 95 cm DBH has one <10 cm mid branch hollow and broken branches with undeveloped hollows	416618.7143	6352347.599	
8043	Dead	3	70	Potential suitable >20 cm chimney hollow from snapped off tree at ~20 m. no signs of wear or chew marks.	415739.95	6354405.293	
8056	Marri	3	100	Potential >10 cm fork hollow 25-30 m up, can't confirm. where visible, it appears to have rough edges, potential cup formation	416027.3841	6352278.012

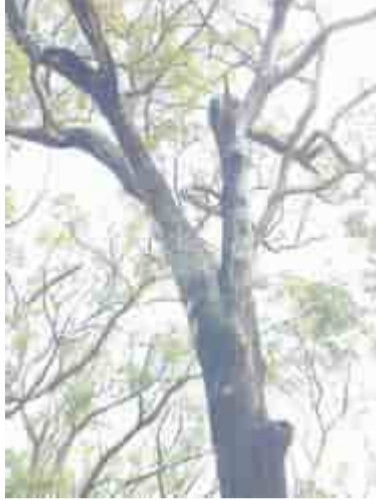
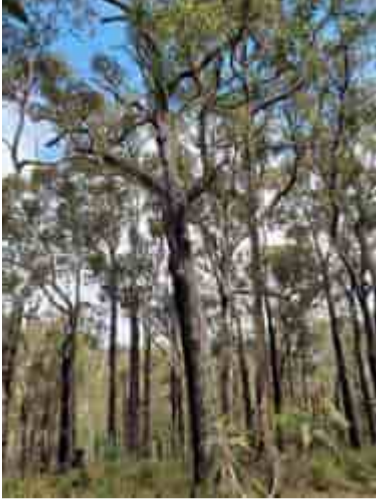
8076	Dead	3	140	Two potential >10 cm spout hollows 20-25 m up, can't confirm from ground	416054.368	6352229.793

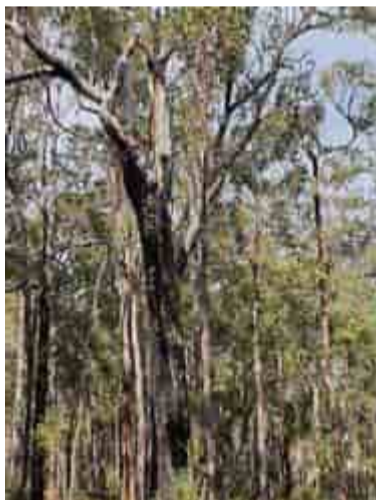
8092	Jarraah	3	100	One potential >10 cm knot hollow ~15 m up. Has rough edges and appears to have wood coming out of it. Also have one >10 cm knot hollow ~20 m up and broken branches scattered.	416079.1834	6352311.827
