Appendix 39 Black Cockatoo Targeted Assessment 2023 – Willowdale

WESTERN
ENVIRONMENTAL

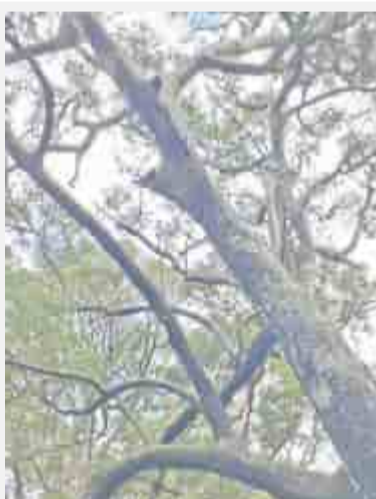
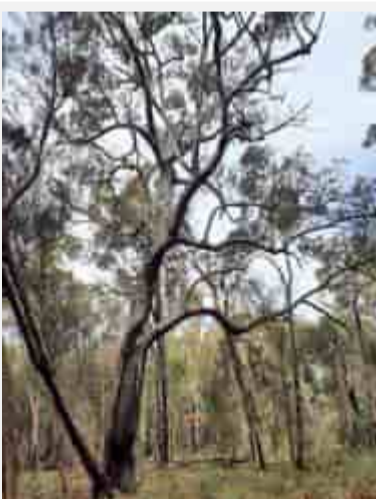
8096	Jarraah	3	115	One >10 cm knot hollow ~10 m up and a few broken branches with undeveloped hollows in canopy	416083.3139	6352184.124

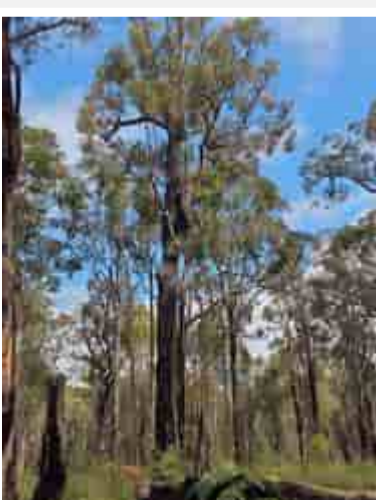
Merge Tree Number	Species	Class Bamford	DBH (cm)	Hollow Comments	Easting (AGD84/AMG zone 50)	Northing (AGD84/AMG zone 50)	Images
8101	Jarraah	3	90	One potential >10 cm knot hollow 15-20 m up. Upwards facing so cant confirm. Also two potential <10 cm knot hollows, upwards facing so can't confirm.	416091.3254	6352224.838

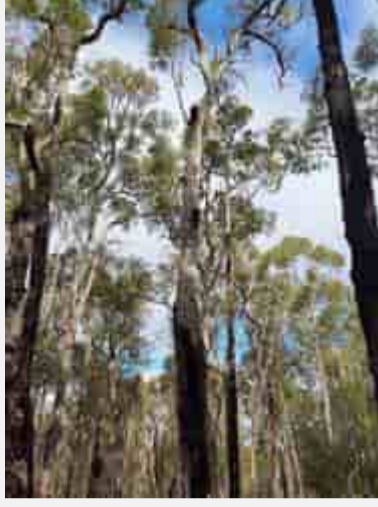
8108	Jarraah	3	95	Tony. Has three >20cm (two mid branch and one knot) hollows 20-25 m up. All has semi smooth edges. Also broken branches with undeveloped hollows and two <10 cm hollows.	416103.648	6352224.437

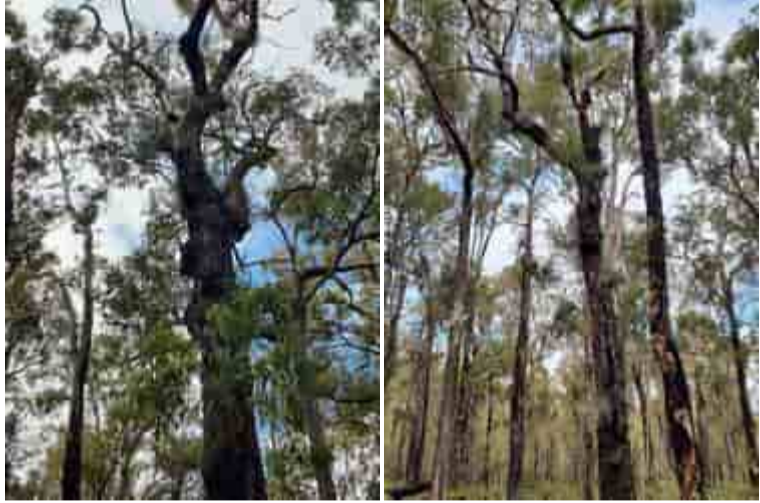
8111	Jarraah	3	105	One pote tial >10 cm hollow 20-25 m up. Can't confirm. Also broken branches and undeveloped knot hollows along the trunk. One <10 cm knot hollow ~30 m up.	416104.7795	6352183.771

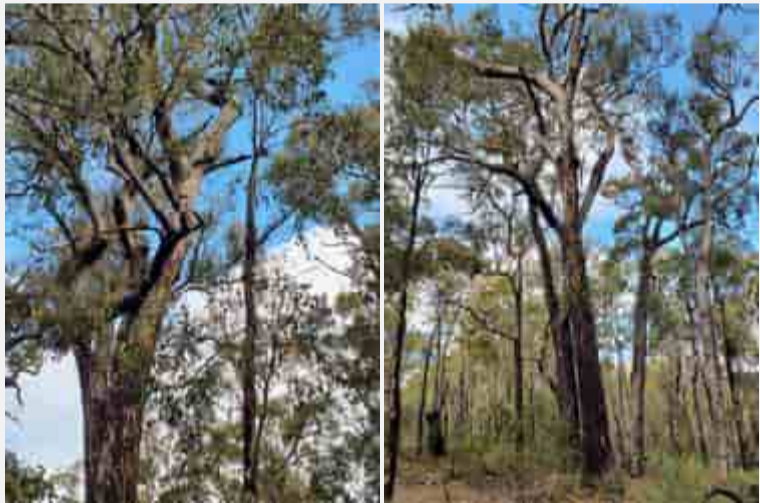
8116	Jarraah	3	210	Tony. One well defined 18 cm side entry hollow opening in 50 cm diameter branch at 15m. Snapped branches with shallow and small spout type hollow forming.	416112.9196	6352335.585

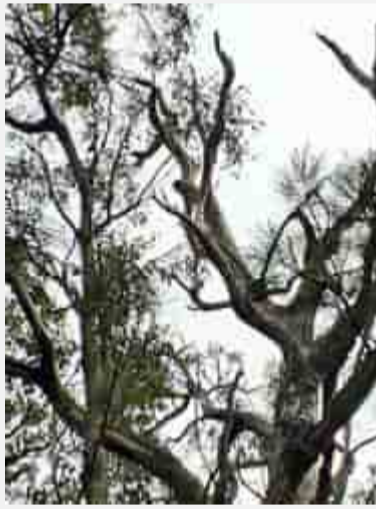
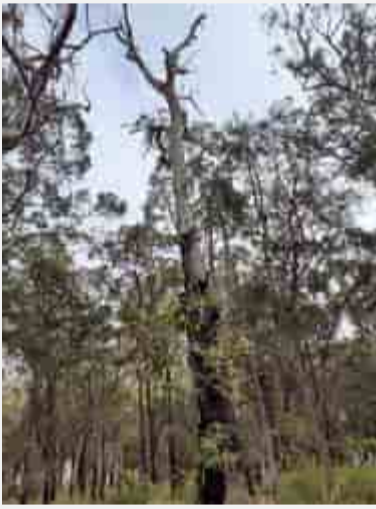
8557	Jarrah	3	120	One potential >10 cm spout hollow ~30 m up, upwards facing so cant confirm. Has rough edges. below it's a <10 cm knot hollow. Also other broken branches with undeveloped hollows in canopy	416335.9026	6352471.457

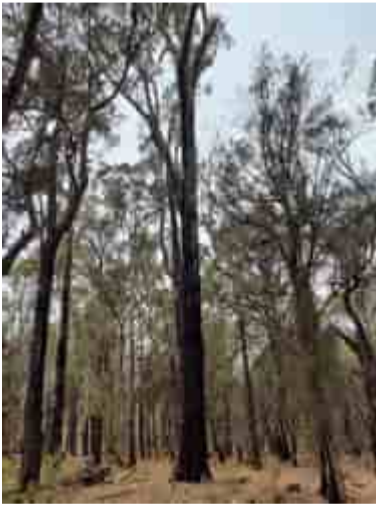
8581	Jarrah	3	150	One >10 cm mid trunk hollow~10 m up with smooth edges. One pote tial >10 cm knot hollow ~15 m up, has rough edges. Can't confirm depth from ground. Also have broken branches with undeveloped hollows	416351.0917	6352152.203

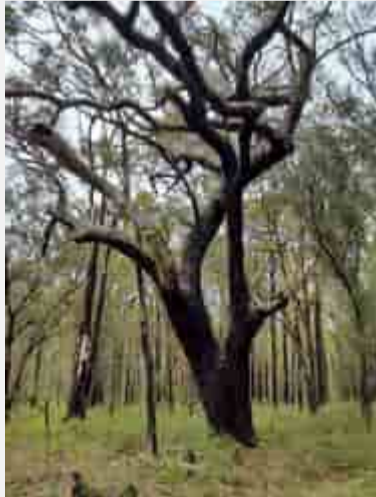
Merge Tree Number	Species	Class Bamford	DBH (cm)	Hollow Comments	Easting (AGD84/AMG zone 50)	Northing (AGD84/AMG zone 50)	Images
8601	Dead	3	125	One potential tial >10 cm slit hollow 15-20 m up, can't confirm depth from ground. Also have broken branches with undeveloped hollows	416370.4219	6352123.794

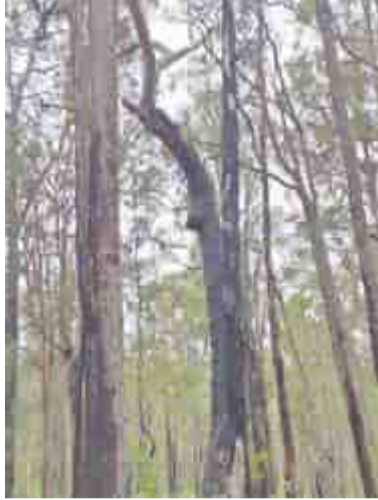
8603	Jarrah	3	135	Two potential >10 cm spout hollows, one ~30 m up and the other ~20 m up. Both has rough edges and no signs of wear however can't confirm from ground. Also have other broken branches with undeveloped hollows	416371.6782	6352371.65

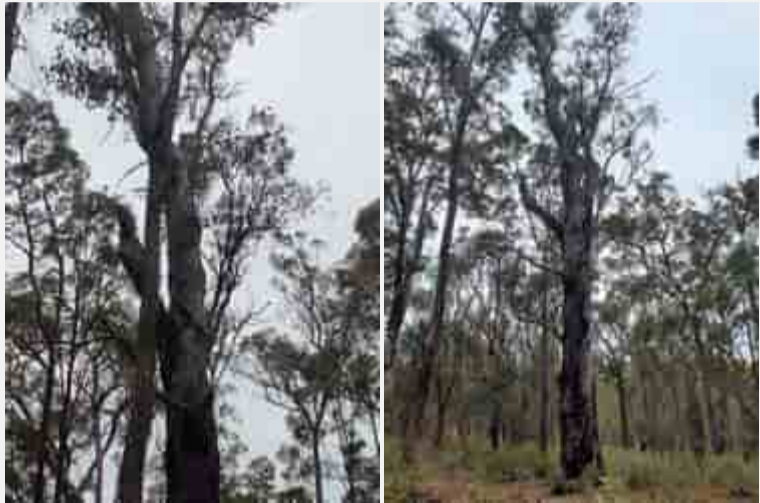
8672	Marri	3	85	Dead central trunk snapped at 8m. Has chimney opening 30cm diameter at top. Can see rim is thin and wall thin in upper sections indicates hollow. Joins to sideways trunk section 40 cm below. Think likely shallow and ends at join	415689.22	6352445.667

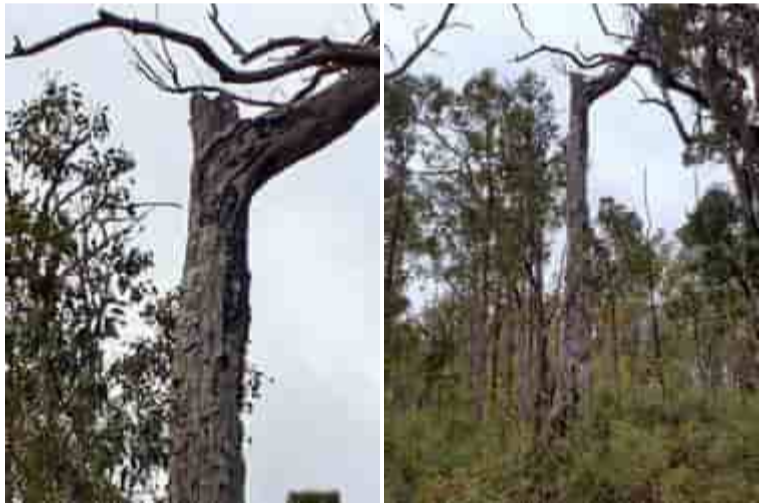
8734	Jarrah	3	80	One 10x15 cm side entry opening in 25cm diameter branch at 20m upper canopy. Entry rim looks well defined smooth and worn at base. Think branch is likely too small to support BC chamber development	415817.5527	6352447.155

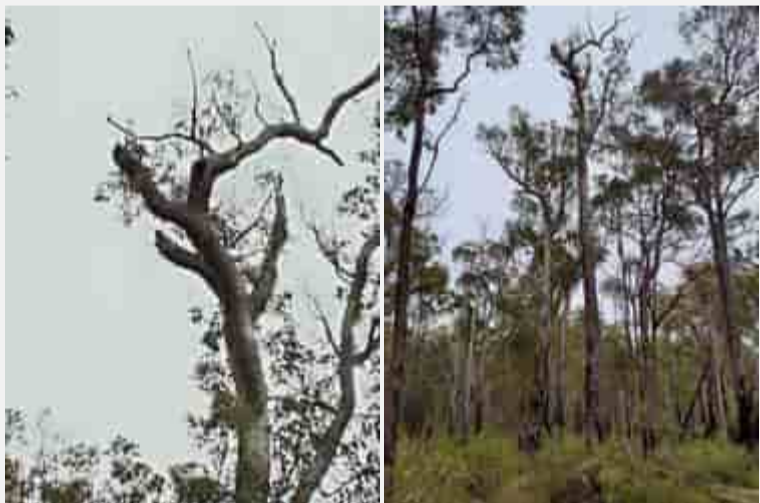
8737	Jarrah	3	100	One side entry 20x30cm opening mid main trunk at 14m. Well defined smooth rim. Second 20x40cm opening 1m below. Can see back looks shallow. Think unlikely openings developed into chamber with depth	415825.6337	6352349.901

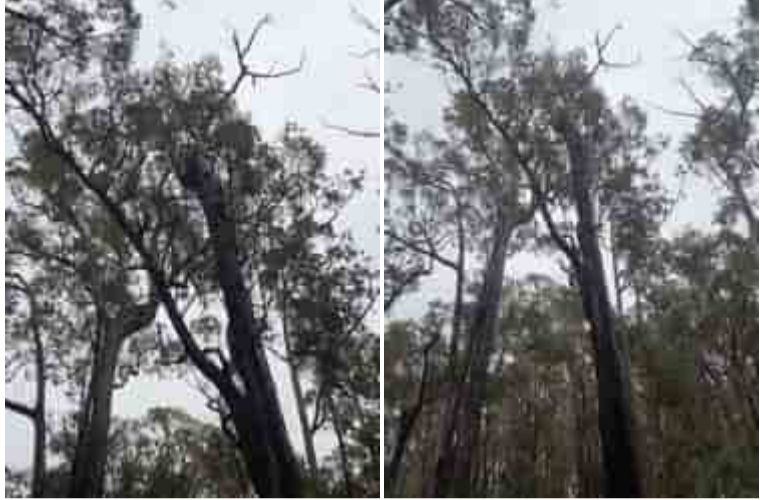
8820	Jarrah	3	85	One potential ~10cm mid branch hollow 25 m up, can't confirm. No signs of wear and the edges are somewhat smooth. Also broken branches with undeveloped hollows in canopy	415960.9266	6352337.114

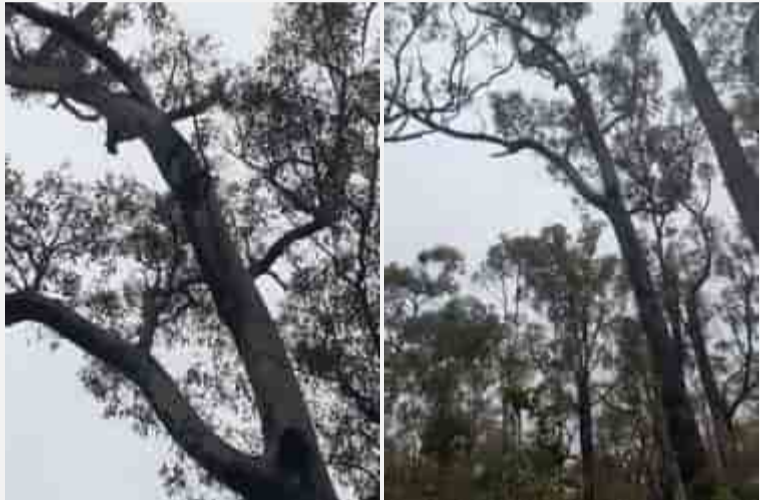
8823	Jarrah	3	135	One large cup formation ~6 m up filled with debris. one potential >20 cm hollow 25-30 m up, it's hidden by branches so cant confirm. Edges appears rough and a large crack running along the top wall appears to be present. Also broken branches with undeve	415969.122	6352368.555

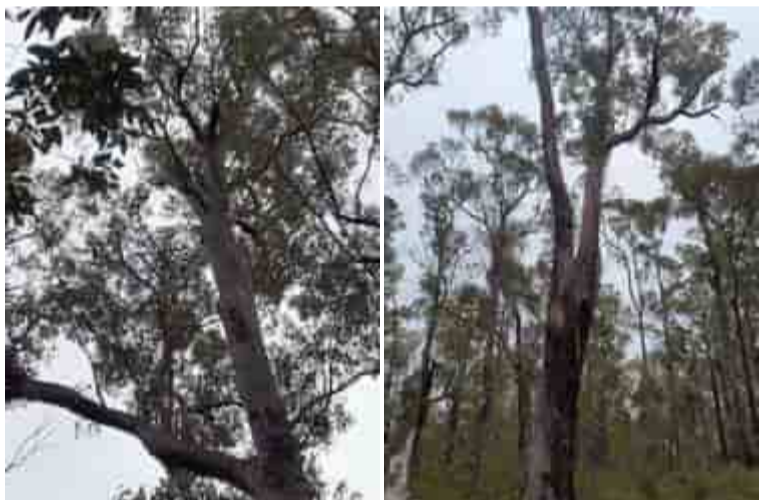
8826	Jarrah	3	130	One >10 cm spout hollow 15-20 m up, has smooth edges. One >20 cm mid trunk hollow 10-15 m up. Smooth and thin edges, potentially too close to ground. broken branches with undeveloped. Burnt out branch, pot. hollow	415974.3859	6352340.489

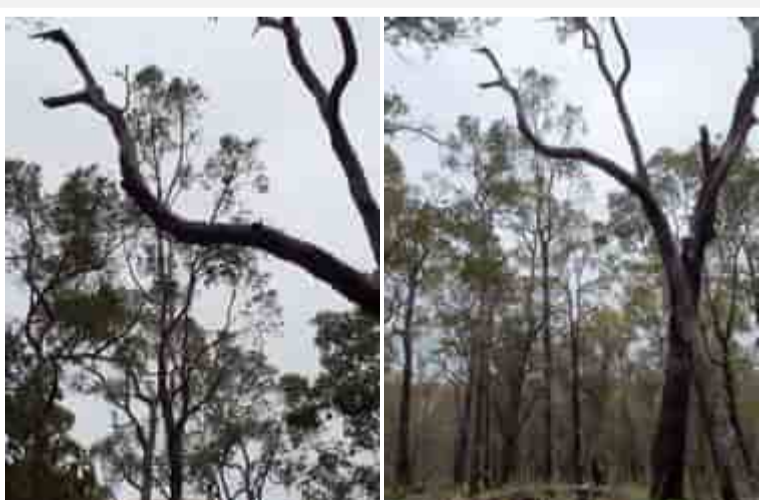
8837	Dead	3	85	One >10 cm mid branch hollow ~20 m up. It has smooth edges but no signs of wear. Also broken branch with undeveloped hollows.	415991.7023	6352175.228

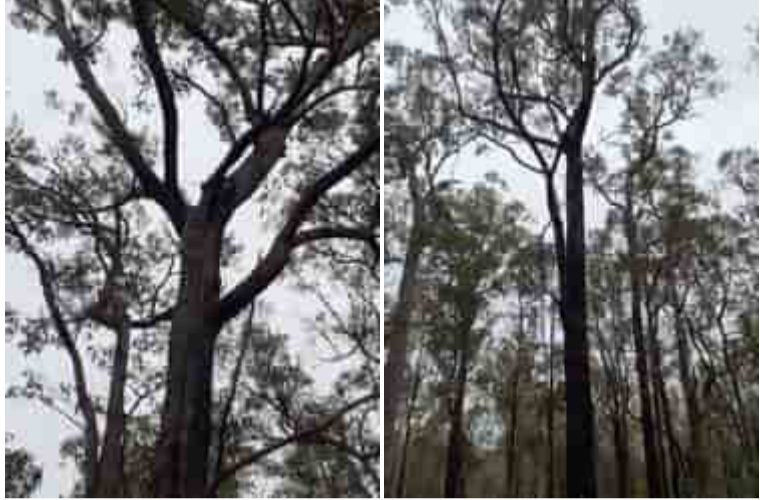
9186	Jarraah	3	110	One >10 cm broken branch with potential spout hollow 15 m up, cant confirm. Appears unlikely to be well developed, edges are very rough. Also a few <10 cm knot and spout hollows in canopy and broken branches.	416484.4253	6352902.287

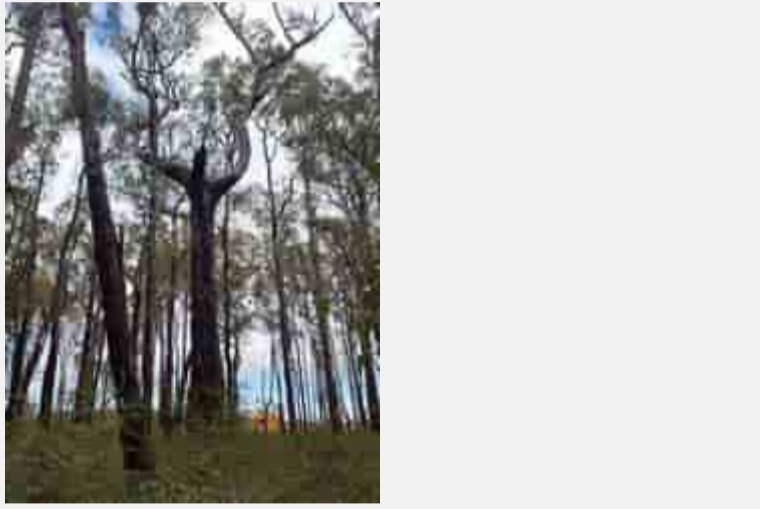
9194	Jarraah	3	100	One potential >10 cm spout hollow 20 m up. Appears to have thin walls but rough edges. Upwards facing so can't confirm,	416491.2149	6352914.671

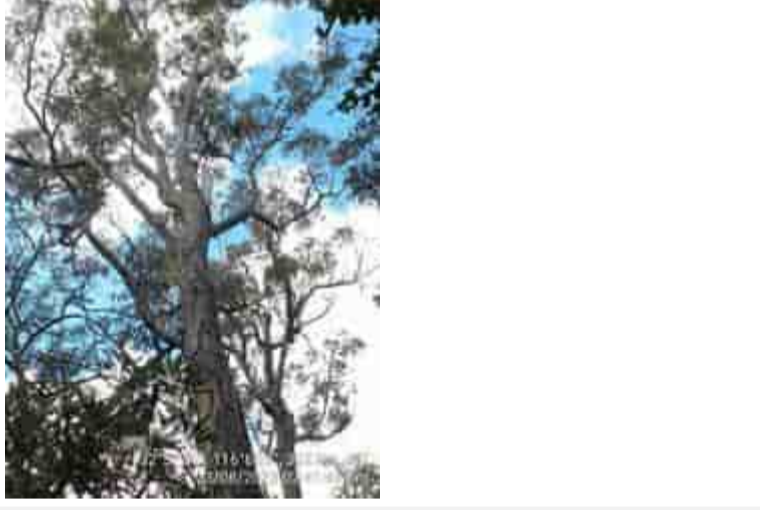
9196	Jarraah	3	120	Two 17cm side entry knot opening. Lower at 8m looks shallow, upper at 15m well defined with smooth rim and wear at base. Think unlikely developed to BC hollow depth.	416492.6607	6352986.302

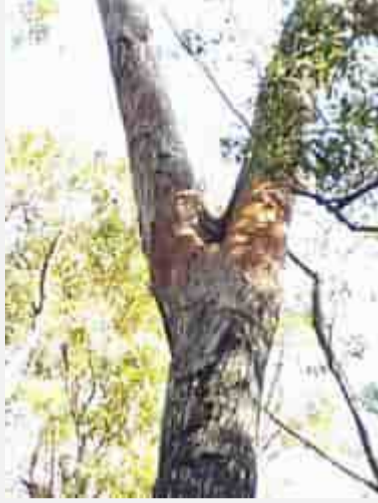
10020	Dead	3	240	Appears to have a cup formation 25 m up from snapped off tree top. Also potential >30 cm knot hollow 20 m up from broken off branch. No evidence of wear and bottom on entrance is rough.	416918.8818	6352418.613	   
10036	Dead	3	90	One potential >20 cm chimney hollow 30 m up. Edges are rough and the walls appears thin. No signs of wear. Can't confirm from ground.	416934.8983	6352589.607

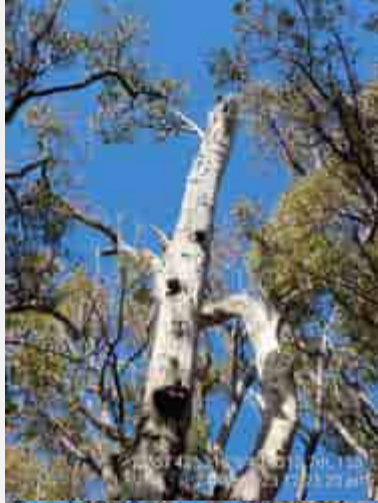
10104	Marri	3	60	Snapped off tree at 15 m potential >10 cm chimney hollow. Walls appear thin however the edges are rough and have no signs of wear. ~50 cm down is a broken branch with an undeveloped hollow	416997.682	6352529.838

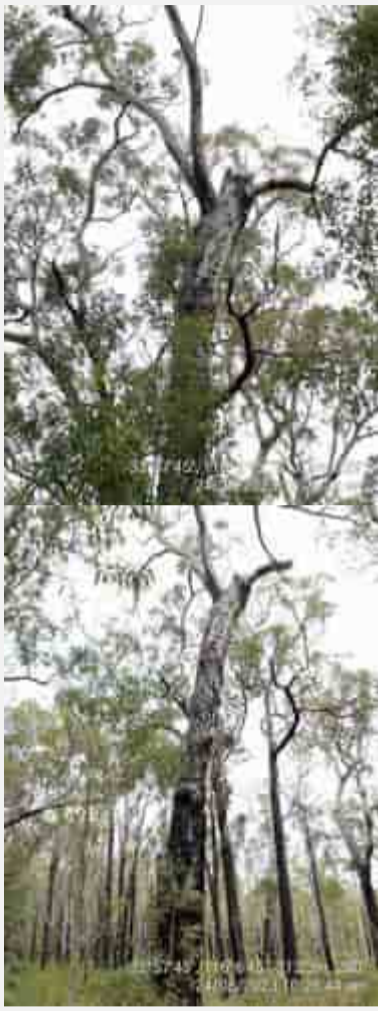
10252	Jarrah	3	70	Tony. Potential >20 cm chimney hollow 20 m up from snapped off tree top. edges are somewhat smooth and appear relatively thin. Can't confirm from ground.	417078.7152	6352490.493	 
-------	--------	---	----	---	-------------	-------------	---

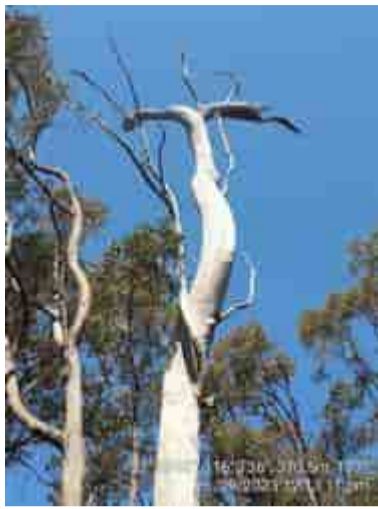
10586	Marri	3	160	Snapped trunk with >30cm chimney hollow. Chew from BC at entrance. BC observed chewing hollow edge. Departed in group. Think prospecting rather than nesting	412351.0873	6352053.565

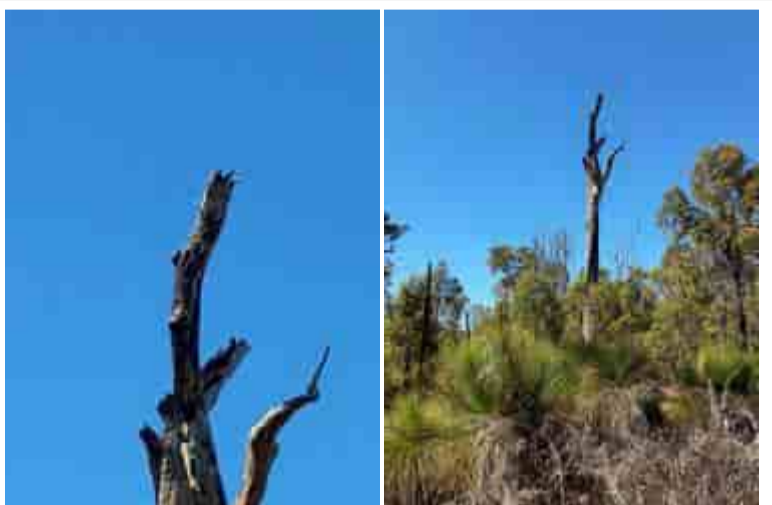
Merge Tree Number	Species	Class Bamford	DBH (cm)	Hollow Comments	Easting (AGD84/AMG zone 50)	Northing (AGD84/AMG zone 50)	Images
10591	Jarrah	3	90	30cm spout opening at 15m in 45 cm diameter branch. At 30 degrees Blackened and burnt. Think unlikely hollow deep and angle not preferred	411169.7156	6353721.328

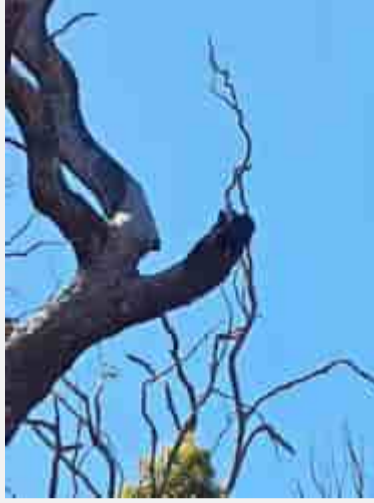
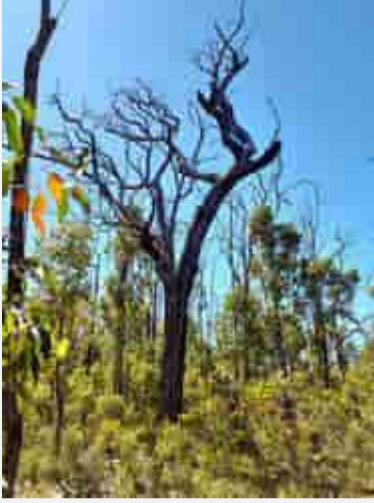
10592	Marri	3	90	Tony. Dead central trunk. 25-30cm upwards facing opening in 40cm diameter branch. At 60 degrees angle. 12m up. Rim thin hollow appears present	410992.1175	6353964.406

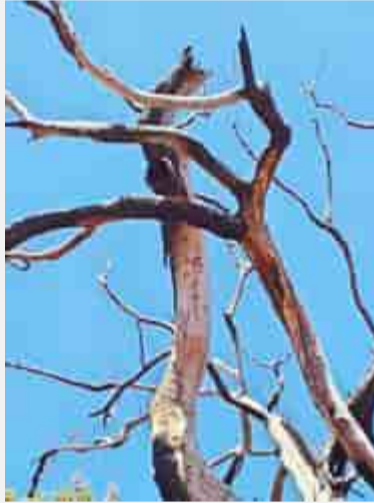
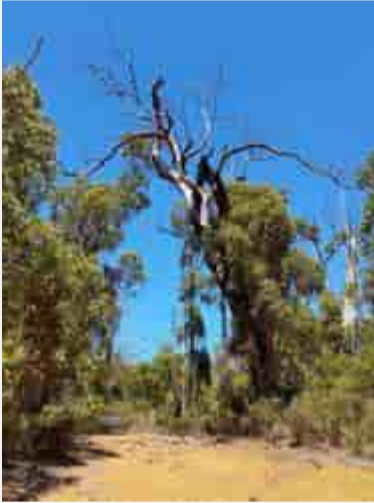
10594	Marri	3	70	Chimney hollow 40cm diameter at 10m in dead central trunk. Partially burnt out and collapsed. Think unlikely developed deep hollow in remaining trunk sections	411027.1315	6353870.343	
10595	Marri	3	80	Chimney hollow entry 15cm in 25cm diameter branch at 12m. Advanced decomp and white ant mud visible. Think unlikely developed suitable chamber	412306.1259	6350008.554

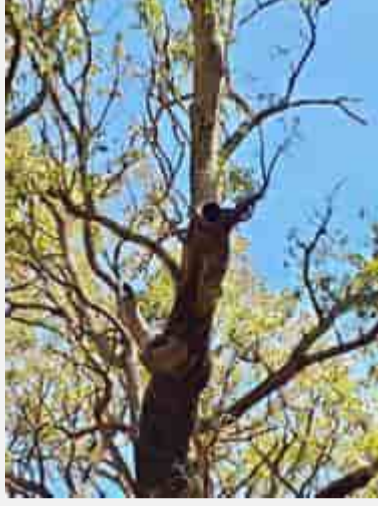
10604	Dead	3	80	Chimney opening 20cm in 30cm diameter trunk. Has wear marks around rim. Also wear marks in tree forks. Potential roosting tree ?	414057.608	6352490.975

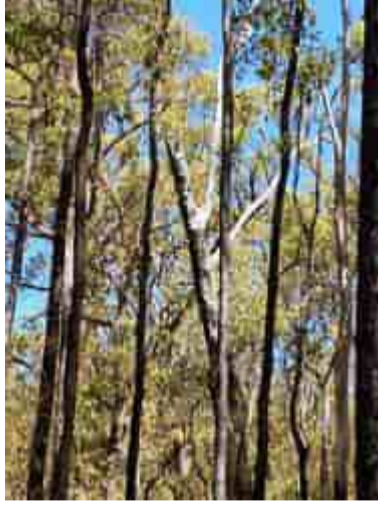
10605	Jarrah	3	120	Tony. 25cm upwards facing hollow in knot mid main trunk at 12m. Rim well defined with wear marks	414232.6364	6352414.488

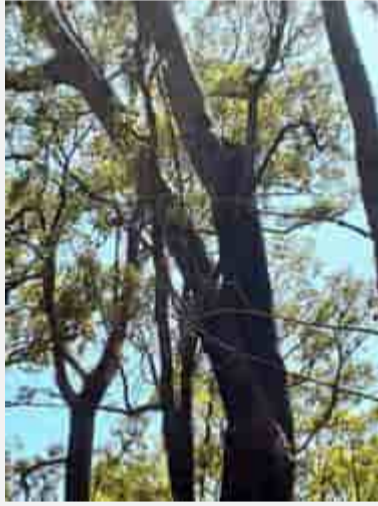
10613	Marri	3	105	Tree snapped at 10 m. Potential for chimney hollow 30cm. Does not appear to be developed	413115.7231	6352031.508	
10616	Jarrah	3	90	One mid trunk 15-20cm upwards knot hollow. Can't tell depth	412955.9962	6352009.238	
10617	Jarrah	3	150	Several potential 30 cm upwards opening entrances. Can't estimate depth. Sig tree.	412582.3365	6352049.282

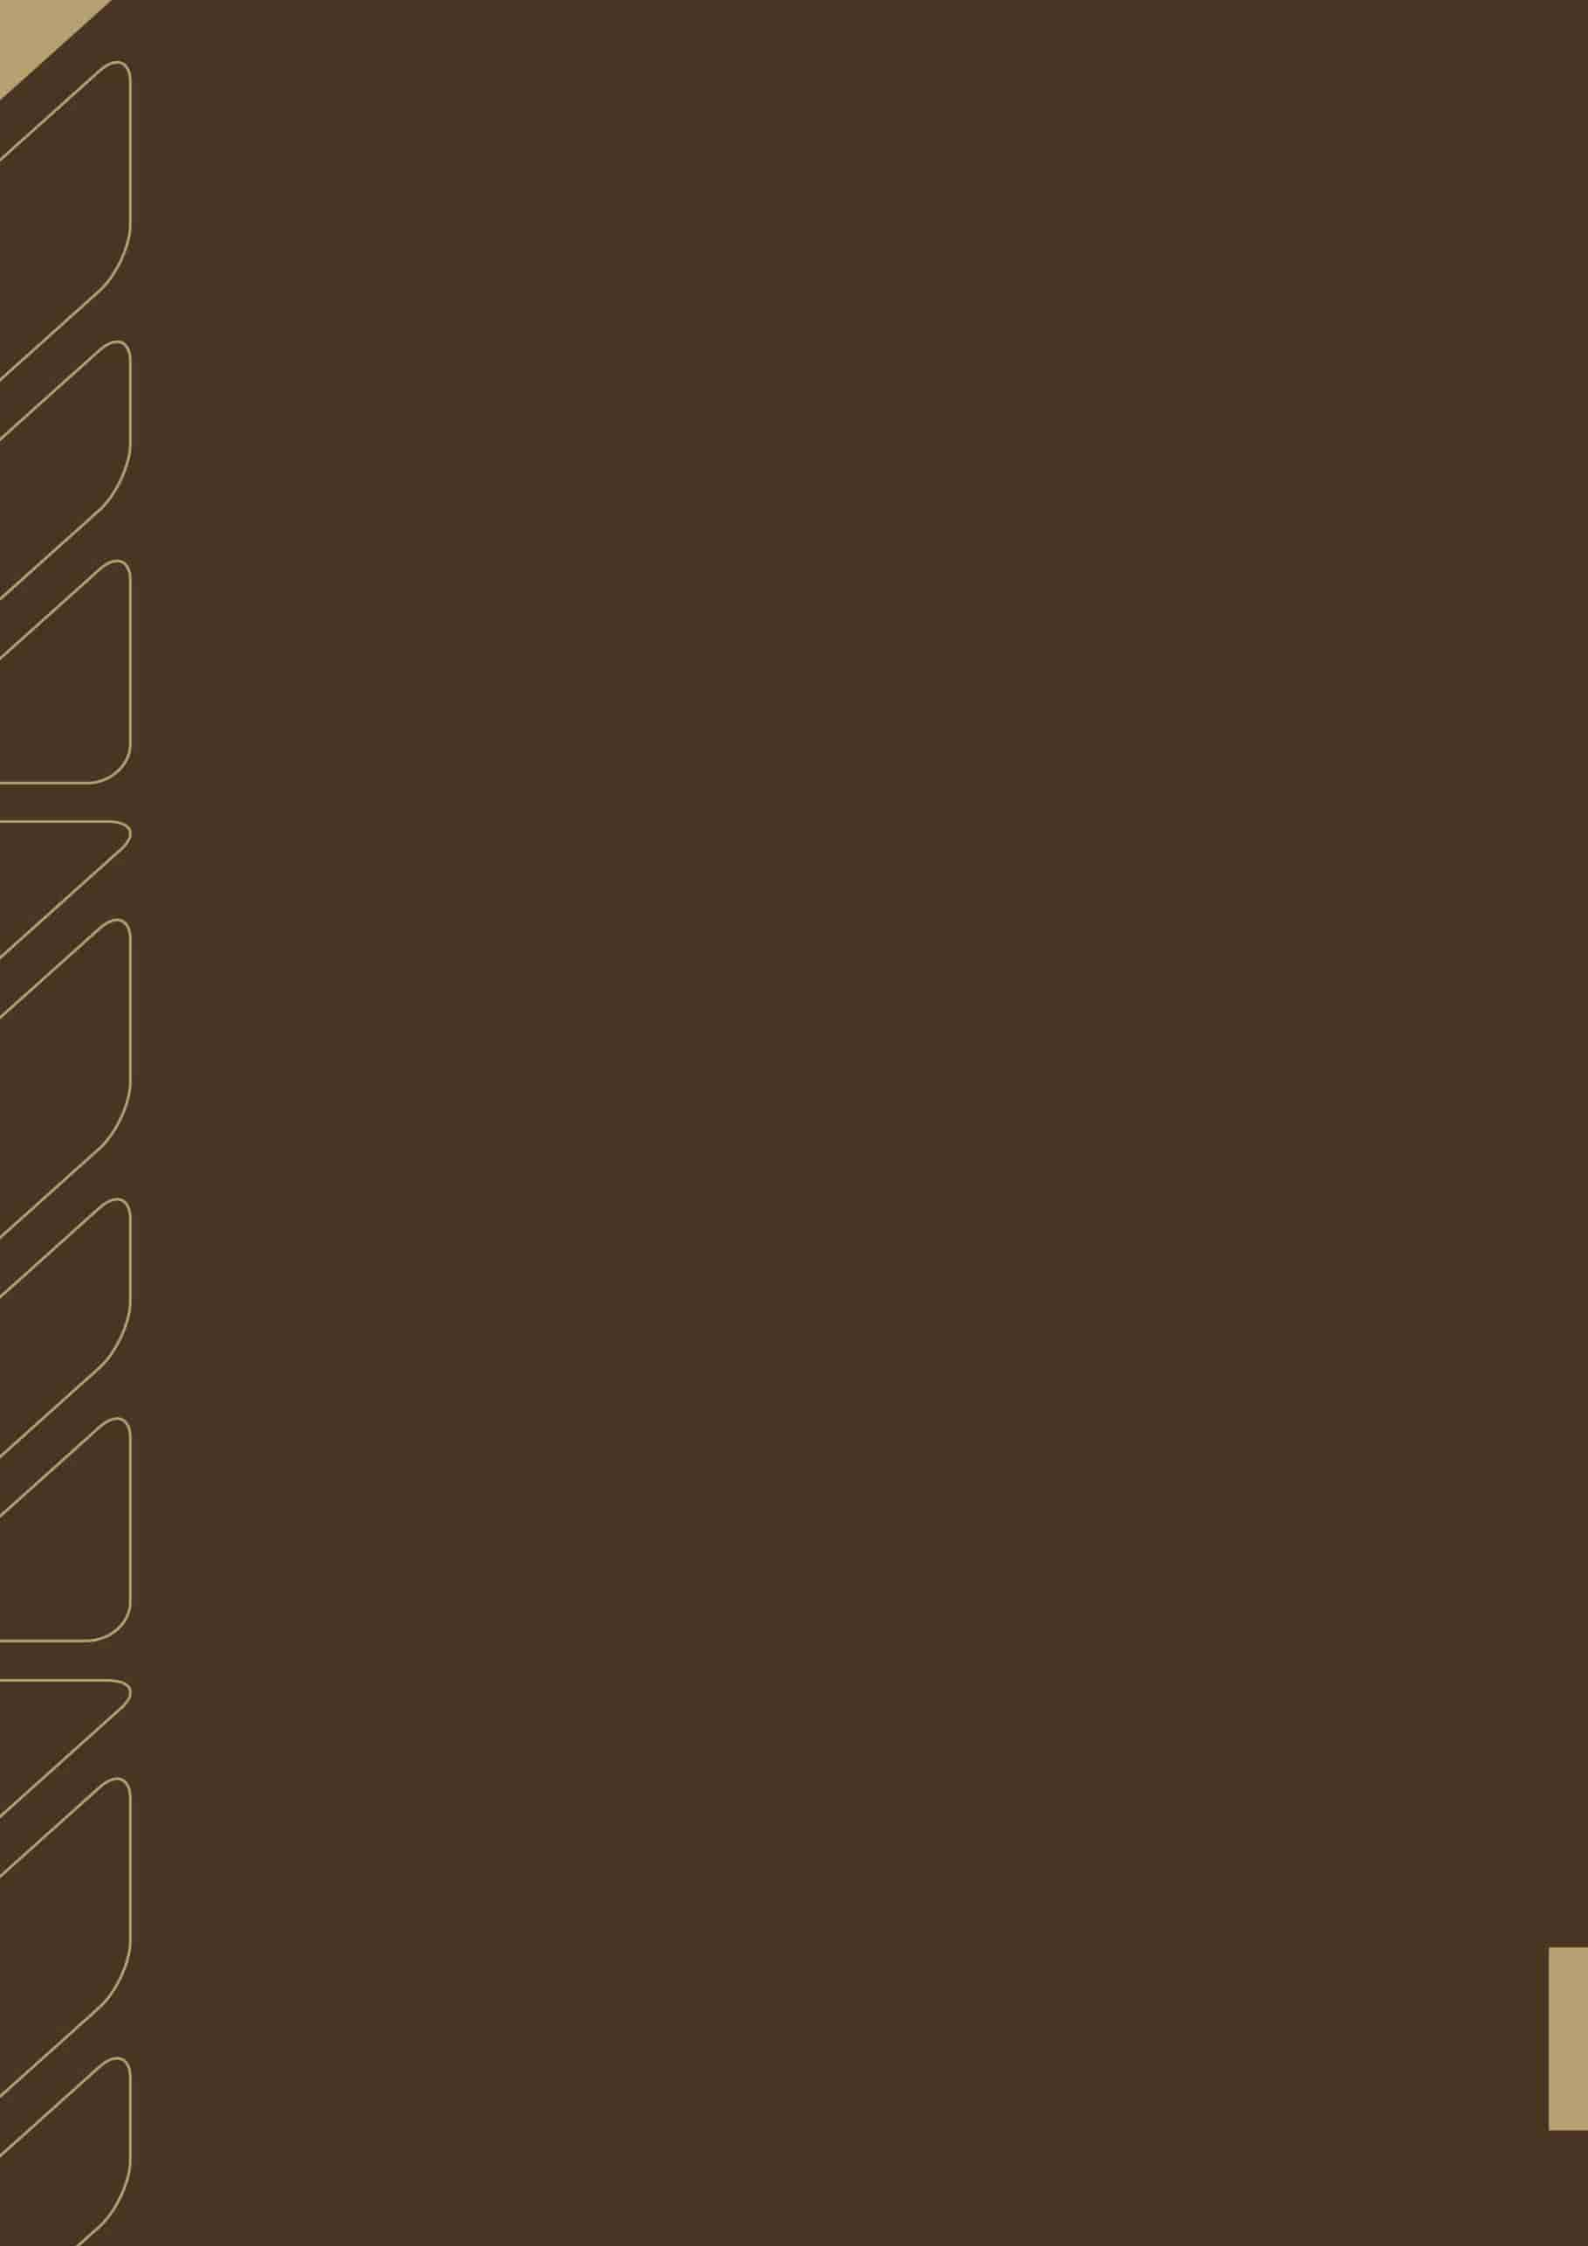
10648	Dead	3	55	Potential >10 cm spout hollow 10 m up, can't confirm from ground but unlikely. Edges are rough, walls have cracks and appear thin.	414147.1015	6352853.127
