ERAMURRA SALT PROJECT

CAPE PRESTON EAST, WESTERN AUSTRALIA

GEOTECHNICAL INVESTIGATION REPORT

PER2020-0143AM Rev 2

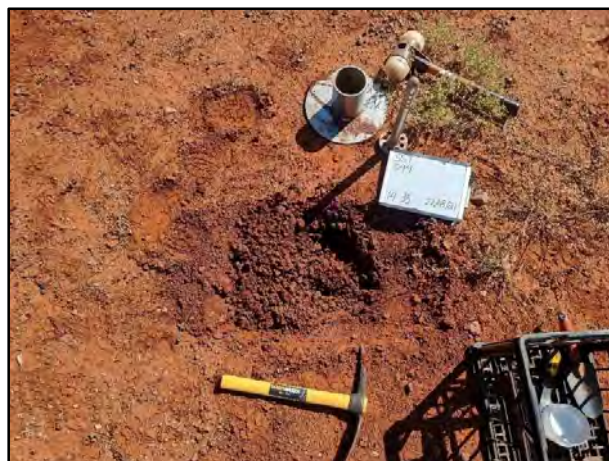
Plate 1: Triaxial surface sample equipment

The sampling method employed involves a stainless-steel tube being fully hammered into the topsoil and recovered containing an undisturbed soil core. To help achieve a reasonably straight drive into the soil, the tube was inserted into a guide cylinder beforehand (see Plate 1 below). The sample tube had dimensions of 100 mm (diameter) x 120mm (height) and has sharpened edges at the cutting end to limit sample disturbance.

The upper 100mm of soil was removed before taking the sample. A panoramic photographic record of the surrounding area taken for an appreciation of the environmental context in which the sample was taken. Subsequently, the steel cylinders were wetted slightly to preserve moisture content during transport, capped and sealed with duct tape prior to onward transport to Leichhardt's shipping destination.

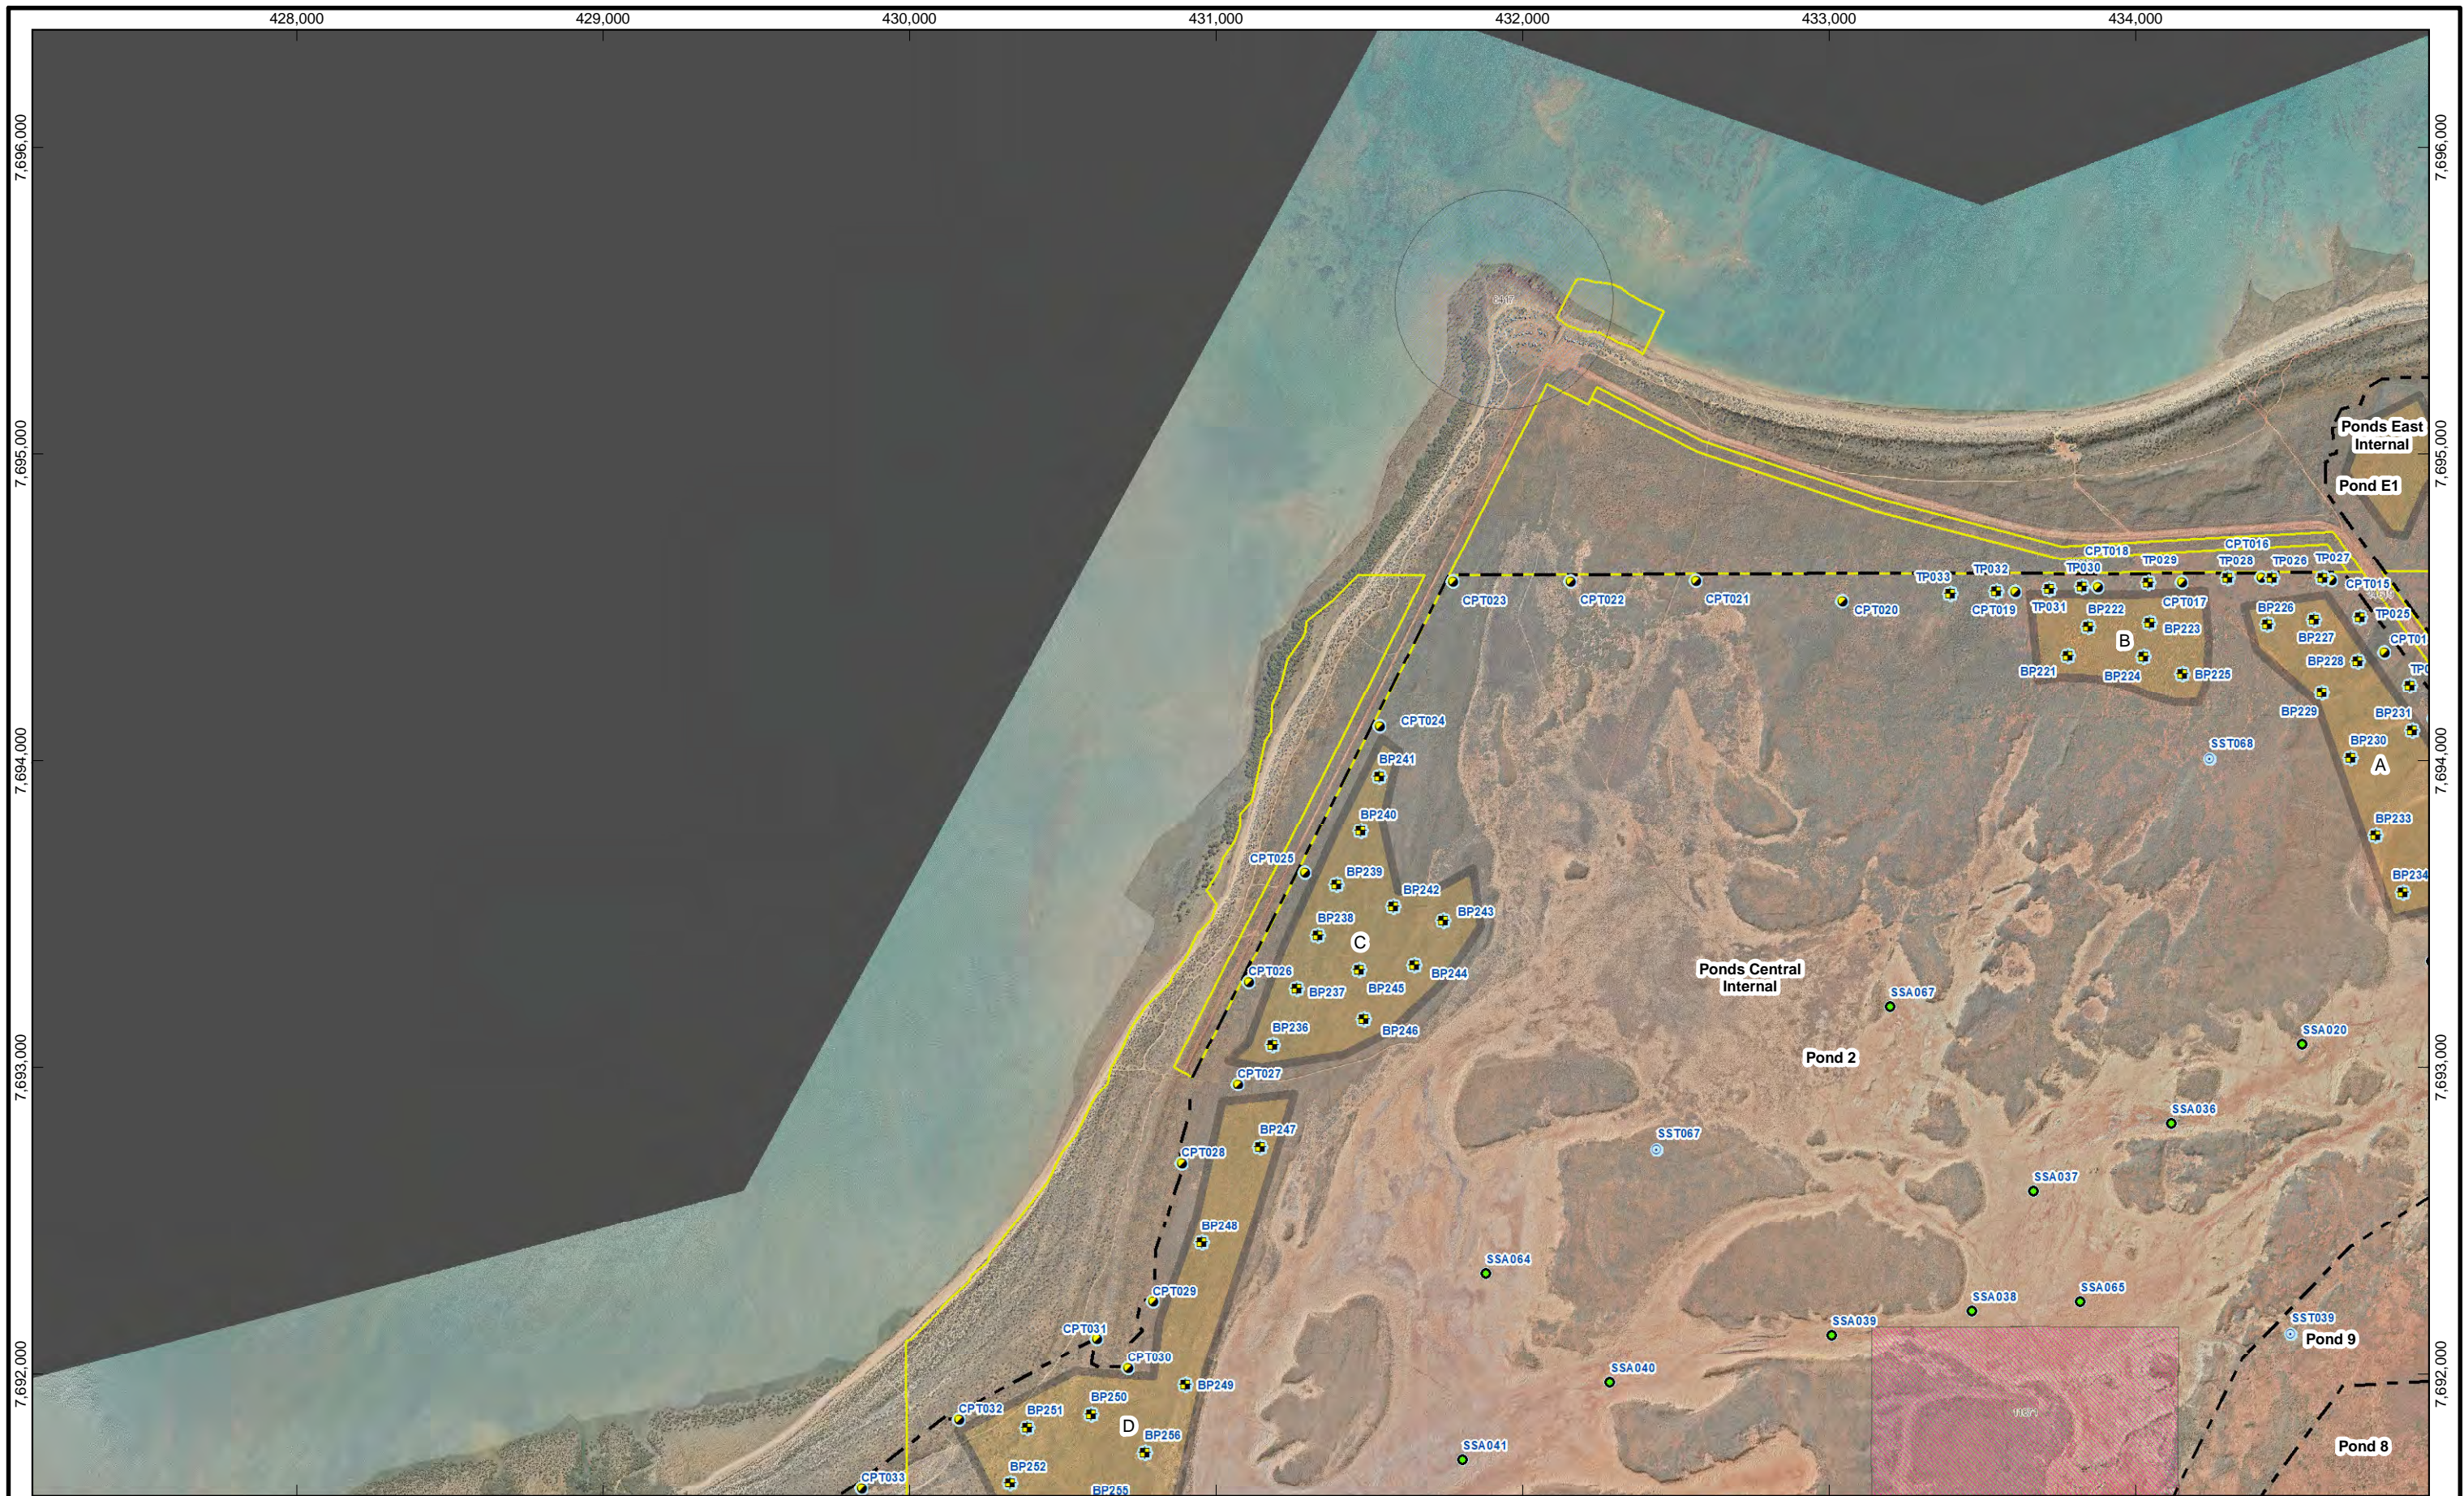
CLIENT:	LEICHHARDT INDUSTRIES	COMPILED:	NR	PROJECT:	PER2020-0143
PROJECT:	ERAMURRA SALT	CHECKED:	MAT, RD	FIGURE:	1A
TITLE:	SITE INVESTIGATION PLAN	REVISION:	0	SCALE:	1:20,000
		DATE:	11/02/2022	SHEET:	A3 L

- CMW Test Locations (Completed)**
- CPT, Marooka
 - Surface sample triaxial
 - Algal sample
 - Test pit
 - Infrastructure Design
- Cadastral boundary
- Investigated borrow area

The location of completed test pits is shown on Figure 1 and Figure 3 Figure Series. Note that test pits denoted TP are generic test pits excavated to provide information on foundation conditions beneath crystalliser and concentrator walls, to assess borrow potential in the crystalliser and concentrator pond areas and to support the overall geological understanding of the site. Test pits denoted BP refer to test pits excavated in areas specifically targeted as potential borrow pit (BP) areas.

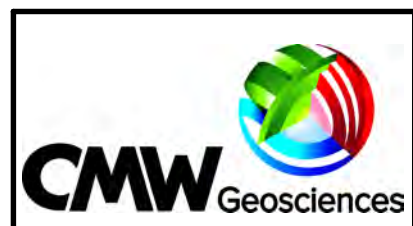
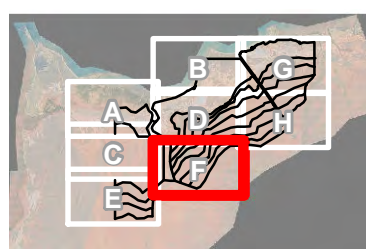
CLIENT:	LEICHHARDT INDUSTRIES	COMPILED:	NR	PROJECT:	PER2020-0143
PROJECT:	ERAMURRA SALT	CHECKED:	MAT, RD	FIGURE:	1F
TITLE:	SITE INVESTIGATION PLAN	REVISION:	0	SCALE:	1:20,000
		DATE:	11/02/2022	SHEET:	A3 L

- CMW Test Locations (Completed)**
- Surface sample triaxial
 - Test pit
- Geophysical Traverse**
- MASW Refraction
 - GPR
- Infrastructure Design**
- Infrastructure Design
 - Cadastral boundary
 - Tenement

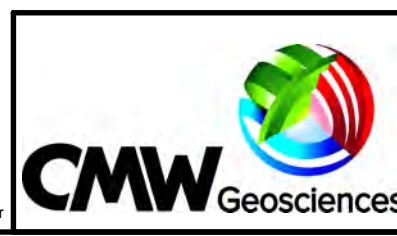
CLIENT:	LEICHHARDT INDUSTRIES	COMPILED:	NR	PROJECT:	PER2020-0143
PROJECT:	ERAMURRA SALT	CHECKED:	MAT, RD	FIGURE:	2D
TITLE:	GEOMORPHOLOGY	REVISION:	0	SCALE:	1:30,000
		DATE:	11/02/2022	SHEET:	A3 L

<ul style="list-style-type: none"> --- Infrastructure Design 	<ul style="list-style-type: none"> Deflated Dunes, Sand Plains and Sandy Islands Fringing Dune Rocky Hills and associated talus Intertidal Flats and Creeks Mangrove (dense and scattered) Islands with rock outcrops or rocky fringes 	<ul style="list-style-type: none"> Alluvial Outwash/Residual Surface with low relief rock outcrop Supra-Tidal Flats (with some low relief igneous rock outcrop)
Channels <ul style="list-style-type: none"> → Devils Creek Channel → Minor Creek Channel 		
Geomorphology <ul style="list-style-type: none"> Beach Former Coastal Rock Ledges 	<p>Coordinate System: GDA 1994 MGA Zone 50 Transverse Mercator</p>

Figure 2 (Figure Series) shows our zonation of the site into Geomorphological Units. This mapping has been undertaken primarily in the office using the digital elevation model, published geology and aerial imagery to delineate units that help inform the pond embankment design (foundation conditions, distribution of borrow, trafficability etc). The mapping was 'truthed' in the field allowing the nature of each unit to be better understood and characterised. The geomorphological map units extend generally a few kilometres beyond the extents of the crystalliser and concentrator ponds.

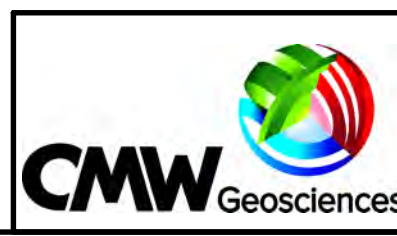
CLIENT:	LEICHHARDT INDUSTRIES	
PROJECT:	ERAMURRA SALT	
TITLE:	ENGINEERING GEOLOGY	
COMPILED:	NR	PROJECT: PER2020-0143
CHECKED:	MAT, RD	FIGURE: 3A
REVISION:	1	SCALE: 1:25,000
DATE:	23/02/2022	SHEET: A3 L

- Mangrove mud
- Lagoonal mud
- Thin Lagoonal Mud over Igneous Rock
- Eolian sand (overlying calcarenite)
- Beach rock
- Calcarenite
- Calcarenite (inferred)
- Eolian sand (overlying granitoid and mafic rocks)
- Alluvial soil (Thin veneer of sheetwash gravel over Residual soil derived from underlying rocks and also weathering of thin alluvium)
- Alluvial soils (Braided channel gravels)
- Residual soil
- Predominantly Granitoid rocks

Along the northern edge of the *Alluvial Outwash/Residual surface* is the presence of a calcarenite fringe. This has been mapped as an Engineering Geological unit, where observed (refer Figure 3 (Figure Series)) however it is part of *Alluvial Outwash/Residual surface* geomorphological unit. The nature of the calcarenite can be seen in Slides 12, 13 and 15. Its origin appears to be variable. In some places it appears to be due to eolian sand accumulation (presumably blown off the surface of the Inter-tidal flats) and containing calcium carbonate which subsequently has become cemented. This is illustrated in Slide 12, Appendix B. There also appear to be some small surface accumulation of calcrete (also refer Slide 12).

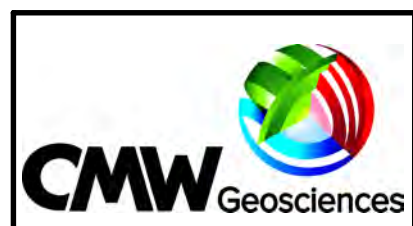
CLIENT:	LEICHHARDT INDUSTRIES		COMPILED:	NR	PROJECT:	PER2020-0143
PROJECT:	ERAMURRA SALT		CHECKED:	MAT, RD	FIGURE:	3D
TITLE:	ENGINEERING GEOLOGY		REVISION:	1	SCALE:	1:25,000
			DATE:	23/02/2022	SHEET:	A3 L

- CMW Test Locations (Completed)**
- Surface sample triaxial
 - Algal sample
 - Test pit
 - CPT, Markooka
 - Infrastructure Design
 - Doleritic dyke
 - Section Line
- Engineering Geology**
- Lagoonal mud
 - Thin Lagoonal Mud over Igneous Rock
 - Eolian sand (overlying calcarenite)
 - Beach rock
 - Calcarenite

- Shallow/outcropping calcarenite with high seepage potential
- Shallow/outcropping rock impacting borrow potential, foundation preparation and seepage under walls
- Calcarenite (inferred)
- Eolian sand (overlying granitoid and mafic rocks)
- Alluvial soil (Thin veneer of sheetwash gravel over Residual soil derived from underlying rocks and also weathering of thin alluvium)
- Alluvial soils (Braided channel gravels)
- Residual soil
- Predominantly Granitoid rocks
- Predominantly Doleritic dyke

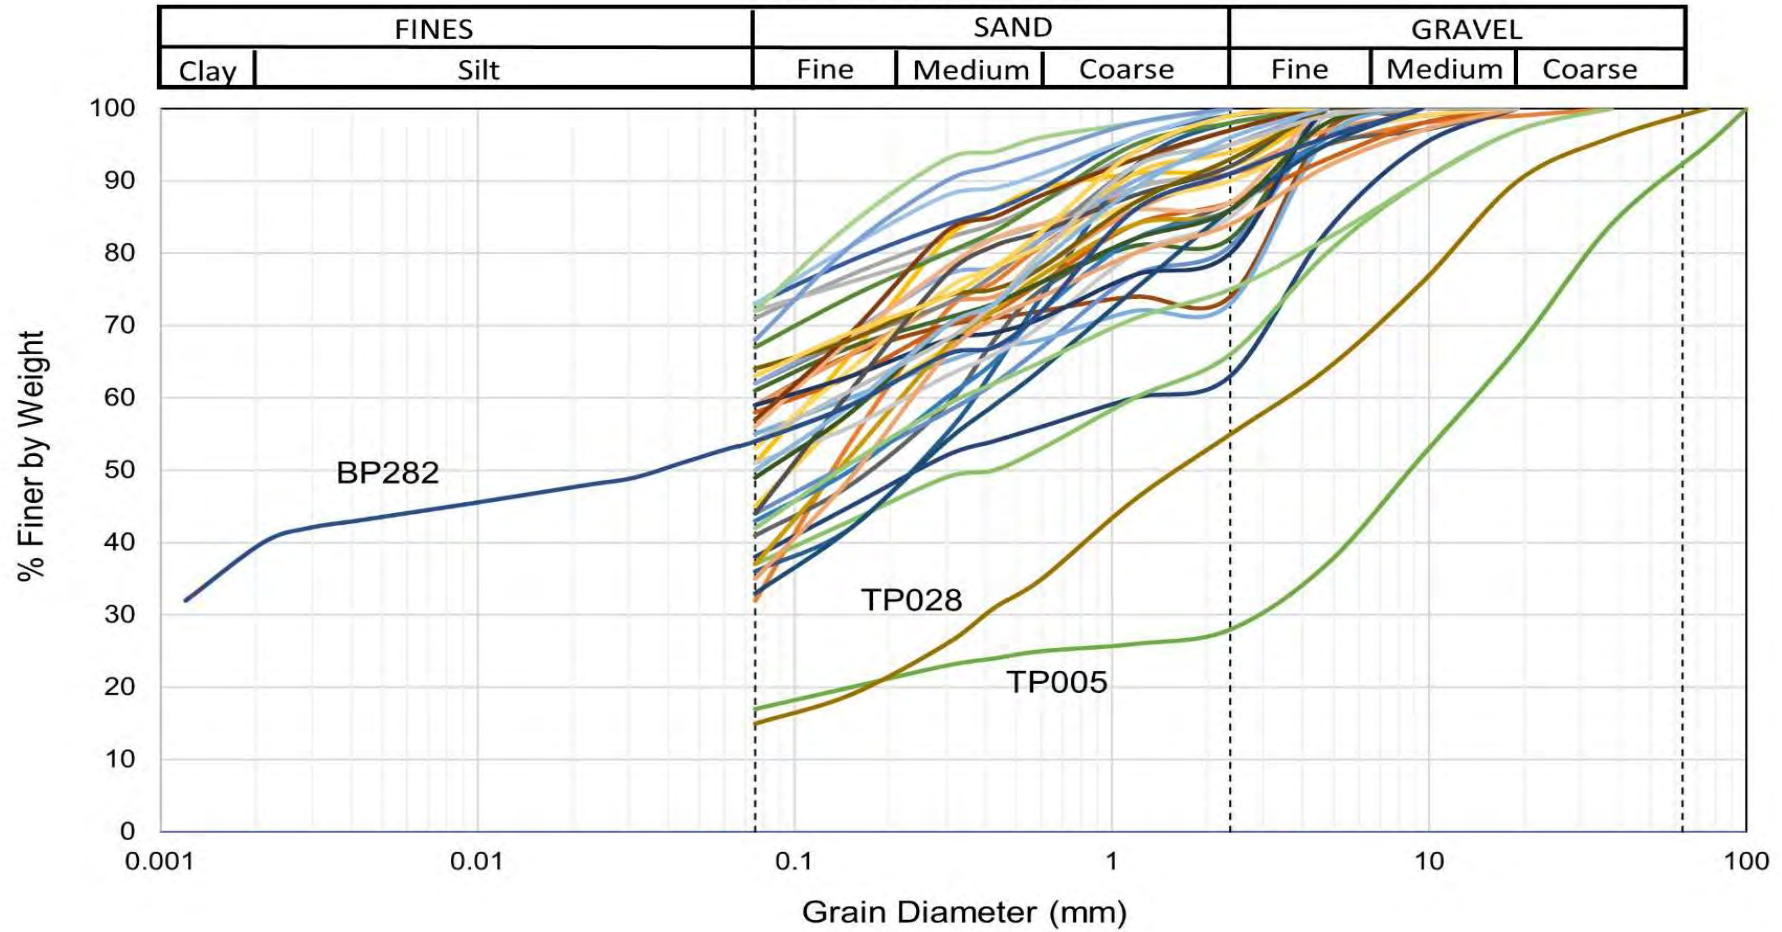
Client:	LEICHHARDT INDUSTRIALS PTY LTD	Project: PER2020-0143
Project:	ERAMURRA SALT PROJECT	Figure: 6
Title:	PSD CHART - RESIDUAL SOIL	Date: 10/02/2022

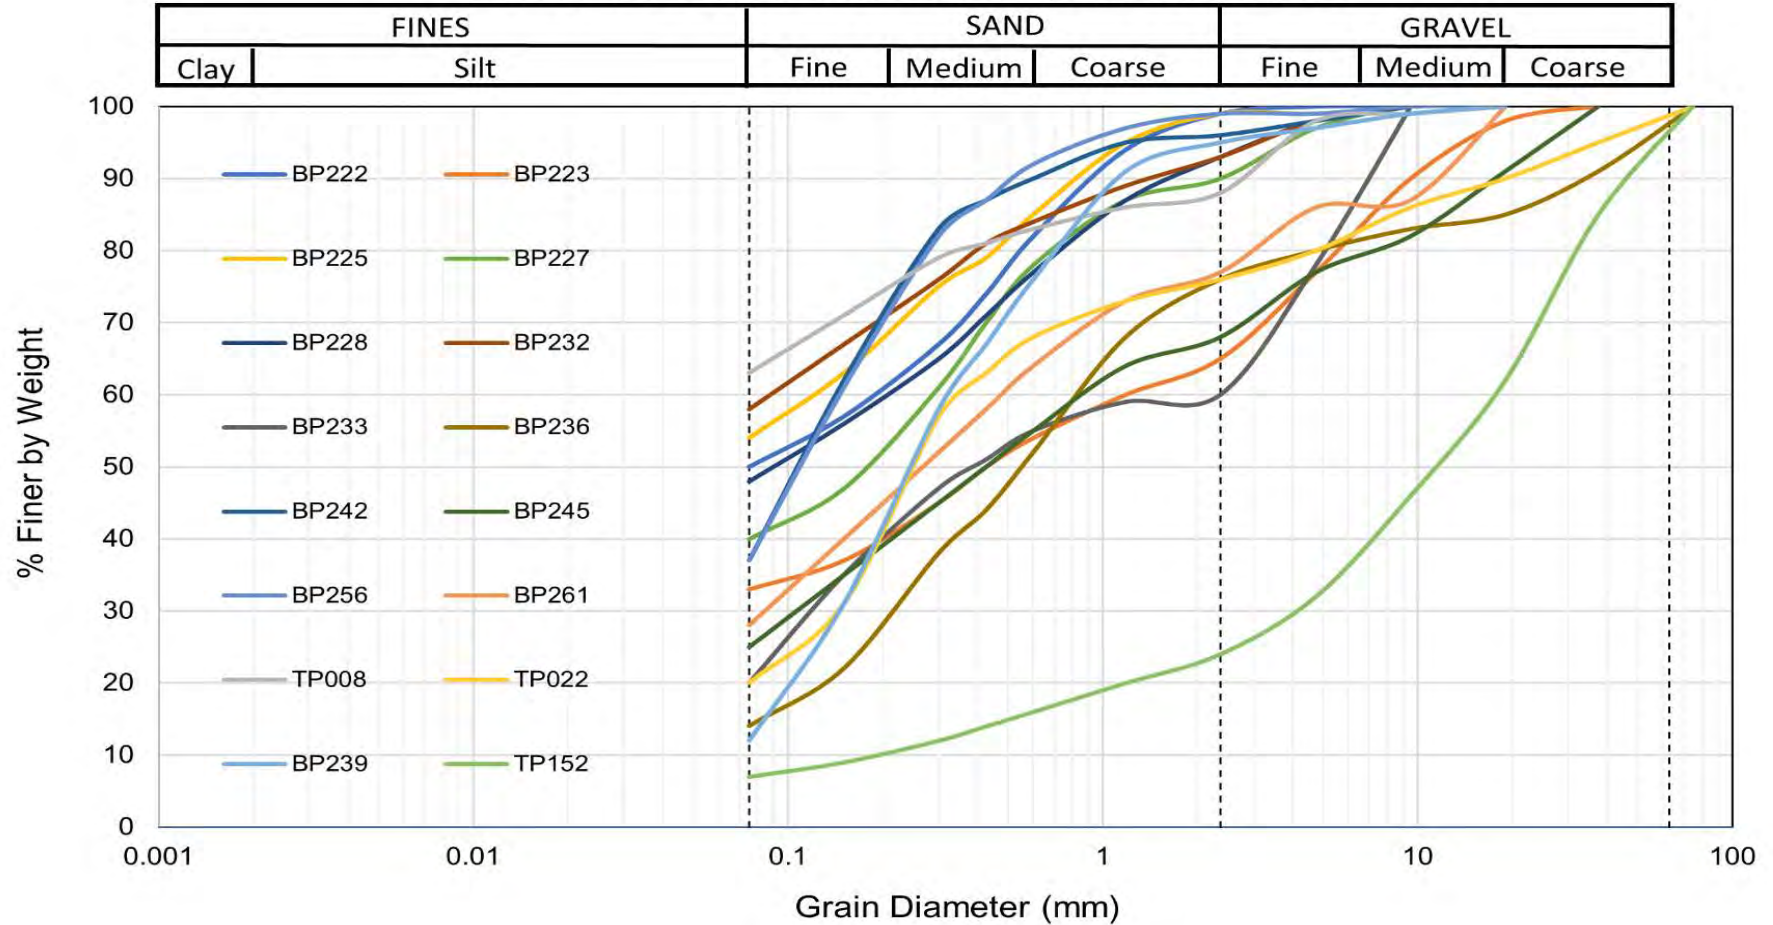
Client:	LEICHHARDT INDUSTRIALS PTY LTD	Project:	PER2020-0143
Project:	ERAMURRA SALT PROJECT	Figure:	9
Title:	PSD CHART - EXTREMELY WEATHERED CALCARENITE	Date:	10/02/2022

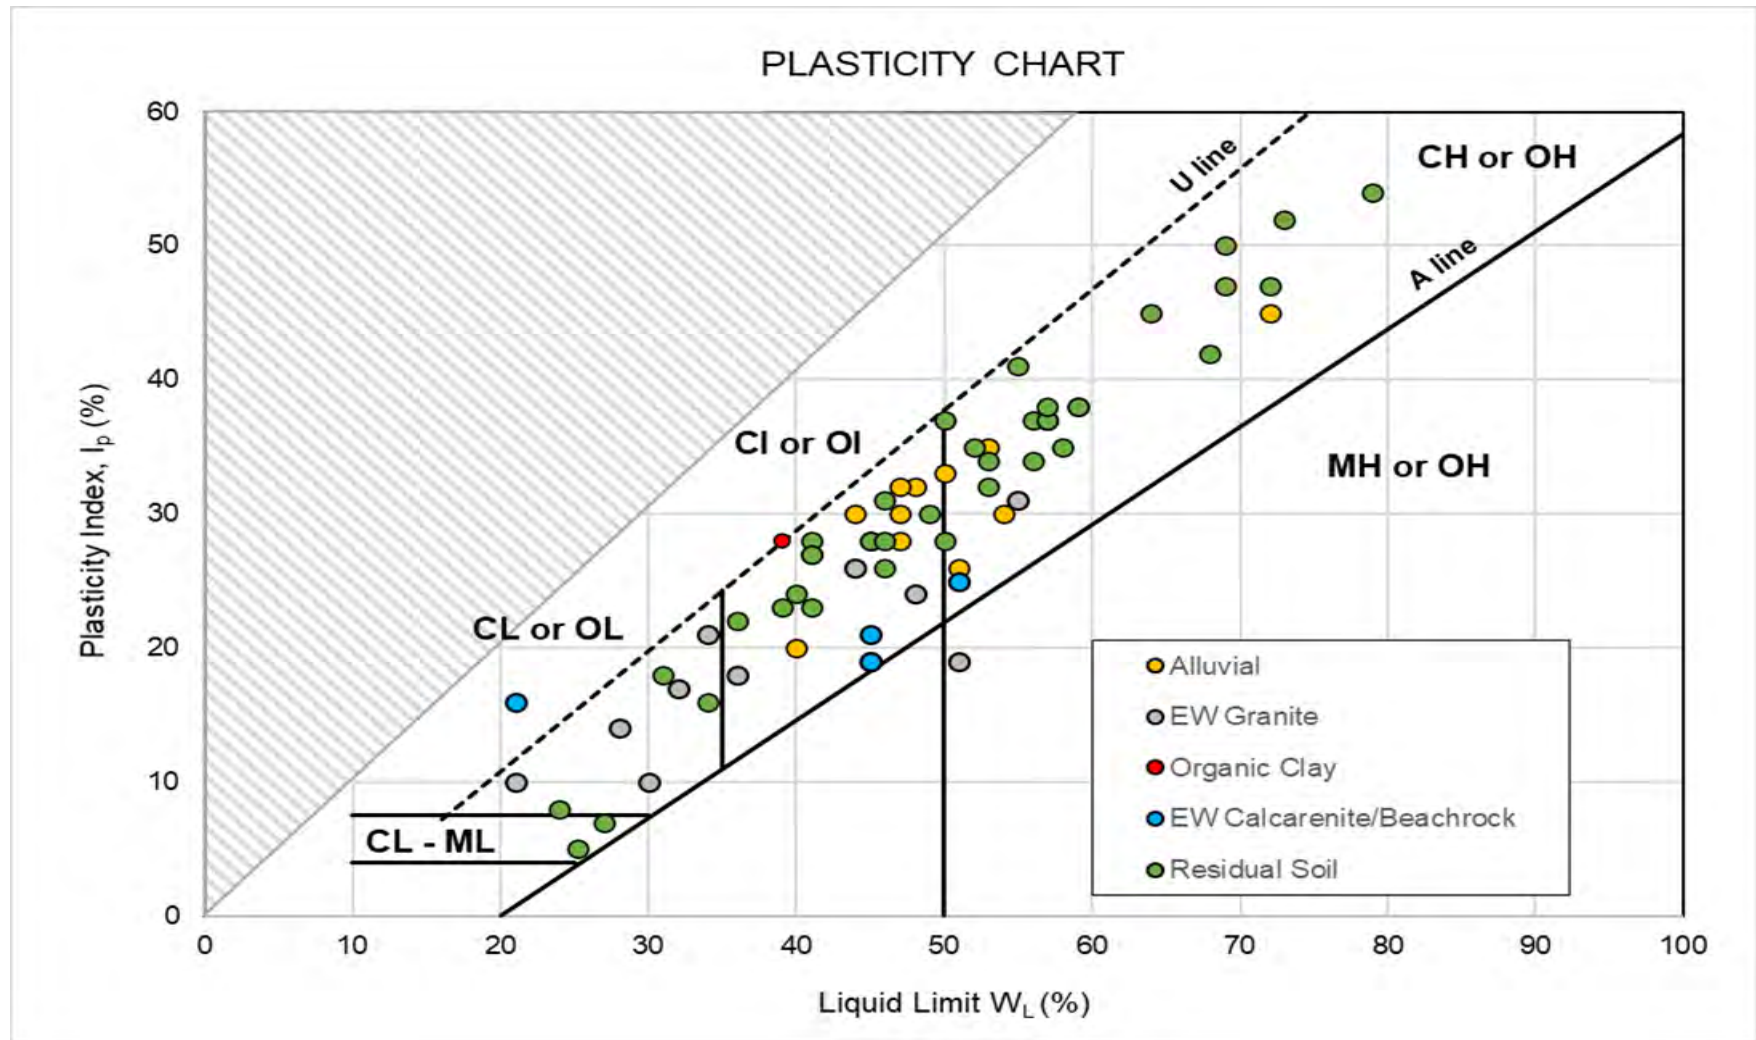
Client:	LIECHHART INDUSTRIALS PTY LTD	Project:	PER2020-0143
Project:	ERAMURRA SALT PROJECT	Figure:	13
Title:	PLASTICTIY CHART - ALL DATA	Date:	FEBRUARY 2022
