TECHNICAL MEMORANDUM

Environmental Factor: Inland Waters

Lot 102 Farrall Road, Midvale

PROJECT NUMBER	EP16-009	DOC. NUMBER	EP16-009(21)--094A ASC
PROJECT NAME	Movida Estate, Midvale	CLIENT	Peet Stratton Pty Ltd
AUTHOR	ASC	REVIEWER	
VERSION	A	DATE	21/11/2019

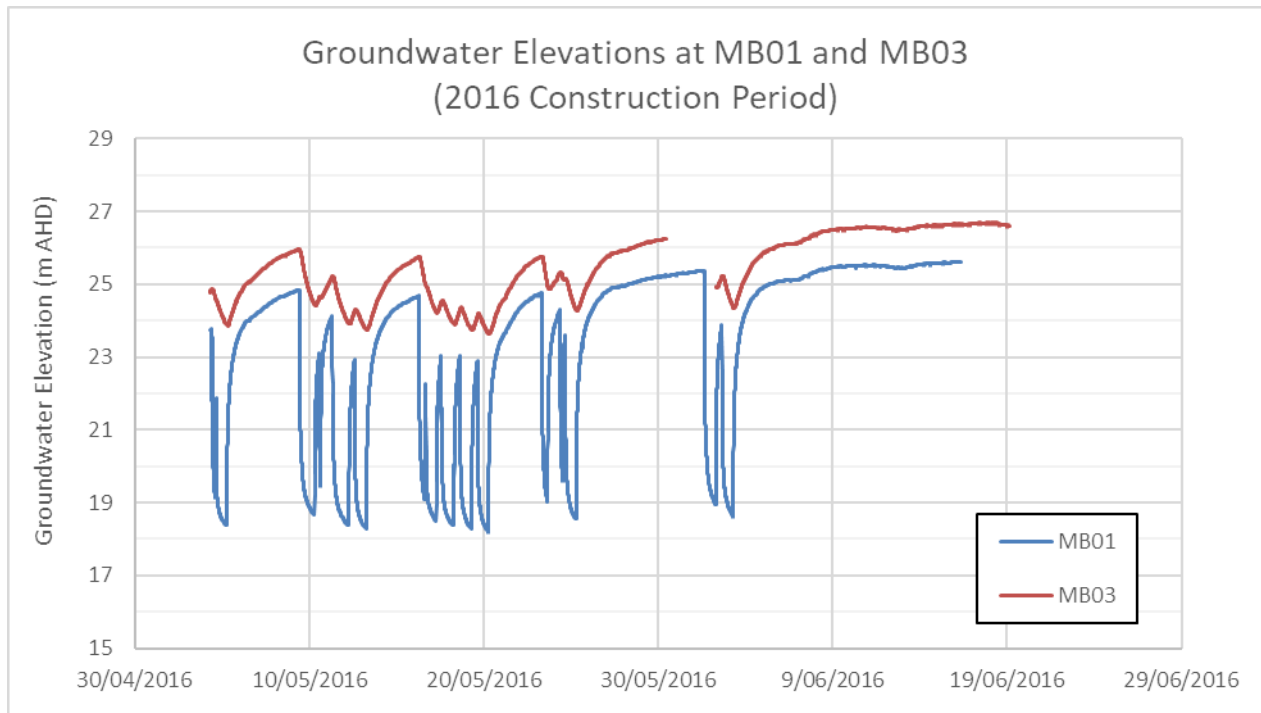
Plate 1: Groundwater elevations, MB01 and MB03, 2016 construction period

Groundwater level data collected at MB01 and MB03 during periods of groundwater abstraction at the production bore are illustrated in **Plate 1** (2016 construction period) and **Plate 2** (2017 construction period).

This data shows the drawdown that occurs in direct response to pumping. It demonstrates that groundwater levels within both monitoring bores, including MB03 (adjacent to the proposed wetland), consistently recover very promptly once abstraction ceased. Impacts to groundwater levels beneath the proposed wetland resulting from the abstraction of groundwater have therefore been minimised by the seasonal and daily scheduling of abstraction.

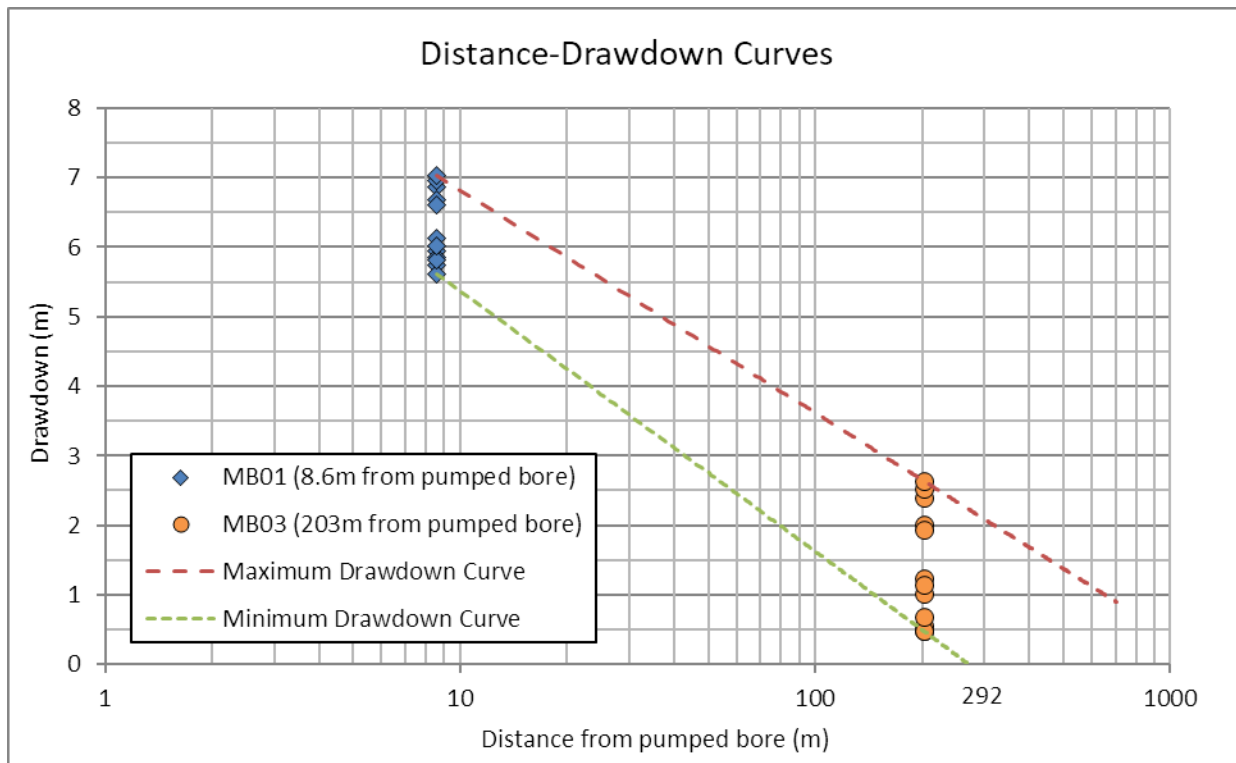
Plate 3: Distance-drawdown curves based on measured data

The maximum drawdown observed at MB03 was 2.63 m, which occurred on 20/05/2016. The corresponding drawdown at MB01 at this time was 7.03 m. This and other measured drawdown data have been plotted on a distance-drawdown curve to enable the magnitude of drawdown at the proposed wetland to be estimated. The resulting distance-drawdown curves are illustrated in **Plate 3**.

Based on the distance-drawdown curves shown in **Plate 3**, the estimated maximum magnitude of drawdown experienced at the northern extent of the proposed wetland (292 m away from the production bore) was 2.12 m in 2016. This magnitude of drawdown is likely to have lowered the groundwater table to below the root zones of some plant species within the proposed wetland and would therefore not be acceptable on a long term basis. However, the measured data (see **Plate 1** and **Plate 2**) demonstrates that the groundwater levels at MB01 and MB03 were able to recover to within 80% of the standing water level within 5 and 12 hours, respectively, following the cessation of pumping. This rapid recovery suggests that plants within the proposed wetland did not experience adverse impacts as a result of taking water from the production bore for temporary construction and dust suppression purposes.

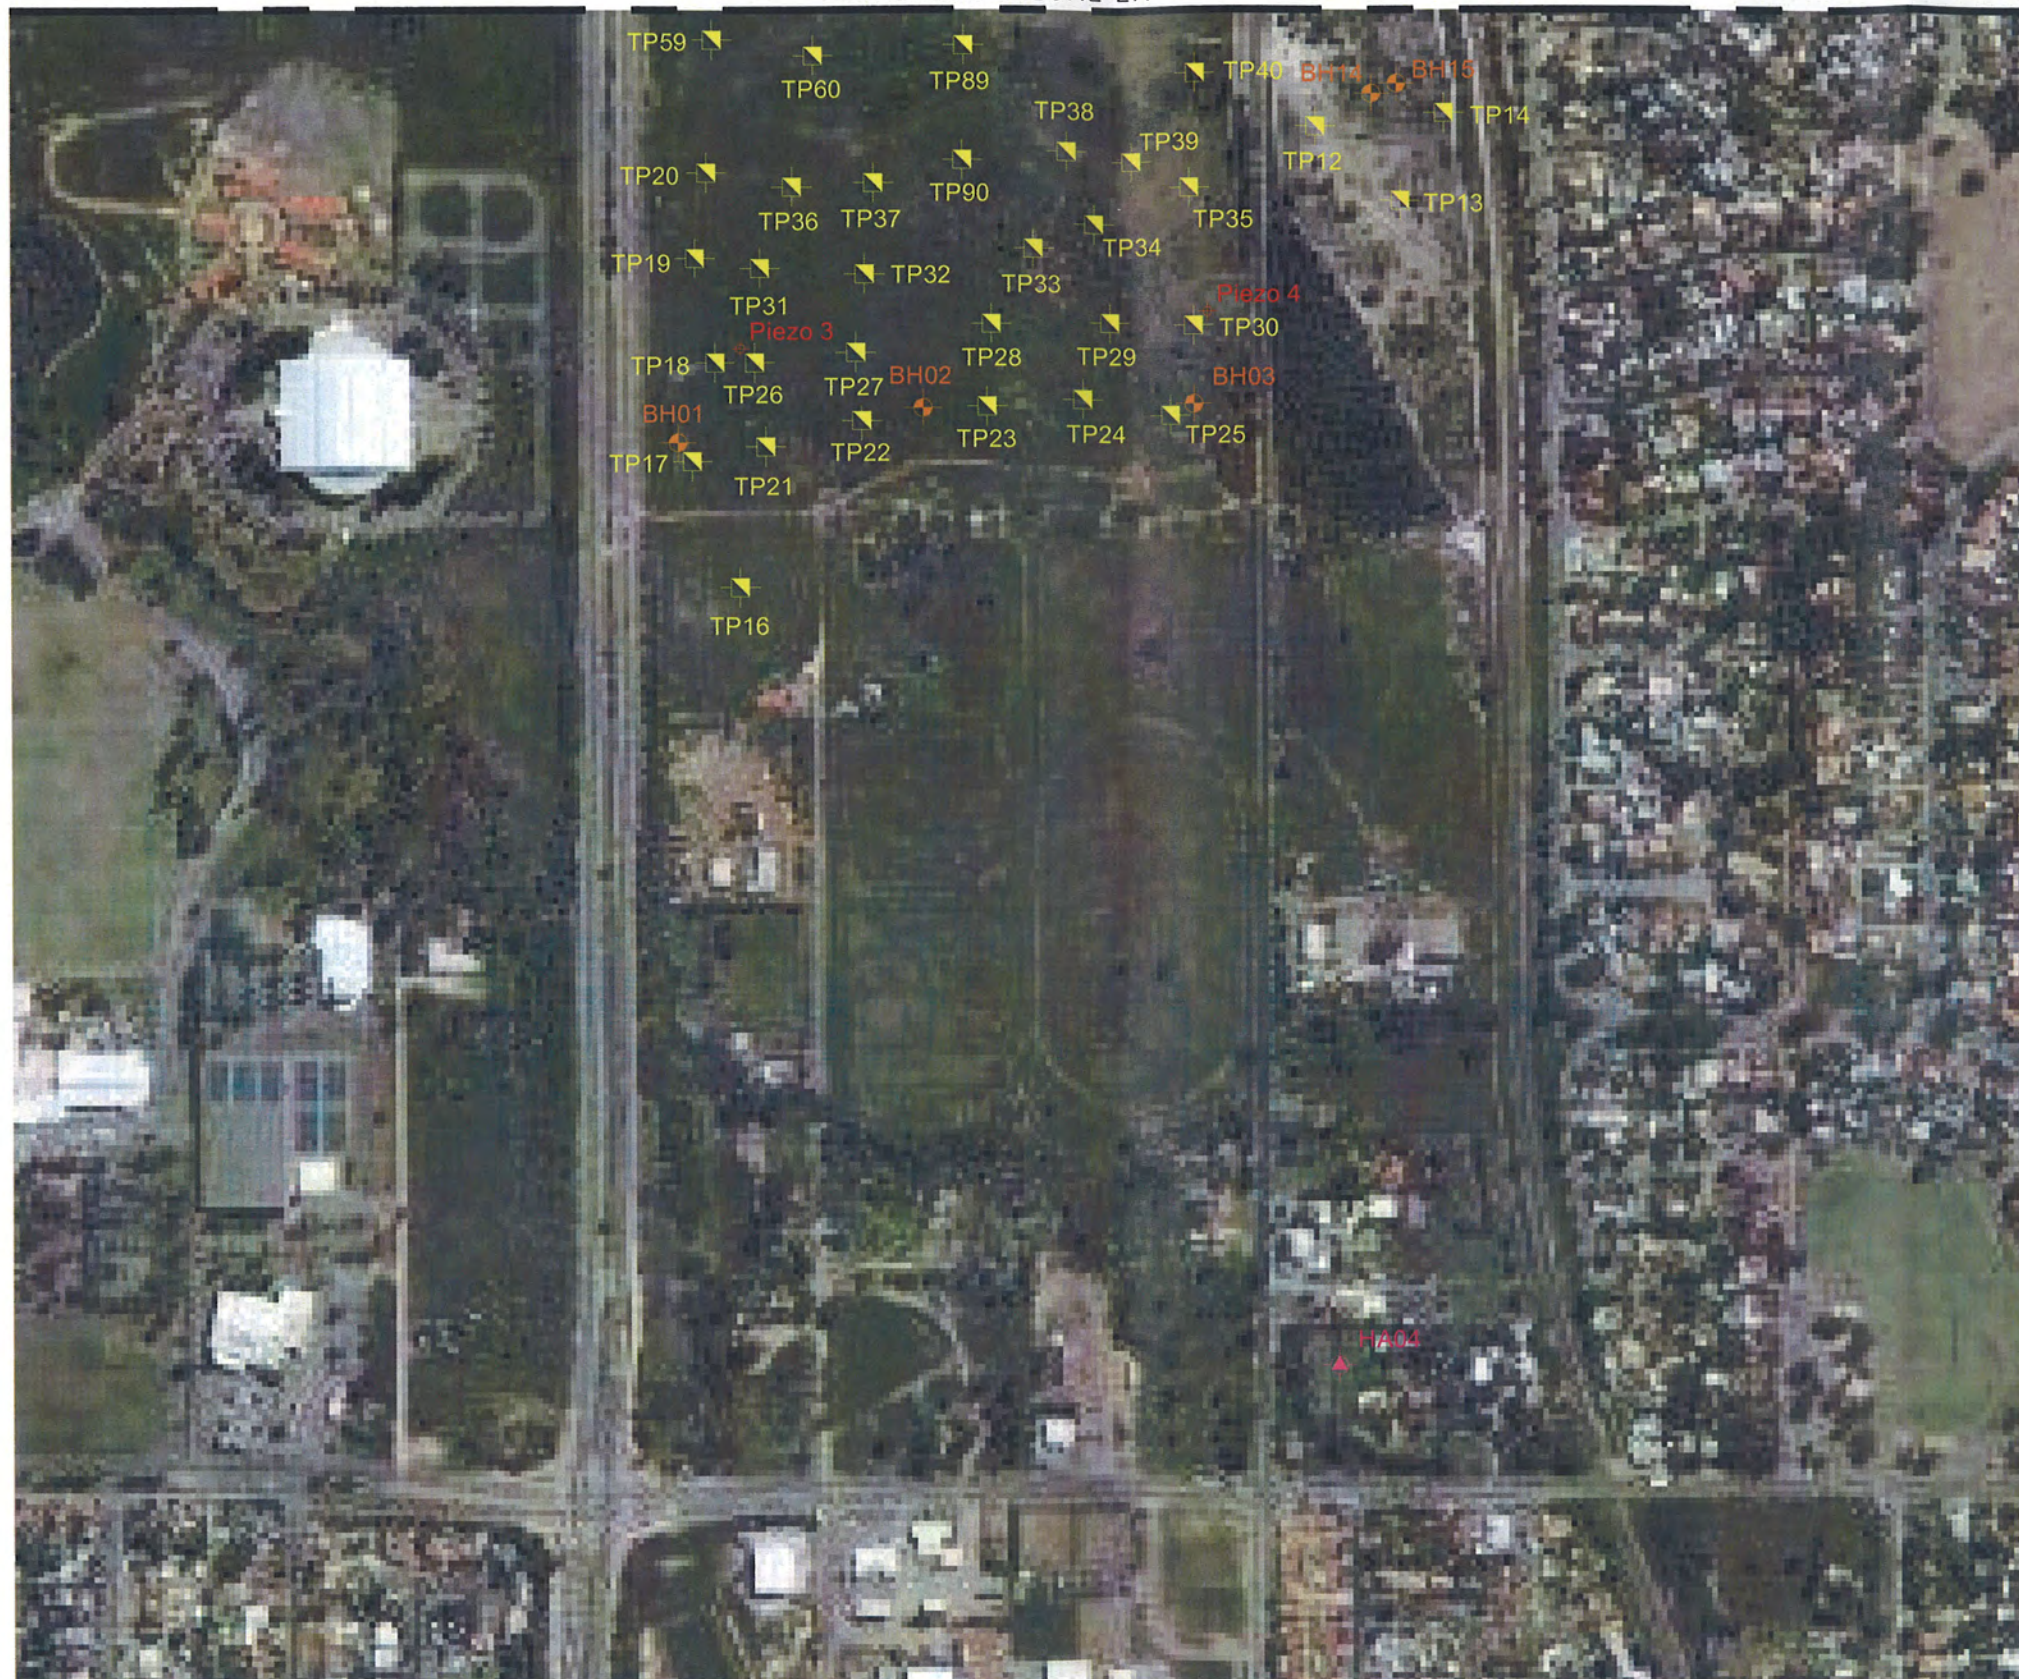
Figure 2.1

-   TP01 = TEST PIT LOCATION
-   Piezo 1 = PIEZO LOCATION
-   BH01 = BOREHOLE LOCATION
-   HAO1 = HAND AUGER LOCATION
