# Geraldton Port Maximisation Project

## Benthic Habitat Survey Report

### Mid West Ports Authority

30 August 2024

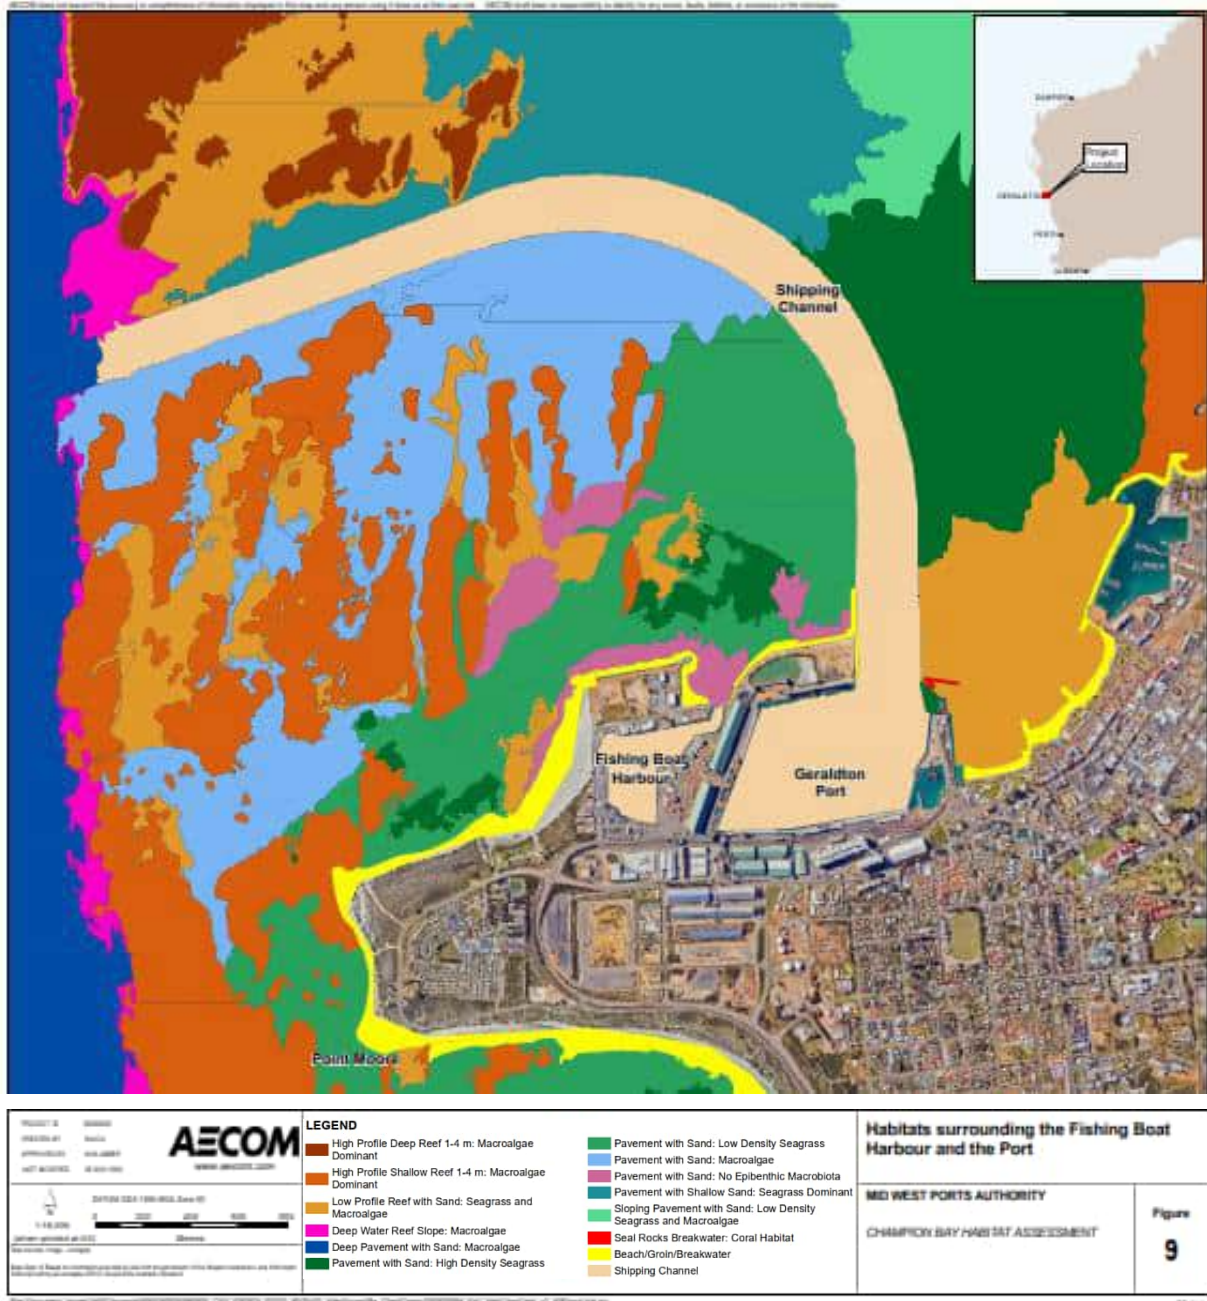
**Figure 3 Previous interpolated map of benthic communities and habitats within and surrounding Champion Bay from data recorded in 2020 (source: AECOM, 2020)**

Previous benthic mapping undertaken within Champion Bay suggests a diverse range of habitats and benthic communities, such as seagrasses, macroalgae and filter feeding organisms exist throughout the bay and surrounding areas (AECOM 2020). Within the area to the south of the shipping channel but north of Fishing Boat Harbour, where the current proposal footprint is situated, the substrate has been described to comprised of a mixture of reef and soft sediments with mostly seagrass and macroalgae dominated benthic communities (**Figure 3**) (AECOM 2020). Seagrasses within this area consisted of low- and high-density patches of *Halophila*, *Posidonia*, *Amphibolus* and *Syringodium* species, whilst macroalgae assemblages tended to be dominated by *Sargassum* and *Ecklonia*. Depths in this area generally range between 4 m and 12 m.

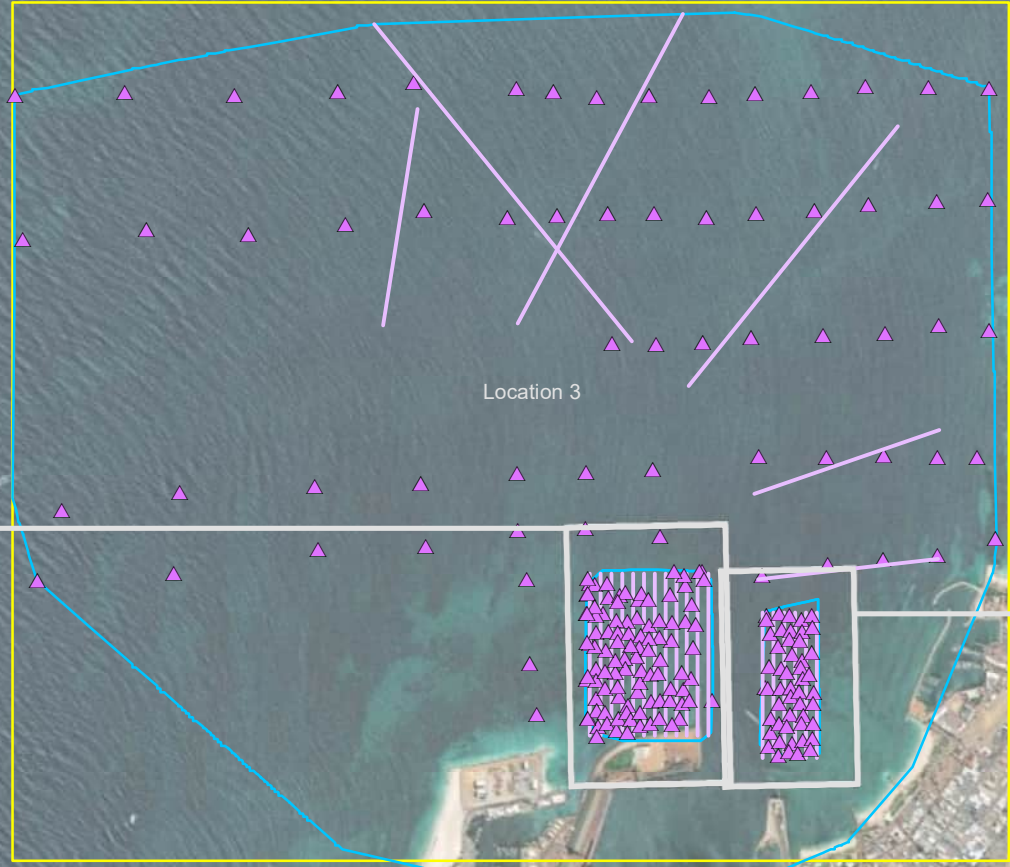
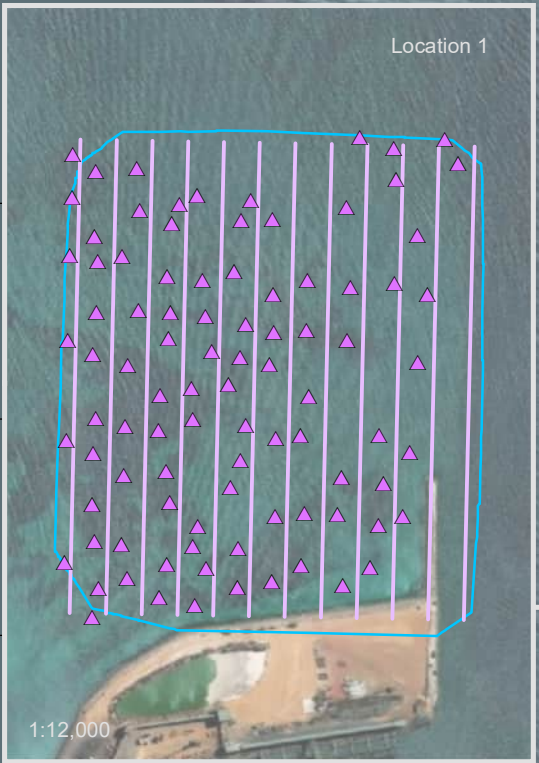
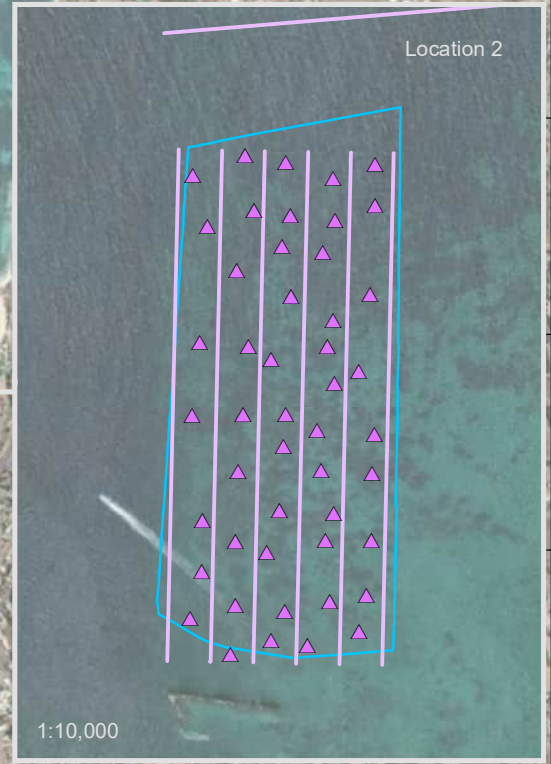
**FIGURE 4**

**LOCATION OF TRANSECTS AND  
DROP CAMERA SAMPLING POINTS**

Slow tow camera transects were used mostly for mapping purposes to provide a good coverage and assessment of the distribution of BCH throughout the Study Area. A total of 12 transects were surveyed throughout Location 1, six transects surveyed throughout Location 2 and five long transects throughout Location 3 (**Figure 4**). Transects were

Drop camera sampling sites for each location (92 for Location 1, 48 for Location 2 and 65 for Location 3) are shown in **Figure 4**. The location of these sites is based on previous mapping and recent aerial imagery and helped to better locate and describe various habitats encountered throughout the Study Area. Images collected by use of a drop camera (in a frame) were utilised to semi-quantitatively sample and describe benthic habitats, such as seagrasses, to better understand their density / cover across the Study Area.

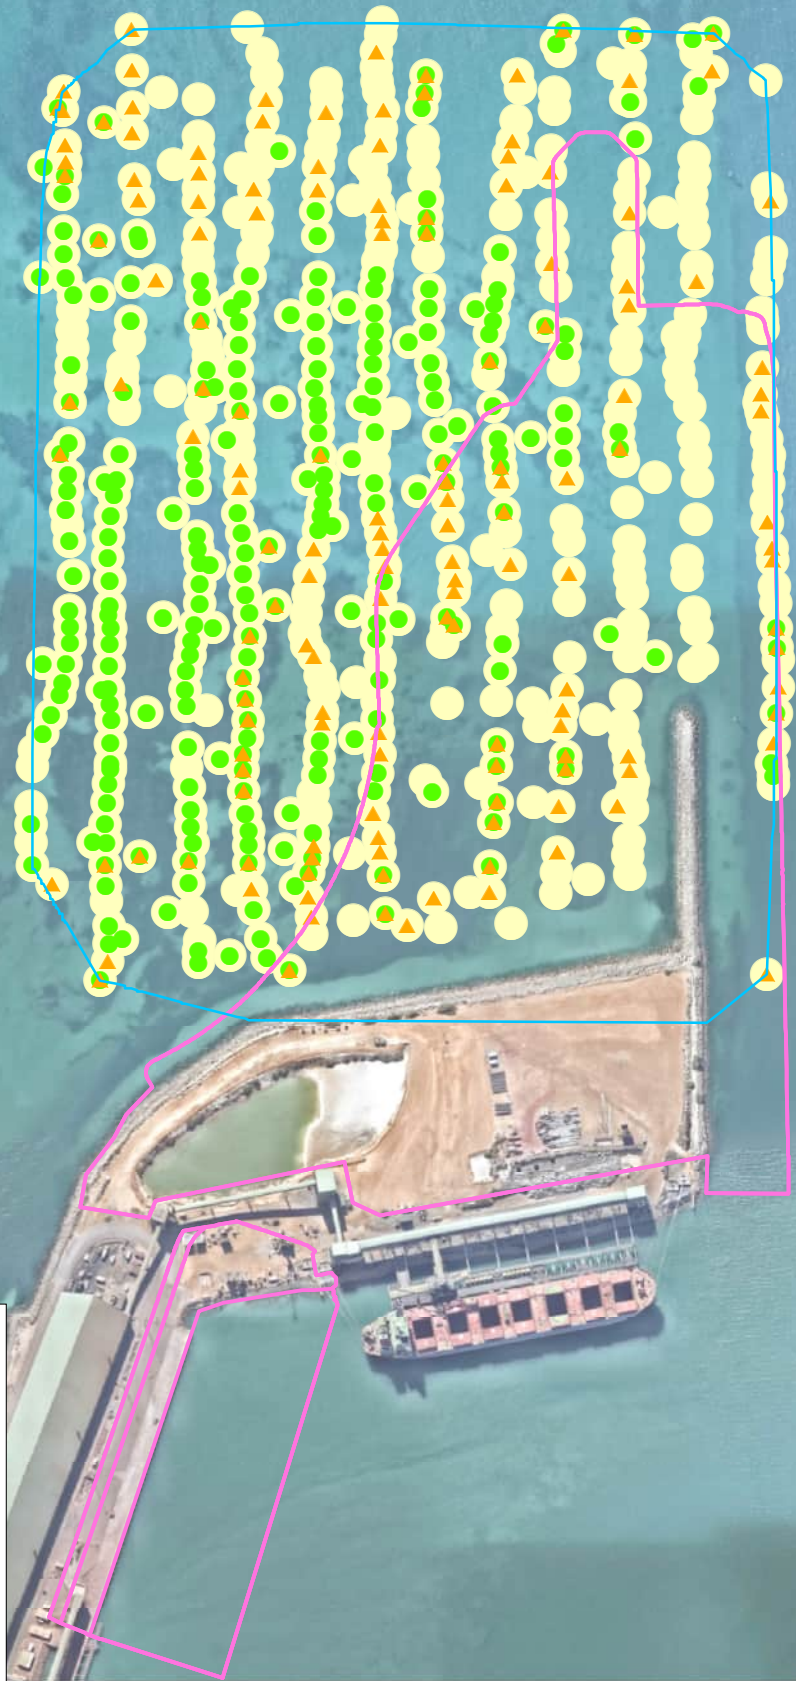
**FIGURE 5**

Location 1 was characterised by soft sediment and moderately dense patchy seagrass, with sparse macroalgae interspersed throughout. Soft sediment was recorded at all sampling sites within Location 1, with an absence of hard substrate throughout this location. Of the 92 sites sampled within Location 1, bare unconsolidated sediment was observed at 36% of these sites, with the remaining 64% having seagrass and / or macroalgae coverage (**Figure 5**). Seagrass and macroalgae were observed together at 10% of the sites sampled.

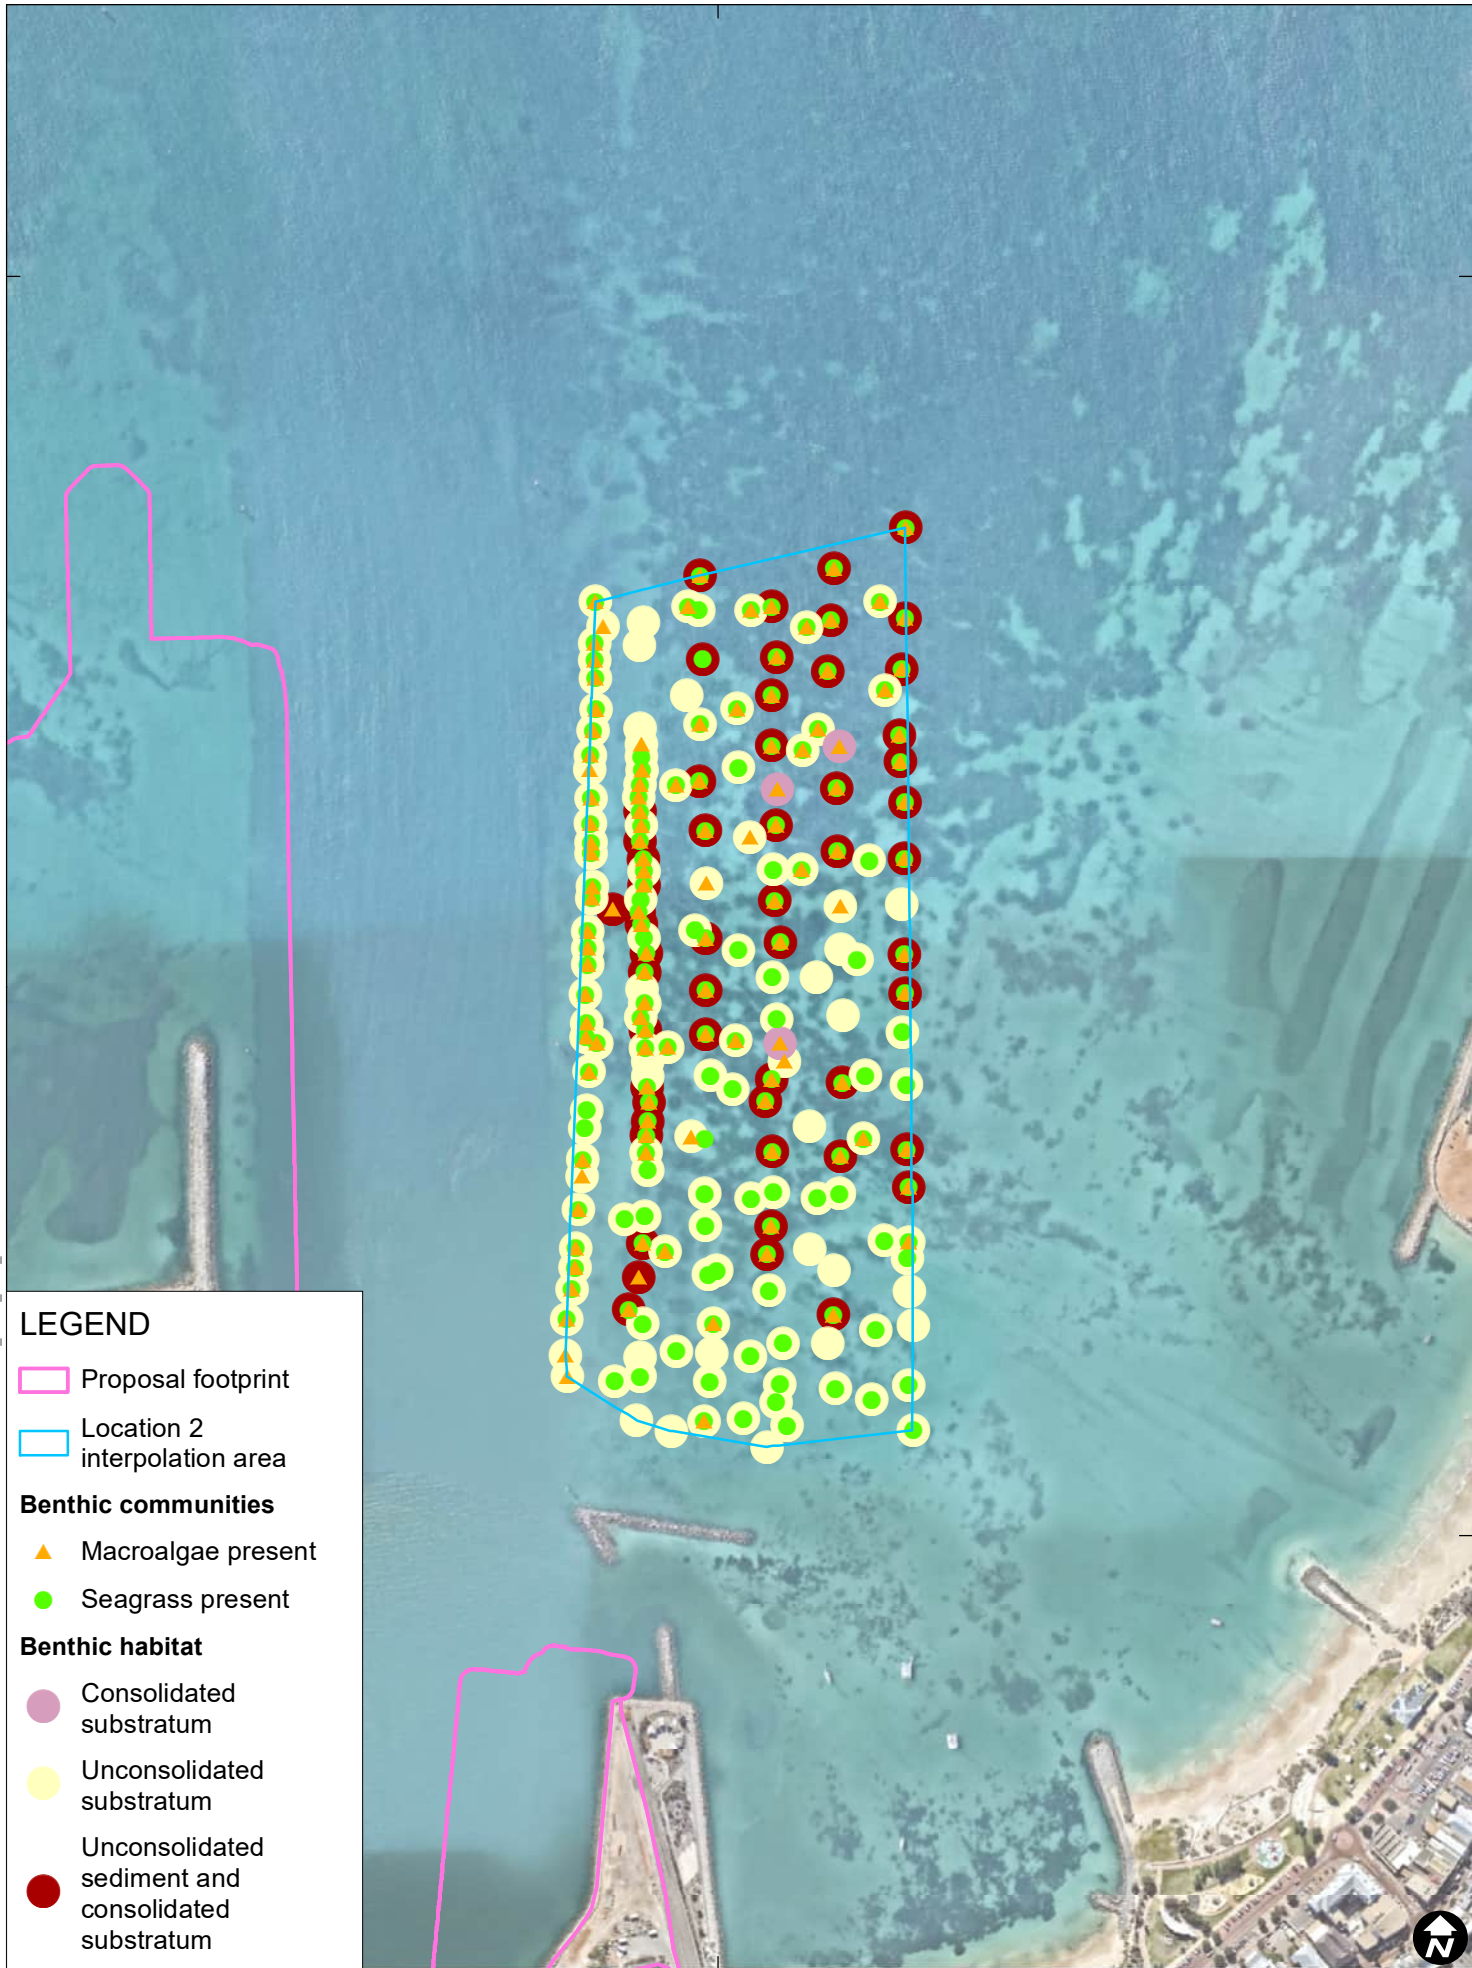
**FIGURE 8**

Location 2 was characterised by a mosaic of low to moderate profile reef and soft sediment associated with mostly low to medium density macroalgae and seagrass (**Figure 8**). Soft sediment was observed across 99% of sites, whilst rocky reef occurred at 37% of sites sampled (**Figure 8**). Seagrass was present at 83% of sites sampled whilst macroalgae was observed at 69% of sites. Seagrass and macroalgae occurred together at 61% of sites sampled in Location 2 (**Figure 8**). Bare soft sediment was observed at only 6% of sites throughout Location 2. Where rocky reef was observed it was always associated with the presence of macroalgae.

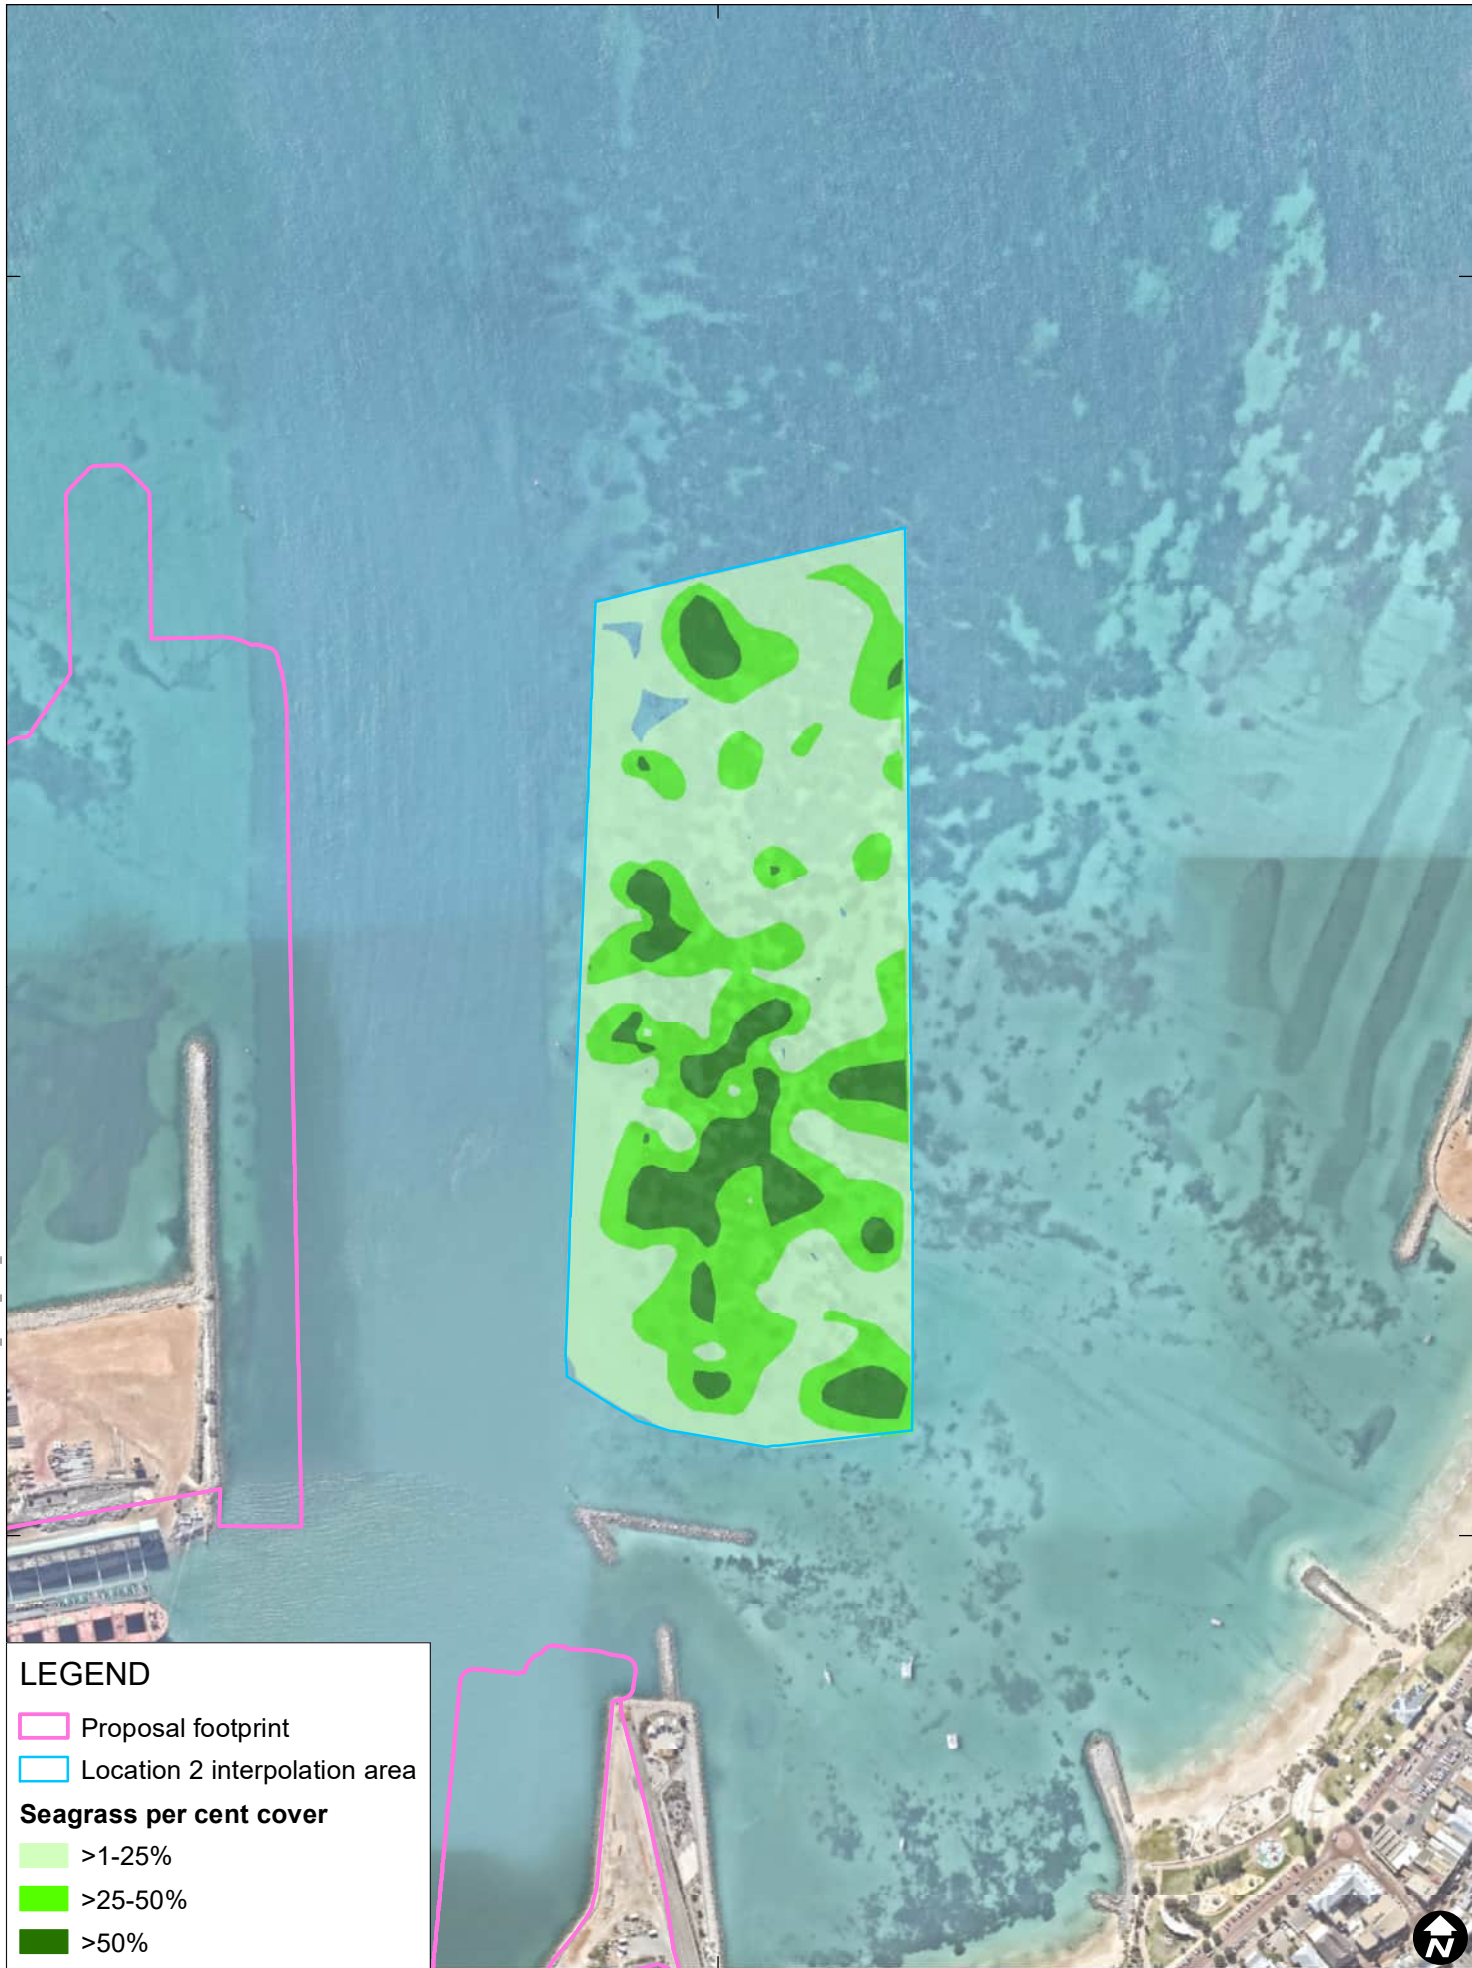
Seagrass and macroalgae were generally co-dominant across Location 2 (**Figure 9** and **Figure 10**). The mean % cover of seagrass at sites where it was observed was 35% ( $\pm 3.0$  SE). Interpolation model results indicate that low density seagrass is distributed throughout the most of Location 2 with denser patches tending to be located more in the southern portion (**Figure 9**). The seagrass taxa observed included *Halophila* sp., *Posidonia* sp., *Syringodium* sp. and *Amphibolis* sp..

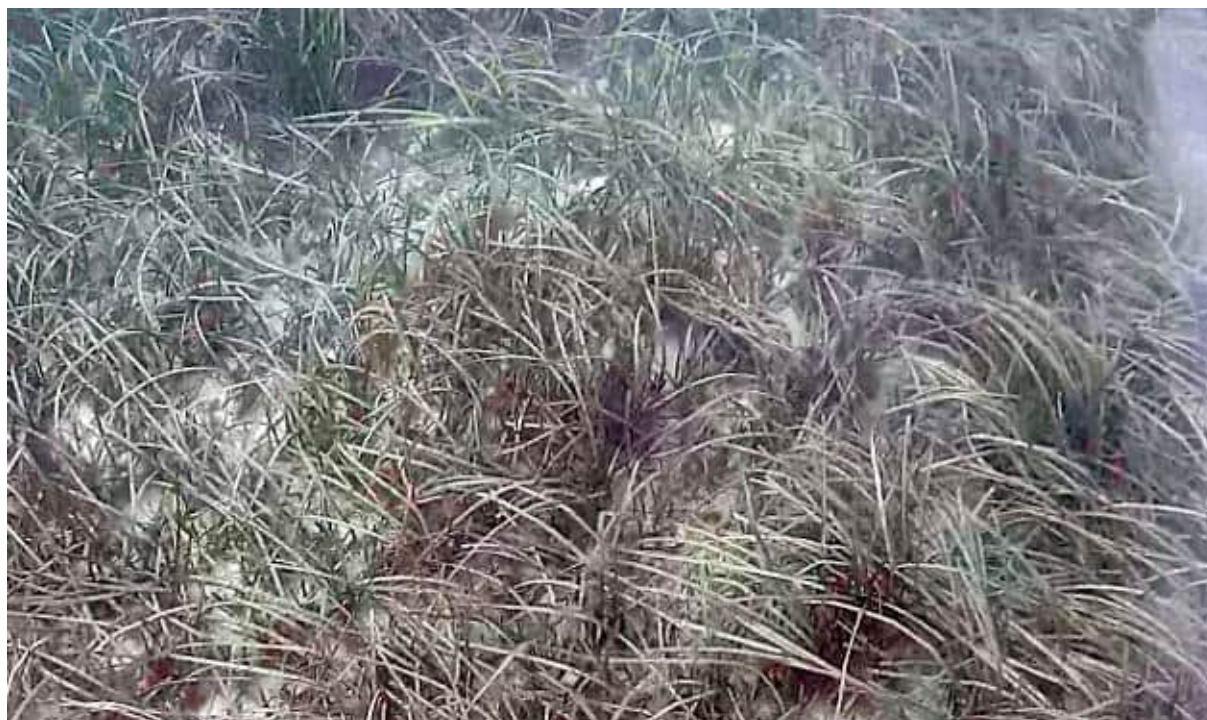
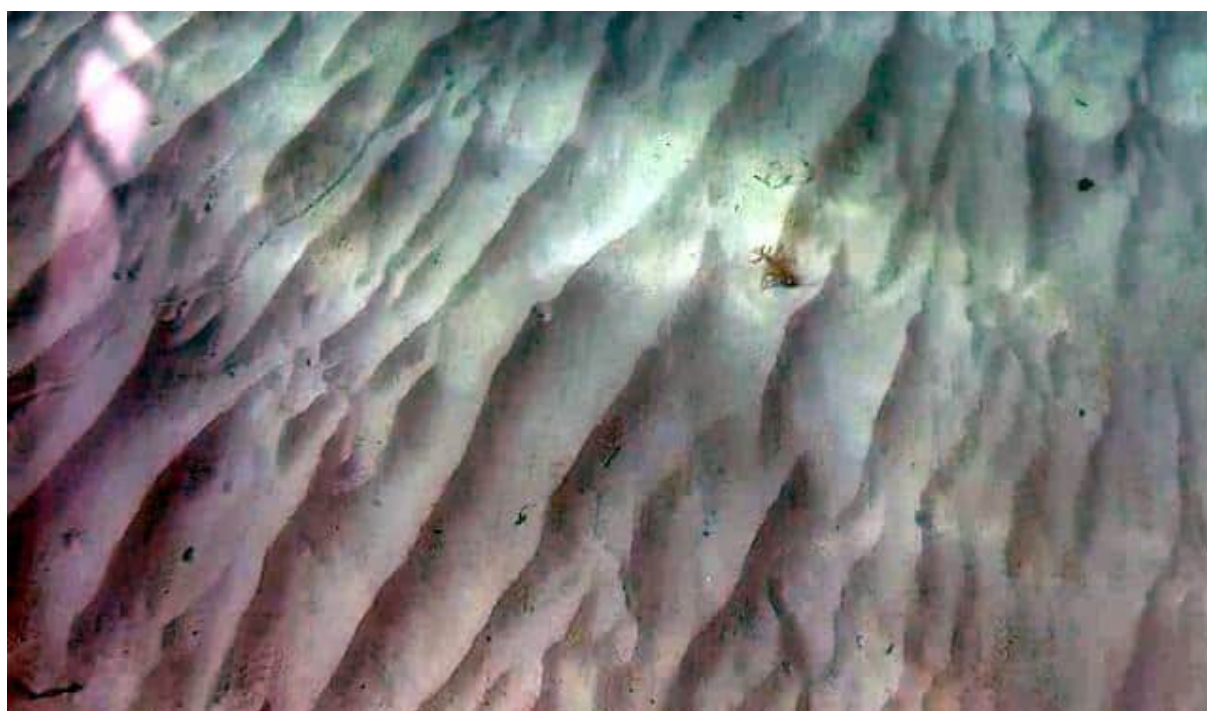
**Plate 1** (Top) High density bed of seagrass (*Posidonia* sp.) within Location 1.  
(Bottom) Bare soft sediment within Location 1.

**Plate 1** to **Plate 4** show examples of the dominant BCH categories observed throughout the three Locations within the Study Area during the survey.

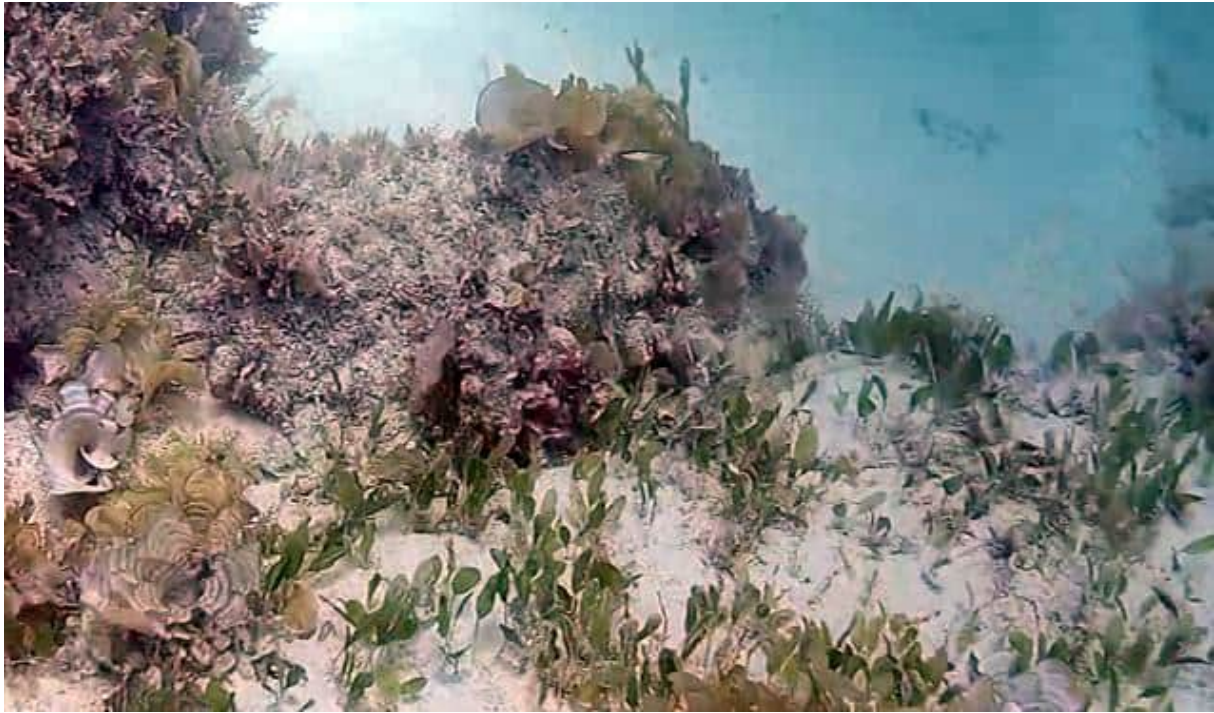
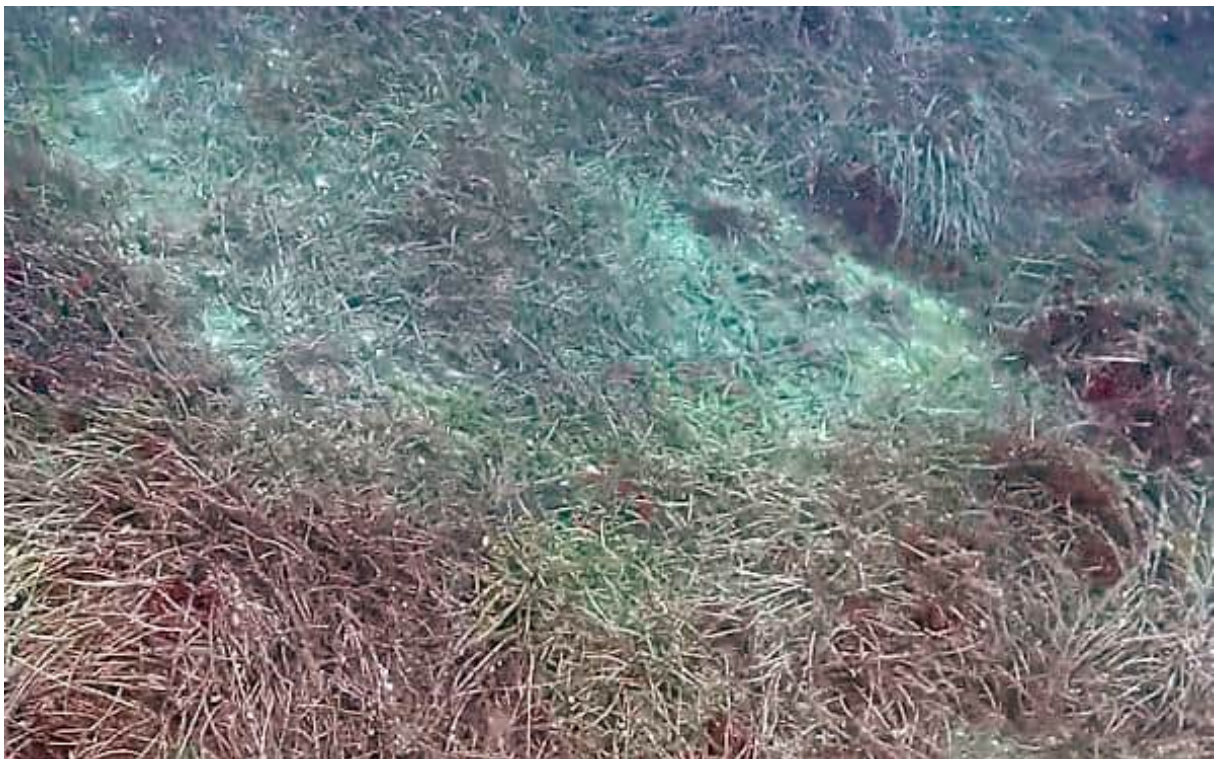
**Plate 2** (Top) Medium profile reef habitat with macroalgae and seagrass (*Halophila* sp.) within Location 2. (Bottom) High density seagrass (*Posidonia* sp.) patch within Location 2.

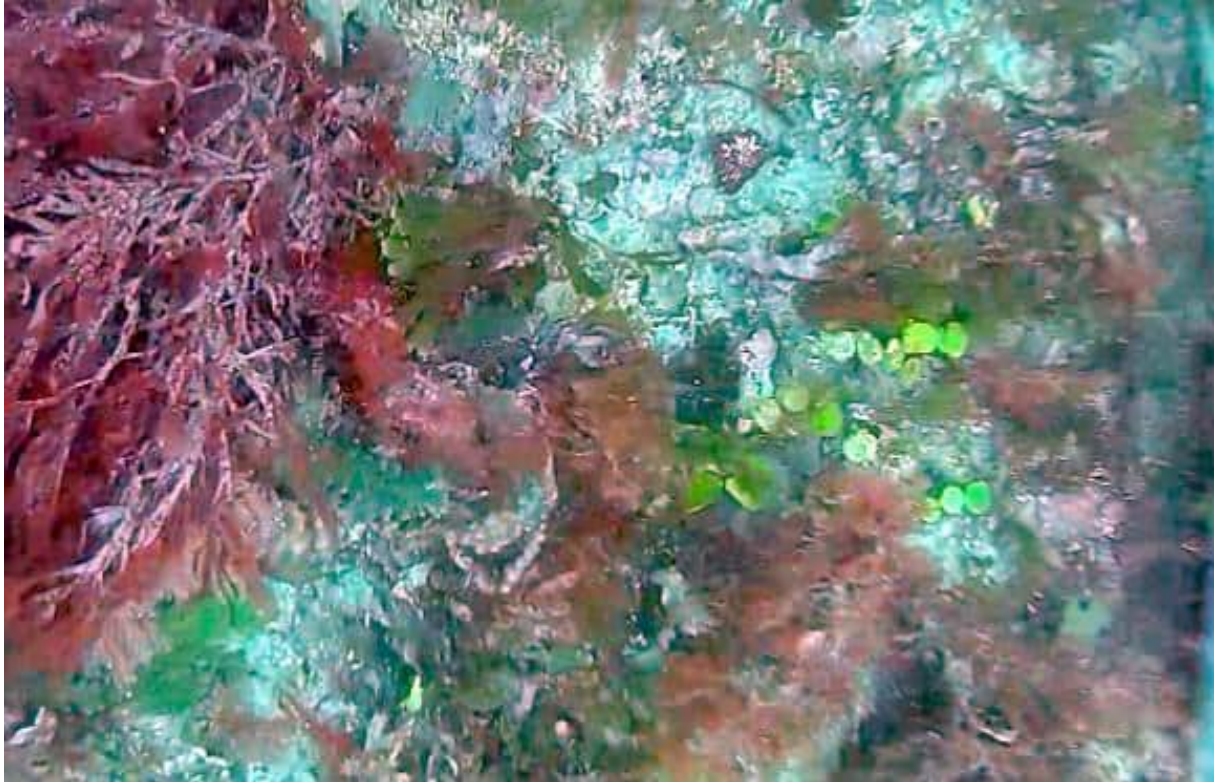
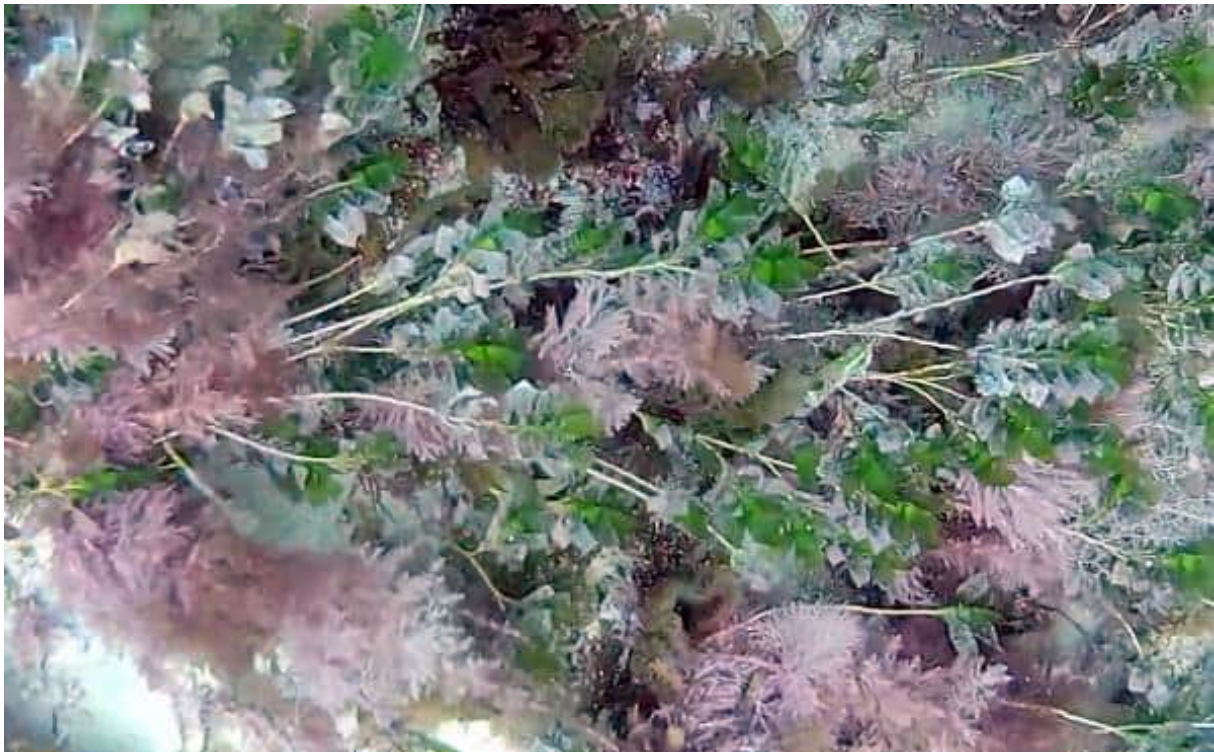
**Plate 3 (Top) Low profile reef habitat with macroalgae within Location 3. (Bottom) Co-dominant seagrass (*Amphibolis* sp.) and macroalgae within Location 3.**

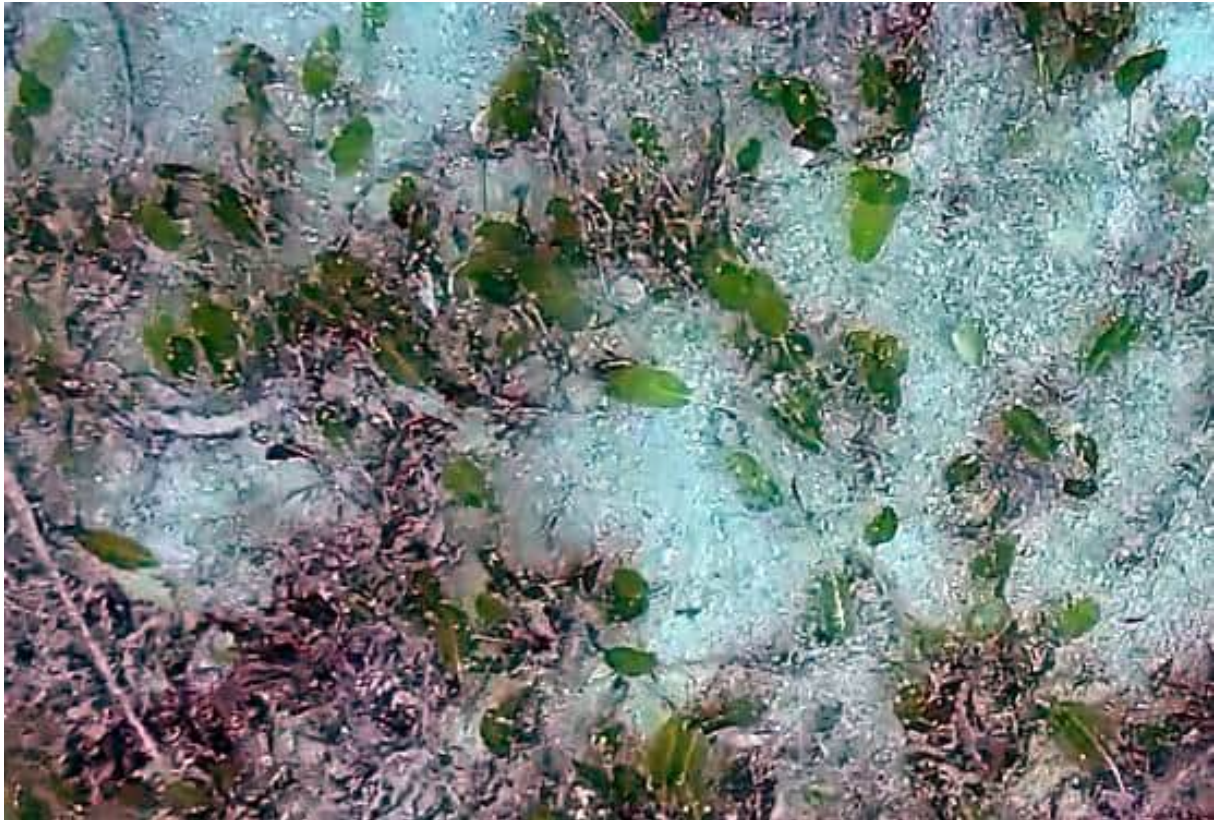
**Plate 4** Low to medium density seagrass (*Halophila* sp.) within Location 3.
