# Smiths Beach Development

## *Preliminary Geotechnical and Pavement Investigation*

**Golder Associates Pty Ltd**

20435097-001-R-Rev0

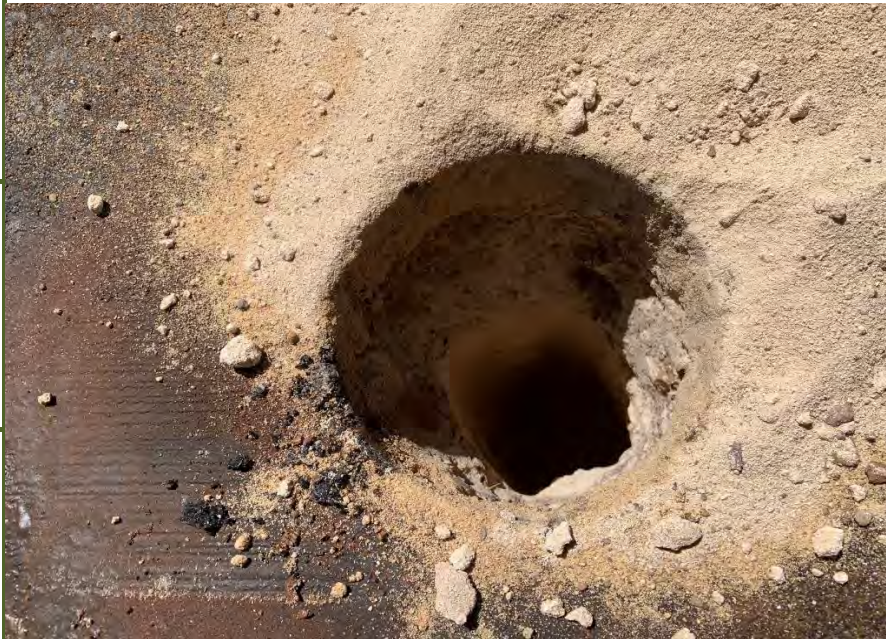
| Pavement Dipping Location | PD01 | northbound lane, closest to Canal Rocks Rd | Approx. Coordinates: 316075 E 6273013 N<br>Logged: DG | Datum: MGA zone 50J<br>Date: 22/12/2020 | Checked: DMS<br>Date: 03-02-21 |
| Pavement Thickness incl. Surfacing (mm) | >520 | | Samples | | |
| Surfacing | ASPHALT<br>14 mm DGA | | 1 x DS | | |

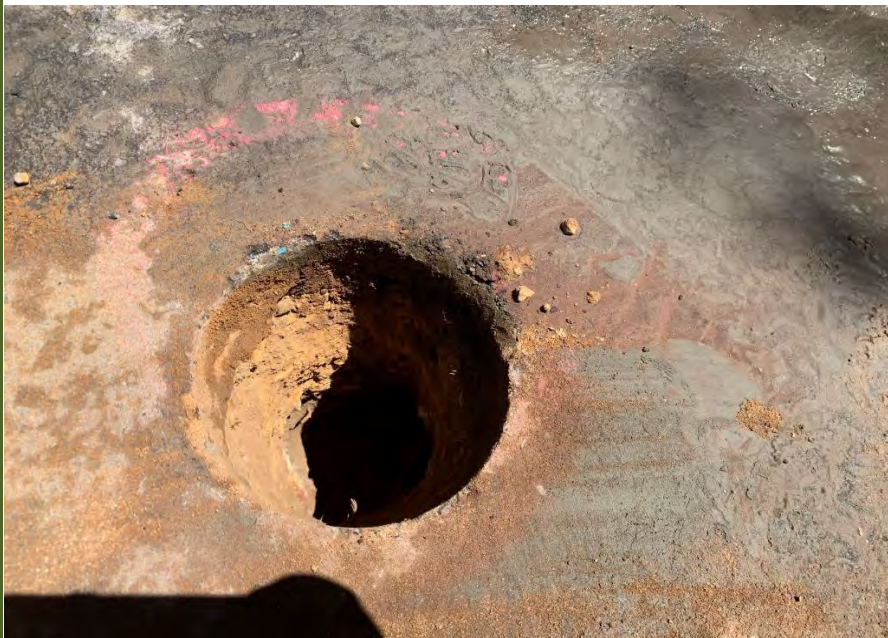
| Pavement Dipping Location | | PD02 | southbound lane | | Approx. Coordinates: 316075 E 6273130 N | | | Datum: MGA zone 50J | | | | |
| Pavement Thickness incl. Surfacing (mm) | | 190 | | Samples | | | | | | | | |
| Surfacing | | ASPHALT<br>14 mm DGA with inferred 10 mm seal | | | | | | | | | | |

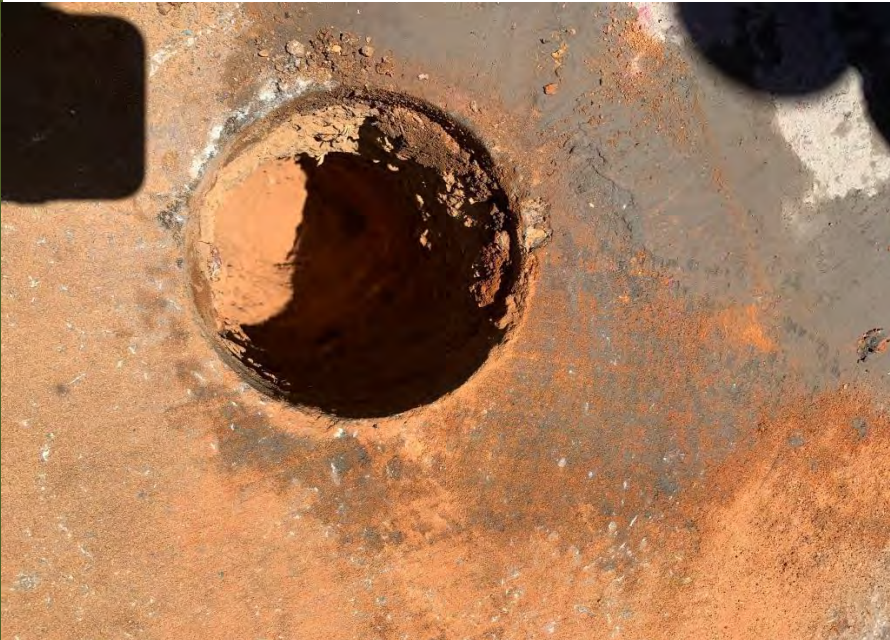
| Pavement Dipping Location | PD03 | southbound lane | | Approx. Coordinates: 316074 E 6273292 N Datum: MGA zone 50J<br>Logged: DG Date: 22/12/2020 Checked: DMS Date: 03-02-21 | | | |
| Pavement Thickness incl. Surfacing (mm) | 300 | | Samples | | | | |
| Surfacing | <b>ASPHALT</b><br>14 mm DGA with inferred 10 mm seal | | | | | | |

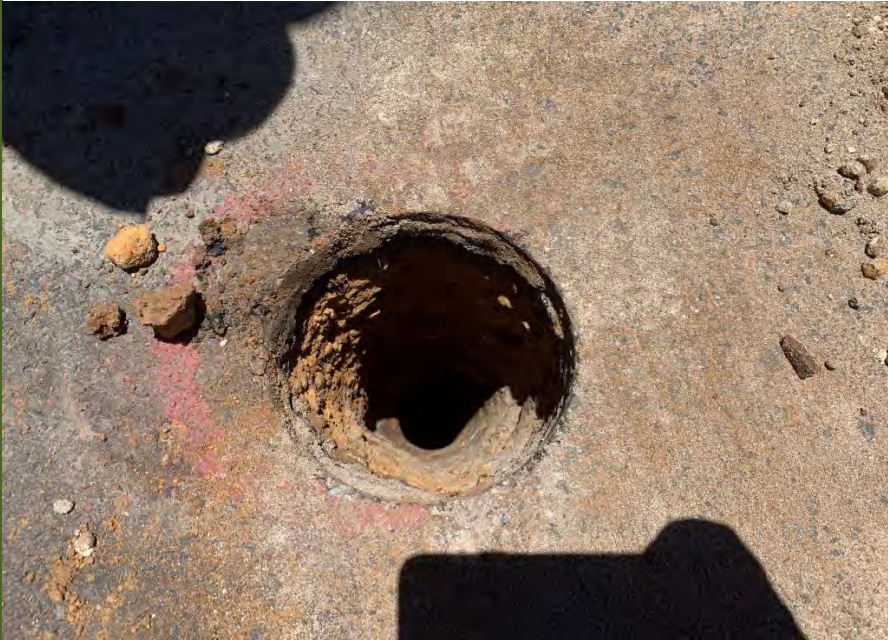
| Pavement Dipping Location | PD04 | northbound lane | Approx. Coordinates: 316065 E 6273444 N<br>Datum: MGA zone 50J<br>Logged: DG Date: 22/12/2020<br>Checked: DMS Date: 03-02-21 |
| Pavement Thickness incl. Surfacing (mm) | 260 | Samples | |
| Surfacing | <b>ASPHALT</b><br>14 mm DGA | | |

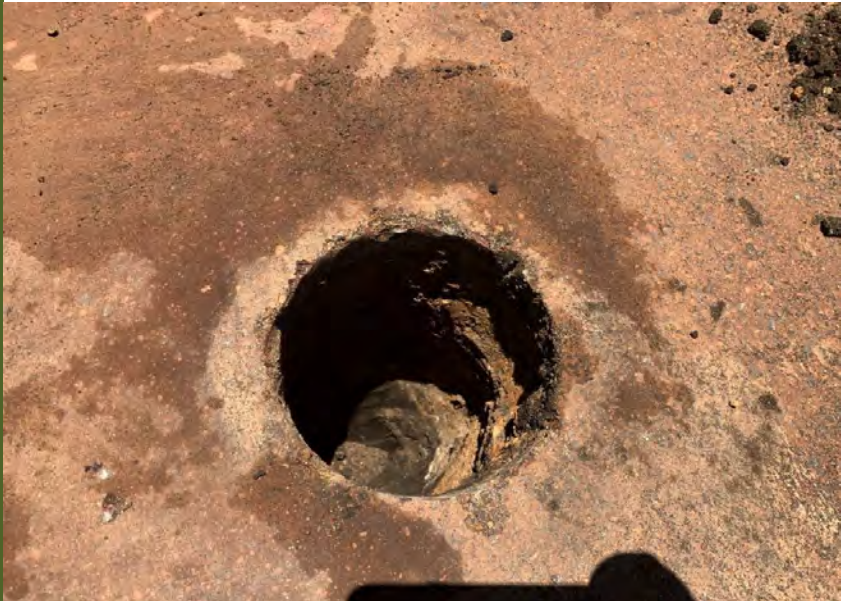
| Pavement Dipping Location | | PD05 | northbound lane | Approx. Coordinates: 316063 E 6273536 N | | Datum: MGA zone 50J | |
| Pavement Thickness incl. Surfacing (mm) | | 290 | Samples | | | | |
| Surfacing | | ASPHALT<br>10 mm red laterite DGA with inferred 5 mm seal | | | | | |

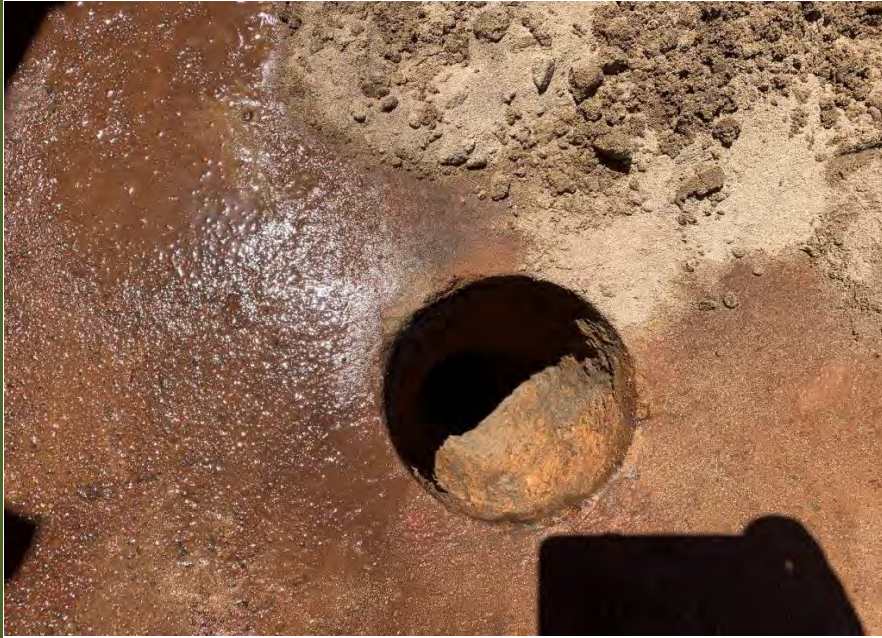
| Pavement Dipping Location | | PD06 | southbound lane | | Approx. Coordinates: 315906 E 6273603 N | | | Datum: MGA zone 50J | | | | | | |
| Pavement Thickness incl. Surfacing (mm) | | 290 | | Samples | | | | | | | | | | |
| Surfacing | | ASPHALT<br>10 mm red laterite DGA with inferred 5 mm seal | | | | | | | | | | | | |

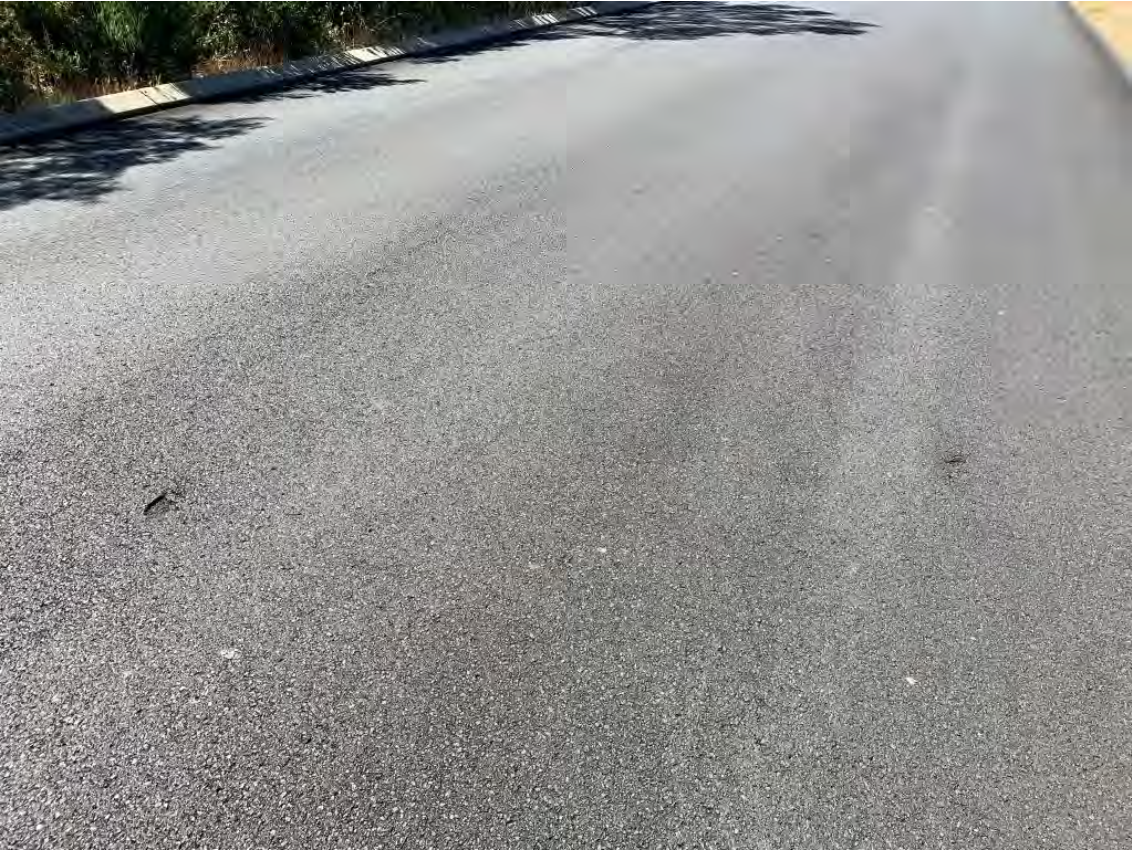
| Photograph | | Location/Description of Defect |
|---|--|---|
| | | Minor potholes on the outer wheel path and outside of the inner wheel path of the northbound lane (approx. 210 m north of the intersection with Canal Rocks Road) |

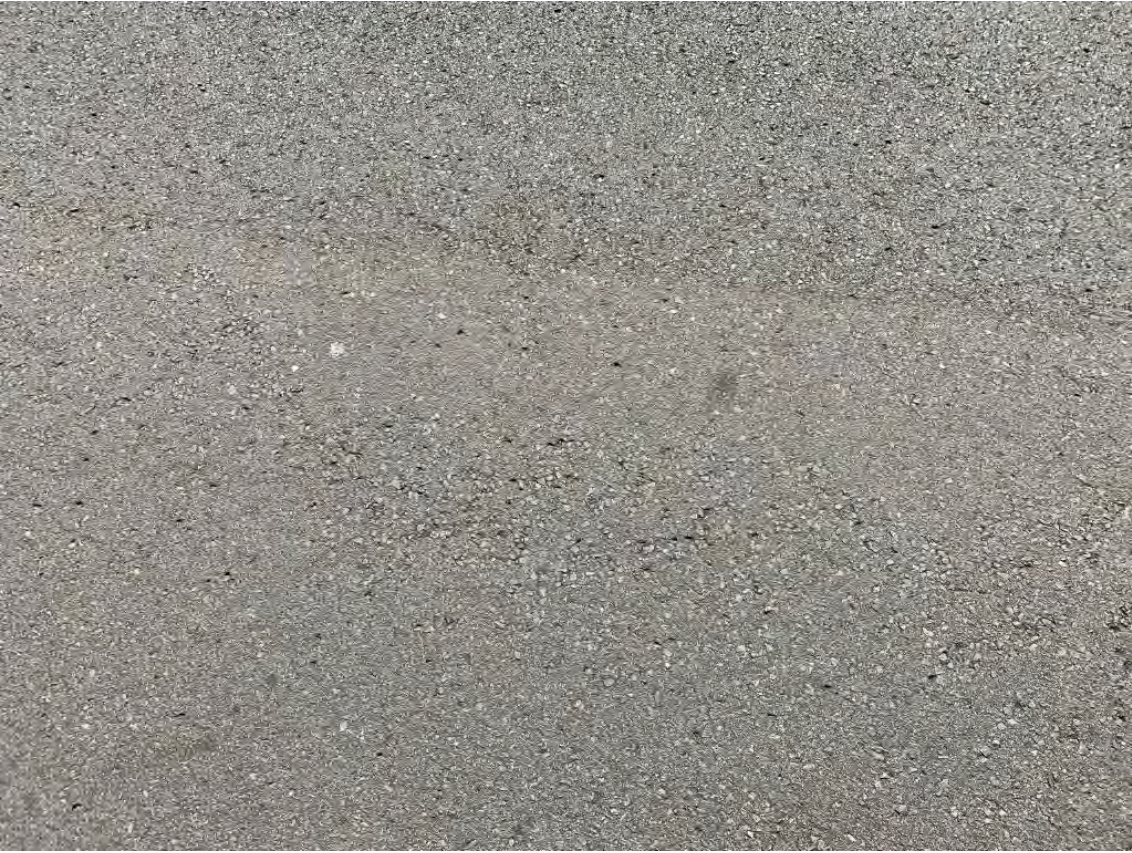
| Photograph | | Location/Description of Defect |
|---|--|---|
| | | Observed minor to moderate ravelling in both lanes, pinhole defects suggest that aggregate have been plucked out by the traffic movement. As the asphalt looks relatively new (inferred age around 2 years), the early ravelling may have been caused by temperature of the mix/temperature during construction. |

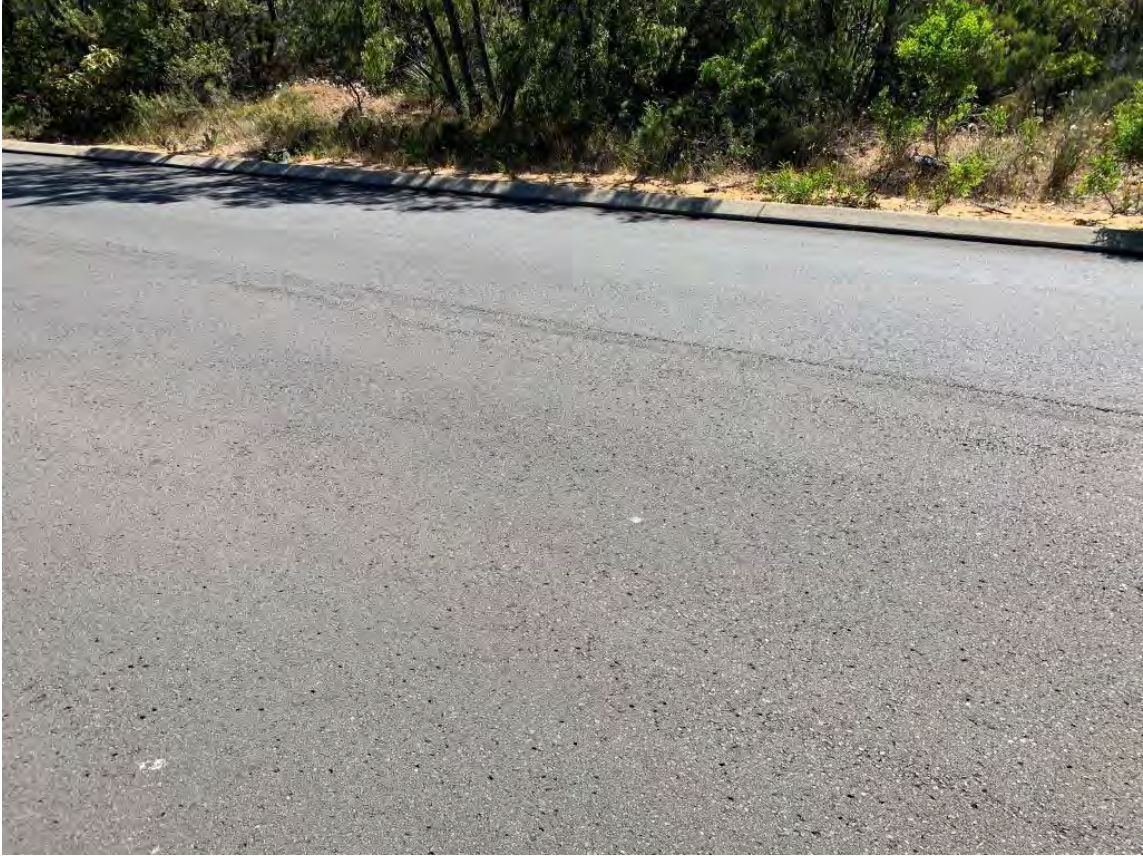
| Photograph | | Location/Description of Defect |
|---|--|---|
| | | Minor ravelling along the longitudinal joint, could be due to construction practices. Pinholes observed across both lanes. |

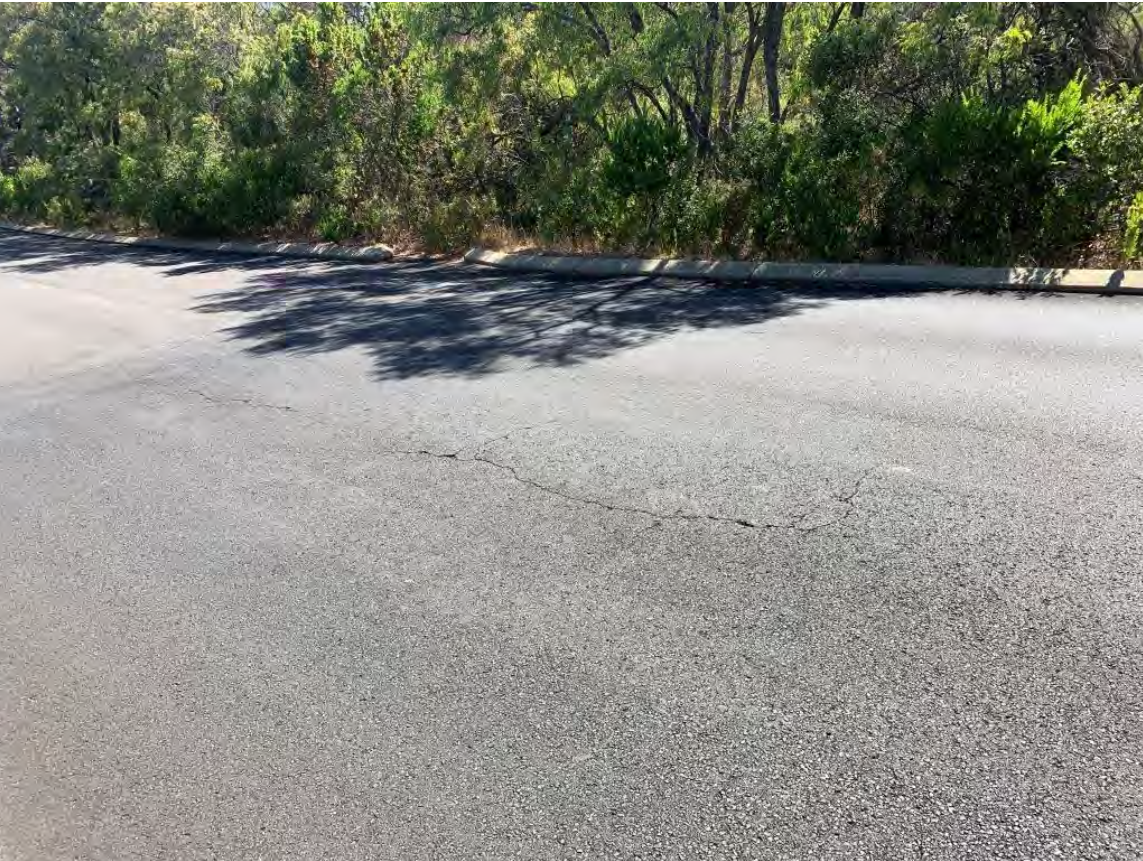
| Photograph | | Location/Description of Defect |
|---|--|---|
| | | Longitudinal and transverse cracking between the two lanes |

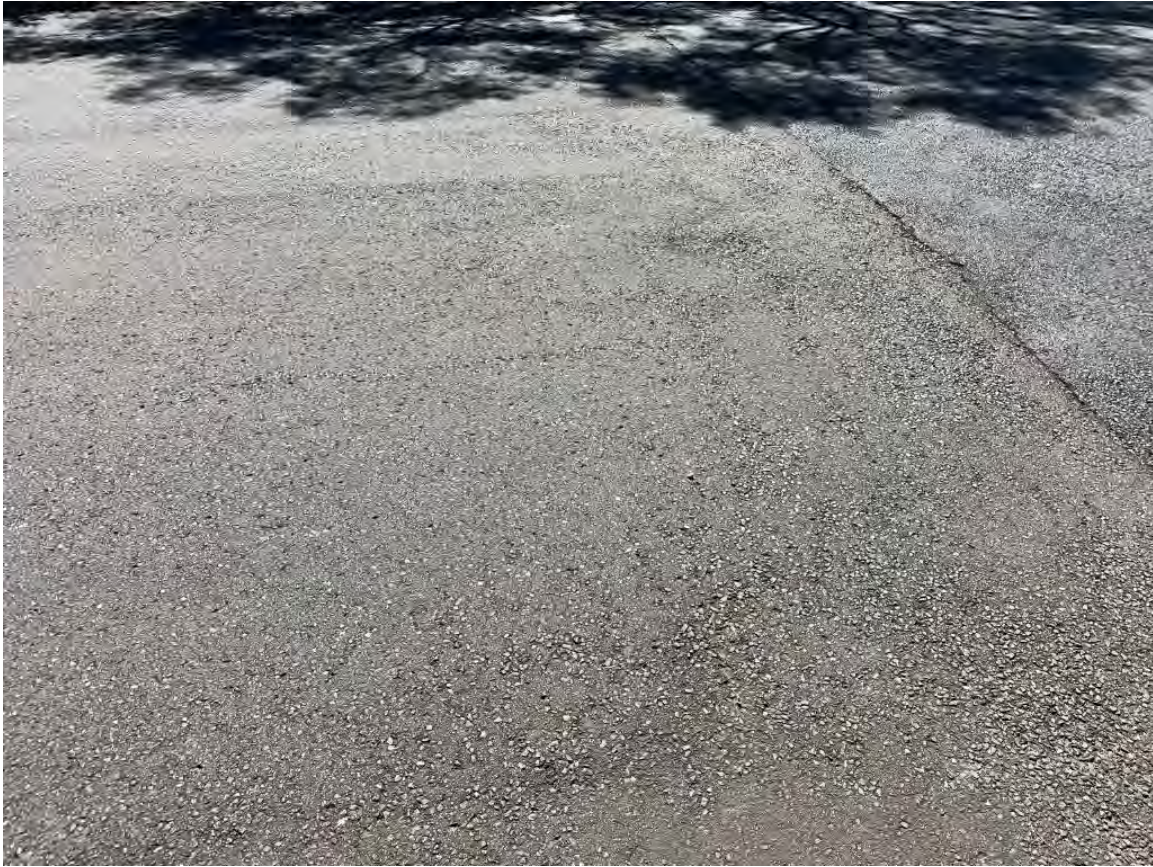
| Photograph | | Location/Description of Defect | |
|---|--|---|--|
| | | Minor to moderate ravelling on both lanes | |

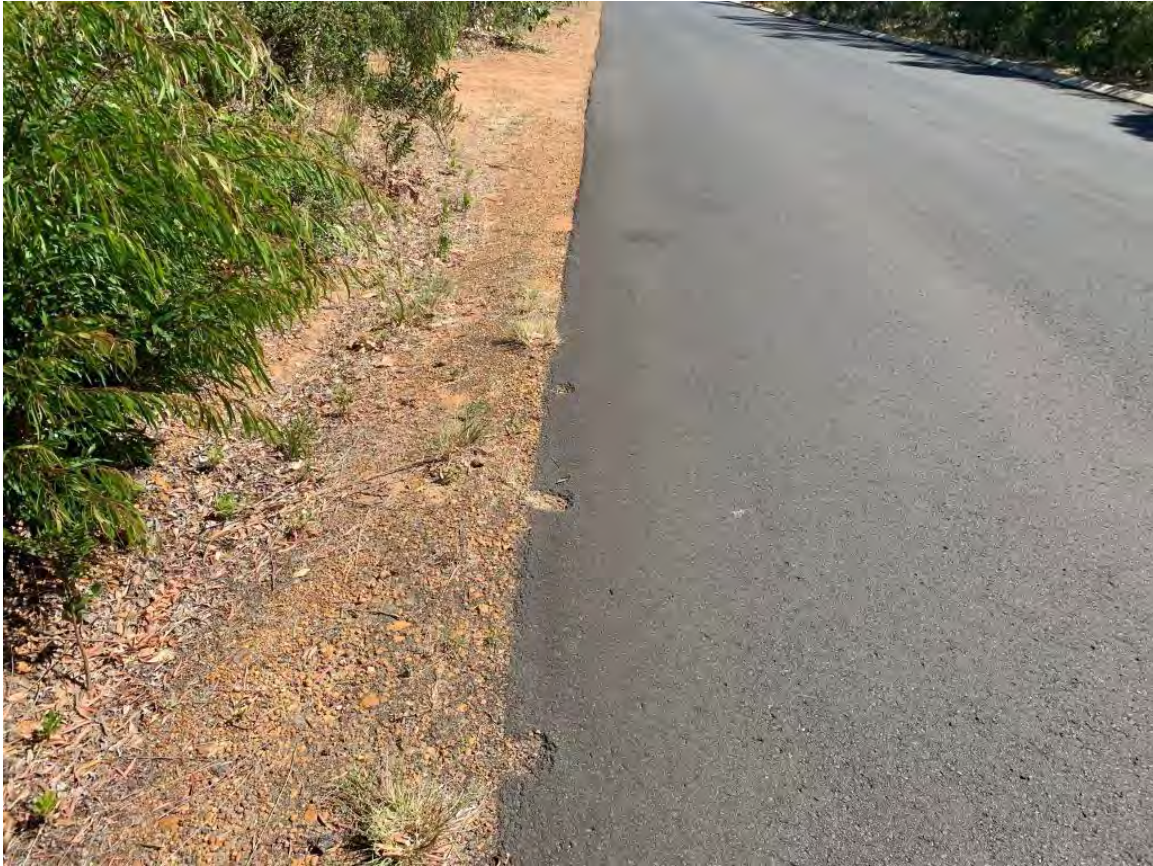
| Photograph | | Location/Description of Defect | |
|---|--|---|--|
| | | Small localised potholes along the edge of pavement (associated with edge break) | |

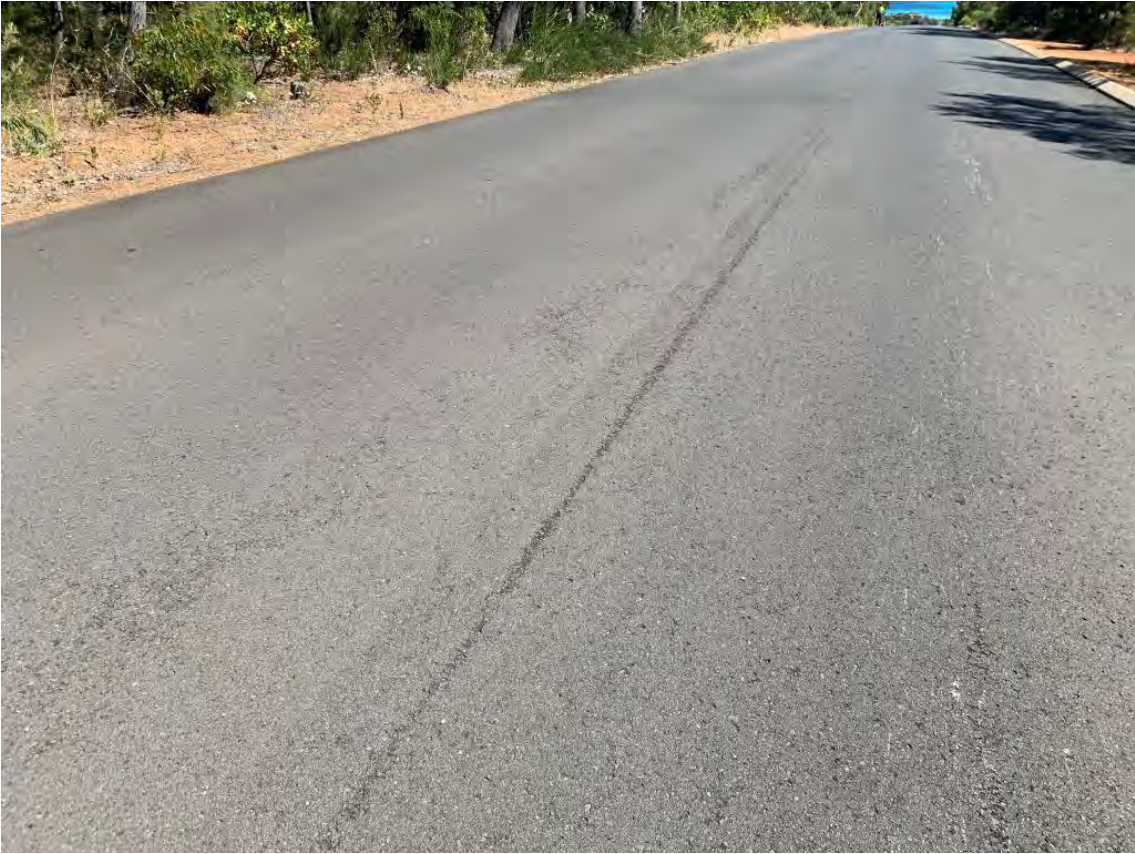
| Photograph | | Location/Description of Defect | |
|---|--|---|--|
| | | Observed minor ravelling outside the wheel path and along the joint on the northbound lane. | |

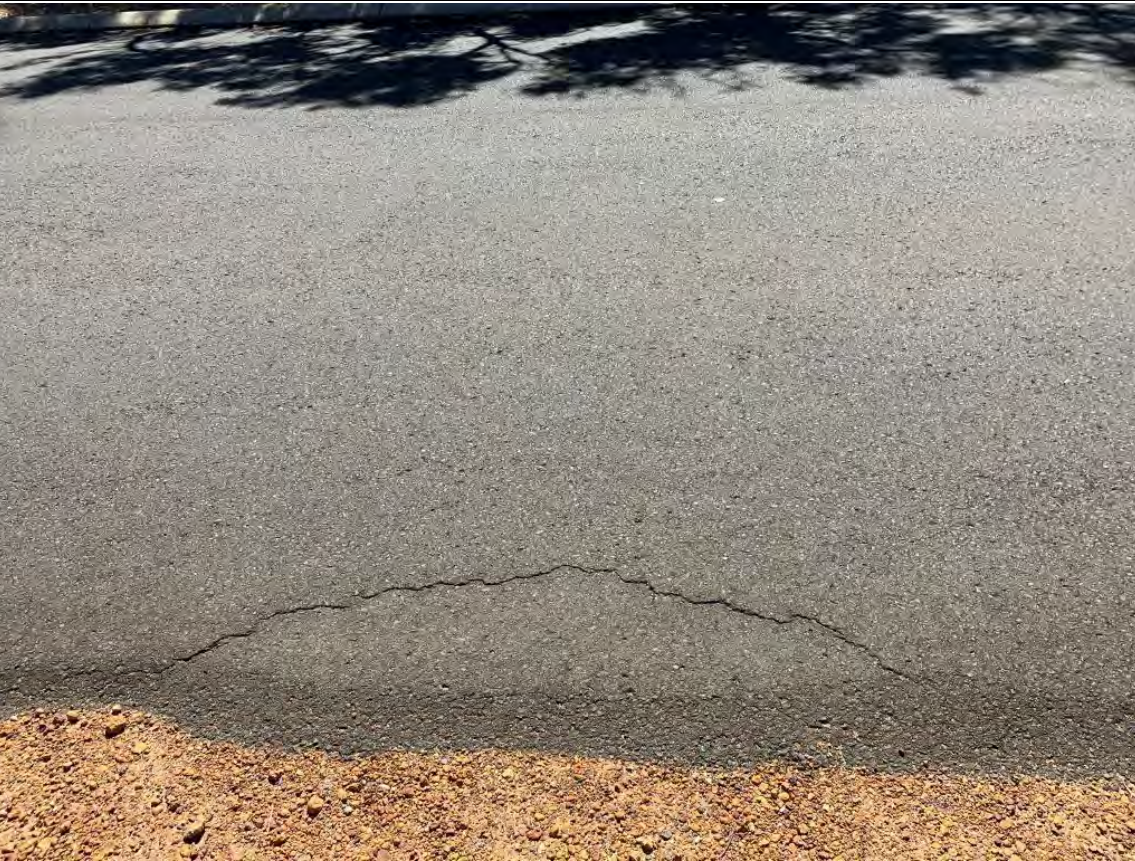
| Photograph | | Location/Description of Defect | |
|---|--|---|--|
| | | Longitudinal crack along the edge of pavement at localised areas | |

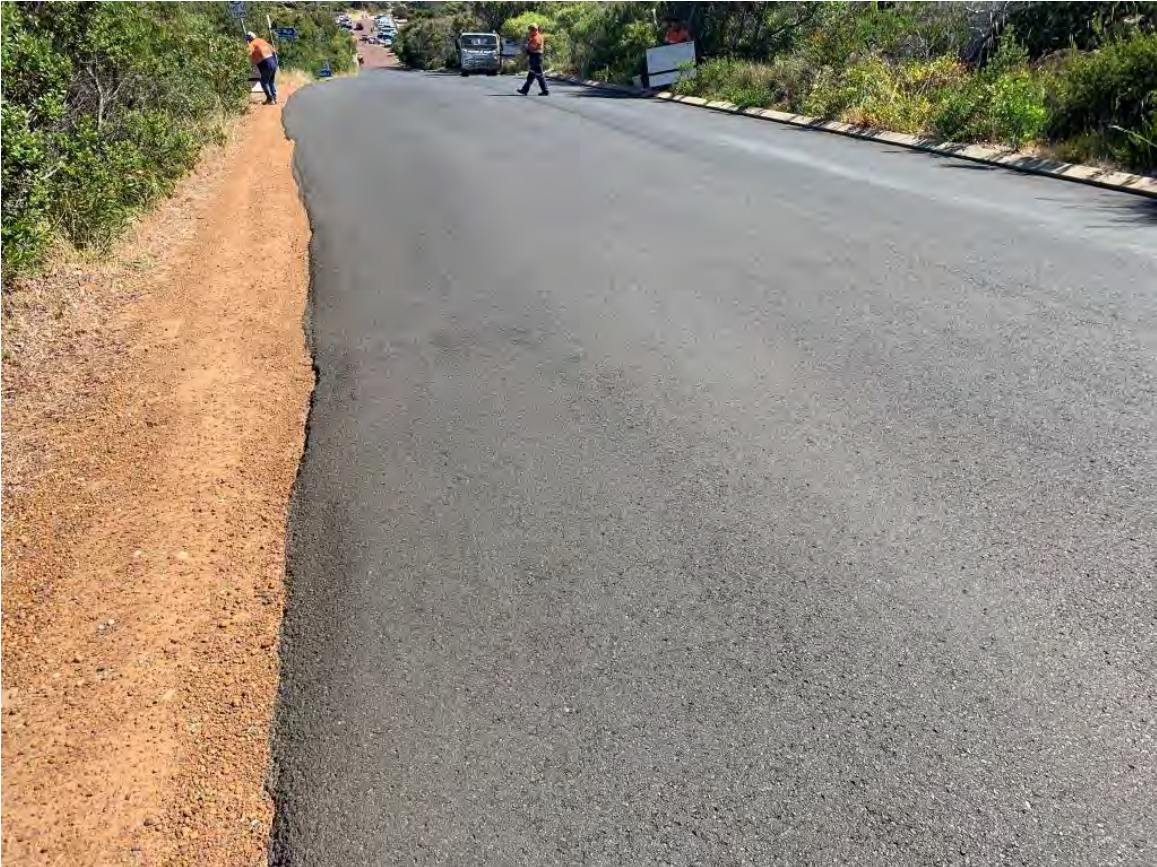
| Photograph | Location/Description of Defect |
|---|---|
| | <p>Pavement shape along the investigated extent of road is good, no crocodile cracking or rutting observed.</p> |

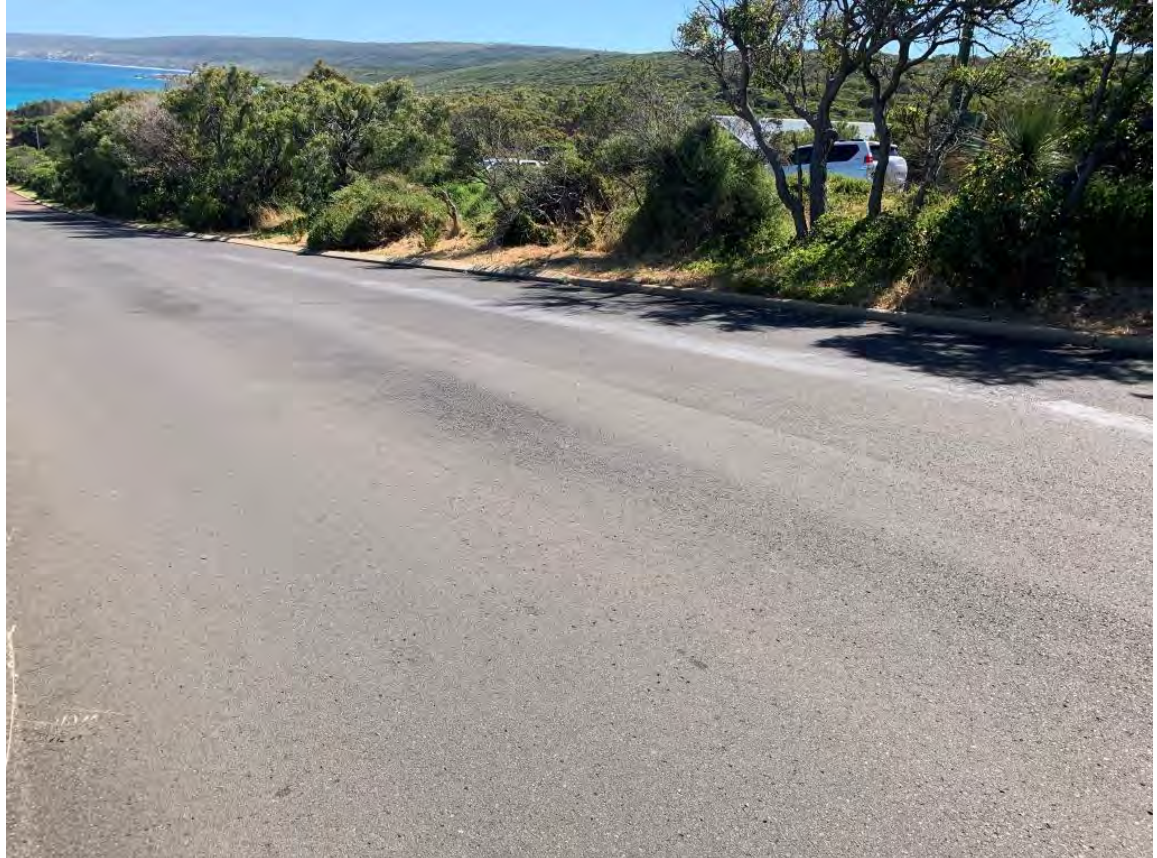
| Photograph | Location/Description of Defect |
|---|---|
| | <p>Ravelling on the inner wheel path of the northbound lane</p> |

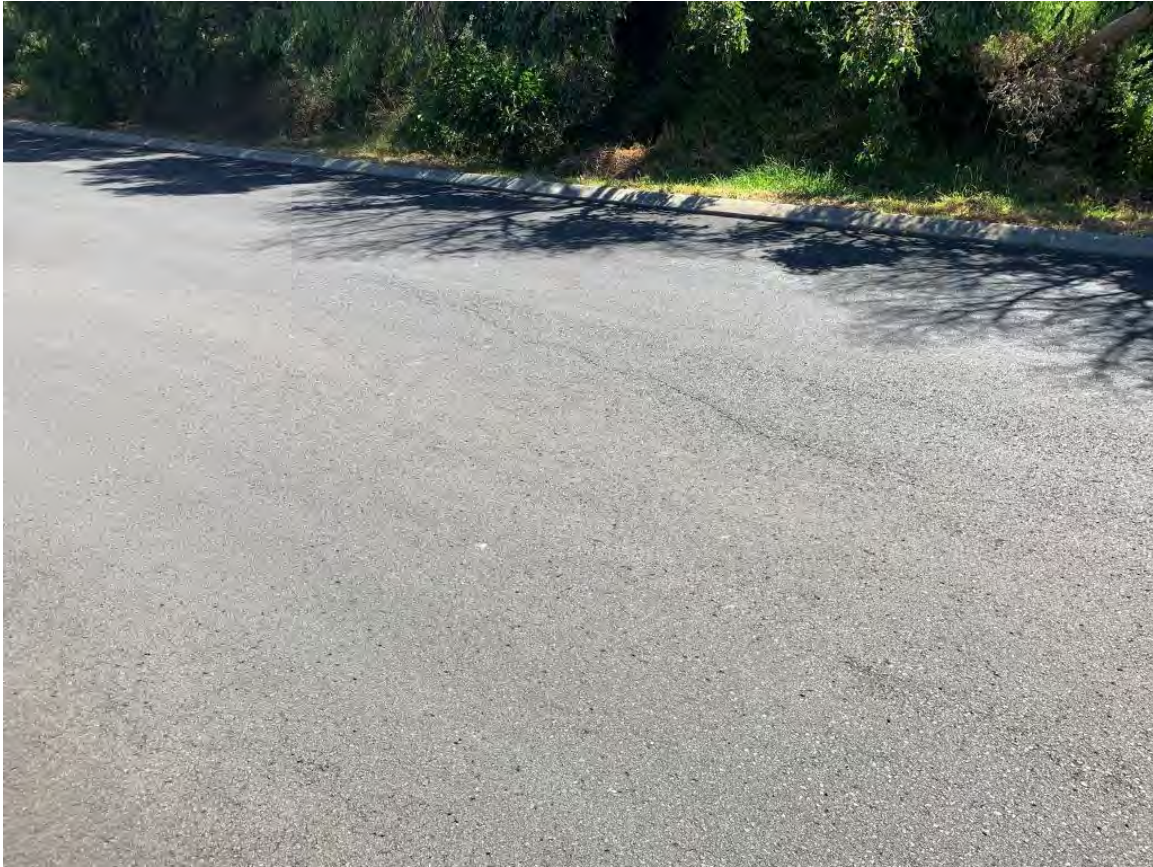
| Photograph | | Location/Description of Defect | |
|---|--|---|--|
| | | Localised longitudinal cracking – southbound lane | |

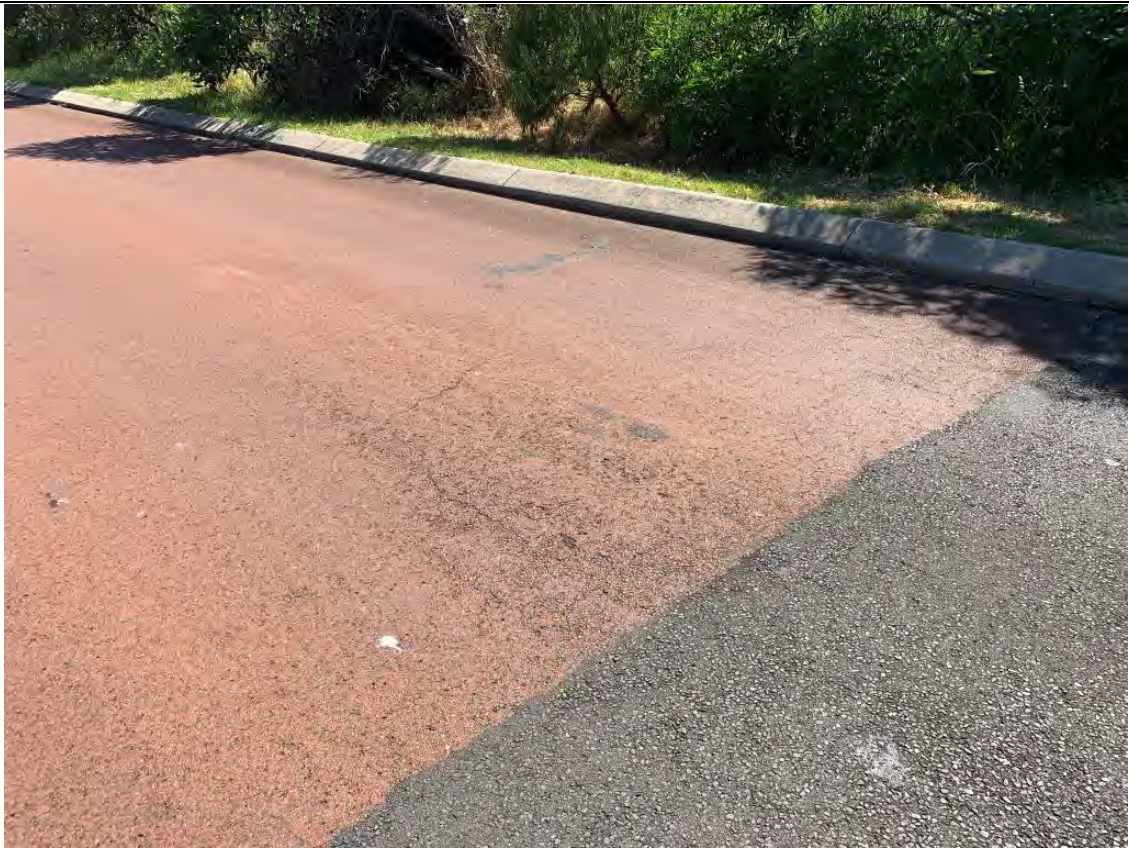
| Photograph | | Location/Description of Defect | |
|---|--|---|--|
| | | Transverse and longitudinal cracking between the lanes. Minor ravelling observed. | |

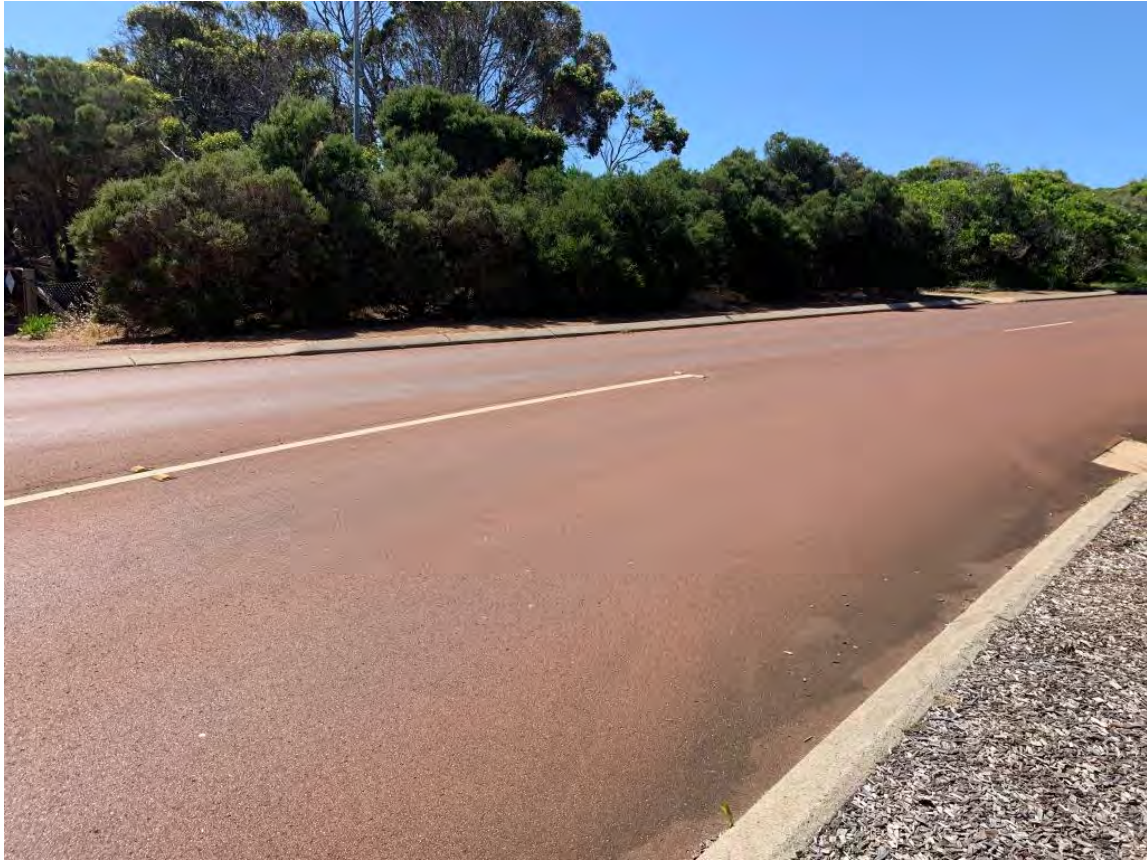
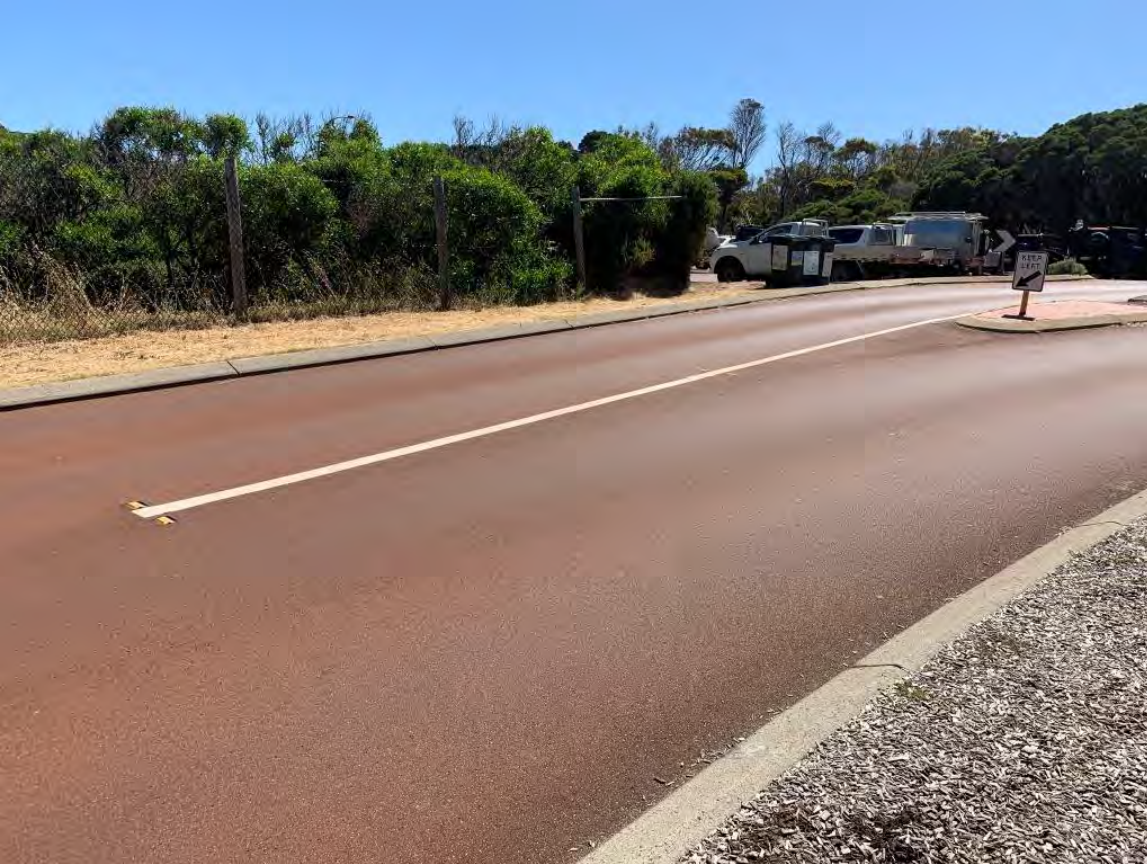
| Photograph | | Location/Description of Defect | |
|---|--|---|--|
| | | Minor flushing observed on the wheel paths, predominantly on the southbound lane along the bend of the road. Increased turning stresses may have contributed to the observed flushing around the bend. | |
| | | As above | |

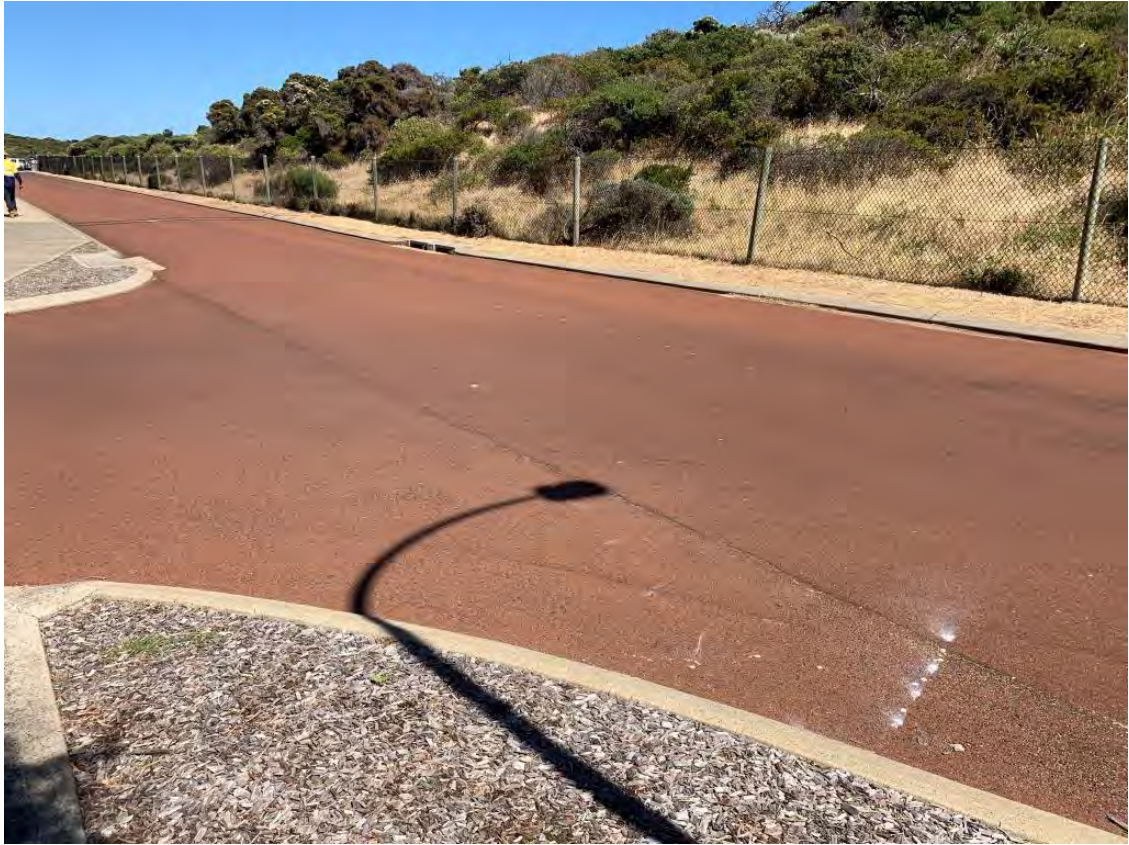
| Photograph | Location/Description of Defect |
|---|---|
| | <p>Some minor cracking along the joints and pumping of fines. Minor ravelling within the turning pocket.</p> |

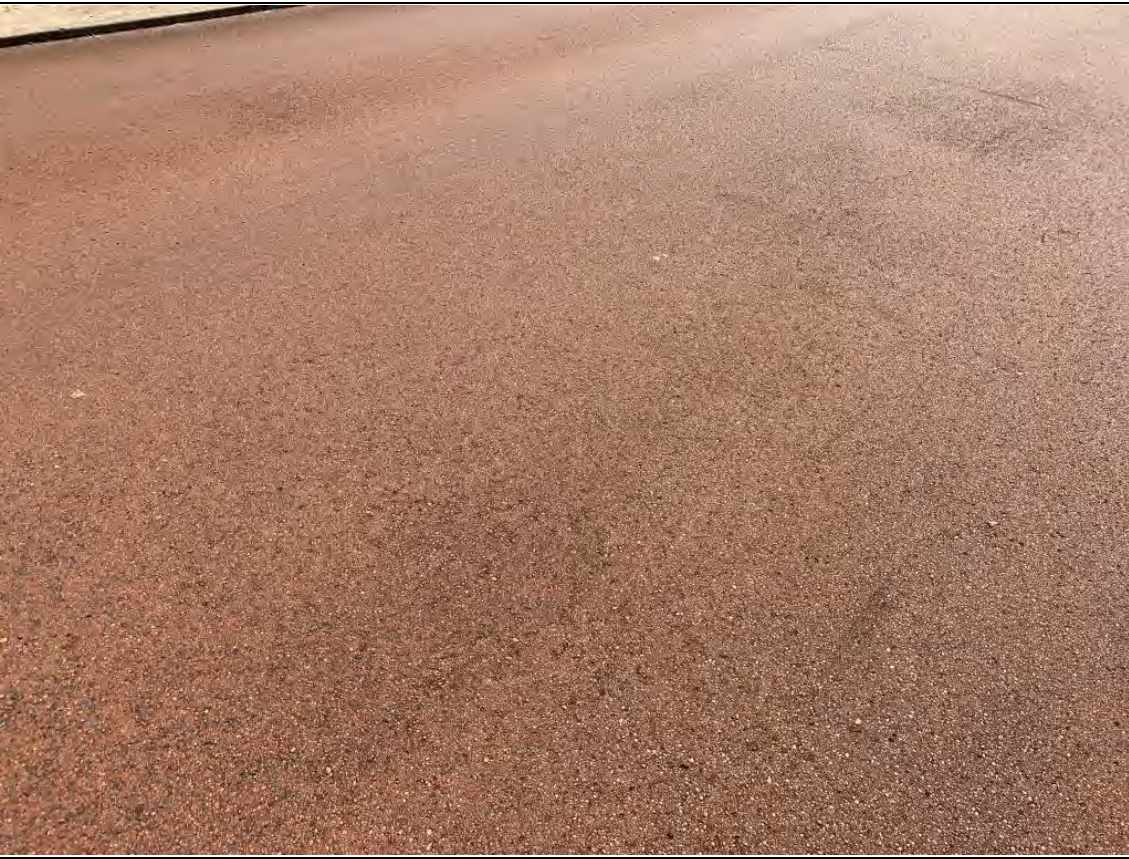
| Photograph | Location/Description of Defect |
|---|---|
| | <p>Close up of pavement – small pin holes were generally observed on the pavement surface, as well as minor ravelling at localised spots, between wheel paths. Pavement may have been constructed during wet or cold weather.</p> |

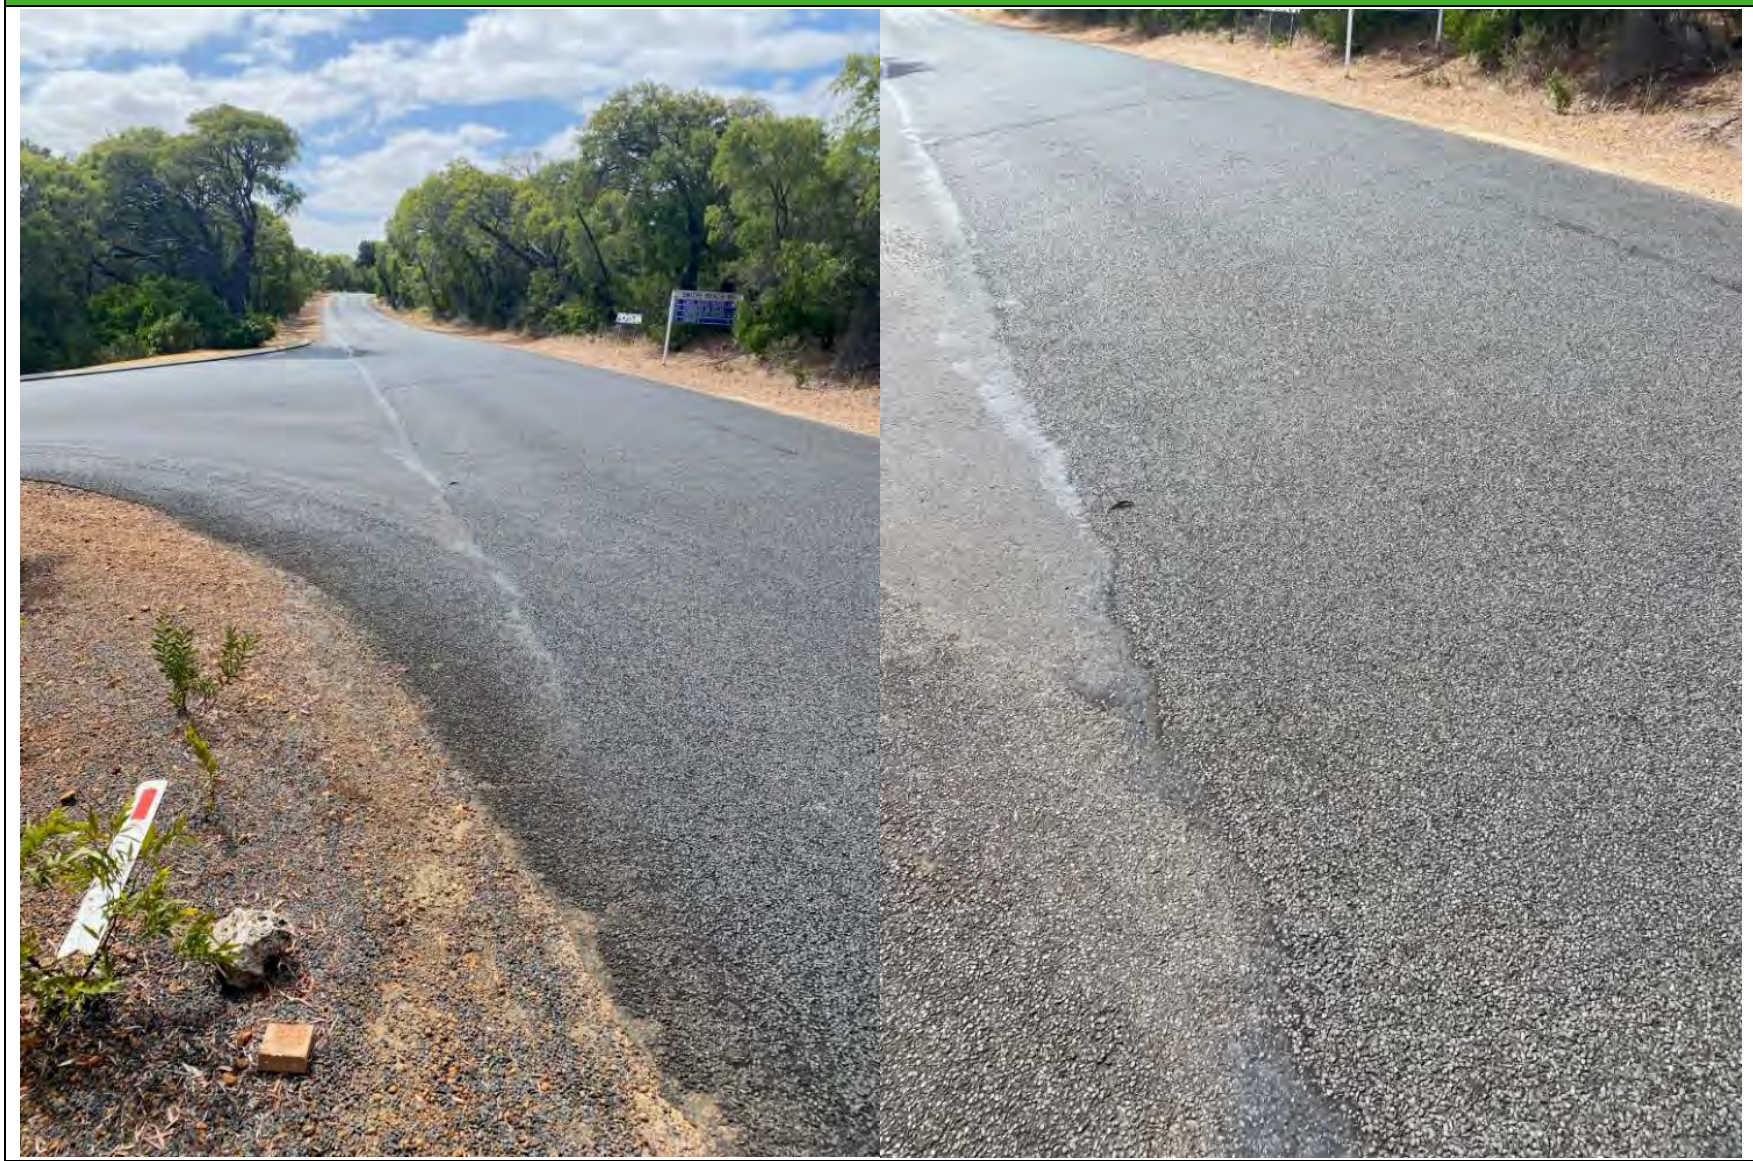
| Photograph | Location/Description of Defect |
|---|---|
| | <p>Intersection stub of Canal Rocks Road and Smiths Beach Road – the asphalt surfacing joins to a spray sealed through lane and the joint sealing is relatively poor. Spray sealed shoulder on the left turn heading north widens the intersection stub, some minor stripping observed on the sealed surface.</p> |
