# Smiths Beach Development

## *Preliminary Geotechnical and Pavement Investigation*

**Golder Associates Pty Ltd**

20435097-001-R-Rev0

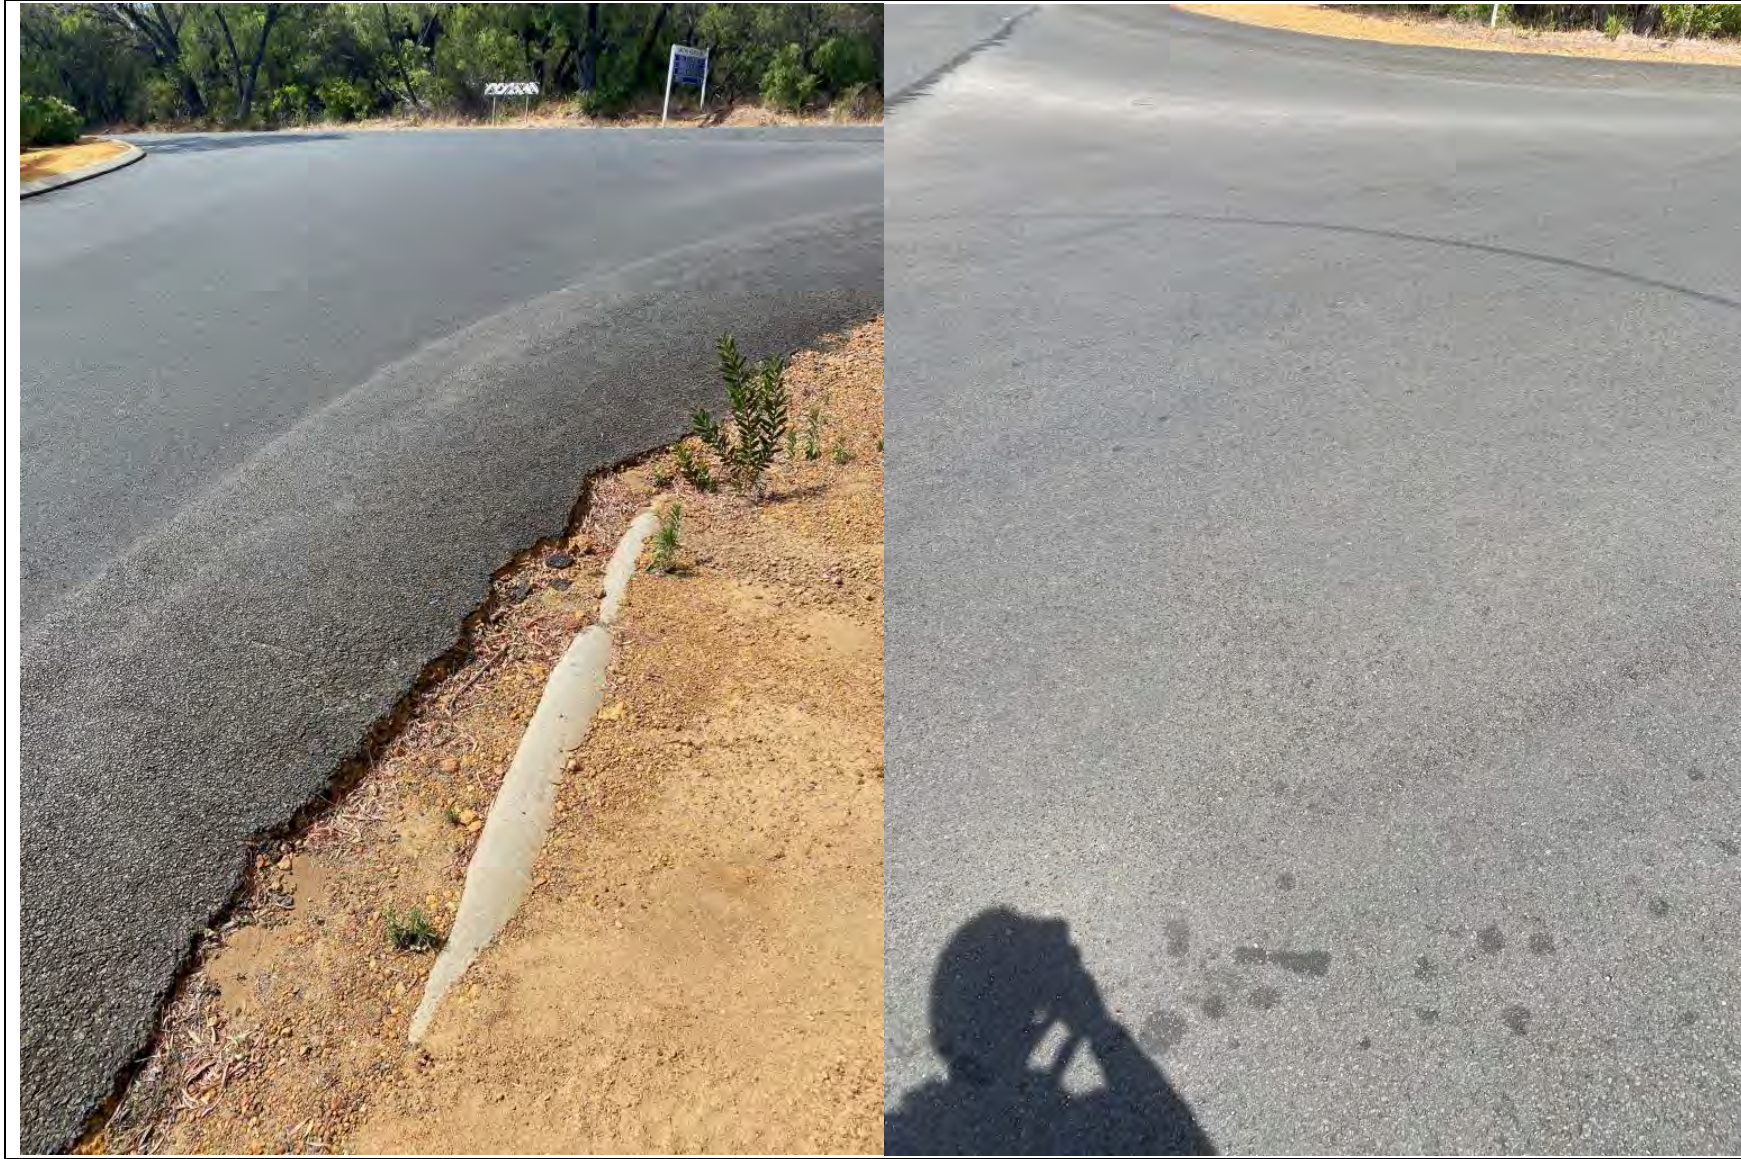
| Photograph | Location/Description of Defect |
|---|---|
| | <p>Edge break and drop off along the edge of the northbound lane (spray seal) and pumping of fines along the joint. Some ravelling was also observed on the wheel path of the turning lane (asphalt surfacing).</p> |

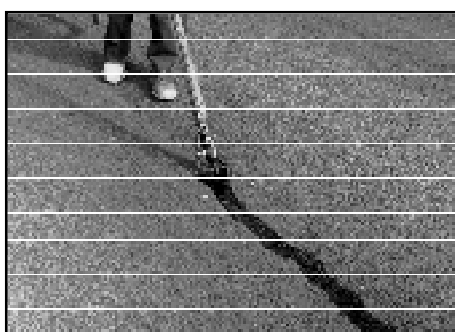
Crack filling with insulated hand lance

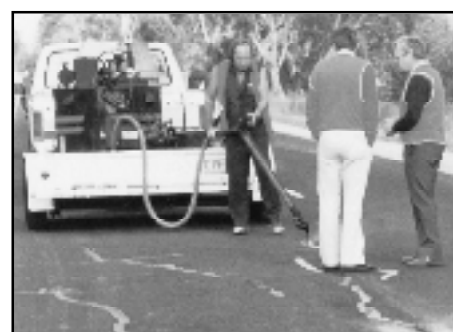
Filling and sanding cracks after routing
