**TAILINGS STORAGE FACILITY (TSF)
DESIGN REPORT
HEMI GOLD PROJECT, WA**

De Grey Mining Ltd
Ref. PER2021-0290AB Rev 3

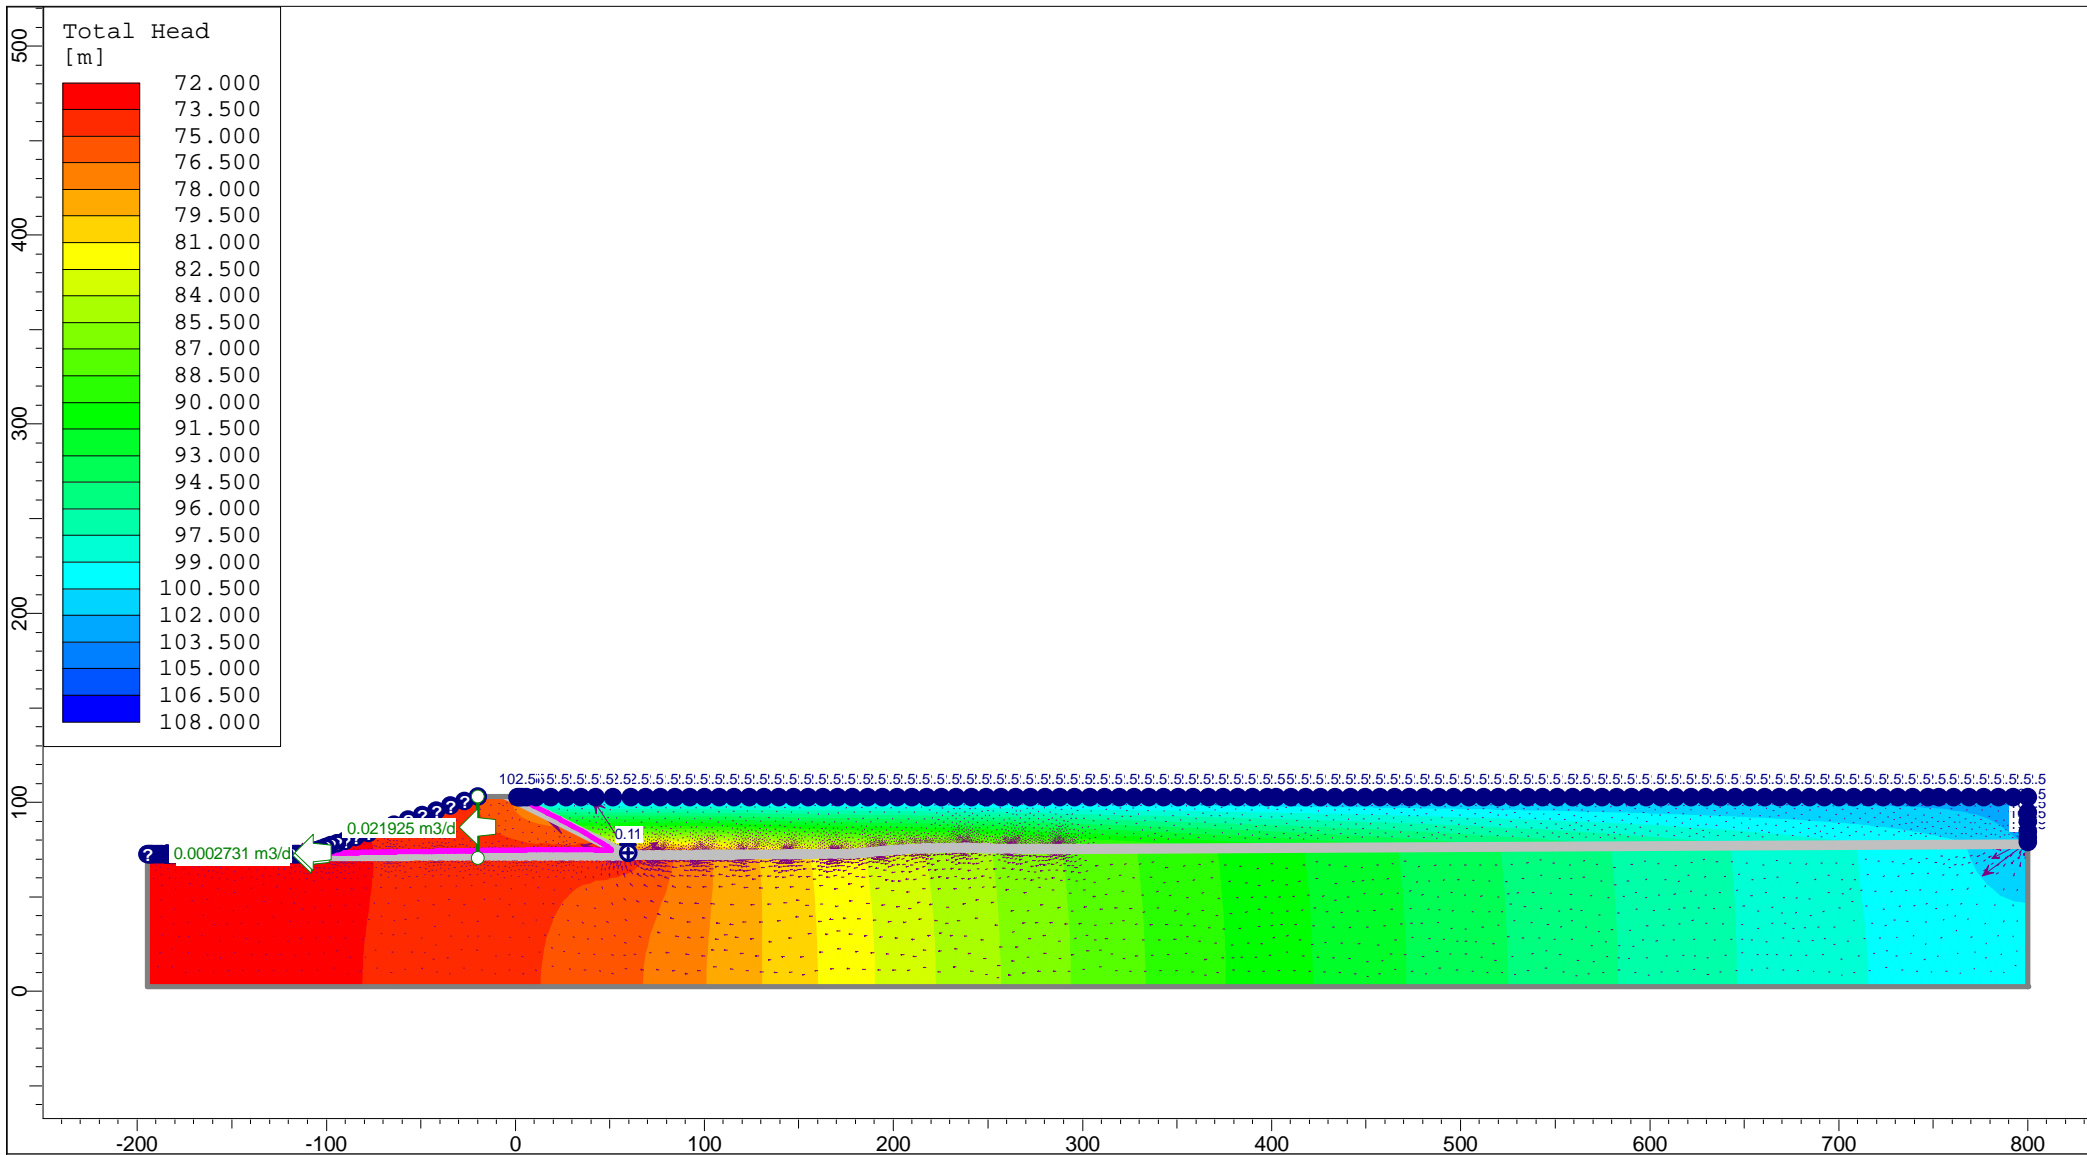
Project	Hemi Gold Project		
Scenario	Seepage - Next to Embankment		
Drawn By	SW	Company	CMW
Date	22/06/2022	File Name	seepage.slmd

Seepage analyses were primarily undertaken to estimate the position of the phreatic surface for the final embankment design at the crest level of RL 103.5 m. The analyses were undertaken using the groundwater module of the Slide software package. Slide uses a 2D finite element analysis to determine groundwater seepage for saturated, steady state flow conditions. It should be noted that: 2D modelling is a simplistic approach, which does not consider 3D effects.

Models have been made to account for the phreatic condition for when decant pond is about 600 m in diameter and maintained at a distance 700 m from the perimeter embankment, as well as to account for a large and uncontrolled decant pond adjacent to the perimeter embankment upstream boundary where on a maximum water pond level of RL 103 m was adopted, which is a conservative assumption base on conditions which are extremely unlikely to occur during operation. The downstream boundary condition was assumed based on the groundwater located at the ground surface level at the downstream toe of the embankment, which is also extremely unlikely to occur during operation. To generate these conditions the underdrainage at the upstream toe of the TSF is considered to be blocked and not functioning.
