TANTABIDDI BOATING FACILITY

Geotechnical Interpretive Report

Department of Transport

Report 2021-10-01

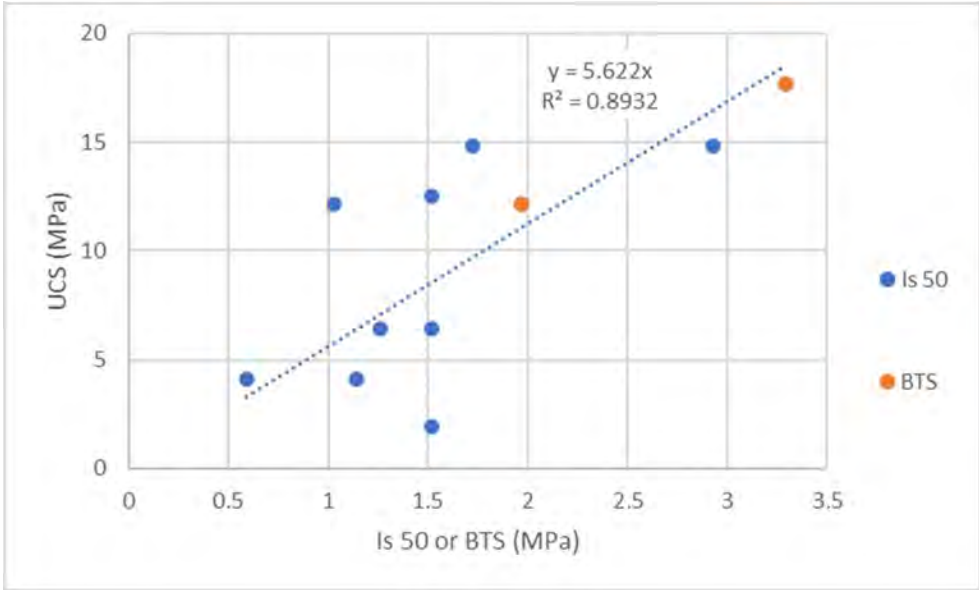
Pairs of UCS and Is₅₀ or BTS results on appropriate adjacent depth samples are plotted below in order to derive a simple correlation between UCS and Is₅₀ or BTS. The linear regression curve fit shown gives a constant of about 5.6 which is a typical value for a weak coastal carbonate rock material found in Western Australia:

Figure 1: Correlation between UCS and Is50 or BTS

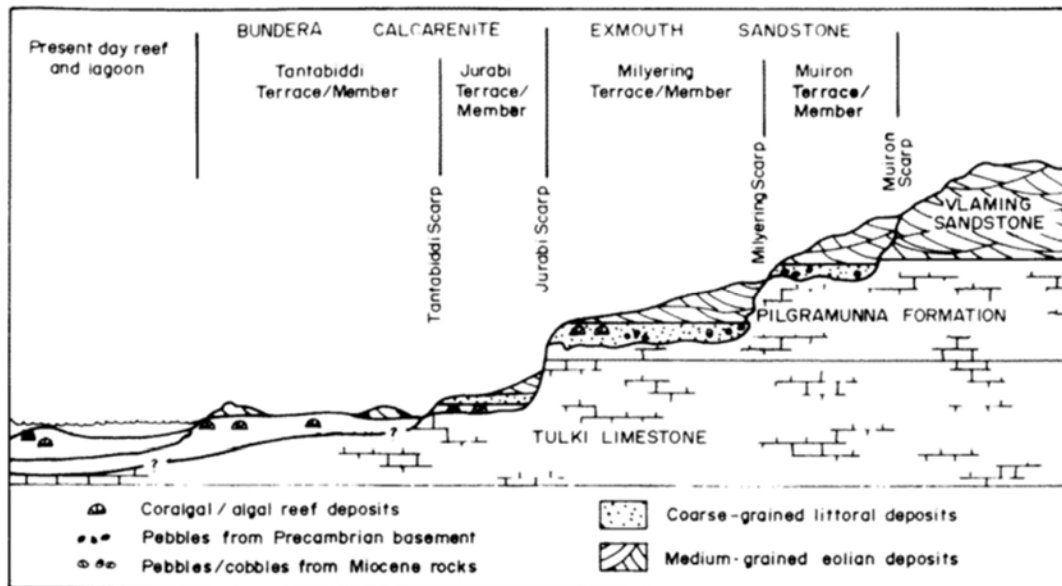
Wyroll et al (1993) Schematic Cross Section

- Holocene coastal deposits – a complex of dune and beach sequences, predominantly sand; underlain by
- Tantabiddi Member (last interglacial) – emergent reef platform, dominant lagoon facies - the Tantabiddi Member is part of the Bunderra Calcrenite unit, and is underlain by
- Tulki Limestone.

Tantabiddi Creek potentially brings deposits of Quaternary alluvial sediments to the site. These sediments comprise fans and alluvial deposits, with dominance of coarse gravel conglomerate, some moderately to well cemented with calcrete development.

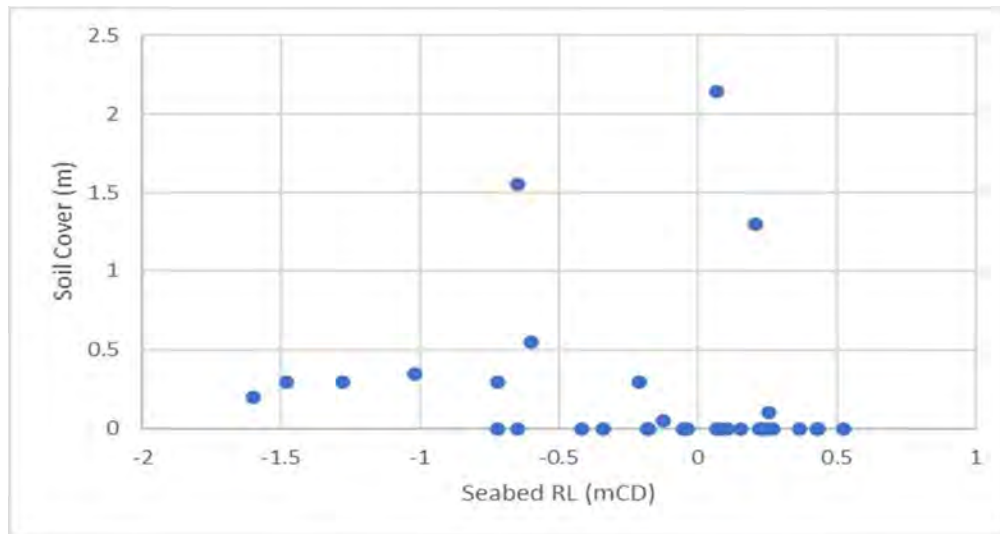
The below figure presents the thickness of the Gravel/Sandy Gravel veneer plotted versus seabed RL for the water jet probe locations.

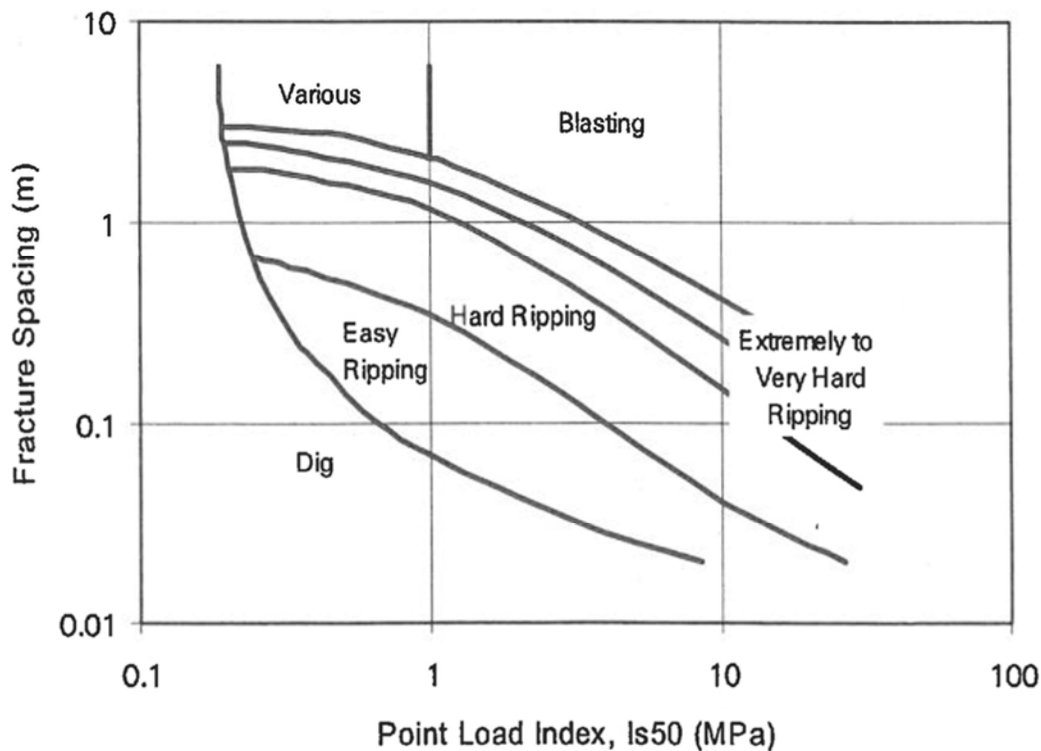
Dredging assessment was undertaken adopting the excavability assessment method of Pettifer and Fookes (1994) wherein the Is_{50} value and fracture spacing for the rock material is compared against field case histories of excavation. The limits for Dig, Easy Ripping, Hard Ripping, Extremely to Very Hard Ripping, and Blasting are presented on the the figure below. It is accepted that blasting will not be permitted in this locality therefore this term should be replaced with “Rock Breaking”.

Figure 3: Excavability assessment method of Pettifer and Fookes based on Point Load Index and Fracture Spacing

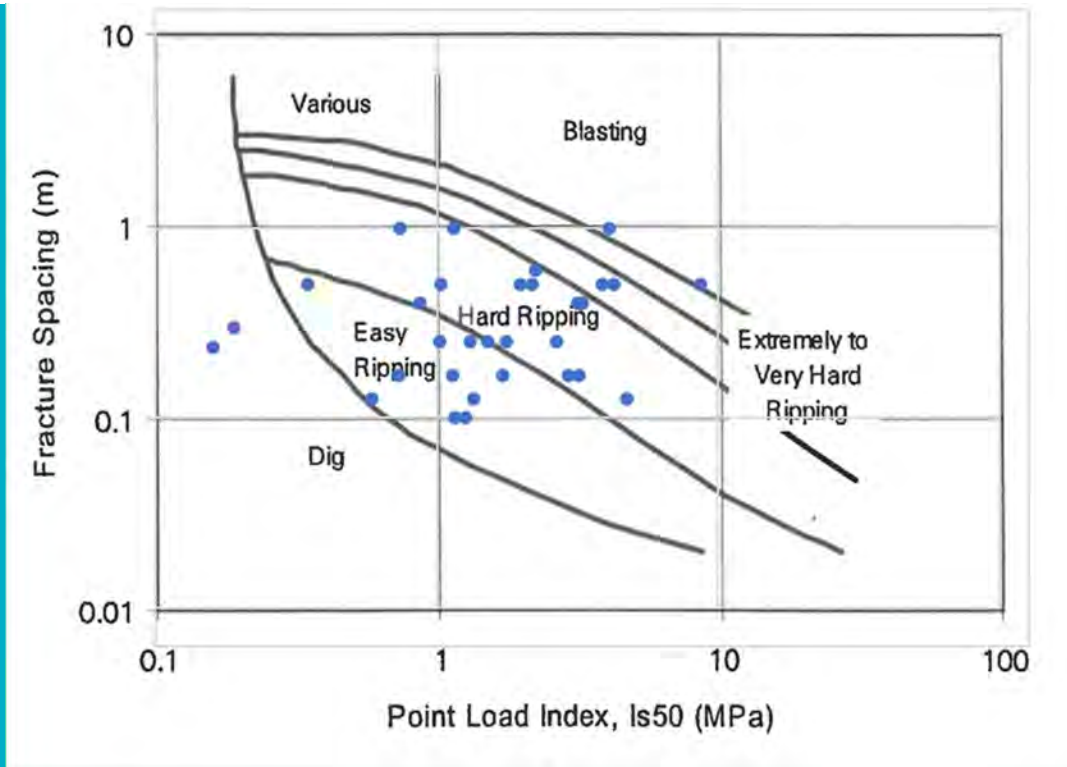
Figure 4: Analysis of dredgability based on Point Load Index and Fracture spacing based on Core Photographs – all boreholes

Point Load Index based on Laboratory test data and Fracture spacing based on review of core photographs

The data are tabulated below, and the results are plotted next page. Also presented next page is the range of rock strength and fracture spacing based on the borehole logs – medium to high strength (Is50 of 0.3MPa to 3MPa) and 0.1m to 1m fracture spacing.

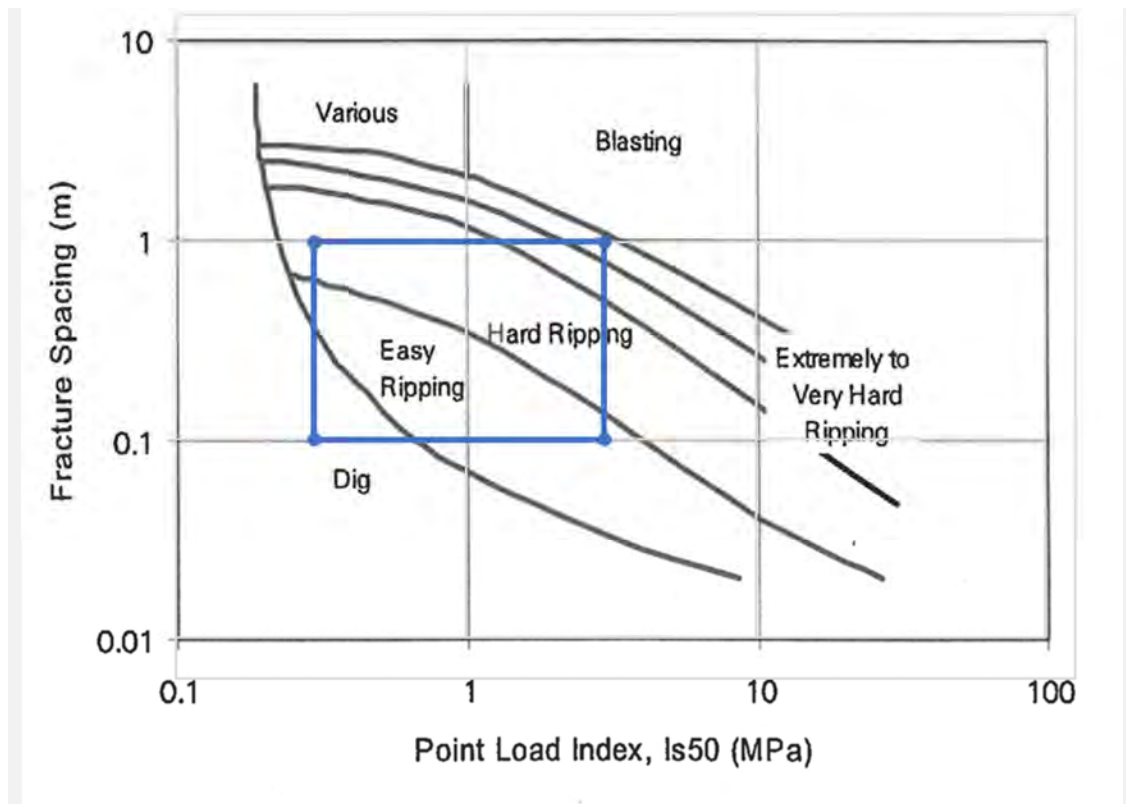
Figure 5: Dredgability range bounds based on all borehole logs

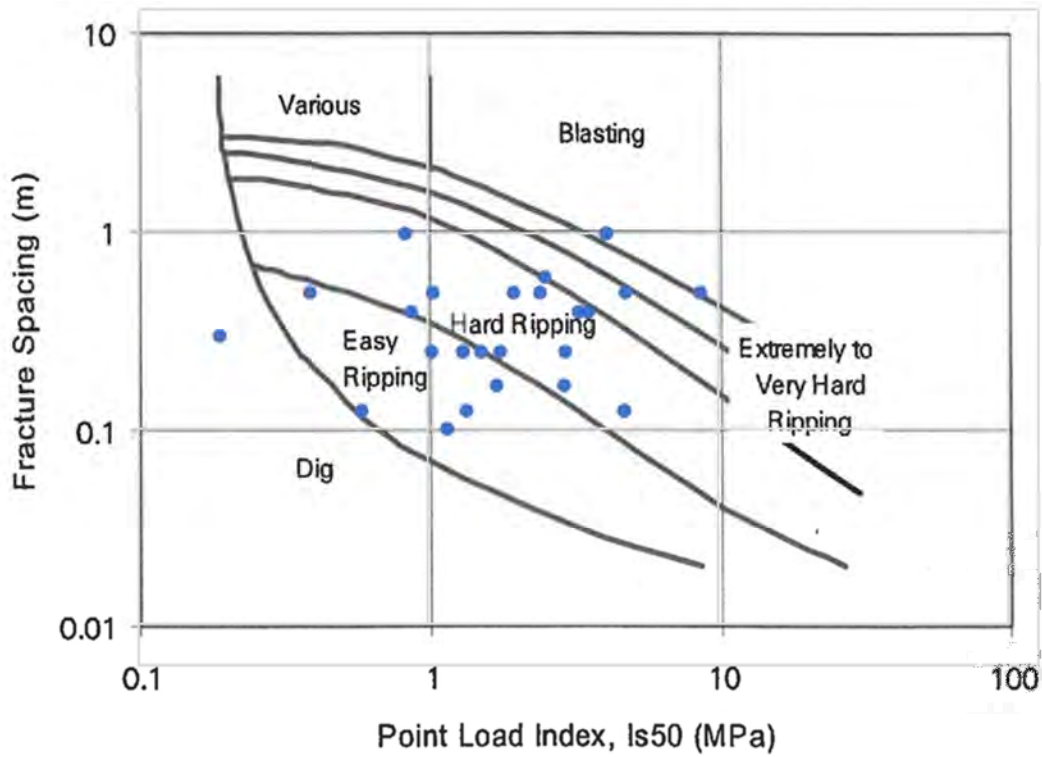
Figure 6: Analysis of dredgability based on those boreholes which terminated above RL -3.15

The dredged level for the Basin is RL-2.65mCD. Allowing for some overdredge, the laboratory test data for rock above RL-3.15mCD is plotted on the Pettifer and Fookes chart in Figure 6 below. This shows that most of the data falls within the Easy and Hard Ripping range except for BH13 which is at the entrance to the basin where hard ripping may be encountered. We note that at BH13, there is no strength data at levels between RL-1.67mCD and RL-3.15mCD, and therefore hard dredging may be encountered at this location and nearby.

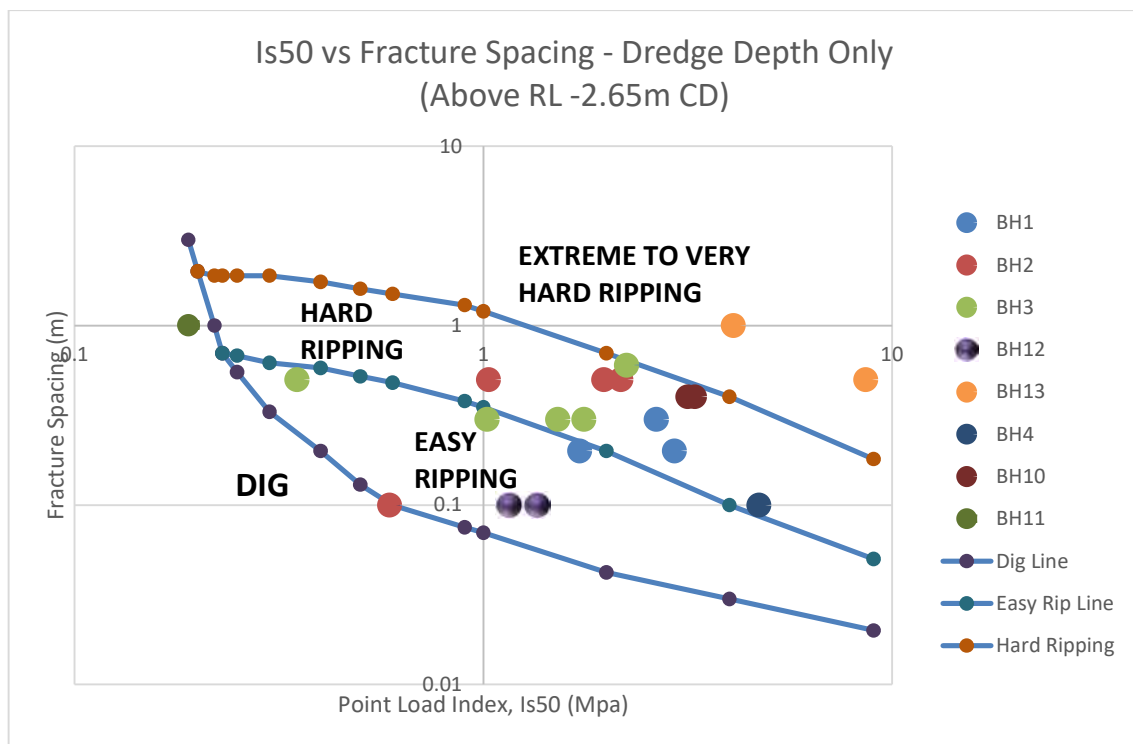
Figure 7: Dredgability analysis for boreholes within the dredge areas

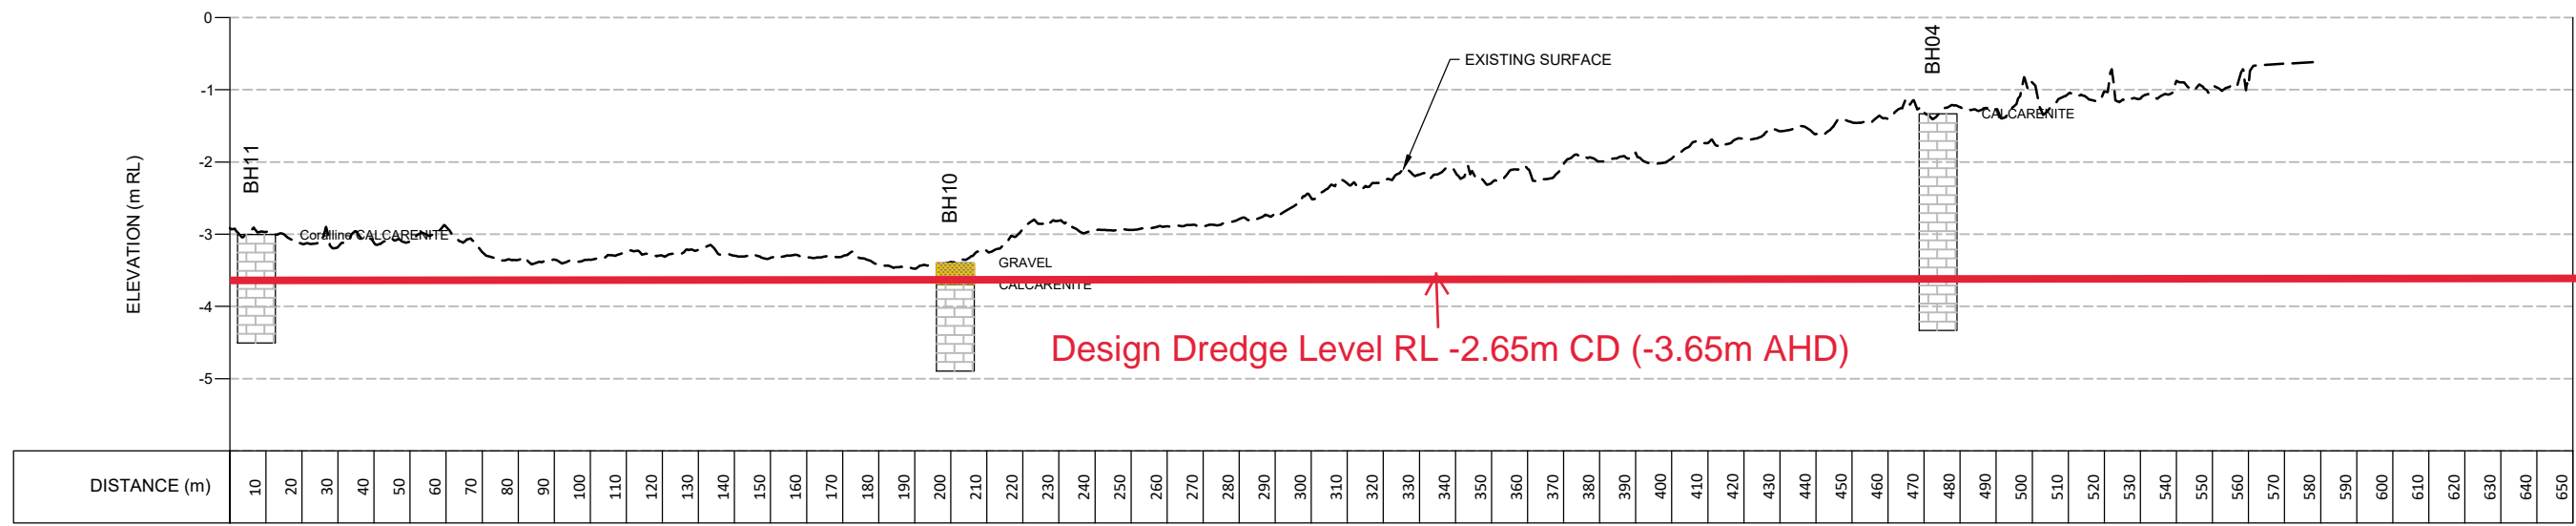
SECTION A
SCALE: H 1:2000, V 1:100.

- NOTES:
1. AERIAL FROM BING MAPS
 2. ELEVATIONS IN m AHD
 3. BOREHOLES ARE OFFSET AND PROJECTED ON TO SECTION LINE

Geotechnical cross sections from CMW (2021) are presented in Appendix A. The cross sections illustrate the relative position of the various soil/rock types. Note that the vertical RLs are presented relative to Australian Height Datum (AHD) in terms of RL datum mAHD rather than mCD.
