SERS
Site Environmental and
Remediation Services

FIGURE 7 – ENVIRONMENTAL FACTORS

Job No: 004-08
Client: Brikmakers
Address: 1728 Great Northern Highway, Bullsbrook, WA 6084.
© This plan must not be reproduced without the permission of SERS
File: N:\A SERS\GIS\Projects\ MXD\

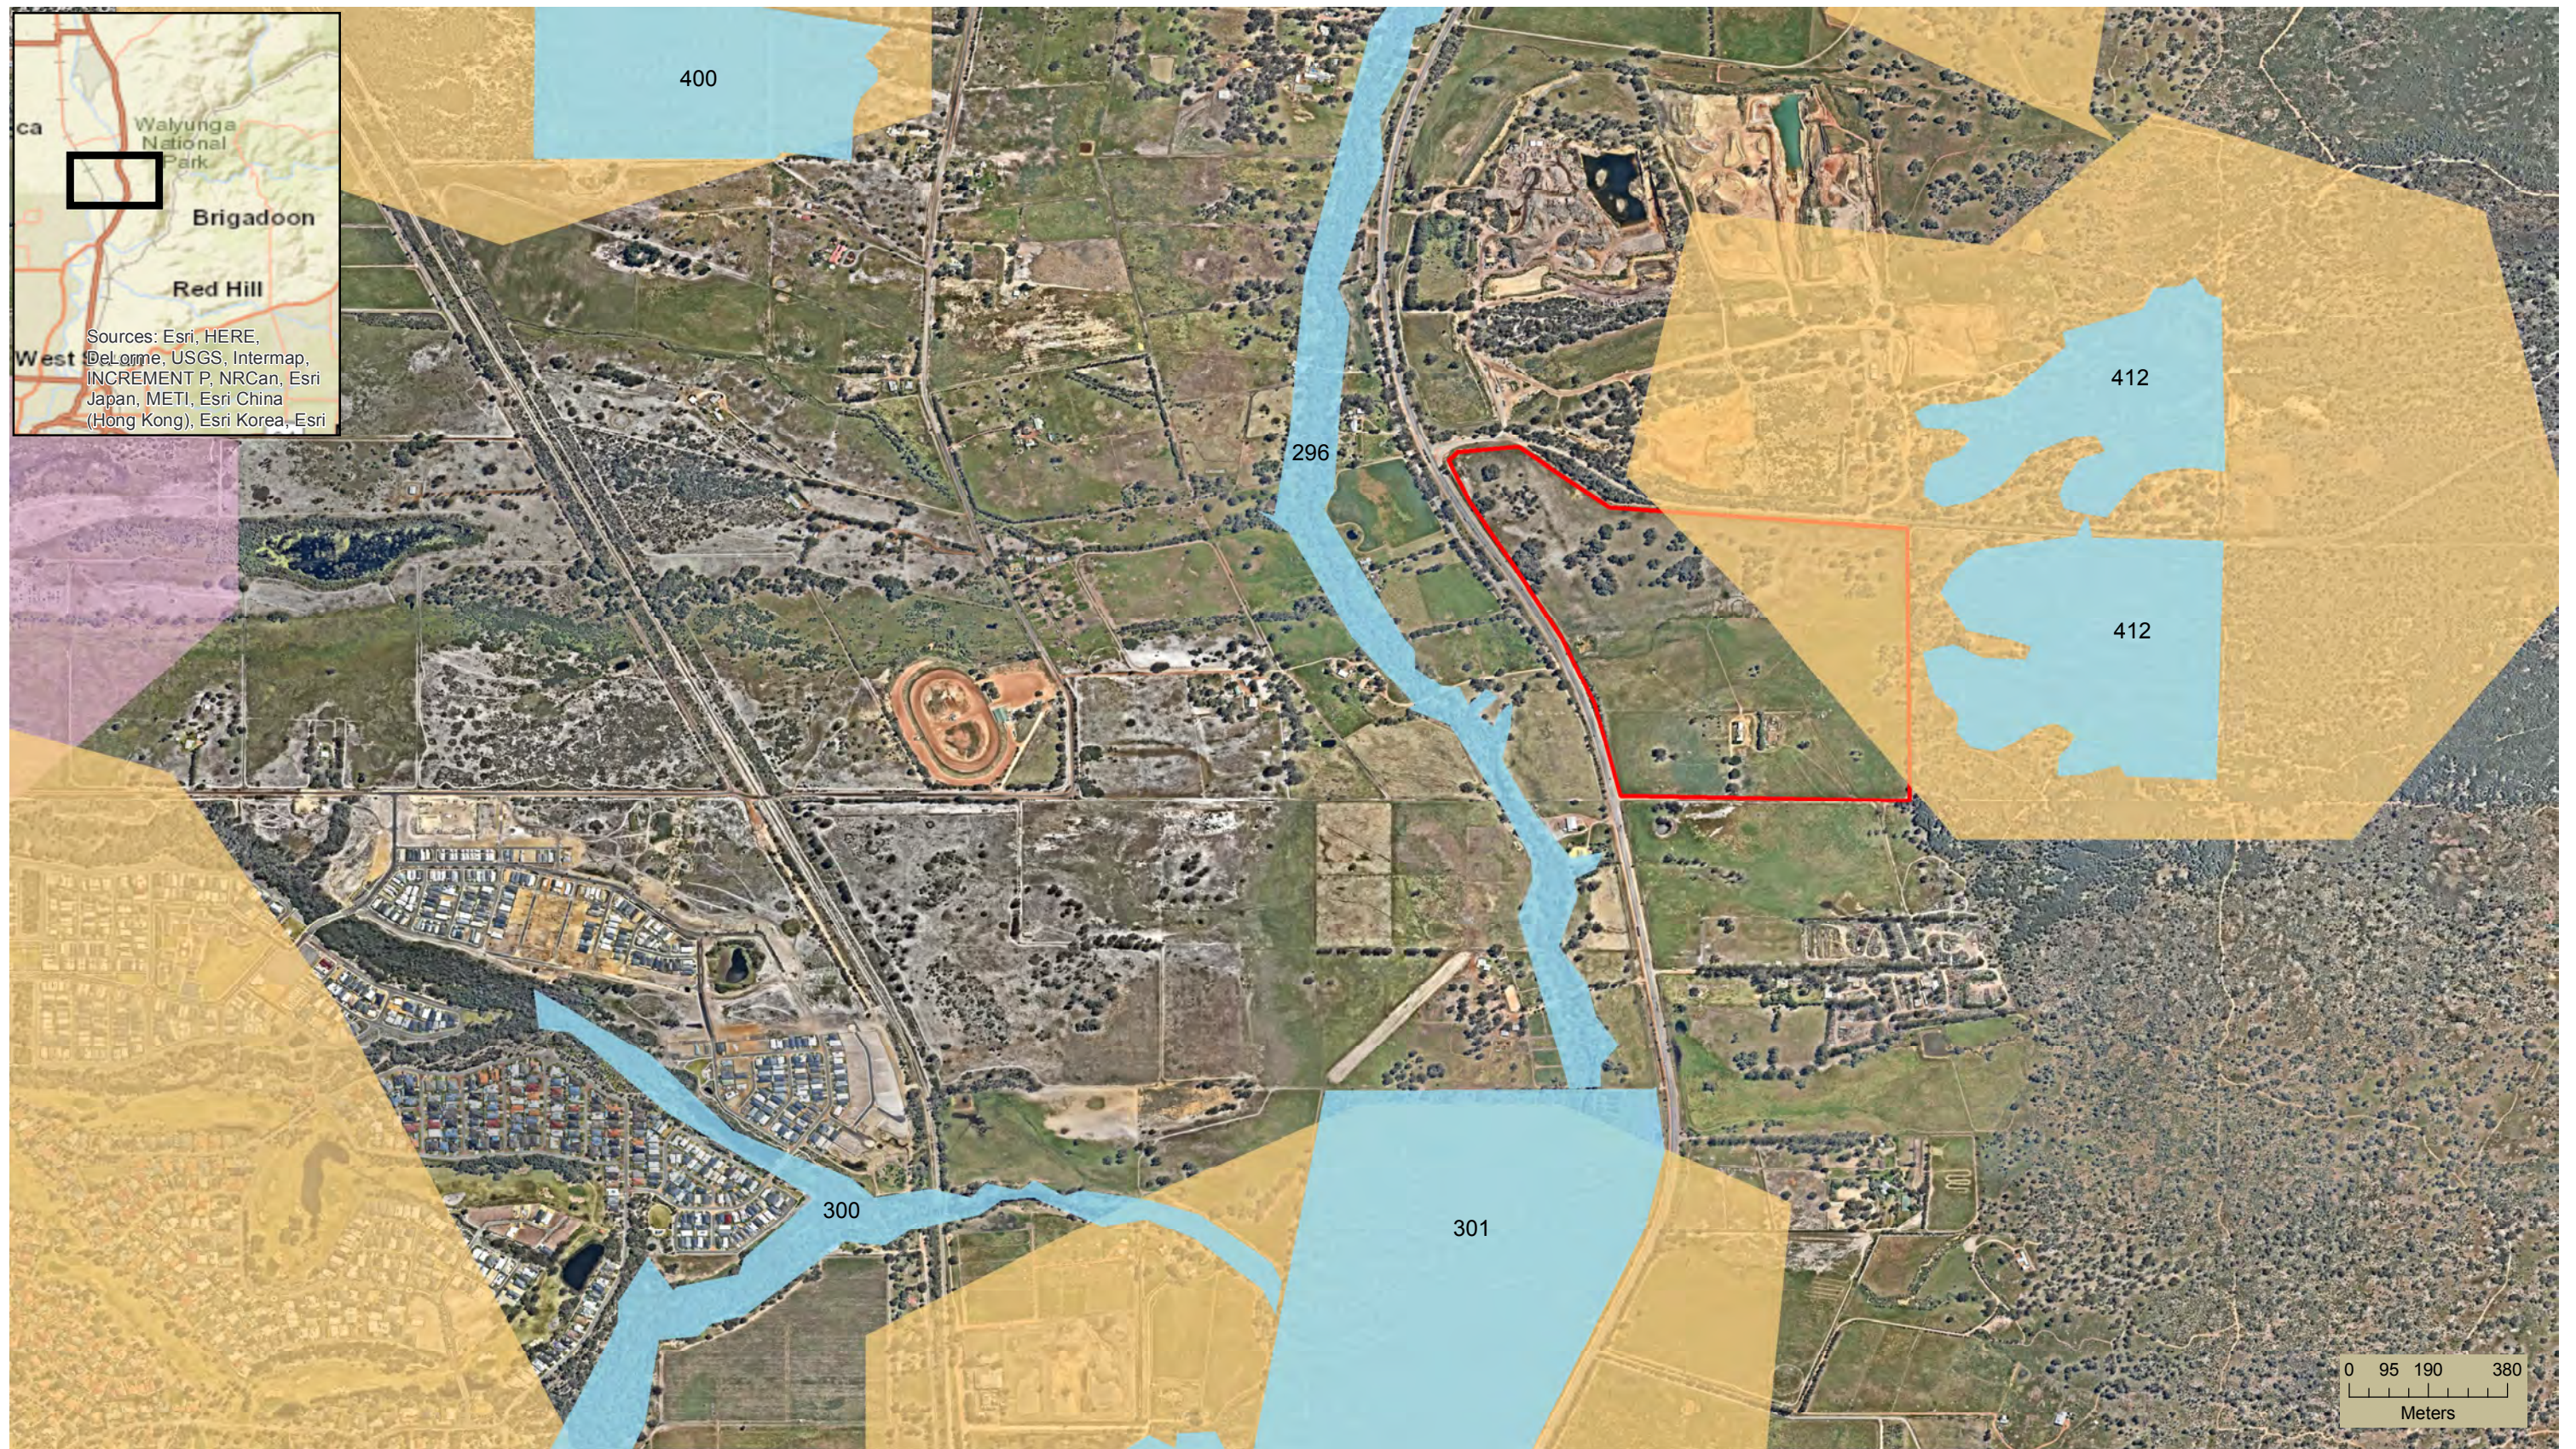
FIGURE 7: Environmental Factors

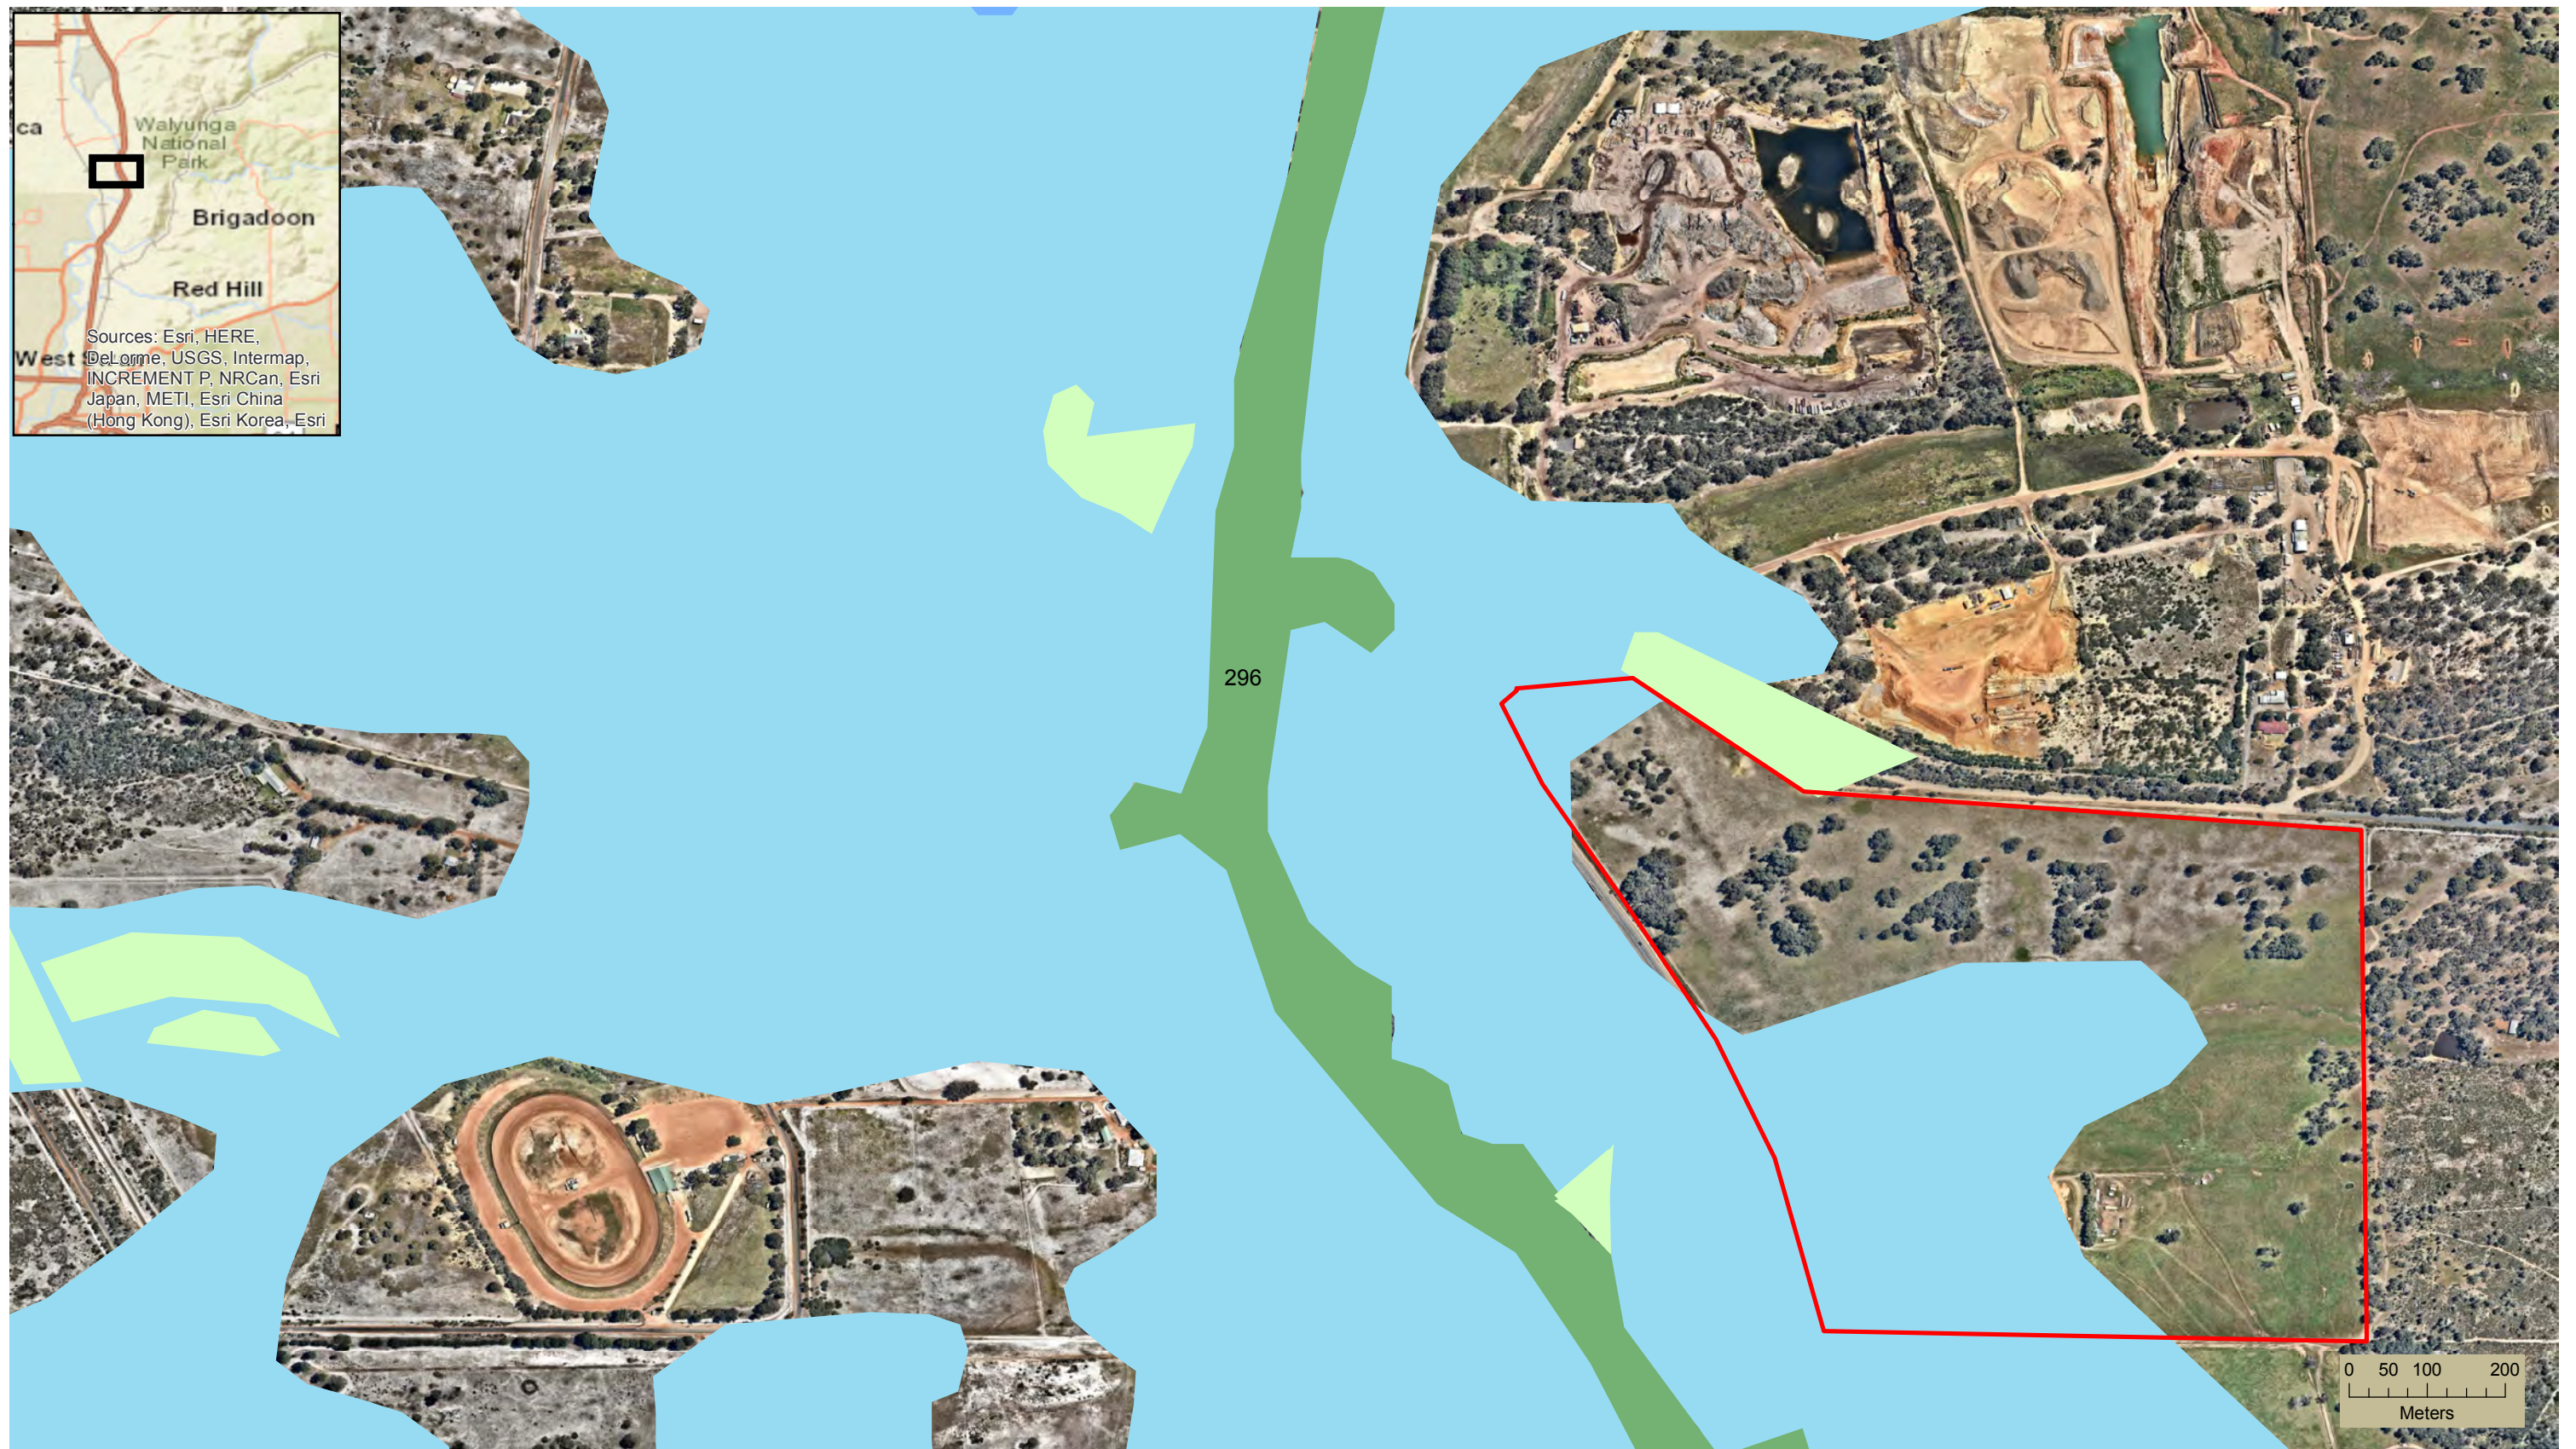
FIGURE 8 – WETLANDS

FIGURE 8 : Geomorphic Wetlands

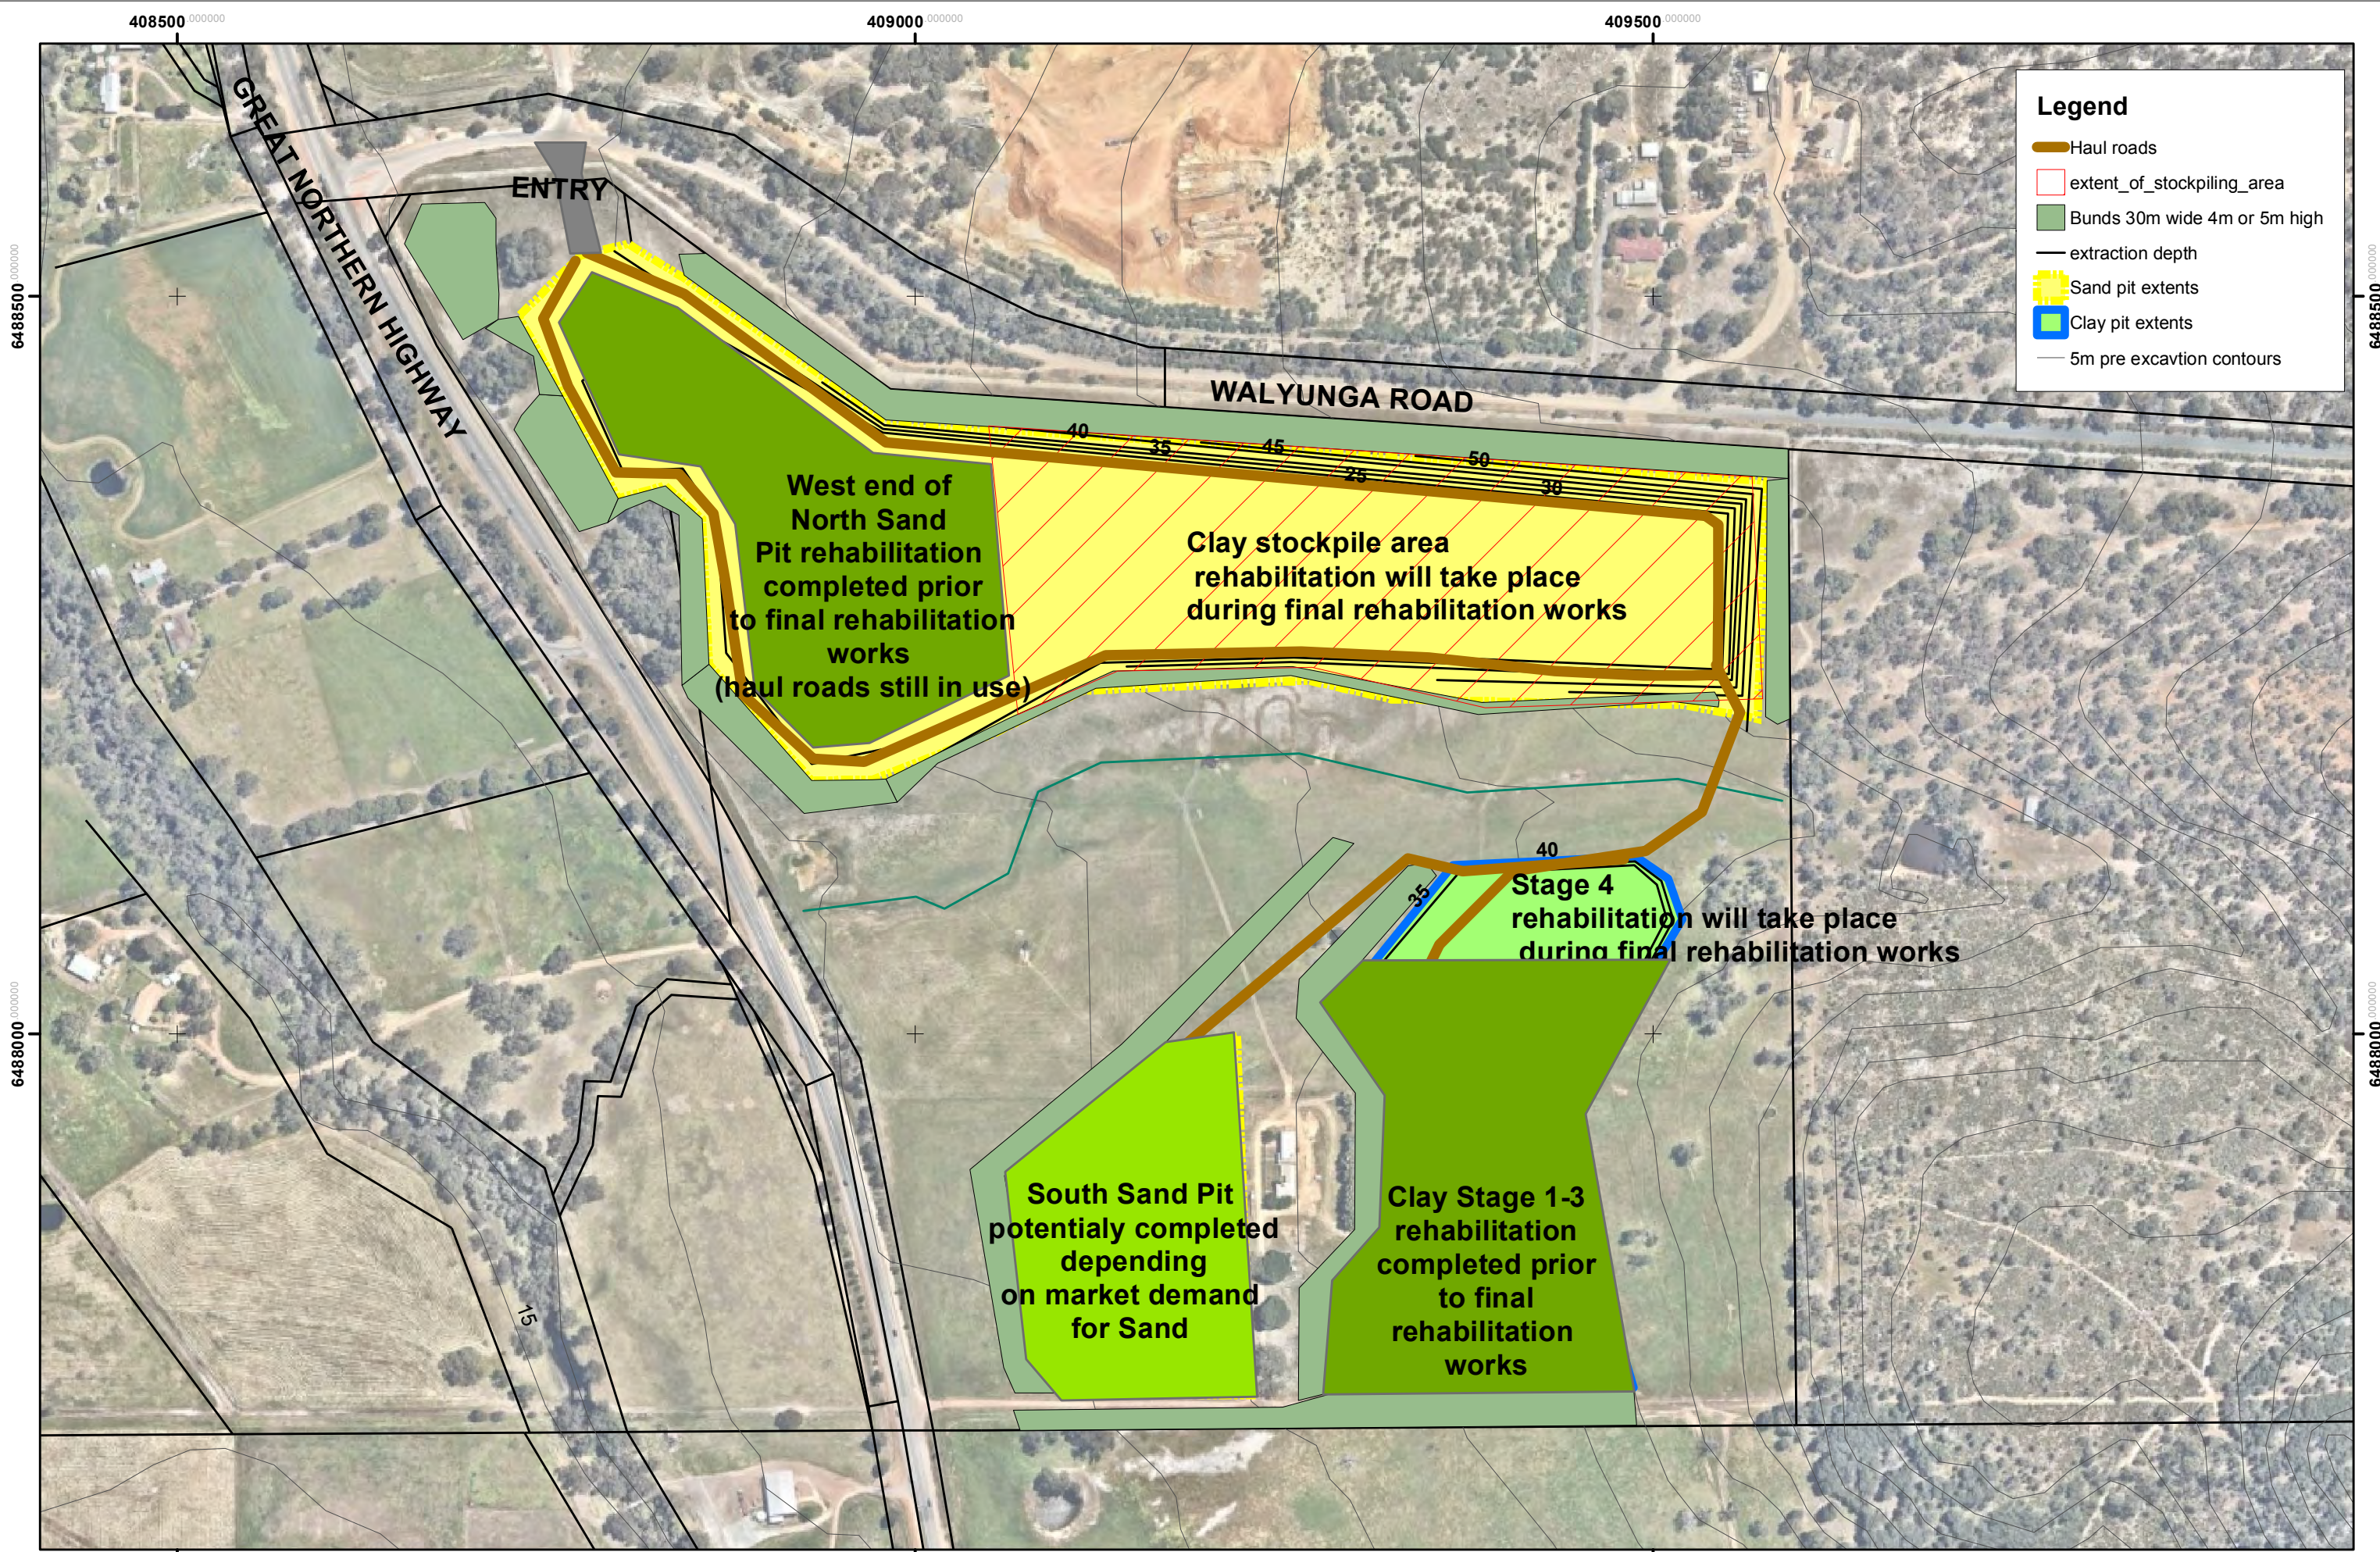
West end of North Sand Pit rehabilitation completed prior to final rehabilitation works (haul roads still in use)

Clay stockpile area rehabilitation will take place during final rehabilitation works

Stage 4 rehabilitation will take place during final rehabilitation works

South Sand Pit potentially completed depending on market demand for Sand

Clay Stage 1-3 rehabilitation completed prior to final rehabilitation works

Darling Downs- Bullsbrook-- Expected situation prior to final rehabilitation works.
