DESKTOP GEOTECHNICAL ASSESSMENT FOR PREFEASIBILITY STUDY

Blacksmith Lease, Pilbara Iron Ore Project

Report Number. 097641461-034-R-Rev0

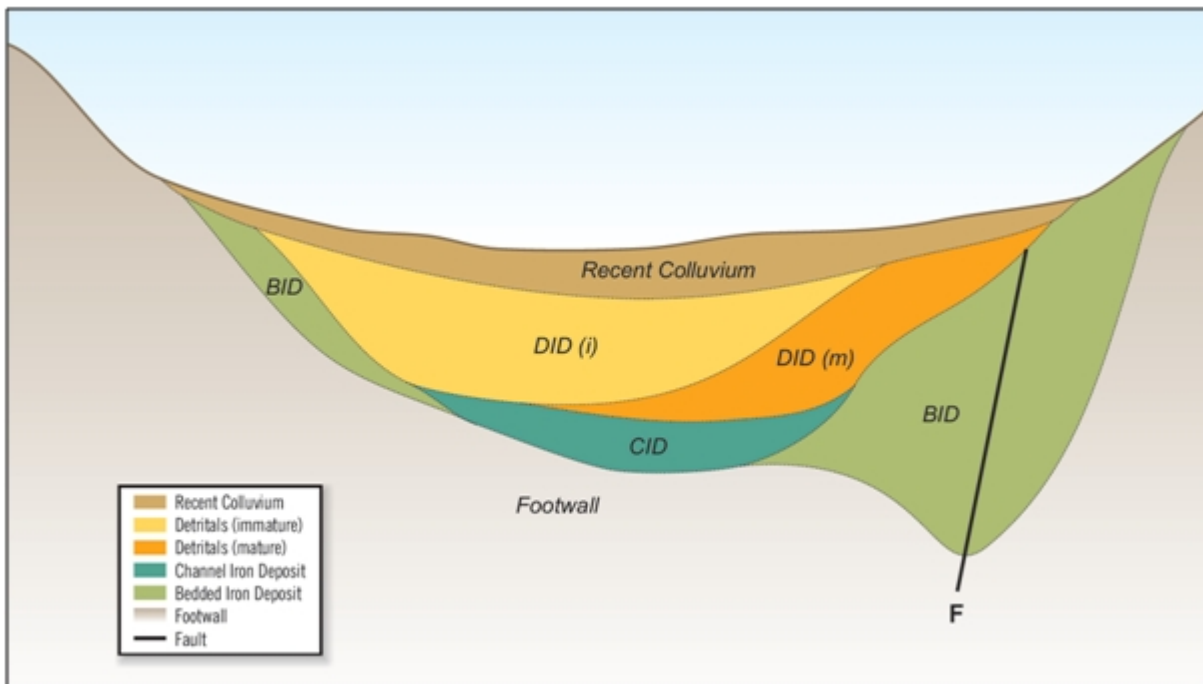
Figure 4: Example of an interpreted geological cross section

In general, the four DID units form a stratigraphic sequence, passing from DID-1 to DID-4, with the iron grade increasing and the contaminant concentrations decreasing with depth (Figure 3). On the basis of similarities in physical and chemical characteristics, the DID is grouped into an upper (DID1 and 2) and lower (DID 3 and 4) unit. A schematic example of a geologically interpreted cross section is shown in Figure 4 .
