Geotechnical Assessment of Bat Caves

Mulga Downs Iron Ore Project

PSM5194-007R REV3 18 December 2024

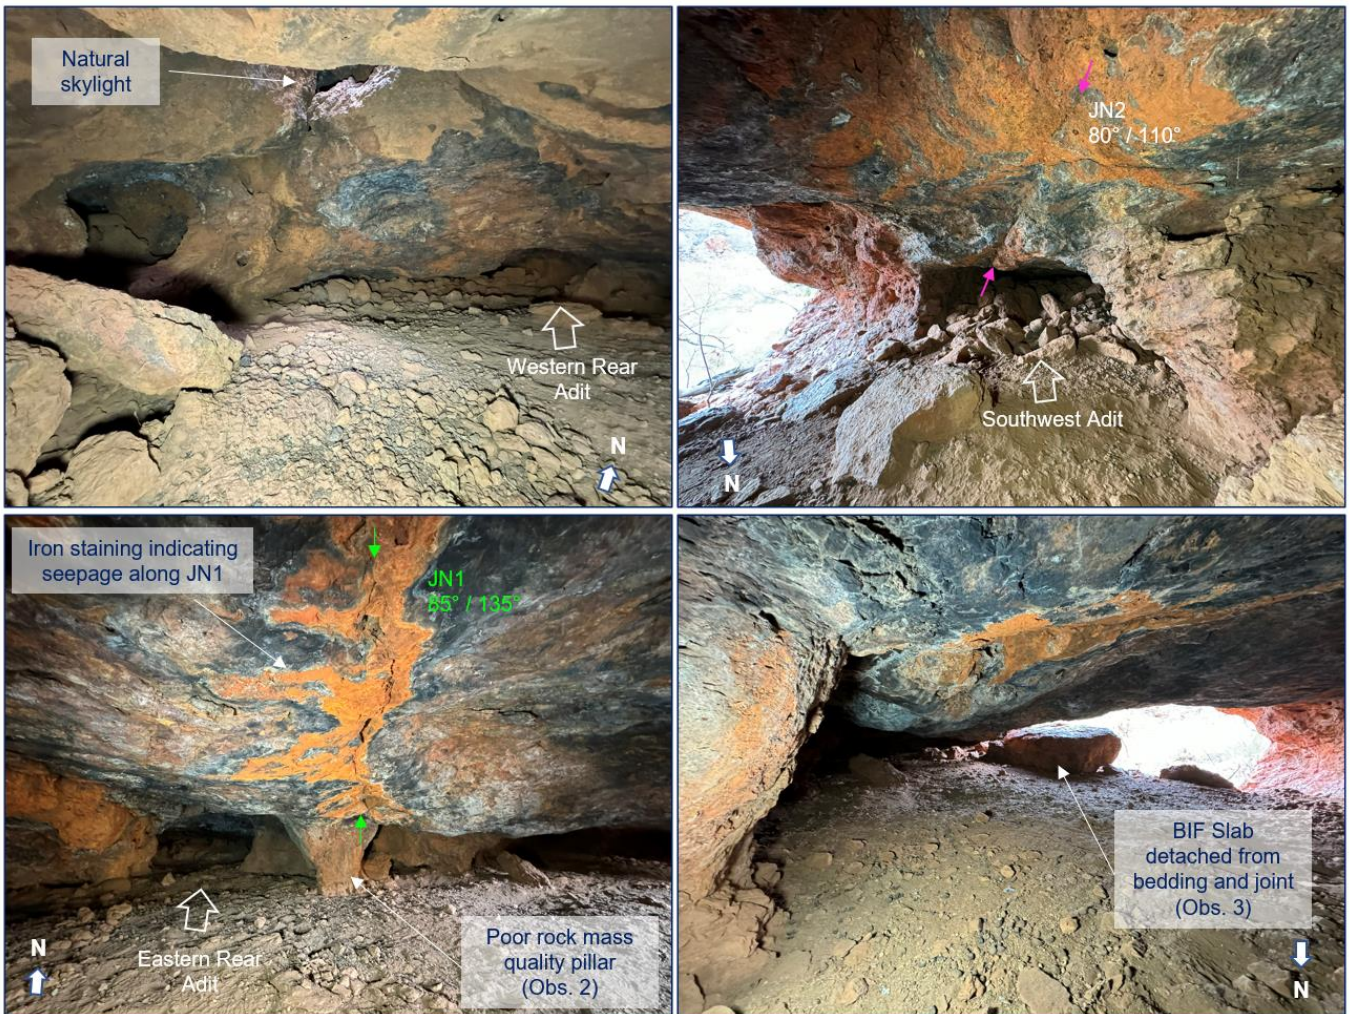
Inset 13: Engineering geological observations of cave MEC016 (MIB-MD13-043) interior.
Top Left: Cave interior viewed towards the northwest showing access point to the western rear adit and the natural skylight developed in the cave roof. **Top Right:** Interior viewed towards the south showing cave entrance and access point to southwest adit. **Bottom Left:** Joint set 1 intersecting the interior roof, and access point to eastern rear adit. **Bottom Right:** Cave interior viewed towards the south showing a large slab detached from bedding in the cave roof.

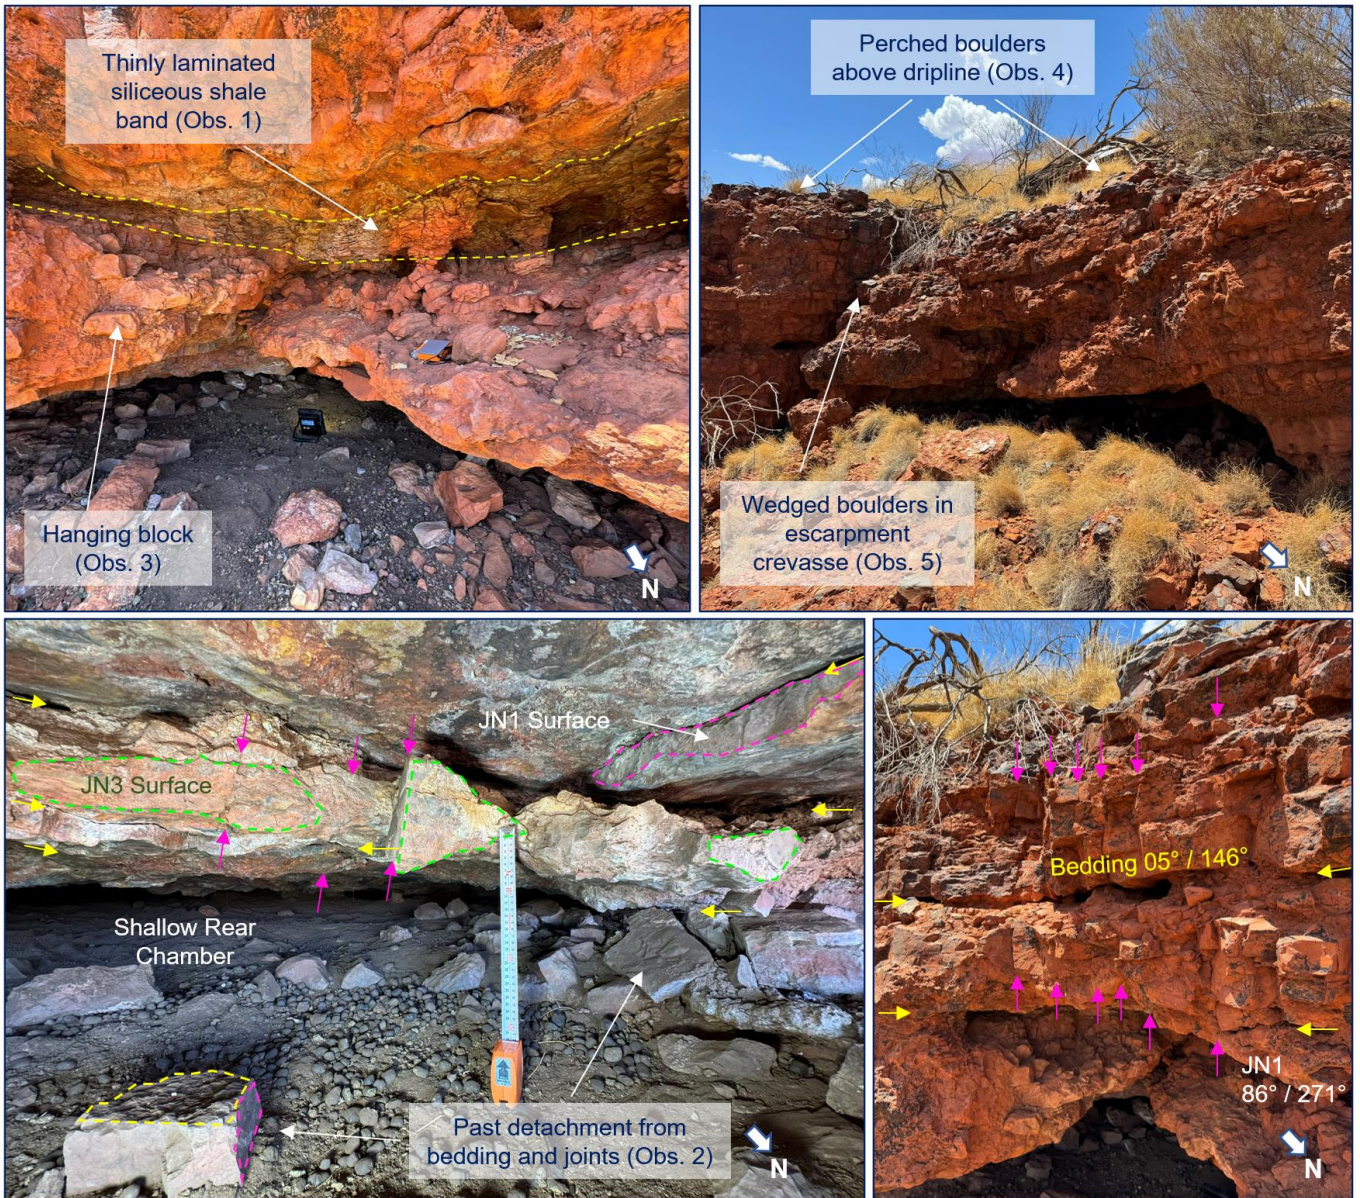
Inset 16: Engineering geological observations of cave MEC061.

- The siliceous shale band dips obliquely into the escarpment. The band is inferred to pass over the rear chamber roof and may be susceptible to block detachment (Obs. 1, Inset 16). Observed preferential weathering of the siliceous shale band also has the potential to undermine the overlying escarpment
- There is potential for blocks in the escarpment and cave roof to detach from bedding where crosscut by vertical joints (Obs. 2, Inset 16). A 150 mm thick chert band located at the access point to the rear chamber appears to be susceptible to this mechanism, Inset 16
- Hanging blocks bounded by open defects were observed in areas of the cave roof and dripline (Obs. 3, Inset 16)
- Perched boulders occur at the top of the escarpment in which the cave is situated (Obs. 4, Inset 16)
- Wedged boulders were observed in a crevasse on the southern side of the cave entrance (Obs. 5, Inset 16).

Top Left: Cave entrance viewed towards the southwest, showing a weathered shale band and hanging blocks in the overhang. **Top Right:** Overview of cave setting showing perched and wedged boulders in the escarpment above the entrance. **Bottom Left:** Cave interior showing developed bedding partings in the cave roof, and past rock detachment from structure. **Bottom Right:** Bedding partings and joint set 1 observed in the dripline above the entrance.

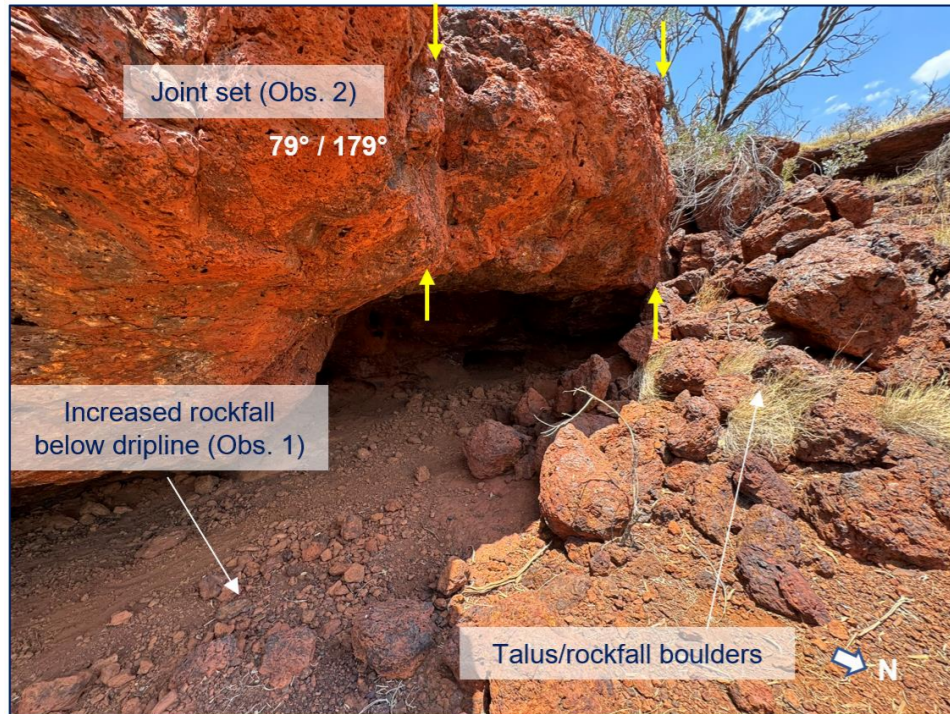
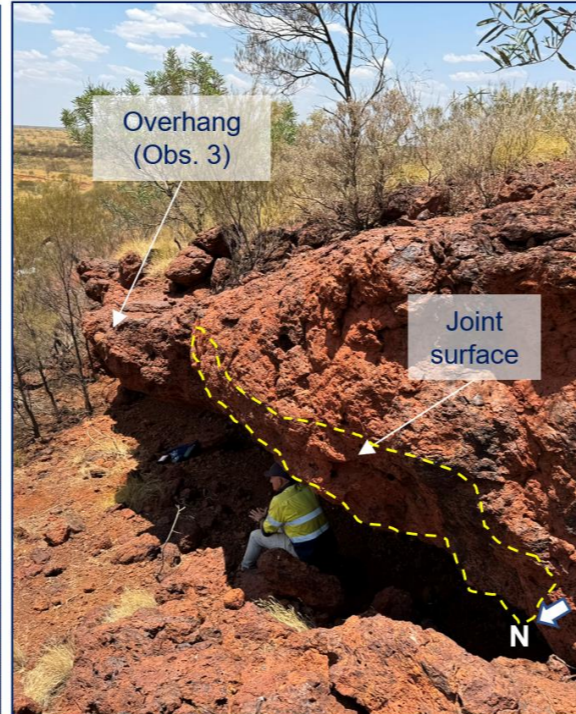
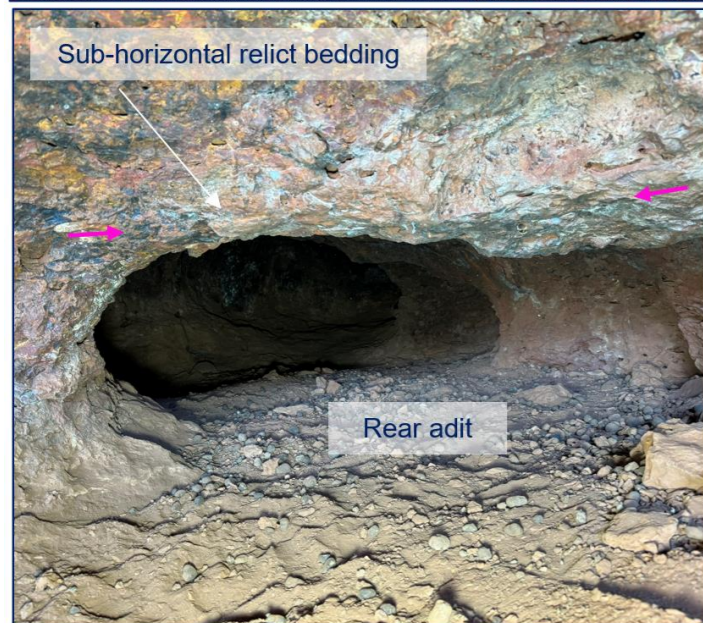
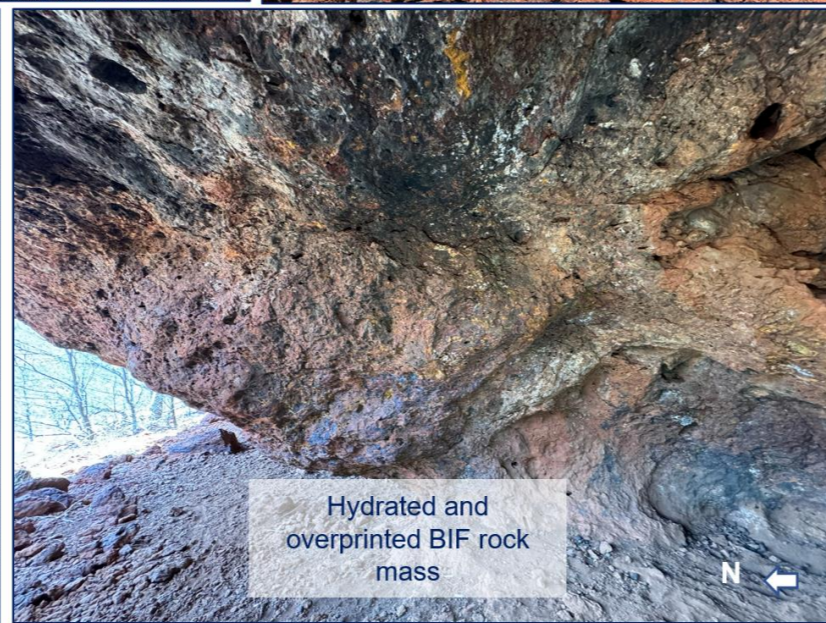
Summary Sheet Cave ID	Approximate Dimensions	Estimated GSI Range and Typical RMR ₈₉	Rock Mass Description	Observed Hazards	Recommendations
MEC042	<p><u>Entrance/Overhang</u> – 10 m wide, 2.5 m deep</p> <p><u>Main Cave</u> – 4 m wide, 3.2 m deep, 1.5 m high</p> <p><u>Rear Adit</u> – 5 m deep, 1.3 m wide, 0.6 m high</p>	<p><u>GSI</u> All Areas 68 – 78</p> <p><u>RMR₈₉</u> All Areas: 78</p>	<p>The rock mass comprises high strength hydrated BIF with elongate vughs up to 50 mm oriented parallel to relict bedding, which is largely overprinted.</p> <p>BIF bedding becomes developed at the entrance to the rear adit and was observed to be sub-horizontal.</p> <p>Two parallel joints were observed at the cave entrance and appear to form a structural set. The joints dip steeply to the south, are undulating to irregular, rough, and iron stained. The joints do not persist greater than 2 m and were only observed at the cave entrance.</p>	<ol style="list-style-type: none"> 1. Increased rockfall risk below the dripline of the cave, evidenced by historical blocks on the cave floor. 2. Sub-vertical open joints intersecting the cave roof. 3. Increased potential for roof collapse due to the wide, flat span. 	<ul style="list-style-type: none"> • Check for or dilation of joints at the cave entrance, and for sub-horizontal partings which may indicate opening of relict bedding planes • Avoid standing or sitting below the dripline of the cave • Check for fresh rock fall debris around the cave entrance before approaching.

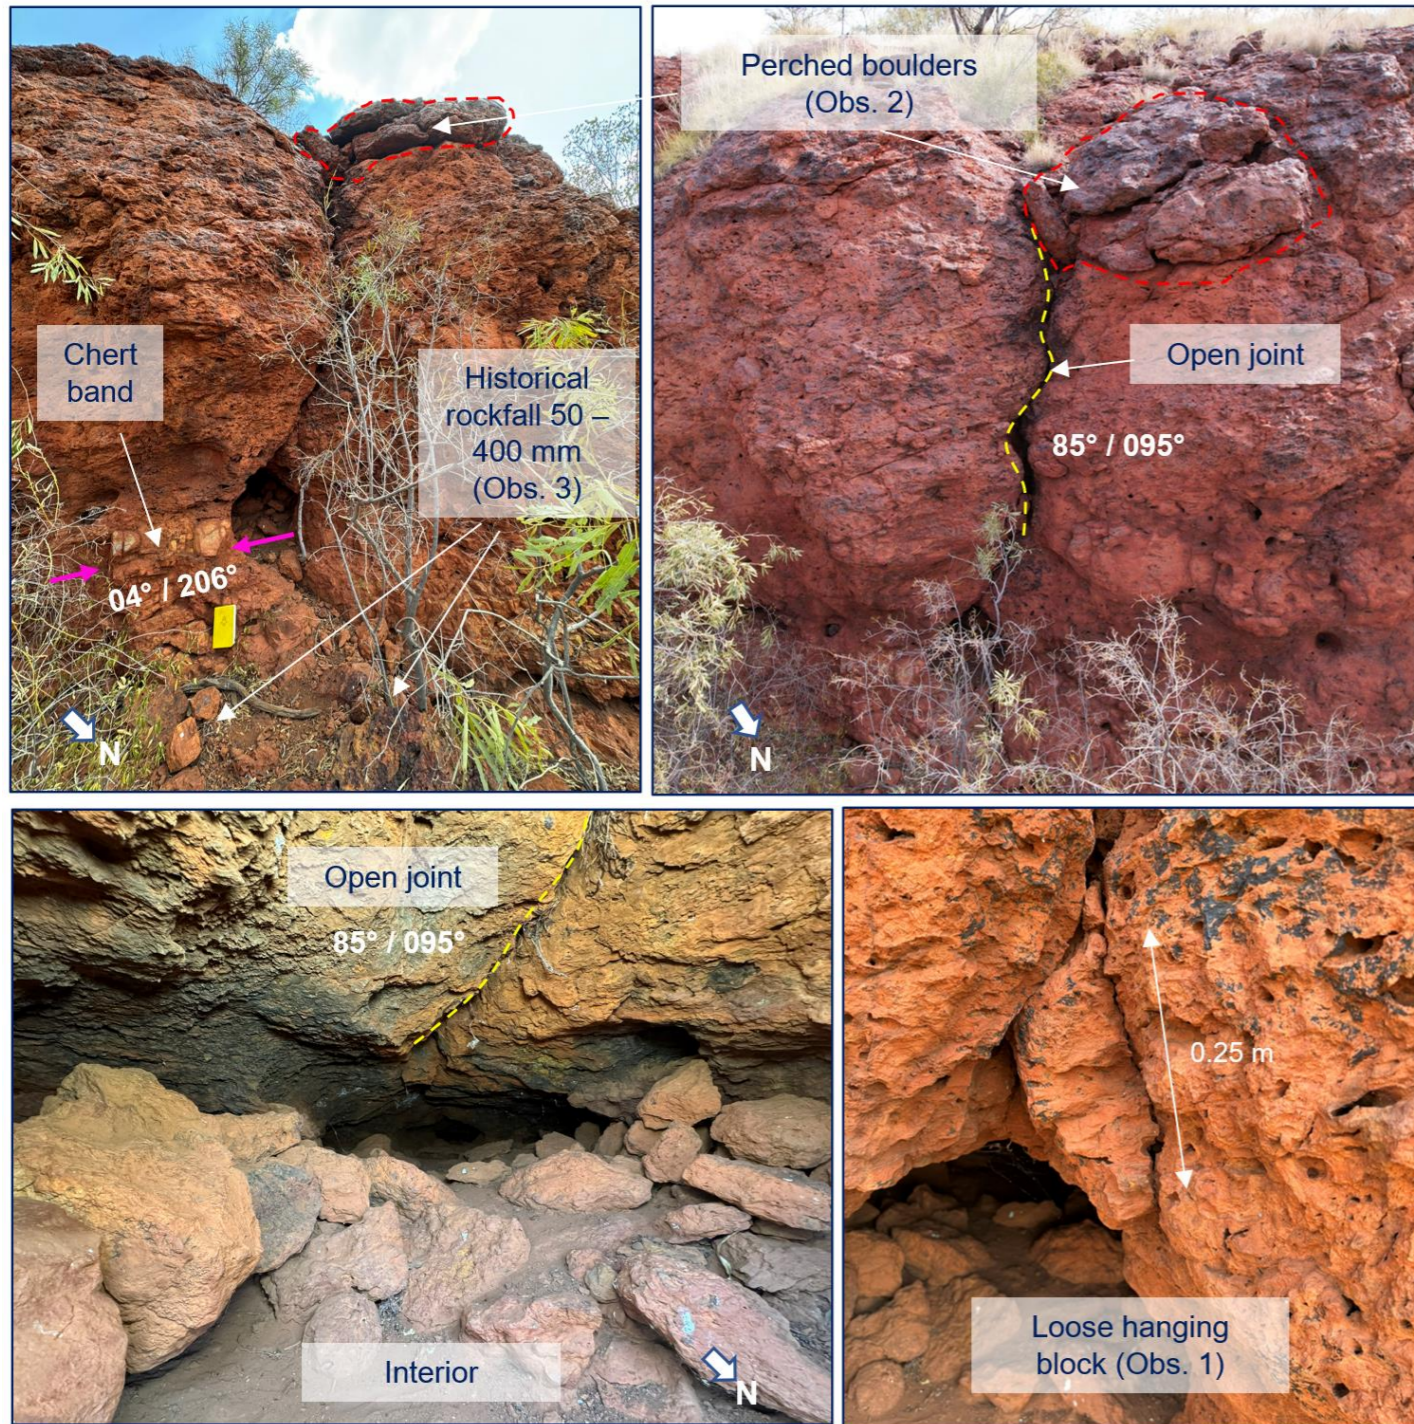
Summary Sheet Cave ID	Approximate Dimensions	Estimated GSI Range and Typical RMR ₈₉	Rock Mass Description	Observed Hazards	Recommendations
MEC014	Cave – 6 m deep, 0.8 m wide, 0.8 m high	GSI All Areas 65 – 75 RMR ₈₉ All Areas: 75	The rock mass comprises medium to high strength hydrated and vughy BIF. Original bedding fabrics have largely been overprinted, though bedding parallel vughs are developed throughout the rock mass. A discrete chert band occurs at the base of the cave. Bedding was measured from the exposed chert band and dips shallowly towards the southwest. The cave has formed along an open joint which persists along the cave roof for the first ~3 m beyond the entrance. The structure dips steeply to the east and is irregular, slightly rough to rough, and infilled with a veneer of iron oxide. Water seepage along the structure is indicated by black staining and plant rootlets growing within the joint	<ol style="list-style-type: none"> 1. A 250 mm hanging block in the dripline immediately above the cave entrance. Bounded by a sub-vertical joint and open fracture. 2. Perched and wedged boulders at the top of the bedrock escarpment, approximately 4 m above the cave entrance. 3. Increased rockfall risk at the cave entrance, with historical 50 – 400 mm fragments of BIF, some of which have detached from bedding. 	<ul style="list-style-type: none"> • Limit time spent at the cave entrance, immediately below the escarpment due to the perched boulders atop the escarpment • Check for movement or dilation of the controlling joint in the escarpment and within the cave roof before approaching • Avoid standing or working below or leaning on the loose boulder in the dripline of the cave.

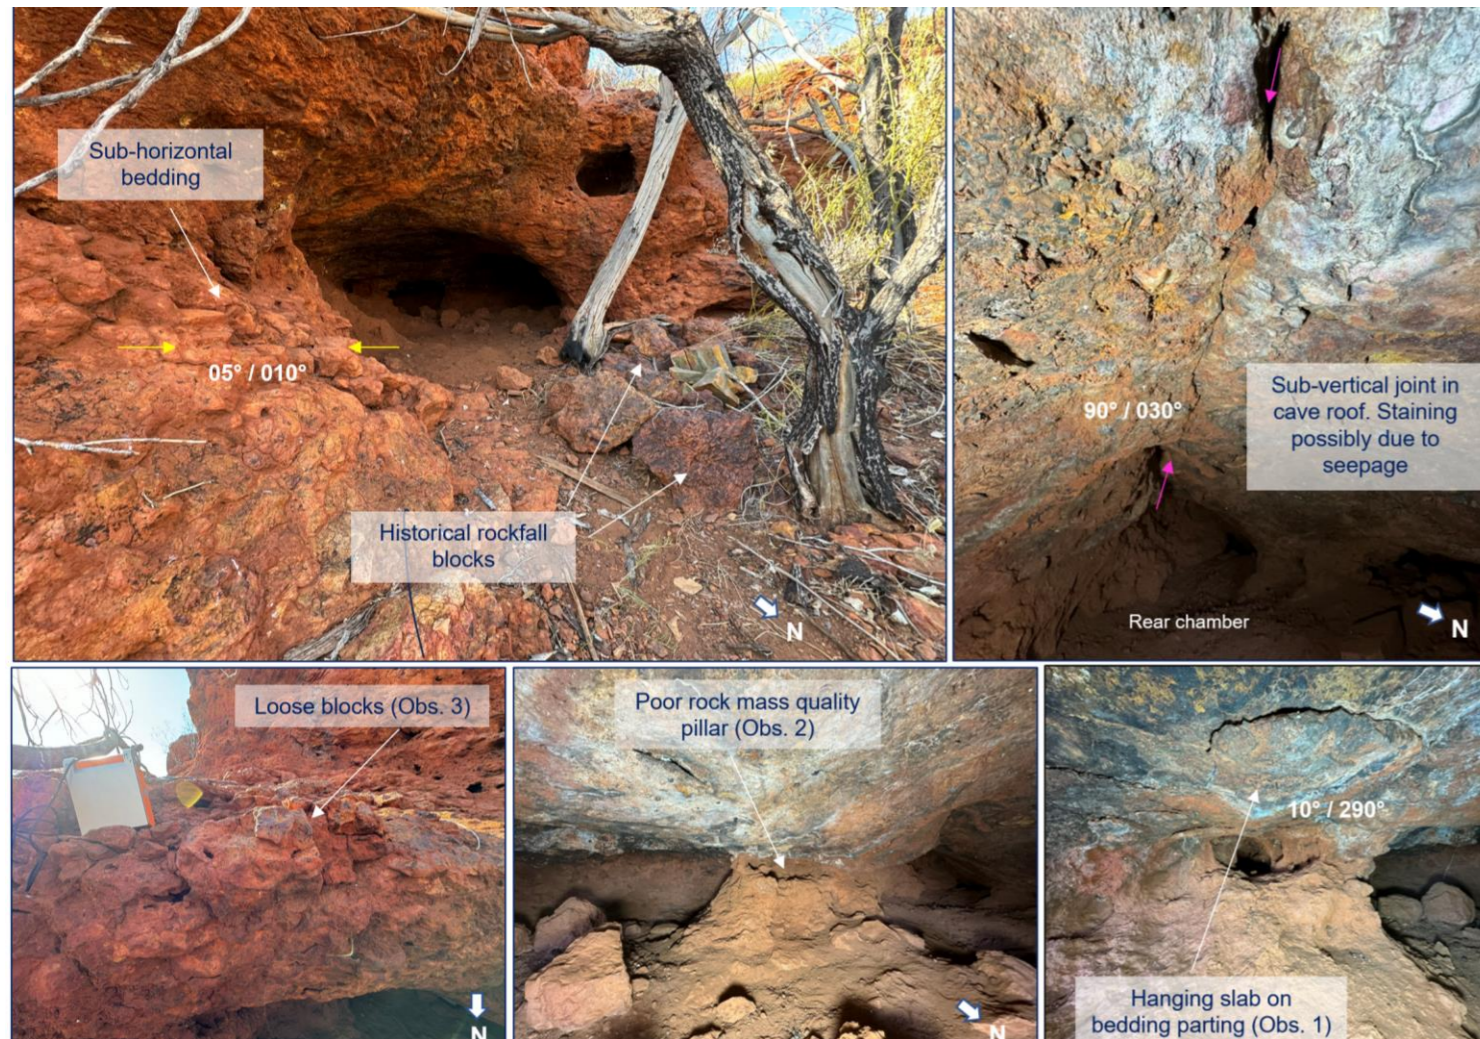
Summary Sheet Cave ID	Approximate Dimensions	Estimated GSI Range and Typical RMR ₈₉	Rock Mass Description	Observed Hazards	Recommendations
MEC013	<p>Entrance – 1.8m wide, 1 m high</p> <p>Main chamber – 3.0 m wide, 3.1 m deep, and 0.7 m high.</p> <p>Rear chamber – 0.4 m wide and 2 m deep.</p>	<p>GSI Exterior 70 – 80 Interior 67 – 77</p> <p>RMR₈₉ Exterior: 80 Interior: 77</p>	<p>The rock mass comprises moderate to high strength, hydrated BIF and banded chert. Vughs up to 120 mm are generally elongated in the direction of bedding. Bedding has been partially overprinted and is better preserved on the cave exterior where it is sub-horizontal, undulating and thickly laminated. Bedding does not form structurally significant partings in the cave walls. The cave roof profile, however, has developed preferentially along sub horizontal bedding.</p> <p>A single vertical joint that strikes 220° was observed in the roof of the rear chamber. The joint is open up to 6 mm and shows evidence of water seepage. At the time of the inspection the joint surface was moist, and the adjacent wall rock showed goethitic and other iron oxide staining</p>	<ol style="list-style-type: none"> 1. A hanging BIF slab bounded by an open bedding parting was observed on the eastern side of the main chamber roof. 2. A rock pillar of poor rock mass quality (low intact strength inferred) identified on the eastern side of the rear chamber. 3. A cluster of loose 50 – 200 mm fragments was observed in the dripline directly above the cave entrance. 	<ul style="list-style-type: none"> • Check for movement or dilation of defects, or fresh rock fall before approaching the cave • Limit time spent below the hanging slab in the main chamber or avoid if possible • Check for signs of fretting of the susceptible rock pillar and/or further erosion at the base • Avoid standing or leaning on the area of loose BIF fragments above the cave entrance. Do not stand in the cave entrance, move past the entrance zone when accessing the cave.

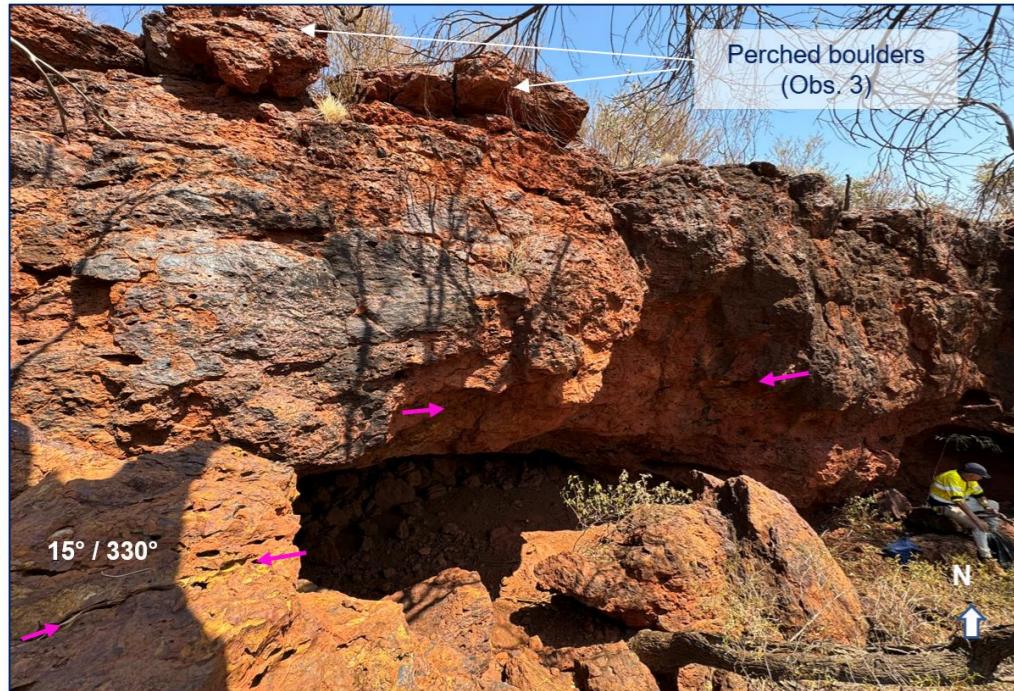
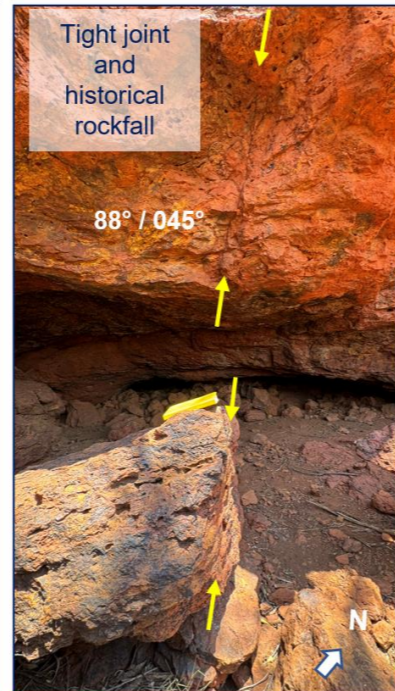
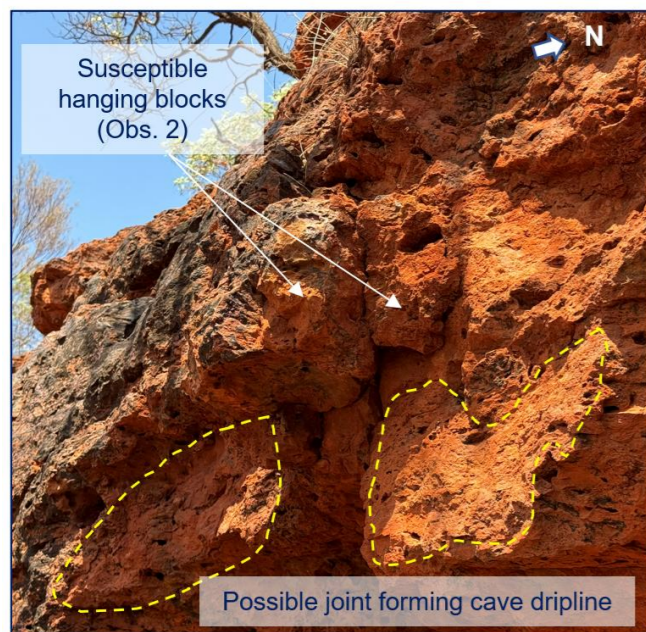
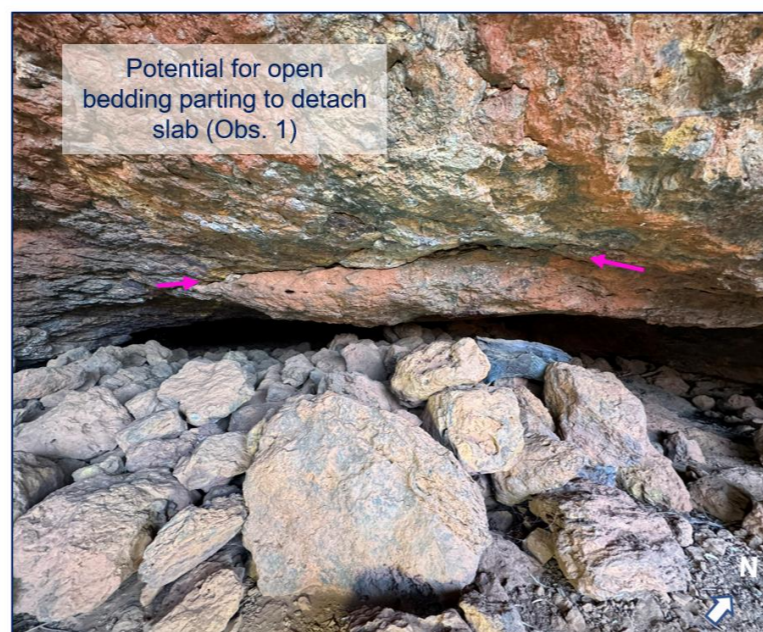
Summary Sheet Cave ID	Approximate Dimensions	Estimated GSI Range and Typical RMR ₈₉	Rock Mass Description	Observed Hazards	Recommendations
MEC012	<p><u>Main Overhang</u> - 7.5 m wide, 3.5 m deep, 1.5 m high.</p> <p><u>Rear Chamber</u> - 7 m deep, 4 m wide, 0.2 to 0.5 m high</p>	<p><u>GSI</u> All Areas 63 – 73</p> <p><u>RMR₈₉</u> All Areas: 73</p>	<p>The rock mass at the cave comprises high strength hydrated BIF with elongate vughs up to 100 mm oriented parallel to relict bedding, which dips shallowly to the northwest. Some vughs are infilled with silt and gravels which are inferred to be residual rock fragments.</p> <p>One steep northeast dipping joint set was identified at the cave site. It has a spacing of 3 to 4 m and is undulating, rough, and stained with iron and dark minerals. The joints appear to persist only around the cave entrance and main overhang, with observable lengths < 2 m.</p>	<ol style="list-style-type: none"> 1. Large BIF slabs bounded by dilated bedding partings in the cave roof, cross-cut by the northeast dipping joint set in places. 2. Loose hanging blocks up to 0.35 m wide in the dripline above the cave entrance. 3. Two perched boulders at the top of the escarpment. 	<ul style="list-style-type: none"> • Check for movement or of hanging blocks and perched boulders above the entrance before approaching the cave. Avoid standing and sitting in this area • Check for dilation of the bedding parting or detachment of the BIF slab in the cave roof at the back of the main overhang.

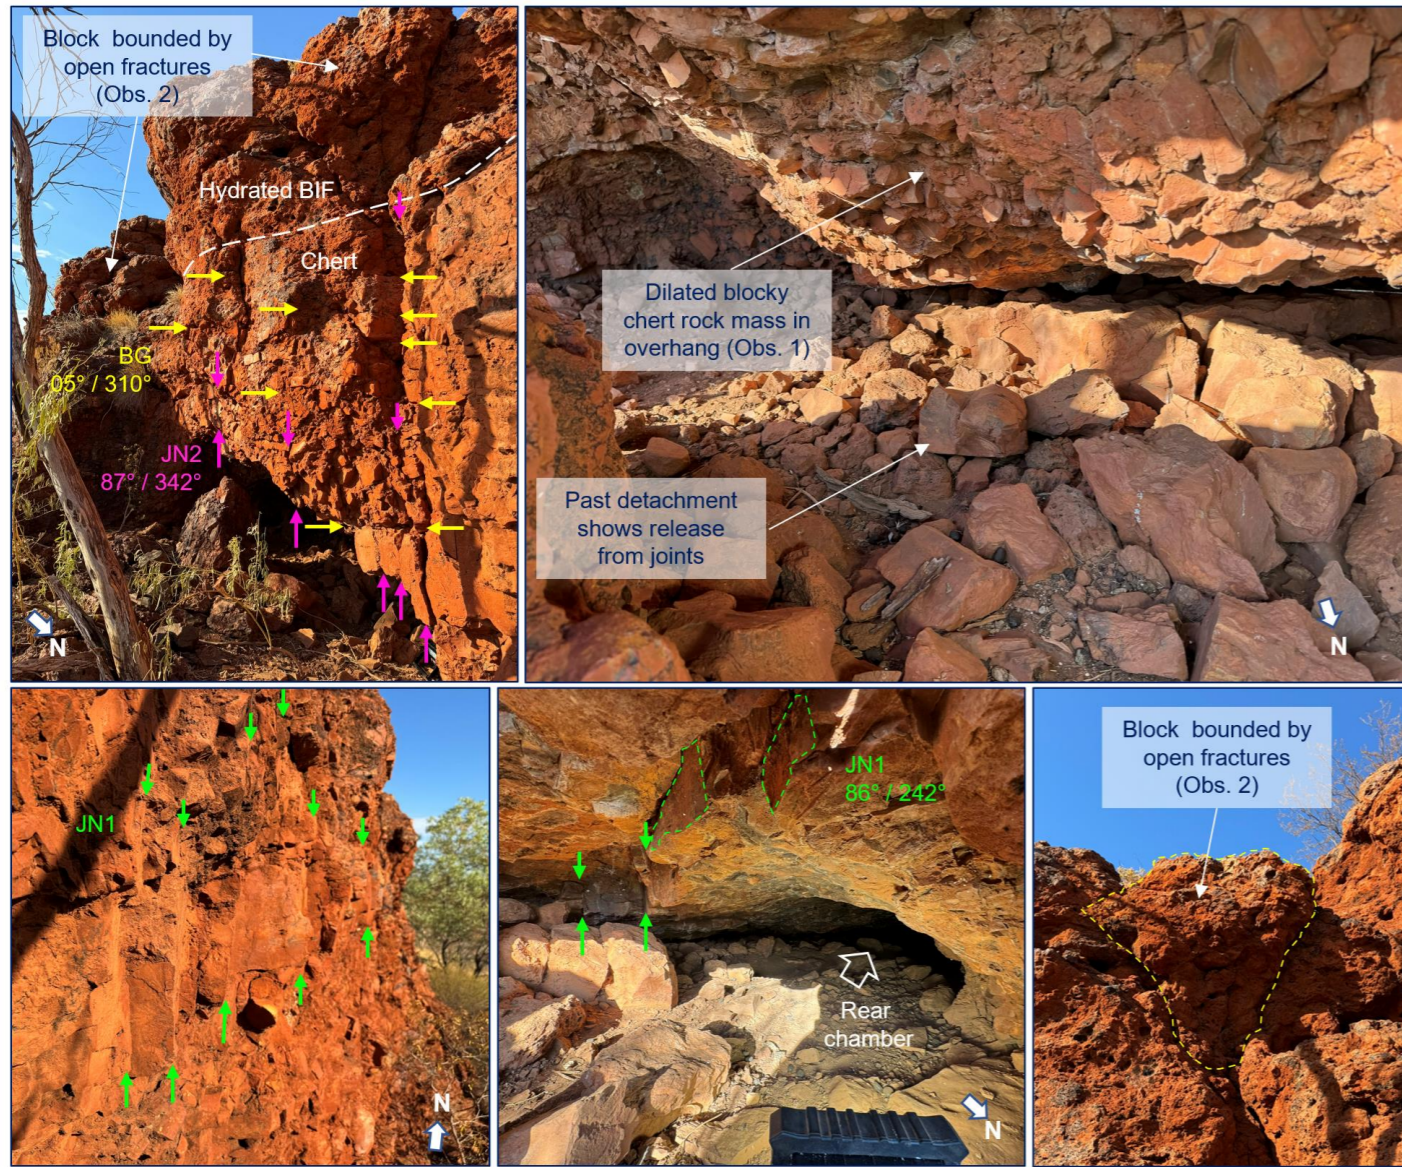
Summary Sheet Cave ID	Approximate Dimensions	Estimated GSI Range and Typical RMR ₈₉	Rock Mass Description	Observed Hazards	Recommendations
MEC074	<p><u>Exterior/Overhang</u> – 3.5 m wide, 1.7 m deep and 1.1 m high.</p> <p><u>Rear Chamber</u> – 3.5 m wide, 4.5 m deep, 0.4 m high</p>	<p><u>GSI</u></p> <p>Exterior/Overhang 55 – 65</p> <p>Rear Chamber 65 – 75</p> <p><u>RMR₈₉</u></p> <p>Exterior/Overhang 65</p> <p>Rear Chamber 75</p>	<p>The rock mass at the cave comprises a thick chert band overlain by hydrated vuggy BIF. The bat cave is hosted entirely within the chert band which approximately makes up the bottom half of the exposed escarpment. The chert rock mass is highly weathered and hydrated, with an apparent medium to high intact strength. The chert is dilated and loose in some areas. Bedding was observed to dip sub-horizontally towards the northwest. Within the chert, partings are spaced between 50 to 300 mm, and have lengths of approximately 0.5 to 1.0 m. Two joint sets were identified:</p> <p>Joint set 1 (JN1) strikes sub-parallel to the cave entrance and controls dripline formation. It dips sub-vertically towards the southwest, and is typically planar to undulating. Joint set 1 is spaced between 100 and 300 mm with lengths ranging from 0.3 to 0.8 m.</p> <p>Joint set 2 (JN2) has a typical spacing of 50 to 200 mm and strikes obliquely into the escarpment. It has an observable length of 100 to 400 mm. A single defect along this orientation on the north side of the entrance appears to bridge through the rock mass along multiple JN2 structures, resulting in a 2.5 m long defect that is open up to 2 mm.</p>	<ol style="list-style-type: none"> 1. Dilated, loose blocky chert rock mass was observed in some areas of the dripline and in the roof of the overhang. There is an increased potential for rockfall in these areas as evidenced by past detached blocks on the ground 2. Hanging blocks bounded by non-systematic open fractures were identified in the BIF escarpment above the cave entrance. 	<ul style="list-style-type: none"> • Limit time spent immediately below identified hanging blocks bounded by open fractures in the escarpment above the entrance • Avoid leaning on the area of dilated loose chert in the overhang when accessing the cave, or sitting directly underneath it • Check for fresh rockfall debris around the cave entrance and overhang when approaching the cave.

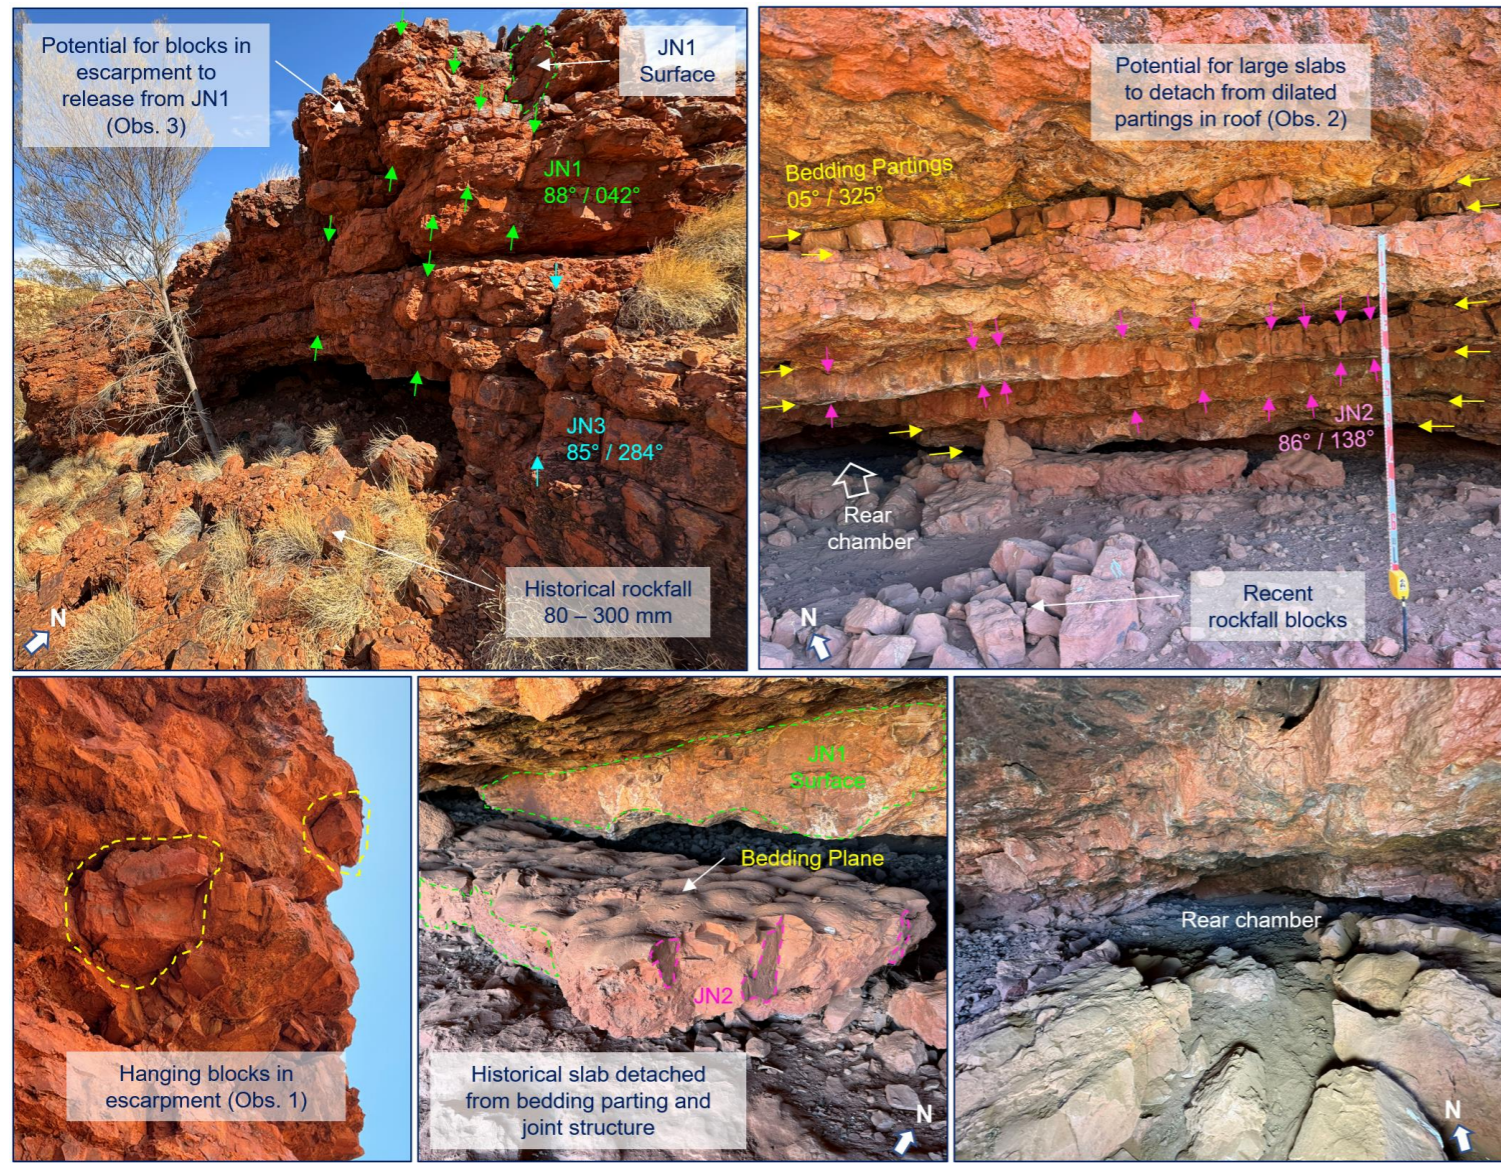
Summary Sheet Cave ID	Approximate Dimensions	Estimated GSI Range and Typical RMR ₈₉	Rock Mass Description	Observed Hazards	Recommendations
MEC065	<p>Main Chamber – 8 m wide, 5.7 m deep, and 1 m high.</p> <p>Rear Chamber – 5.7 m deep and up to 0.4 m high.</p>	<p>GSI Exterior and Main Chamber 52 – 65 Rear Chamber 59 – 69</p> <p>RMR₈₉ Exterior and Main Chamber 65 Rear Chamber 69</p>	<p>The rock mass comprises interbedded BIF and blocky chert. The rock mass is highly weathered and appears to be medium to high strength. Bedding at the cave is undulating and was measured in the main chamber to dip shallowly to the northwest. Bedding partings are spaced 0.2 to 0.5 m and are up to 8 m in length (greater than the span of the cave). Partings surfaces are slightly rough to rough, open 1 to 2 mm and iron stained. Partings become more dilated toward the cave entrance where they were observed to be open up to 5 mm. Residual hematitic silt was observed to infill dilated partings in places.</p> <p>Joint set 1 (JN1) is oriented parallel to the cave entrance and dips sub-vertically towards the northeast, Inset 7. It is spaced at 100 to 200 mm and is typically 0.5 to 1.0 m long. JN1 is planar to stepped, slightly rough to rough, and iron stained.</p> <p>Joint set 2 (JN2) is a sub-vertical joint set that strikes perpendicular to the cave entrance, Inset 7. JN2 is 0.2 to 0.5 m long and spaced between 50 to 150 mm.</p> <p>Joint set 3 (JN3) was only observed on the eastern side of the main chamber. It was measured to dip steeply towards the west, with a spacing between 1.0 to 1.5 m. Defect lengths up to 0.5 m were measured on the main chamber's east wall.</p>	<ol style="list-style-type: none"> 1. Hanging blocks bounded by open joints or non-systematic fractures occur in the dripline above the cave entrance. 2. There is significant potential for large slabs of chert and hydrated BIF to detach from dilated bedding partings and joints in the main chamber roof. This mechanism is evidenced by past detachment on the cave floor. 3. In the escarpment above the cave, there is potential for blocks to release from Joint set 1. This presents a rockfall hazard at the cave entrance. 	<ul style="list-style-type: none"> • Limit time spent immediately outside the cave entrance due to hanging blocks in the escarpment and the potential for blocks above to detach from joint set 1. • Before entering the cave, check for fresh rockfall debris and for movement or further dilation of the open bedding partings in main chamber roof. • No standing or sitting below the area of dilated chert slabs in the main chamber roof. Move quickly past these areas if necessary.

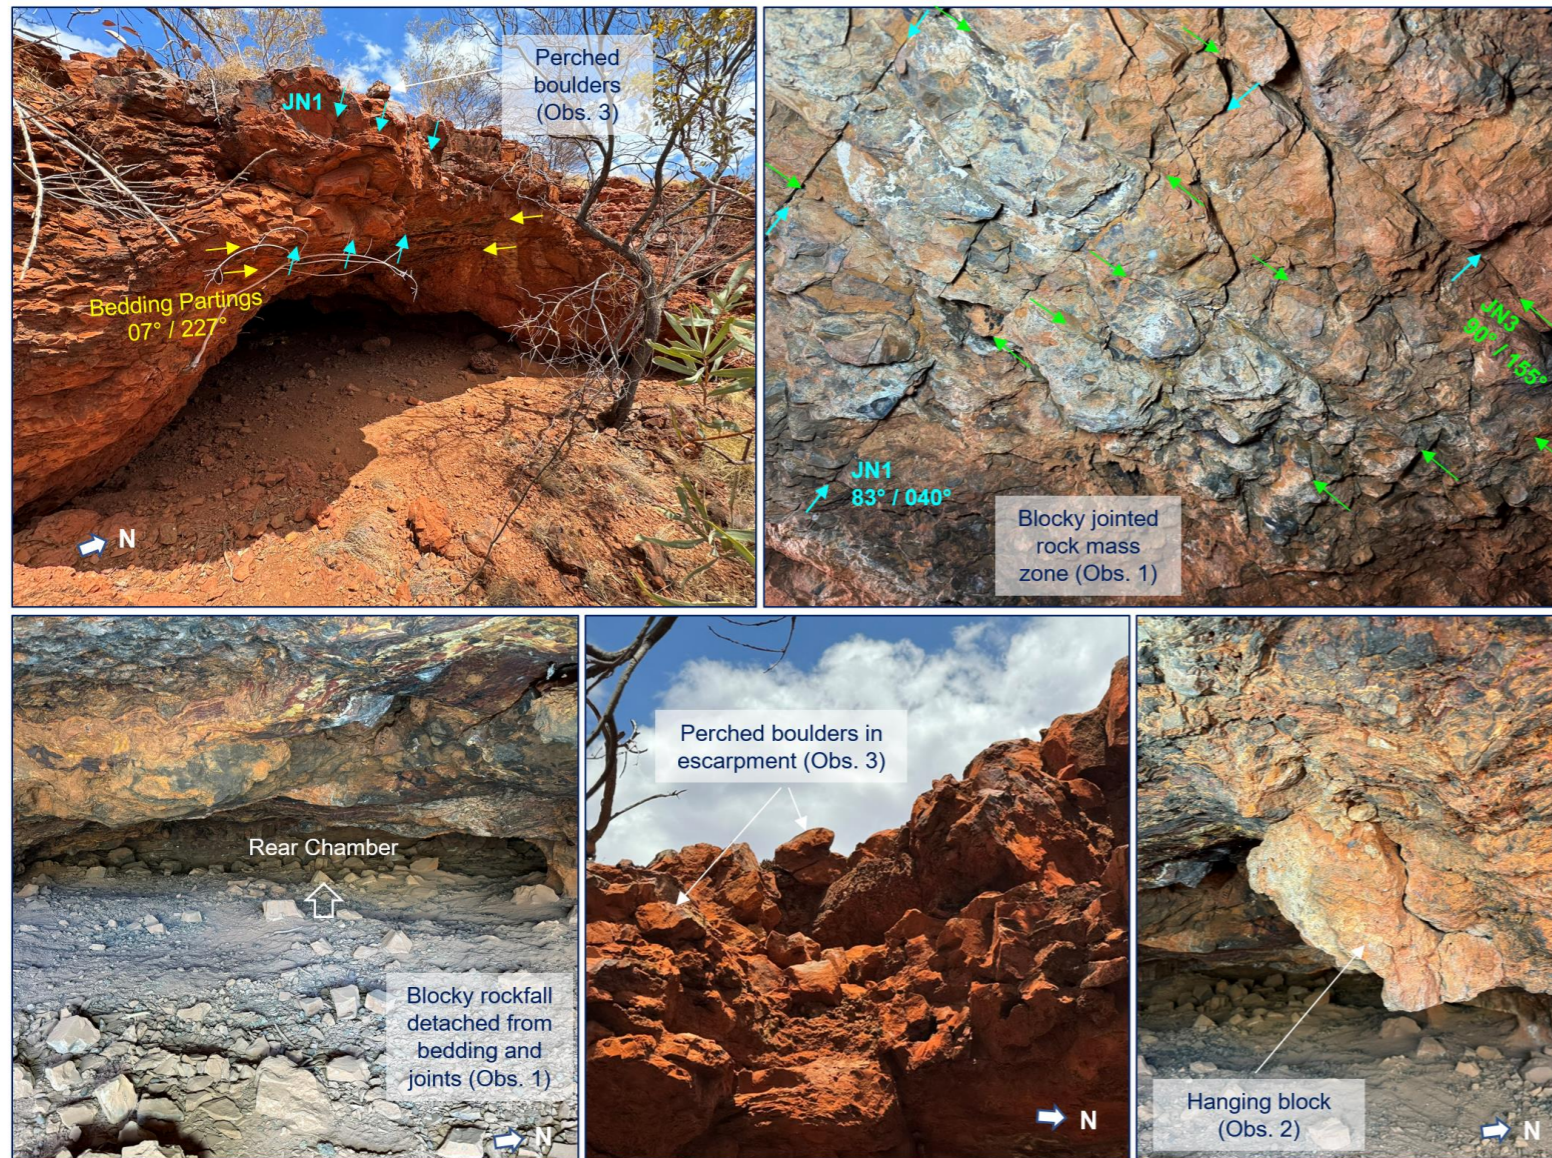
Summary Sheet Cave ID	Approximate Dimensions	Estimated GSI Range and Typical RMR ₈₉	Rock Mass Description	Observed Hazards	Recommendations
MEC007	Cave – 6 m wide, 10 m deep, and up to 1 m high.	<p><u>GSI</u> Exterior and Front 62 – 72 Obs. 1 Zone 59 – 69 Rear 65 – 75</p> <p><u>RMR₈₉</u> Exterior and Front 72 Obs. 1 Zone 69 Rear 75</p>	<p>The rock mass at the cave comprises hydrated BIF and interbedded chert. It is highly weathered and has a medium to high intact strength. Water seepage into the cave was evidenced by iron staining around the entrance, which overprints original bedding fabrics in parts of the cave. Where visible, bedding partings are undulose and spaced at 60 to 150 mm, with variable lengths between 0.5 and 2.5 m. Bedding is best developed in the cave roof and southern wall, where it was measured to dip shallowly towards the southwest. Three joint sets were identified at the cave</p> <p>JN1 dips steeply to the northeast. Joint set 1 is typically undulating to irregular and open less than 1 mm. Joints along this orientation are up to 4.5 m long and are spaced at 0.5 to 1.5 m. Seepage along JN1 was observed at the back of the cave.</p> <p>JN2 is vertical joint set that strikes east northeast, and is irregular, rough and iron stained. Defect lengths range between 1 and 2 m and are spaced at 0.5 to 1.0 m.</p> <p>JN3 is a northeast striking joint set that is oriented sub-vertically, and is undulating, rough, and iron stained. JN3 is only developed in the central part of the cave roof. The joints are between 0.5 and 0.8 m in length and are spaced 100 to 200 mm.</p>	<ol style="list-style-type: none"> 1. A blocky jointed rock mass zone was observed in the roof of the cave interior. The area is limited to where joint set 3 is visible, resulting in multiple intersecting sub-vertical joint sets that produce a 'blocky' BIF rock mass. 2. Hanging blocks bounded by open fractures on the interior of the cave. 3. Multiple perched boulders are situated in the escarpment above the cave entrance. 	<ul style="list-style-type: none"> • Assess the area for any hanging blocks that may have detached from the cave roof, or for any perched boulders that have dropped from the escarpment above the entrance • Check for dilation or water seepage in the joint structures, particularly in the 'blocky' rock mass zone • Limit time spent below the dripline and identified hanging blocks.

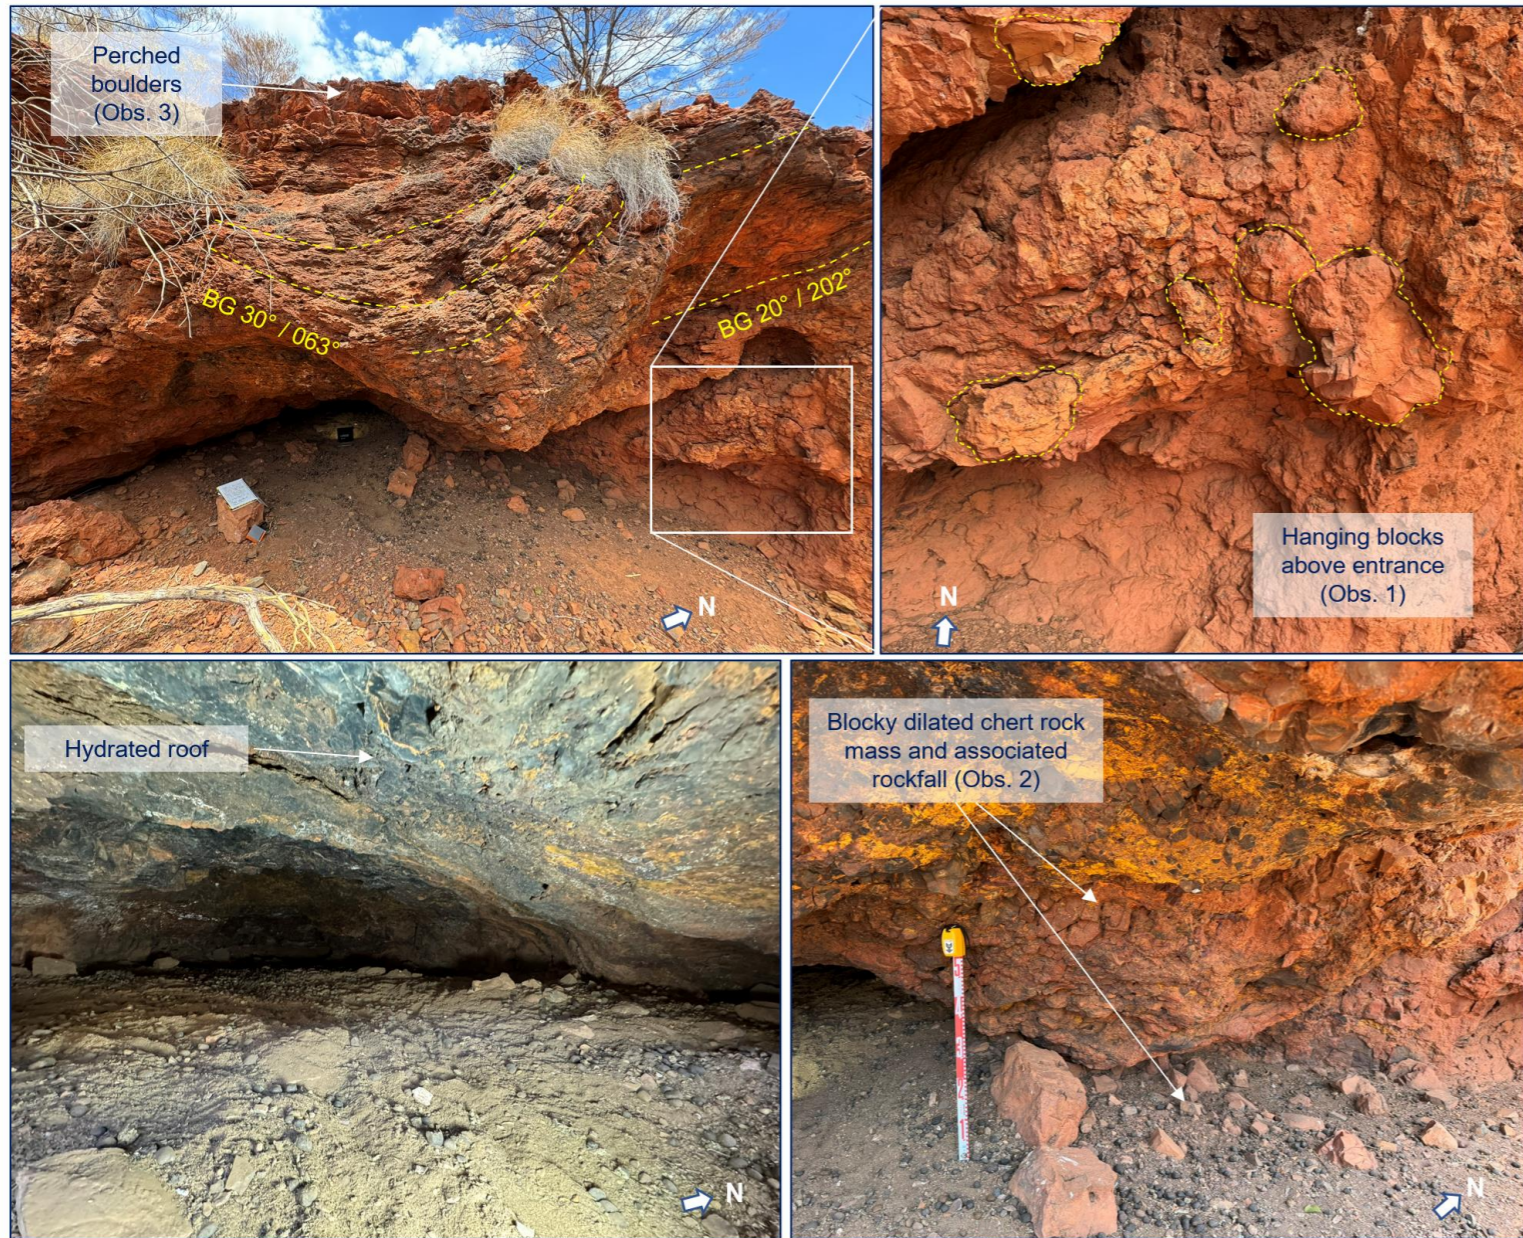
Summary Sheet Cave ID	Approximate Dimensions	Estimated GSI Range and Typical RMR ₈₉	Rock Mass Description	Observed Hazards	Recommendations
MEC033	<p><u>Overhang</u> – 4.5 m wide, 1.8 m deep and 1.3 m high.</p> <p><u>Interior</u> 2.5 m wide, 5.6 m deep, and 1 m high.</p>	<p><u>GSI</u> Exterior and Overhang 70 – 80 Interior 64 – 74</p> <p><u>RMR₈₉</u> Exterior and Overhang 80 Interior 74</p>	<p>The rock mass at the cave comprises highly weathered, hydrated BIF, with elongate vughs oriented parallel to well-developed bedding. A thick blocky chert band forms the lower third of the cave entrance. Bedding generally has a shallow dip and is partially overprinted due to hydration of the rock mass. The dip direction of bedding is variable due to the degree of undulation, with the dip becoming moderate in some highly folded areas, as observed at the cave entrance.</p> <p>Partings are spaced 50 to 150 mm and are generally more persistent in the overhang and exterior with lengths between 0.8 and 1.2 m. Bedding partings are typically open less than 1 mm and exhibit iron staining. No structurally significant joint sets were observed at MEC033, though some open non-systematic fractures were observed around the exterior and overhang.</p>	<ol style="list-style-type: none"> Loose hanging blocks were identified in the overhang. Blocky dilated chert rock mass was observed in the lower part of the overhang, with detached blocky to tabular chert fragments evident on the floor below. Perched boulders were identified in the escarpment above the overhang. These boulders have the potential to fall down the escarpment and over the dripline. 	<ul style="list-style-type: none"> Before approaching the cave, assess the top of the escarpment for perched boulders that may be at risk of falling Check the area beneath the overhang for fresh rockfall Check for water seepage in the cave roof.
