Geotechnical Assessment of Bat Caves

Mulga Downs Iron Ore Project

PSM5194-007R REV3 18 December 2024

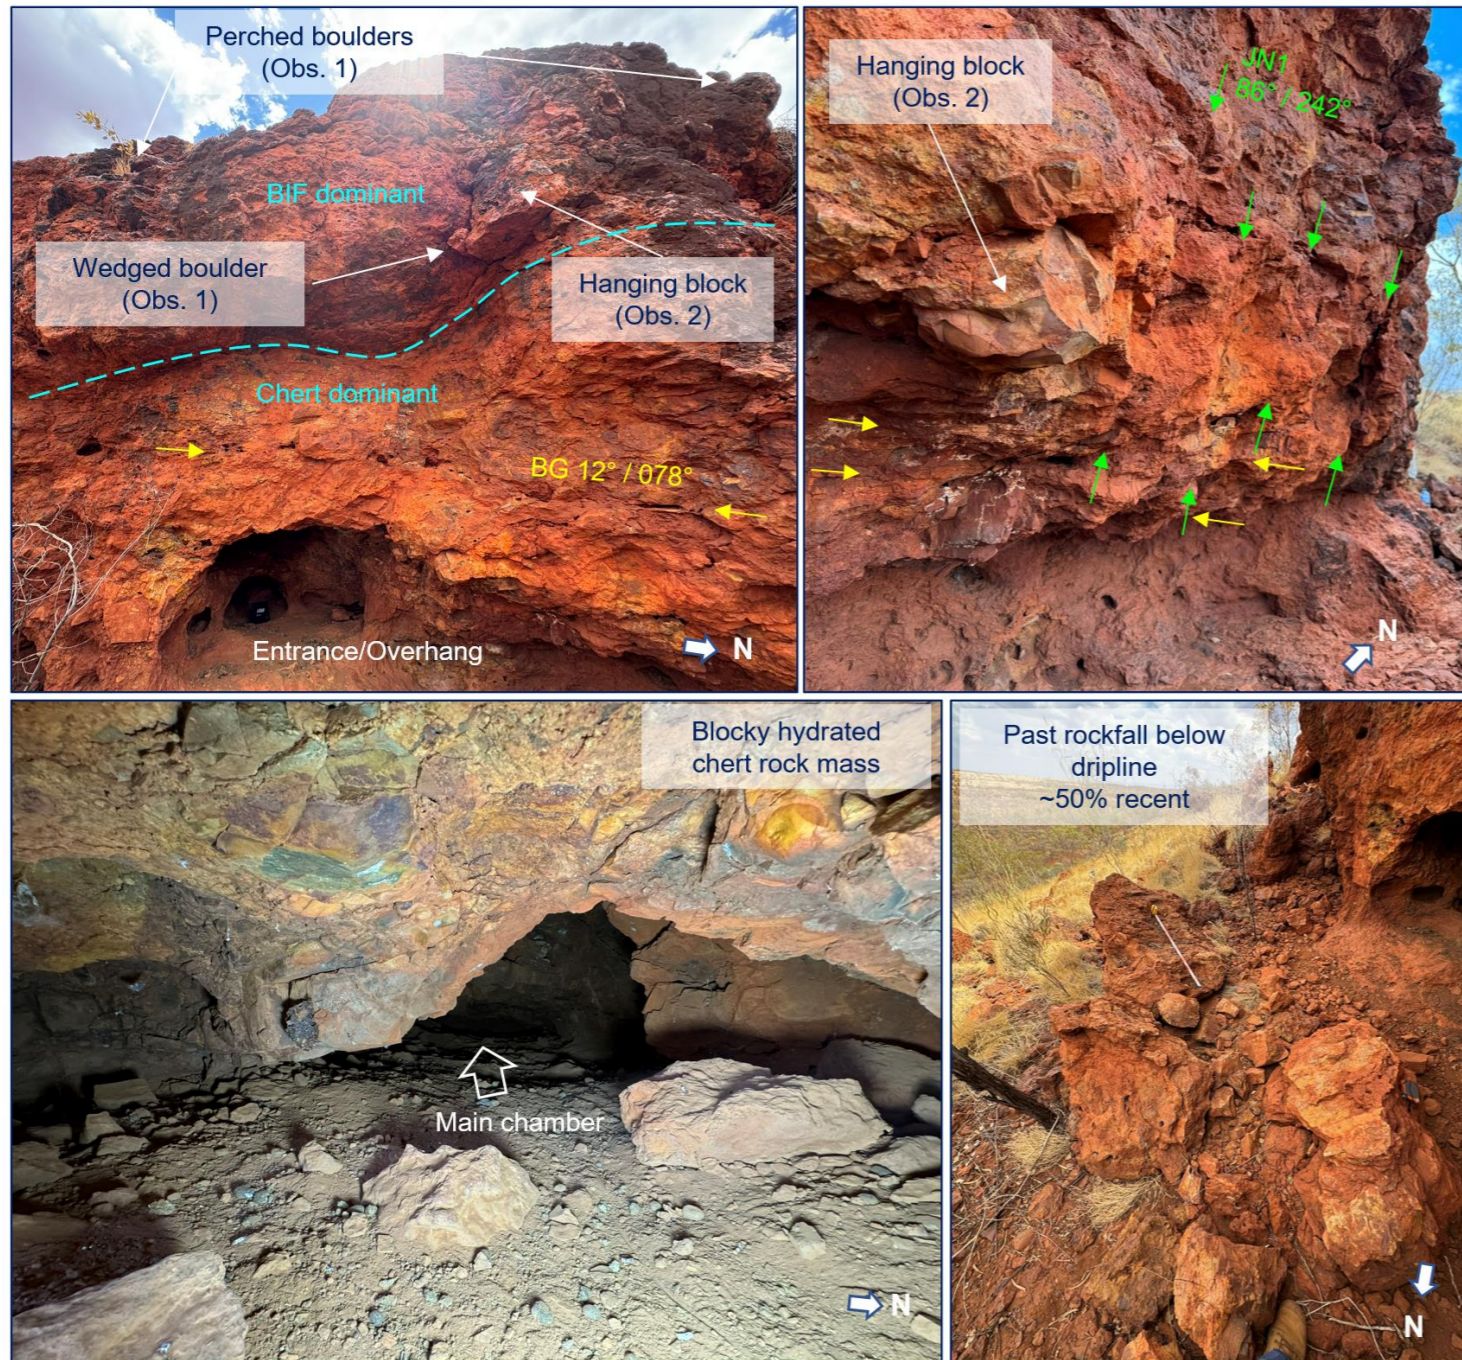
Summary Sheet Cave ID	Approximate Dimensions	Estimated GSI Range and Typical RMR ₈₉	Rock Mass Description	Observed Hazards	Recommendations
MEC073	<p><u>Entrance/Overhang</u> – 4m wide, 1.7 m deep, and 1 m high.</p> <p><u>Main Chamber</u> – 1.5 m wide, 6 m deep, and 0.5 m high.</p>	<p><u>GSI</u> Entrance/ Overhang 58 – 68 Main Chamber 66 – 76</p> <p><u>RMR₈₉</u> Entrance/ Overhang 68 Main Chamber 76</p>	<p>The rock mass at the cave comprises hydrated chert and interbedded BIF. The chert dominant rock mass that hosts the cave is high strength and highly weathered. Bedding is developed in the chert with partings spaces at 50 to 300 mm and between 0.5 and 1.0 m long. Partings are undulating, slightly rough to rough, and have an iron oxide stain to veneer on dilated surfaces. Bedding was measured at the back of the overhang to dip shallowly to the east. Bedding appears to become overprinted in the cave's main chamber.</p> <p>Two joint sets were observed at the cave and are confined to the chert dominant rock mass. JN1 is oriented sub-parallel to the escarpment. It dips steeply to the southwest and is spaced at approximately 0.1 m, and is 0.4 to 0.7 m long. JN2 dips steeply to the southeast. It is spaced between 100 to 200 mm and is typically 0.1 to 0.3 m long. Both of the joint sets are tight, and surface conditions are undulating and rough.</p>	<ol style="list-style-type: none"> 1. Wedged and perched boulders were identified in the escarpment above the cave entrance. 2. Loose hanging blocks bounded by open fractures were also identified in the escarpment, both above and adjacent to the cave entrance. 	<ul style="list-style-type: none"> • Limit time spent at against the rock face below any identified hanging or wedged boulders • Assess the area for any perched blocks that may have fallen from the escarpment above • Check for dilation of fractures bounding hanging blocks or any new cracks that may have formed in the escarpment and cave roof.

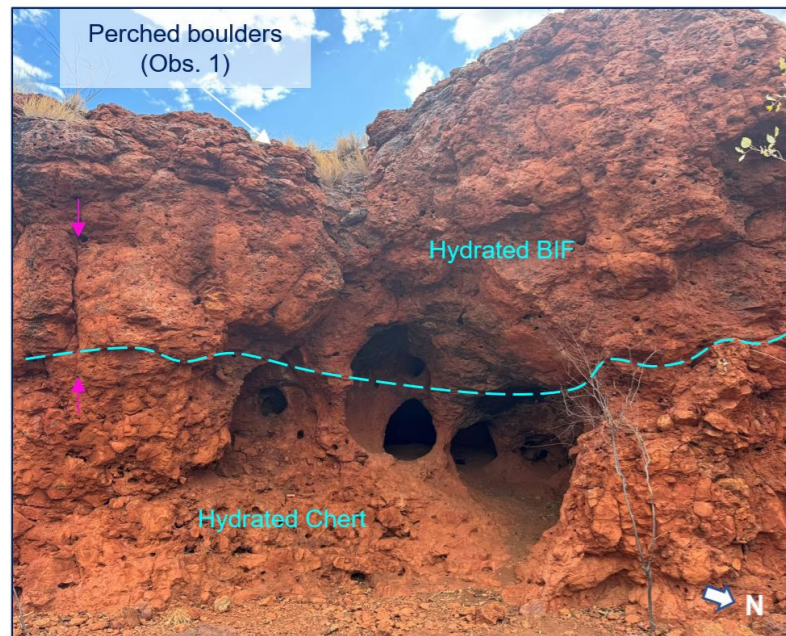
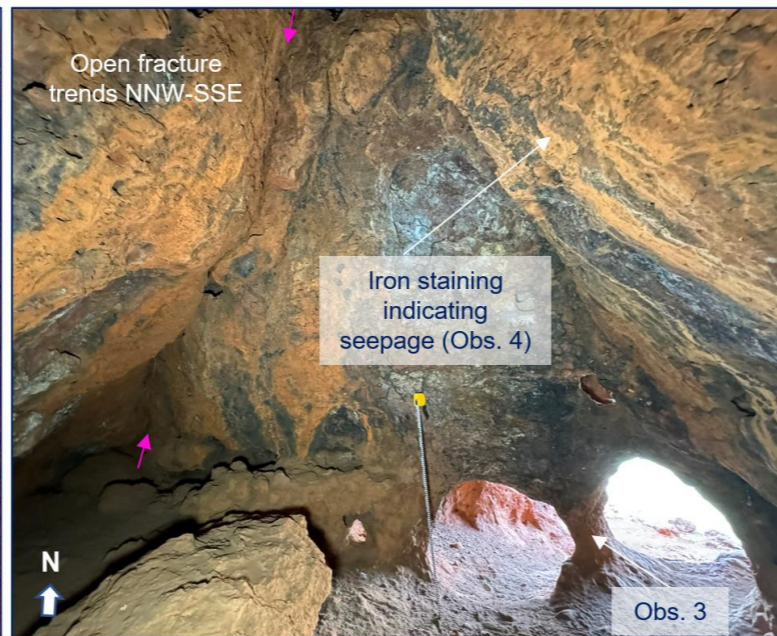
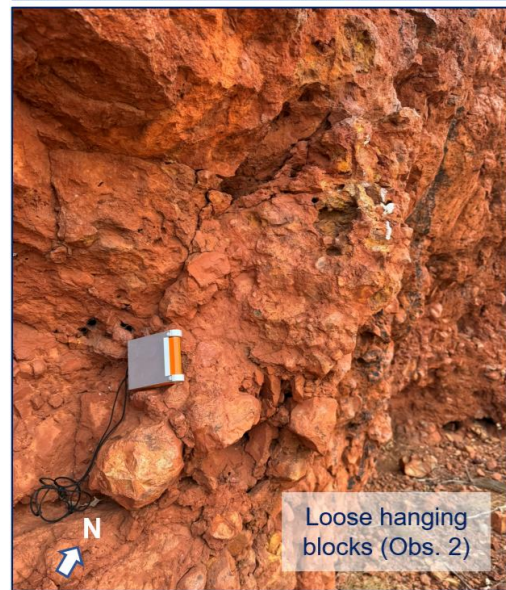
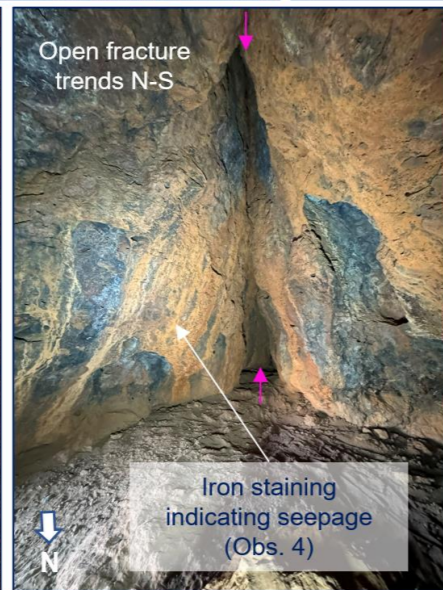
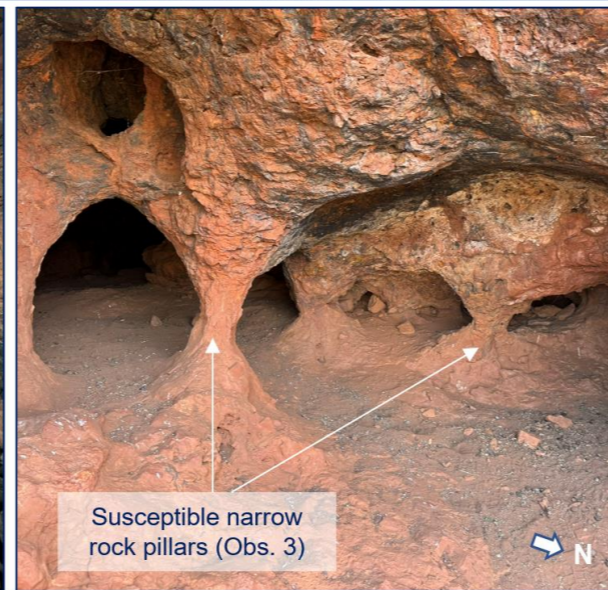
Summary Sheet Cave ID	Approximate Dimensions	Estimated GSI Range and Typical RMR ₈₉	Rock Mass Description	Observed Hazards	Recommendations
MEC039	<p><u>Entrance/Overhang</u> – 2.1 m wide and 1.1 m high</p> <p><u>Interior Chamber</u> – 4.5 m wide, 5.7 m deep and 1.8 m high.</p>	<p><u>GSI</u> Entrance/ Overhang 67 – 77 Main Chamber 70 – 80 Exterior (chert band) 58 – 68</p> <p><u>RMR₈₉</u> Entrance/ Overhang 77 Main Chamber 80 Exterior (chert band) 68</p>	<p>The lower third of the outcropping escarpment comprises chert, which is overlain by BIF comprising the upper two-thirds of the escarpment. Both rock types are highly weathered and hydrated. The cave appears to have preferentially developed along the contact between the chert and the BIF. Due to the upward sloping floor into the cave, the cave's interior chamber is almost entirely hosted within the BIF overlying the chert.</p> <p>The chert rock mass which makes up the lower half of the cave entrance is blocky and loose in places. The blockiness within the chert is a product of multiple intersecting joints. These joints within the chert are considered to not be significant on the scale of the cave due to the relatively short defect lengths. In the overlying BIF, original bedding has been overprinted but can be distinguished by elongate bedding parallel vughs. Where original rock fabrics are preserved, bedding partings were observed to have a spacing of 0.4 to 0.7 m and lengths of 0.5 to 1.5 m.</p> <p>None of the fractures observed appear to be systematic joints. The main north to north-northwest striking fracture inside the cave is interpreted to have formed due to slumping of the bedrock escarpment. Bedding partings are not developed inside the cave and are completely overprinted.</p>	<ol style="list-style-type: none"> 1. Boulders are perched on the edge of the escarpment above the cave entrance. 2. Multiple hanging blocks bounded by non-systematic, dilated fractures occur in the cave dripline. 3. Narrow rock pillars located at the entrance to the interior chamber may be susceptible to cracking and collapse from blast induced vibrations. The pillars occur at the interface between the chert and overlying BIF. 4. Seepage into the cave was observed to occur along the north to north-northwest trending fracture inside the cave, evidenced by considerable iron staining. 	<ul style="list-style-type: none"> • Check for fresh rock fall debris around the cave entrance before approaching • Limit time spent immediately below identified hanging blocks bounded by open fractures in the escarpment above the entrance • Check for signs of fretting or cracking within the susceptible rock pillars • Check for dilation or water seepage in the north to north-northwest trending fracture inside the cave before accessing.

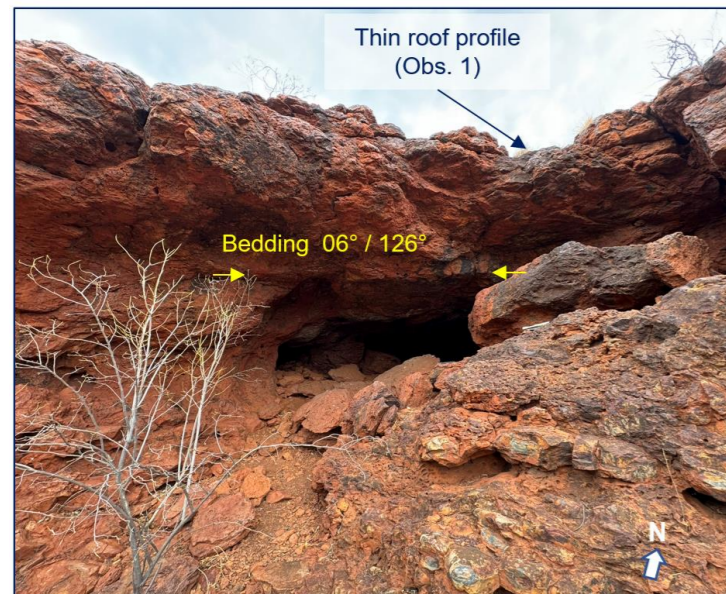
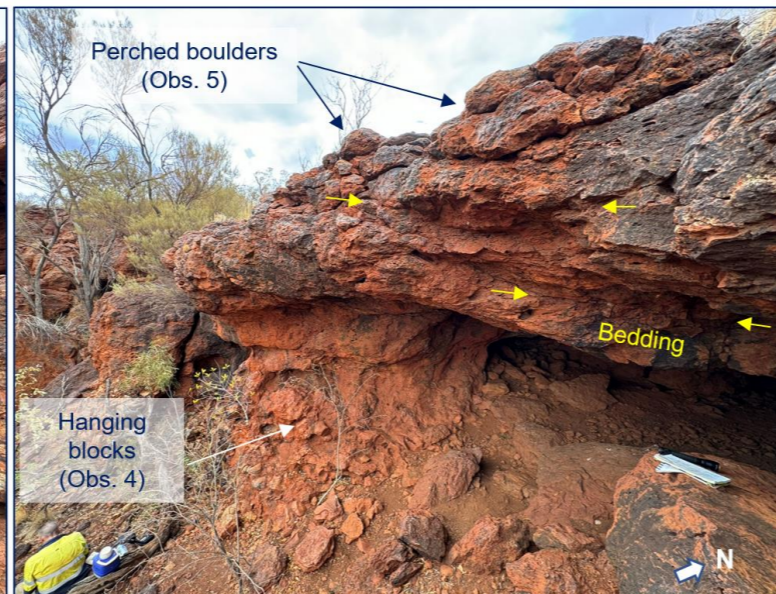
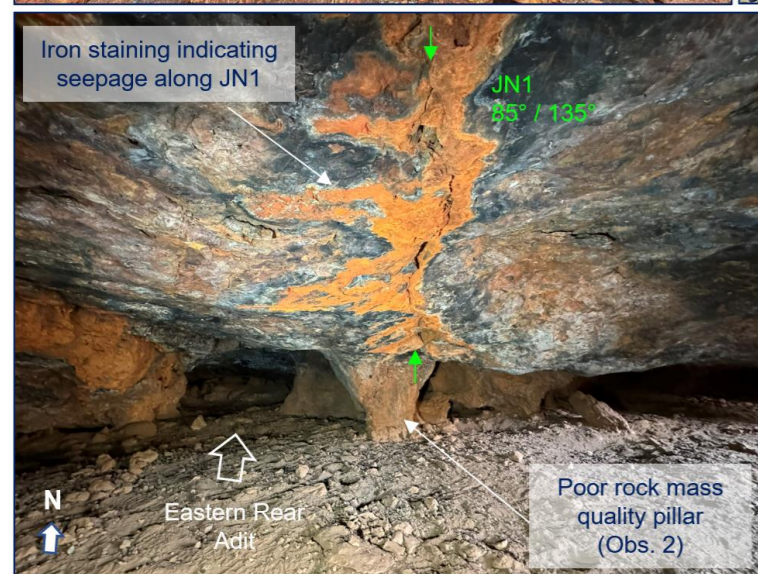
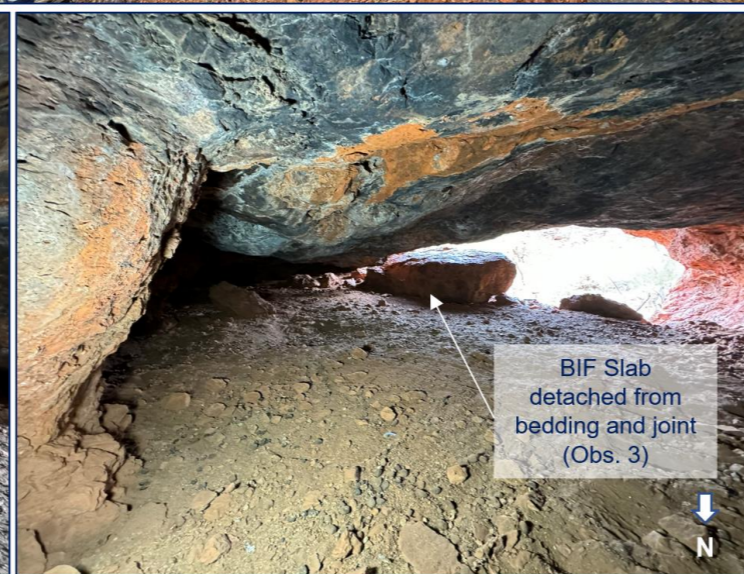
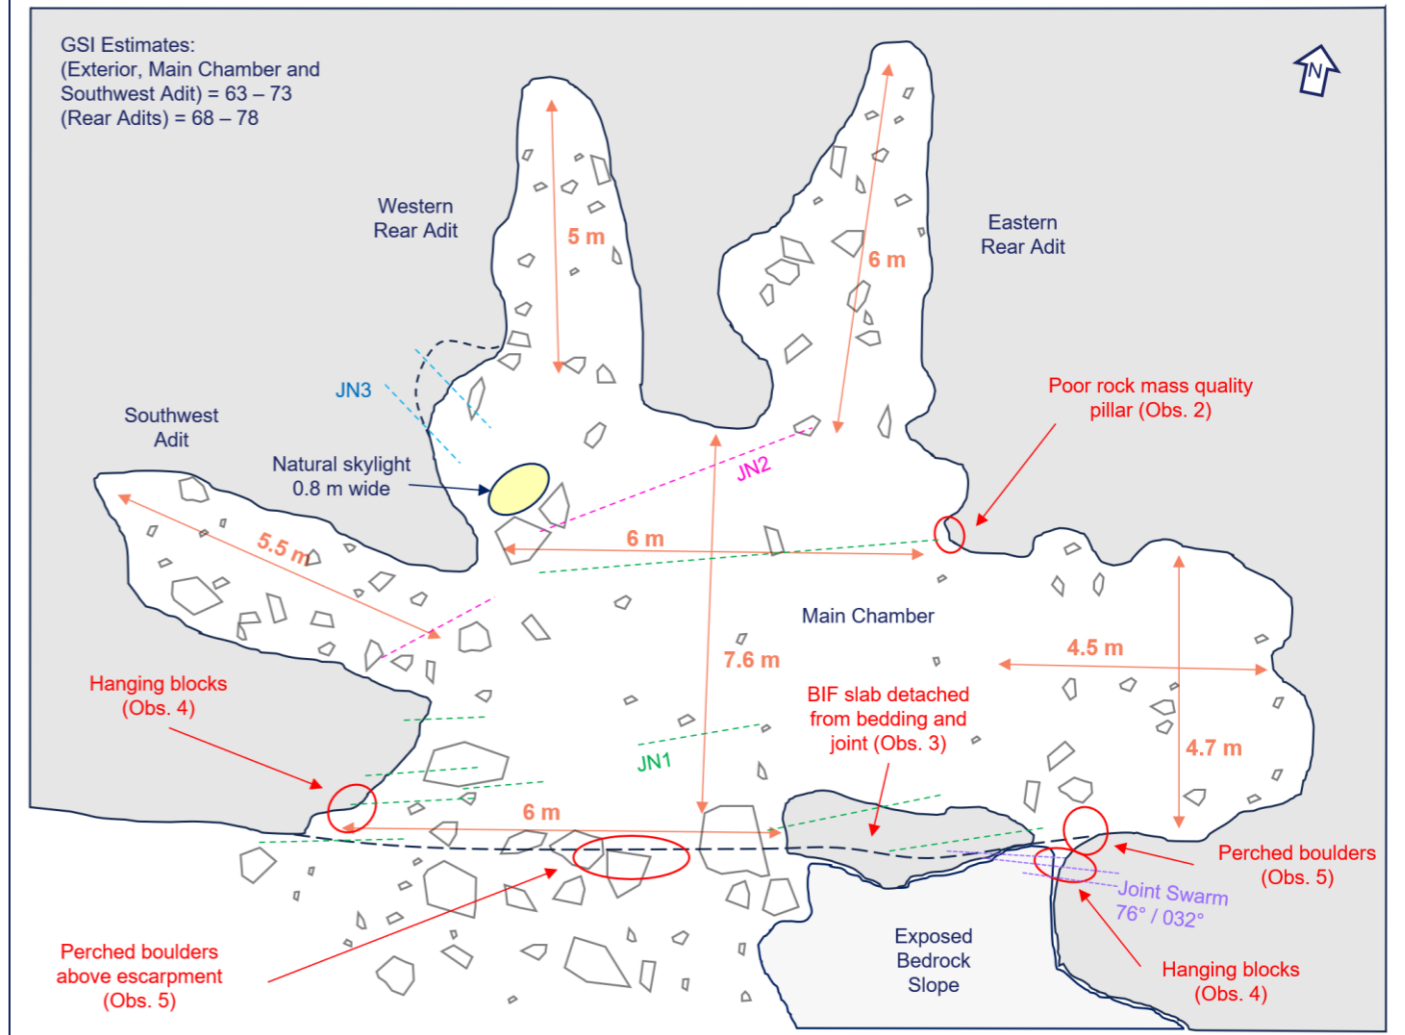
Summary Sheet Cave ID	Approximate Dimensions	Estimated GSI Range and Typical RMR ₈₉	Rock Mass Description	Observed Hazards	Recommendations
MEC016 (MIB-MD13-043)	<p>Main Chamber – 6 m wide, 7.6 m deep, and up to 1.2 m high.</p> <ul style="list-style-type: none"> A skylight 0.8m wide occurs in the roof of the central chamber Eastern main chamber – 4.5 m deep and 0.7 m. <p>Three natural adits:</p> <ul style="list-style-type: none"> Southwest adit 5.5 m deep Western rear adit 5 m deep Eastern rear adit 6 m deep <p>The adits are 1.8 to 2.2 m wide, and all < 0.8 m high</p>	<p>GSI Exterior, Main Chamber and Southwest Adit 63 – 73 Western and Eastern Rear Adits 68 – 78</p> <p>RMR₈₉ Exterior, Main Chamber and Southwest Adit 73 Western and Eastern Rear Adits 78</p>	<p>The rock mass comprises partially hydrated, vughy BIF and chert that dips shallowly towards the southeast. The roof profile is undulating and sub-horizontal, suggesting the cave developed along BIF bedding planes. Bedding partings are spaced at 150 to 300 mm, though are not continuous across the cave. Parting spacings increase to 0.5 m towards the top of the escarpment where bedding becomes largely overprinted. Observed parting lengths are typically between 2 and 4 m. Three joint sets were identified and have the following characteristics:</p> <p>Joint set 1 (JN1) dips steeply to the southeast. It has a spacing of 0.4 to 1.0 m at the entrance. The spacing increases into the cave where it is spaced at approximately 3 m. Defect lengths are highly variable and range between 1.5 and 5.0 m. A single joint along this orientation in the main chamber roof is open up to 3 mm and infilled with silt and a veneer of iron oxide</p> <p>Joint set 2 (JN2) dips steeply to the east northeast. Only two joints were observed along this orientation in the roof of the main chamber, indicating a spacing of 1.2 m and lengths between 3.0 and 4.5 m.</p> <p>Joint set 3 (JN3) dips steeply to the northeast. Only two joints were observed on the western side of the main chamber, indicating a spacing of 0.7 m and lengths of approximately 1 m.</p>	<ol style="list-style-type: none"> A thin roof profile (measured 1 to 2 m thick above the entrance) in combination with the cave's wide span increases the susceptibility to collapse. A pillar of poorer quality rock quality is situated at the back of the main chamber, and may be susceptible to cracking. There is potential for blocks to detach from bedding partings in the cave roof or overhang where cross cut by a sub-vertical joint set. This mechanism is evidenced by past tabular rockfall below the entrance. Loose hanging blocks were identified in the escarpment around the entrance. No hanging blocks were identified on the interior. Perched boulders are situated in the escarpment above the cave have the potential to fall. 	<ul style="list-style-type: none"> Assess the area for any blocks that may have detached from the overhang at the entrance Check for dilation and water seepage in structures within the entrance overhang and inside the main chamber. Also check for any new fractures that may have formed Limit time spent immediately below the dripline where perched boulders are at risk of falling, or loose hanging blocks have been identified Check for signs of fretting or cracking within the susceptible rock pillar.

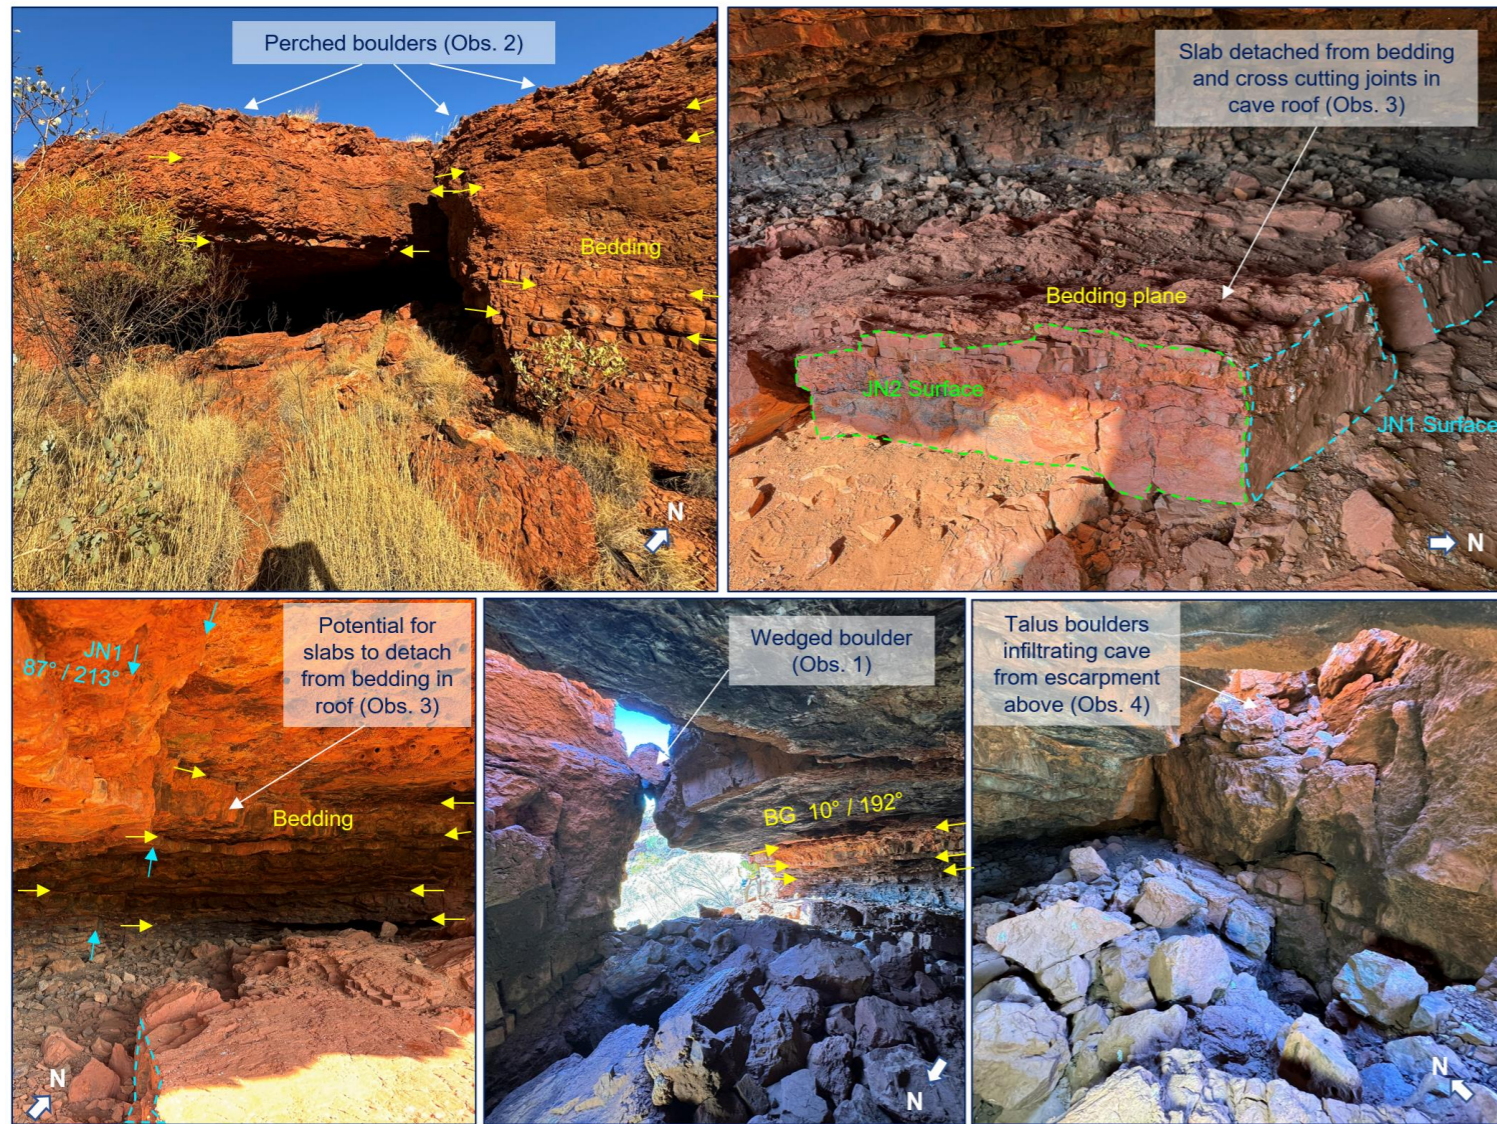
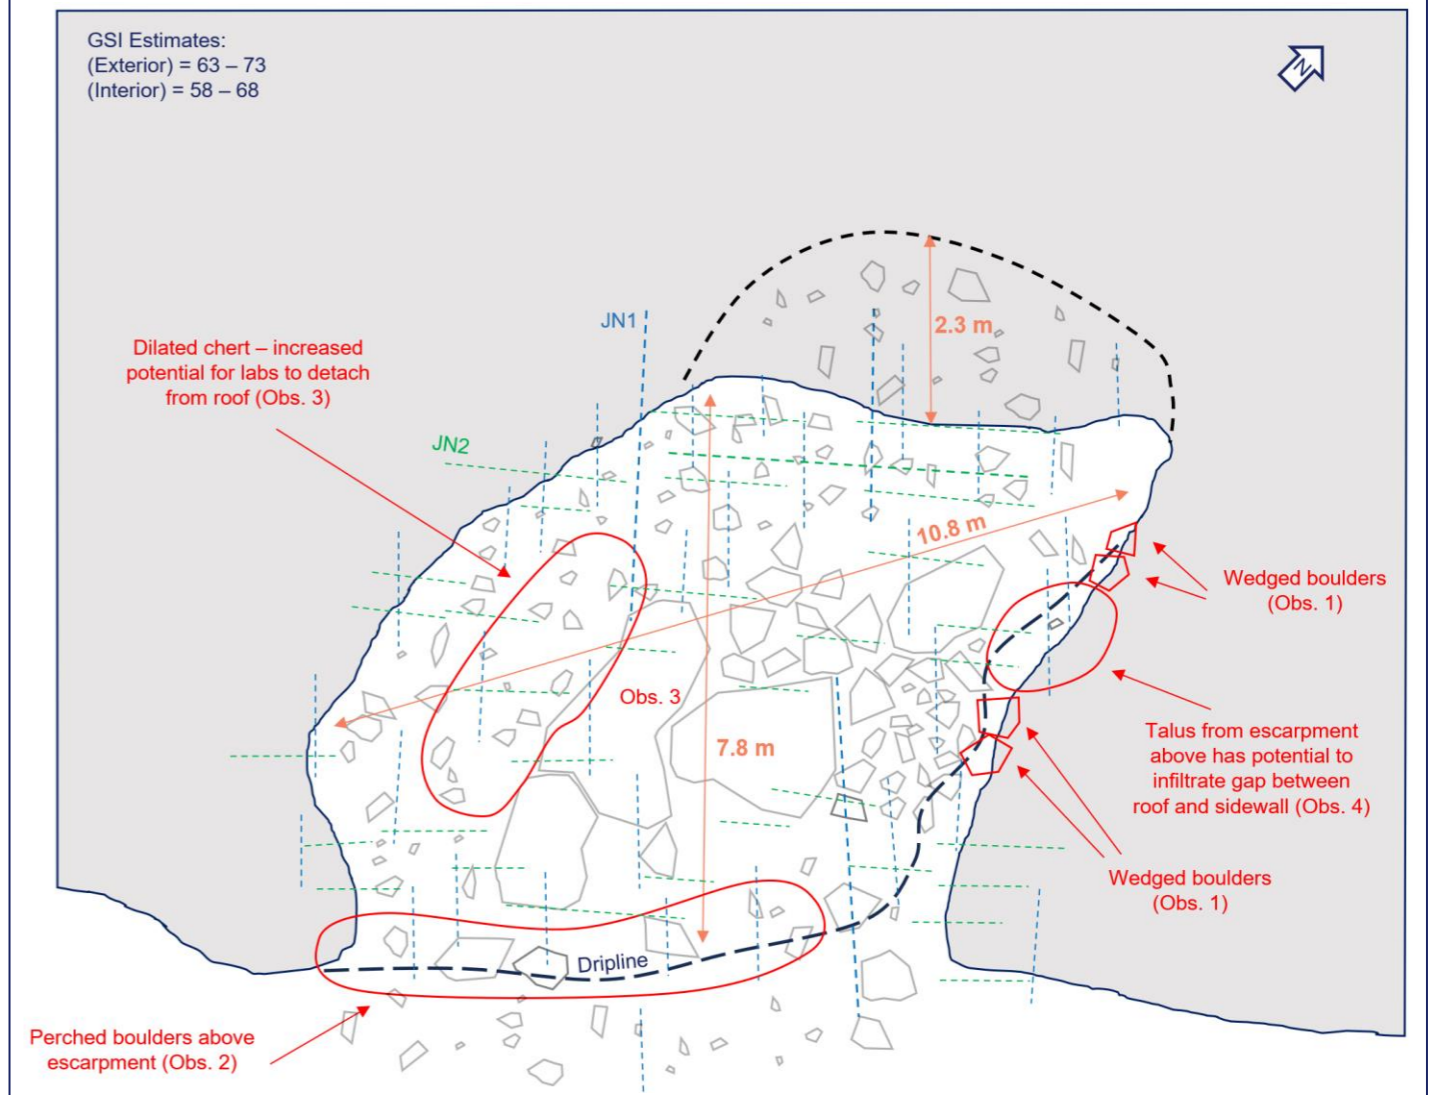
Summary Sheet Cave ID	Approximate Dimensions	Estimated GSI Range and Typical RMR ₈₉	Rock Mass Description	Observed Hazards	Recommendations
MEC063	Main Chamber – 10.8 m wide, 7.8 m deep, and up to 1.2 m high.	<p>GSI Exterior 63 – 73 Interior 58 – 68</p> <p>RMR₈₉ Exterior 73 Interior 68</p>	<p>The rock mass at the cave comprises high strength, highly weathered interbedded BIF and chert. Bedding is well developed, undulating and strongly controls cave development. Bedding was measured in the centre of the cave to dip shallowly to the south. Partings are spaced between 80 and 300 mm. Some partings persist greater than the span of the cave, though most are between 5 and 10 m in length and are open less than 1 mm. Two pervasive joint sets were identified at the cave throughout the exterior and interior:</p> <p>Joint set 1 (JN1) is oriented sub-vertically and strikes northeast-southwest. Defects along this orientation are typically 0.3 to 0.8 m long but some JN1 structures were observed up to 5 m in length. The joint set has a spacing of 0.2 to 0.5 m and is tight.</p> <p>Joint set 2 (JN2) dips steeply to the northwest, sub-parallel to the bedrock escarpment. Surfaces are planar to undulating and range between 0.3 and 1.0 m in length. Some exposed JN2 surfaces where past blocks have detached are up to 2.5 m long.</p>	<ol style="list-style-type: none"> 1. Wedged boulders were observed on the eastern side of the cave, in the gap between the cave dripline and escarpment. 2. Perched boulders are situated atop the escarpment above the cave entrance. 3. There is potential for large slabs of hydrated BIF and chert to detach from dilated bedding partings and joints in the cave roof. 4. Talus boulders from the escarpment above the cave were observed to infiltrate the gap between the cave dripline and eastern escarpment edge. 	<ul style="list-style-type: none"> • Avoid spending time spent below the gap between the eastern escarpment and cave dripline, where wedged boulders and talus from the above escarpment present multiple potential rockfall sources • Watch footing below identified Obs. 1 areas due to a drop in the floor profile • Before entering the cave, check for fresh rockfall debris and for movement or further dilation of the open bedding partings in the cave roof • No standing or sitting below dilated the area of dilated rock mass in the cave roof (Obs. 3). Move quickly past these areas if necessary.

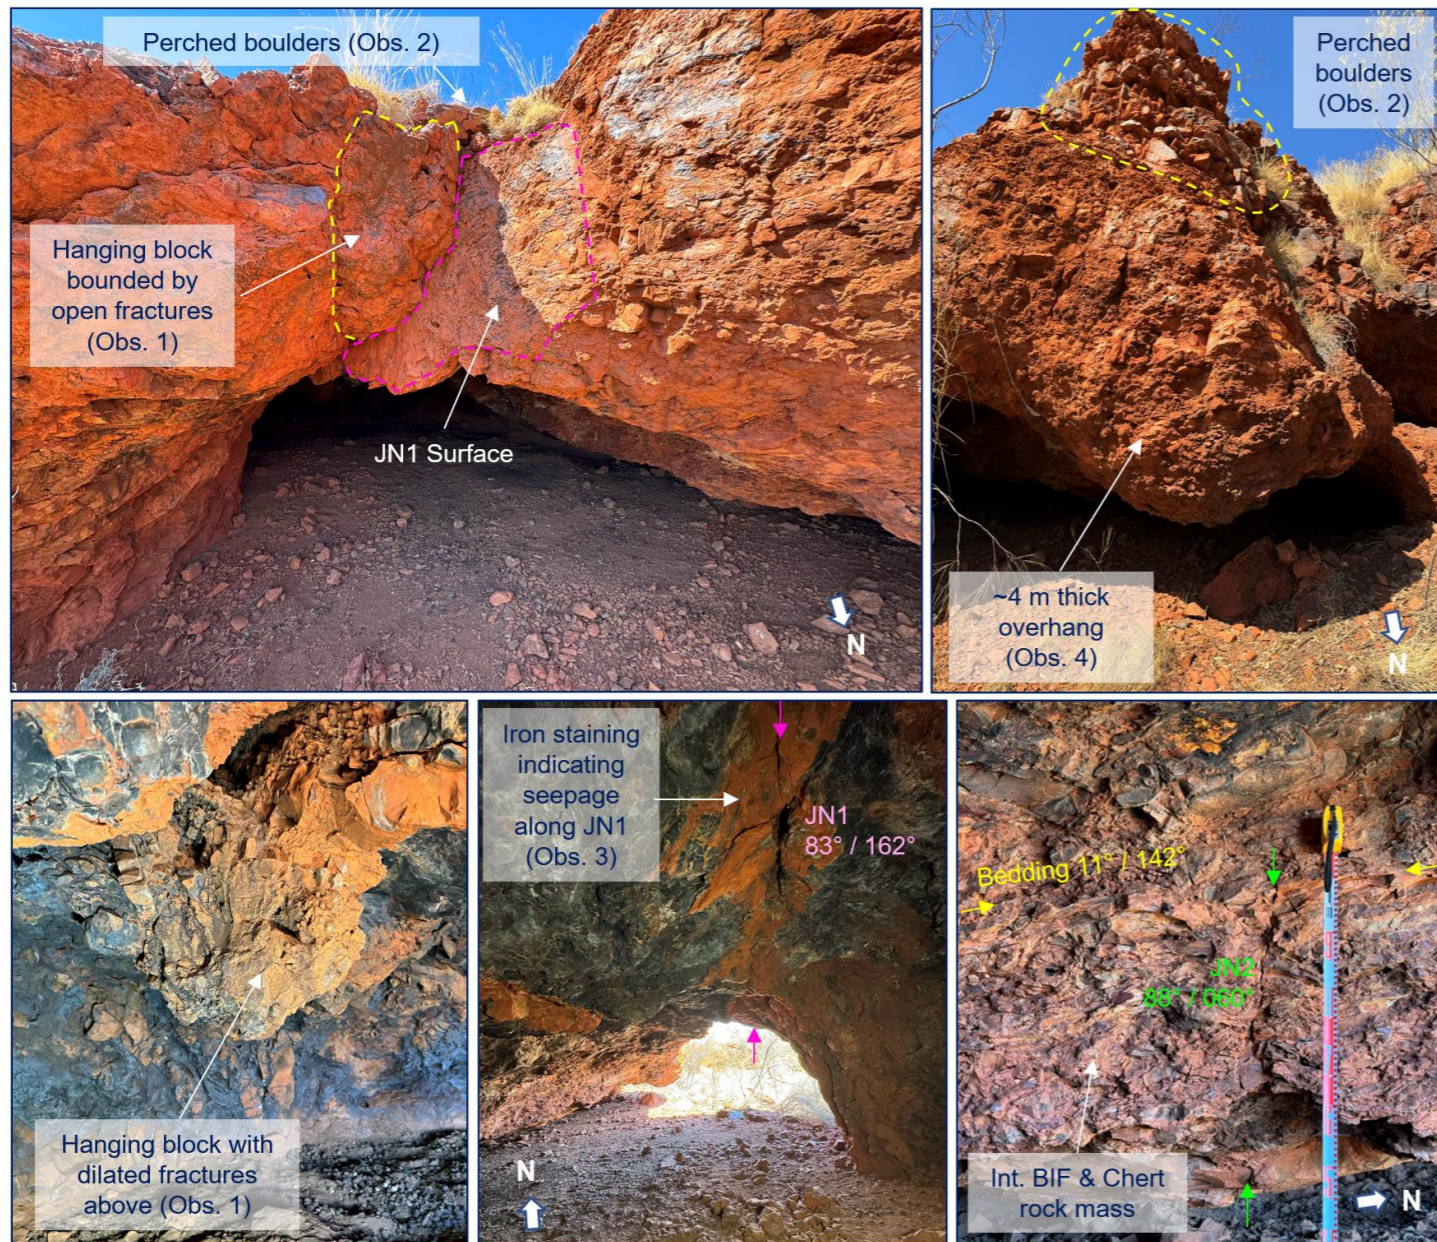
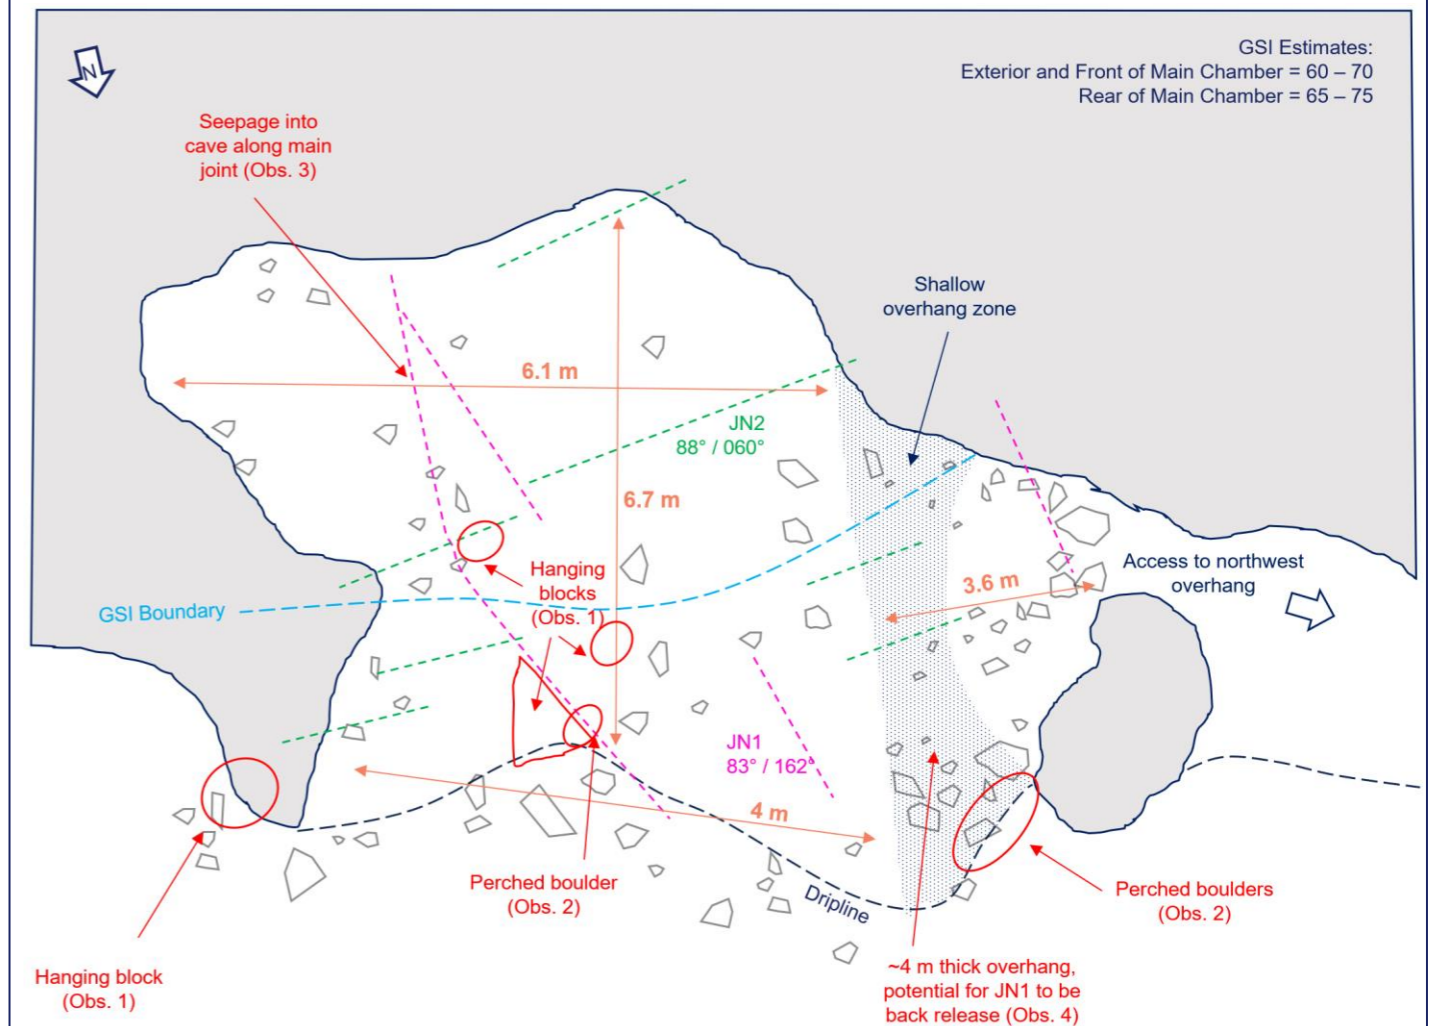
Summary Sheet Cave ID	Approximate Dimensions	Estimated GSI Range and Typical RMR ₈₉	Rock Mass Description	Observed Hazards	Recommendations
MEC062	Main Chamber – 6.1 m wide, 6.7 m deep, 1.5 m high	<p>GSI Exterior and Front of Main Chamber 60 – 70 Rear of Main Chamber 65 – 75</p> <p>RMR₈₉ Exterior and Front of Main Chamber 70 Rear of Main Chamber 75</p>	<p>The rock mass at the cave comprises hydrated, interbedded BIF and chert. The rock mass is highly weathered. Intact strength was estimated to be high. Hydration has overprinted bedding in parts of the cave, particularly on the cave roof and southern wall. Where visible, bedding is sub-horizontal and is highly undulose. The dip direction of bedding is variable due to the degree of undulation, with the dip becoming moderate to steep in some highly folded areas at the rear of the cave. Structurally significant partings were observed to have a 100 to 400 mm spacing at the front of the main chamber. The partings are between 0.5 and 1.5 m in length and are either tight or open less than 1 mm.</p> <p>Two joint sets were identified at the cave. Joint set 1 (JN1) dips steeply to the south-southeast and is 0.6 to 2.8 m long. The second joint set (JN2) dips sub-vertically to the northeast and is 1.0 to 2.5 m long. Both joint sets have irregular and rough surface conditions, and are typically tight with an iron stain infill. The joint sets are spaced variable between 1 and 3 m apart. A large open fracture in the cave roof appears to initiate along JN1 in at the cave entrance, and then rotates along folded bedding towards the rear of the cave.</p>	<ol style="list-style-type: none"> Hanging blocks were observed on the cave exterior and interior. A large hanging block situated immediately above the entrance is bounded by joint set 1 and open fractures. Multiple perched boulders up to 0.6 m in width were observed on the escarpment above the cave entrance. Water seepage into the cave was observed along a dilated fracture in the cave roof, which is partially aligned along joint set 1. Seepage was evidenced by iron staining of the wall rock either side of the fracture. The overhanging escarpment on the western side of the cave entrance is up to 4 m thick. Due to the orientation of joint set 2, there is potential for the substantial overhang to detach from the sub-vertical structure. 	<ul style="list-style-type: none"> Before approaching the cave, assess the area for any fresh rockfall and loose blocks that may have formed in the escarpment Avoid standing or sitting below identified hanging blocks in the cave dripline and interior. When accessing the cave, move past the large block above the entrance quickly Check for dilation of joint fractures inside the cave and for the formation of any new cracks in the substantial overhang on the western side of the entrance.

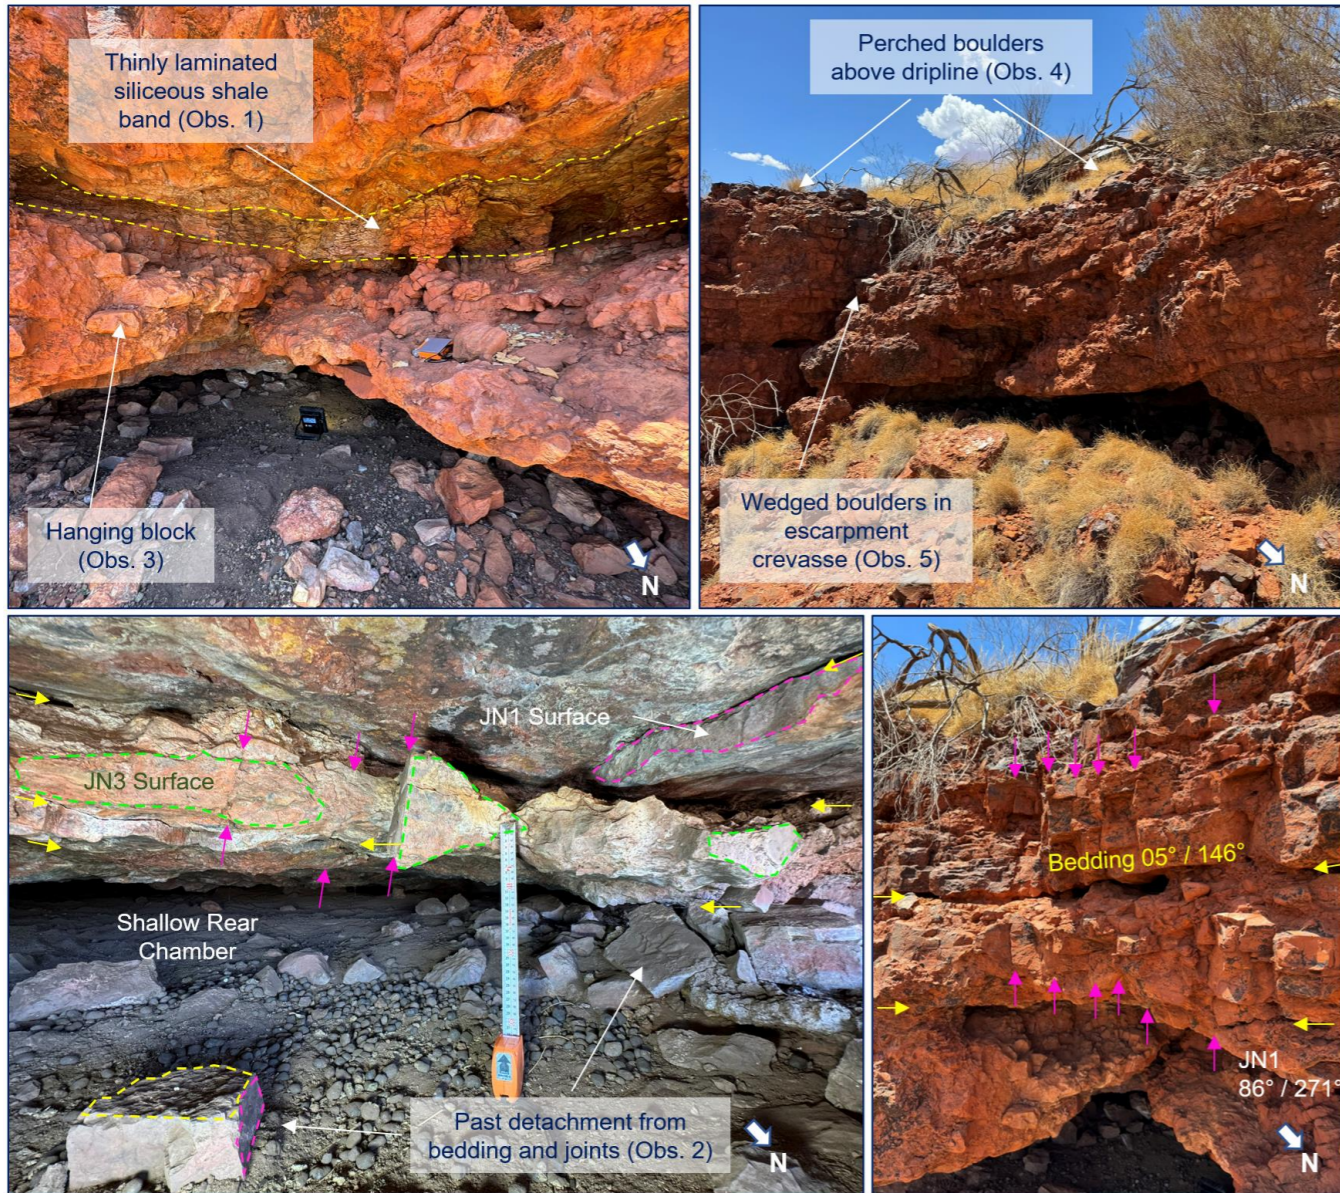
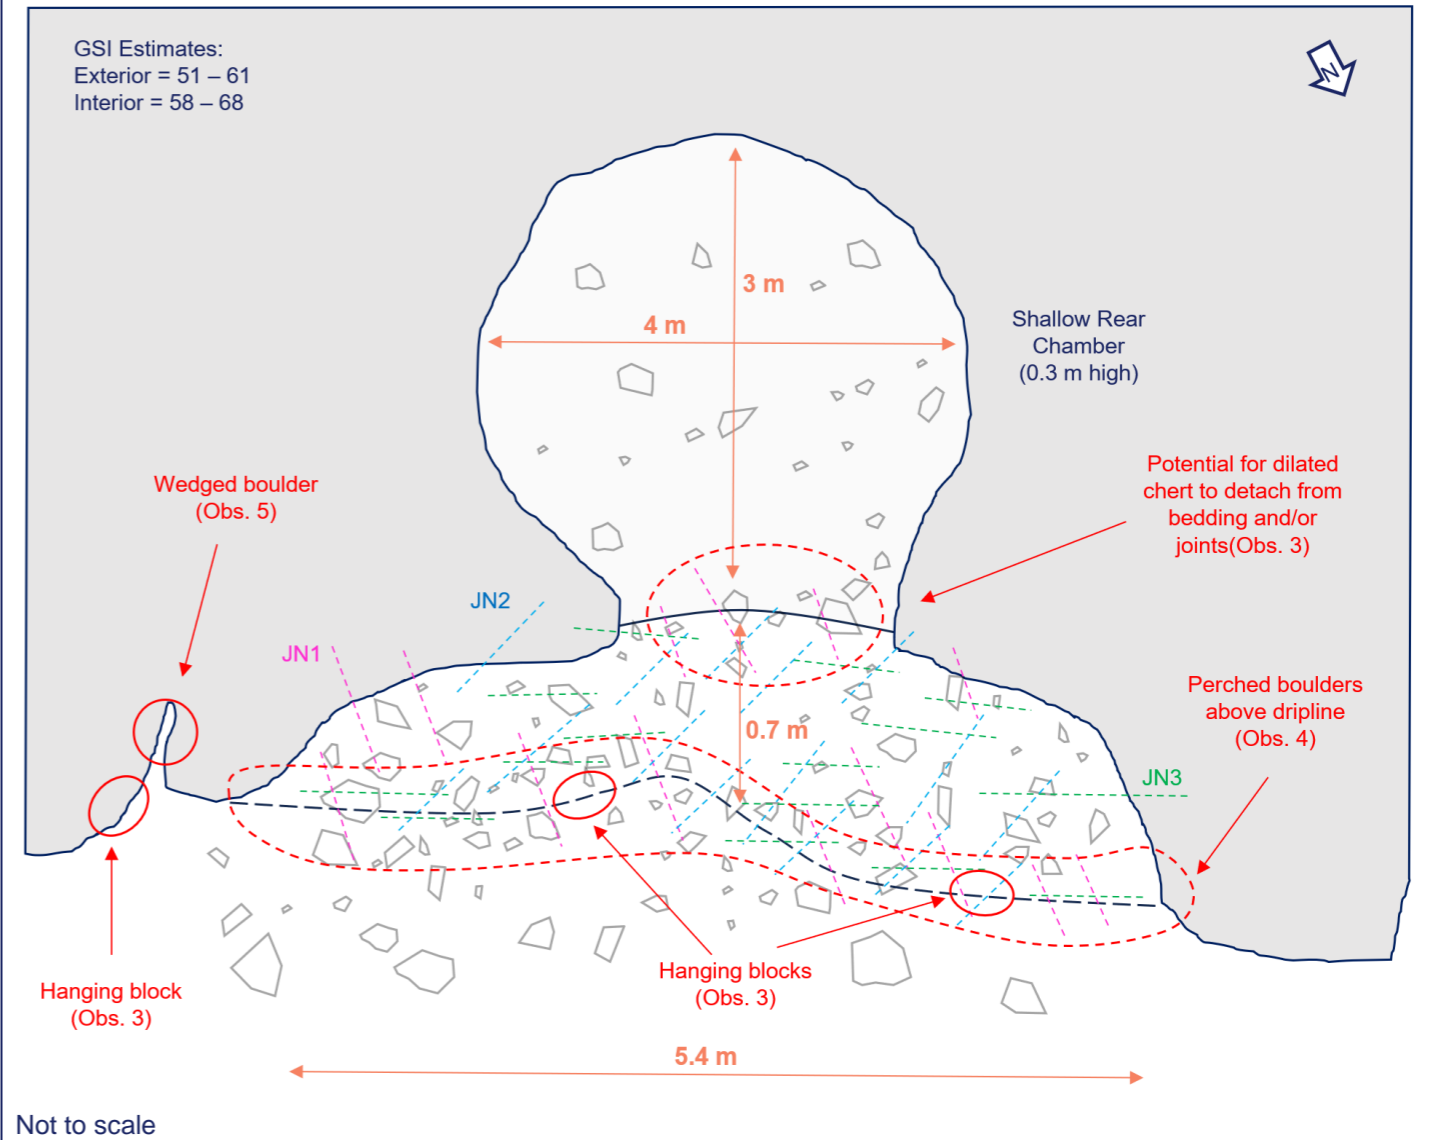
MEC061	<u>Overhang</u> – 5.4 m wide, 1.7 m deep, 0.6 m high <u>Rear Chamber</u> – 4 m wide, 3 m deep, 0.3 m high (approximate)	<u>GSI</u> Exterior 51 – 61 Interior 58 – 68 <u>RMR₈₉</u> Exterior 61 Interior 68	The rock mass comprises hydrated interbedded BIF and chert. The rock mass is highly weathered and has a medium to high intact strength. A thinly laminated siliceous shale band was observed above the cave entrance. The band is approximately 100 mm thick and appears to have been preferentially weathered. Bedding is well developed and is undulating with 1.5 to 3.5 m long partings that are open less than 1 mm. Some dilated partings around the entrance are open up to 4 mm. Partings are spaced variable between 0.15 and 0.4 m. Surfaces are typically slightly rough to rough and are iron stained. Bedding is partially overprinted in some areas of the escarpment due to hydration of the rock mass. Bedding was measured to dip shallowly to the southeast. Within the siliceous shale band, laminations are spaced at approximately 10 mm, though are not laterally persistent. Three major joint sets were identified: JN1 strikes into the cave and dips steeply to the west. The joint set has a spacing of 50 to 100 mm and is open over lengths of 0.2 to 0.5 m. JN2 also strikes into the cave, and dips steeply to the southeast. The joint set has a spacing of 50 to 300 mm and is open over lengths of 0.2 to 0.5 m JN3 strikes sub-parallel to the cave entrance and was measured to dip steeply to the northeast. The joint set is spaced between 100 and 200 mm and has an observable length of up to 1 m.	<ol style="list-style-type: none"> The siliceous shale band dips obliquely into the escarpment. Although not directly observed, there is potential for the shale band to intersect the rear chamber roof and for blocks to detach from the laminated band if it passes close enough to the cave roof. Observed preferential weathering of the siliceous shale band also has the potential to undermine the overlying escarpment. There is potential for blocks in the escarpment and cave roof to detach from bedding where cross cut by vertical joints. A 150 mm thick dilated chert band located at the access point to the rear chamber appears to be susceptible mechanism Hanging blocks bounded by open defects were observed in areas of the cave roof and dripline Perched boulders occur at the top of the escarpment in which the cave is situated Wedged boulders were observed in a crevasse on the southern side of the cave entrance 	<ul style="list-style-type: none"> Assess the area for any hanging blocks that may have detached from the cave roof, or for any perched boulders that have dropped from the escarpment above the entrance. Check for dilation of defects in the escarpment and cave roof before accessing the cave. Avoid spending time below the 150 mm thick dilated chert band just beyond the cave entrance. Check for further dilation or seepage along the dilated bedding partings and do not access if observed. Limit time spent immediately below the dripline where perched boulders are susceptible to falling, or loose hanging blocks have been identified.

Summary Sheet Cave ID	Approximate Dimensions	Estimated GSI Range and Typical RMR ₈₉	Rock Mass Description	Observed Hazards	Recommendations
MEC061	<p>Overhang – 5.4 m wide, 1.7 m deep, 0.6 m high</p> <p>Rear Chamber – 4 m wide, 3 m deep, 0.3 m high (approximate)</p>	<p>GSI Exterior 51 – 61 Interior 58 – 68</p> <p>RMR₈₉ Exterior 61 Interior 68</p>	<p>The rock mass comprises hydrated interbedded BIF and chert. The rock mass is highly weathered and has a medium to high intact strength. A thinly laminated siliceous shale band was observed above the cave entrance. The band is approximately 100 mm thick and appears to have been preferentially weathered. Bedding is well developed and is undulating with 1.5 to 3.5 m long partings that are open less than 1 mm. Some dilated partings around the entrance are open up to 4 mm. Partings are spaced variable between 0.15 and 0.4 m. Surfaces are typically slightly rough to rough and are iron stained. Bedding was measured to dip shallowly to the southeast. Within the siliceous shale band, laminations are spaced at approximately 10 mm, though are not laterally persistent. Three major joint sets were identified:</p> <p>JN1 strikes into the cave and dips steeply to the west. The joint set has a spacing of 50 to 100 mm and is open over lengths of 0.2 to 0.5 m.</p> <p>JN2 also strikes into the cave, and dips steeply to the southeast. The joint set has a spacing of 50 to 300 mm and is open over lengths of 0.2 to 0.5 m</p> <p>JN3 strikes sub-parallel to the cave entrance and was measured to dip steeply to the northeast. The joint set is spaced between 100 and 200 mm and has an observable length of up to 1 m.</p>	<ol style="list-style-type: none"> 1. The siliceous shale band dips obliquely into the escarpment. Although not directly observed, there is potential for the shale band to intersect the rear chamber roof and for blocks to detach from the laminated band if it passes close enough to the cave roof. Observed preferential weathering of the siliceous shale band also has the potential to undermine the overlying escarpment. 2. There is potential for blocks in the escarpment and cave roof to detach from bedding where cross cut by vertical joints. A 150 mm thick dilated chert band located at the access point to the rear chamber appears to be susceptible mechanism. 3. Hanging blocks bounded by open defects were observed in areas of the cave roof and dripline. 4. Perched boulders occur at the top of the escarpment in which the cave is situated. 5. Wedged boulders were observed in a crevasse on the southern side of the cave entrance. 	<ul style="list-style-type: none"> • Assess the area for any hanging blocks that may have detached from the cave roof, or for any perched boulders that have dropped from the escarpment above the entrance • Check for dilation of defects in the escarpment and cave roof before accessing the cave • Avoid spending time below the 150 mm thick dilated chert band just beyond the cave entrance. Check for further dilation or seepage along the dilated bedding partings and do not access if observed • Limit time spent immediately below the dripline where perched boulders are at risk of falling, or loose hanging blocks have been identified.
