Geotechnical Assessment of Bat Caves

Mulga Downs Iron Ore Project

PSM5194-007R REV3 18 December 2024

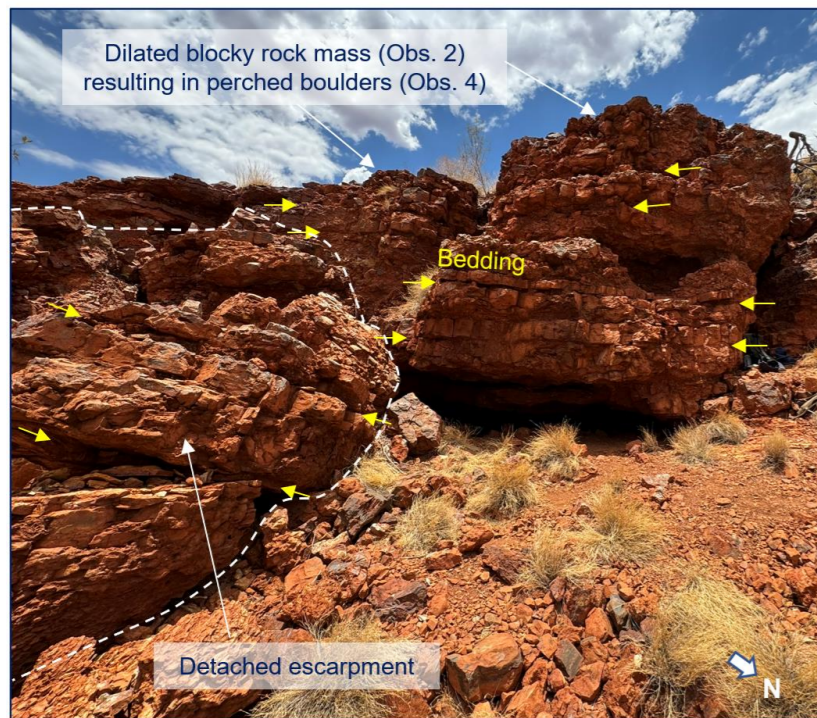
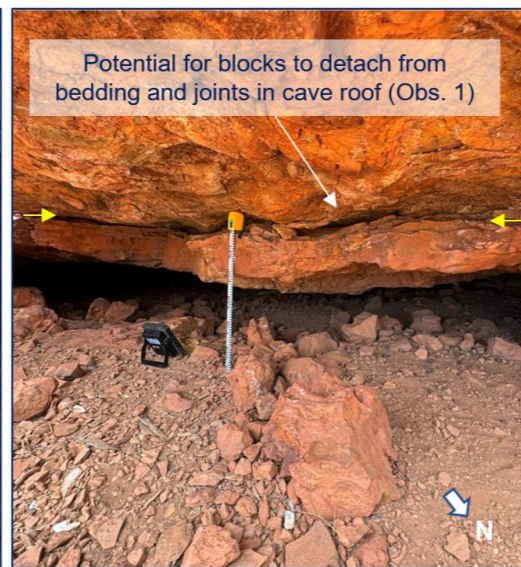
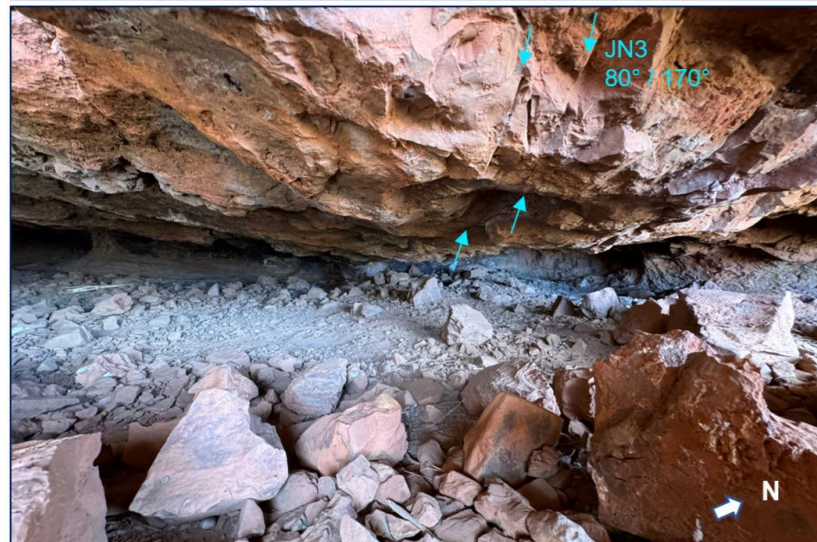
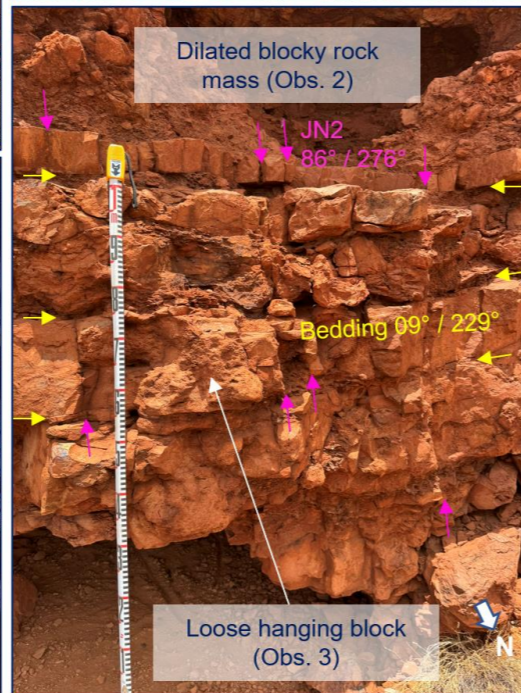
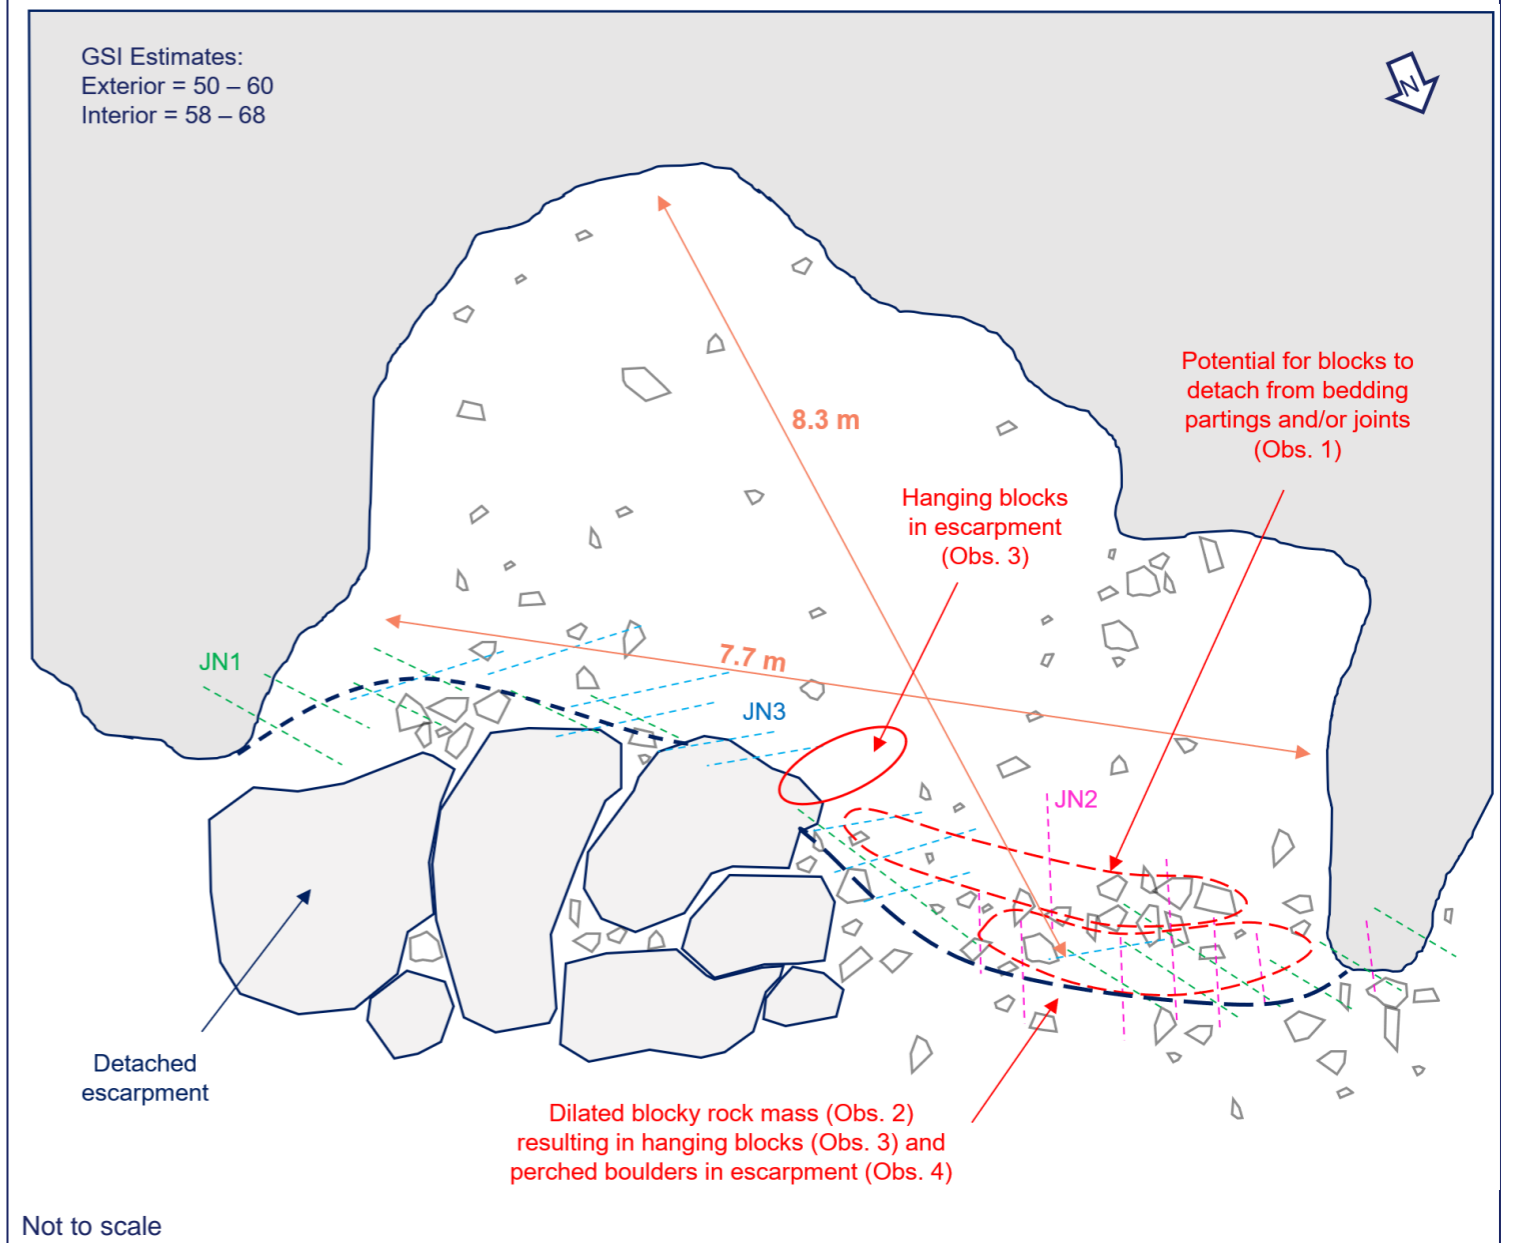
MEC060	<u>Main Chamber</u> – 7.7 m wide, 8.3 m deep, 0.7 m high	<u>GSI</u> Exterior 50 – 60 Interior 58 – 68 <u>RMR₈₉</u> Exterior 60 Interior 68	The rock mass at the cave comprises hydrated interbedded BIF and chert. The rock mass is highly weathered and has a medium to high intact strength. The rock mass appears blocky due to multiple intersecting joint sets and bedding partings. Bedding is well developed with partings were commonly observed on the upper and lower contacts of interbedded chert bands. Bedding dips shallowly to the southwest and is undulating. Partings are typically 1 to 4 m in length and are spaced between 70 and 300 mm. Three joint sets were identified: JN1 strikes obliquely to the cave entrance, dipping steeply to the south-southwest. JN1 has an observable length of 0.2 to 0.9 m and a spacing of 100 to 200 mm, Inset 17. JN2 dips steeply to the west. It has relatively short defect lengths between 150 and 500 mm. JN2 is best preserved in the escarpment and areas around the entrance where it was observed to have a spacing of 100 to 300 mm. JN3 strikes parallel to the escarpment and was only observed on the eastern side of the cave. JN3 dips steeply to the south,	<ol style="list-style-type: none"> There is potential for slabs of hydrated BIF and chert to detach from bedding and/or joints in the cave roof The rock mass in the escarpment is loose and dilated in parts. This a potential source for future rockfall as evidenced in past rockfall product on the cave exterior. Hanging blocks bounded by dilated bedding partings and joints were observed in the dripline above the cave entrance Perched boulders were observed along the top of the escarpment in which the cave is hosted. Some tabular boulders appear to have become perched due to continual weathering of the dilated blocky rock mass. 	<ul style="list-style-type: none"> Assess the identified hanging blocks and the BIF slab at the entrance for dilation of bedding partings and joint structures that bound the them. Before approaching the cave, assess the top of the escarpment for perched boulders that may be at risk of falling. Check the area below the dripline for fresh rockfall. Limit time spent at the escarpment face where loose dilated rock mass has been identified. Avoid leaning or sitting below these areas.

Summary Sheet Cave ID	Approximate Dimensions	Estimated GSI Range and Typical RMR ₈₉	Rock Mass Description	Observed Hazards	Recommendations
MEC060	Main Chamber – 7.7 m wide, 8.3 m deep, 0.7 m high	<p>GSI Exterior 50 – 60 Interior 58 – 68</p> <p>RMR₈₉ Exterior 60 Interior 68</p>	<p>The rock mass at the cave comprises hydrated interbedded BIF and chert. The rock mass is highly weathered and has a medium to high intact strength. The rock mass appears blocky due to multiple intersecting joint sets and bedding partings.</p> <p>Bedding is well developed with partings were commonly observed on the upper and lower contacts of interbedded chert bands. Bedding dips shallowly to the southwest and is undulating. Partings are typically 1 to 4 m in length and are spaced between 70 and 300 mm. Three joint sets were identified:</p> <p>JN1 strikes obliquely to the cave entrance, dipping steeply to the south-southwest. JN1 has an observable length of 0.2 to 0.9 m and a spacing of 100 to 200 mm, Inset 17.</p> <p>JN2 dips steeply to the west. It has relatively short defect lengths between 150 and 500 mm. JN2 is best preserved in the escarpment and areas around the entrance where it was observed to have a spacing of 100 to 300 mm.</p> <p>JN3 strikes parallel to the escarpment and was only observed on the eastern side of the cave. JN3 dips steeply to the south,</p>	<ol style="list-style-type: none"> 1. There is potential for slabs of hydrated BIF and chert to detach from bedding and/or joints in the cave roof. 2. The rock mass in the escarpment is loose and dilated in parts. This a potential source for future rockfall as evidenced in past rockfall product on the cave exterior. 3. Hanging blocks bounded by dilated bedding partings and joints were observed in the dripline above the cave entrance. 4. Perched boulders were observed along the top of the escarpment in which the cave is hosted. Some tabular boulders appear to have become perched due to continual weathering of the dilated blocky rock mass. 	<ul style="list-style-type: none"> • Assess the identified hanging blocks and the BIF slab at the entrance for dilation of bedding partings and joint structures that bound them • Before approaching the cave, assess the top of the escarpment for perched boulders that may be at risk of falling. Check the area below the dripline for fresh rockfall • Limit time spent at the escarpment face where loose dilated rock mass has been identified. Avoid leaning or sitting below these areas.

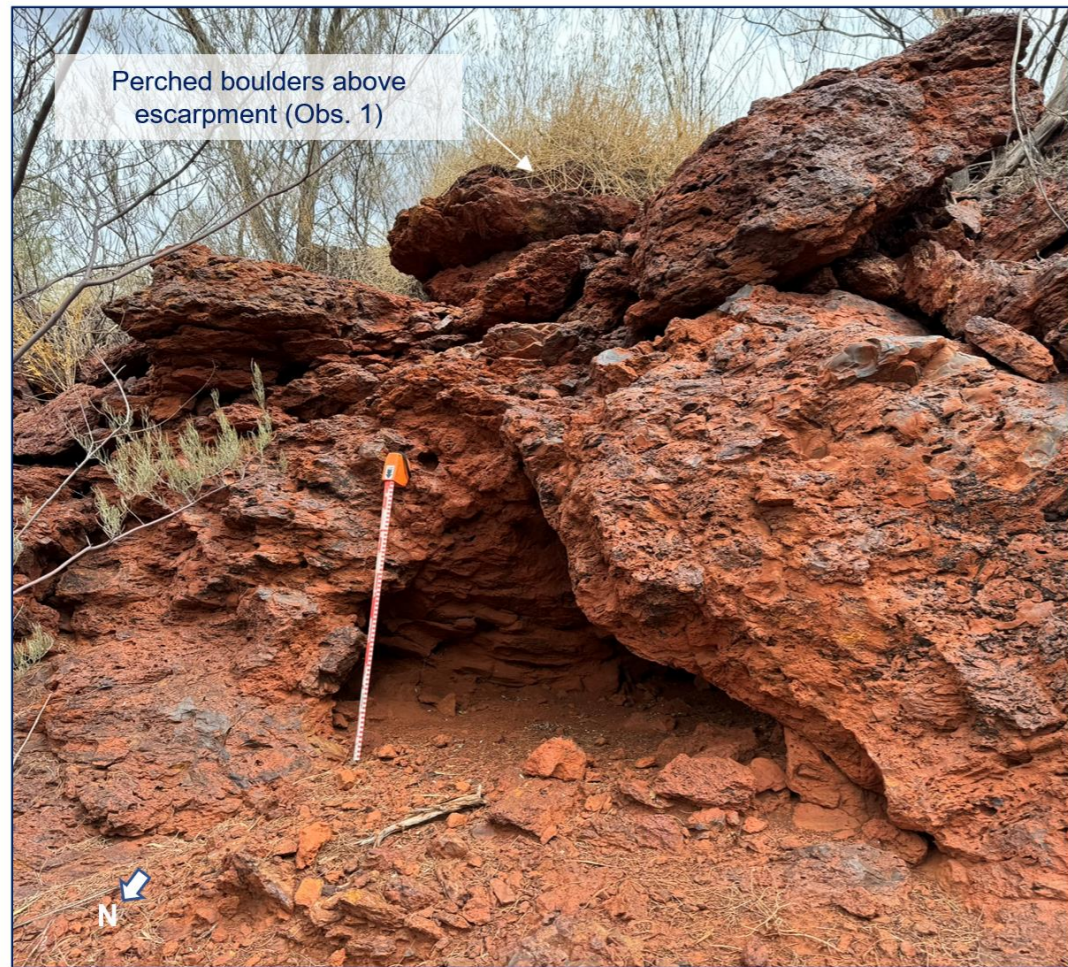
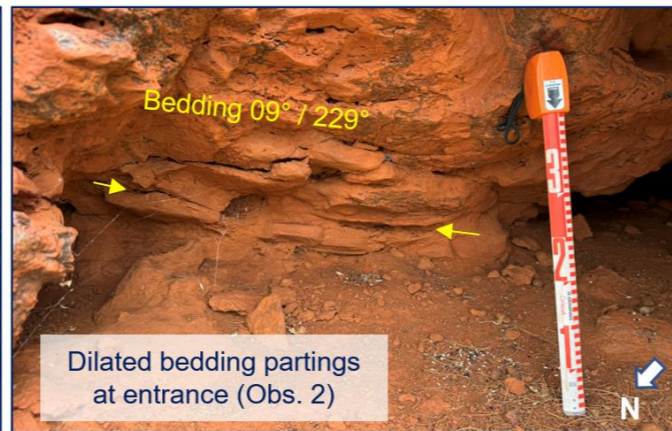
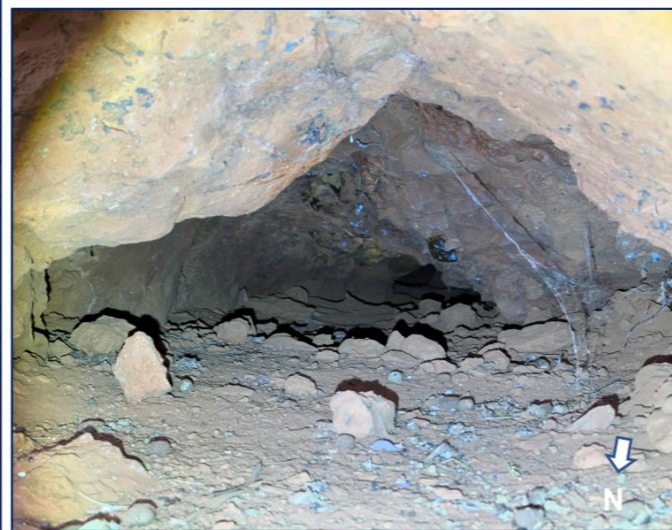
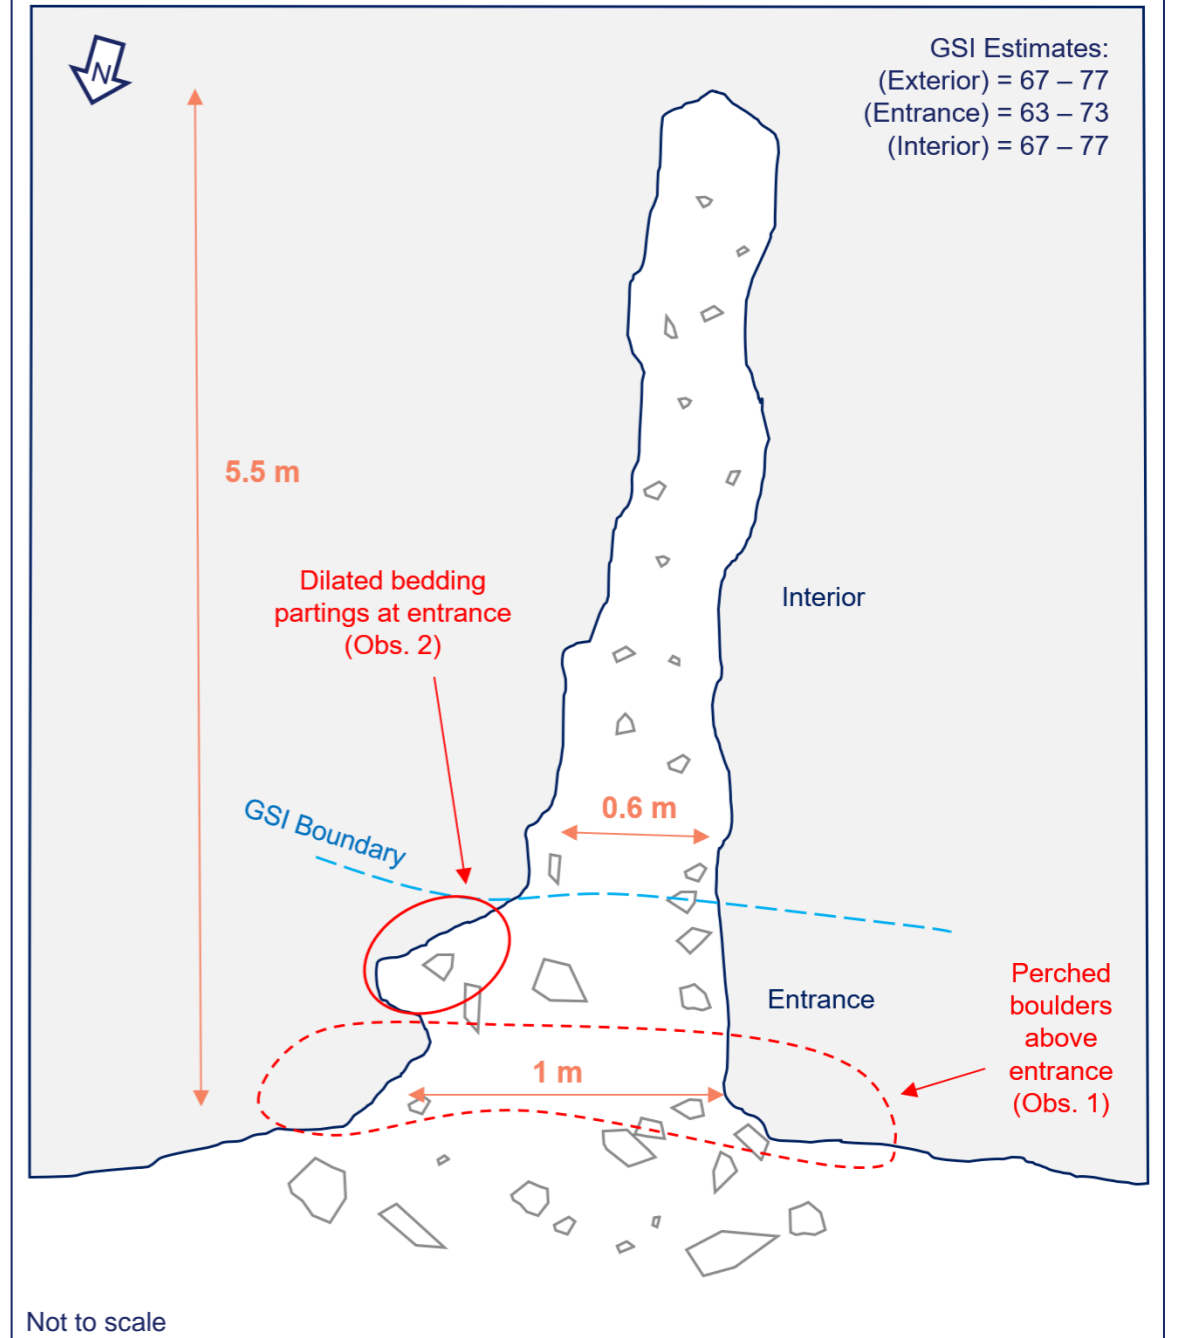
MEC072	<u>Entrance</u> – 1 m wide, 0.6 m high <u>Interior</u> – 0.6 m wide, 5.5 m deep, 0.4 m high	<u>GSI</u> Exterior 67 – 77 Entrance 63 – 73 Interior 67 – 77 <u>RMR₈₉</u> Exterior 77 Entrance 73 Interior 77	The rock mas at the cave comprises hydrated, highly weathered BIF. The intact strength is high to very high. Bedding is developed and elongate vughs were observed on the exterior oriented parallel to bedding. Bedding dips shallowly to the southeast with partings that are undulating and up to 0.5 m long. The partings are spaced at 60 to 200 mm and have surfaces that are slightly rough to trough. They are tight to open less than 1 mm. Bedding appears to become overprinted deeper into the cave. No structurally significant joint sets were identified.	<ol style="list-style-type: none"> Perched boulders are situated above the cave entrance There is potential for blocks to detach from bedding where partings are developed around the entrance. If blocks detach they are likely not going to restrict access for bats in to the cave 	<ul style="list-style-type: none"> Before accessing the cave, assess the perched blocks above the entrance that have the potential to fall and check for any fresh rockfall and on the ground.

Summary Sheet Cave ID	Approximate Dimensions	Estimated GSI Range and Typical RMR ₈₉	Rock Mass Description	Observed Hazards	Recommendations
MEC072	<p><u>Entrance</u> – 1 m wide, 0.6 m high</p> <p><u>Interior</u> – 0.6 m wide, 5.5 m deep, 0.4 m high</p>	<p><u>GSI</u></p> <p>Exterior 67 – 77 Entrance 63 – 73 Interior 67 – 77</p> <p><u>RMR₈₉</u></p> <p>Exterior 77 Entrance 73 Interior 77</p>	<p>The rock mass at the cave comprises hydrated, highly weathered BIF. The intact strength is high to very high. Bedding is developed and elongate vugs were observed on the exterior oriented parallel to bedding. Bedding dips shallowly to the southeast with partings that are undulating and up to 0.5 m long. The partings are spaced at 60 to 200 mm and have surfaces that are slightly rough to trough. They are tight to open less than 1 mm. Bedding appears to become overprinted deeper into the cave. No structurally significant joint sets were identified.</p>	<ol style="list-style-type: none"> Perched boulders are situated above the cave entrance. There is potential for blocks to detach from bedding where partings are developed around the entrance. If blocks detach they are likely not going to restrict access for bats in to the cave. 	<ul style="list-style-type: none"> Before accessing the cave, assess the perched blocks above the entrance that have the potential to fall and check for any fresh rockfall and on the ground.

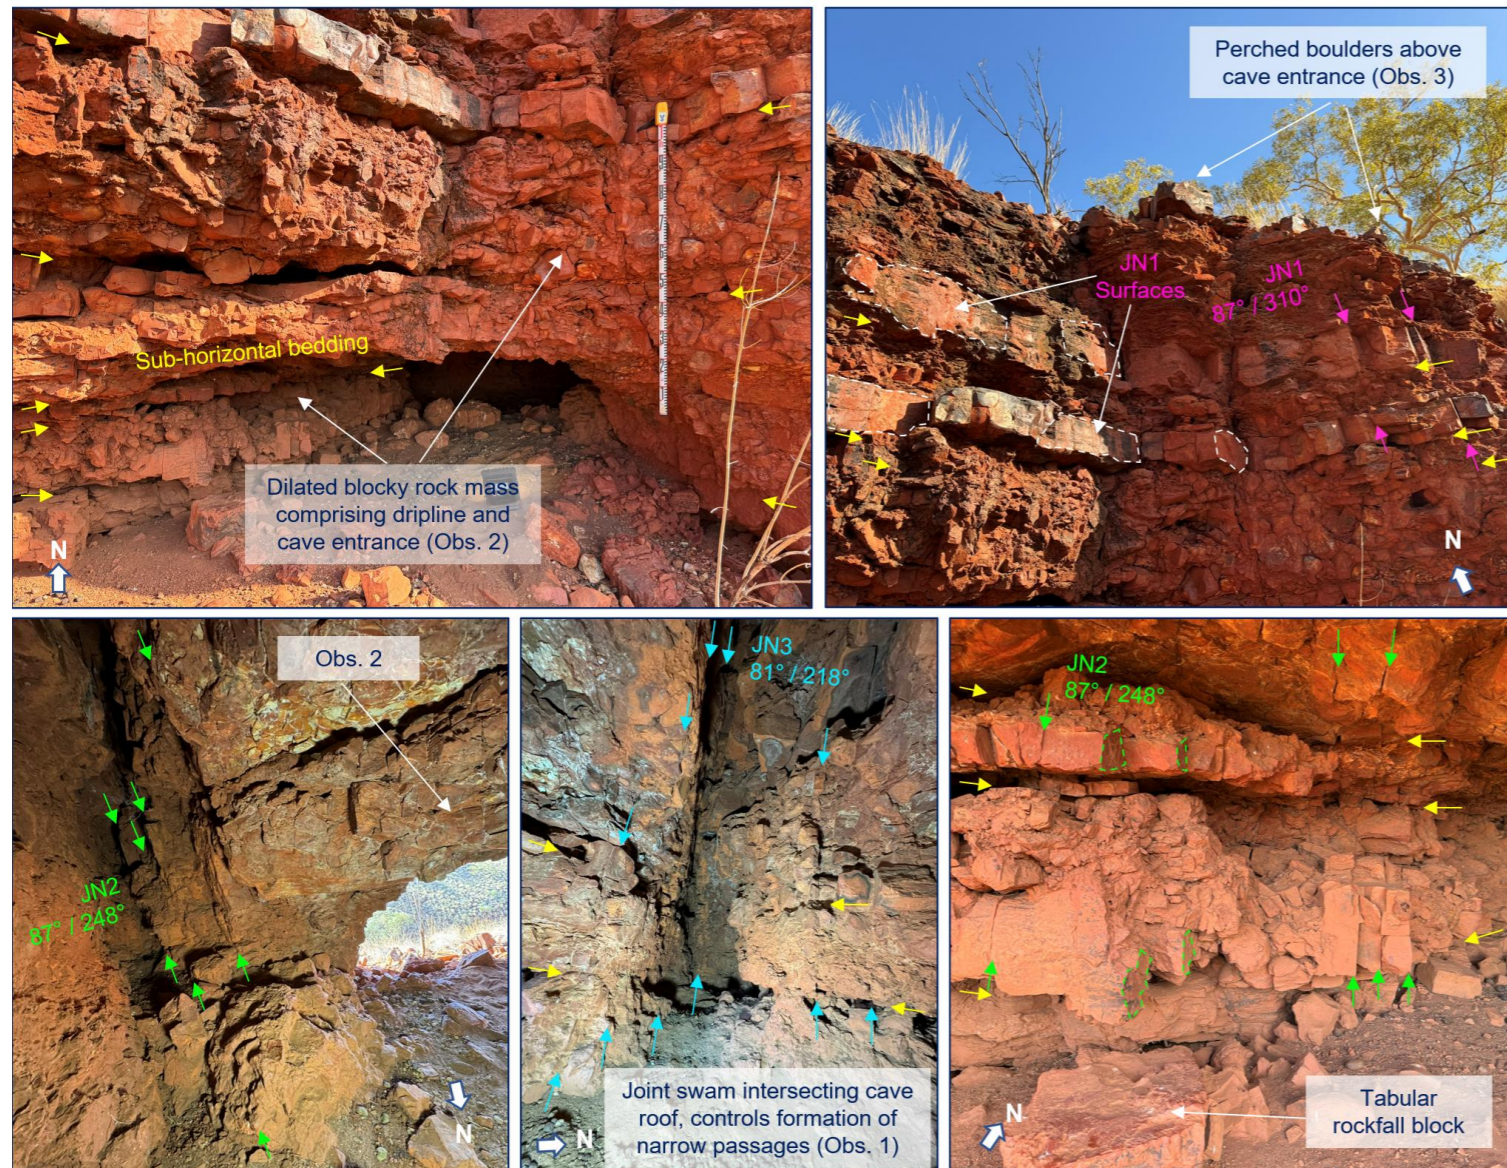
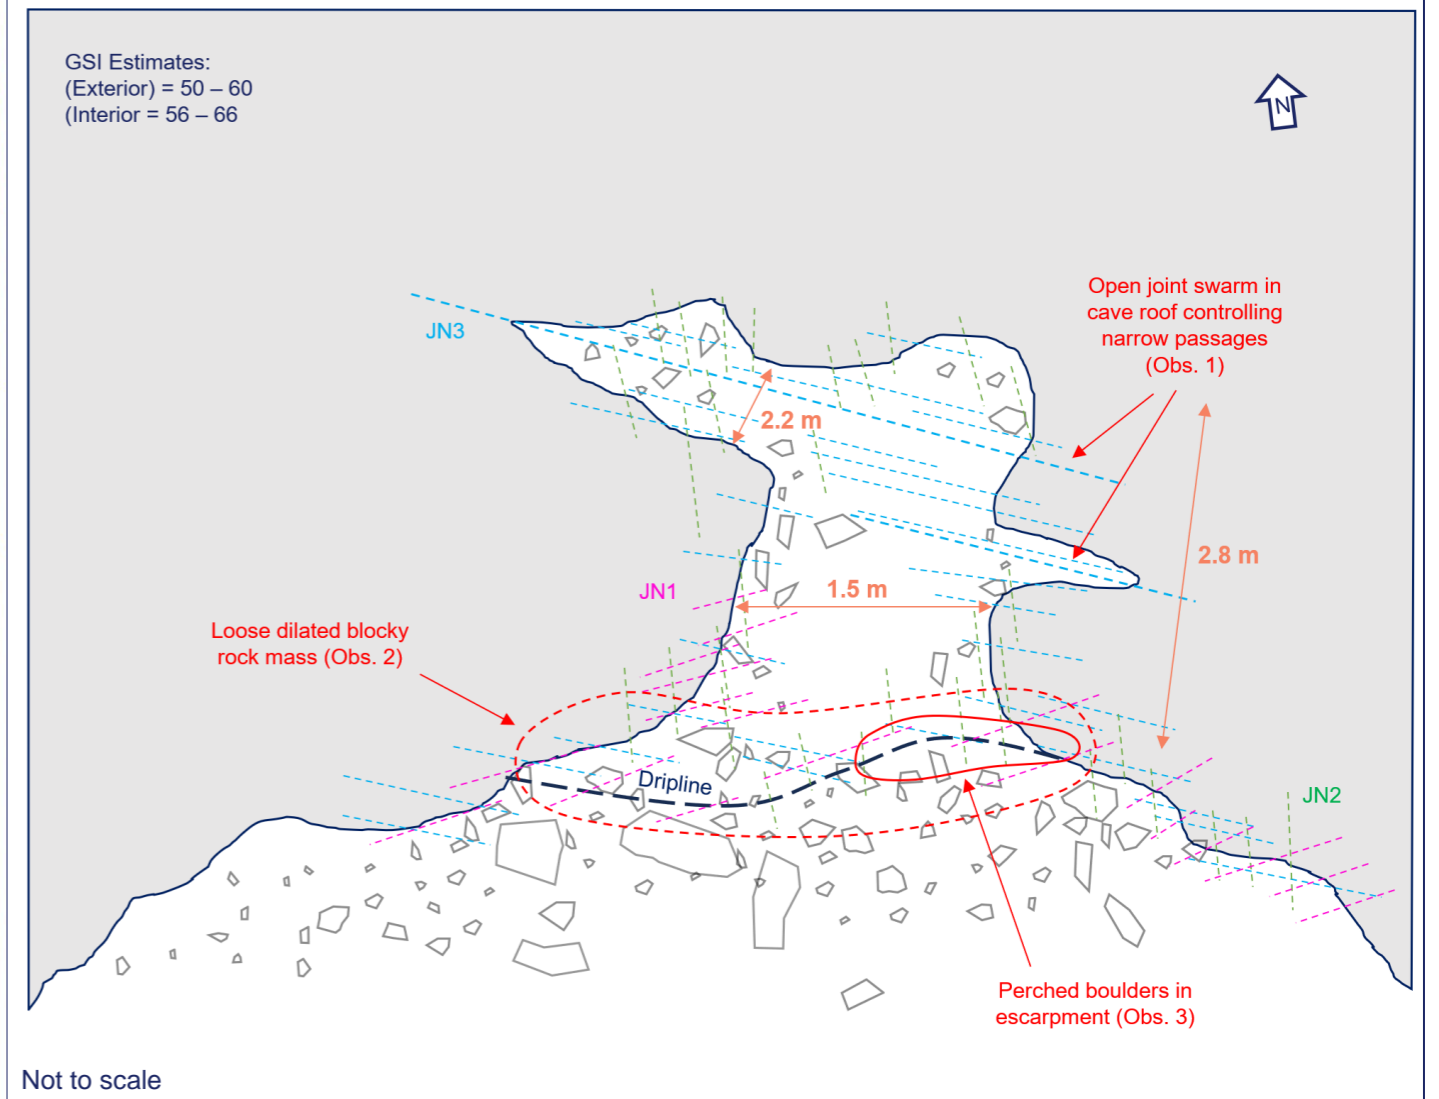
MEC049	<u>Interior</u> – 1.5m wide, 2.8 m deep, and 0.8 m high (up to 2 m high at rear)	<u>GSI</u> Exterior 50 – 60 Interior 56 – 66	The rock mass comprises partially hydrated interbedded chert and BIF. It is highly weathered and typically has a high to very high intact strength. In some areas around the entrance, medium strength was observed. The rock mass is generally blocky and dilated.	<ol style="list-style-type: none"> A dilated joint swarm along joint set 3 orientation was observed to control cave development at the back of the interior chamber. 	<ul style="list-style-type: none"> Before accessing the cave, assess the perched blocks above the entrance that have the potential to fall and check for any fresh rockfall and on the ground.

Summary Sheet Cave ID	Approximate Dimensions	Estimated GSI Range and Typical RMR ₈₉	Rock Mass Description	Observed Hazards	Recommendations
MEC049	Interior – 1.5m wide, 2.8 m deep, and 0.8 m high (up to 2 m high at rear)	<p>GSI</p> <p>Exterior 50 – 60 Interior 56 – 66</p> <p>RMR₈₉</p> <p>Exterior 60 Interior 66</p>	<p>The rock mass comprises partially hydrated interbedded chert and BIF. It is highly weathered and typically has a high to very high intact strength. In some areas around the entrance, medium strength was observed. The rock mass is generally blocky and dilated.</p> <p>Bedding is well developed with partings 2 to 6 m long observed throughout the cave and surrounding escarpment. Partings are typically undulating and oriented sub-horizontally. They are open up to 4 mm in places but typically have an aperture of approximately 1 mm with an iron veneer infill. Partings are spaced at 100 to 300 mm and have rough surfaces. Three joint sets were observed:</p> <p>JN1 dips steeply to the northwest and has an observable length of 1 to 3 m. The set is spaced at 100 to 200. JN1 was only observed in the escarpment and around the entrance of the cave.</p> <p>JN2 dips steeply to the west-southwest. Joints along this orientation are relatively short with lengths between 0.1 and 0.4 m. JN2 has a spacing of 40 to 120 mm.</p> <p>JN3 dips steeply to the southwest and is generally spaced between 0.1 and 0.3 m. Two large open structures along this orientation occur at the back of the interior chamber resulting roof profiles up to 2 m high. At the back of the main chamber, JN3 is up to 3 m long and spaced at 50 mm proximal to the joint swarm.</p>	<ol style="list-style-type: none"> 1. A dilated joint swarm along joint set 3 orientation was observed to control cave development at the back of the interior chamber. 2. Loose dilated blocky rock mass was observed in the escarpment above and adjacent to the cave, and also in areas around the cave entrance. 3. Perched boulders are situated atop the escarpment. 	<ul style="list-style-type: none"> • Before accessing the cave, assess the perched blocks above the entrance that have the potential to fall and check for any fresh rockfall and on the ground • Limit time spent immediately below the dripline where there is potential for blocks to detach from the dilated blocky rock mass. Avoid leaning on these areas when accessing the cave • Check for dilation of defects in the escarpment and cave roof before accessing the cave • Inside the cave, check for seepage along the dilated joint structures. Do not continue to access the cave if water is observed.

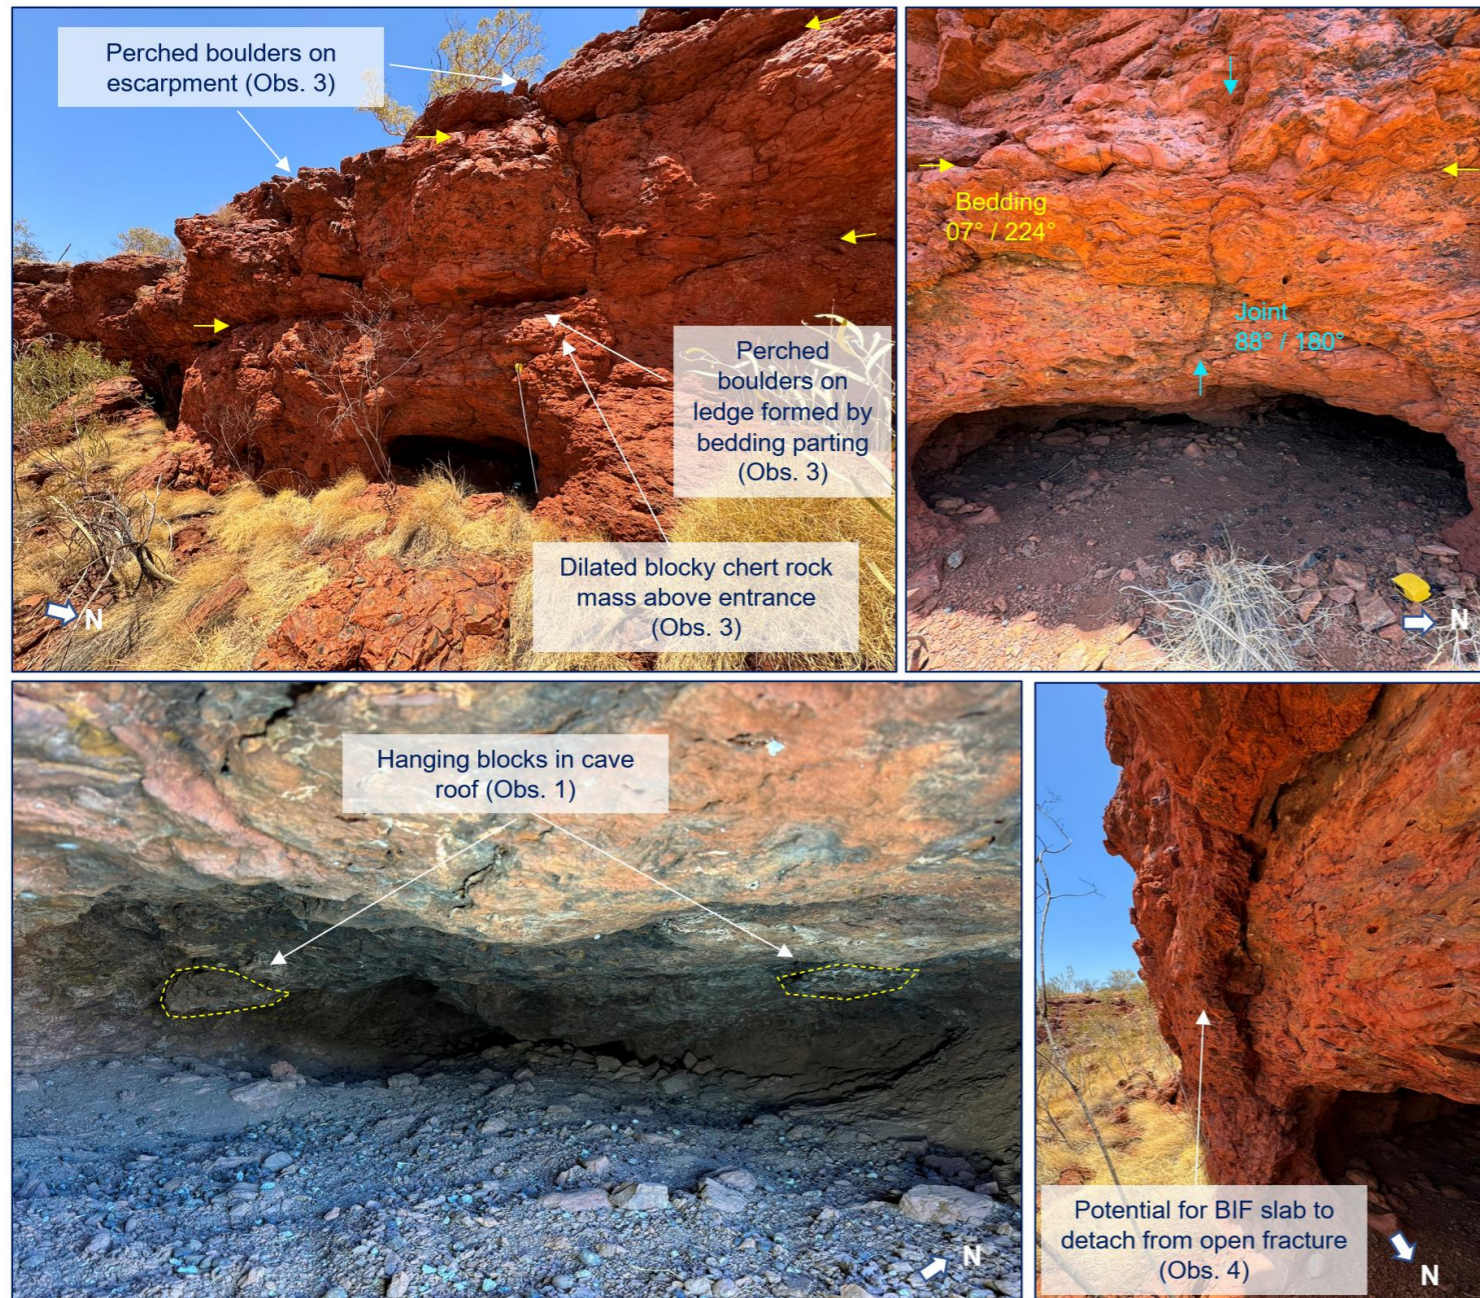
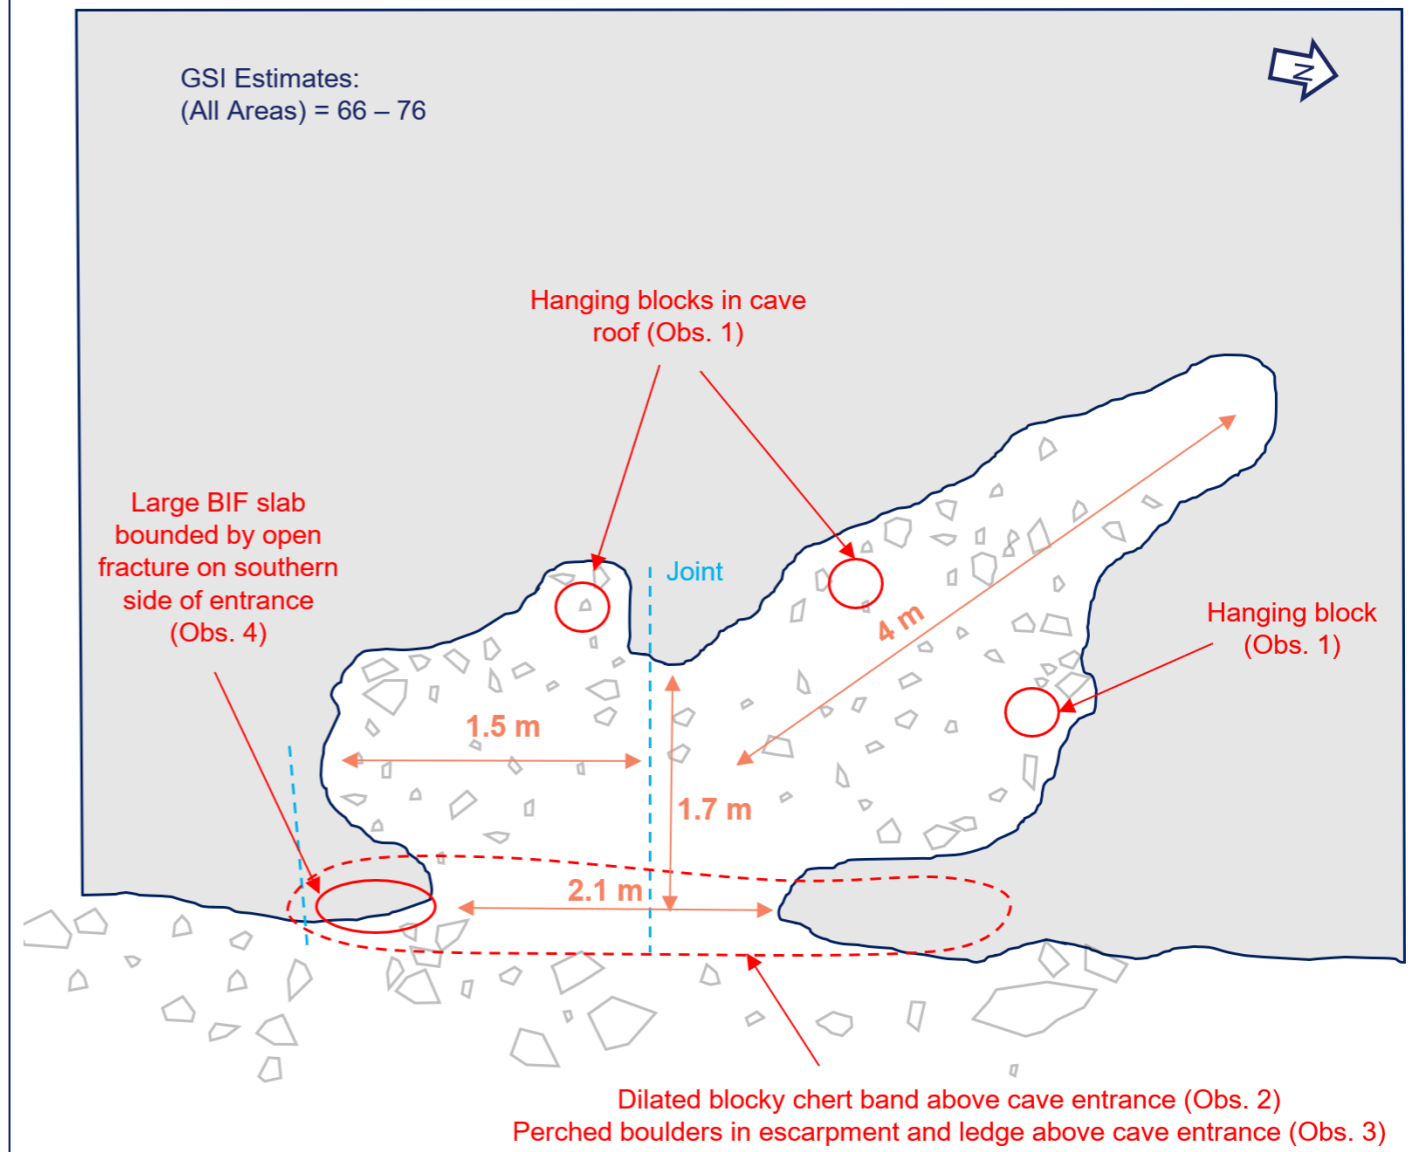
MEC025	<p><u>Entrance</u> – 2.1 m wide and 6 m high</p> <p><u>Interior</u> – 5.5 m wide, 1.7 m deep, 0.5 m high</p>	<p>GSI All Areas 66 – 76</p> <p>RMR₈₉ All Areas 76</p>	<p>Rock mass at the cave comprises interbedded hydrated BIF and chert. The cave itself is hosted within the hydrated BIF which makes up the lower part of the exposed escarpment, with blocky chert bands observed in the escarpment above the cave. The rock mass is high strength, with elongate vughs oriented parallel to BIF bedding. Bedding dips shallowly to the southwest and does not form structurally significant partings at the cave level, however, partings do persist in the rock above the cave along the contacts of interbedded chert bands. Above the cave, partings are 1 to 6 m long and spaced between 200 and 400 mm.</p> <p>A single joint set was observed at the cave. The joints are oriented sub-vertical and strike east-west. Only two open joints were observed along this orientation, indicating a spacing of approximately 2 m and lengths up to 1.7 m.</p>	<ol style="list-style-type: none"> Hanging blocks bounded by open fractures were observed in the cave roof inside the cave. Blocky chert bands occur in the escarpment above the cave entrance, and have the potential to release dilated blocks from the escarpment face. Perched boulders were observed along the top of the escarpment in which the cave is situated A large BIF slab is bounded by an open fracture on the southern side of the cave entrance. 	<ul style="list-style-type: none"> Before approaching the cave, assess the area for any fresh rockfall and loose blocks that may have formed in the blocky chert escarpment Check the escarpment above the cave for perched boulders when traversing the cave dripline Avoid leaning on or sitting below the large BIF slab on the southern side of the cave entrance Assess the identified hanging BIF blocks inside the cave for dilation of bounding fractures and for signs of detachment.

Summary Sheet Cave ID	Approximate Dimensions	Estimated GSI Range and Typical RMR ₈₉	Rock Mass Description	Observed Hazards	Recommendations
MEC025	<p>Entrance – 2.1 m wide and 6 m high</p> <p>Interior – 5.5 m wide, 1.7 m deep, 0.5 m high</p>	<p>GSI All Areas 66 – 76</p> <p>RMR₈₉ All Areas 76</p>	<p>Rock mass at the cave comprises interbedded hydrated BIF and chert. The cave itself is hosted within the hydrated BIF which makes up the lower part of the exposed escarpment, with blocky chert bands observed in the escarpment above the cave. The rock mass is high strength, with elongate vughs oriented parallel to BIF bedding. Bedding dips shallowly to the southwest and does not form structurally significant partings at the cave level, however, partings do persist in the rock above the cave along the contacts of interbedded chert bands. Above the cave, partings are 1 to 6 m long and spaced between 200 and 400 mm. A single joint set was observed at the cave. The joints are oriented sub-vertical and strike east-west. Only two open joints were observed along this orientation, indicating a spacing of approximately 2 m and lengths up to 1.7 m.</p>	<ol style="list-style-type: none"> 1. Hanging blocks bounded by open fractures were observed in the cave roof inside the cave. 2. Blocky chert bands occur in the escarpment above the cave entrance, and have the potential to release dilated blocks from the escarpment face. 3. Perched boulders were observed along the top of the escarpment in which the cave is situated. 4. A large BIF slab is bounded by an open fracture on the southern side of the cave entrance. 	<ul style="list-style-type: none"> • Before approaching the cave, assess the area for any fresh rockfall and loose blocks that may have formed in the blocky chert escarpment • Check the escarpment above the cave for perched boulders when traversing the cave dripline • Avoid leaning on or sitting below the large BIF slab on the southern side of the cave entrance • Assess the identified hanging BIF blocks inside the cave for dilation of bounding fractures and for signs of detachment.

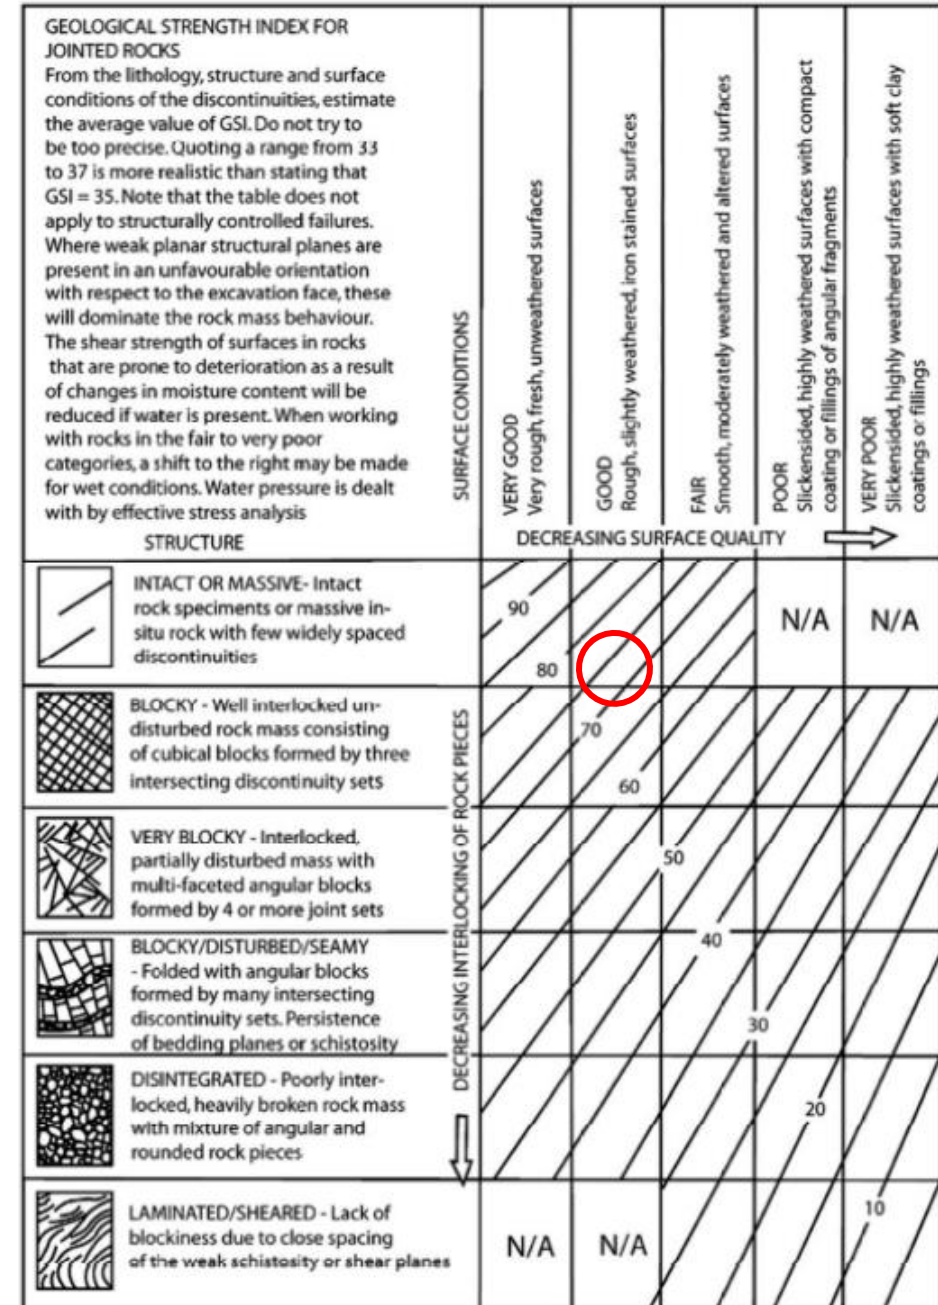
GSI Estimates MEC042

Area	GSI Range	GSI Best Estimate	Equivalent RMR89
All	68 – 78	73	78

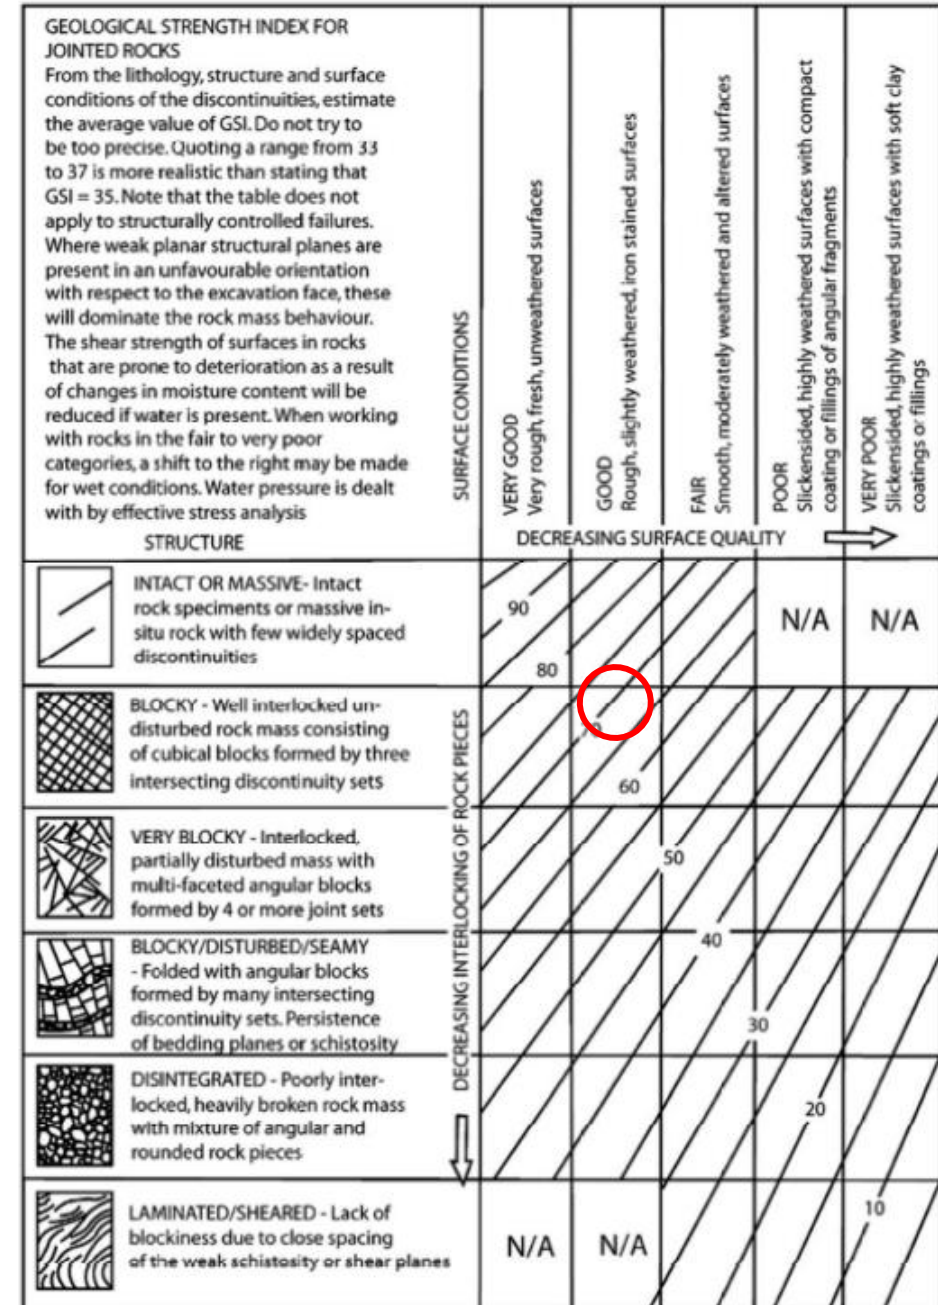
GSI Estimates MEC014

Area	GSI Range	GSI Best Estimate	Equivalent RMR89
All	65 – 75	70	75

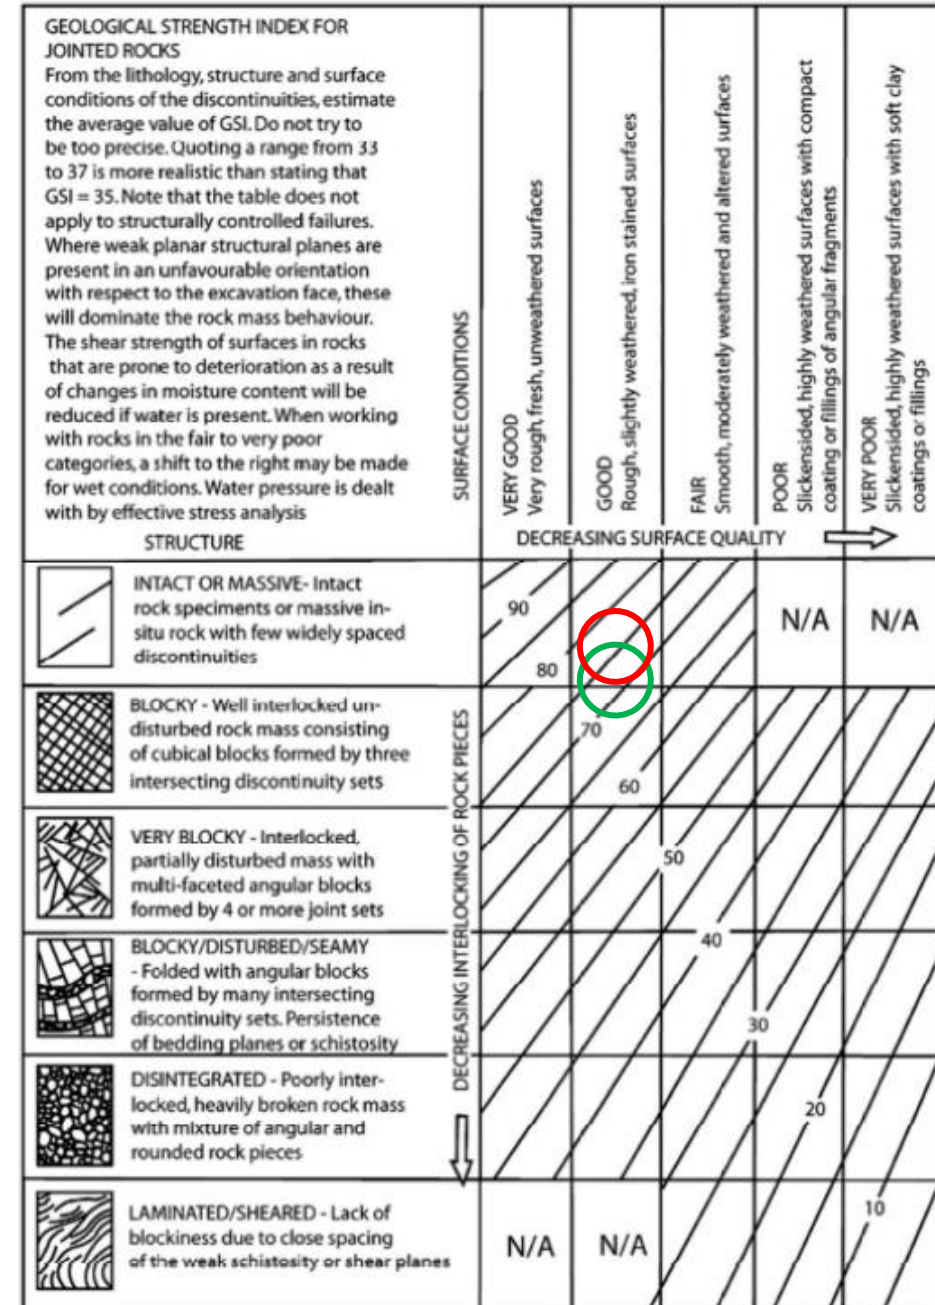
GSI Estimates MEC013

Area	GSI Range	GSI Best Estimate	Equivalent RMR89
Exterior	70 – 80	75	80
Interior	67 – 77	72	77

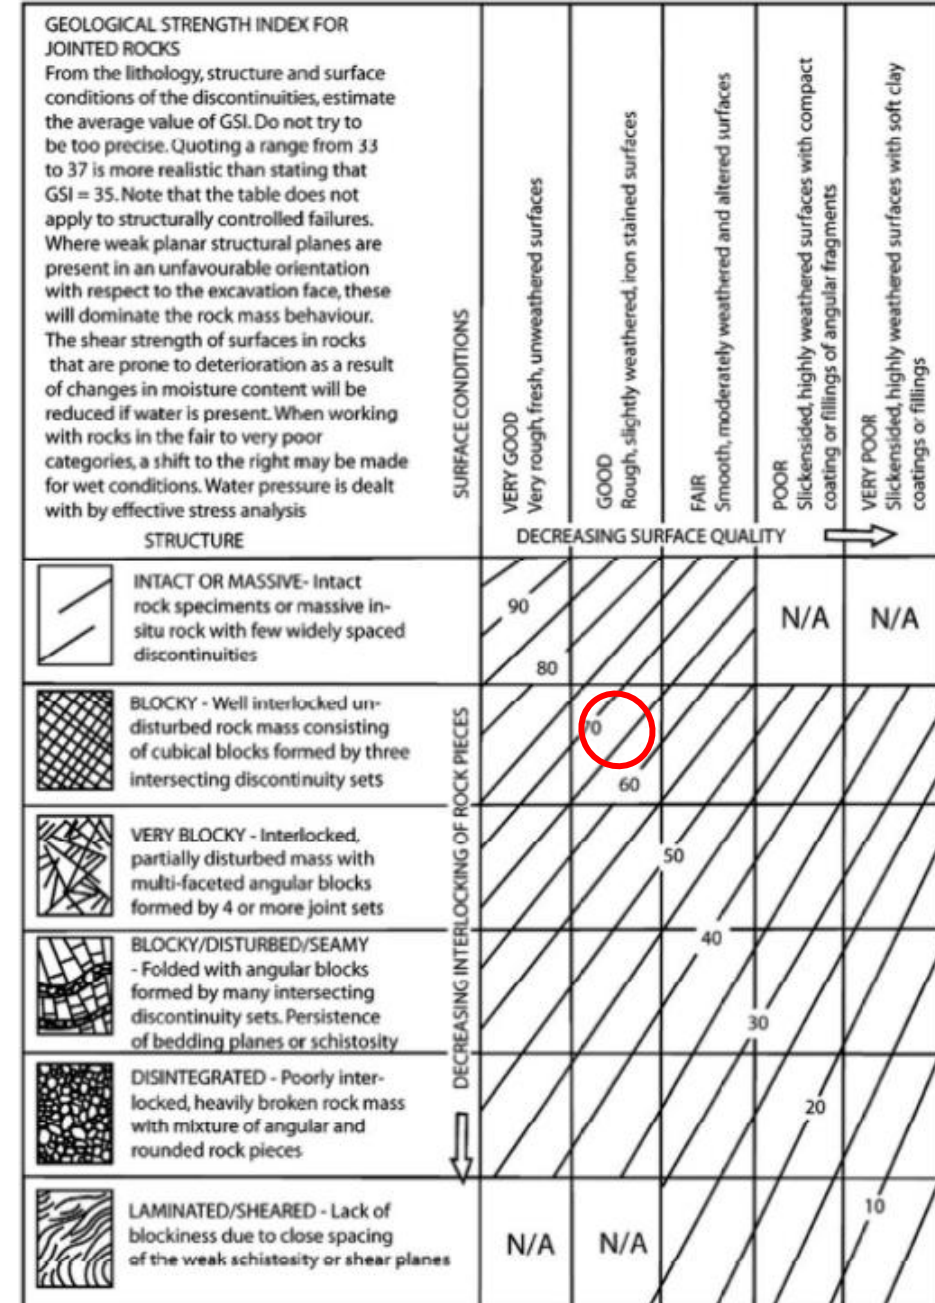
GSI Estimates MEC012

Area	GSI Range	GSI Best Estimate	Equivalent RMR89
All	62 – 72	67	72
