Geotechnical Assessment of Bat Caves

Mulga Downs Iron Ore Project

PSM5194-007R REV3 18 December 2024

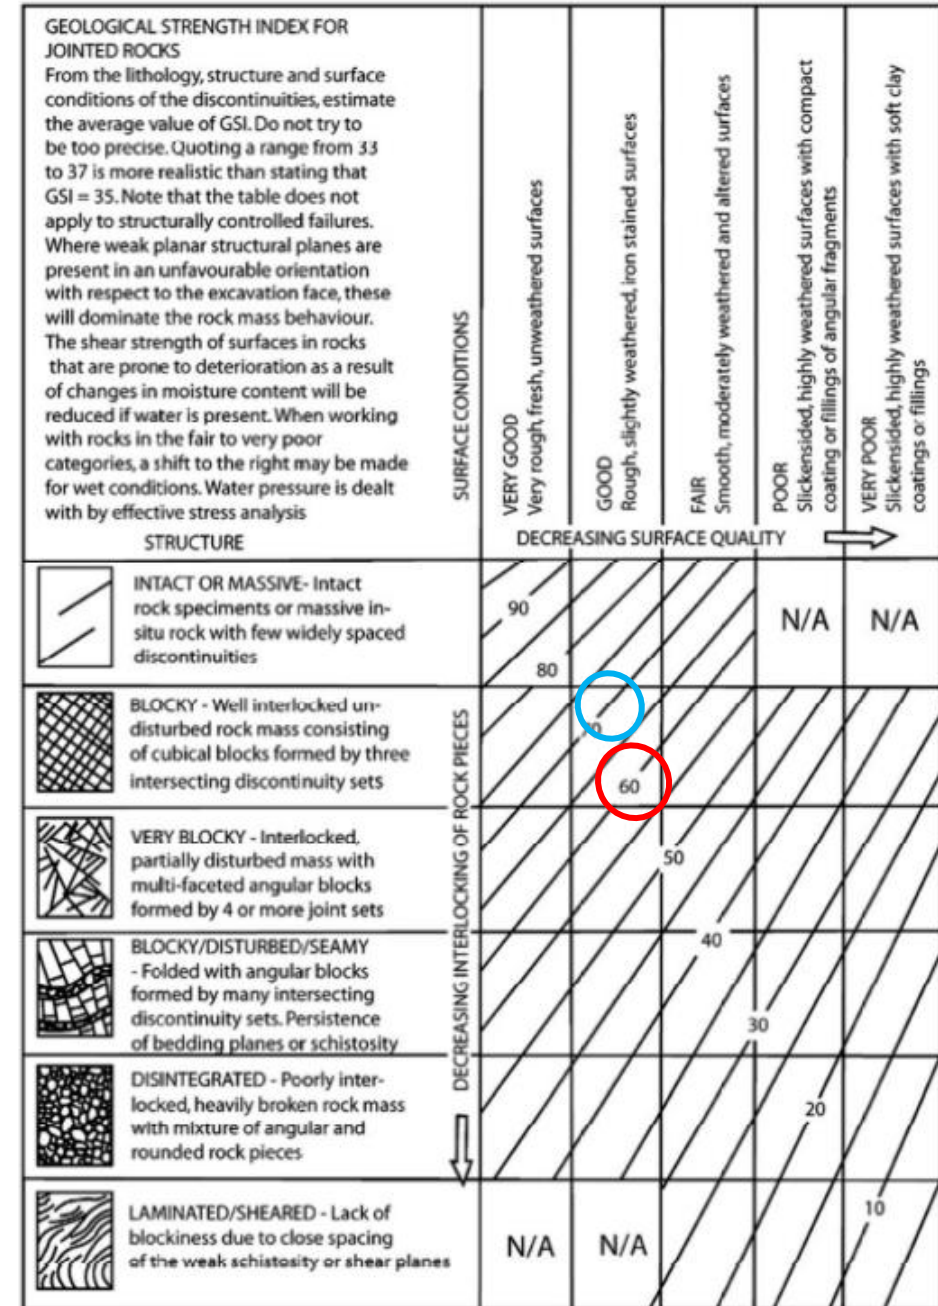
GSI Estimates MEC074

Area	GSI Range	GSI Best Estimate	Equivalent RMR89
Exterior and Overhang	55 – 65	60	65
Rear Chamber	65 – 75	70	75

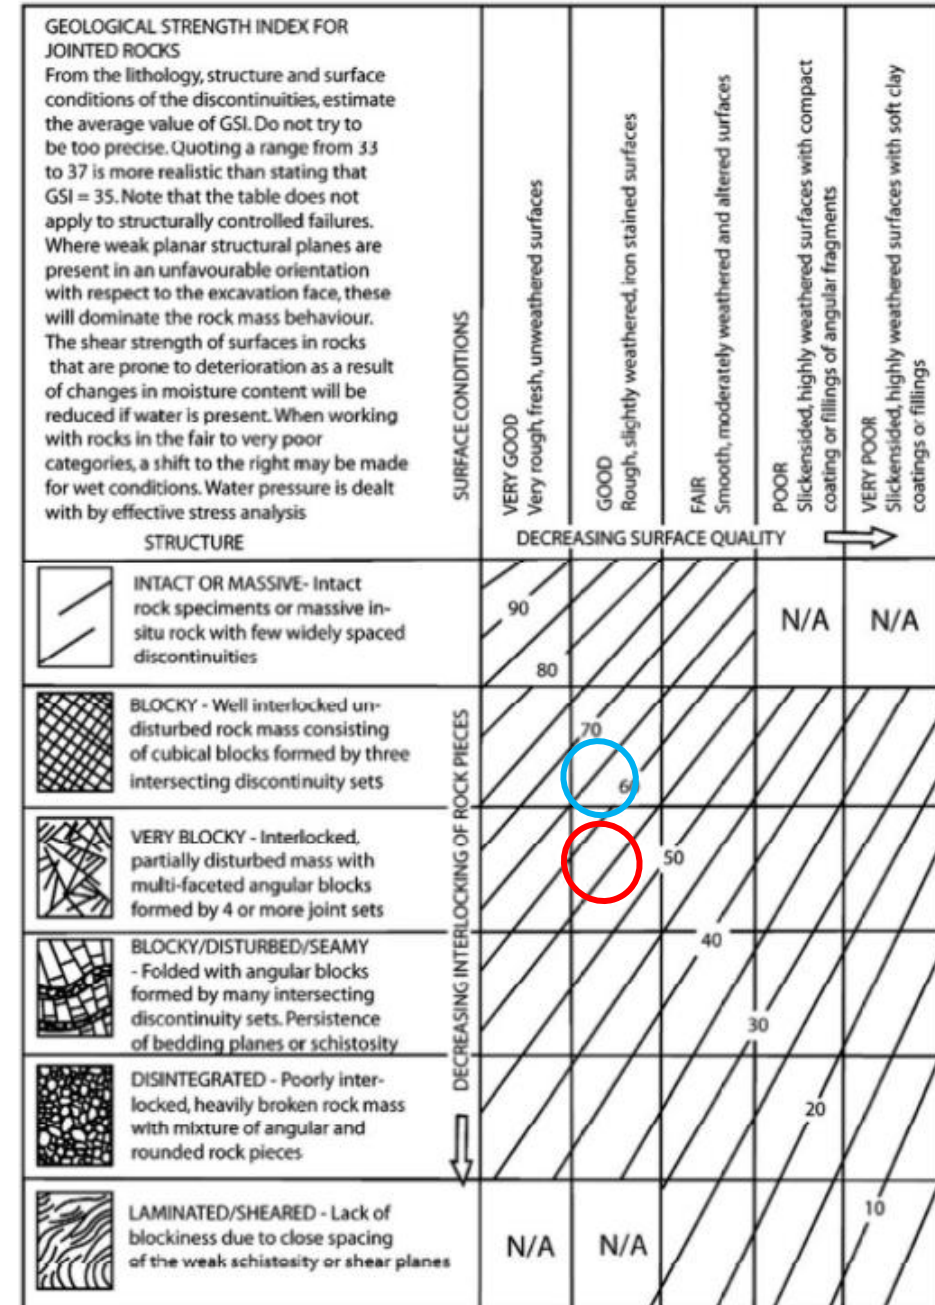
GSI Estimates MEC065

Area	GSI Range	GSI Best Estimate	Equivalent RMR89
Exterior and Main Chamber	52 – 62	57	62
Rear Chamber	59 – 69	64	69

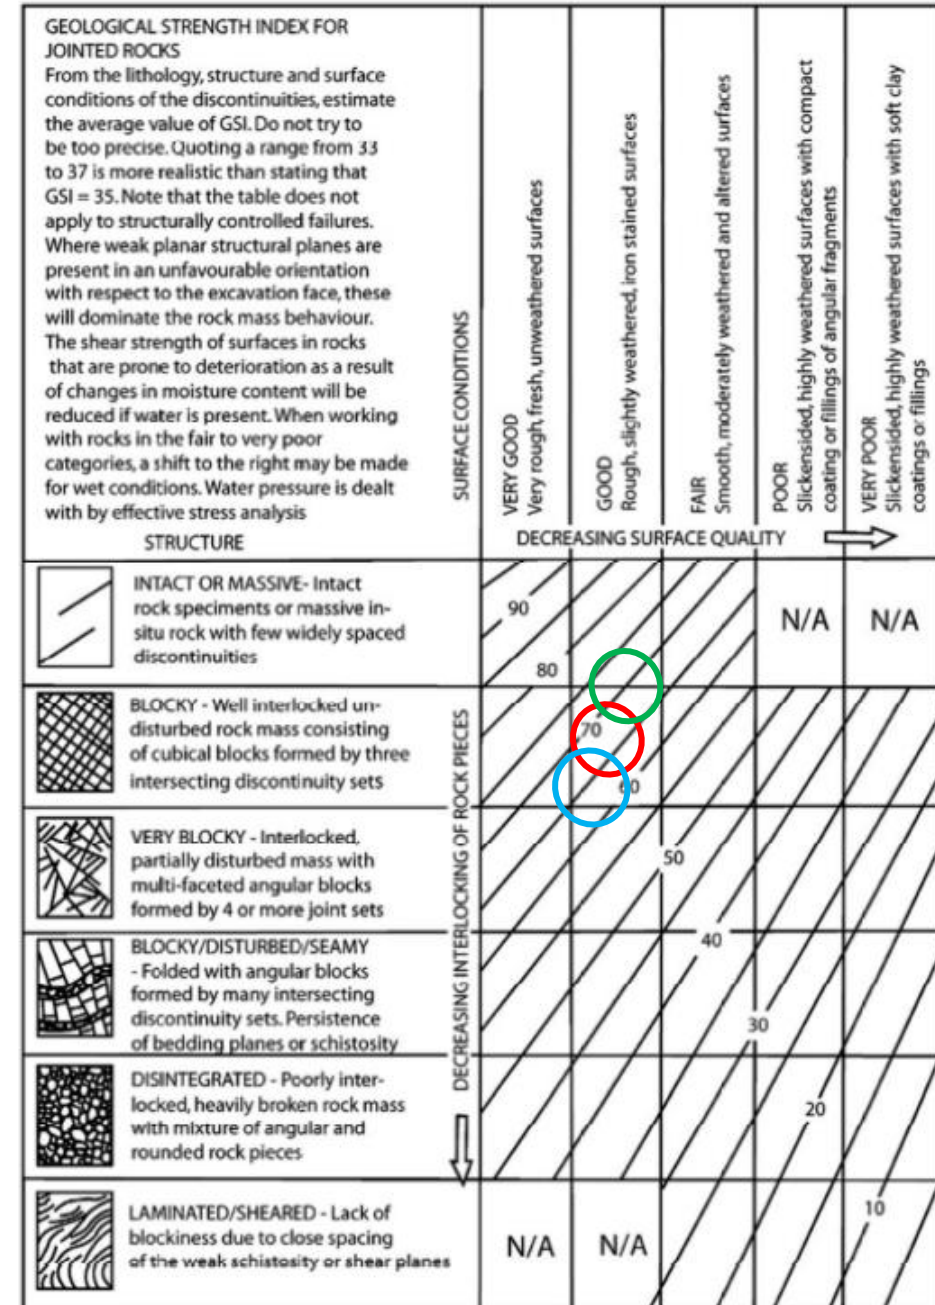
GSI Estimates MEC007

Area	GSI Range	GSI Best Estimate	Equivalent RMR89
Exterior and Front	62 – 72	67	72
Obs. 1 Zone	59 – 69	64	69
Rear	65 – 75	70	75

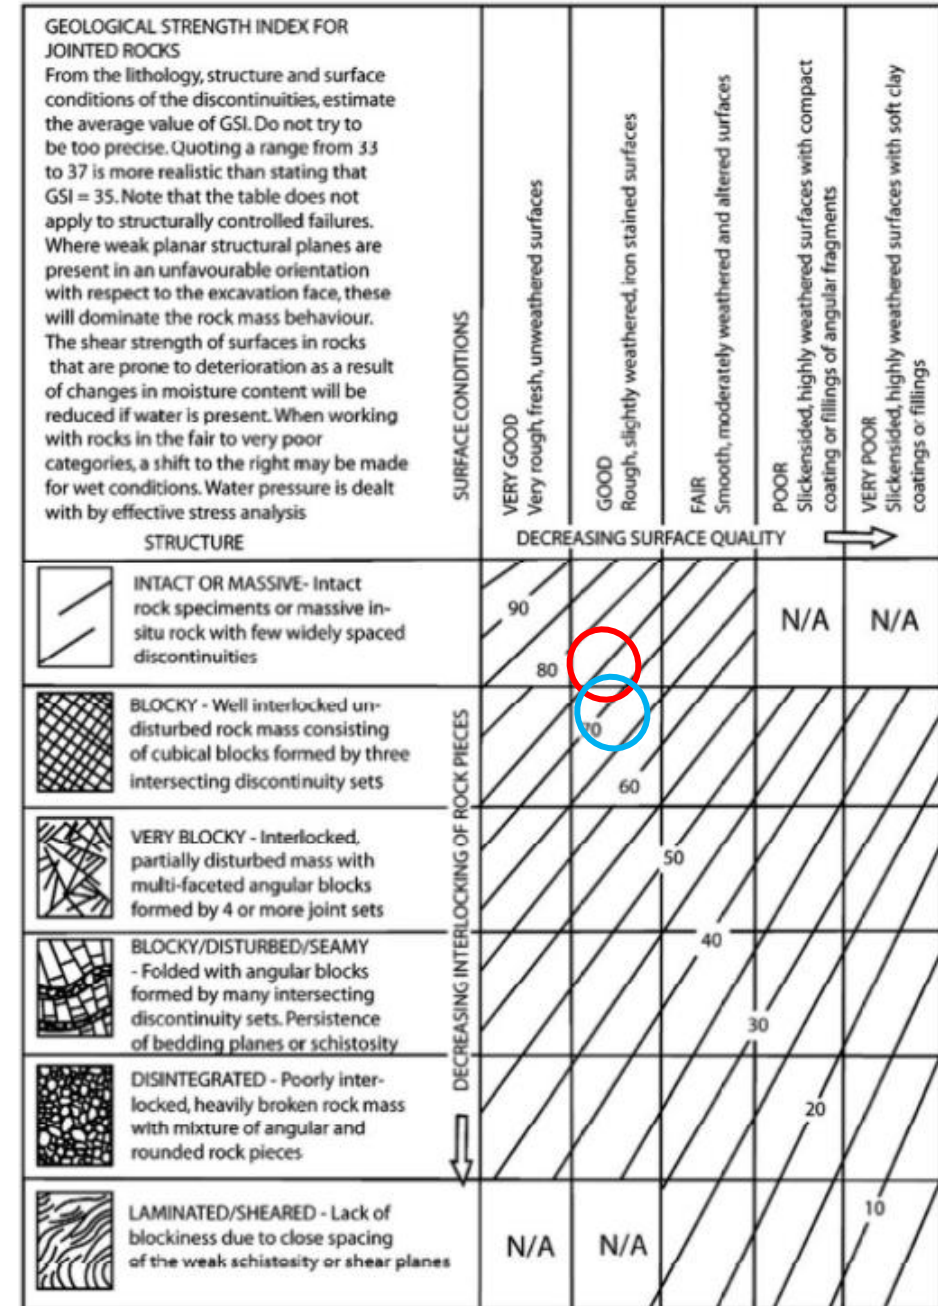
GSI Estimates MEC033

Area	GSI Range	GSI Best Estimate	Equivalent RMR89
Exterior and Overhang	70 – 80	75	80
Interior	64 – 74	69	74

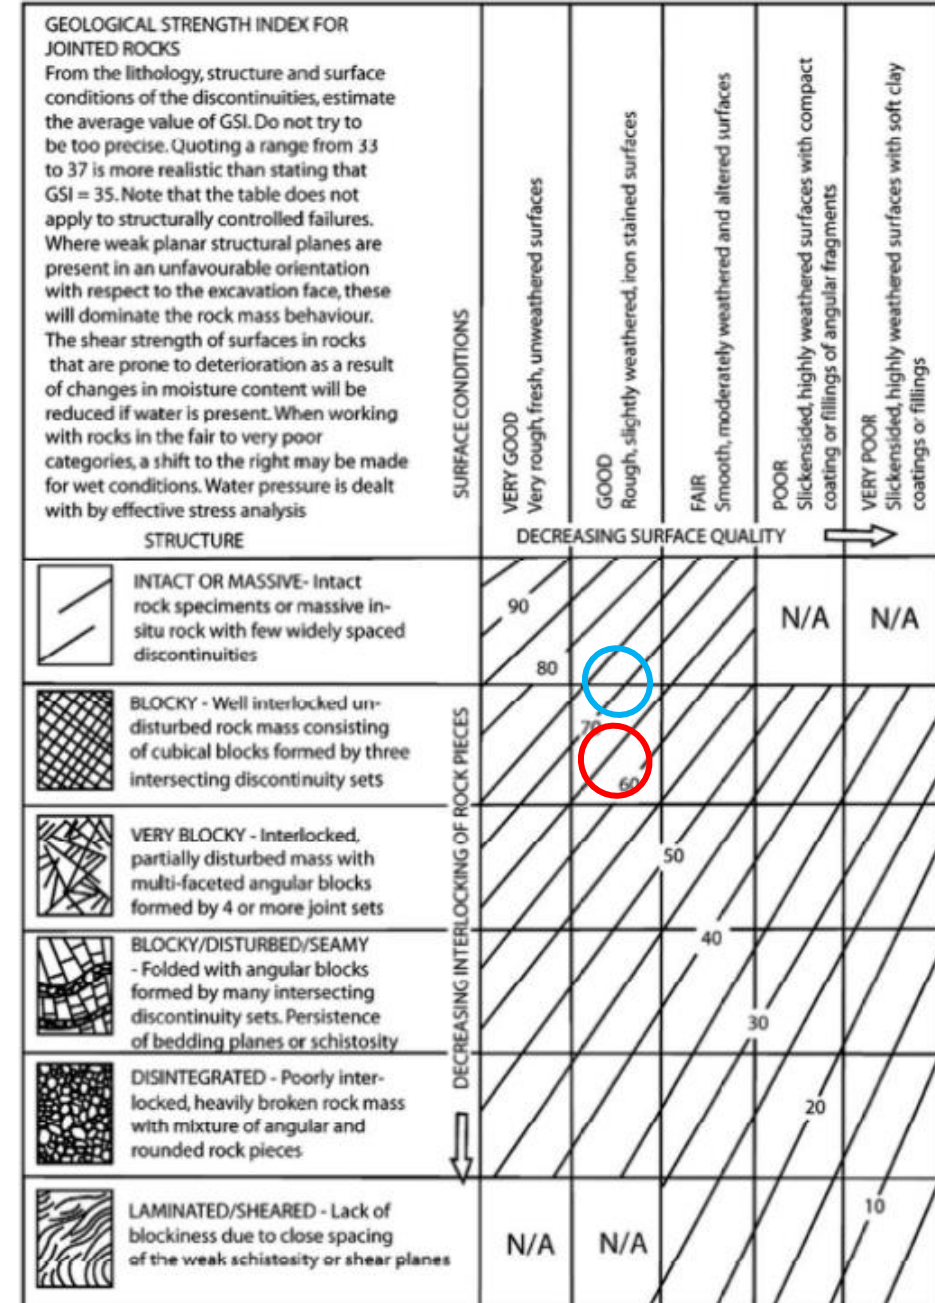
GSI Estimates MEC073

Area	GSI Range	GSI Best Estimate	Equivalent RMR89
Exterior and Overhang	58 – 68	63	68
Main Chamber	66 – 76	71	76

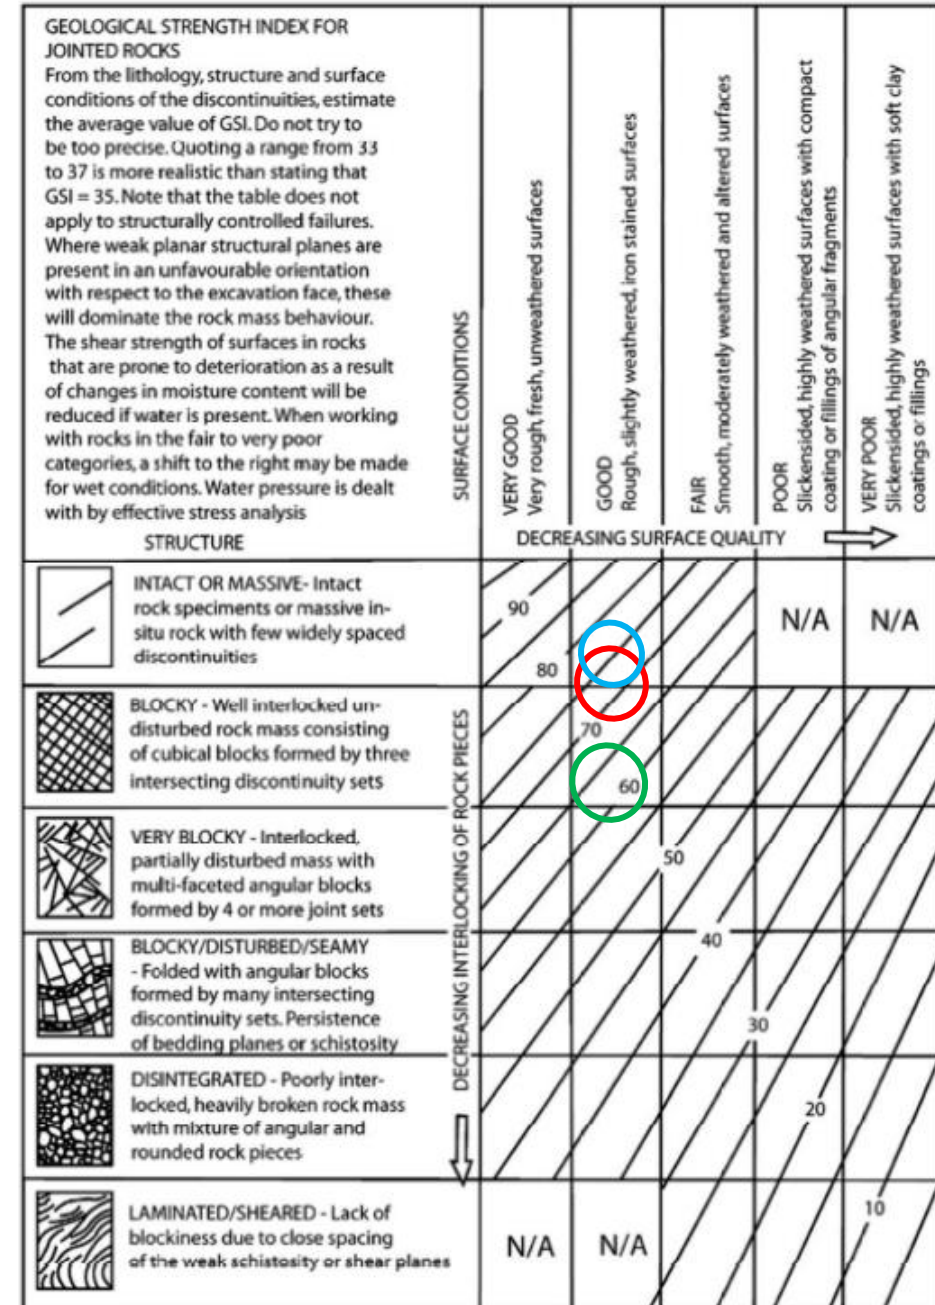
GSI Estimates MEC039

Area	GSI Range	GSI Best Estimate	Equivalent RMR89
Entrance/ Overhang	67 – 77	72	77
Main Chamber	70 – 80	75	80
Exterior (chert band)	58 – 68	63	68

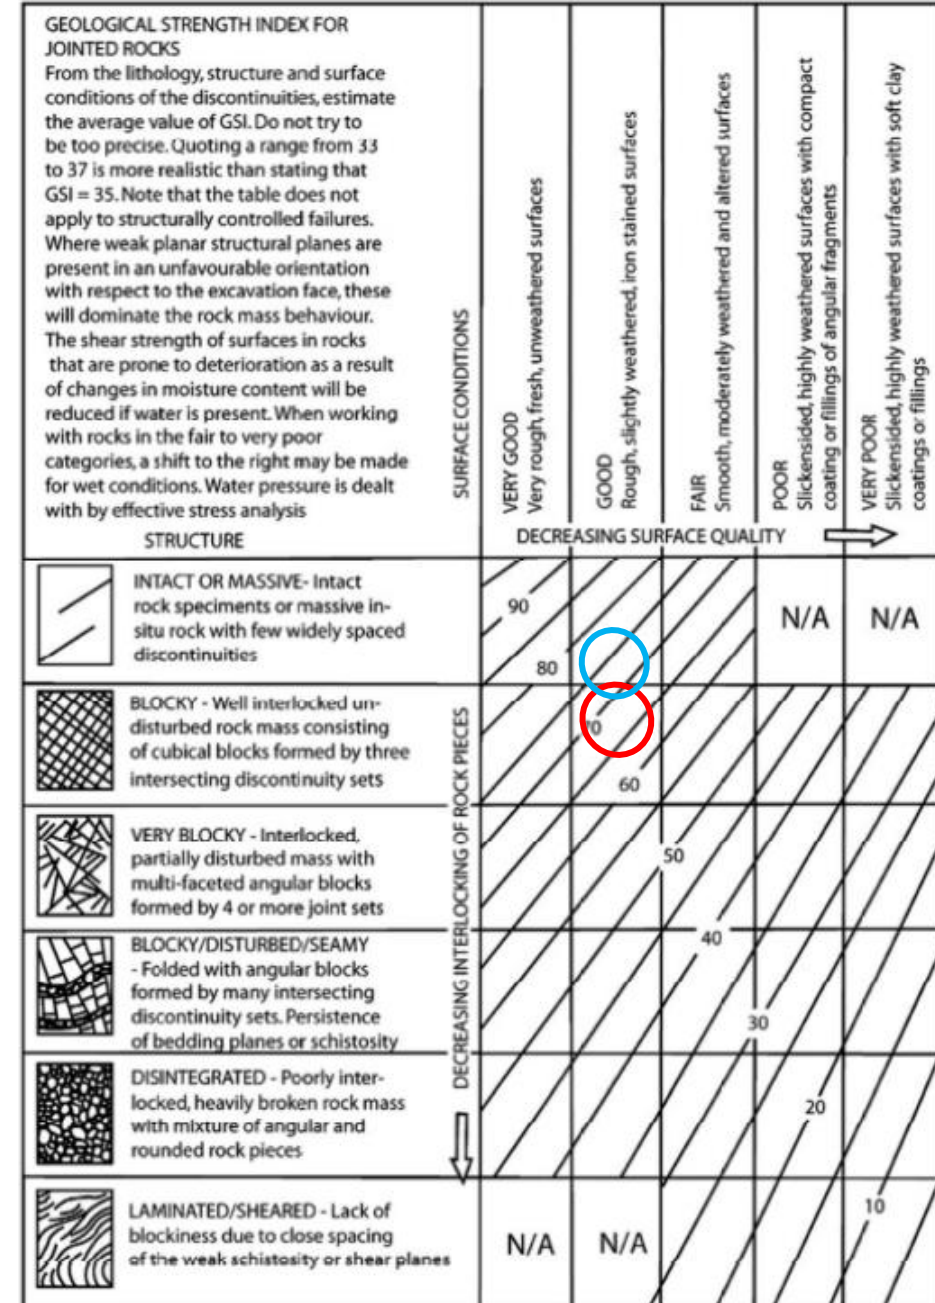
GSI Estimates MEC016 (MIB-MD13-043)

Area	GSI Range	GSI Best Estimate	Equivalent RMR89
Exterior, Main Chamber, and SW Adit	63 – 73	68	73
Western and Eastern Rear Adits	68 – 78	73	78

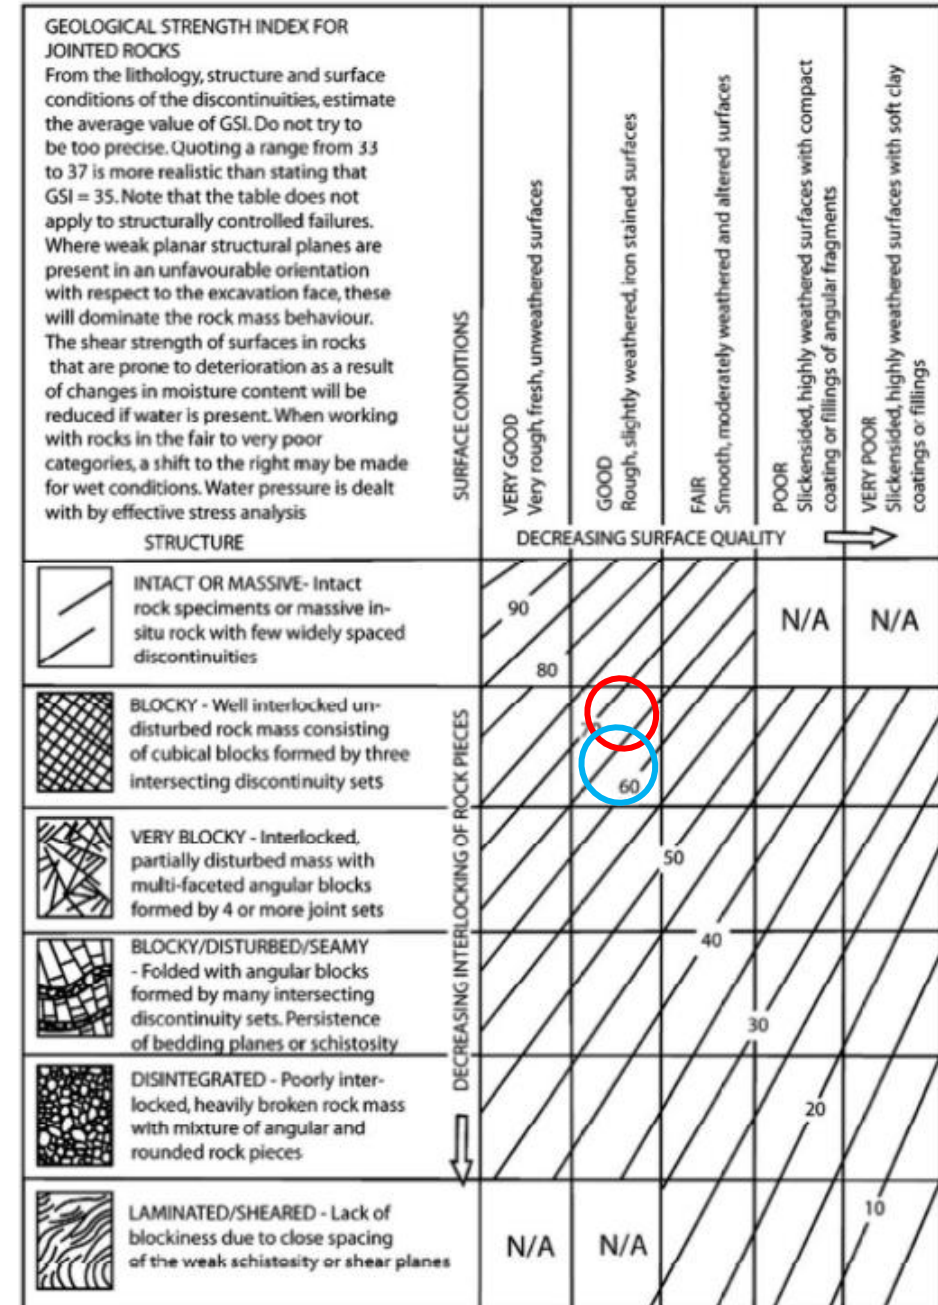
GSI Estimates MEC063

Area	GSI Range	GSI Best Estimate	Equivalent RMR89
Exterior	63 – 73	68	73
Interior	58 – 68	63	68

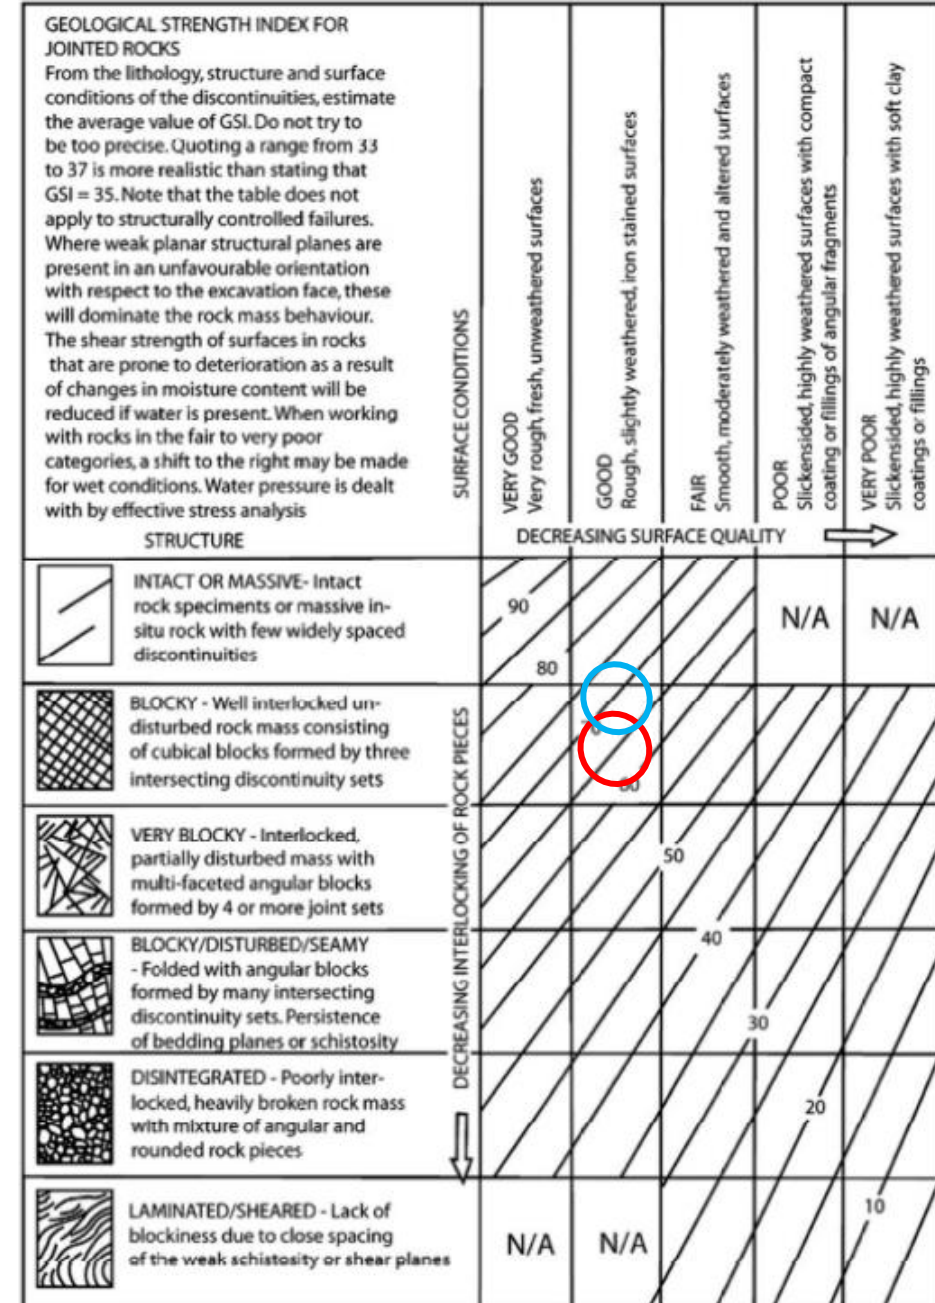
GSI Estimates MEC062

Area	GSI Range	GSI Best Estimate	Equivalent RMR89
Exterior and Front of Main Chamber	60 – 70	65	70
Rear of Main Chamber	65 – 75	70	75

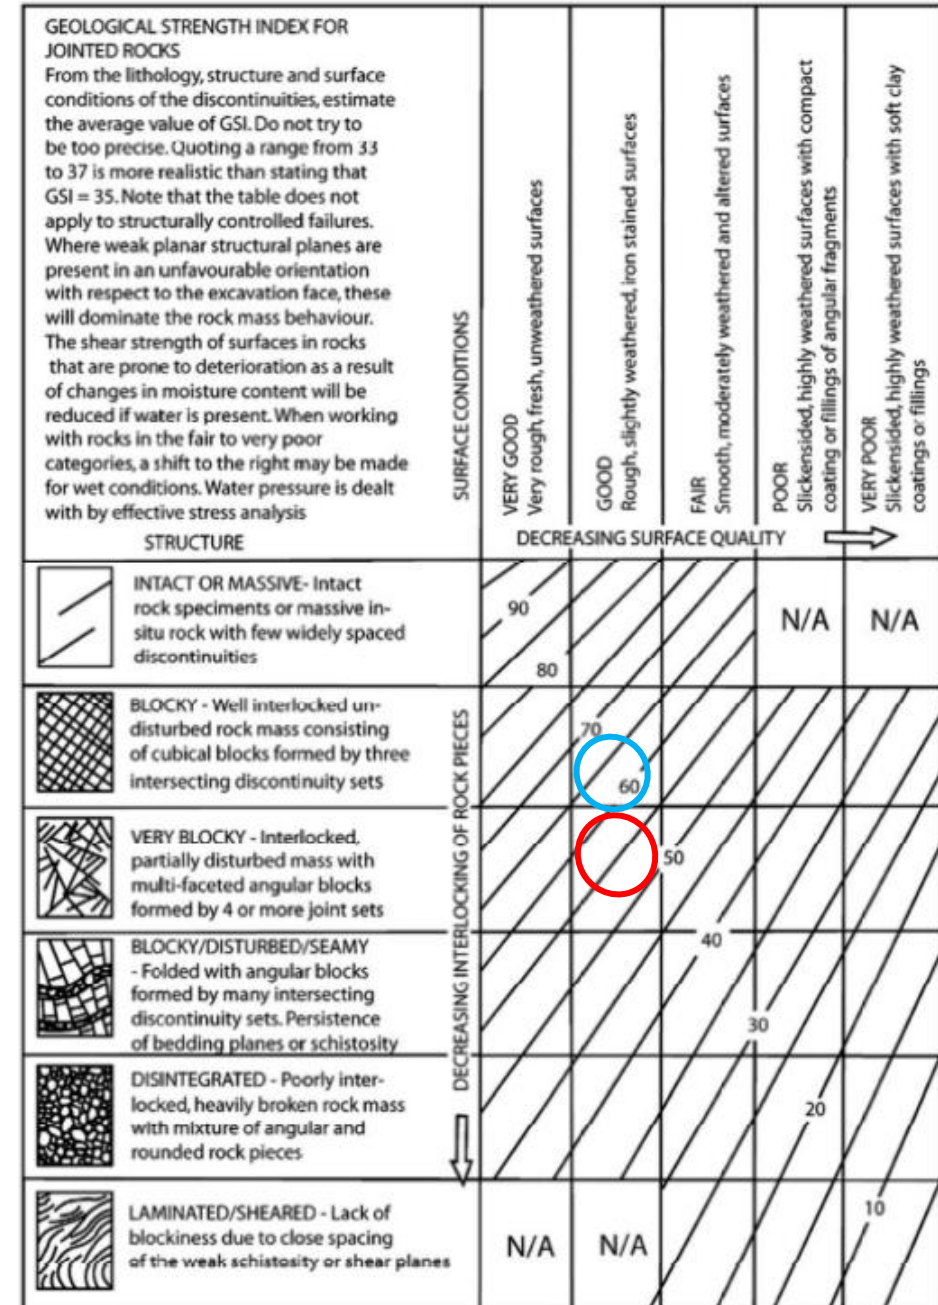
GSI Estimates MEC061

Area	GSI Range	GSI Best Estimate	Equivalent RMR89
Exterior	50 – 60	55	60
Interior	58 – 68	63	68

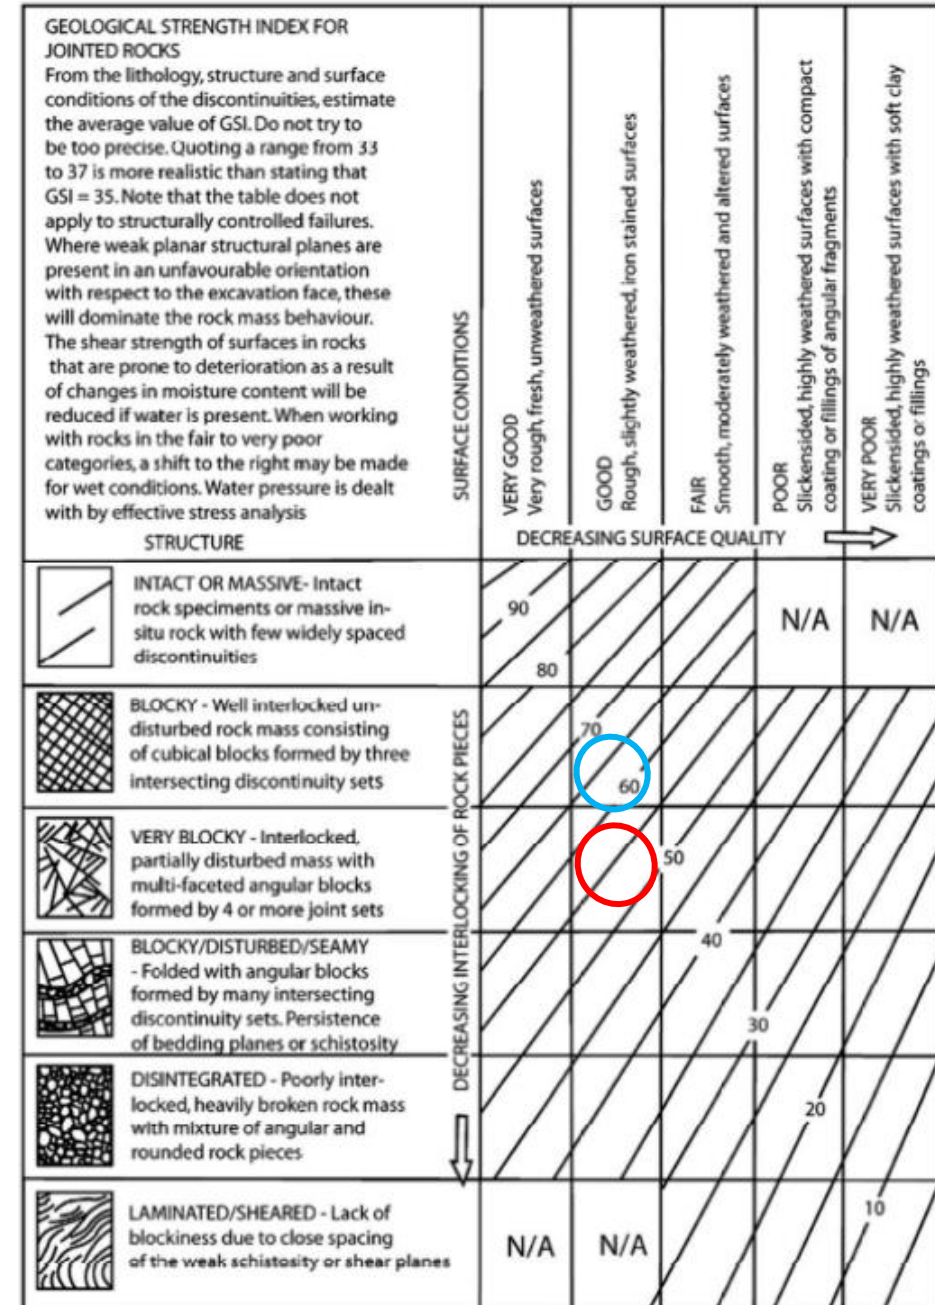
GSI Estimates MEC060

Summary Sheet Cave ID	Approximate Dimensions	Estimated GSI Range and Typical RMR ₈₉	Rock Mass Description	Observed Hazards	Recommendations
MEC060	Main Chamber – 7.7 m wide, 8.3 m deep, 0.7 m high	<p>GSI Exterior 50 – 60 Interior 58 – 68</p> <p>RMR₈₉ Exterior 60 Interior 68</p>	<p>The rock mass at the cave comprises hydrated interbedded BIF and chert. The rock mass is highly weathered and has a medium to high intact strength. The rock mass appears blocky due to multiple intersecting joint sets and bedding partings.</p> <p>Bedding is well developed with partings were commonly observed on the upper and lower contacts of interbedded chert bands. Bedding dips shallowly to the southwest and is undulating. Partings are typically 1 to 4 m in length and are spaced between 70 and 300 mm. Three joint sets were identified:</p> <p>JN1 strikes obliquely to the cave entrance, dipping steeply to the south-southwest. JN1 has an observable length of 0.2 to 0.9 m and a spacing of 100 to 200 mm, Inset 17.</p> <p>JN2 dips steeply to the west. It has relatively short defect lengths between 150 and 500 mm. JN2 is best preserved in the escarpment and areas around the entrance where it was observed to have a spacing of 100 to 300 mm.</p> <p>JN3 strikes parallel to the escarpment and was only observed on the eastern side of the cave. JN3 dips steeply to the south,</p>	<ol style="list-style-type: none"> 1. There is potential for slabs of hydrated BIF and chert to detach from bedding and/or joints in the cave roof. 2. The rock mass in the escarpment is loose and dilated in parts. This a potential source for future rockfall as evidenced in past rockfall product on the cave exterior. 3. Hanging blocks bounded by dilated bedding partings and joints were observed in the dripline above the cave entrance. 4. Perched boulders were observed along the top of the escarpment in which the cave is hosted. Some tabular boulders appear to have become perched due to continual weathering of the dilated blocky rock mass. 	<ul style="list-style-type: none"> • Assess the identified hanging blocks and the BIF slab at the entrance for dilation of bedding partings and joint structures that bound them • Before approaching the cave, assess the top of the escarpment for perched boulders that may be at risk of falling. Check the area below the dripline for fresh rockfall • Limit time spent at the escarpment face where loose dilated rock mass has been identified. Avoid leaning or sitting below these areas.

Area	GSI Range	GSI Best Estimate	Equivalent RMR89
Exterior	51 – 61	56	61
Interior	58 – 68	63	68

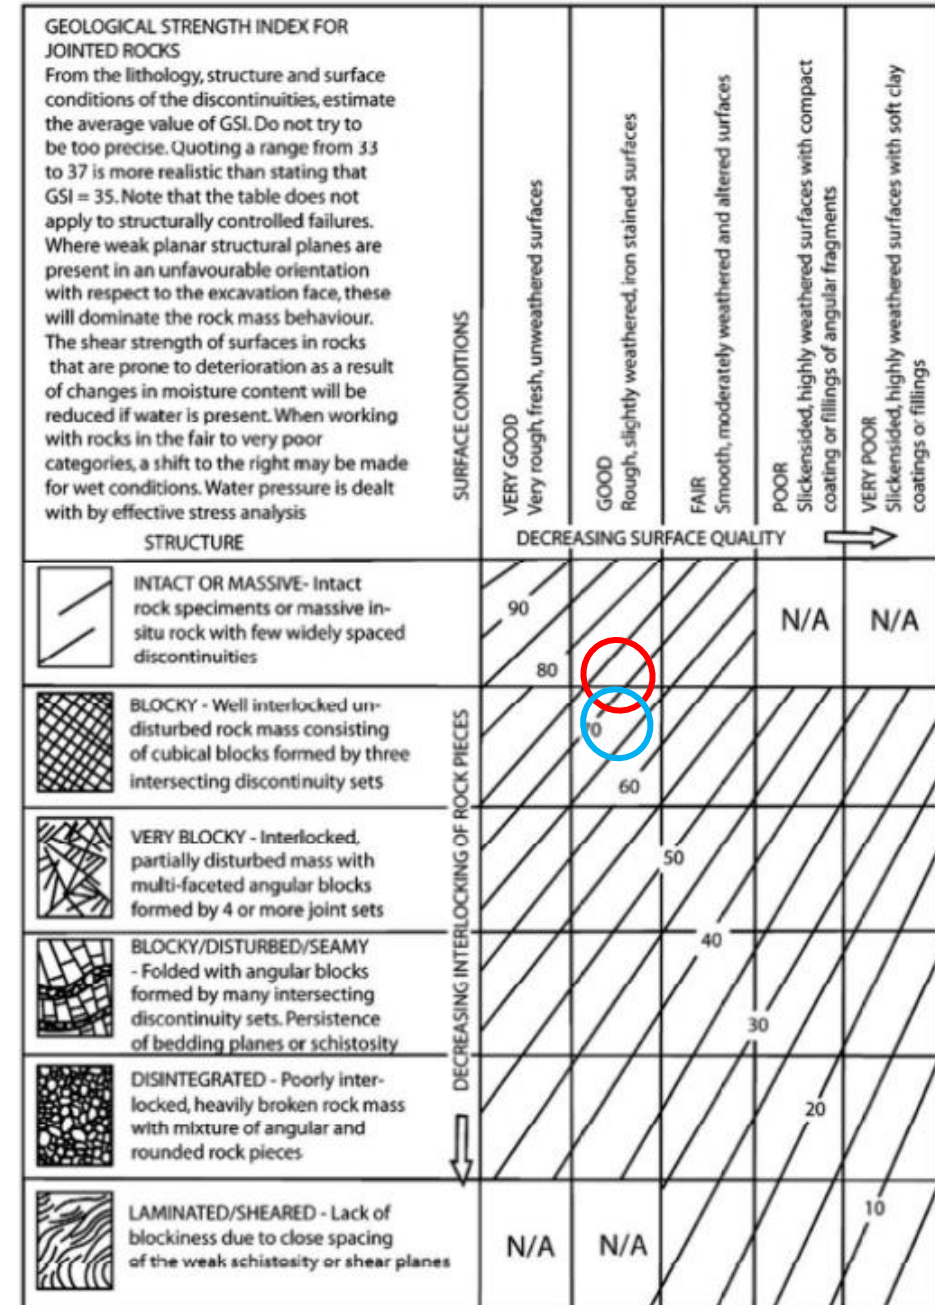
GSI Estimates MEC072

Summary Sheet Cave ID	Approximate Dimensions	Estimated GSI Range and Typical RMR ₈₉	Rock Mass Description	Observed Hazards	Recommendations
MEC072	<p><u>Entrance</u> – 1 m wide, 0.6 m high</p> <p><u>Interior</u> – 0.6 m wide, 5.5 m deep, 0.4 m high</p>	<p><u>GSI</u></p> <p>Exterior 67 – 77 Entrance 63 – 73 Interior 67 – 77</p> <p><u>RMR₈₉</u></p> <p>Exterior 77 Entrance 73 Interior 77</p>	<p>The rock mass at the cave comprises hydrated, highly weathered BIF. The intact strength is high to very high. Bedding is developed and elongate vugs were observed on the exterior oriented parallel to bedding. Bedding dips shallowly to the southeast with partings that are undulating and up to 0.5 m long. The partings are spaced at 60 to 200 mm and have surfaces that are slightly rough to trough. They are tight to open less than 1 mm. Bedding appears to become overprinted deeper into the cave. No structurally significant joint sets were identified.</p>	<ol style="list-style-type: none"> Perched boulders are situated above the cave entrance. There is potential for blocks to detach from bedding where partings are developed around the entrance. If blocks detach they are likely not going to restrict access for bats in to the cave. 	<ul style="list-style-type: none"> Before accessing the cave, assess the perched blocks above the entrance that have the potential to fall and check for any fresh rockfall and on the ground.

Area	GSI Range	GSI Best Estimate	Equivalent RMR89
Exterior and Interior Chamber	67 – 77	72	77
Entrance	63 – 73	68	73

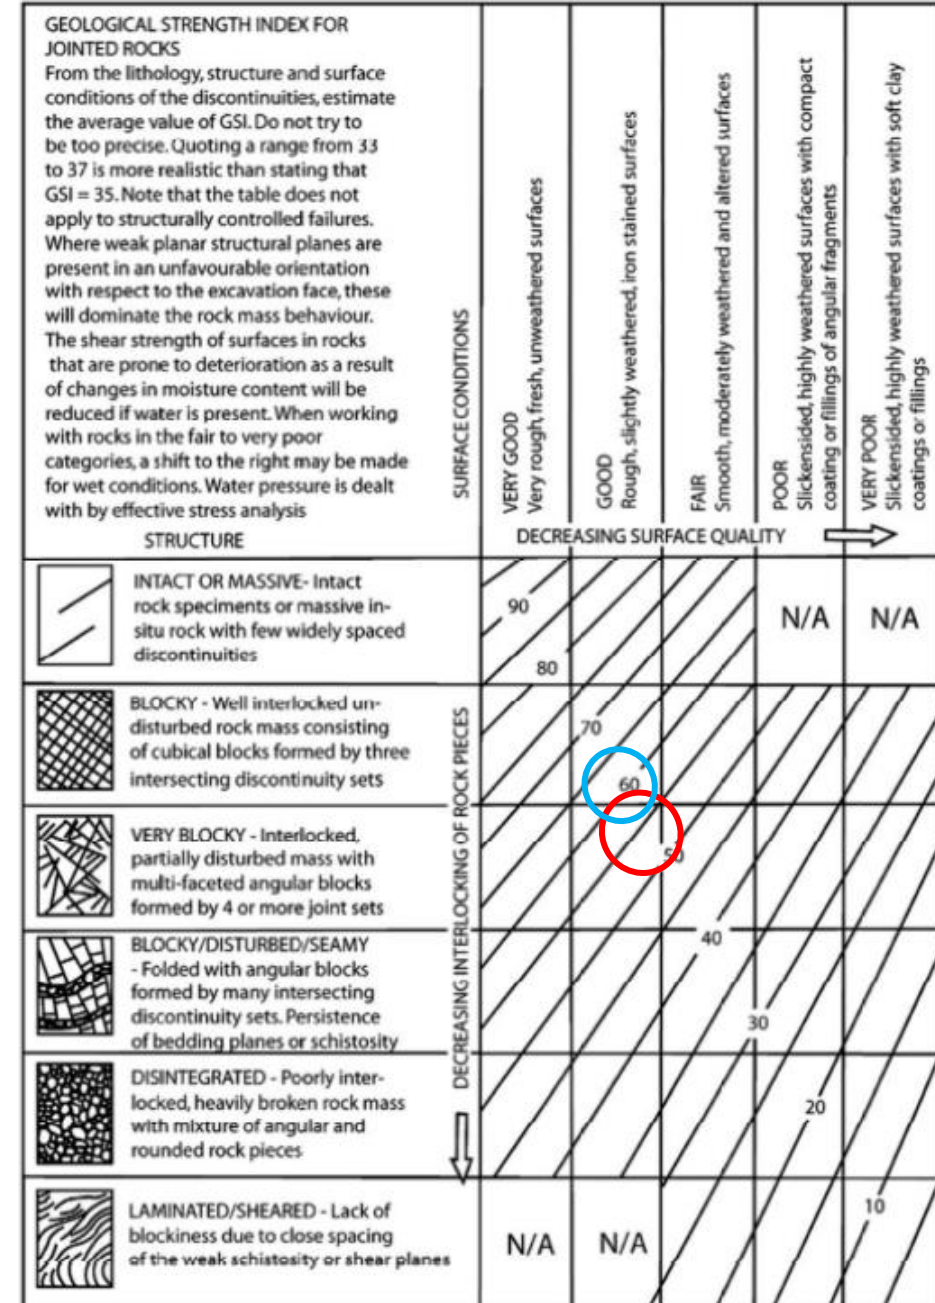
GSI Estimates MEC049

Summary Sheet Cave ID	Approximate Dimensions	Estimated GSI Range and Typical RMR ₈₉	Rock Mass Description	Observed Hazards	Recommendations
MEC049	Interior – 1.5m wide, 2.8 m deep, and 0.8 m high (up to 2 m high at rear)	<p>GSI</p> <p>Exterior 50 – 60 Interior 56 – 66</p> <p>RMR₈₉</p> <p>Exterior 60 Interior 66</p>	<p>The rock mass comprises partially hydrated interbedded chert and BIF. It is highly weathered and typically has a high to very high intact strength. In some areas around the entrance, medium strength was observed. The rock mass is generally blocky and dilated.</p> <p>Bedding is well developed with partings 2 to 6 m long observed throughout the cave and surrounding escarpment. Partings are typically undulating and oriented sub-horizontally. They are open up to 4 mm in places but typically have an aperture of approximately 1 mm with an iron veneer infill. Partings are spaced at 100 to 300 mm and have rough surfaces. Three joint sets were observed:</p> <p>JN1 dips steeply to the northwest and has an observable length of 1 to 3 m. The set is spaced at 100 to 200. JN1 was only observed in the escarpment and around the entrance of the cave.</p> <p>JN2 dips steeply to the west-southwest. Joints along this orientation are relatively short with lengths between 0.1 and 0.4 m. JN2 has a spacing of 40 to 120 mm.</p> <p>JN3 dips steeply to the southwest and is generally spaced between 0.1 and 0.3 m. Two large open structures along this orientation occur at the back of the interior chamber resulting roof profiles up to 2 m high. At the back of the main chamber, JN3 is up to 3 m long and spaced at 50 mm proximal to the joint swarm.</p>	<ol style="list-style-type: none"> 1. A dilated joint swarm along joint set 3 orientation was observed to control cave development at the back of the interior chamber. 2. Loose dilated blocky rock mass was observed in the escarpment above and adjacent to the cave, and also in areas around the cave entrance. 3. Perched boulders are situated atop the escarpment. 	<ul style="list-style-type: none"> • Before accessing the cave, assess the perched blocks above the entrance that have the potential to fall and check for any fresh rockfall and on the ground • Limit time spent immediately below the dripline where there is potential for blocks to detach from the dilated blocky rock mass. Avoid leaning on these areas when accessing the cave • Check for dilation of defects in the escarpment and cave roof before accessing the cave • Inside the cave, check for seepage along the dilated joint structures. Do not continue to access the cave if water is observed.

Area	GSI Range	GSI Best Estimate	Equivalent RMR89
Exterior	50 – 60	55	60
Interior	56 – 66	61	66

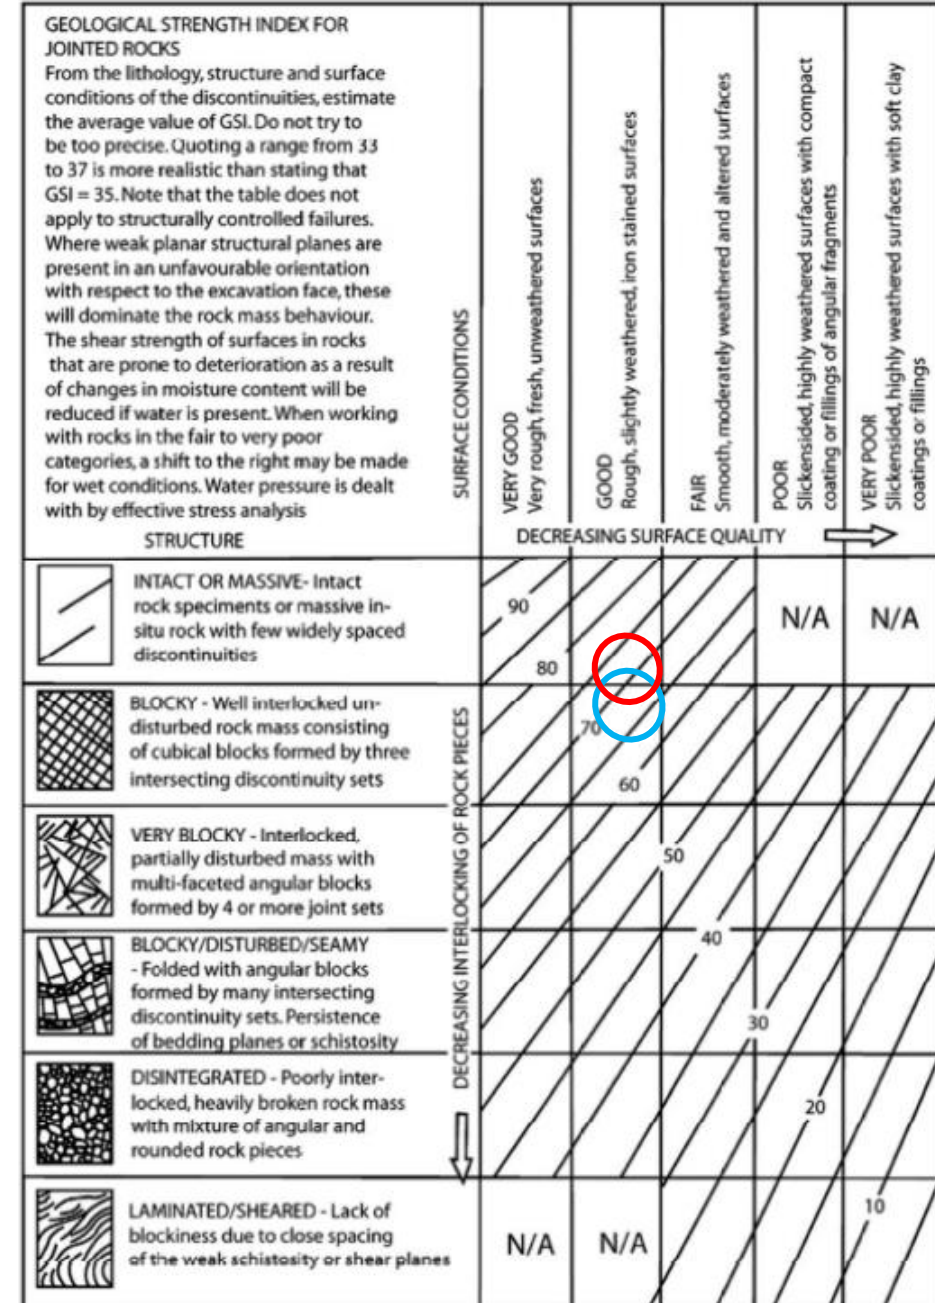
GSI Estimates MEC003

Summary Sheet Cave ID	Approximate Dimensions	Estimated GSI Range and Typical RMR ₈₉	Rock Mass Description	Observed Hazards	Recommendations
MEC003	<p>Main Chamber – 5.2 m wide, 4.0 m deep, 0.7 m high.</p> <p>Rear Chamber – 1.8 m wide, 4.1 m deep, 0.6 m high</p>	<p>GSI Exterior and Main Chamber 67 – 77 Rear Chamber 63 – 73</p> <p>RMR₈₉ Exterior and Main Chamber 77 Rear Chamber 73</p>	<p>The rock mass at the site comprises interbedded hydrated BIF and chert. The rock is dilated and loose in areas around the entrance, and in the escarpment above the cave. The intact strength is high to very high. A laminated siliceous shale band was observed on the roof the main chamber, and was assessed to have a low to medium intact strength. The laminations within the shale band are intact.</p> <p>Bedding at the cave is well developed and forms partings with lengths between 1 and 10 m long. The partings are spaced between 80 and 200 mm, and are open up to 2 mm. Bedding dips shallowly to the west.</p> <p>Three joint sets were recorded at the cave. JN1 dips steeply to the east-northeast. It has lengths of 0.3 to 0.5 m and is spaced 50 to 150 mm. Joints along this orientation are typically tight to open <1 mm. JN2 controls dripline formation on the southern side of the escarpment. It dips steeply to the south-southeast and has defect lengths between 0.4 and 0.8 m. The joints are typically undulating and are spaced between 100 and 200 mm apart. JN3 dips steeply to the southeast and was observed to be tight. JN3 is typically 0.5 to 1.5 m long and spaced at 100 to 400 mm.</p>	<ol style="list-style-type: none"> 1. There is potential for blocks of rock to detach from bedding partings and joints in the cave roof, evidenced by past rockfall debris throughout the cave main chamber and below the dripline. 2. A thinly laminated siliceous shale band was observed to intersect the roof of the main chamber. Although the laminations are intact, blocks below the shale band may be able to detach from the band due to the lower intact strength. 3. Loose hanging blocks up to 0.8 m wide were observed on the southern side the escarpment. The hanging blocks are bounded by dilated joints or non-systematic fractures. 4. Perched boulders are situated in the escarpment above the cave have the potential to fall. 	<ul style="list-style-type: none"> • Limit time spent immediately below the dripline where perched boulders are at risk of falling, or loose hanging blocks have been identified • Check for fresh rock fall debris around the cave entrance before approaching • Check for dilation of defects bounding blocks in the escarpment and main chamber roof • Assess the main chamber for signs of water seepage, particularly around any hanging blocks bounded by joints in the cave roof.

Area	GSI Range	GSI Best Estimate	Equivalent RMR89
Exterior and Main Chamber	67 – 77	72	77
Rear Chamber	63 – 73	68	73

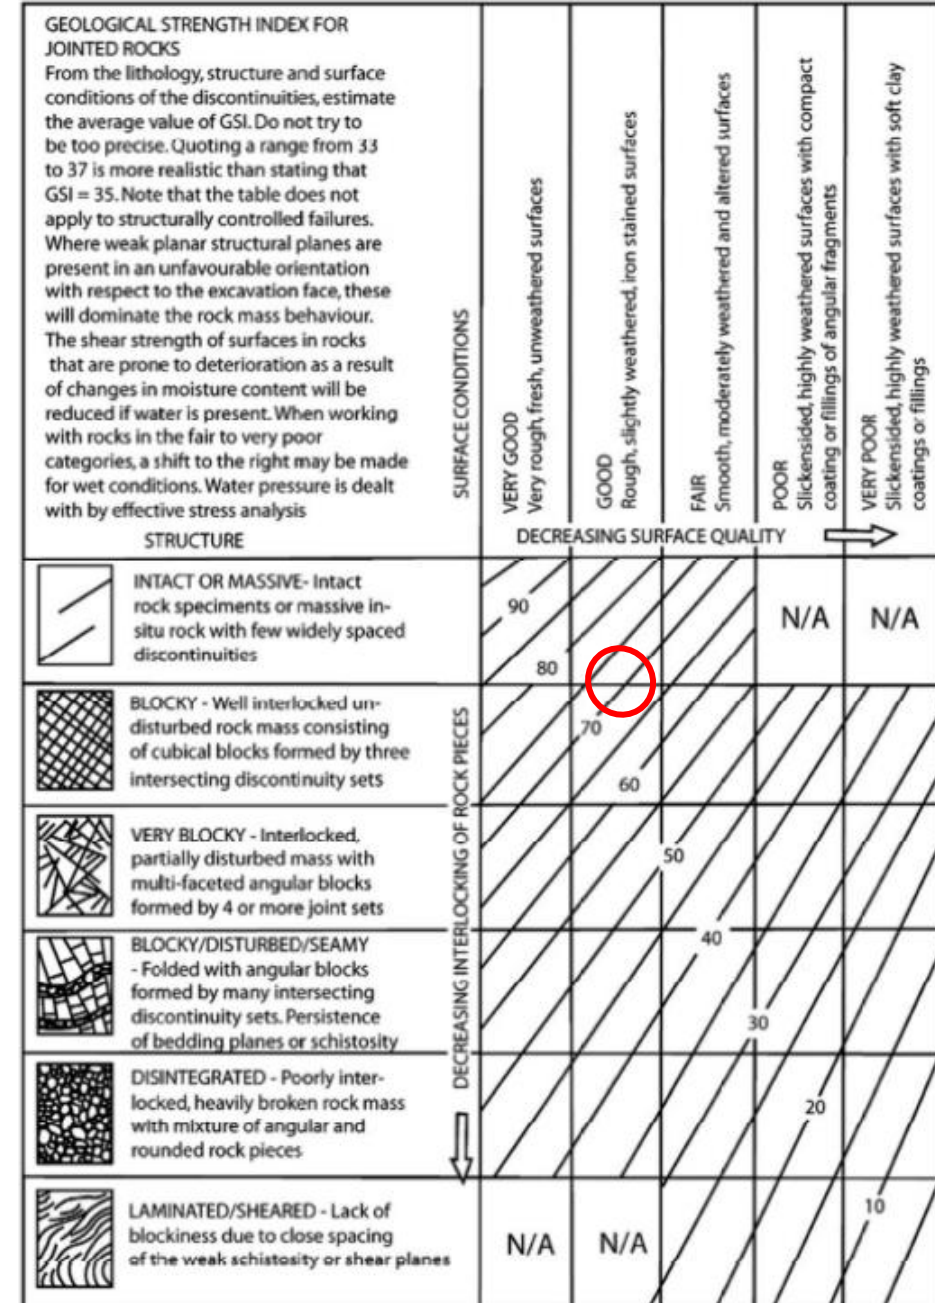
GSI Estimates MEC025

Summary Sheet Cave ID	Approximate Dimensions	Estimated GSI Range and Typical RMR ₈₉	Rock Mass Description	Observed Hazards	Recommendations
MEC025	<p>Entrance – 2.1 m wide and 6 m high</p> <p>Interior – 5.5 m wide, 1.7 m deep, 0.5 m high</p>	<p>GSI All Areas 66 – 76</p> <p>RMR₈₉ All Areas 76</p>	<p>Rock mass at the cave comprises interbedded hydrated BIF and chert. The cave itself is hosted within the hydrated BIF which makes up the lower part of the exposed escarpment, with blocky chert bands observed in the escarpment above the cave. The rock mass is high strength, with elongate vughs oriented parallel to BIF bedding. Bedding dips shallowly to the southwest and does not form structurally significant partings at the cave level, however, partings do persist in the rock above the cave along the contacts of interbedded chert bands. Above the cave, partings are 1 to 6 m long and spaced between 200 and 400 mm. A single joint set was observed at the cave. The joints are oriented sub-vertical and strike east-west. Only two open joints were observed along this orientation, indicating a spacing of approximately 2 m and lengths up to 1.7 m.</p>	<ol style="list-style-type: none"> 1. Hanging blocks bounded by open fractures were observed in the cave roof inside the cave. 2. Blocky chert bands occur in the escarpment above the cave entrance, and have the potential to release dilated blocks from the escarpment face. 3. Perched boulders were observed along the top of the escarpment in which the cave is situated. 4. A large BIF slab is bounded by an open fracture on the southern side of the cave entrance. 	<ul style="list-style-type: none"> • Before approaching the cave, assess the area for any fresh rockfall and loose blocks that may have formed in the blocky chert escarpment • Check the escarpment above the cave for perched boulders when traversing the cave dripline • Avoid leaning on or sitting below the large BIF slab on the southern side of the cave entrance • Assess the identified hanging BIF blocks inside the cave for dilation of bounding fractures and for signs of detachment.

Area	GSI Range	GSI Best Estimate	Equivalent RMR89
All Areas	66 – 76	71	76
