Detailed Site Investigation for
Potential Soil and Groundwater Contamination
333 High Street/11 Montreal Street, Fremantle
Western Australia

Main Roads WA

Report Number: 1430/489/DSI/AH/02082013					
Status	Rev	Date	Prepared	Checked	Authorised
Final	1	Sept 2013	AH	CK	AR

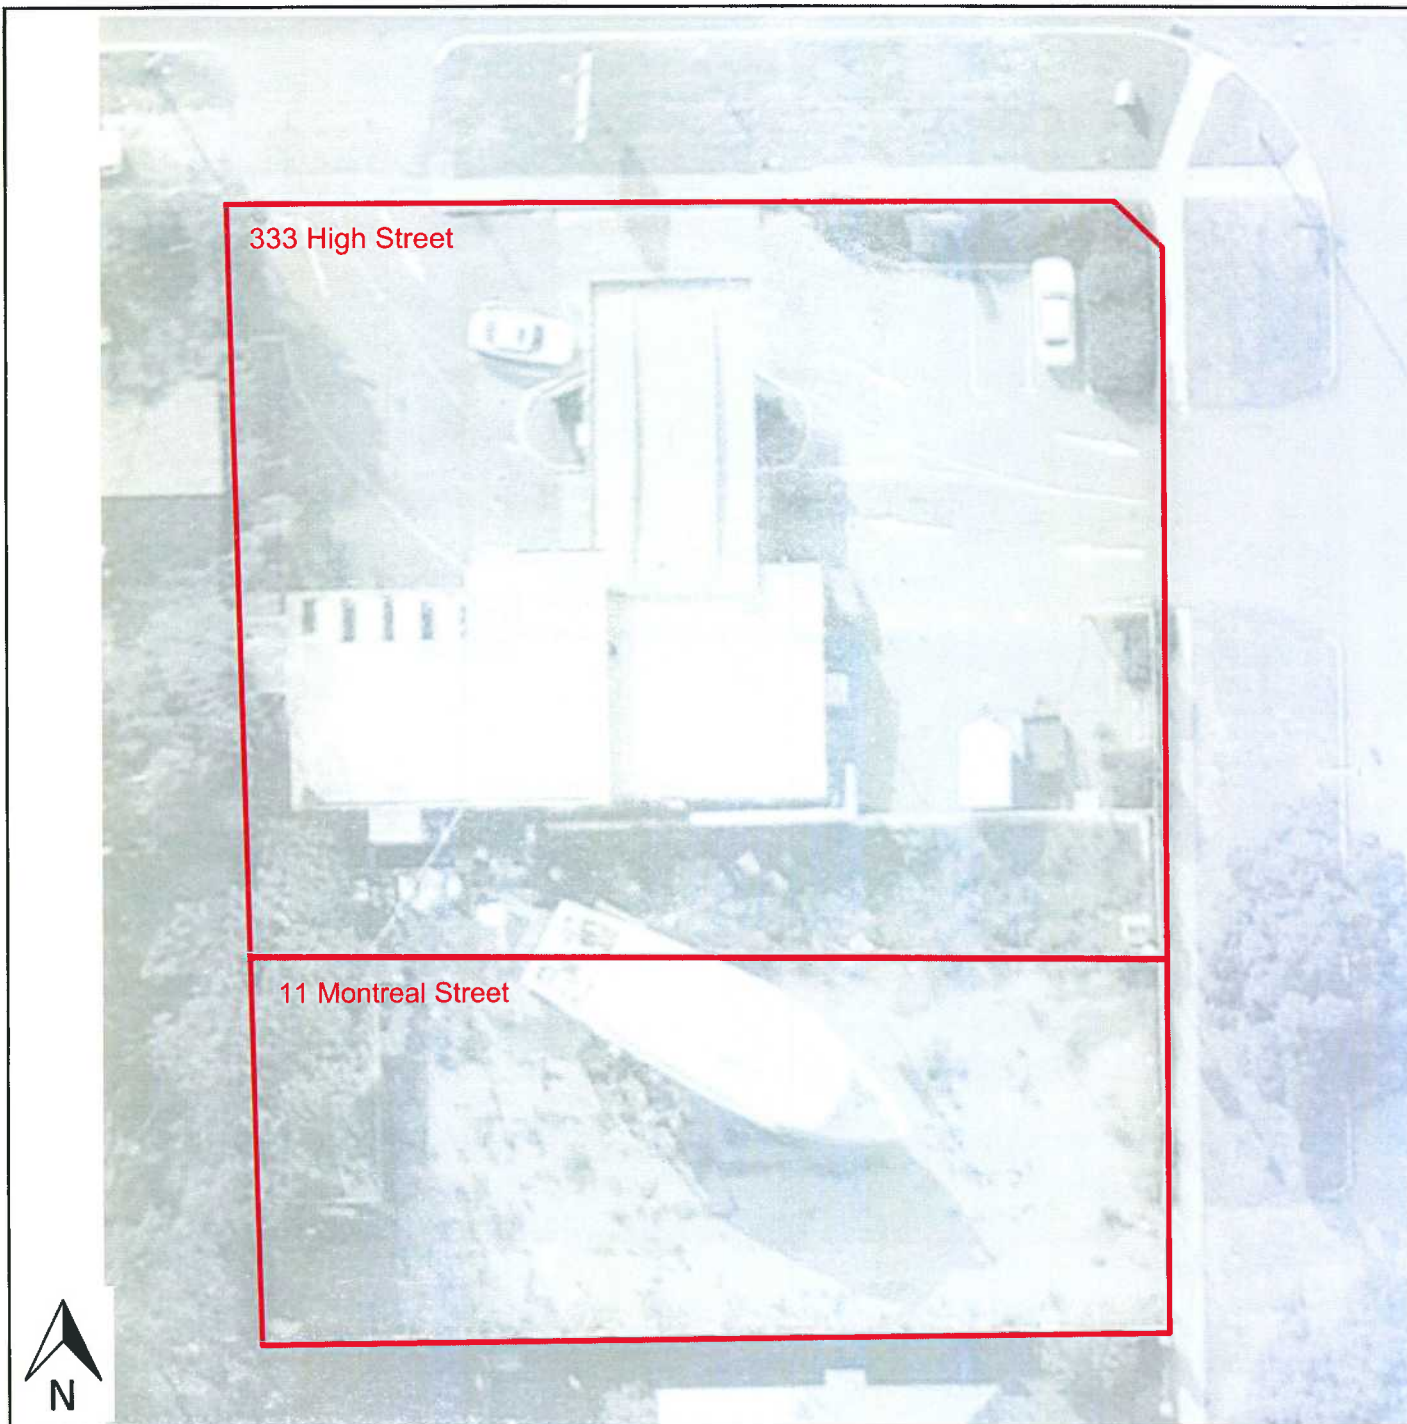
DRAWING No:
Figure 3

Prior to the OTEK investigation the bowisers had been removed however the USTs were not removed and are still present on site. Figure 3 (Appendix A) shows approximate location of the USTs as reported by OTEK.

Sample locations are shown on Figure 3, Appendix A.
