# **FY23 Ministers North SUR Phase 1 Hydrogeological Drilling Completion Report**

**Jim McDiarmid  
30 March 2023**

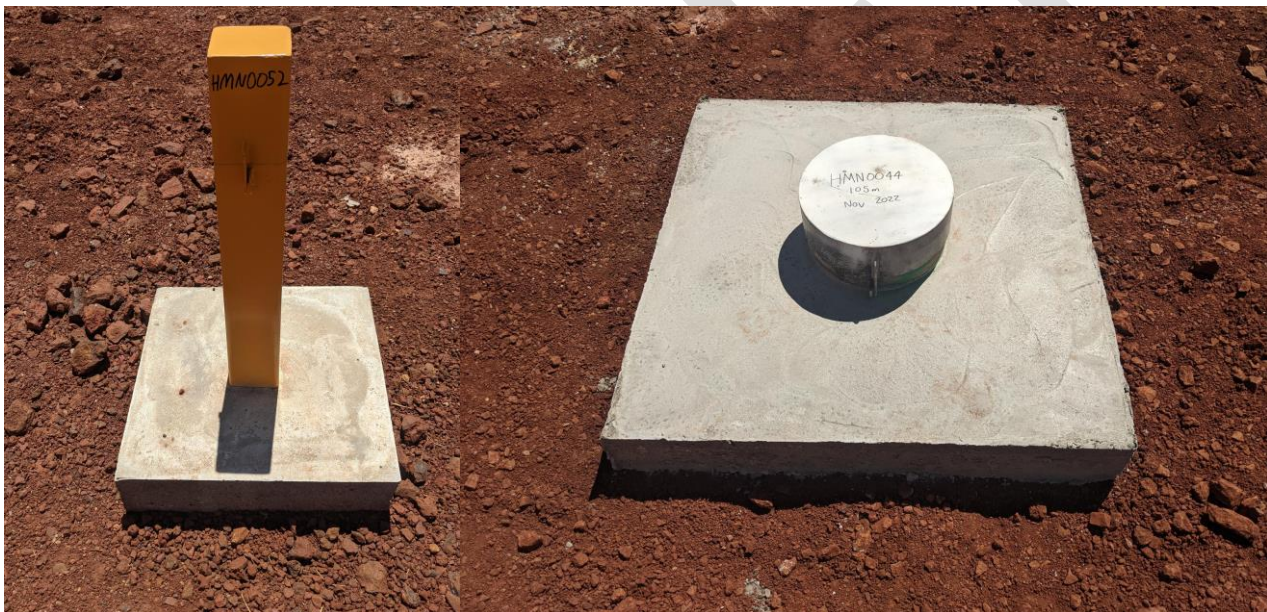
**Figure 4. Monitoring bore completion (Left) Production bore completion (Right)**

Monitoring bores were constructed using Class 25 50 mm NB slotted and blank PVC (Figure 4), using flush-threaded environmental casing. A medium specification gravel (size range 3.2 – 6.4 mm) was poured from hopper at surface into the hole annulus to provide a filter pack, and a 5-metre cement surface seal was placed at surface. Headworks consisted of lockable steel monument and a 0.6 x 0.6 m cement plinth.

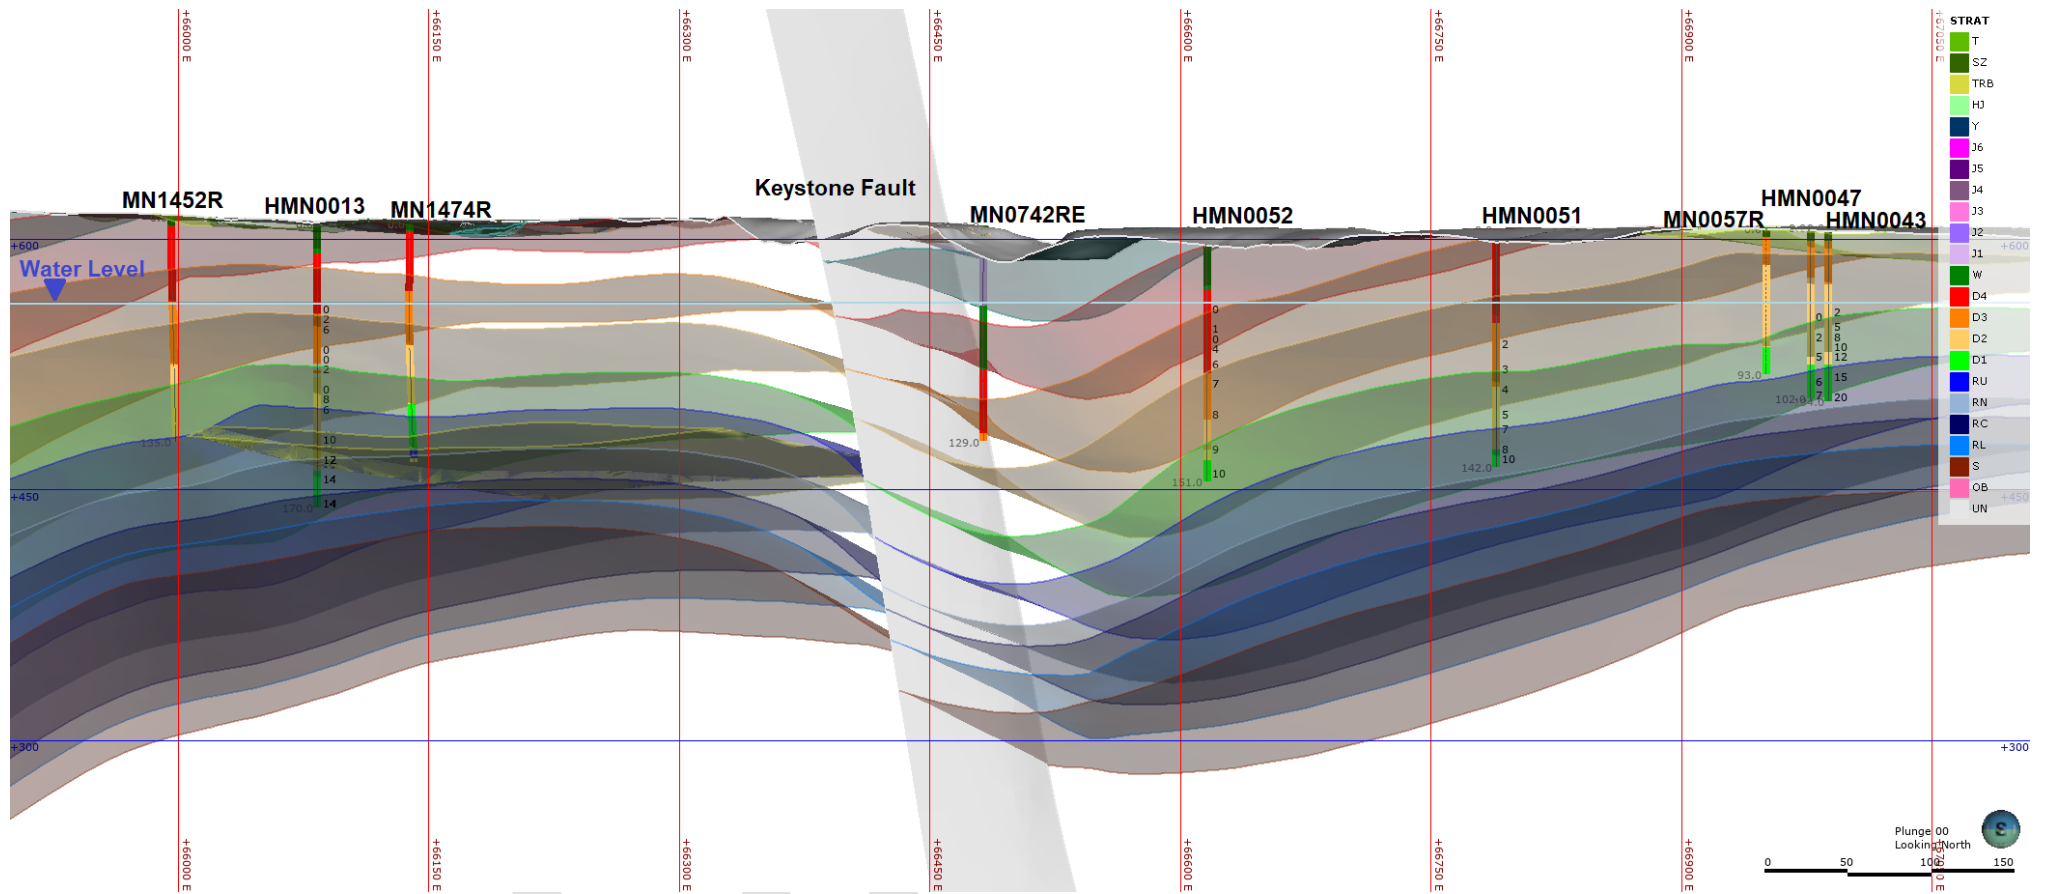
Figure 14: Crossing the Keystone fault through HMN0013, HMN0052 and HMN0053 looking north

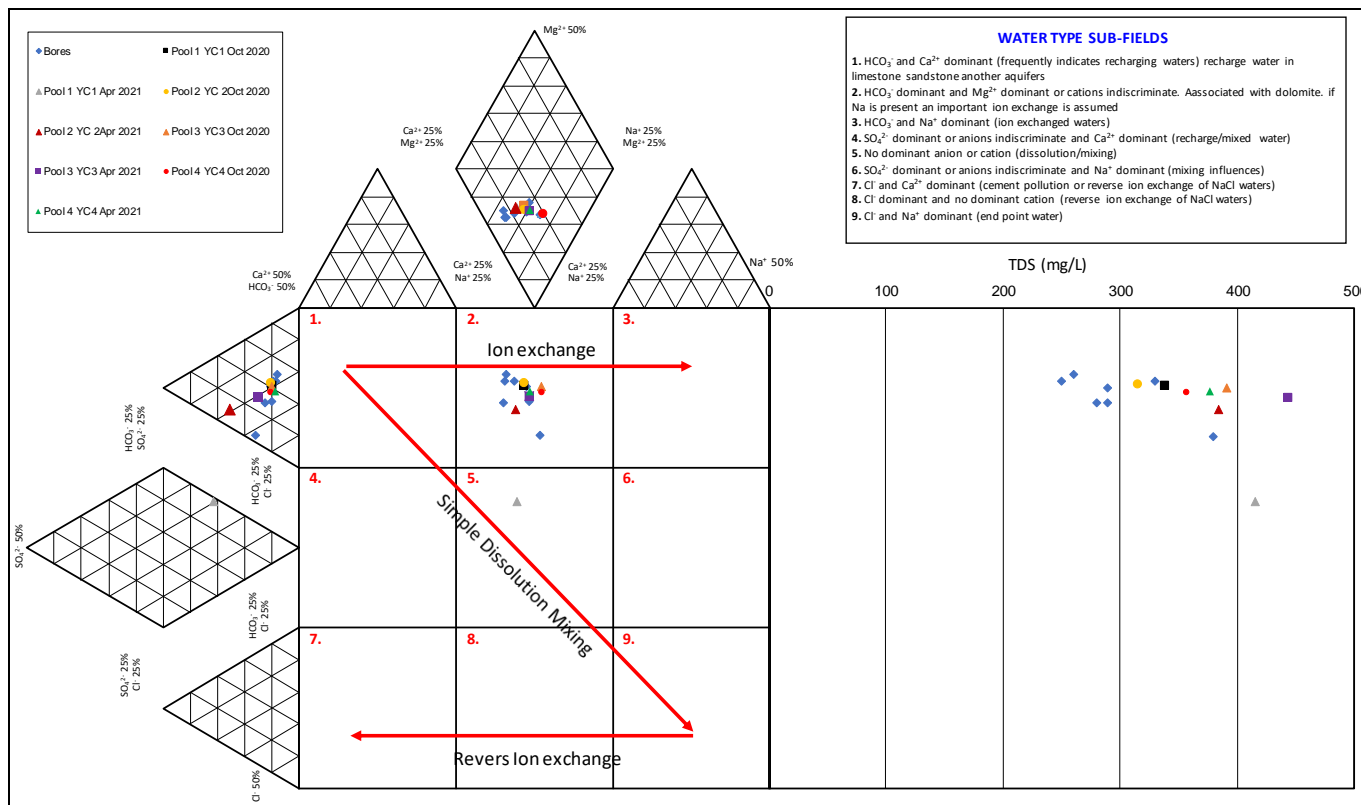
Figure 16: Expanded Durov Diagram for all Yandicoogina Pool Water Samples

Two rounds of sampling were undertaken from four pools (YC1 Upstream to YC4 Downstream) within the Yandicoogina Gorge and are compared to samples taken from production bores (Figure 16). The samples were taken at the end of the dry season (October) and end of the wet season (April). Most samples represent the same groundwater type as the production bores, however the April 2021 sample taken from Pool 1 (YC1) shows the imprint of mixing or dissolution. Sulphate ( $\text{SO}_4$ ) is also elevated in the end of wet season in YC1 and YC2 sampling locations. These locations have likely been affected by mixing with a different source water, namely surface water inflow from the upstream catchment. The source of sulphate is potentially interaction with pyrite hosted in the black shale source rock of the cobbles, which form the alluvial sediments at the base of the gorge. Additionally, all samples taken from the pools during the April 2021 sampling event have slightly elevated EC and lower pH than samples taken during the dry season or from the production bores.

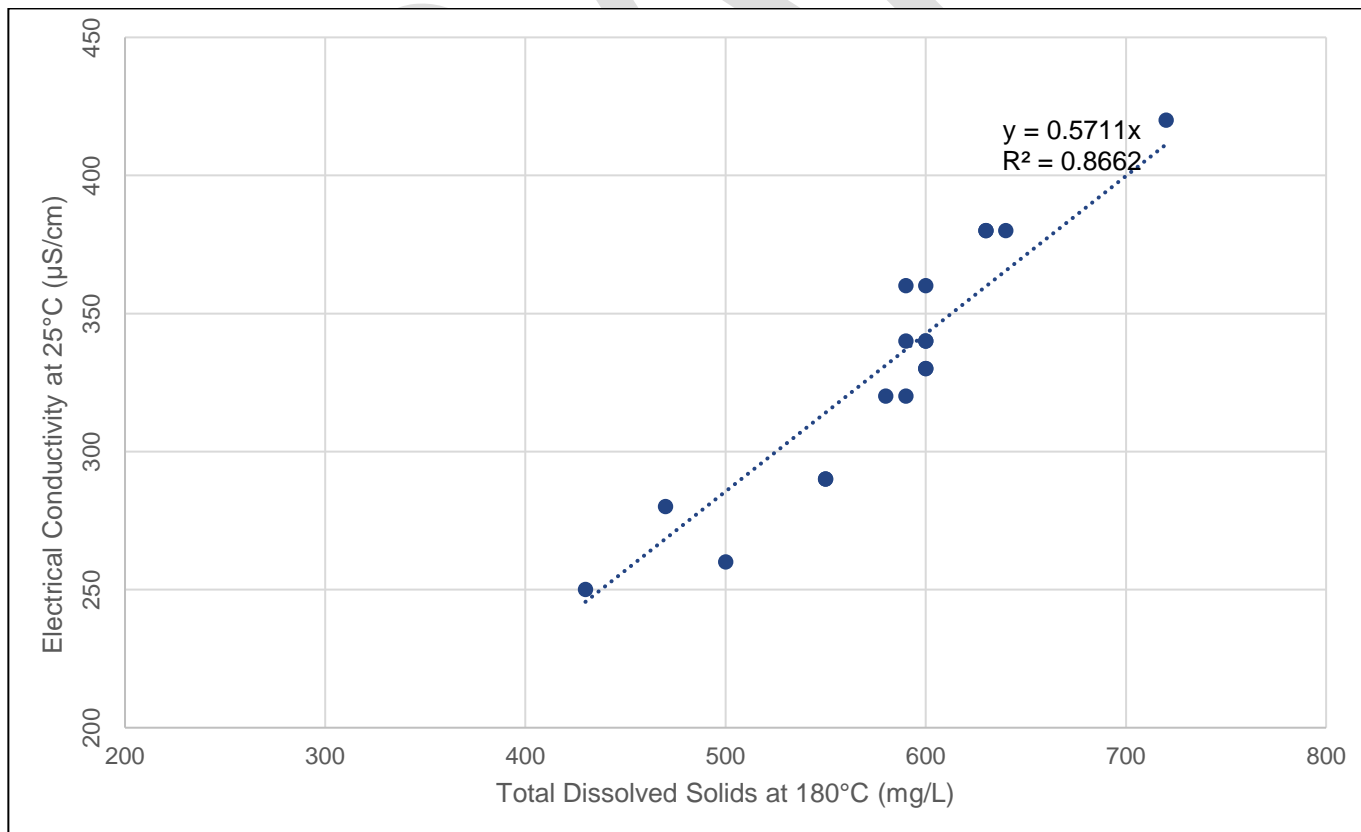
Figure 17: Electrical conductivity to TDS for Ministers North to establish conversion ratio

Note: \* TDS derived from electrical conductivity conversion factor of 0.5711 given in Figure 17.
