KOJONUP WIND FARM

# Shadow Flicker and Blade Glint Assessment

Kojonup Wind Farm Pty Ltd

**Report No.:** 10557557-AUMEL-R-02, Rev. D

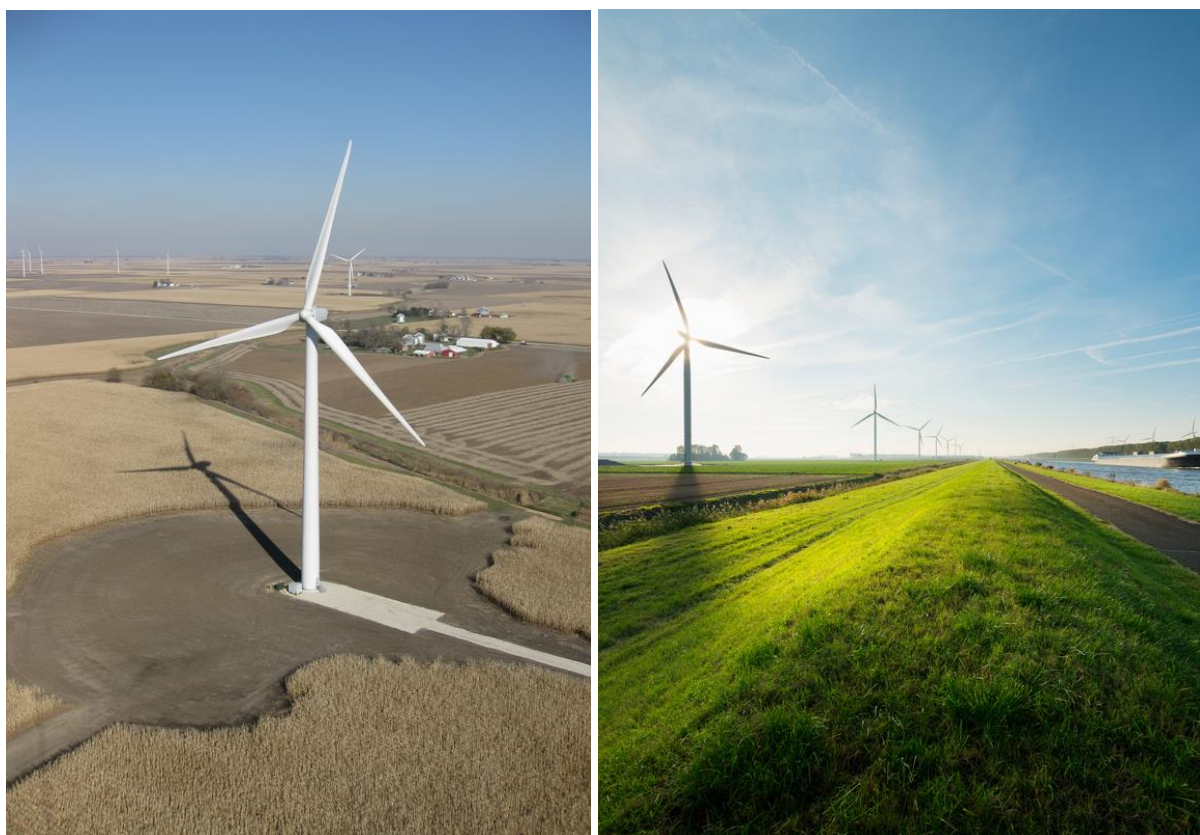
**Figure 1 Examples of wind turbine shadows**

Example photographs of wind turbines and associated shadows which have the potential to cause flicker are shown in Figure 1 below.

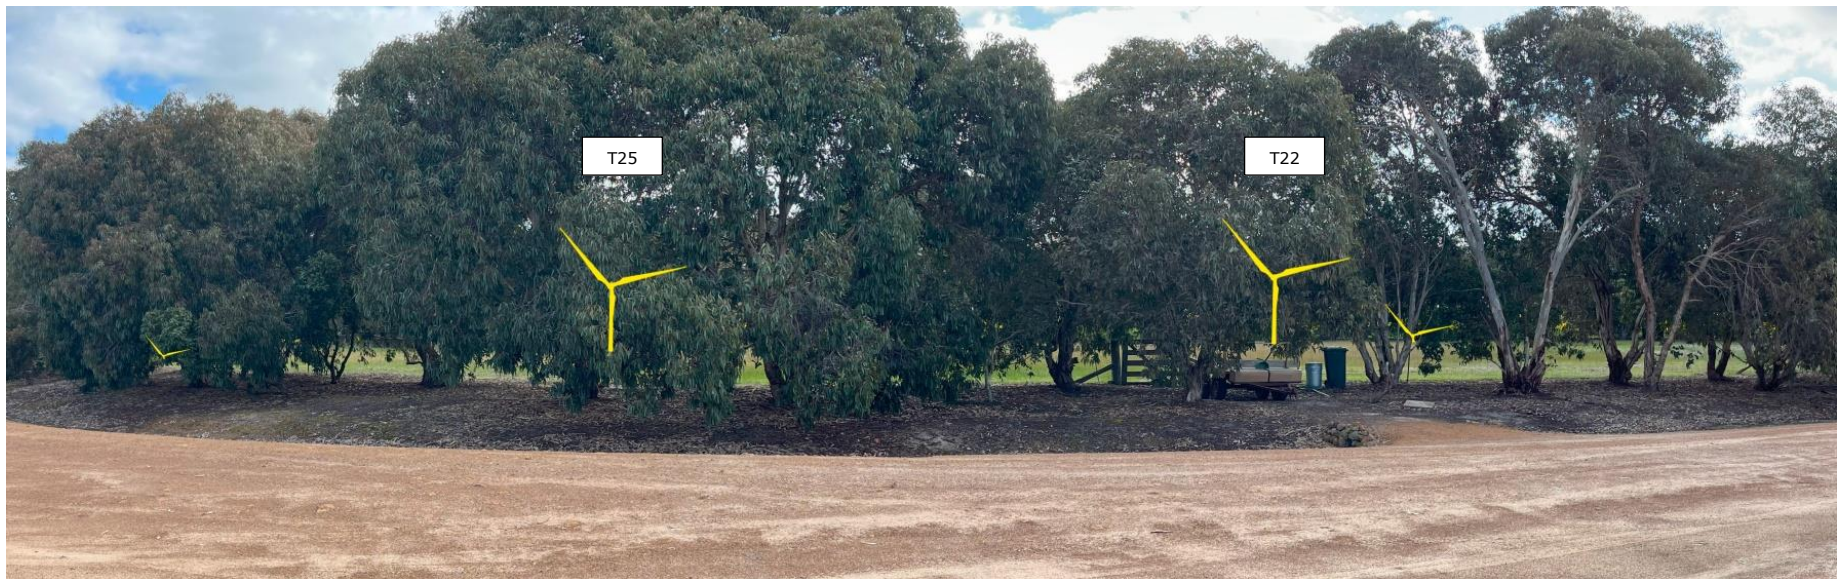
**Figure 8 Photomontage taken near Dwelling 10 (view towards the West)**

Photomontages for viewpoints located near the west and northwest and east sides of the dwelling, with the view facing west, north-northwest and northeast are presented in Figure 8, Figure 9, Figure 10 respectively in Appendix A.

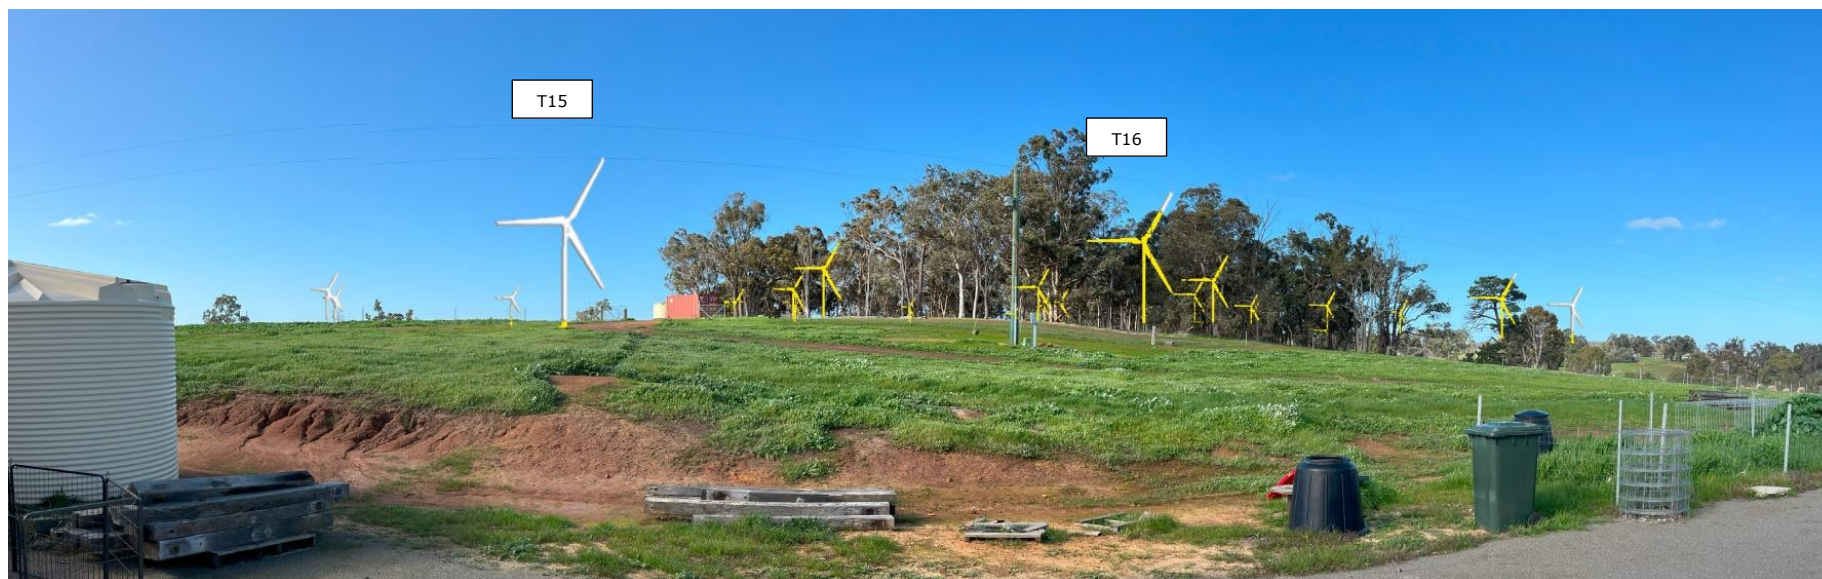
**Figure 11 Photomontage taken near Dwelling 17 (view towards the East)**

A photomontage for a viewpoint located near the east side of the dwelling, with the view facing east, is presented in Figure 11 in Appendix A.
