Robe River Mining Co. Pty Ltd ABN: 71 008 694 246

# West Angelas Closure Plan

April 2018

Mineral Field 47 – West Pilbara FDMS No RTIO-HSE-0228290

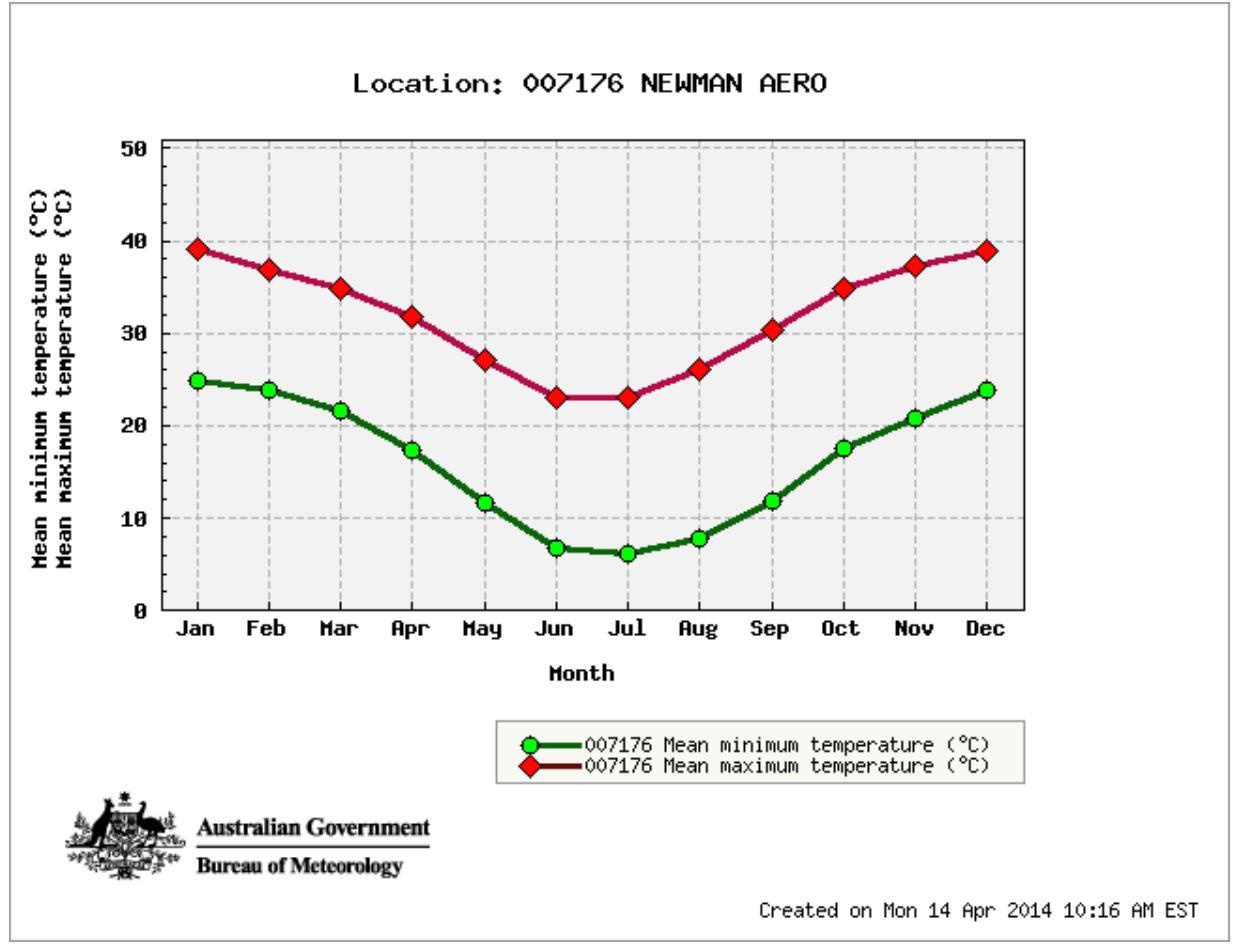
Figure 5: Mean monthly temperatures, Newman Airport 1996-2013.

The climate in the area can be characterised as arid tropical with two distinct seasons, hot wet summers and cooler dry winters. Mean daily maxima temperatures range from 40°C in summer to 22°C in winter (Figure 5).

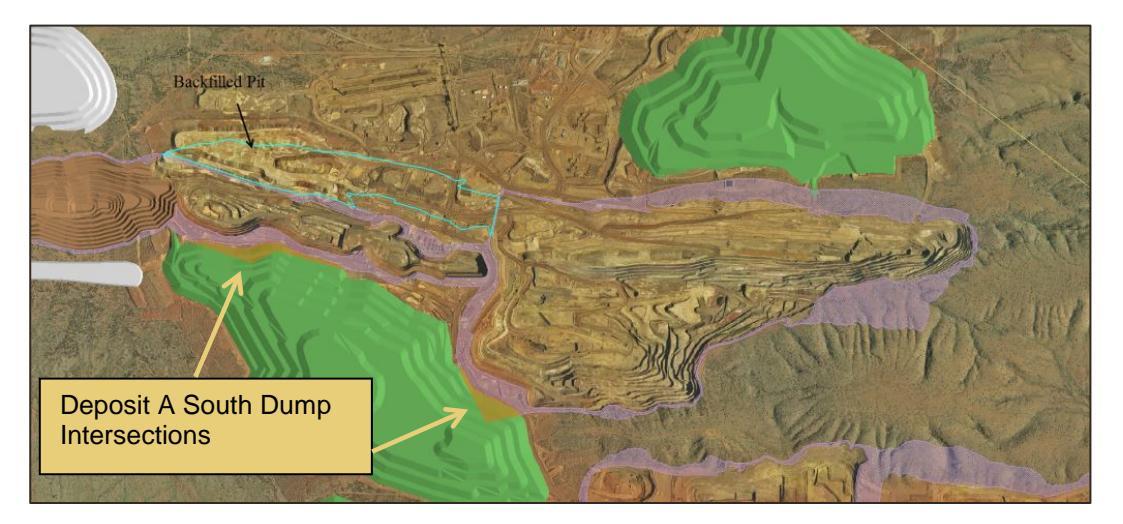
Figure 8: Zone of geotechnical instability around Deposit A

Preliminary zones of geotechnical instability have been identified around all pits covered within the scope of this closure plan, except for Deposit G which is yet to be sufficiently defined. Methodology is based on the angle method described in DMP abandonment bund guideline<sup>3</sup>, using the conservative assumption that all pit walls are embedded into weathered rock (i.e. the polygons are lines drawn at a 25<sup>o</sup> angle from the base of the pit). Further geotechnical evaluation is being undertaken, and may result in a reduction of the current polygons. These are shown in Figure 8 – Figure 14.

The Deposit A South Dump and Deposit E South Dump intersect with the zones of instability for the adjacent pits.

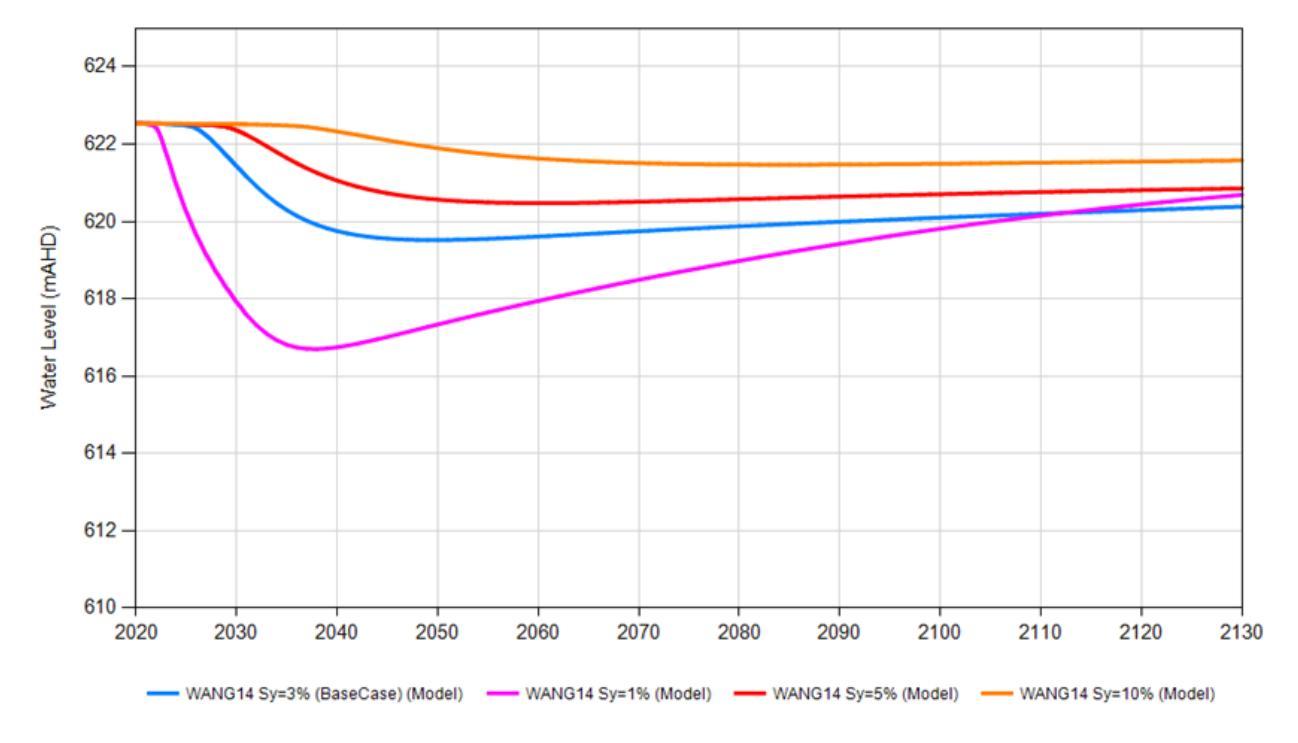
The base case scenario (Sy 3%) will result in drawdown of the groundwater of 3 m in approximately 2050. This will translate to a rate of groundwater drawdown of up to 30 cm per year. The upper limit (worst case) scenario (Sy 1%) will translate to a rate of groundwater drawdown of up to 80 cm per year.

Figure 16: Modelled groundwater drawdown for specific yield (Sy) scenarios at bore WANG14, located approximately 2.5 km within the boundary of Karijini National Park.

<sup>&</sup>lt;sup>9</sup> Noting this worst case rate of groundwater drawdown is predicted to be of limited duration as indicated by Sy = 1% drawdown curve in Figure 16. The average rate of drawdown over the modelling period (100 years) is 3.5cm per year for Sy = 1%.

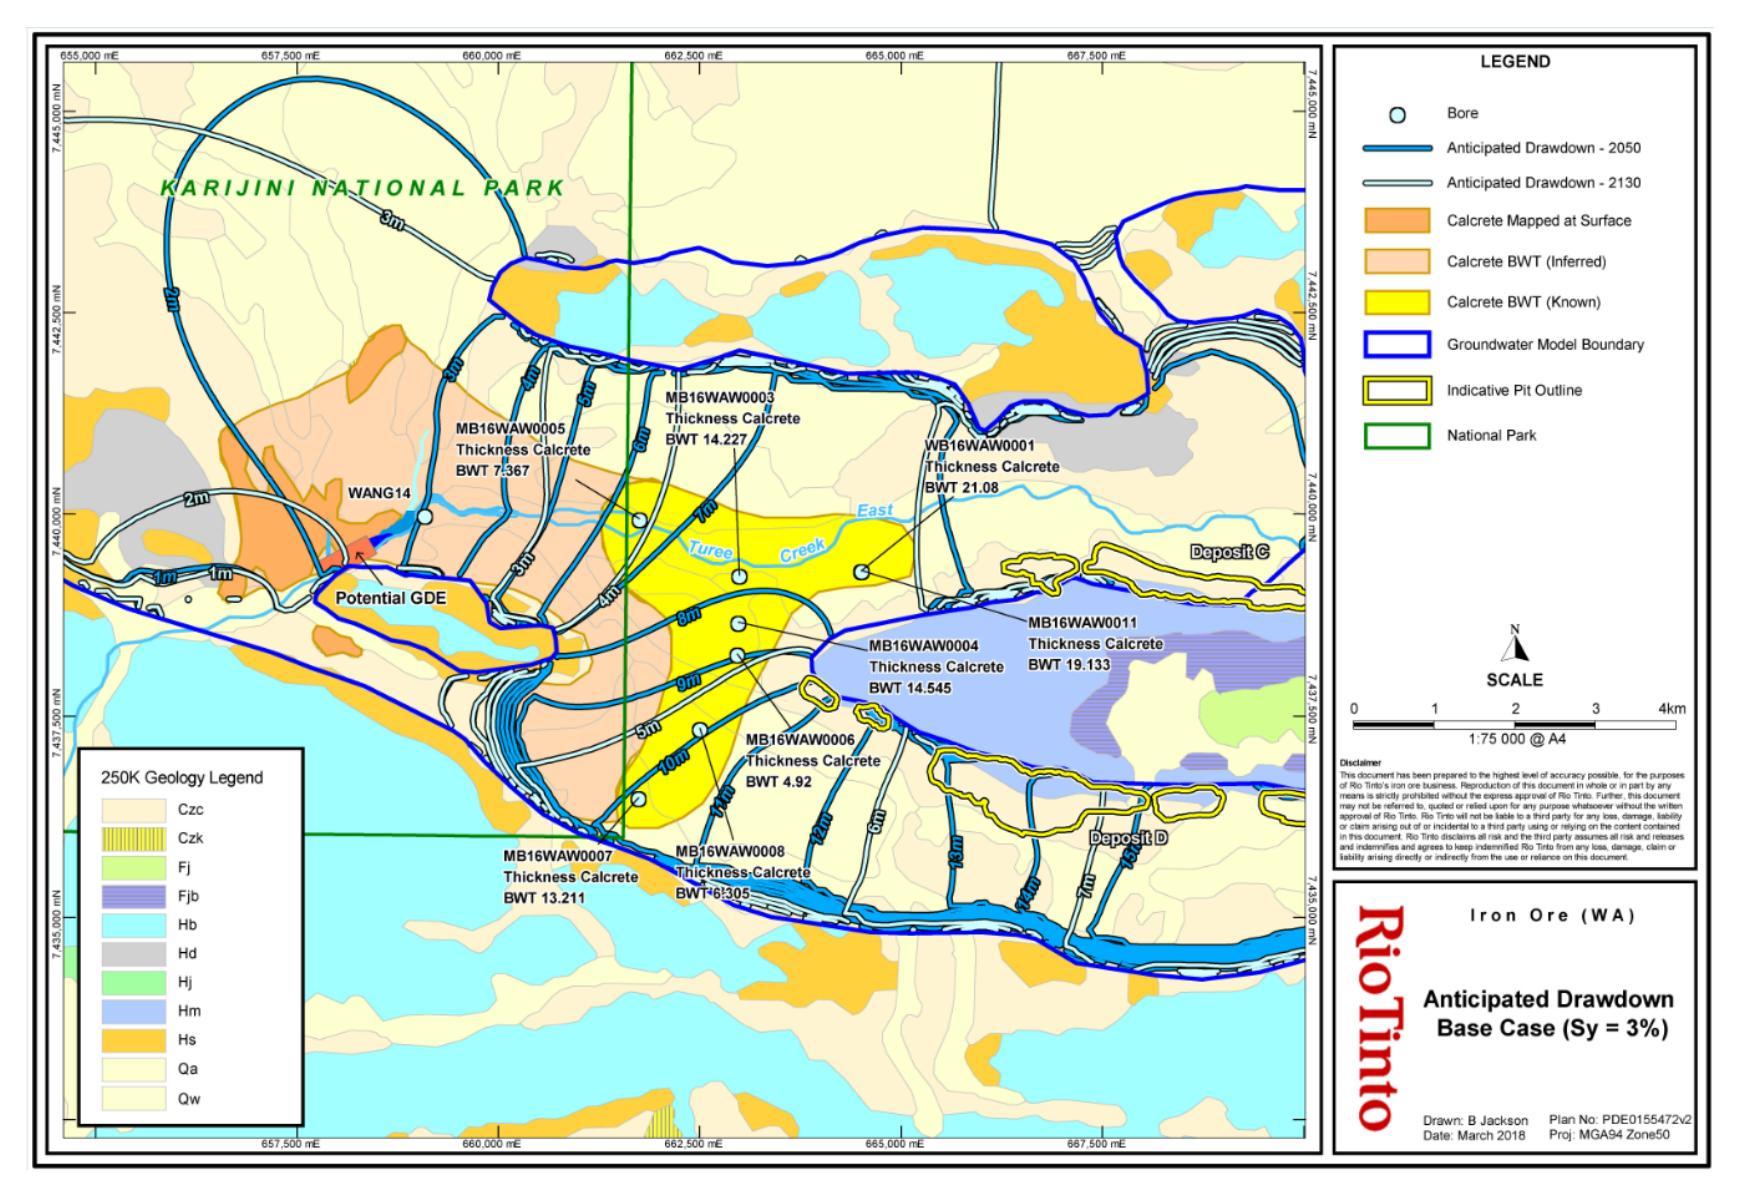
Maximum groundwater drawdown beneath Karijini National Park (at WANG14) is not predicted to be affected by cyclonic events. However, drawdown recovery is predicted to be increased – between 0.3 m and 1 m recovery after 100 years (Figure 17 and Figure 18).

Figure 17: Anticipated drawdown (base case, sy=3%)

The numerical modelling also does not accommodate additional complexity to the west of the deposits and beneath Karijini National Park due to the presence of calcrete (Figure 17, Figure 21). A significant amount of calcrete is present based on the surface geology mapping and observed intersections. Calcrete may have much higher storage capacity than the surrounding aquifer and create enhanced recharge and groundwater mounding during the wet season.

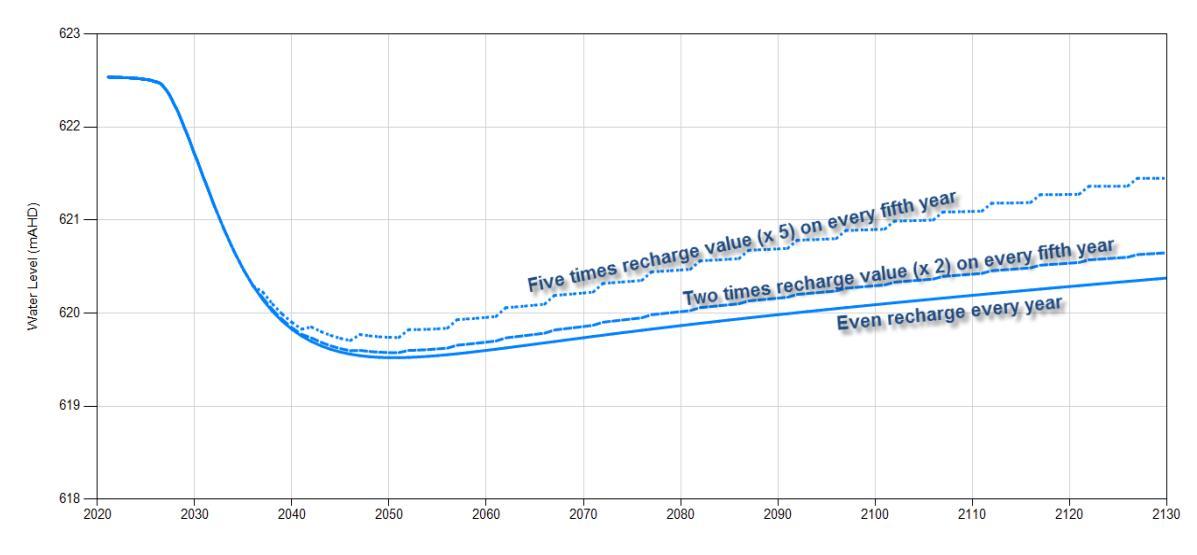
Figure 18: Effect of cyclical cyclone events on modelled groundwater drawdown at bore WANG14, located approximately 2.5 km within the boundary of Karijini National Park

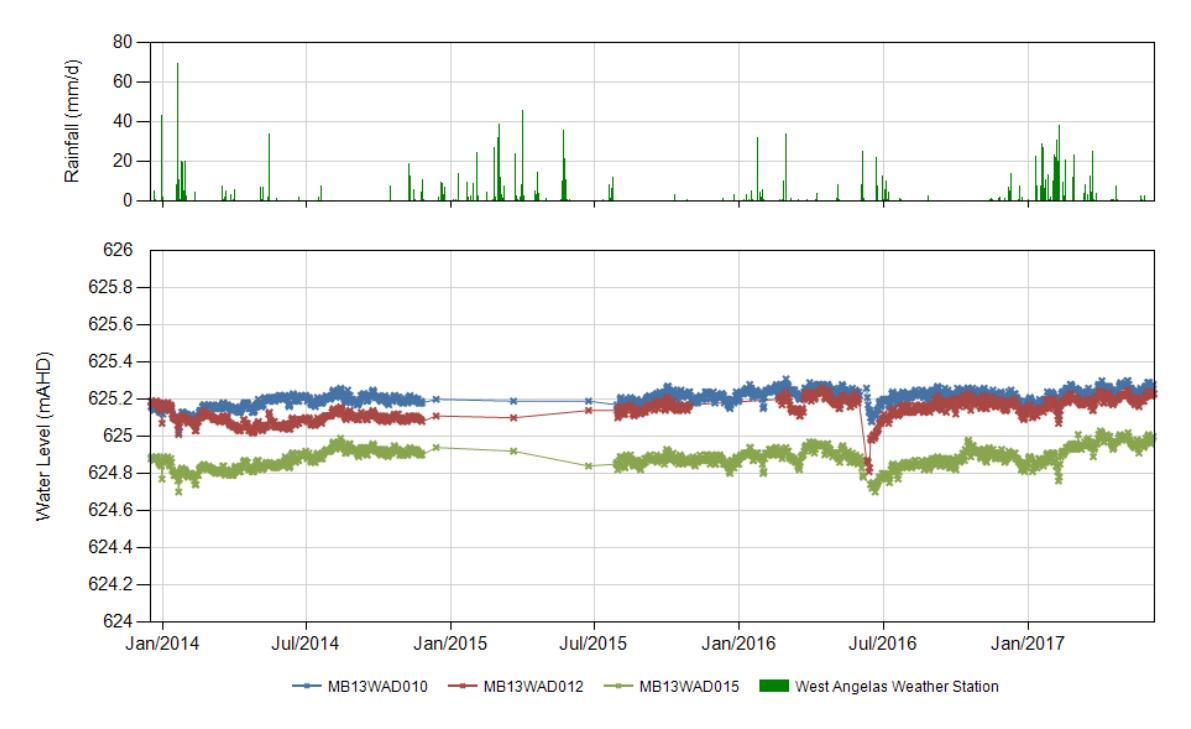
Owing to the depth to groundwater, recharge within the deposits is expected to be limited. Hydrographs show no observable response in groundwater level elevation within the deposits associated with rainfall events (Figure 19). Given the limited recharge, recovery of the groundwater elevation is conservatively assumed not to occur. As such, the drawdown of the groundwater beneath potentially groundwater dependent vegetation within Karijini National Park is conservatively assumed to continue to persist beyond 100 years. However groundwater level elevations observed at bore WANG14, located approximately 2.5km within the boundary of Karijini National Park, show appreciable response up to 4m to flooding events (Figure 20).

Figure 19: Hydrographs: groundwater level elevation within the deposits in response to rainfall data

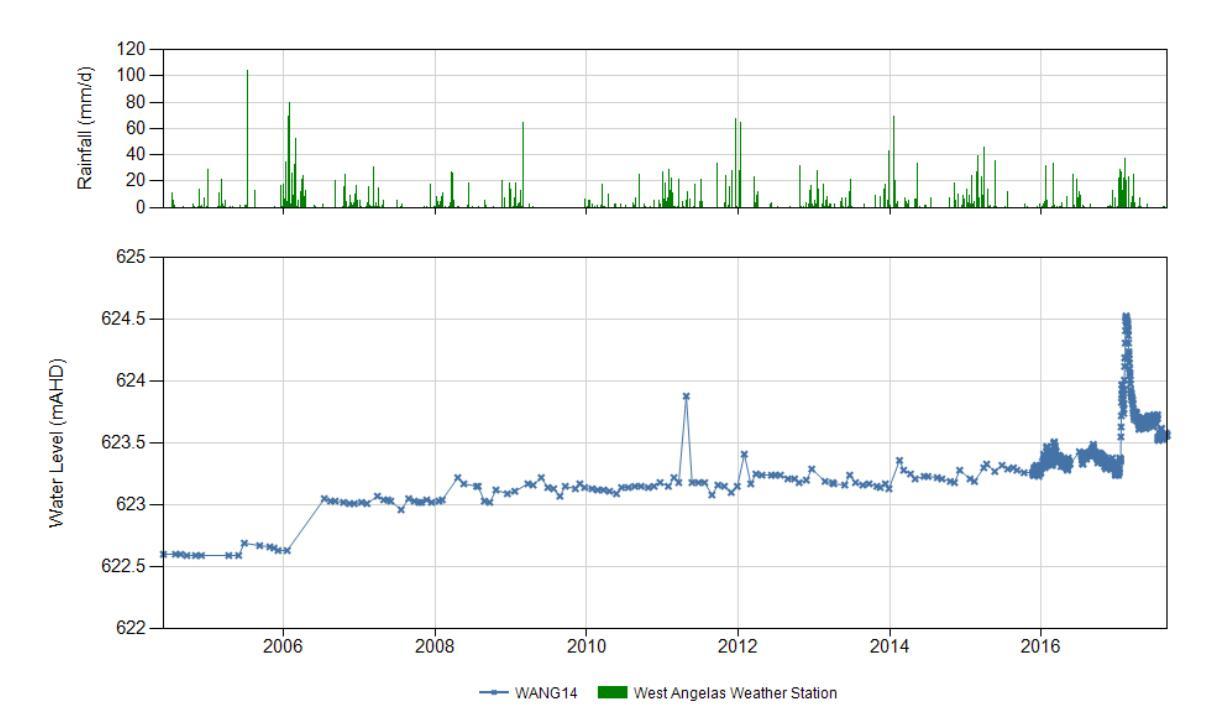
Figure 20: Hydrographs: groundwater level elevation within bore WANG14, located within Karijini National Park in response to rainfall data

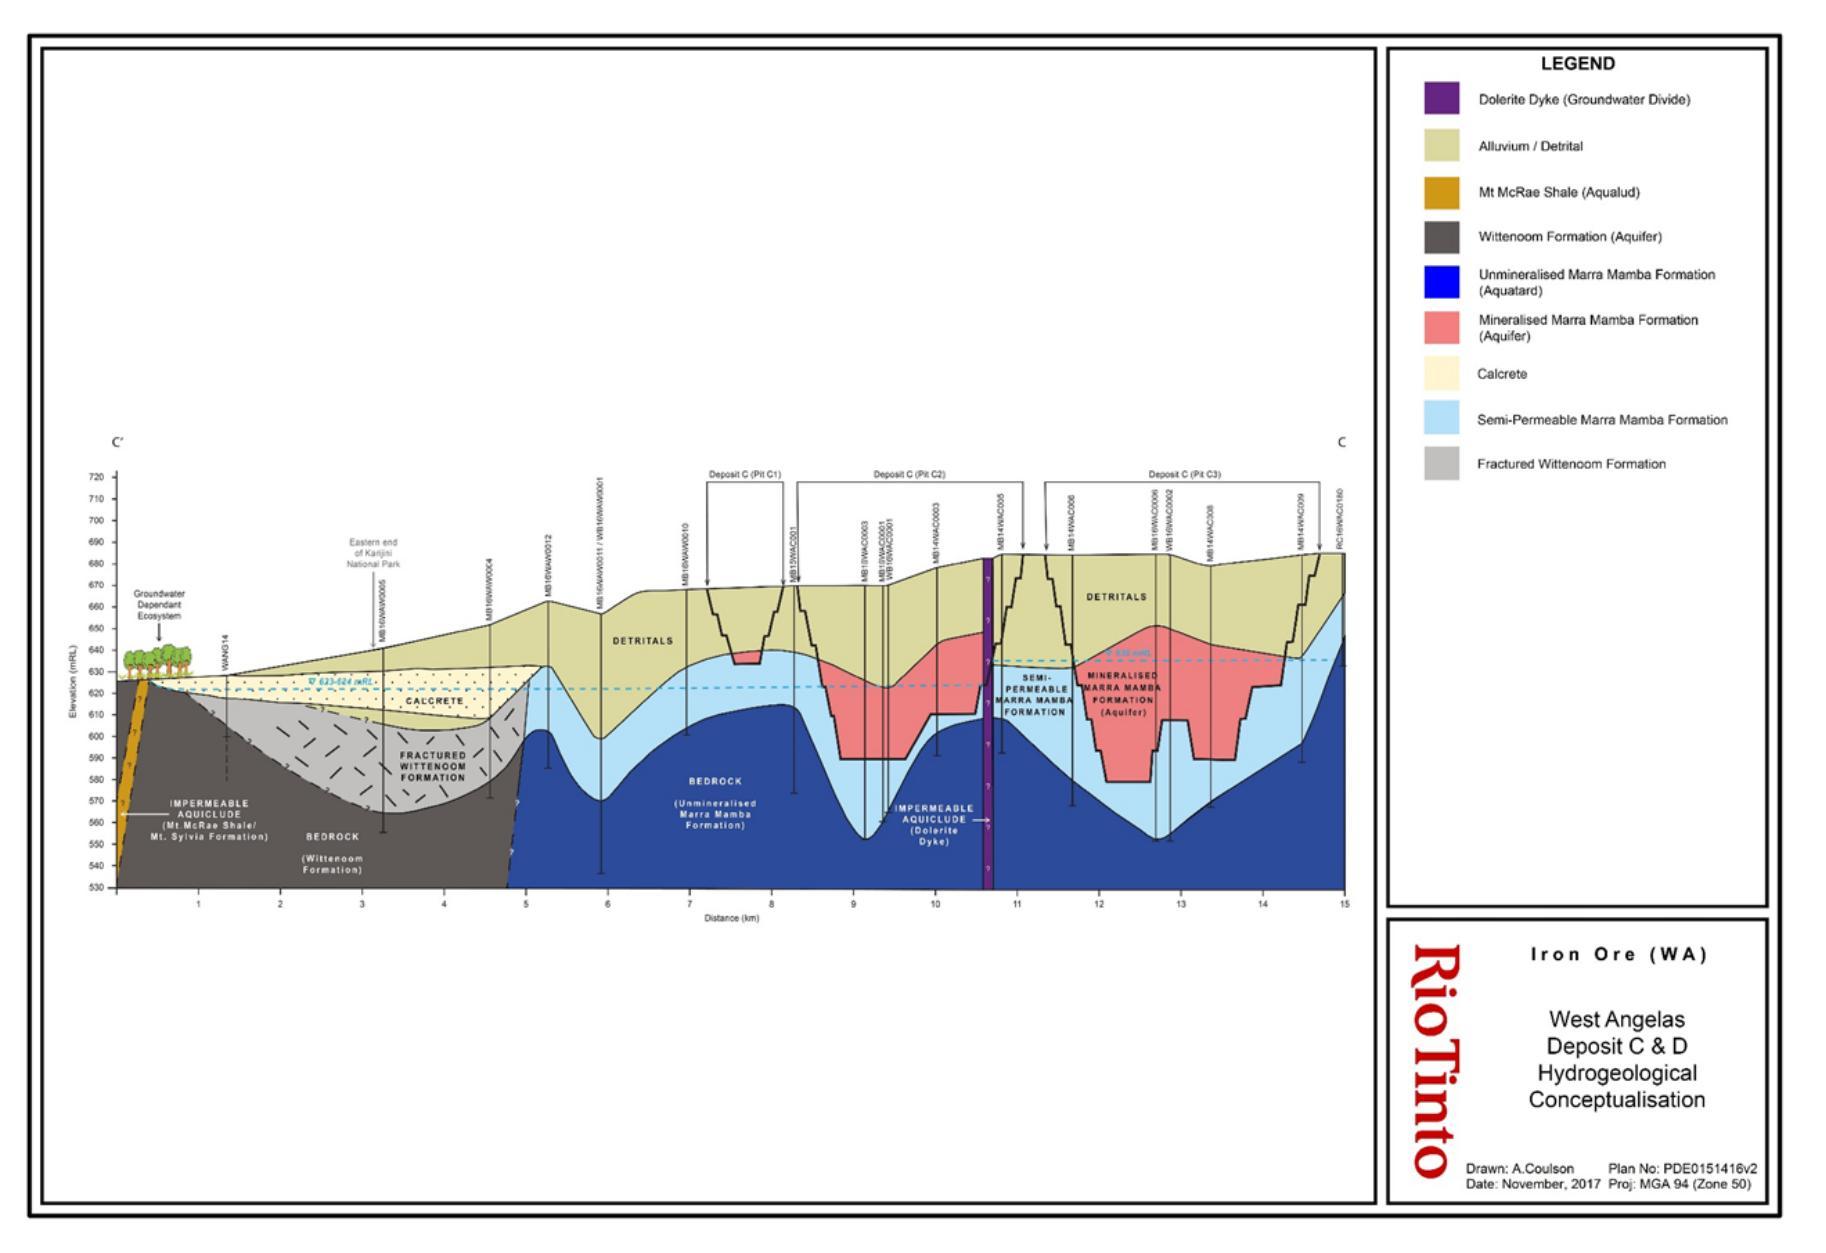
Figure 21: Hydrogeological conceptualisation, cross section; Deposit C, west of Deposit C and Karijini National Park (east-west)

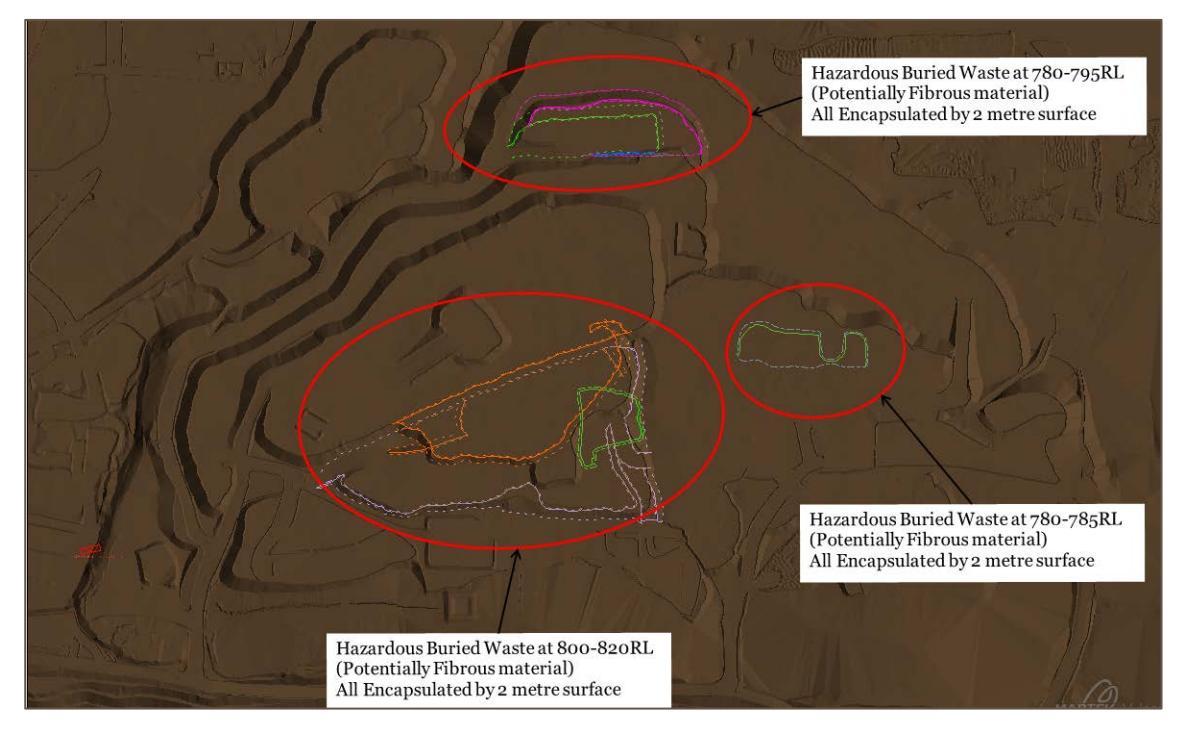
Figure 29: Potentially Fibrous Material Storage at Deposit A North Waste Dump

Deposit B East Waste Dump has also been designated as a storage location for potentially fibrous material in the future, but specific storage locations within the dump are yet to be determined.

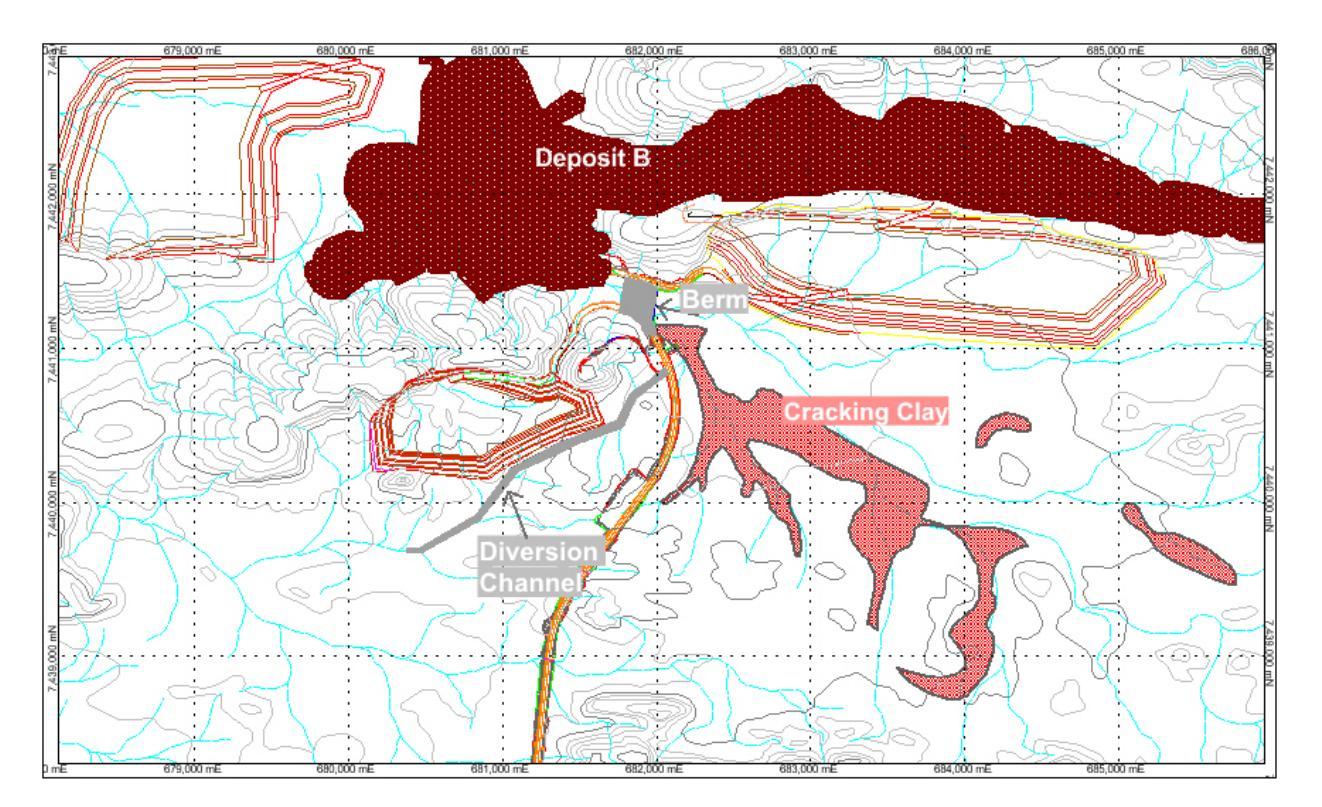
Figure 31: Deposit B diversion berm and channel

The performance of the channel will be evaluated during operations, and the closure strategy will be reassessed as the site approaches closure.

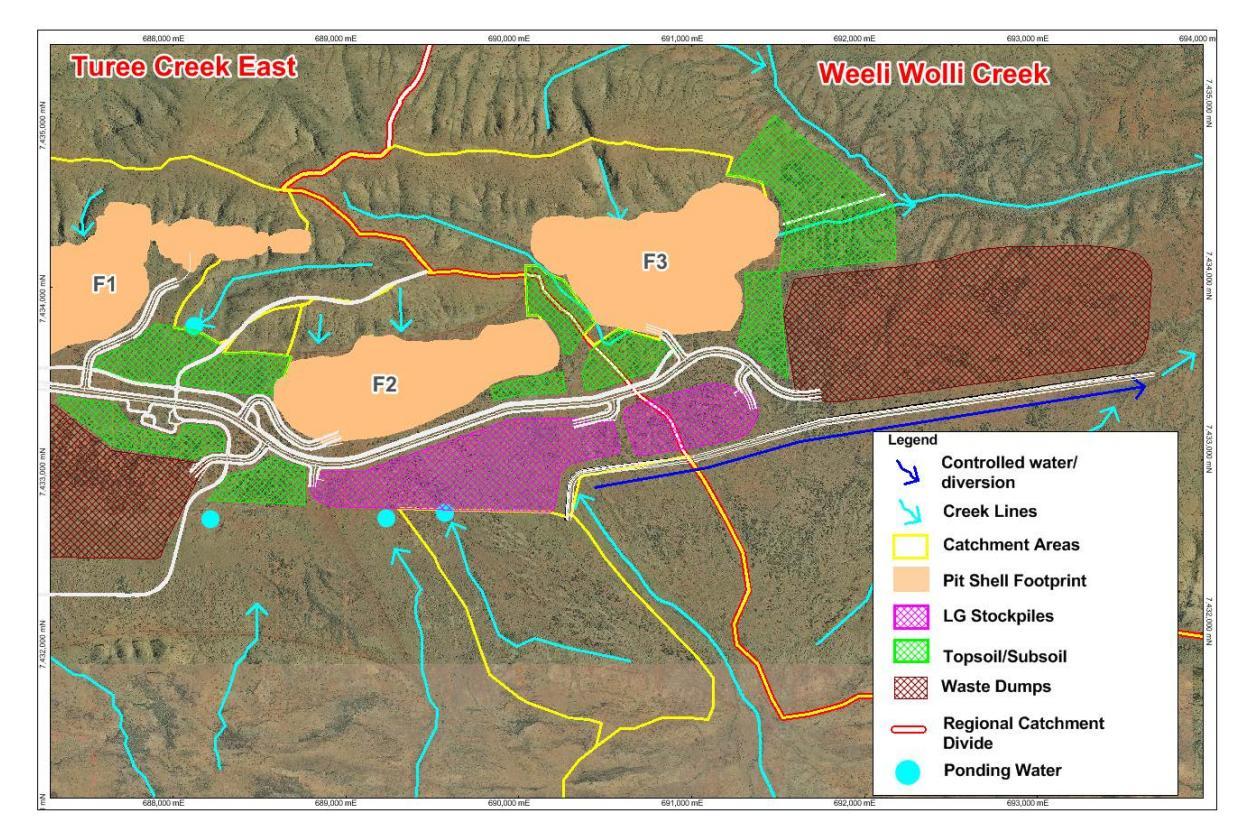
Figure 32: Deposit F diversion

One of the Deposit F pits (F2 pit) intercepts an unnamed ephemeral creek. In order to manage flows, a diversion and levee has been placed upstream of the pit to direct flows eastwards into the Weeli Wolli Creek catchment, as shown on Figure 32.

The diversion and levee is 3.4 km in length and ranges in height from 3.5 m to 5.6 m. It is 15 m wide at the base, tapering to 3 m wide at the top.

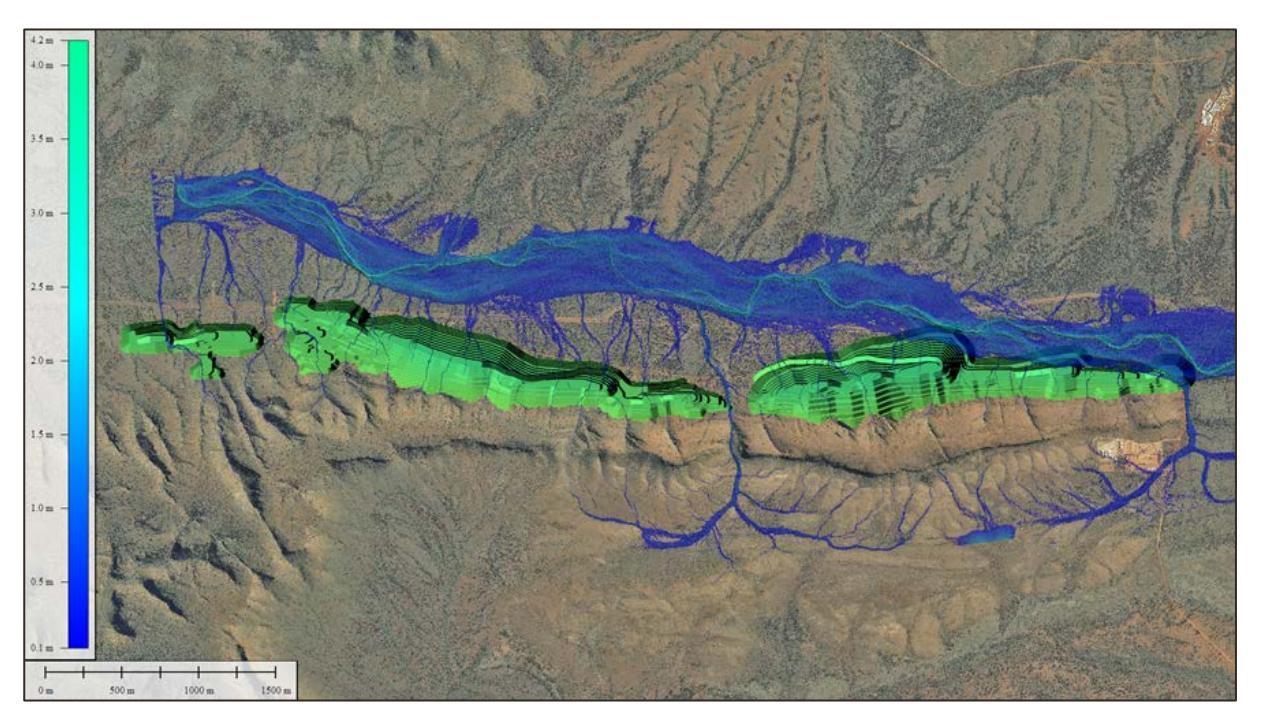
Figure 33: Maximum extent of 1% AEP flood event under existing conditions at Deposit C

Therefore, to manage surface water flows from the Turee Creek East tributary intercepted by Deposit C, a 1% AEP capacity diversion channel is proposed to the north of Deposit C (Pit 3). The 3 km diversion channel, referred to as the Turee Creek East Realignment Diversion, will be designed to redirect the surface water flows which would otherwise be captured by Deposit C northwards, to maintain the continuation of natural surface water flows in Turee Creek East during operations.

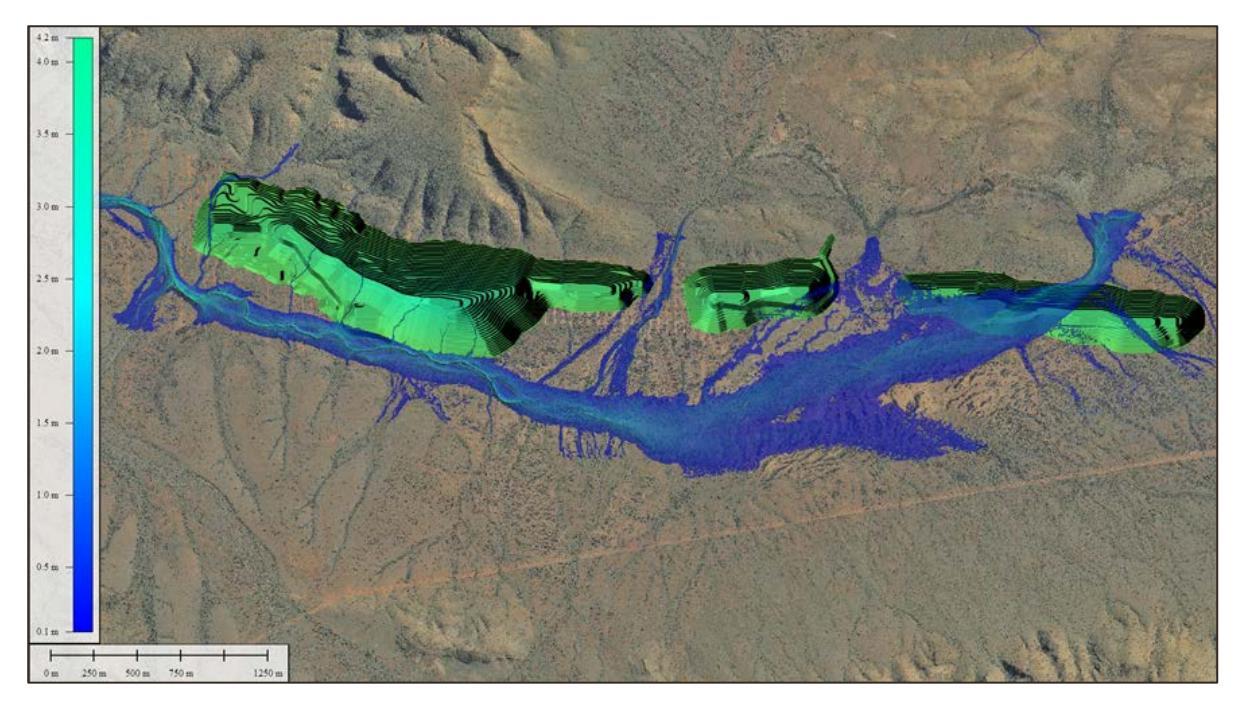
Figure 34: Maximum extent of 2% AEP flood event under existing conditions at Deposit D

Similarly, with no flood protection, water from Turee Creek East South would flow into Deposit D (Pit D3). To manage flows from the Turee Creek East South tributary intercepted by Deposit D, a 2% AEP capacity diversion channel is proposed to the north and west of Deposit D (Pit 3). The 2.7 km diversion channel will redirect surface water flows, which would otherwise be captured by Deposit D, around the north and west of Pit D3 to maintain the continuation of natural surface water flows in Turee Creek East.
