GEOMORPHIC WETLANDS Swan Coastal Plain Dataset Request For Modification

Lot 123 Mortimer Rd Casuarina

Getin Keel

Prepared by: Mia Harris BSc Bioscience Pty Ltd

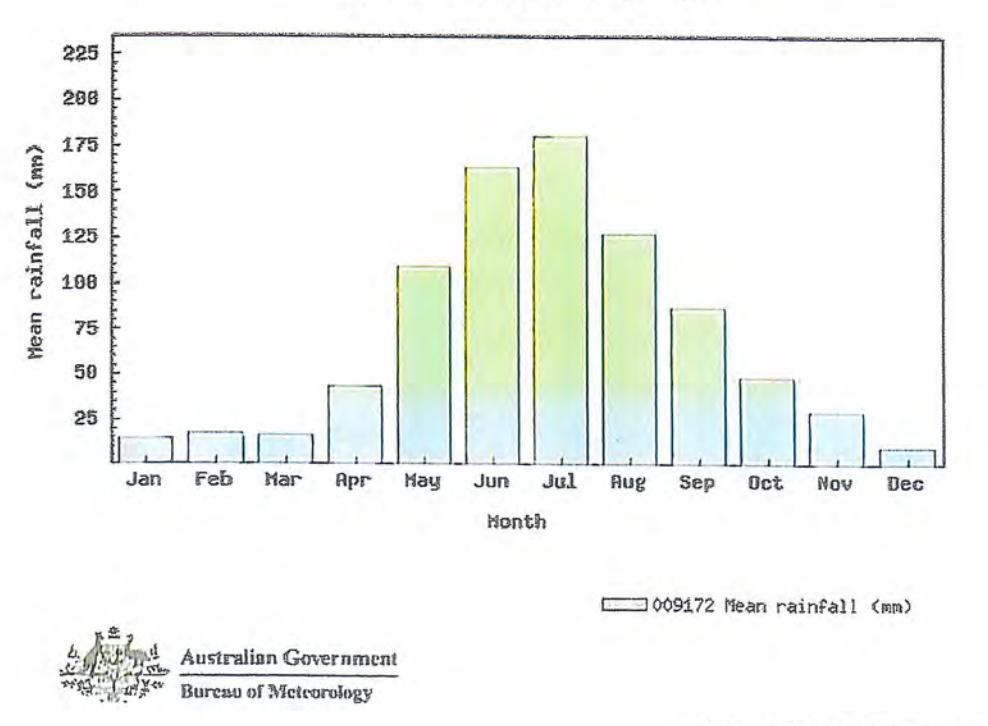
Figure 2: Average Annual Rainfall 1972-2010

The south west of Western Australia is characterised by a Mediterranean climate comprising hot dry summers and cool wet winters. According to the Bureau of Meteorology the average annual rainfall within the vicinity of the site is 827.7mm (Jandakot Aero No. 009172). The monthly distribution of rainfall (Figure 2) indicates approximately 85% of the rainfall occurs during the months of May to October. The potential annual evaporation of the area is 1800 mm, which is significantly more than annual precipitation (Davidson and Yu, 2006). The prevailing wind is from a southwesterly direction, however easterly winds common, particularly in the summer months.

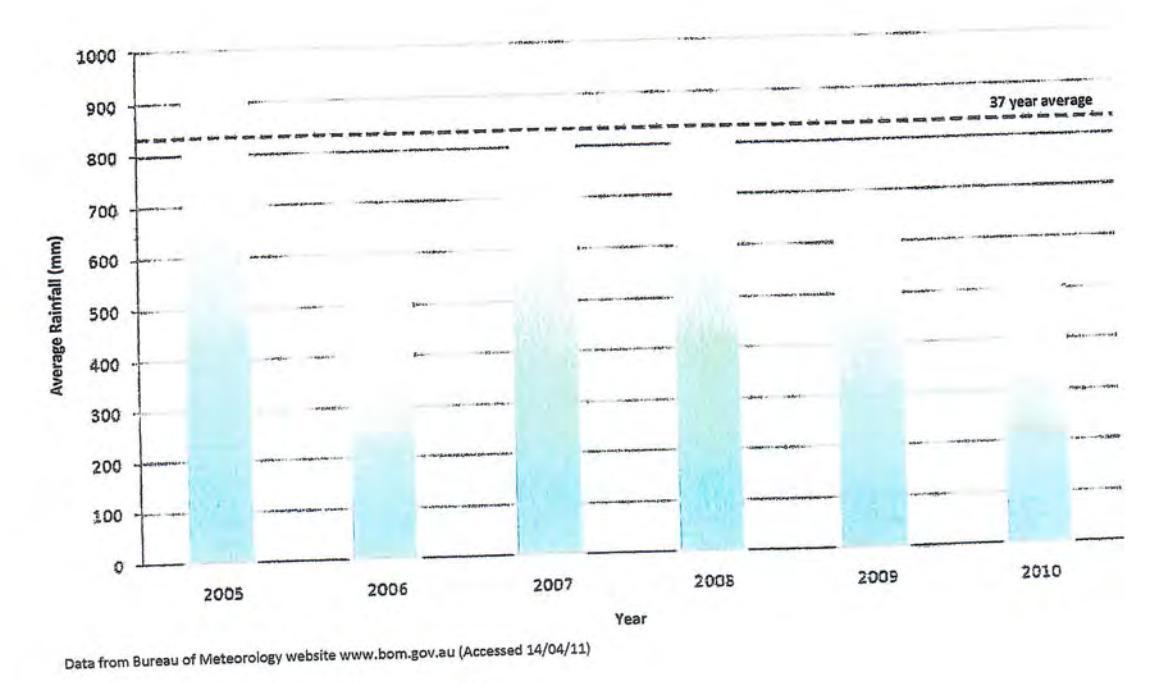
Figure 3: Rainfall over the study period

The average rainfall over the 6 year study period for this report varied markedly, with some years receiving average or slightly above average rainfall and others with significantly less rainfall than the 37 year average, with 2006 and 2010 receiving nearly half the average amount. However, 2005 recieved 13% more rainfall than the average and 2008 received 5% more rainfall than the average (Figure 3).

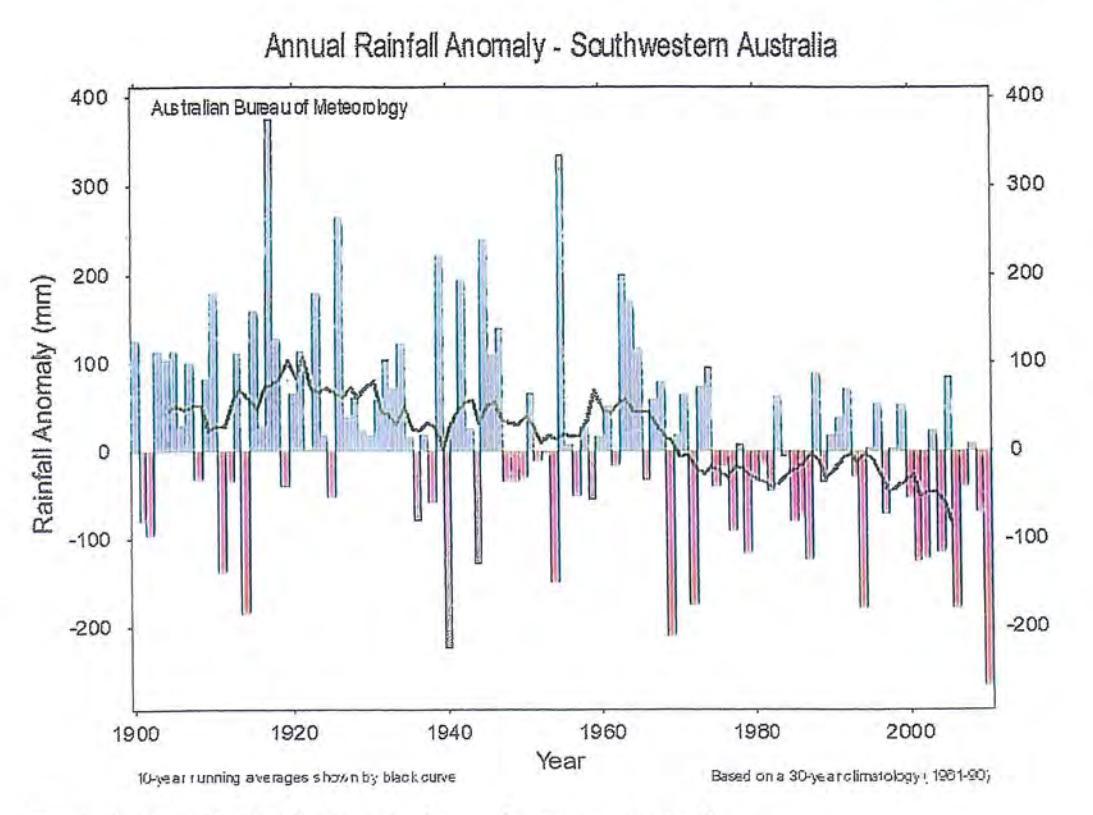
Figure 4: Annual rainfall anomaly for south-western Australia

Australia is one of the driest continents in the world and the affects of climate change are no more obvious than in south-western Australia. Time series charts such as figure 4 illustrate an excessive decrease in annual rainfall over the past 100 years. Decreasing rainfall and increasing temperatures over south-western Australia has had grim consequences for the Swan Coastal Plain's diverse wetlands. These factors have left many wetlands dry due to decreased groundwater recharge and increased evaporation.

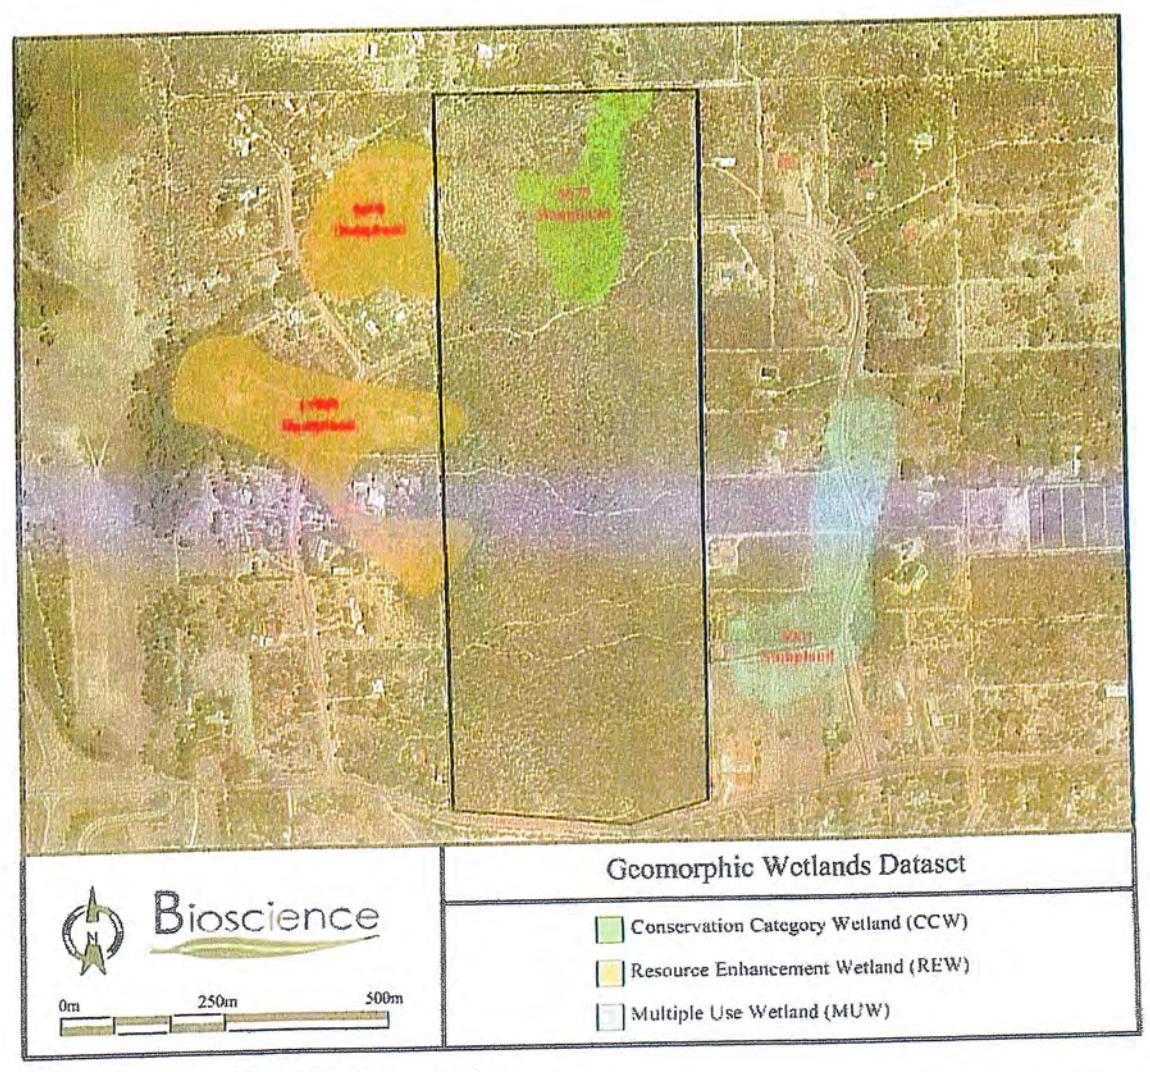
Figure 5: Geomorphic Wetlands Dataset Map

In 2002 part of the northern section of the property was classified as Conservation Category Wetland (CCW) under the Department of Environment's Wetland classification guidelines. Four other areas respectively classified as Resource Enhancement Wetlands (REW) also overlap the site (Figure 9).

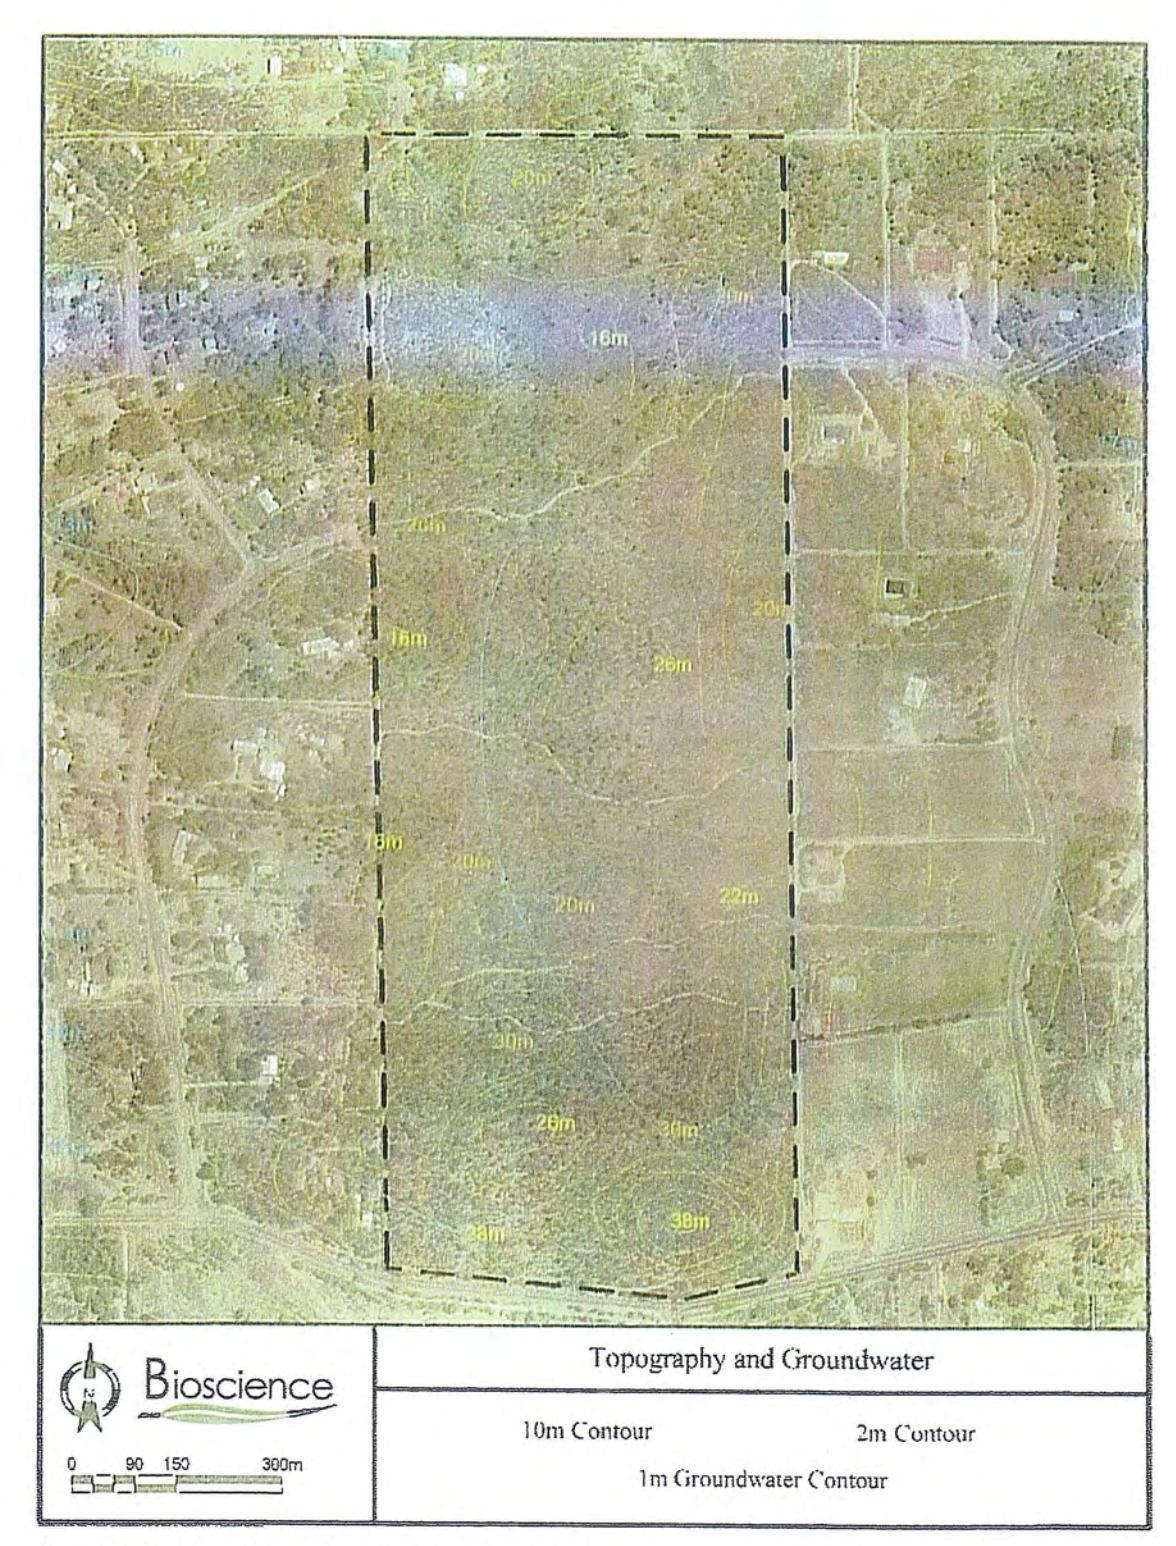
The area is undulating and according to the WA Atlas, elevation ranges from 38m AHD in the south eastern corner to 16m AHD in the demarked northern wetland areas and areas along the western boundary. The average height for the area is between 24 to 30m AHD with a general slope from south-east to north-west (Figure 6 contours from WA Atlas).

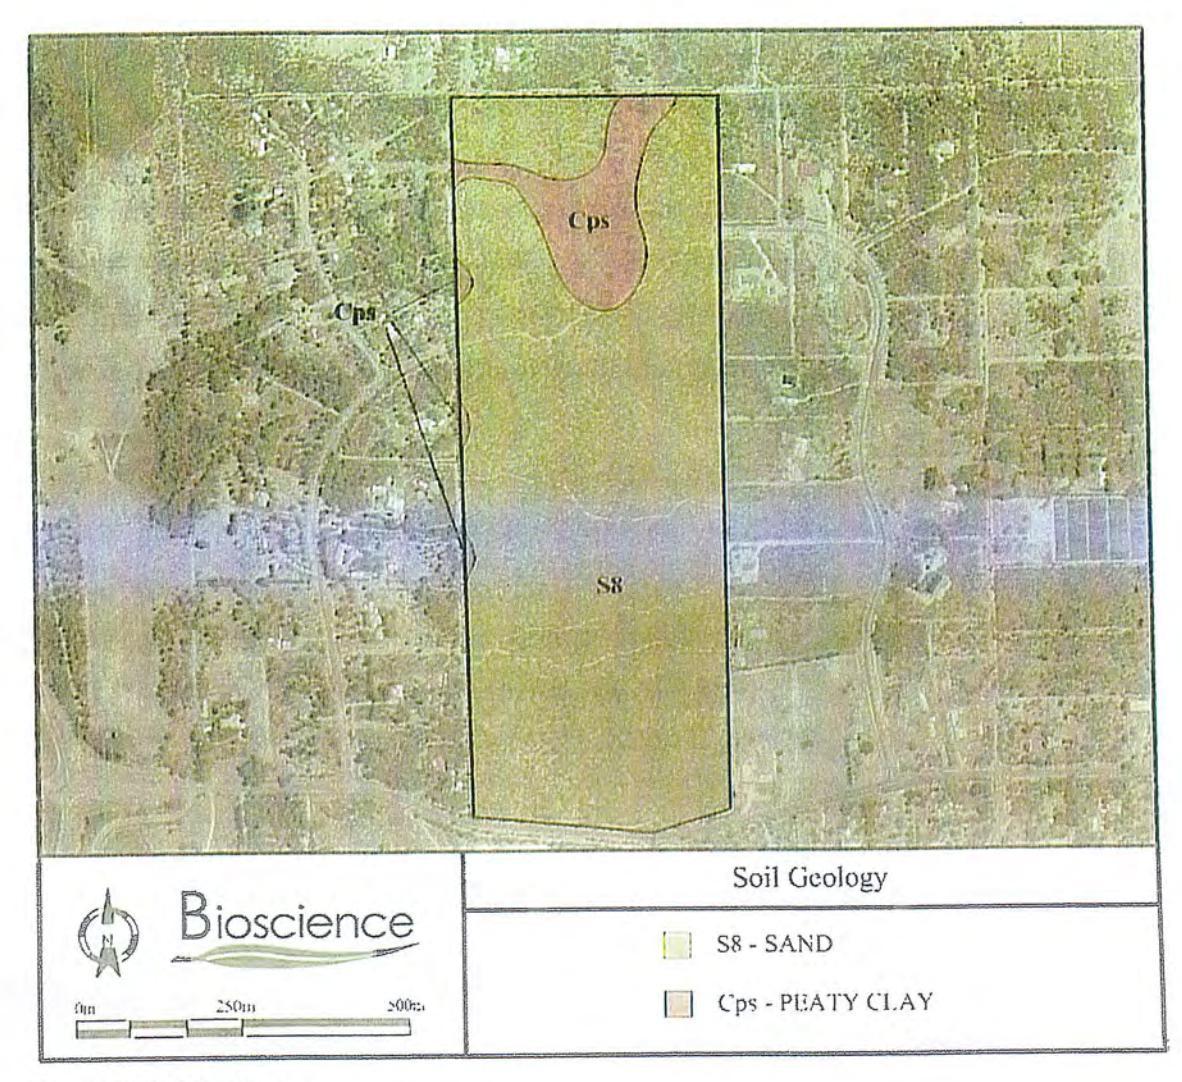
Figure 7: Soil Geology

The geology at the site as per the Geological Survey of Western Australia 1:50000 Environmental Geological Series Fremantle Map part of sheets 2033 I and 2033 IV and Rockingham Map part of sheets 2033 II and 2033 III are either (Figure 6):

- CPS PEATY CLAY Dark grey and black, soft, variable organic content, some quartz sand in places, of lacustrine origin
- S8 SAND Very light grey at surface, yellow at depth, fine to medium grained, sub-rounded quartz, moderately well sorted, of eolian origin .

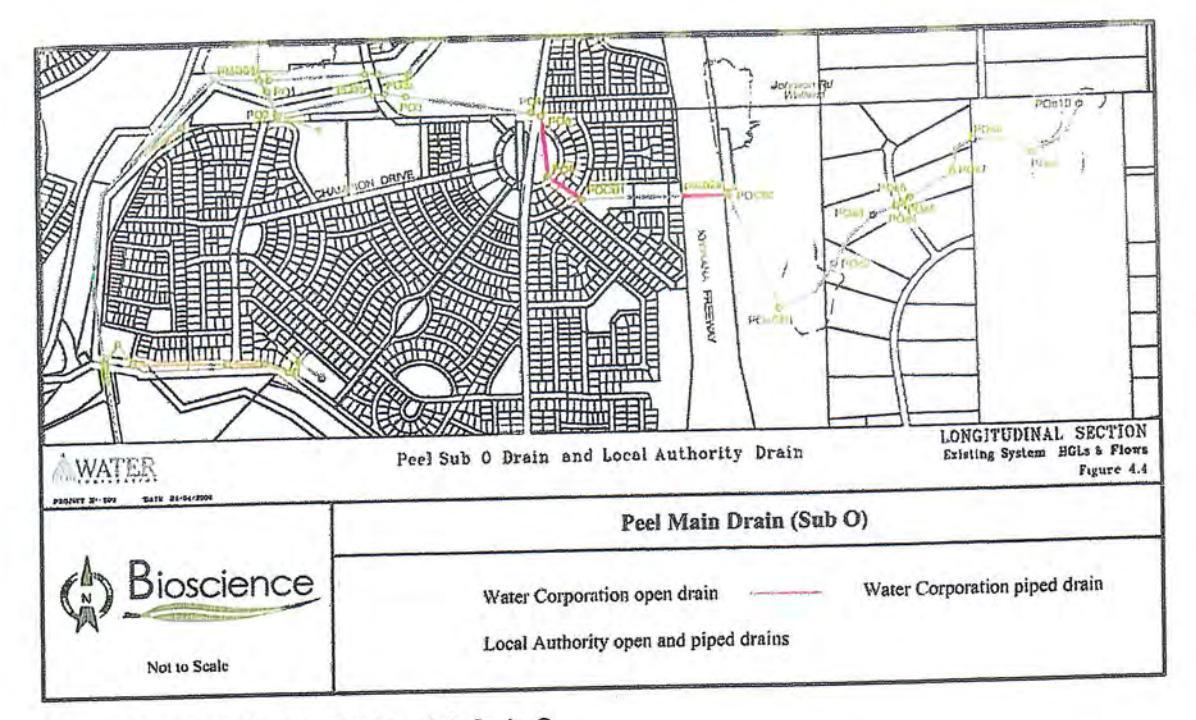
The Mortimer Road site is part of the Peel main drain system as outlined in the DoWs (2009) *Jandakot drainage and water management plan* (Figure 7). The Peel sub drain O begins at the northern part of the property at its highest point and runs west around 2 km before entering the main drain.

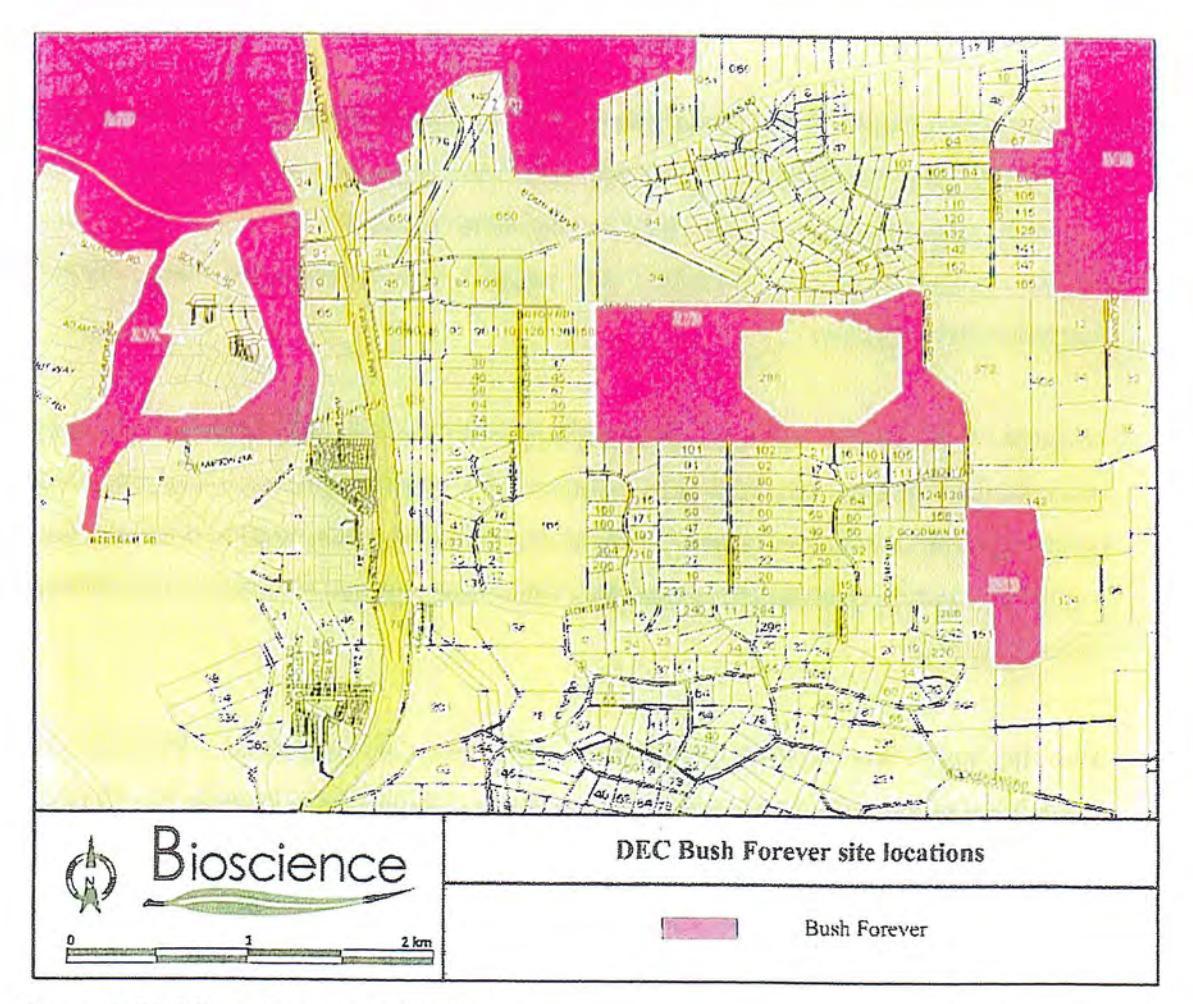
Figure 9: DEC Bush Forever site locations

The Bush Forever Site Number 273 is located north-east of the study area (Figure 8) and depicts the likely vegetation complexes that reside within the property. According to the *Bush Forever* site description (DEP, 2000) only one complex exists within site number 273; the Bassendean complex (Central and South).

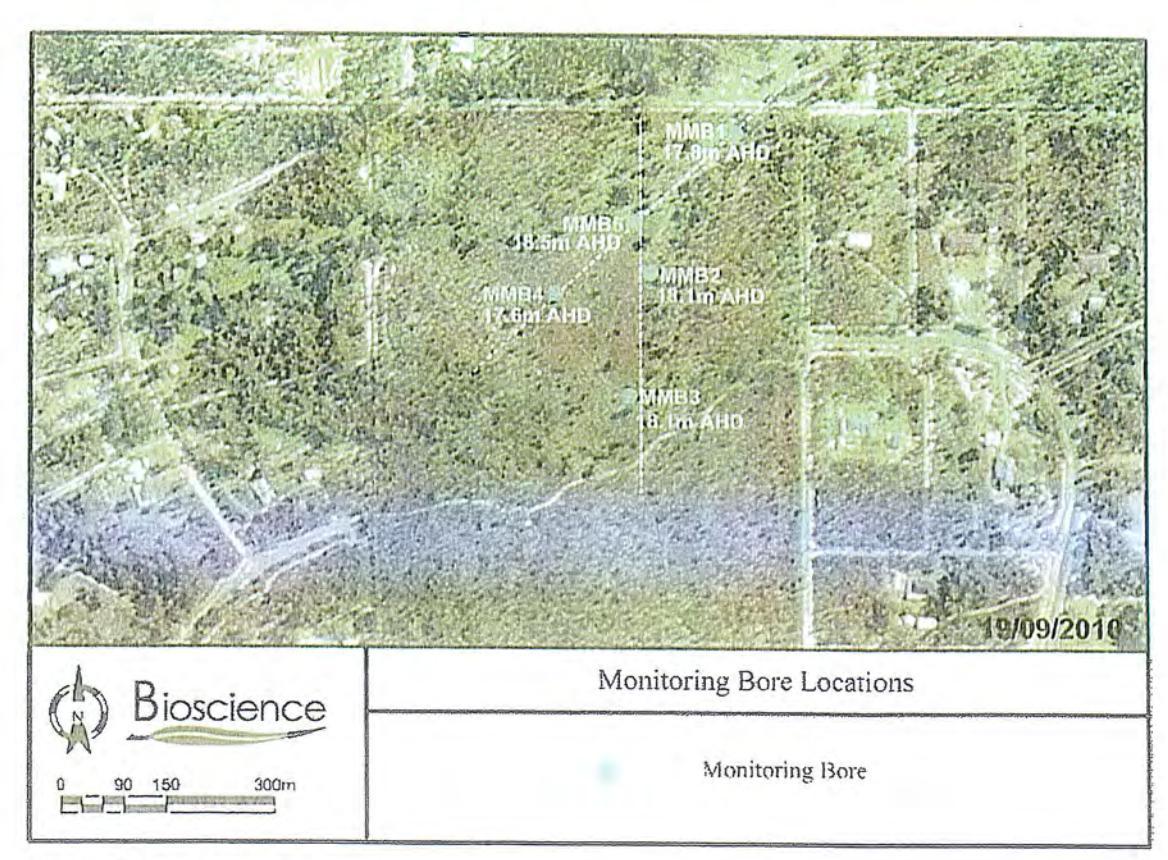
After the holes were drilled, piezometers made from 50 mm slotted PVC pipe were inserted below the minimum groundwater level to a depth of 4m (bottom 3m slotted and end capped) with 0.5m above the surface. The annulus around the screened interval was packed with gravel. Piezometer tops were capped and locations were logged by GPS (Figure 10).

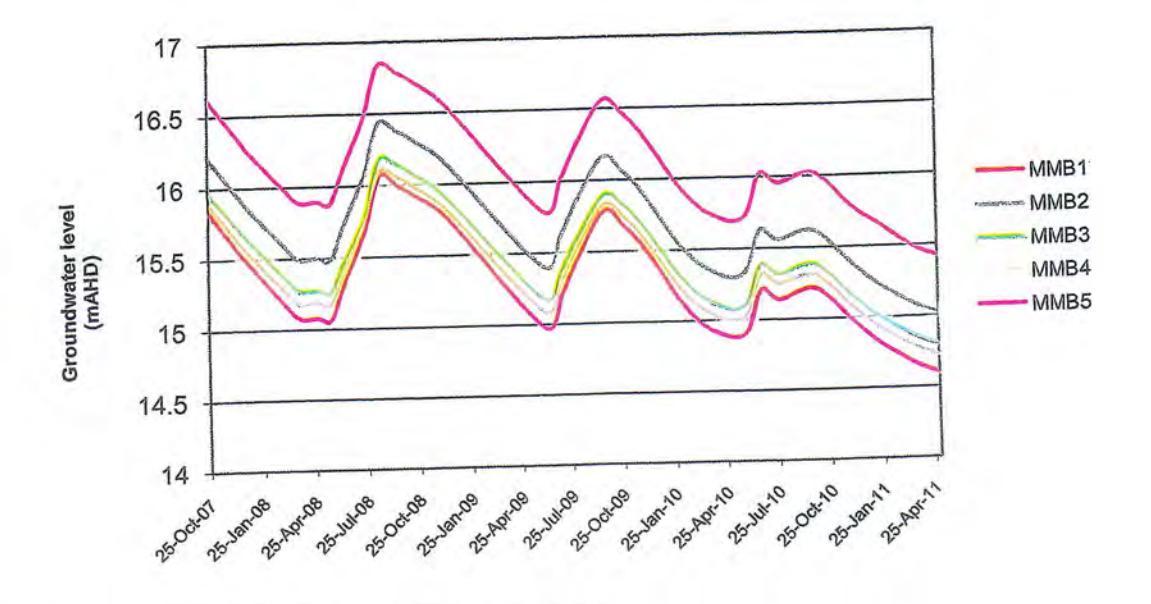
Figure 11: Groundwater levels October 2007-May 2011

Piezometer water level data was recorded for 6 months in 2005, then monthly from October 2007 until May 2011 (Figure 9). Groundwater levels were closest to the surface

during August and began to recede after this time. Groundwater was closest to the surface at MMB4 during 2008 reaching a maximum of 1519mm below the surface.

This data correlates with local groundwater data of surrounding monitoring bores (DoE, 2005) that suggest levels fluctuate annually about 1m reaching minimum depth around August. However, despite having above average rainfall in 2008 the groundwater reaches no closer than 1519mm below the surface. This is inconsistent with the Hill et al (1996) wetland classification which suggests that in order to be classified as a dampland the soil should become waterlogged through the capillary rise of water or raising of the water table. It is unlikely that capillary action would have an effect of more than 10-20cm in the medium/coarse sands found throughout the area.

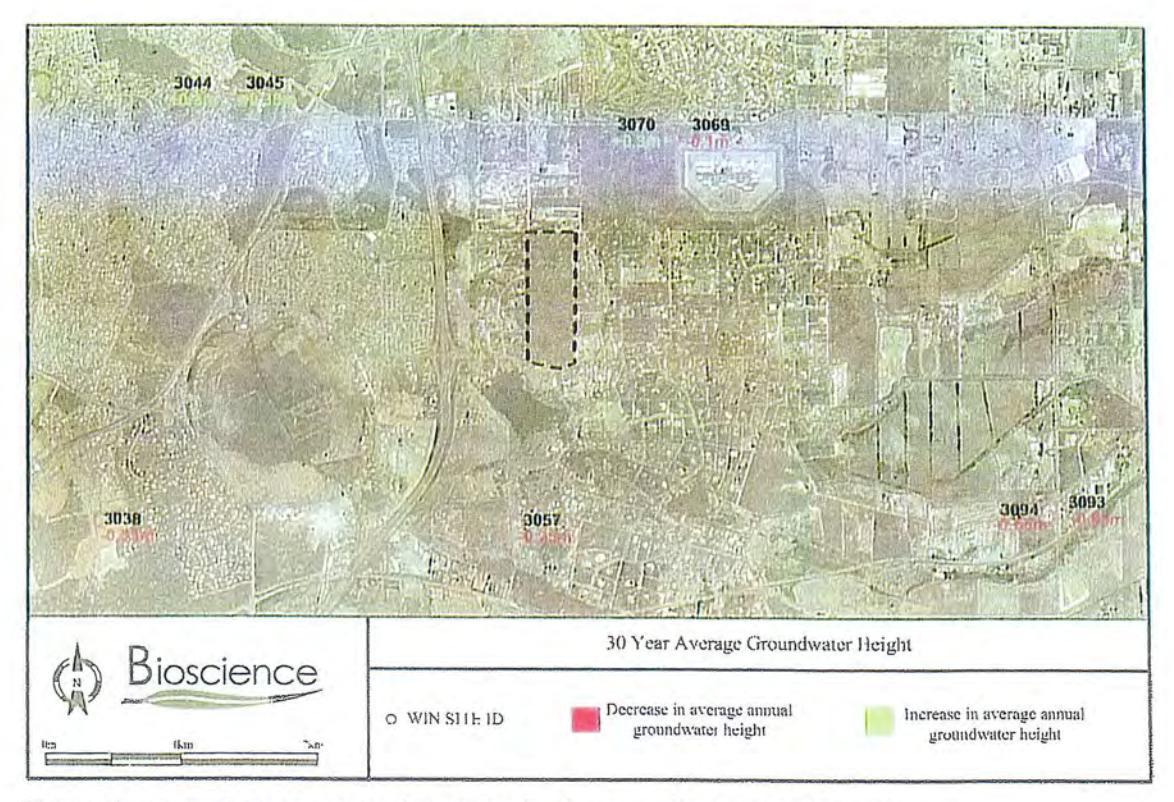
Figure 12: Annual average groundwater levels of surrounding monitoring bores

Eight monitoring bores within a 4km radius (location in Figure 12)were examined for average annual groundwater level. Results show that there is a general decline from

approximately 0.1m to 0.95m in average annual groundwater levels across 5 monitoring bores (3038, 3057, 3069, 3093, and 3094). Three of the eight monitoring bores increased from approximately 0.3m to 0.38m (3044, 3045, and 3070) however, although monitoring bore 3070 has increased in average annual groundwater level, the annual maximum groundwater level has decreased 0.34m in the past 10 years compared with the previous decade.

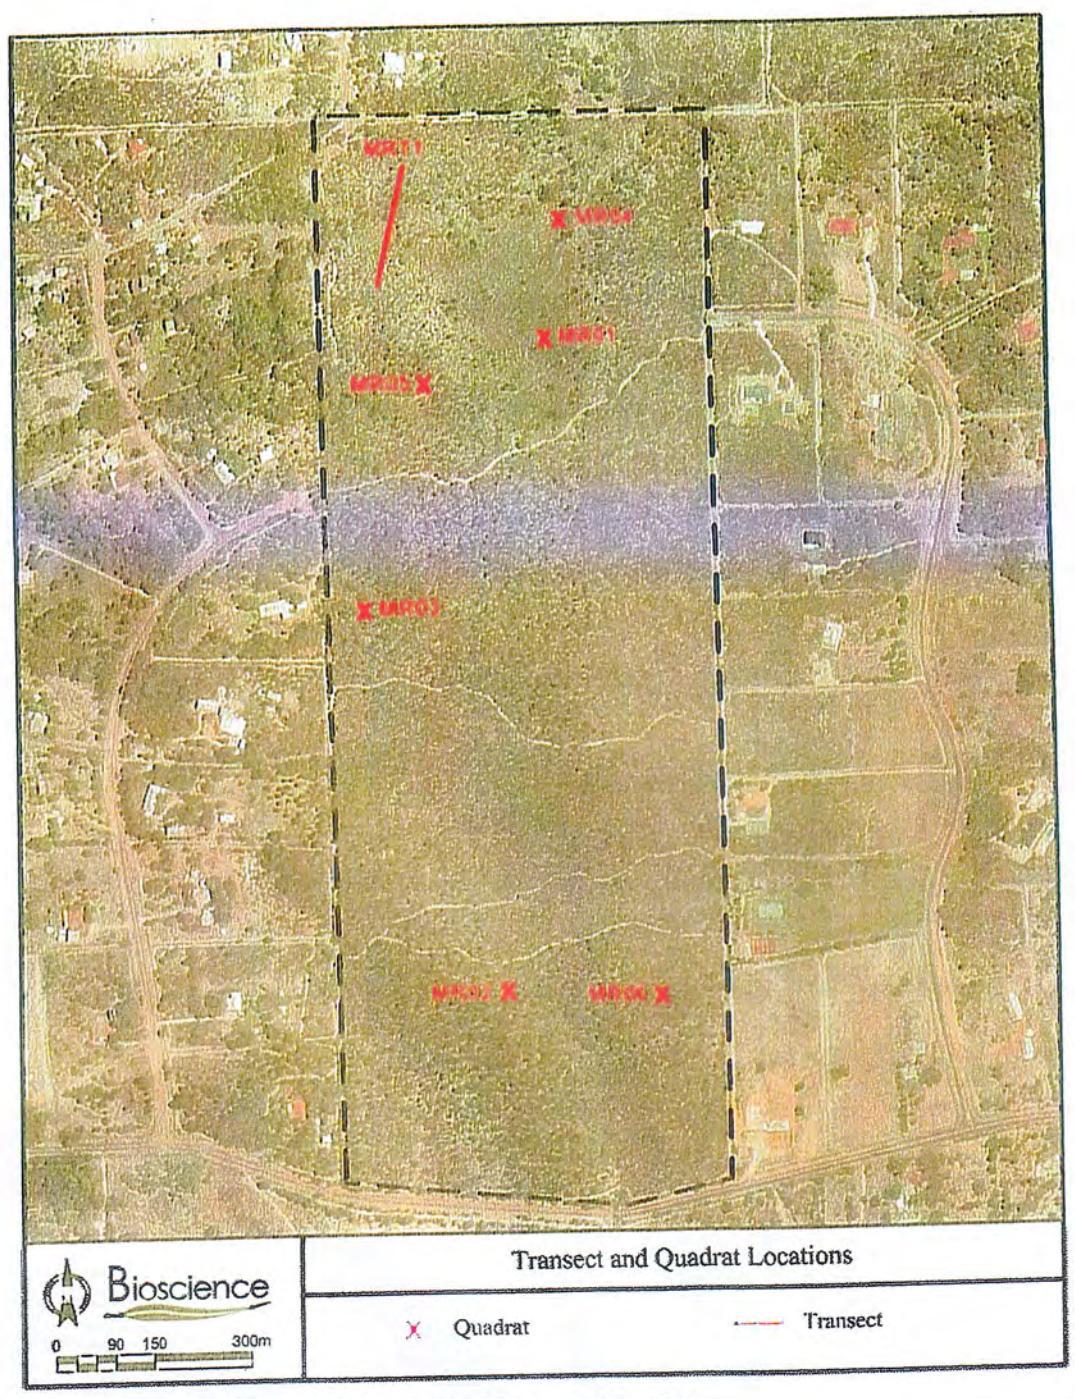
Figure 13: EPA Guidance 51 Quadrat and Transect Locations

Bioscience undertook a detailed vegetation survey which met the requirements of EPA Guidance 51. Six 10m quadrats were clearly marked out covering each vegetation uni and one 100m transect were studied in detail (Figure 13) (Appendix 2). The demarked CCW was assessed using two quadrats. Quadrat one (MR01) surveyed a 10 x 10 m representative area of the centre of the wetland, whilst quadrat four (MR04) surveyed a 10 x 10 m representative area of the transitional zone between wetland and dry land vegetation along the edge of the wetland boundary. A REW wetland on the western boundary (MR03) was also investigated for comparison.

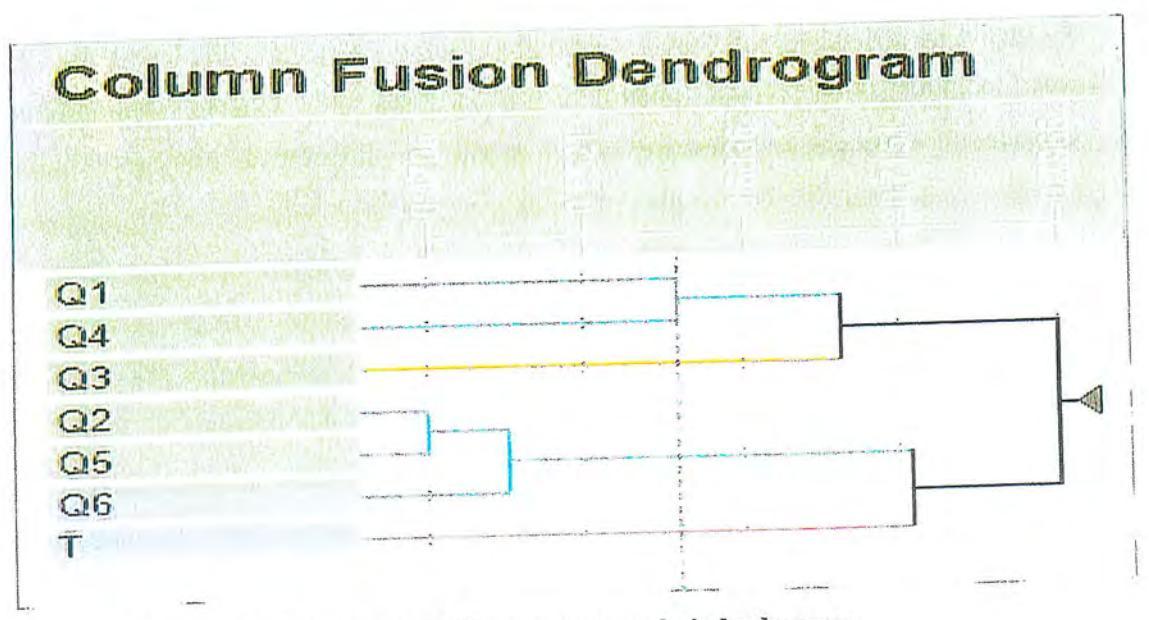
Figure 14: Bray and Curtis nearest neighbour pattern analysis dendrogram

Statistical pattern analysis (PATN) was used to analyse similarities between each of the community types within the subject area. Bray and Cutis similarity index and nearest neighbour analysis show a distinct dissimilarity between the CCW and REW areas and *Banksia / Eucalyptus* areas (Figure 14). However there is still a clear distinction between the REW and the CCW areas. Due to the fact that the REW represents a functioning wetland the dissimilarity between it and the said wetland supports the evidence previously highlighted that the CCW wetland was once a wetland however due to a reduction in water table level is now functioning as a dryland.

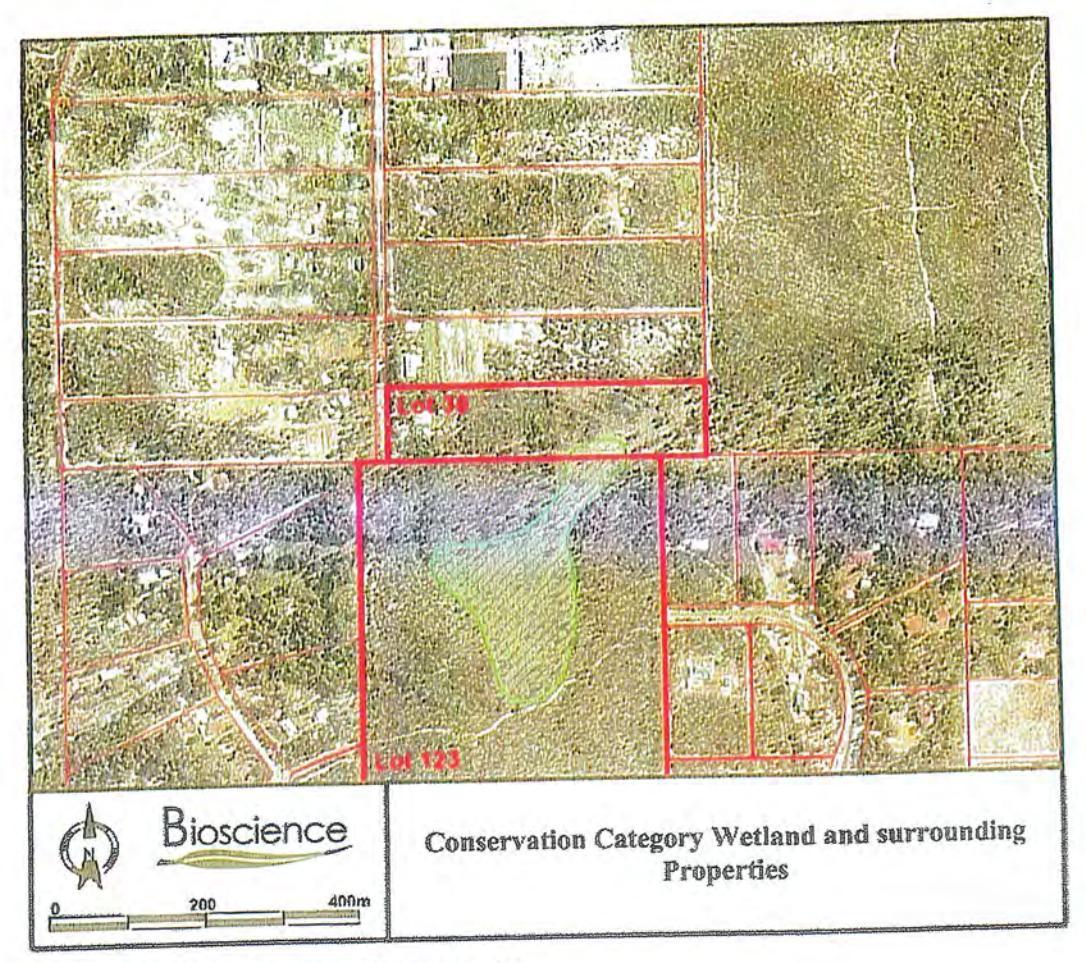
Figure 15: CCW and surrounding properties

The current owner of the Landgren Road property has advised the eastern half of the property including the said wetland was once cleared for market gardening although it has not been used for this purpose for about 10 years. Native regrowth has largely been limited to areas of lower elevation consisting mostly of *Pericalymma ellipticum*, *Astartea sp.* and sedges (a formal floral assessment has not been undertaken). Sparse *Banksia-Eucalypt* woodland surrounds the wetland with dense populations of non-native grasses (esp. *Ehrharta calycina*) throughout. The western half of the property is characterised by *Banksia-Eucalypt* woodland, part of which has been cleared to accommodate the building envelope.
