GEOMORPHIC WETLANDS Swan Coastal Plain Dataset Request For Modification

Lot 123 Mortimer Rd Casuarina

Getin Keel

Prepared by: Mia Harris BSc Bioscience Pty Ltd

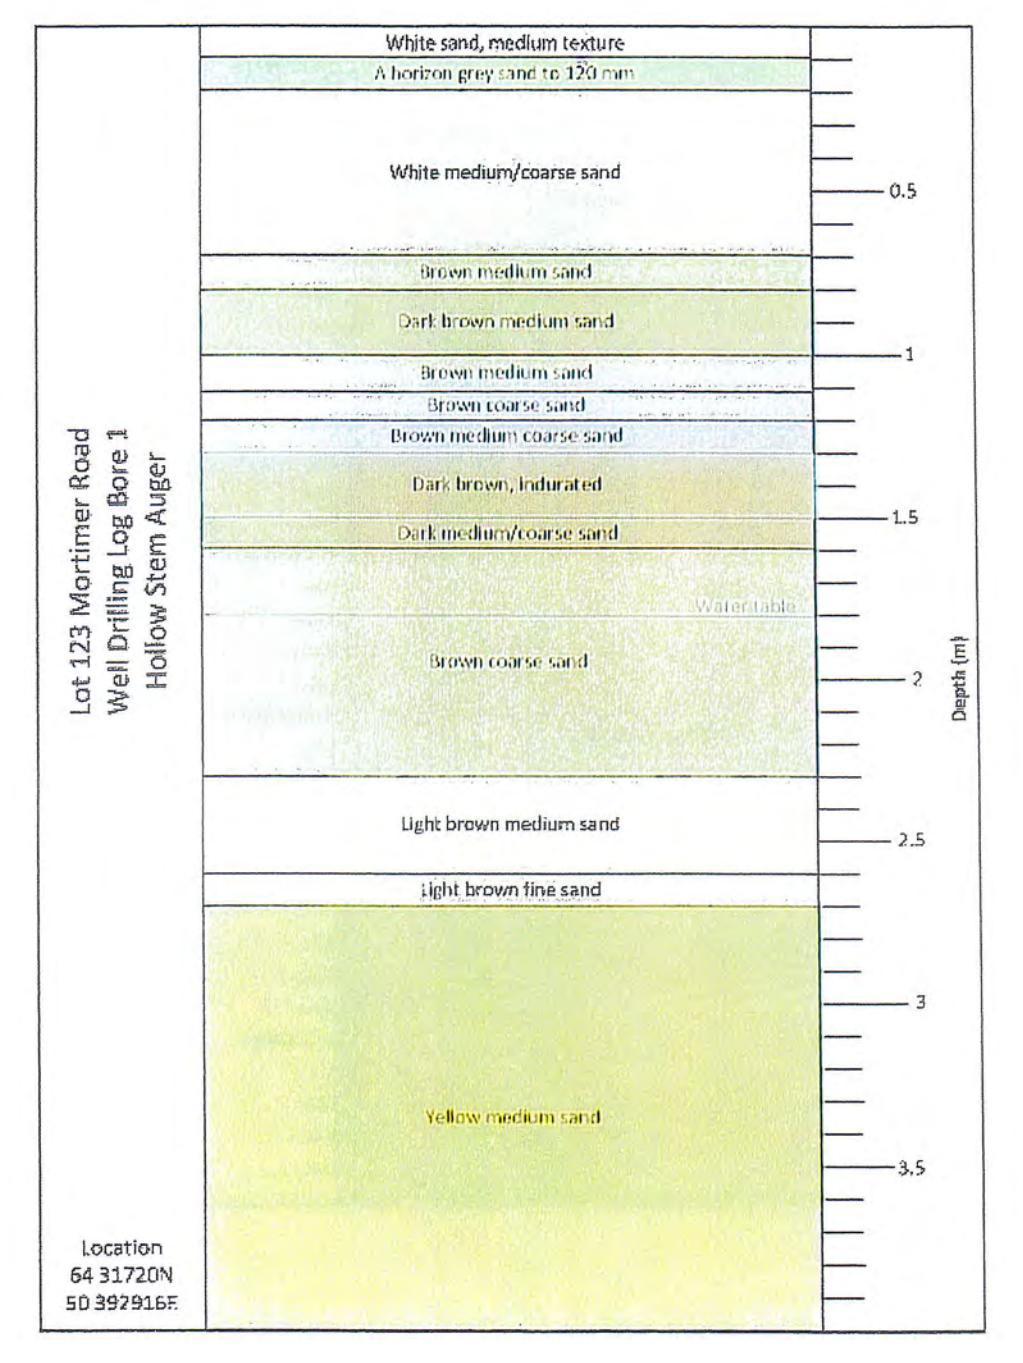
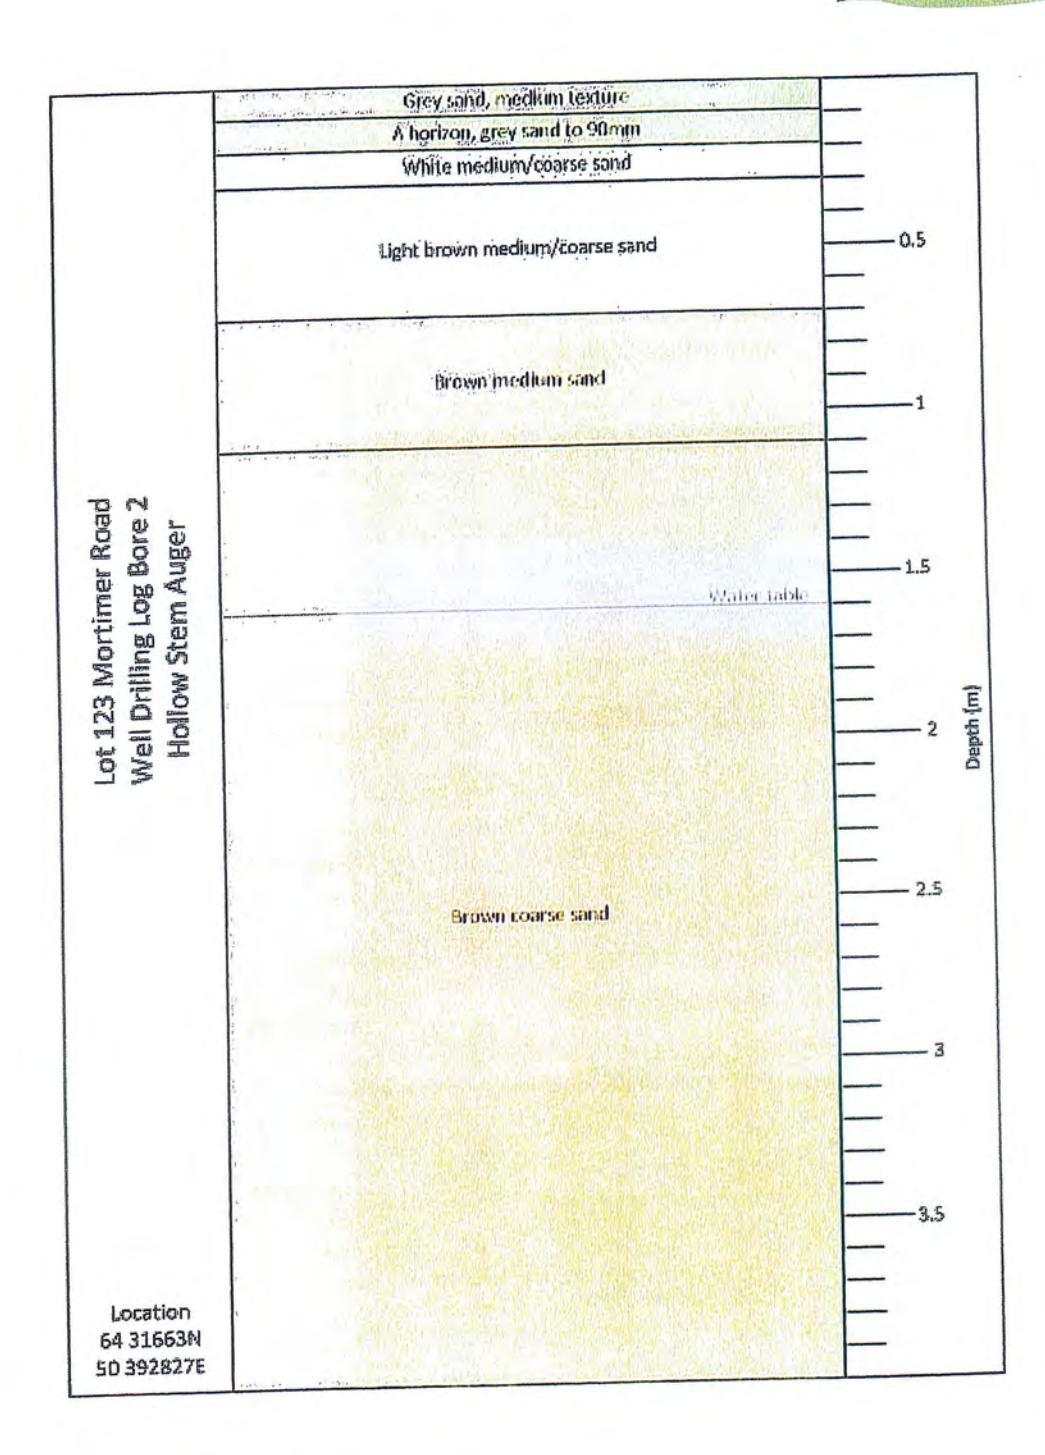
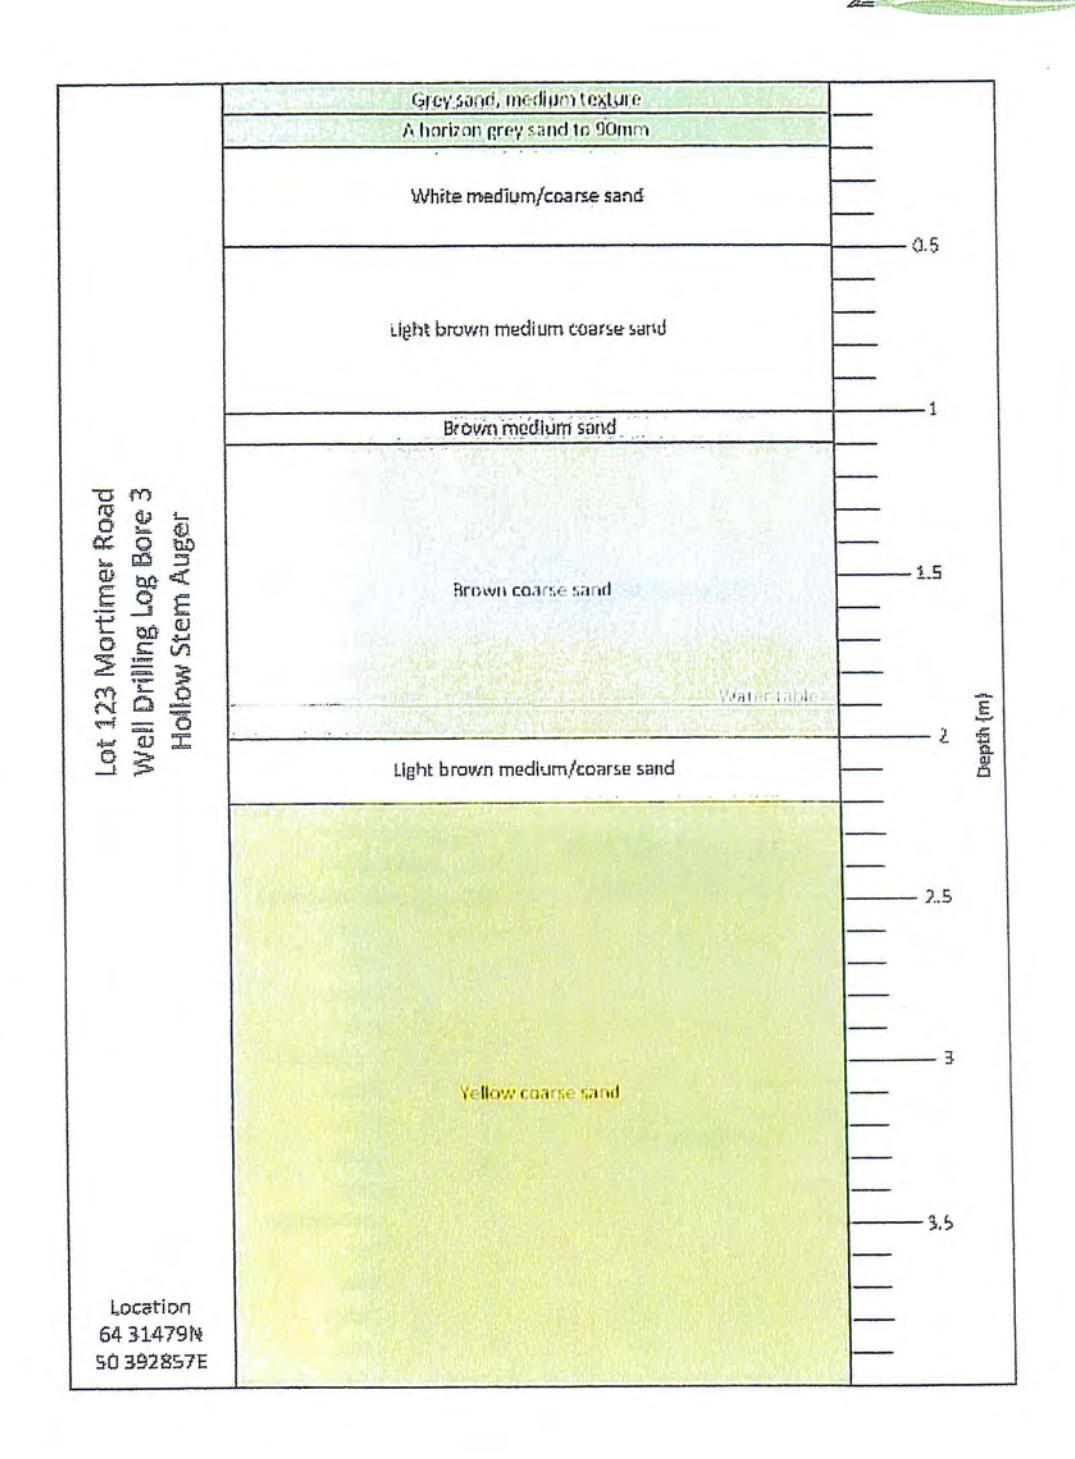
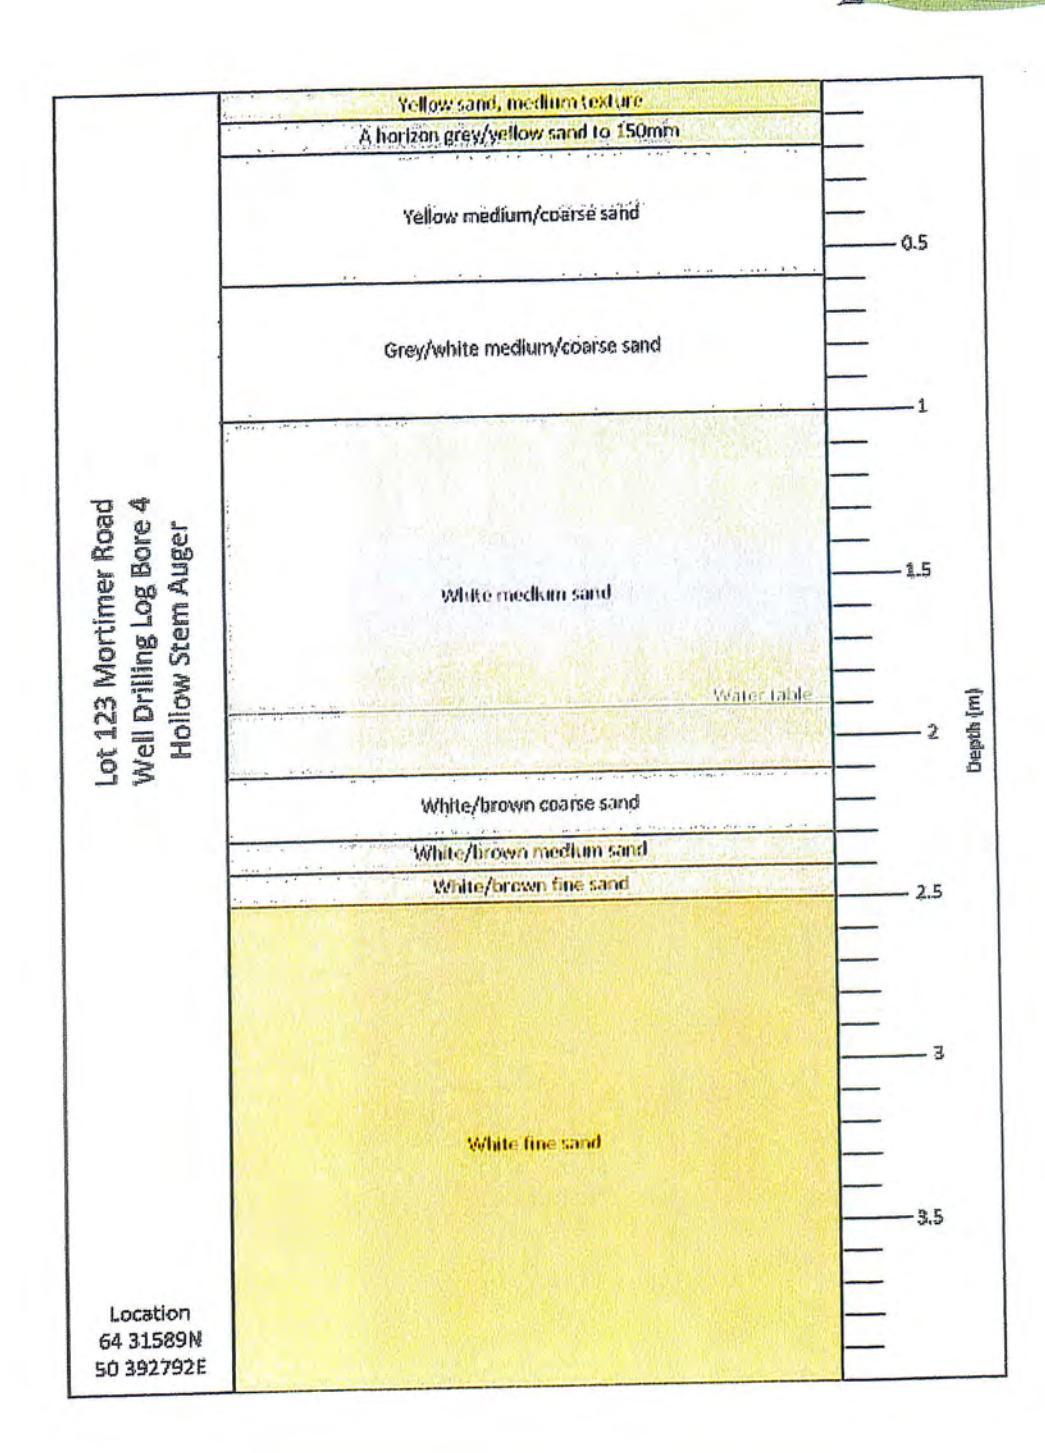
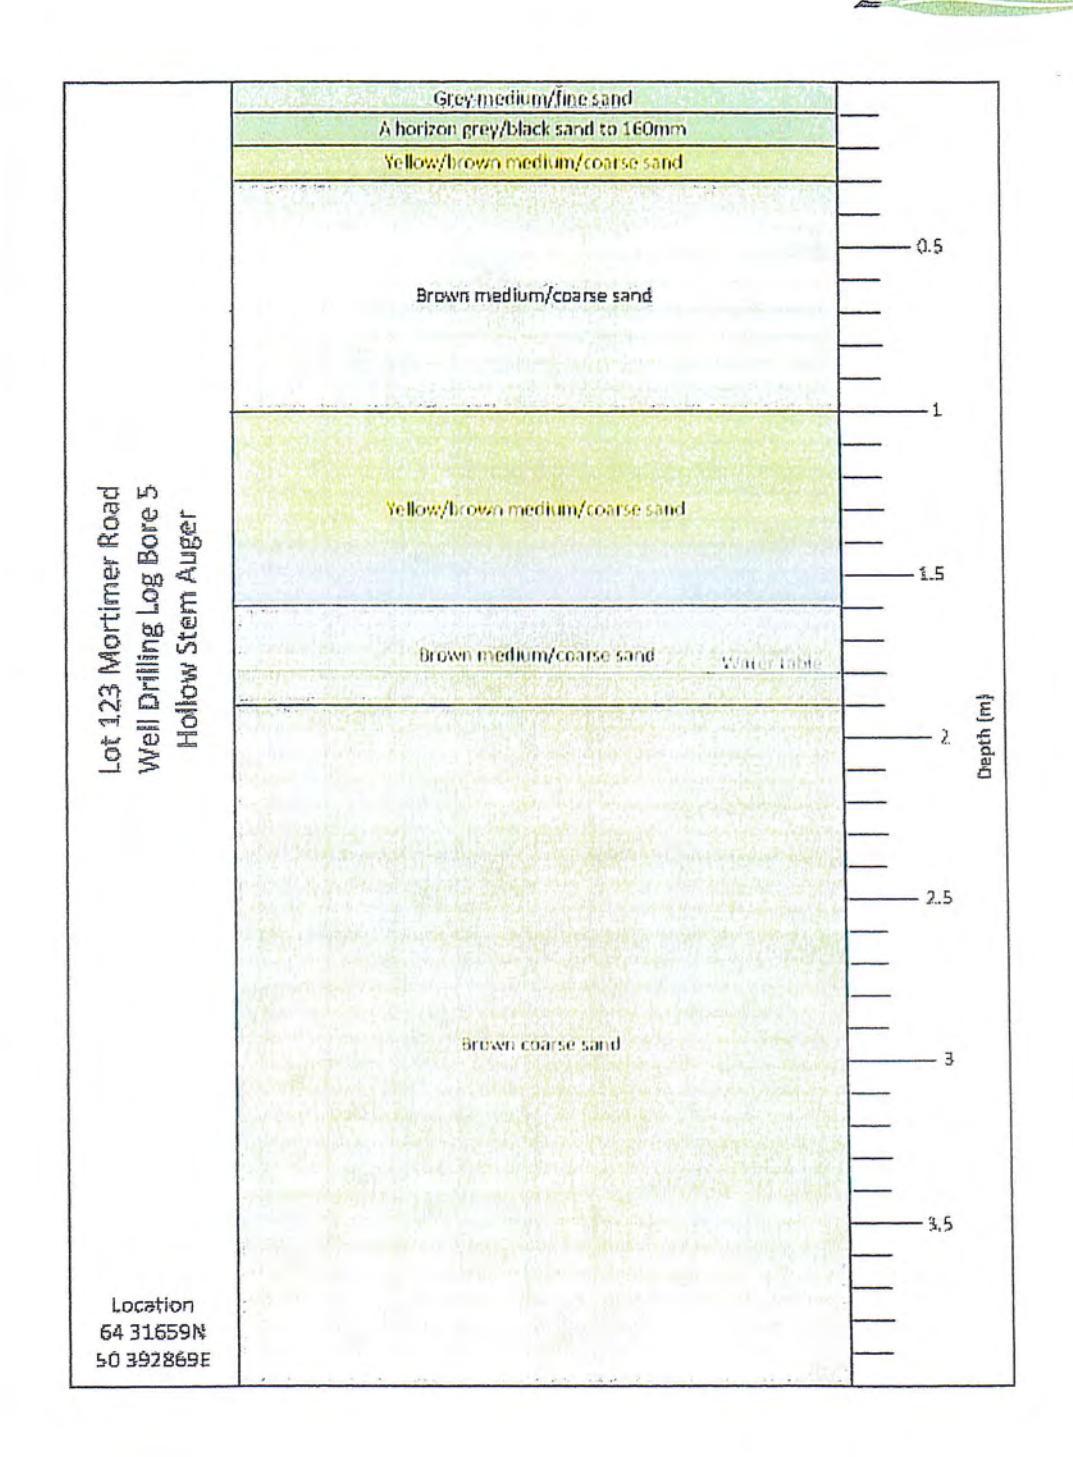
APPENDIX 1: Soil Profiles

Each drill hole presented a very similar soil profile consisting of a shallow A horizon (100 - 150 mm) of grey sand overlying white medium/coarse grained white sand typically to a depth of about 1m. Sand then became uniform grading coarse yellow to brown sand to 4m (Appendix 1).
