BHP Pilbara Expansion Strategic Proposal Derived Proposal Rehabilitation Report

22 July 2025

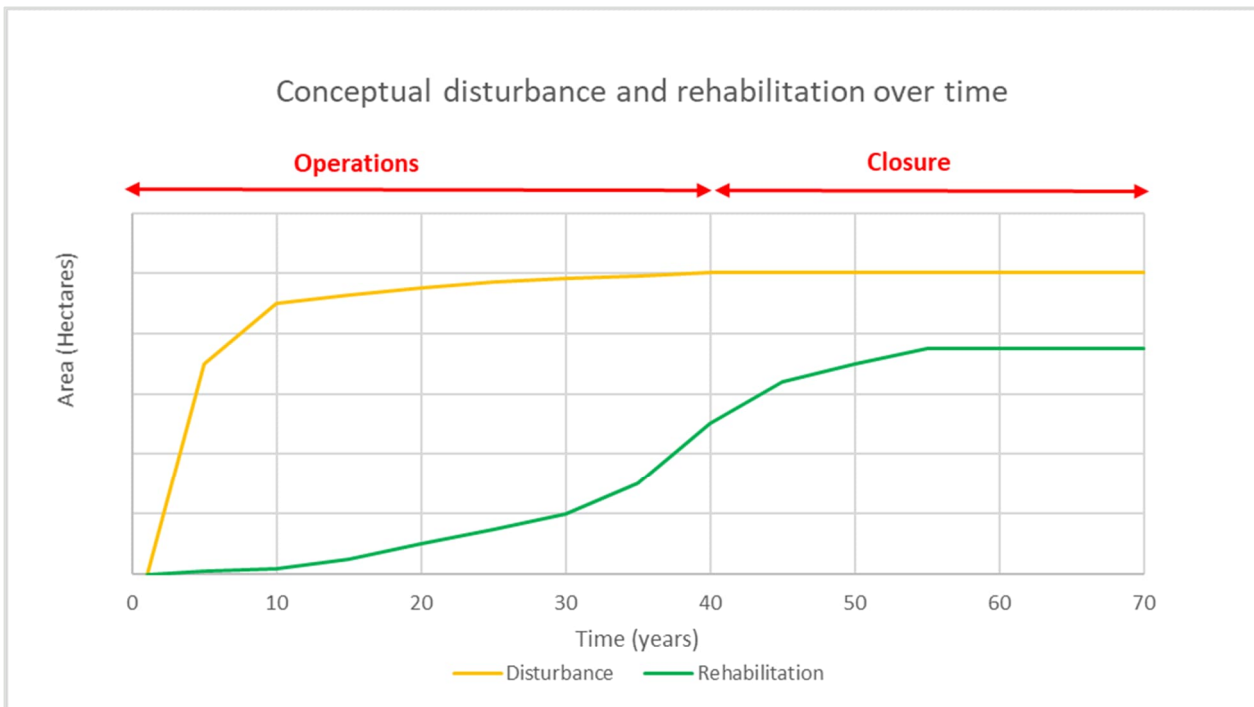
Figure 4 Conceptual disturbance and rehabilitation over time

Note: Area rehabilitated is less than the area disturbed, as pits that remain as voids will not be rehabilitated (revegetated)

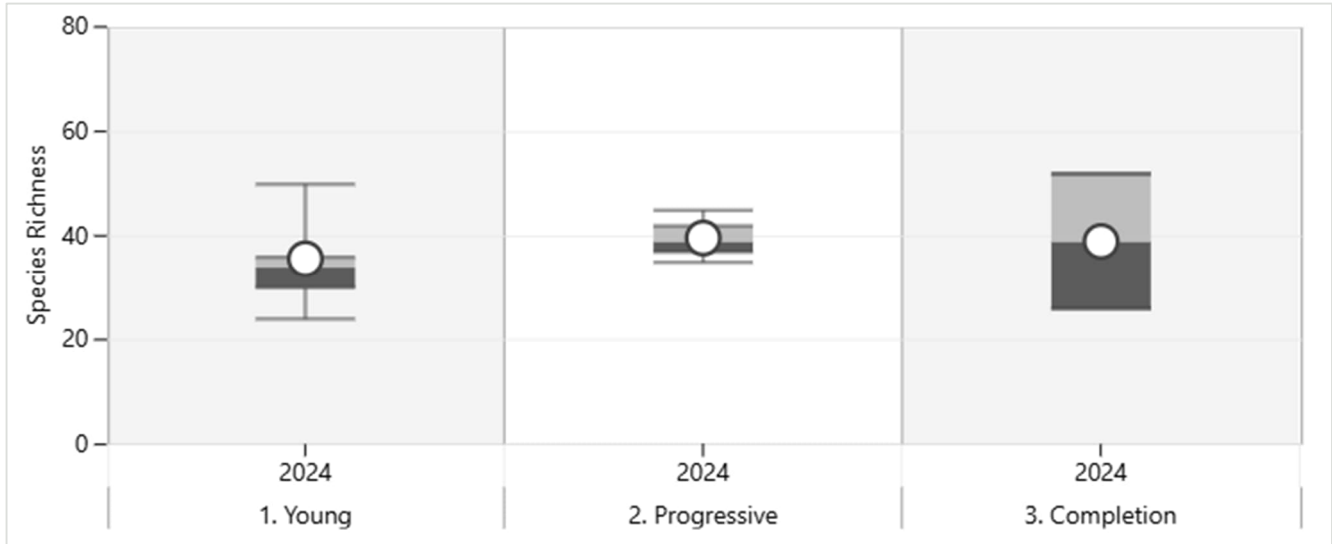
Figure 8: Species Richness (Perennials) across Age Groups

The on-ground assessment for Mining Area C was conducted between 23 and 25 March 2024. A total of 14 quadrats (12 flat and 2 slope) were surveyed for Species Richness. Quadrats surveyed represented all age groups; young (9), progressive (3) and completion (2). A total of 144 perennial species and 32 annual species were identified at Mining Area C. The mean number of perennial species per quadrat, across all age groups was 38 species. Completion and progressive plots had the greatest average perennial species richness of 39, while young was 36, respectively (Figure 8).

A total of 4 weed species were identified (*Cenchrus ciliaris*, *Cenchrus setiger*, *Malvastrum americanum* and *Setaria verticillata*).

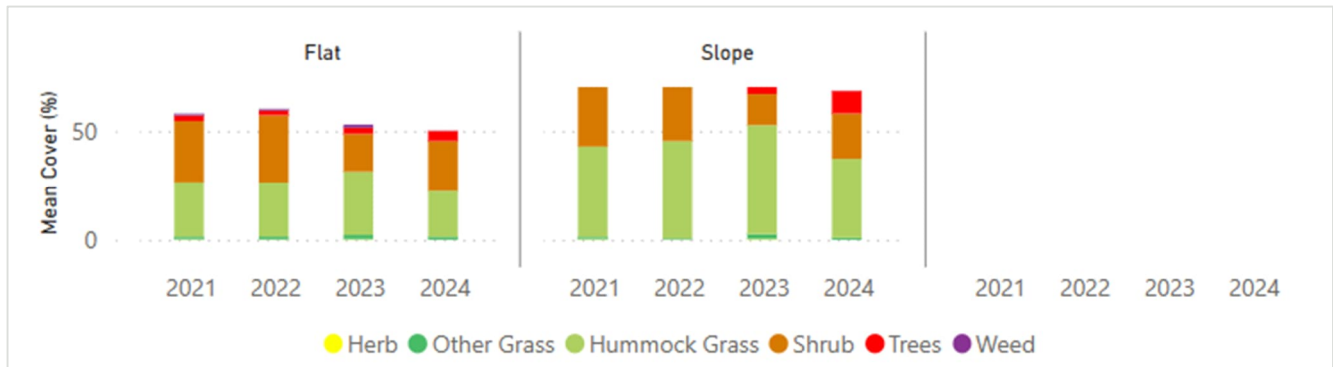
Figure 10: Mean % cover of lifeforms at Mining Area C for each landform (sites older than 15 years)

Rehabilitated sites greater than 15 years old accounted for 45.17 ha of the total rehabilitation at Mining Area C, of which 0.62% (0.28 ha) is currently meeting all completion criteria targets for “Low Tree Steppe” (Table -13).

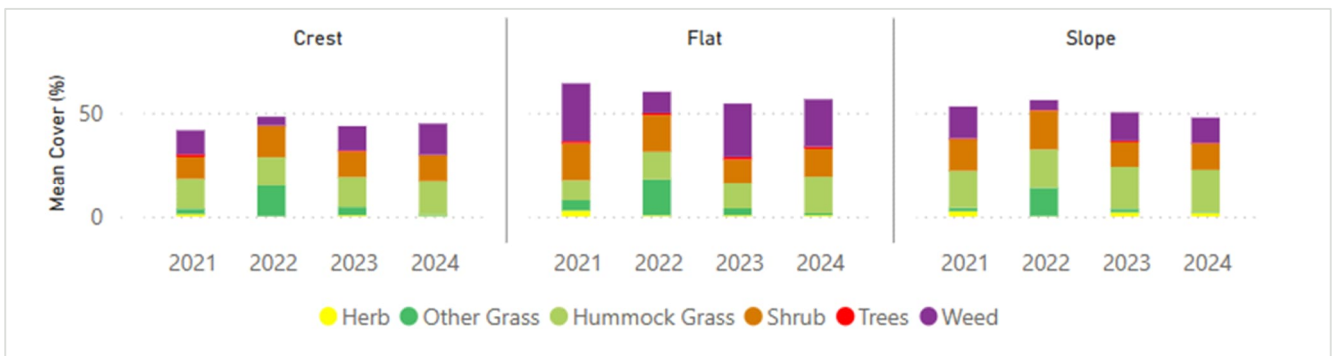
Figure 13: Mean % cover of lifeforms at Newman for each landform (sites older than 5 years but less than 15 years).

A total of 18.04% (88.24 ha of 489.06 ha) rehabilitated land between 5 and 15 years old is currently meeting the progressive criteria targets (Table -15).

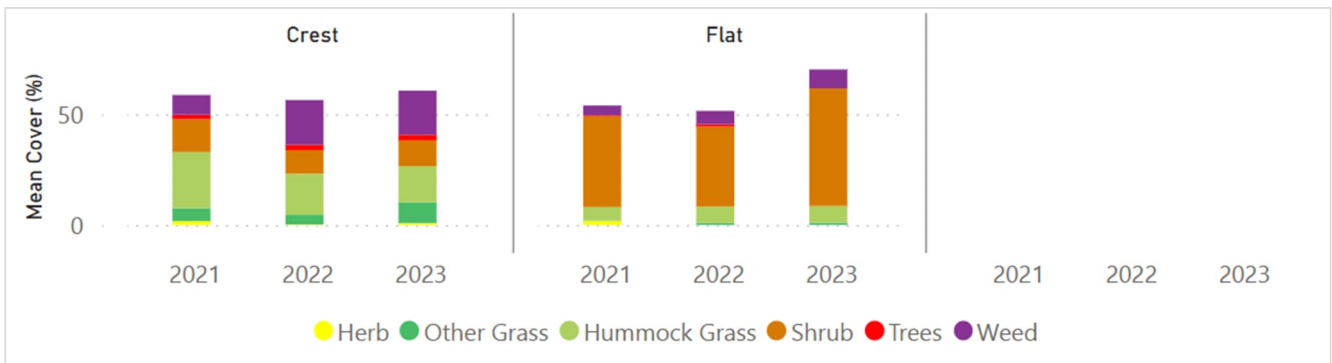
Figure 25: Mean % cover of lifeforms at Goldsworthy for each landform (sites older than 5 years but less than 15 years).

No rehabilitated land between 5 and 15 years old (1.85 ha) is currently meeting all progressive criteria targets (Table -21).

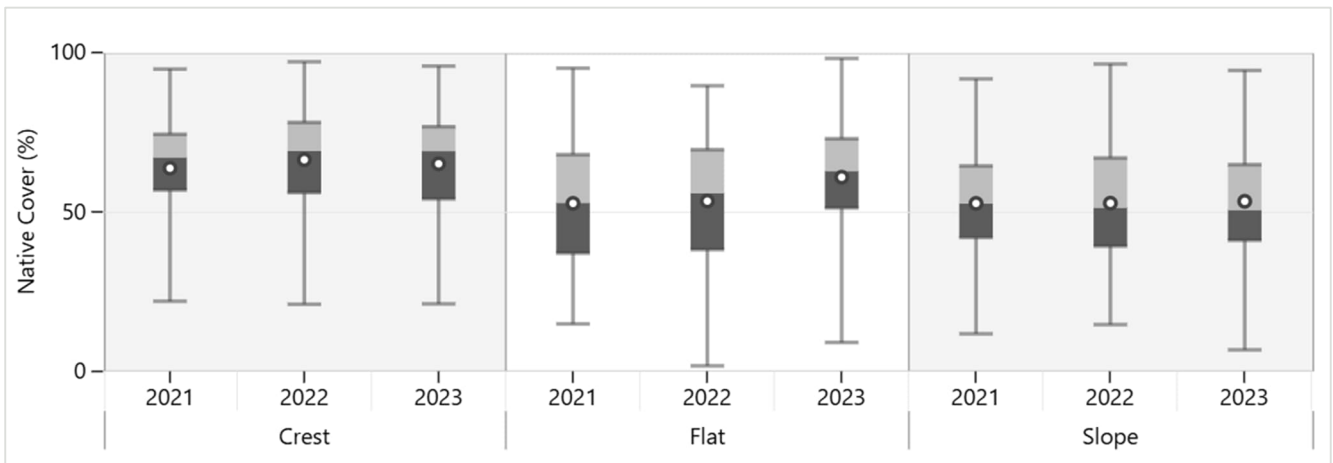
Figure 29: Boxplots summarising the total native vegetation cover recorded at rehabilitated sites at Yarrie (sites older than 5 years but less than 15 years)

The average native cover across progressive sites at Yarrie was 59.97% and ranged between 6.72% and 98.40%. Rehabilitated crests, flats, and slopes had an average native cover of 65.27%, 61.04%, and 53.47% (Figure 29). On average, native vegetation cover at Yarrie consisted of 9.06% other grass (tussock), 26.97% hummock grass (*Triodia spp.*), 17.37% shrub, 0.43% herb and 6.14% tree cover. Mean hummock grass cover was lowest at slope sites (12.83%), relative to crest (28.63%), and flat (42.91%) landforms (Figure 30). Introduced plant species (weeds) covered 2.16% of Yarrie rehabilitation on average and mean weed cover varied between crest (1.31%), flat (4.85%), and slope (1.00%) landforms (Figure 30). Bare ground on average covered 37.81% of a site; and ranged between 0.18% and 93.24%. Bare ground percentage was highest on slope (45.49%), then flat (33.94%), then crest (33.42%) landforms.
